MEMORANDUM

DATE	March 1, 2023	PROJECT NUMBER	22226
TO	Nick Towstopiat, Associate Project Manager	PROJECT	615 & 749 W. El Camino Real, Mountain View – HRER Peer Review
OF	David J. Powers & Associates, Inc 1871 The Alameda, Suite 200 San Jose, CA 95126	FROM	Hannah Simonson, Associate, Cultural Resources Planner/ Architectural Historian
CC	Peter Birkholz, Principal-in-Charge, Page & Turnbull	VIA	Email

REGARDING 615 & 749 W. El Camino Real, Mountain View, HRER Peer Review Memorandum

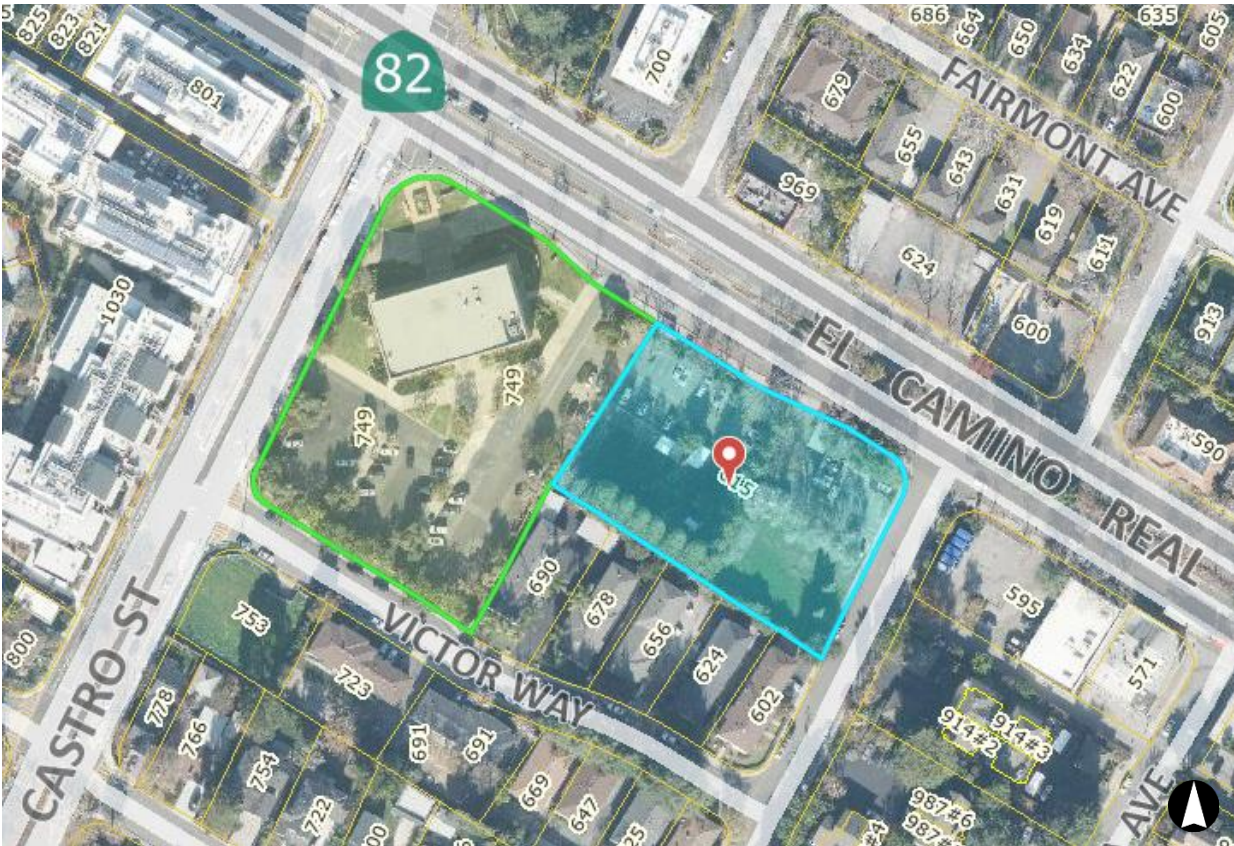
Figure 1. Subject properties: 615 W. El Camino Real (right, shaded blue) and 749 W. El Camino Real (left, shaded green). Source: SCC Map, County of Santa Clara, 2023. Edited by Page & Turnbull.

The two properties are immediately adjacent, both on the south side of West El Camino Real, between Castro Street and Lane Avenue, immediately south of downtown Mountain View. The property at 615 W. El Camino Real is an approximately rectangular, 1.2-acre parcel at the southwest corner of W. El Camino Real and Lane Avenue. 615 W. El Camino Real includes a one-story restaurant, built c. 1945, currently vacant and is surrounded by a surface parking lot, as well as an un-landscaped area surrounded by trees and a large surface parking lot that serves the adjacent bank property. The property at 749 W. El Camino Real is an approximately rectangular, 1.9-acre parcel at the southeast corner of W. El Camino Real and Castro Street. 749 W. El Camino Real contains a two-story bank, currently occupied by Chase Bank, built in 1977 for Home Savings & Loan Association and designed by Millard Sheets Designs, Inc. (later named Millard Sheets & Associates Designs, Inc.). The property also includes a plaza at the northwest corner and surface parking to the south and east of the building.

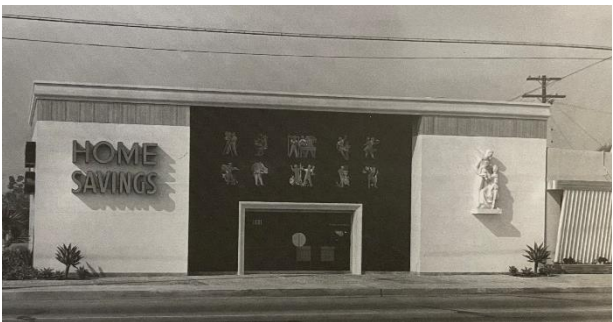
Figure 2. Compton Home Savings branch, built 1958, typifies the Home Savings Style. Source: Ahmanson Foundation Archives, in Arenson, *Banking on Beauty*, 112.

The Home Savings Style was characterized by its New Formalist style, monumental and geometric massing, white travertine marble, and integrated artwork. Based on the success of the first branch, the Millard Sheets Studio refined the Home Savings Style to its recognizable, and sometimes repeated, forms. Prototypical examples include the Compton branch (1958) and Buena Park branch (1960), and more elaborate examples include the Pasadena branch (1963) and Santa Monica branch (1971) (**Figure 2 - Figure 5**).

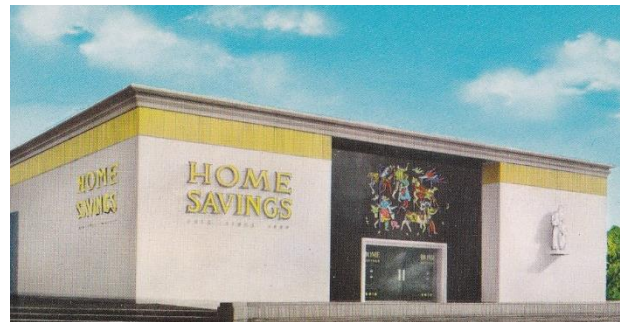
Figure 3. Buena Park Home Savings branch, built 1960, closely resembles the Compton branch and others. Source: Adam Arenson, Jason Foo, Laurene Harding Rivas, Regina O'Brien, and Cheryl Dudley Roberts, “Millard Sheets, A Legacy of Art and Architecture” (LA Conservancy, 2012).

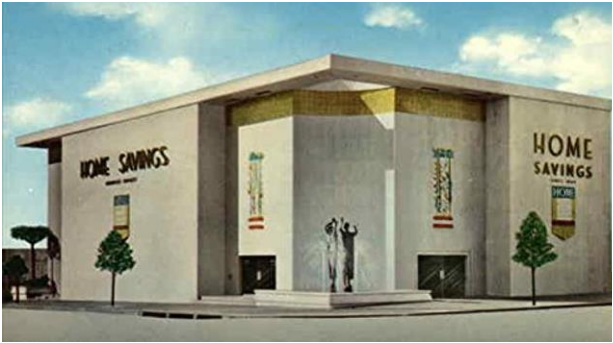
Figure 4. Pasadena Home Savings branch, built 1963.
Source: "Millard Sheets, A Legacy of Art and Architecture" (LA Conservancy, 2012).

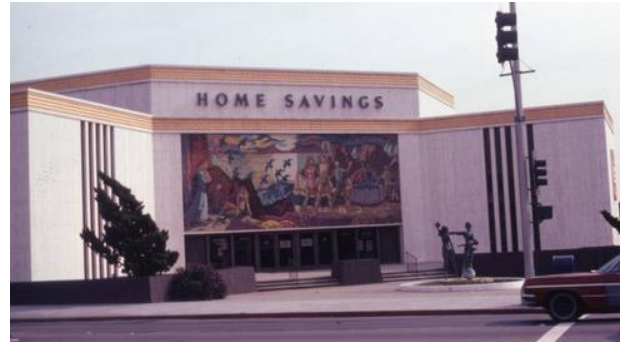
Figure 5. Santa Monica Home Savings branch, completed 1969 (later altered). Source: Hadley Meares, "The Iconic Murals Of Millard Sheets Are Disappearing From LA," *LAist*, July 31, 2019.

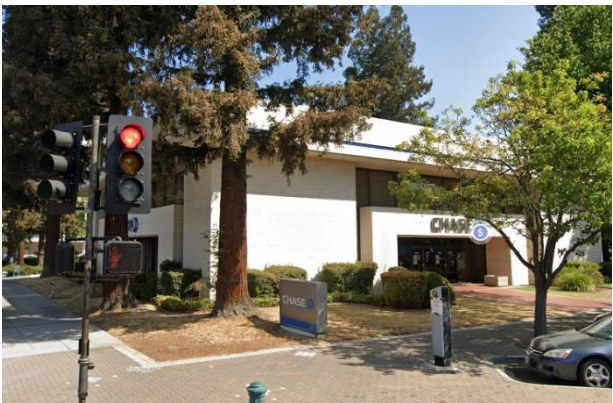
Figure 6. Redwood City branch (2320 Broadway), mid-1980s. Mural, which appears to be inside, has since been painted over. Source: Google Street View, 2023.

explains why the Home Savings branches in the Bay Area were constructed during this later period of Sheets' career **(Figure 6)**.

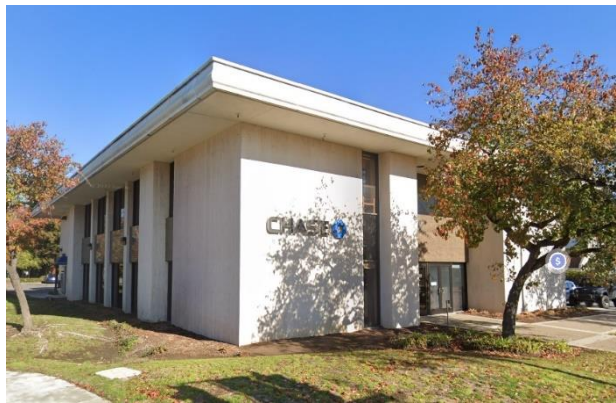
Figure 7. Cupertino branch (20673 Stevens Creek Boulevard), 1976, does not have an exterior mosaic. Source: Google Street View, 2023.

Based on Page & Turnbull's research, when put into context, the San Jose branch is a transitional design that exhibits many of the typical features of the Home Saving Style that characterized the era of collaboration with Ahmanson.³³ Several of the other branches built on the Peninsula date to the period of after Ahmanson's death and new laws that allowed the bank to expand north, which was a period of both creative experimentation for the Millard Sheets Studio and compromise with local planning review bodies as city planning became more professionalized and additional regulations and review processes were established.³⁴ The untimely death of Nancy Nielsen Colbath, deemed the "driving force in the mosaic studio," in 1974 meant that some of the branches built in the mid-1970s were completed without exterior mosaics. For example, the Cupertino branch does not appear to have ever had a mosaic (20673 Stevens Creek Blvd, built in 1977) **(Figure 7)**.³⁵

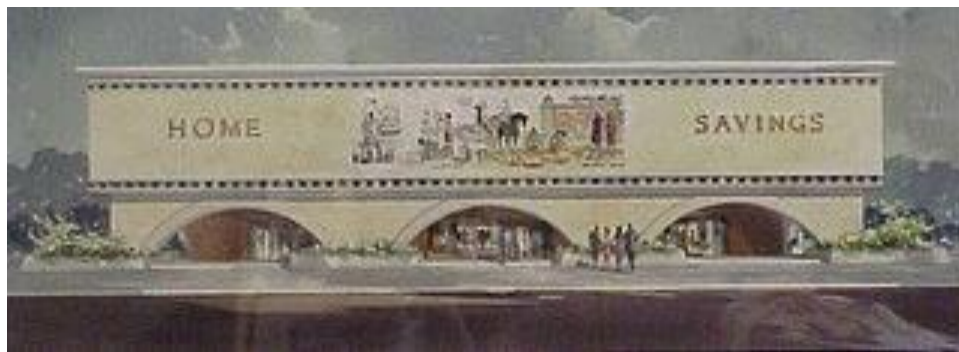
Figure 8. Color rendering of a proposed branch, which is likely a preliminary design for Mountain View and/or San Diego. Source: Alan Wofsy Fine Arts, San Francisco.

Based on Page & Turnbull's research, it appears that the design for the Mountain View branch may have initially featured travertine marble cladding, which would be similar to the material palette used for previous Home Saving Style banks (**Figure 8**). However, the design departed from previous designs by incorporating large arched window openings along the ground floor, evoking the style of New Formalism. A version of this design was executed for the San Diego Pacific Beach Home Savings branch location (4650 Mission Bay Drive) in 1977, and features a similar angled siting facing a major street intersection with a plaza and sculpture (**Figure 9**). However, Mountain View zoning administrator Glen Gentry, who later became the planning director, wanted a more "contemporary" design for the site, rather than the off-the-shelf Home Savings branch design (**Figure 10**).

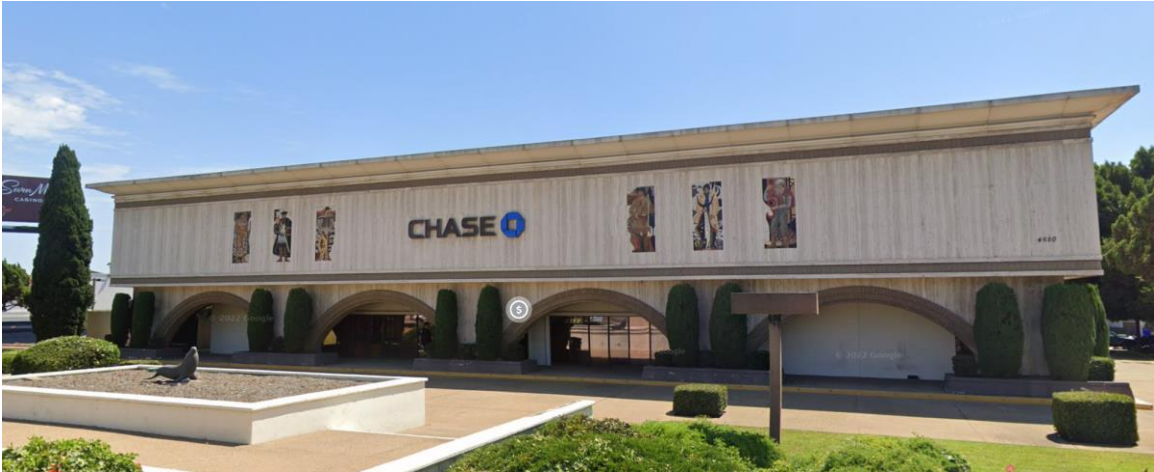
Figure 9. Former Home Savings & Loan Association branch in Pacific Beach, San Diego, built 1977 and rendered in white travertine. Source: Google Street View, July 2022.

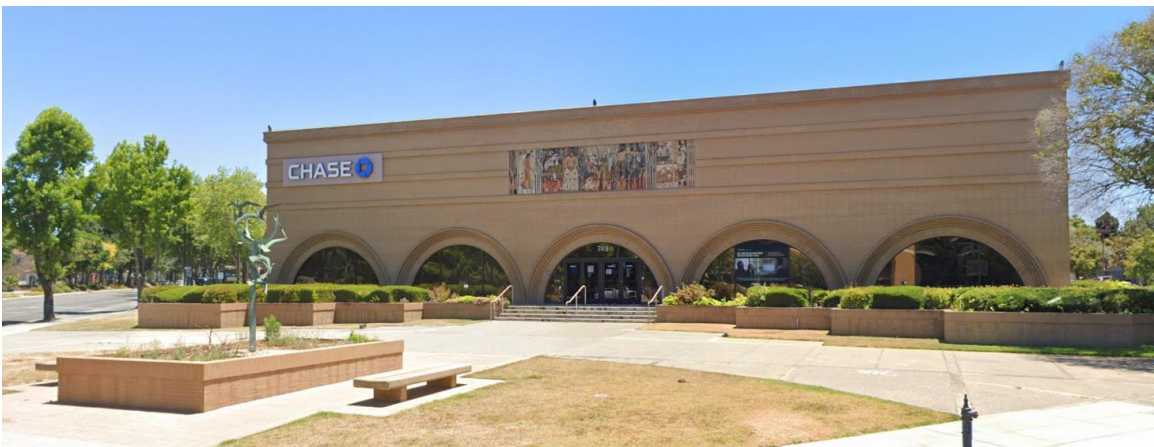
Figure 10. Former Home Savings & Loan Association branch in Mountain View, built in 1977 rendered in brick. Source: Google Street View, June 2022.

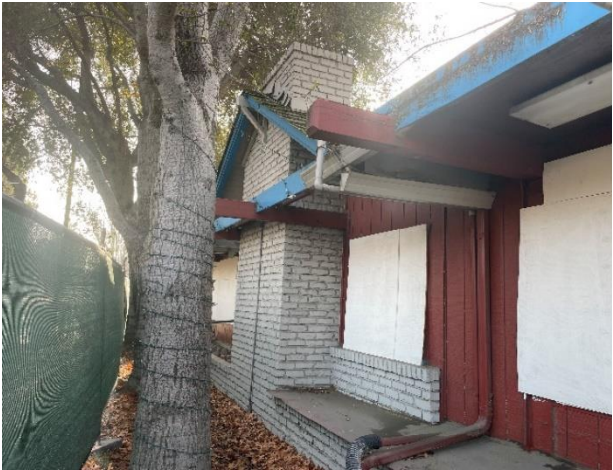
Figure 14. Primary (north) façade, looking southeast.

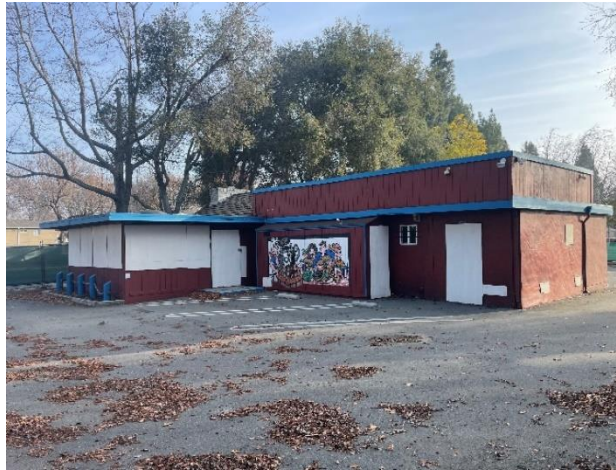
Figure 15. West and south facades, looking northeast.

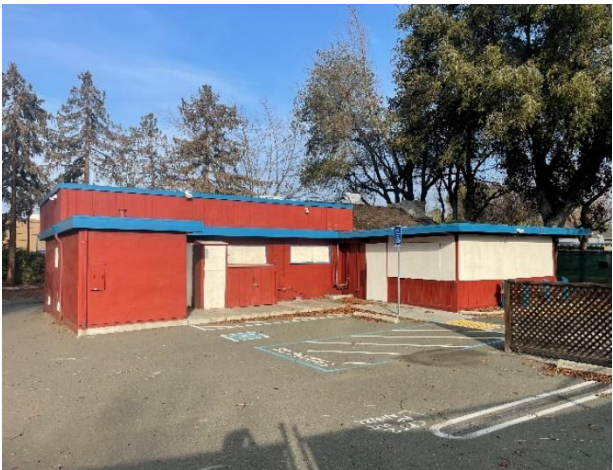
Figure 16. East façade, looking northwest.

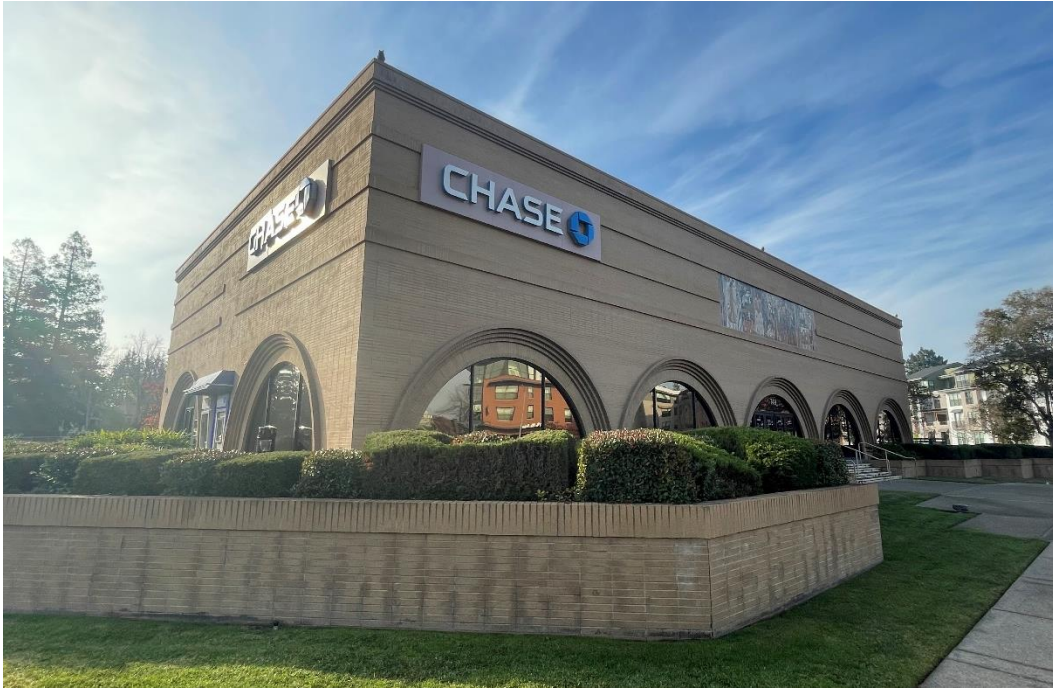
Figure 18. Primary (right) and east (left) facades, looking southwest.

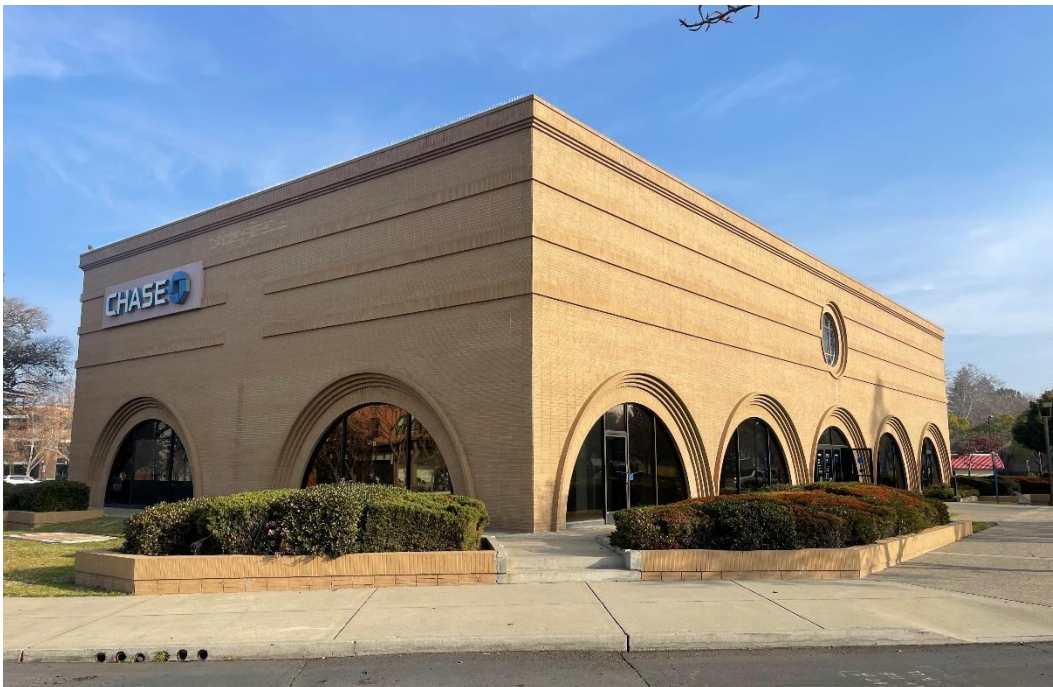
Figure 19. Rear (right) and west (left) facades, looking northeast.

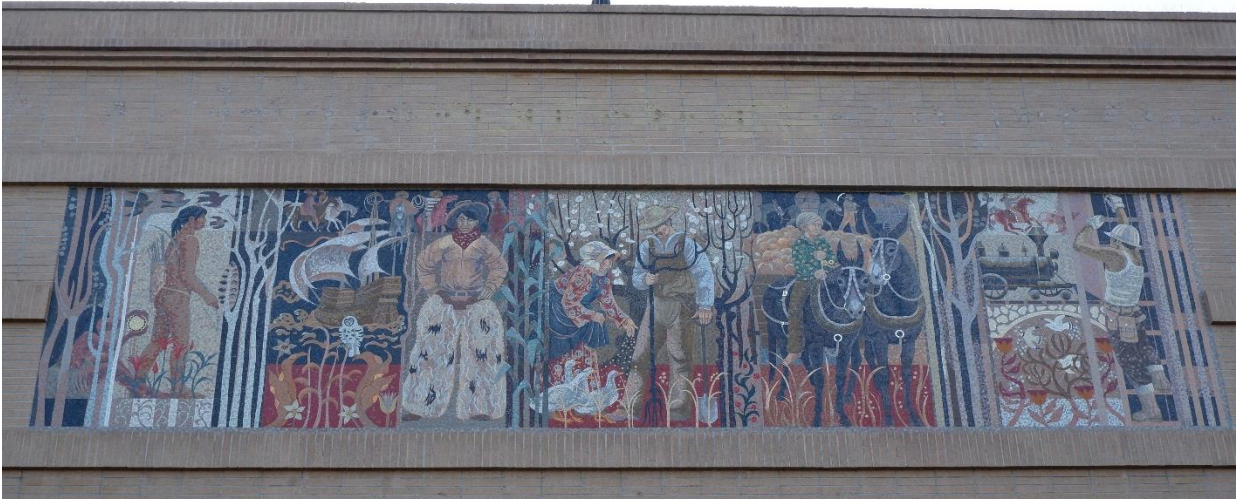
Figure 20. Exterior mosaic above the main entrance on the primary (north) façade.

The five-panel mosaic depicts imagined scenes from the history of Mountain View and surrounding areas. It includes depictions of Native Americans, a cowboy and ship, man and woman planting surrounded by trees, a man with mules carrying gold, and a construction worker in front of a bridge and train **(Figure 20)**.⁴⁴ Additional details regarding the plaza design that are not included in the 2021 HRER include the grid of the exposed aggregate concrete plaza, which is aligned with the stepped or zigzag profile of the brick planters that flank the entrances **(Figure 21)**. Also missing from the description is any mention of the seven-foot-diameter, round stained-glass medallion window above the rear entrance, which features a motif of several figures riding horses **(Figure 22 and Figure 23)**.

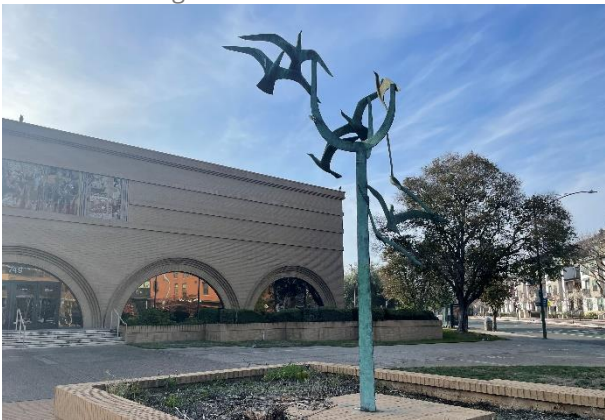
Figure 21. Bird sculpture by John Edward Svenson of Millard Sheets Studio, looking southwest.

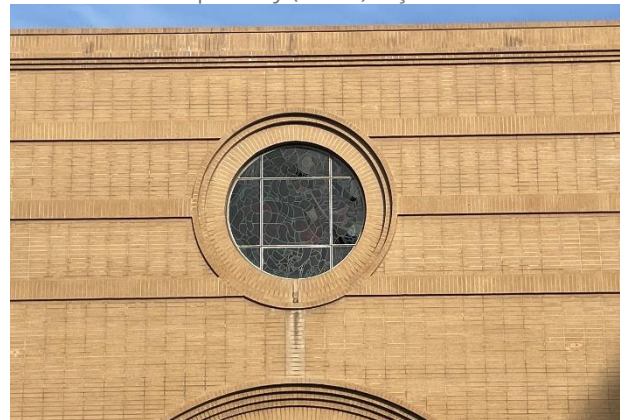
Figure 22. Exterior view of round stained-glass window at the rear façade, looking north.

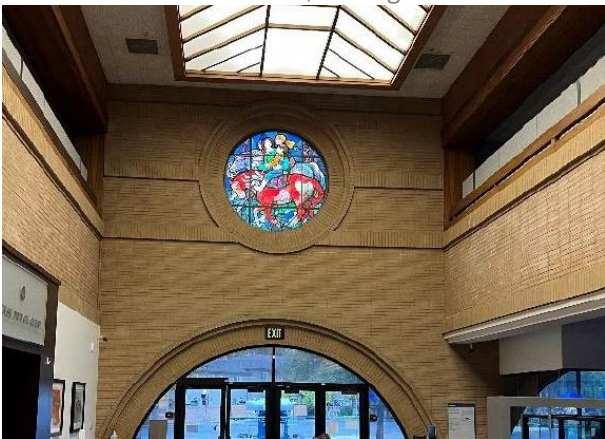
Figure 23. Interior view of the round stained-glass window at the south wall, looking south. Source: ARG Conservation Services, 2022.

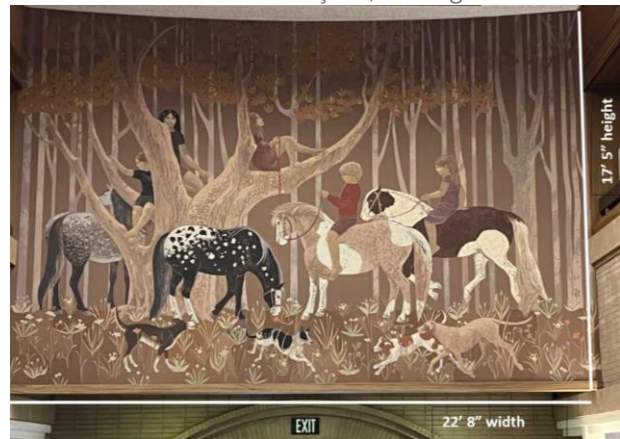
Figure 24. Painted mural at interior, above the main entrance on the north wall, looking north. Source: ARG Conservation Services, 2022.

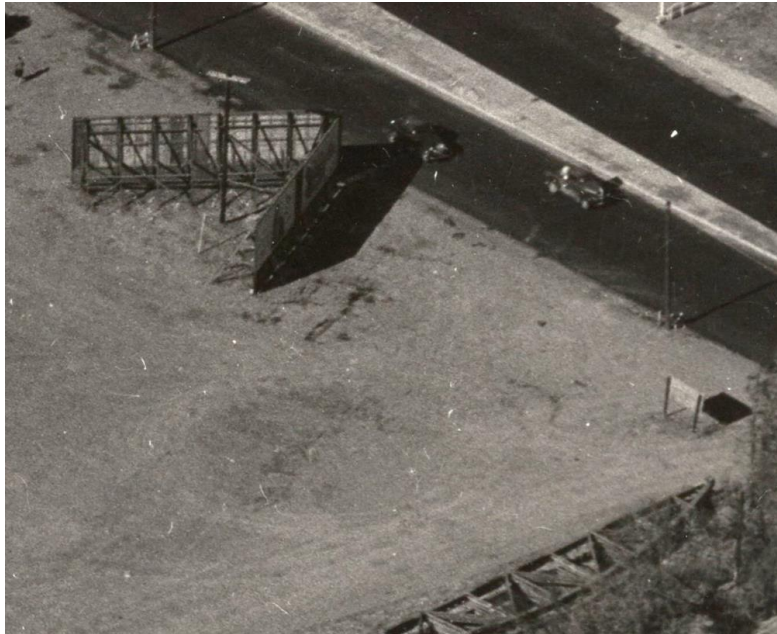
Figure 25. Detail view of the c.1950-55 photograph cited in the 2021 HRER (Figure 6) showing that the structure on the site was a billboard. The restaurant was later built to the southeast (right) of the billboards.

iteration of the restaurant was located somewhere other than 615 W. El Camino Real prior to the early 1950s.

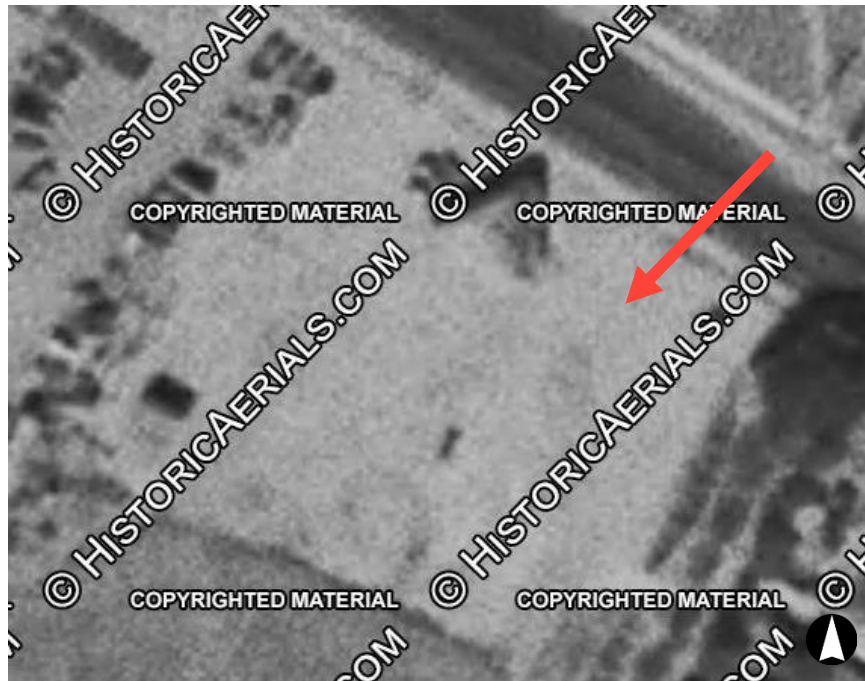
Figure 27. 1948 aerial photograph. Red arrow indicates approximate future location of the restaurant building. Source: NETR Online, 2023. Edited by Page & Turnbull.

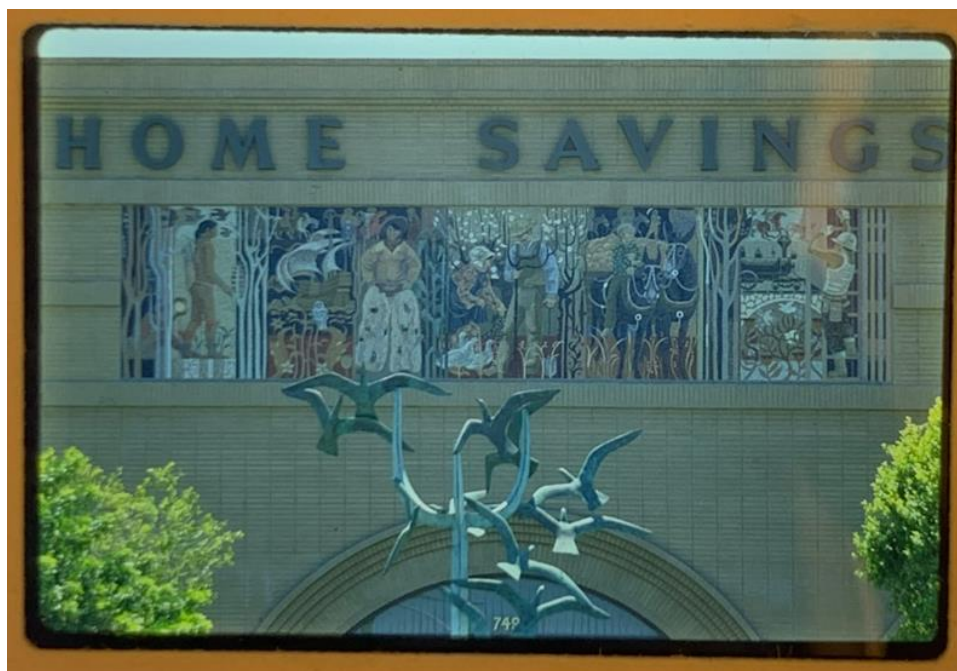
Figure 29. Installation view of the mosaic at the Mountain View Home Savings branch, c.1977-8. Source: Denis O'Connor Collection, The Huntington Library.

Page & Turnbull finds that the 1977 year of construction provided in Santa Clara County Assessor Records is consistent with other accounts, including a photograph on file at the Denis O'Connor Collection at the Huntington Library, Arenson's database, and a newspaper article that indicates that the installation of the mosaic was completed soon after, by early 1978 (**Figure 29**).⁴⁸ Page & Turnbull requested and reviewed the available building permit history from the City of Mountain View for 749 W. El Camino Real, and while the permit history did not include an original building permit, the available records did include permits for minor alterations to exterior doors, the addition of one ATM for Washington Mutual (1999), replacement of the ATM with two ATMs for Chase (2009), and various changes in exterior signage when the ownership changed. Other alterations observed by Page & Turnbull include the addition of bird deterrent statues mimicking owls and the removal of mature trees flanking the front statue; both alterations occurred sometime after 1993 but before 2007, based on comparison with Google Street View imagery (**Figure 30**).

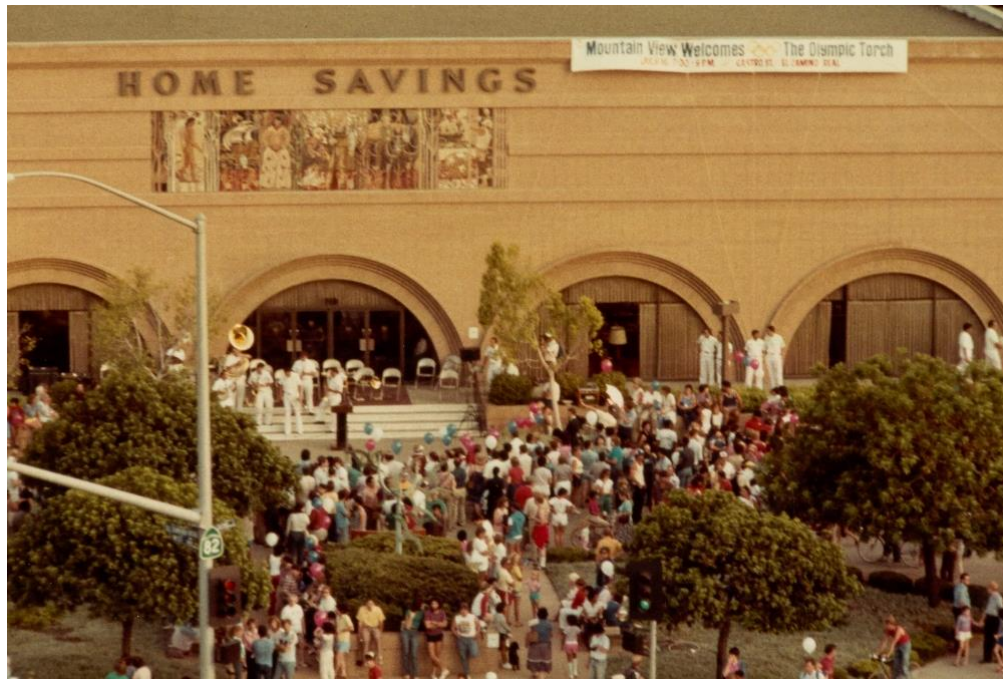
Figure 30. Home Savings & Loan Association at 749 W. El Camino Real during what appears to be an event related to the Olympic torch tour, 1993. Note that the Home Savings sign and trees have since been removed and the non-original owl statues added. Source: Mountain View Public Library.

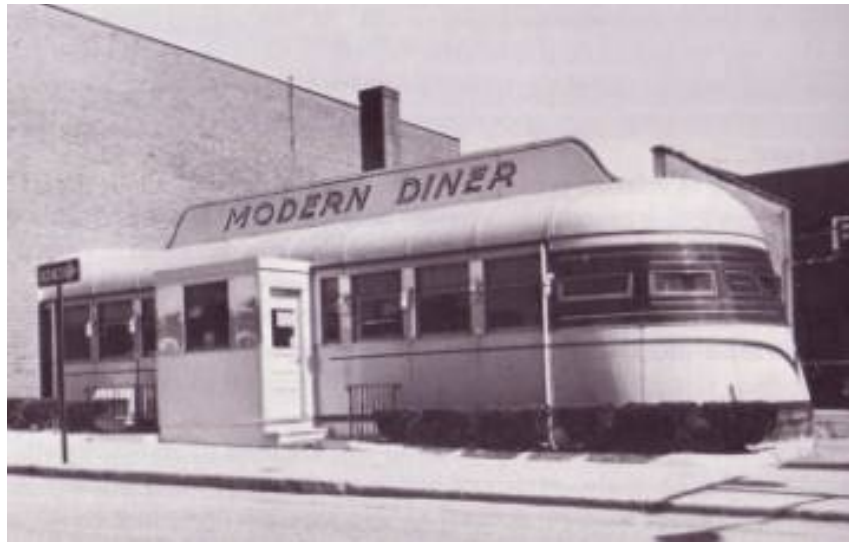
Figure 3-4. Railroad Car Diner. (Image courtesy of Chester H. Liebs as cited in University of Vermont 2021)

The diner continued to prosper in the post-WWII years; at this time, the diner began to take on the aesthetics of a railroad car. Along the road they provided truck drivers, businessmen and other travelers with the hearty home-cooked fare that was first served to urban factory workers. As the 1950s drew to a close, the diner began losing business to the fast food chains. As a result, the railroad motif was abandoned in favor of a more family-oriented atmosphere and traditional look. The new diners featured columns, mansard roofs, trellises, and stone cladding; in Los Angeles the space-age Googie style was popular from roughly 1945 to the early 1970s (University of Vermont 2021; Rosin and Bowers 1992:11-12).

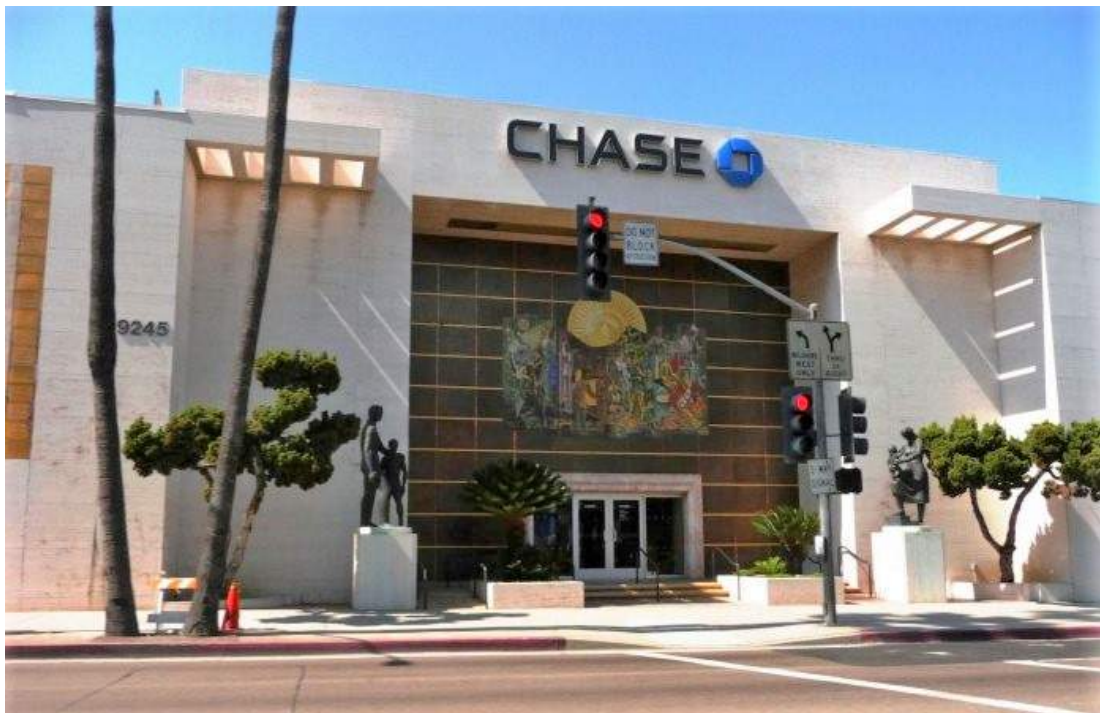
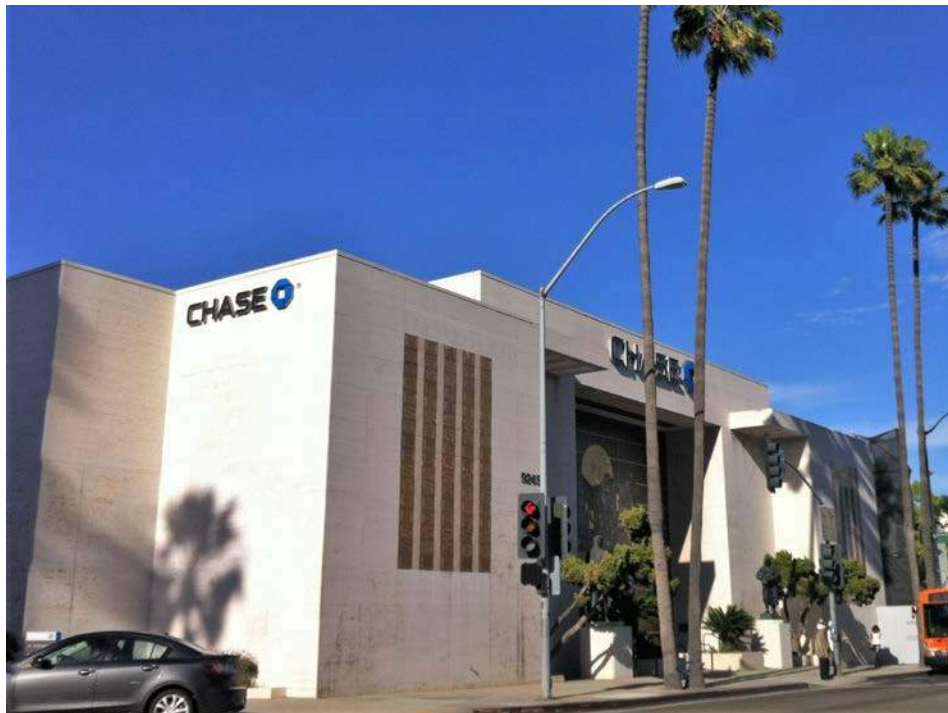
Figure 3-5. Former Home Savings & Loan Association (1956), Beverly Hills. (L.A. Conservancy)

Figure 3-6. Former Home Savings & Loan Association (1956), Beverly Hills. (L.A. Conservancy)

For the design of his buildings, Ahmanson gave Sheets complete freedom. This included design of the facades and the interiors. The quintessential example of the studio's integration of art, particularly mosaics, sculpture, stained glass, tapestry and sometimes furnishings, and commercial space is embodied in one of the firms first commissions from Ahmanson, the Home Savings & Loan Association at 9245 Wilshire Boulevard, Beverly Hills (Figures 3-5 and 3-6).

Millard Sheets Design, Inc. was responsible for the design of over 40 Home Savings & Loan Association buildings throughout California (Arenson 2018); at least 168 were designed and constructed throughout the United States. All of the bank designs were based on the Beverly Hills branch (see Figures 3-5 and 3-6): prominent location; solid, imposing materials to suggest permanence; and the integration of art, local history, and familial themes (Chattel 2011:9). These elements balanced robust building forms and materials with delicate artistic details that projected an image of luxury and community. However, after Ahmanson's death in 1968, Sheets decreased his role in the design of each individual branch. As a result, designs became more standardized, although based on the location's unique history and character. Similarly, the Home Savings & Loan Association itself became more interested in economy and efficiency in construction of branches. Along with the banks, the Sheet's studio created works for restaurants, churches, hotels, airports, libraries, stores, government agencies, schools, hospitals, Masonic Halls, and cemeteries (Kahn 2016). The studio was behind the design of the Pomona Mall, one of the first pedestrian malls in the United States and nationally recognized as a blueprint for urban revitalization (Lin 2017). Sheet's work can be found all over California and the United States.

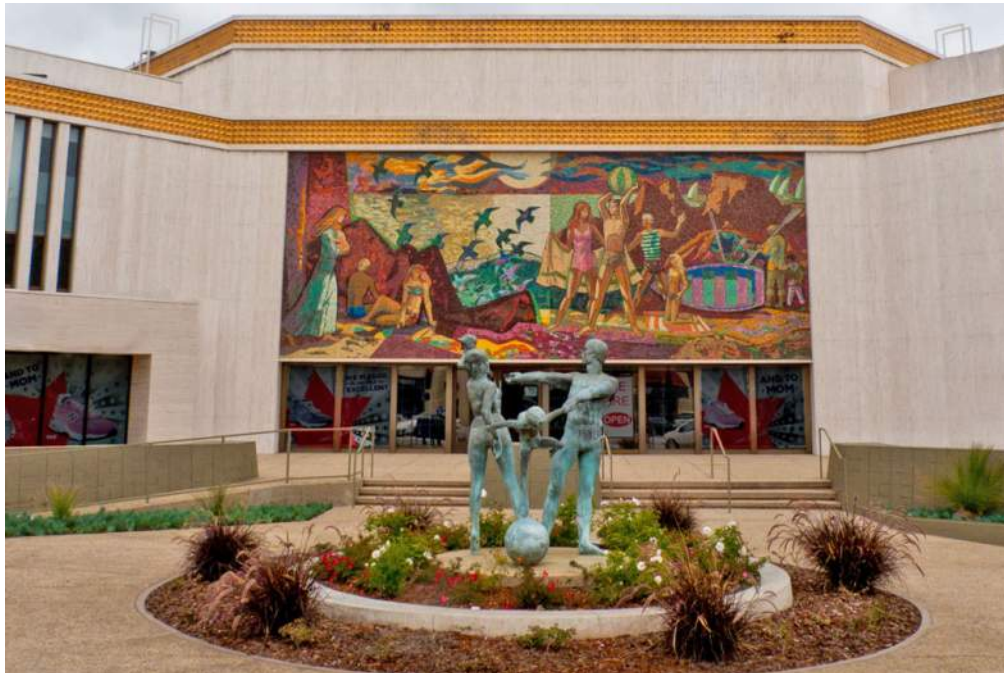
Figure 3-7. Former Home Savings & Loan Association (1969), Santa Monica. (Karel)

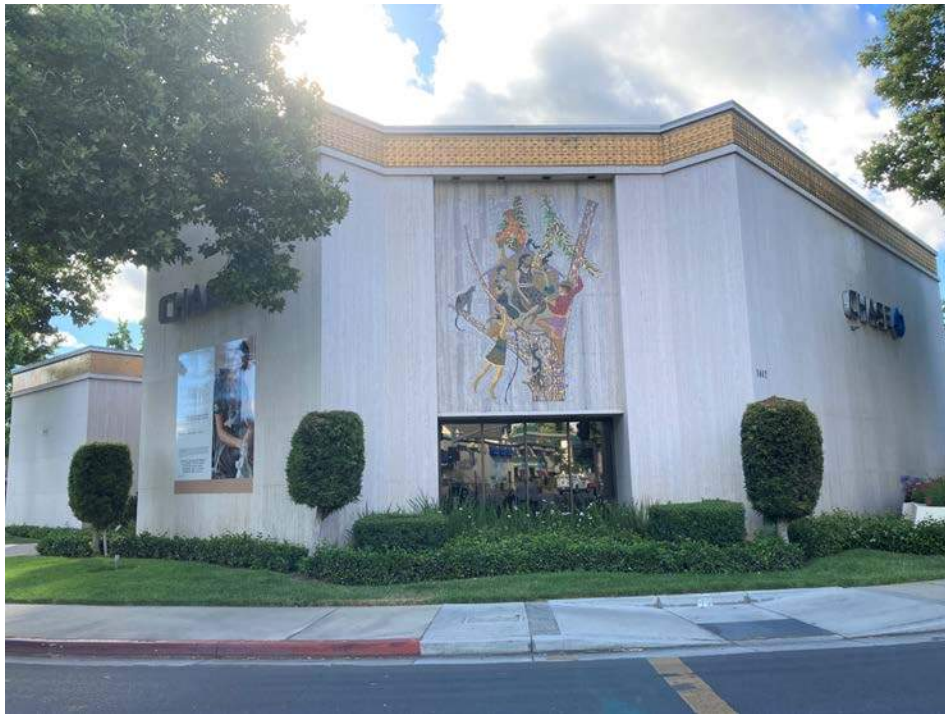
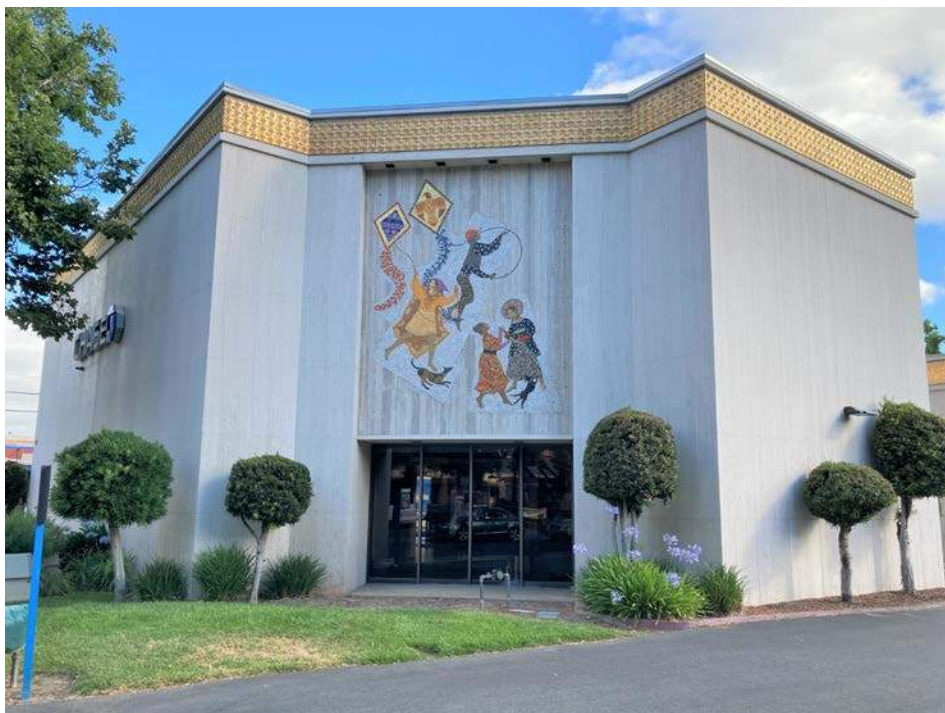
Figure 3-8. Former Home Savings & Loan Association (1972), San Jose. Photo by Ascent Environmental.

Figure 3-9. Former Home Savings & Loan Association (1972), San Jose. Photo by Ascent Environmental.

In Santa Clara County, the most prominent example of Sheet's work is located at 1402 Lincoln Avenue in San Jose's Willow Glen community. This former Home Savings & Loan Association building was constructed in 1972 and features four large mosaics on the exterior and two in the interior (see Figures 3-8 and 3-9). A sculpture depicting a mother and child is located along the southwest façade. The building is clad in square panels of travertine. A frieze of gold glazed tiles with a geometric pattern in relief wraps around the building at the roofline. The overall feeling of the artwork is that of a community at play. Both O'Connor and Hertel worked on this San Jose branch as well (Arenson 2018).

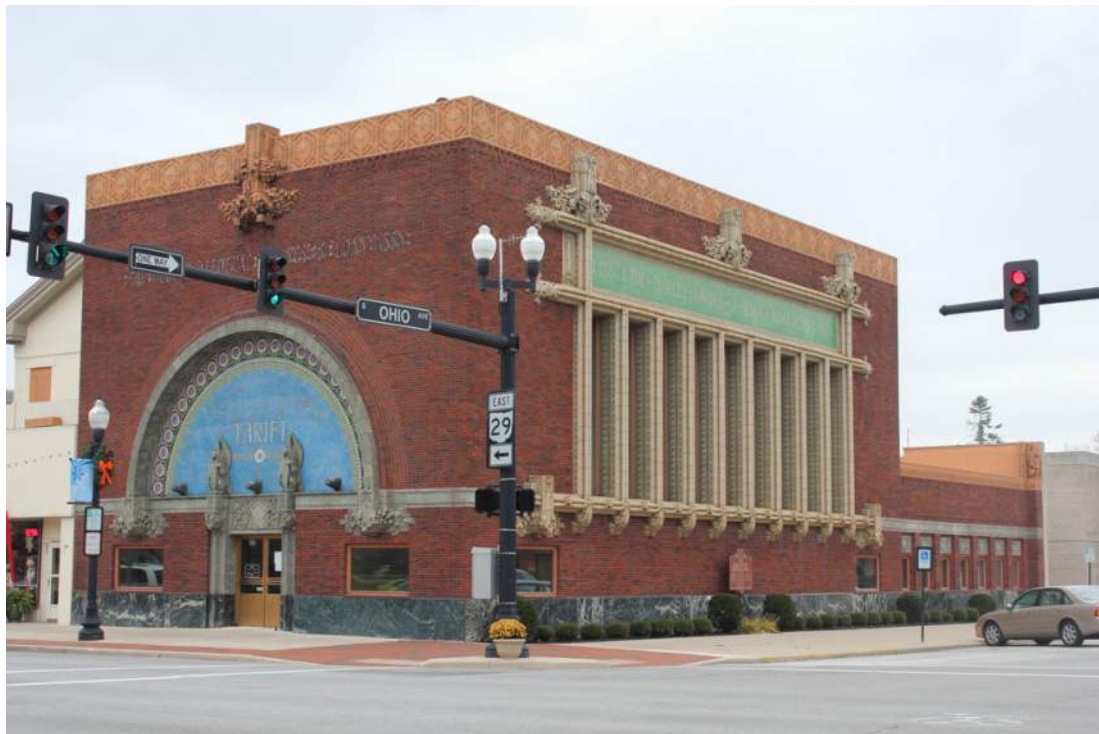
Figure 3-11. Peoples' Savings and Loan Association in Sidney, Ohio. Constructed 1917. (Rudge 2021)

Termed "jewel box" banks, Sullivan's box-shaped bank buildings were all constructed between 1902 and 1920 and located in rural towns of states such as Indiana, Iowa, Minnesota, Ohio, and Wisconsin (NPS 2018). The banks were largely austere rectangular or square brick buildings that contained brilliant Tiffany-like stained glass windows and richly ornamented interiors. In the lunettes, generic bucolic murals were also often painted of subjects such as cattle in the field or clouds over the prairie. Exterior decorations were minimal, with few well-placed fanciful terracotta reliefs, friezes, and tiled or stained glass filled arches (see Figures 3-10 and 3-11).

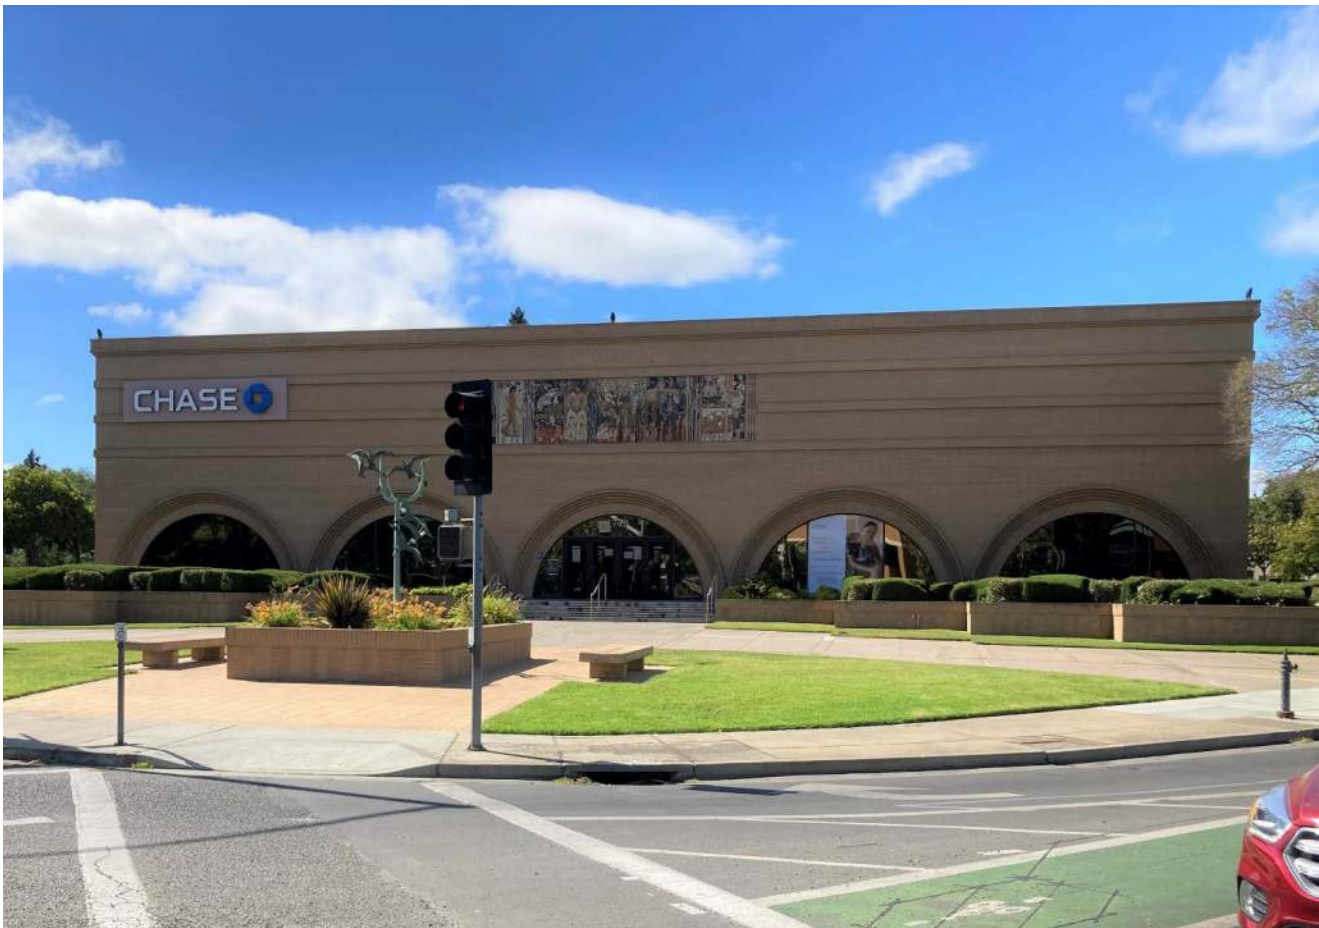
Figure 4-1. Chase Bank Building

The Bank Building is located on the southeast corner of El Camino Real and Castro Street, rotated 45 degrees so the primary entrance faces the corner. A landscaped plaza sets the building back from the street. The two-story building has a rectangular plan measuring approximately 130 feet east-west and 70 feet north-south. It is clad in beige brick with a stack bond pattern. The roof is flat with three rows of corbelling at the roofline. Owl statues are located along the northern roofline, at the center and each corner. The primary entrance is located on the northern façade, centered in the middle of five arched bays. The arches are also corbelled, and the bays are filled with display glass. The southern façade also has five bays, while the eastern and western facades each have two; an ATM is located between the two bays on the eastern façade.

Three soldier courses lay between the bays and the roofline and wrap around the building. A large mosaic is centered over the primary entrance, between the top and bottom soldier course. It features five panels that appear to depict the evolution of Mountain View. The entry plaza features a centralized brick planter box comprised of a stack bond pattern, topped with a soldier course. The planter box contains a metal sculpture of seagulls in flight. Brick benches are located on the east and west sides of the planter box, with areas of grass beyond the benches. Closer to the building entrance, more brick planter boxes of the same design line the northern façade.

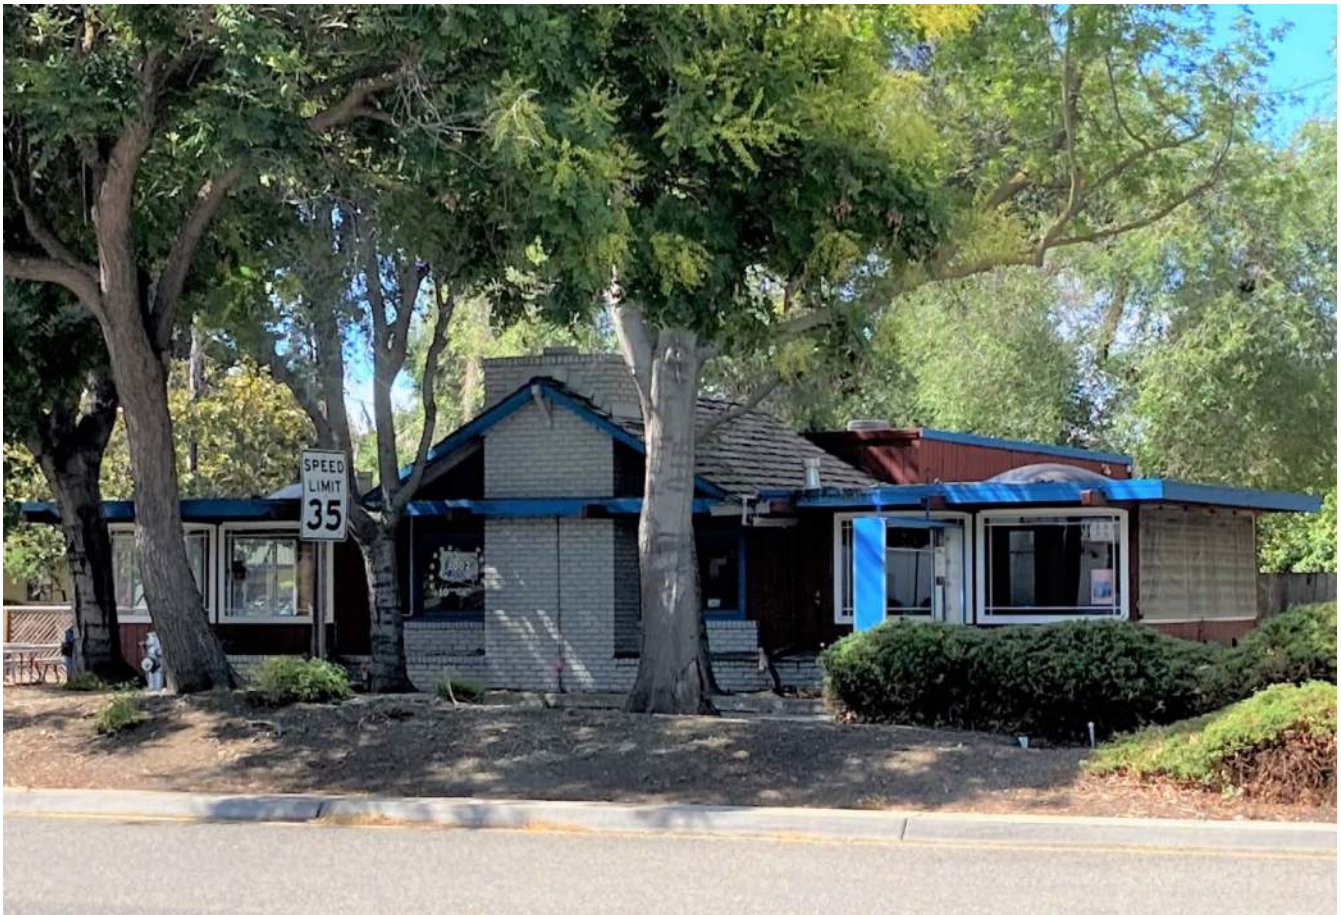
Figure 4-2. Bank Building

The subject property is located on the southwest corner of El Camino Real and Lane Avenue. The front half of the building is constructed of wood, while the rear wing is constructed of concrete. The one-story building has a "T" shaped plan with a gabled portion centered on the primary façade; the side and rear wings have a flat roof. The roof of the rear wing is capped with a large cornice that projects slightly. Exposed rafter tails are located on the primary façade of the left and right wings. The primary façade is symmetrical, with a painted white brick chimney at the center; wood-framed fixed windows are located on either side of the external chimney. Two sets of fixed, vinyl-trim windows are located to adjacent to the wood-frame windows.

A planter box of painted white brick extends from the chimney almost the full length of the primary façade. Additional brickwork is located under the wood-framed windows. All brickwork is running bond with a soldier course along the top edge. The two entrances are located at the rear of the left and right wings. Window openings adjacent to the entrances have been boarded up. Both the southeast and northwest facades have shed-roof additions. The one located on the northwest façade has a mural of a barbecue spit and a family enjoying their meal. The southeast façade also features a bump-outs for the restroom. Wooden posts that have been painted blue are located along the southeast and northwest; the posts are connected by thick nautical rope. Two small accessory buildings are located at the rear of the parking lot. The space between them is enclosed with a wooden fence, likely used for dumpster storage.
