MEMORANDUM

DATE	March 1, 2023	PROJECT NUMBER	22226
TO	Nick Towstopiat, Associate Project Manager	PROJECT	615 & 749 W. El Camino Real, Mountain View – HRER Peer Review
OF	David J. Powers & Associates, Inc 1871 The Alameda, Suite 200 San Jose, CA 95126	FROM	Hannah Simonson, Associate, Cultural Resources Planner/ Architectural Historian
CC	Peter Birkholz, Principal-in-Charge, Page & Turnbull	VIA	Email

REGARDING 615 & 749 W. El Camino Real, Mountain View, HRER Peer Review Memorandum

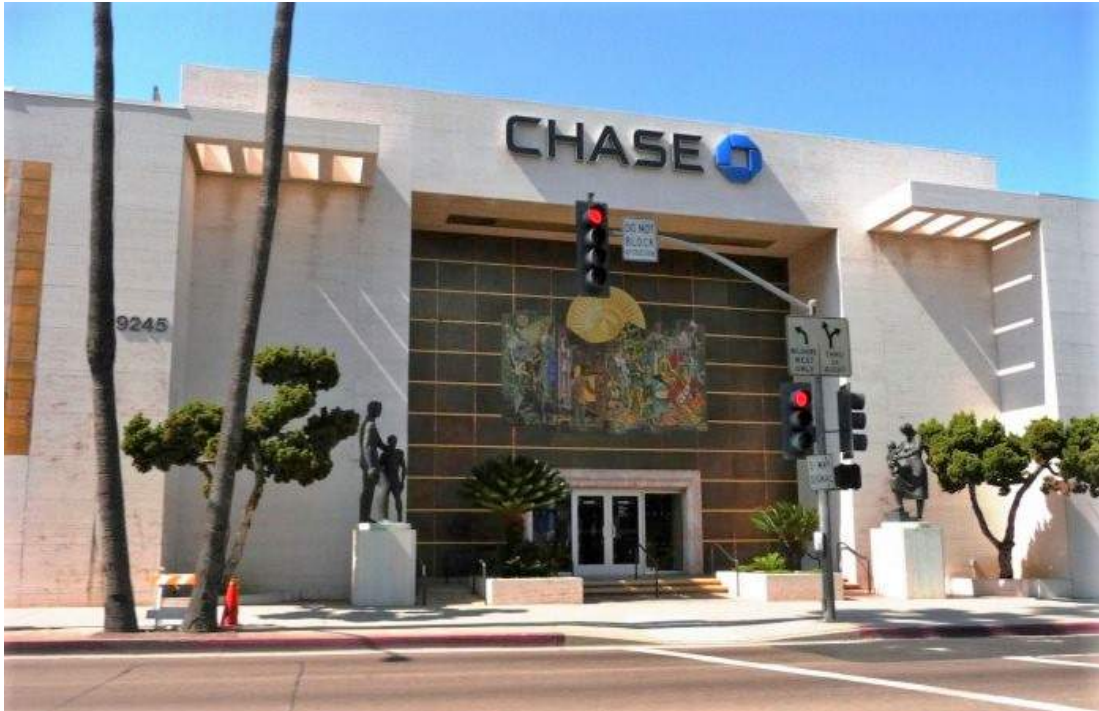
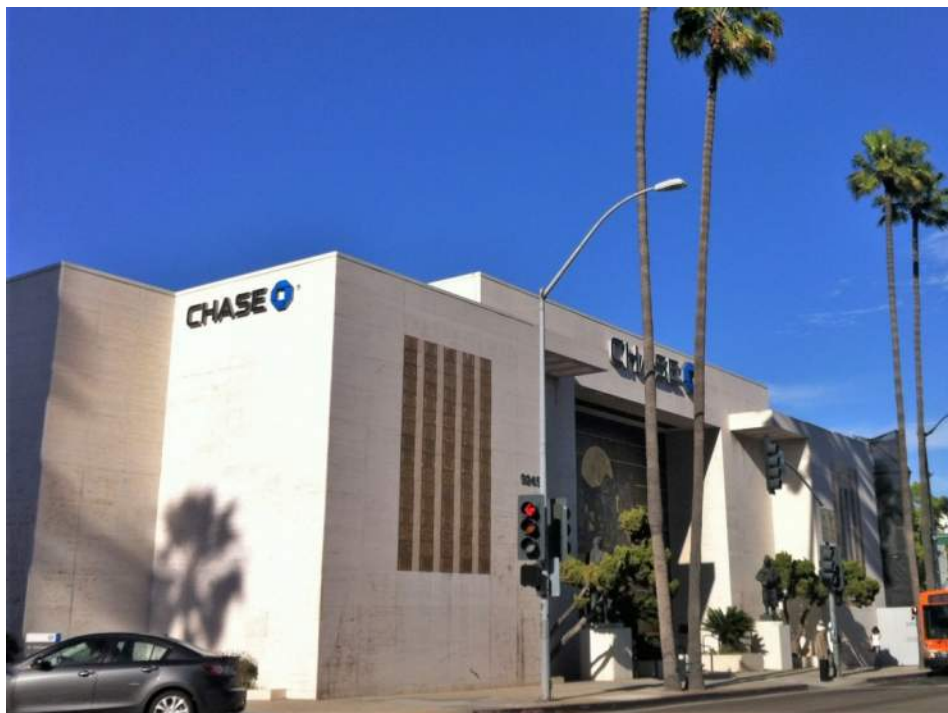
Figure 1. Former Home Savings & Loan Association (1956), Beverly Hills. Photo by Adrian Scott Fine for L.A. Conservancy.

Figure 2. Former Home Savings & Loan Association (1956), Beverly Hills. Photo by Adrian Scott Fine for L.A. Conservancy.

Millard Sheets Design, Inc. was responsible for the design of over 40 Home Savings & Loan Association buildings throughout California (Arenson 2018); at least 168 were designed and constructed throughout the United States. All of the bank designs were based on the Beverly Hills branch (see Figures 1 and 2): prominent location; solid, imposing materials to suggest permanence; and the integration of art, local history, and familial themes (Chattel 2011:9). These elements balanced robust building forms and materials with delicate artistic details that projected an image of luxury and community. However, after Ahmanson's death in 1968, Sheets decreased his role in the design of each individual branch. As a result, designs became more standardized, although based on the location's unique history and character. Similarly, the Home Savings & Loan Association itself became more interested in economy and efficiency in construction of branches. Along with the banks, the Sheet's studio created works for restaurants, churches, hotels, airports, libraries, stores, government agencies, schools, hospitals, Masonic Halls, and cemeteries (Kahn 2016). The studio was behind the design of the Pomona Mall, one of the first pedestrian malls in the United States and nationally recognized as a blueprint for urban revitalization (Lin 2017). Sheet's work can be found all over California and the United States.

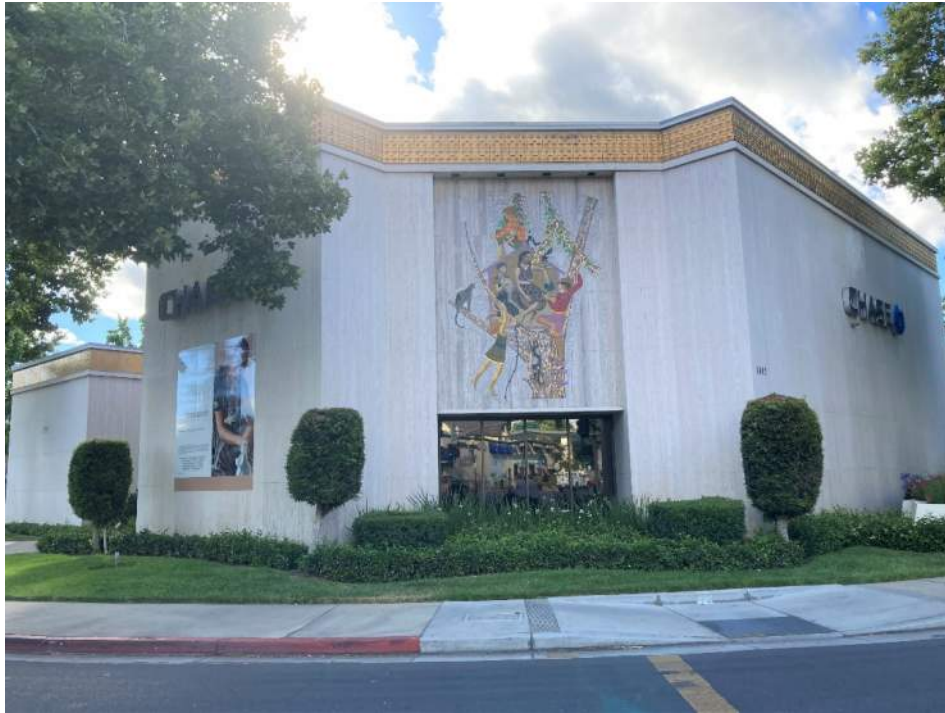
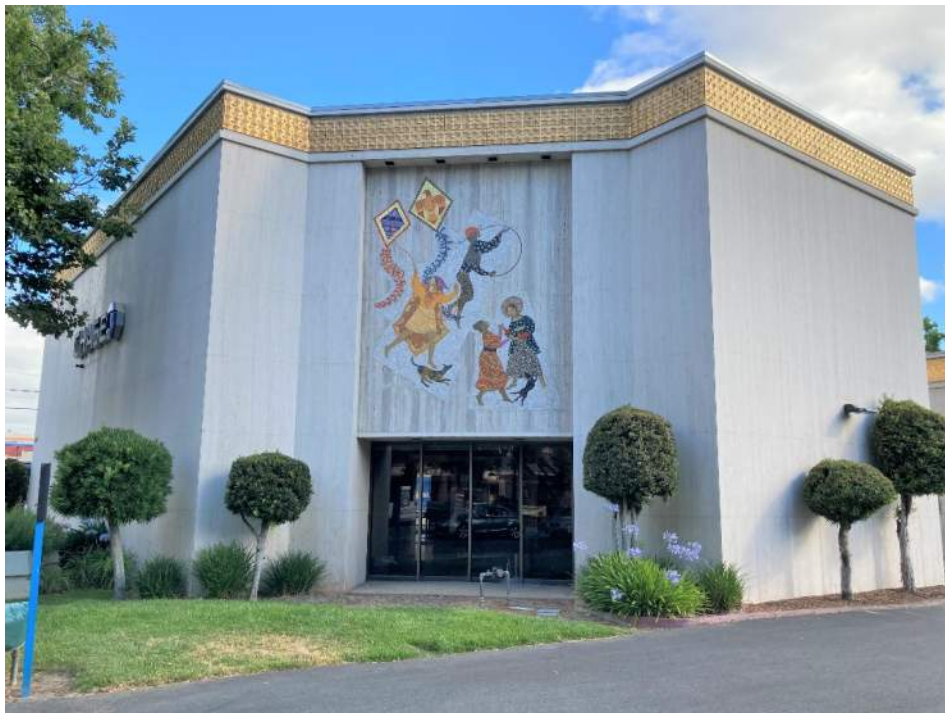
Figure 3. Former Home Savings & Loan Association (1972), San Jose. Photo by Ascent Environmental.

Figure 4. Former Home Savings & Loan Association (1972), San Jose. Photo by Ascent Environmental.

In Santa Clara County, the most prominent example of Sheet's work is located at 1402 Lincoln Avenue in San Jose's Willow Glen community. This former Home Savings & Loan Association building was constructed in 1972 and features four large mosaics on the exterior and two in the interior (see Figures 3 and 4). A sculpture depicting a mother and child is located along the southwest façade. The building is clad in square panels of travertine. A frieze of gold glazed tiles with a geometric pattern in relief wraps around the building at the roofline. The overall feeling of the artwork is that of a community at play. Both O'Connor and Hertel worked on this San Jose branch as well (Arenson 2018).

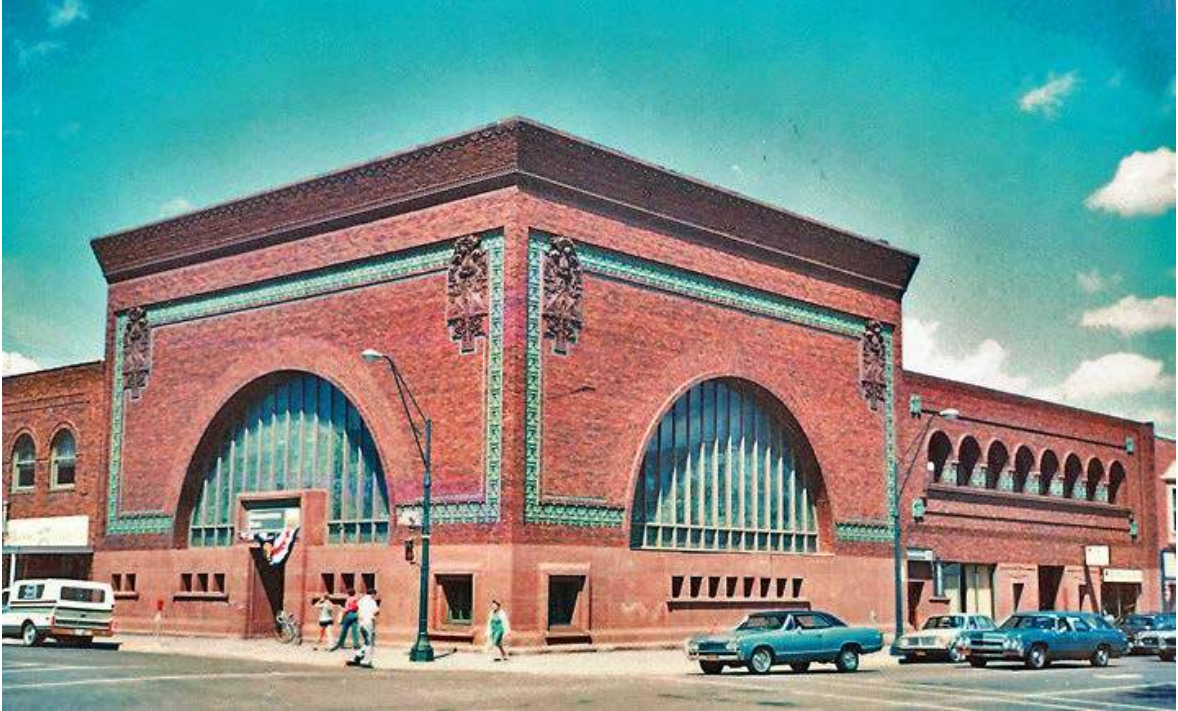
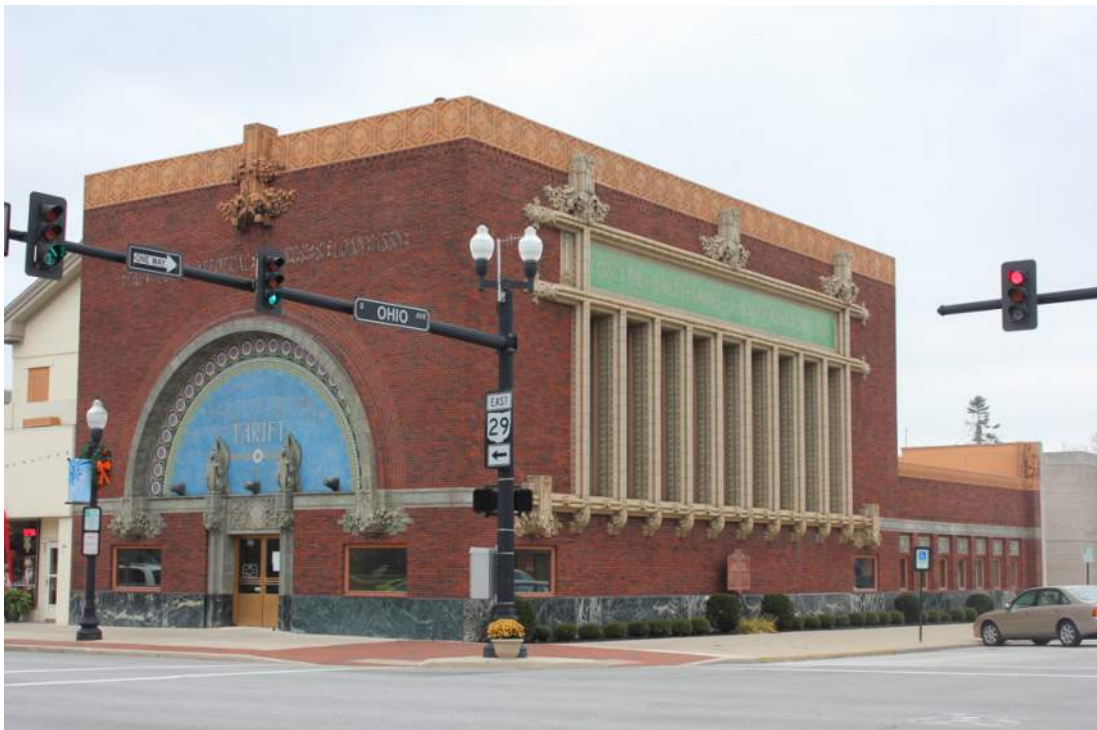
Figure 5. National Farmers' Bank in Owatonna, Minnesota. Constructed in 1908. (NPS 2018)

Figure 6. Peoples' Savings and Loan Association in Sidney, Ohio. Constructed 1917. (Rudge 2021)

Termed "jewel box" banks, Sullivan's box-shaped bank buildings were all constructed between 1902 and 1920 and located in rural towns of states such as Indiana, Iowa, Minnesota, Ohio, and Wisconsin (NPS 2018). The banks were largely austere rectangular or square brick buildings that contained brilliant Tiffany-like stained glass windows and richly ornamented interiors. In the lunettes, generic bucolic murals were also often painted of subjects such as cattle in the field or clouds over the prairie. Exterior decorations were minimal, with few well-placed fanciful terracotta reliefs, friezes, and tiled or stained glass filled arches (see Figures 5 and 6).

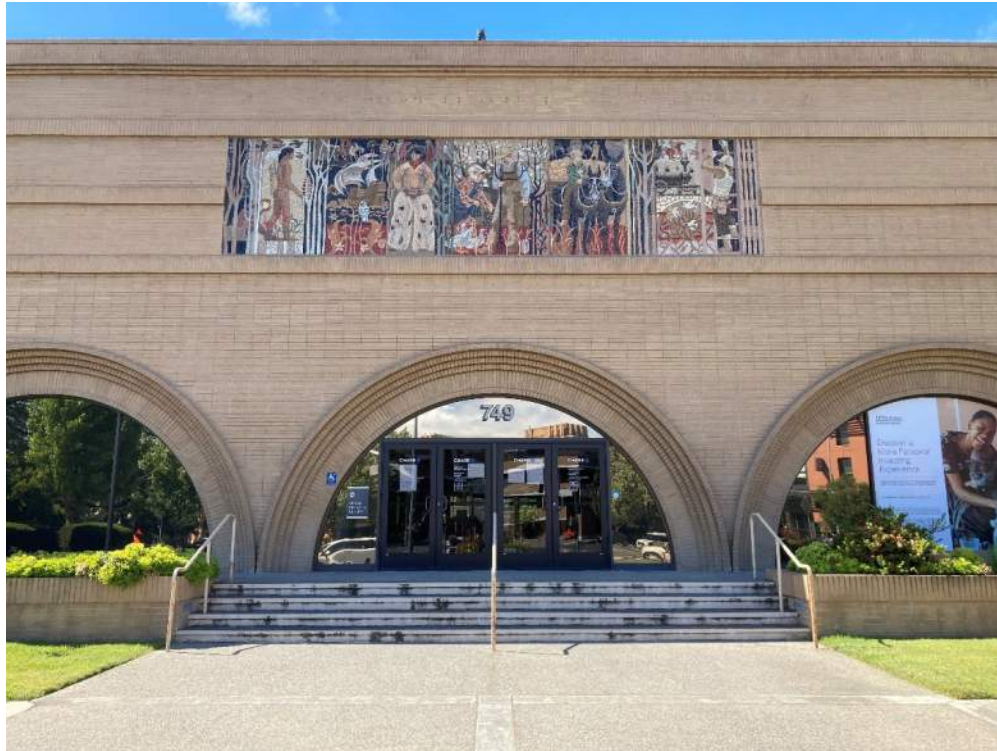
Photo 1. Primary entrance, facing southeast. Photo taken 6/22/2021.

The subject property is located on the southeast corner of El Camino Real and Castro Street, rotated 45 degrees so the primary entrance faces the corner. A landscaped plaza sets the building back from the street. The two-story building has a rectangular plan measuring approximately 130 feet east-west and 70 feet north-south. It is clad in beige brick with a stack bond pattern. The roof is flat with three rows of corbelling at the roofline. Owl statues are located along the northern roofline, at the center and each corner. The primary entrance is located on the northern façade, centered in the middle of five arched bays (Photo 1). The arches are also corbelled, and the bays are filled with display glass. The southern façade also has five bays, while the eastern and western facades each have two; an ATM is located between the two bays on the eastern façade (Photo 2). See Continuation Sheet, page 4.

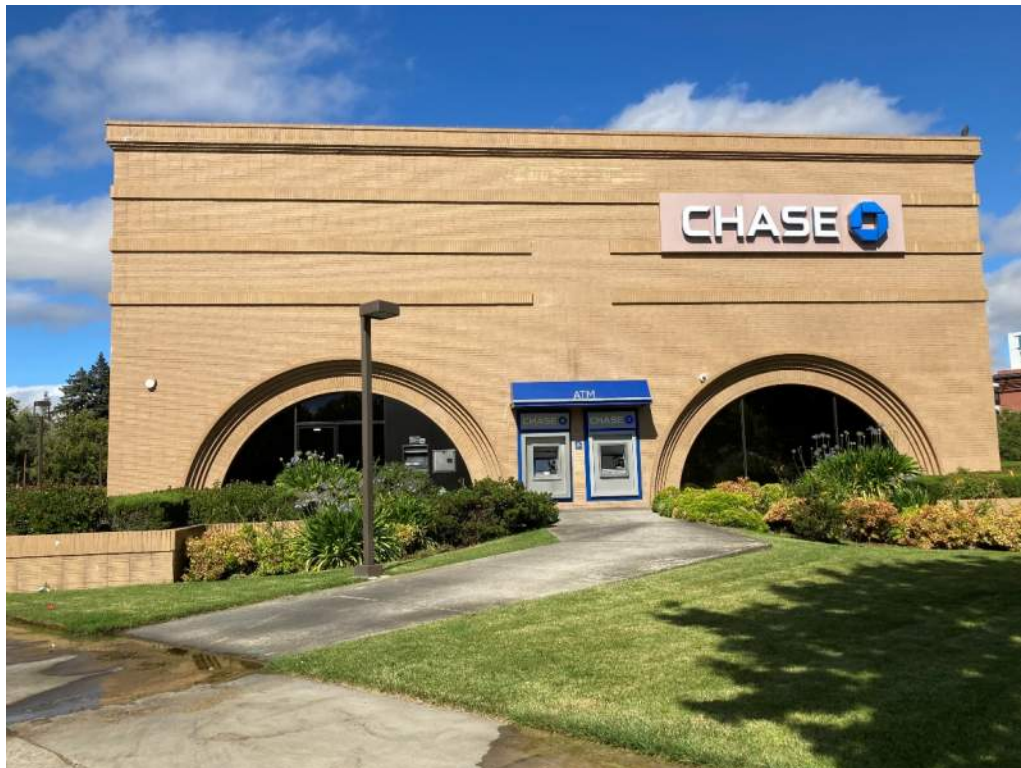
Photo 2. Eastern façade, facing west. Photo taken 6/22/2021.

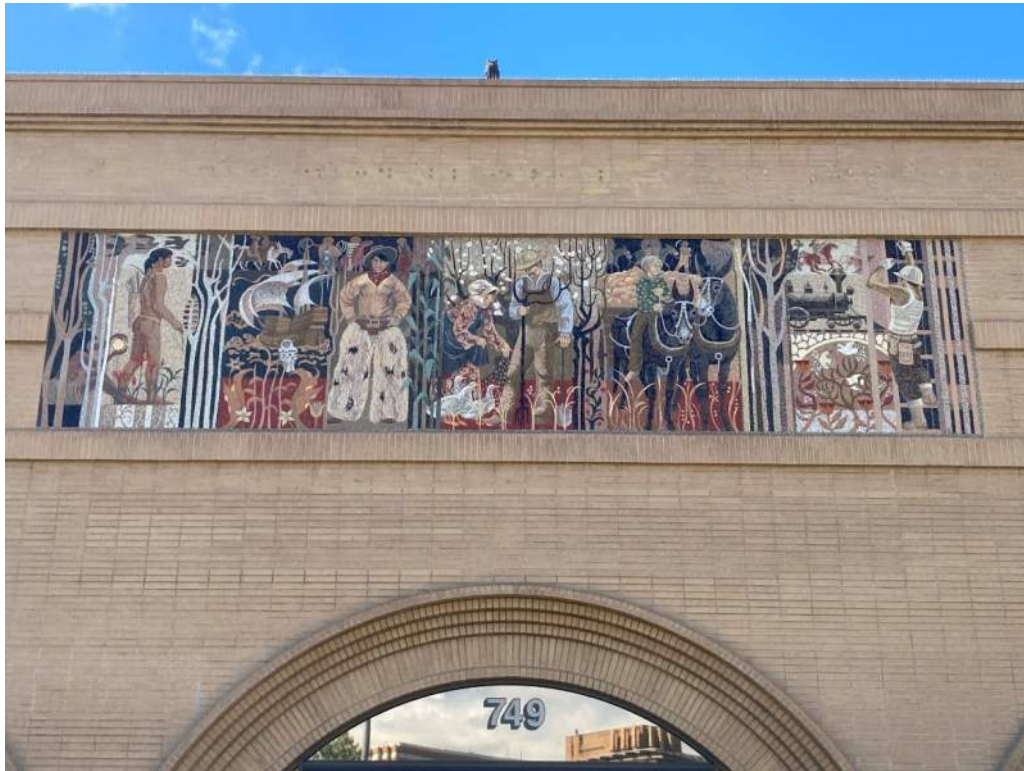
Photo 3. Mosaic, located above primary entrance. Photo taken 6/22/2021.

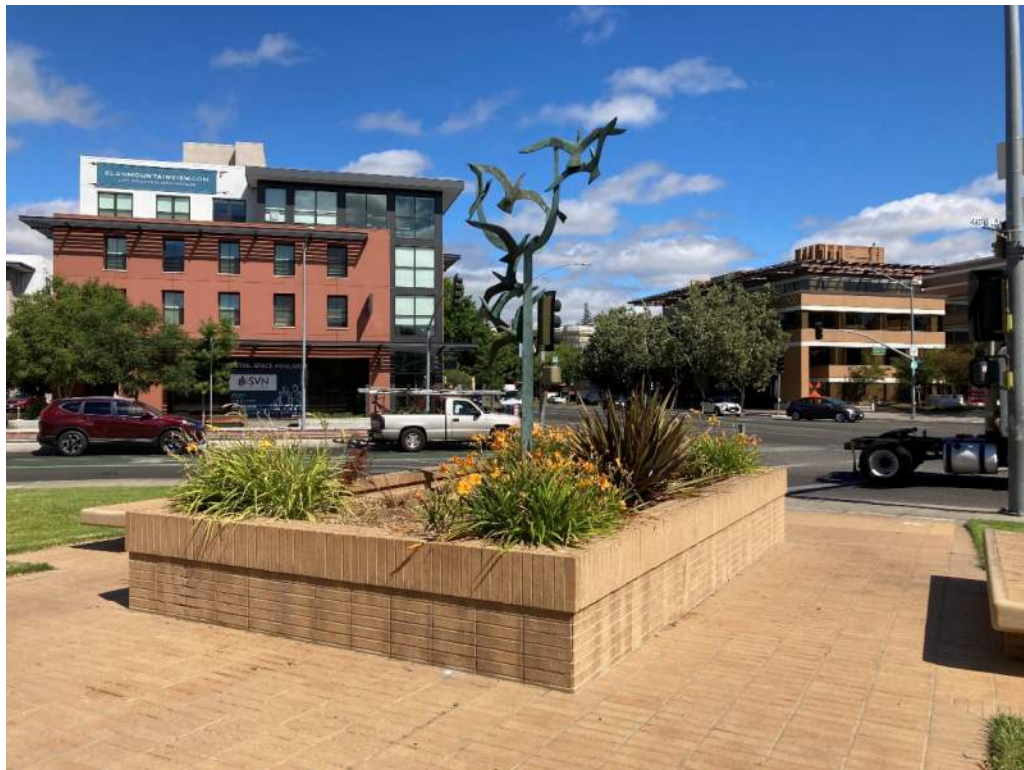
Photo 4. Seagull sculpture located in entrance plaza. Facing north. Photo taken 6/22/2021.

Three soldier courses lay between the bays and the roofline and wrap around the building. A large mosaic is centered over the primary entrance, between the top and bottom soldier course. It features five panels that appear to depict the evolution of Mountain View (Photo 3). The entry plaza features a centralized brick planter box comprised of a stack bond pattern, topped with a soldier course. The planter box contains a metal sculpture of seagulls in flight (Photo 4). Brick benches are located on the east and west sides of the planter box, with areas of grass beyond the benches. Closer to the building entrance, more brick planter boxes of the same design line the northern façade.

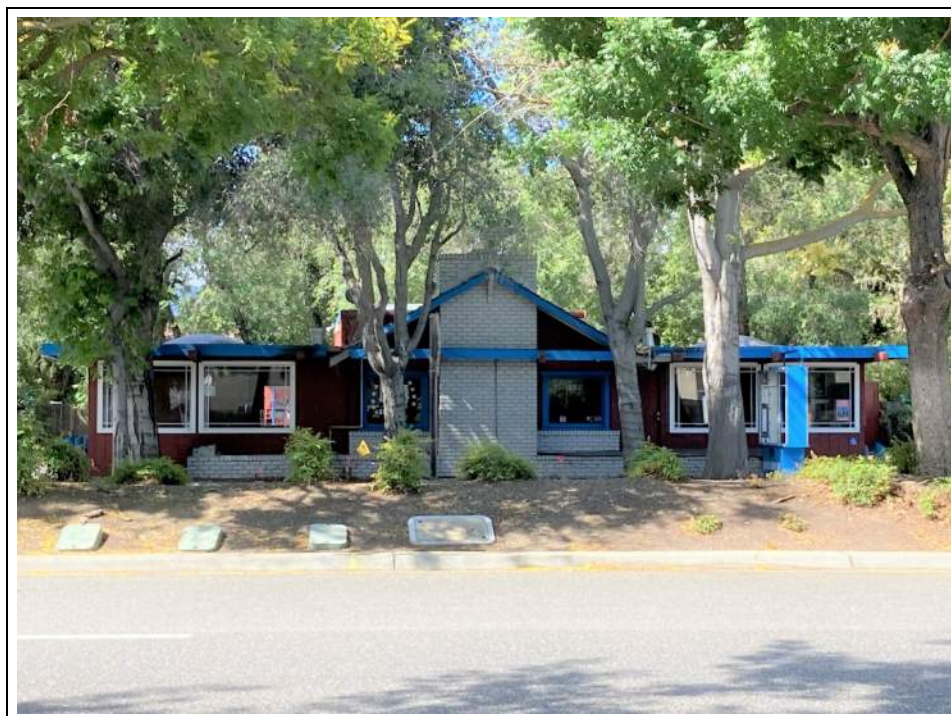
P5b. Description of Photo: (view, date, accession #) View facing southwest, 6/22/2021

The subject property is located on the southwest corner of El Camino Real and Lane Avenue. The front half of the building is constructed of wood, while the rear wing is constructed of concrete. The one-story building has a "T" shaped plan with a gabled portion centered on the primary façade; the side and rear wings have a flat roof. The roof of the rear wing is capped with a large cornice that projects slightly (Photo 1). Exposed rafter tails are located on the primary façade of the left and right wings. The primary façade is symmetrical, with a painted white brick chimney at the center; wood-framed fixed windows are located on either side of the external chimney. Two sets of fixed, vinyl-trim windows are located to adjacent to the wood-frame windows. See Continuation Sheet, page 4.

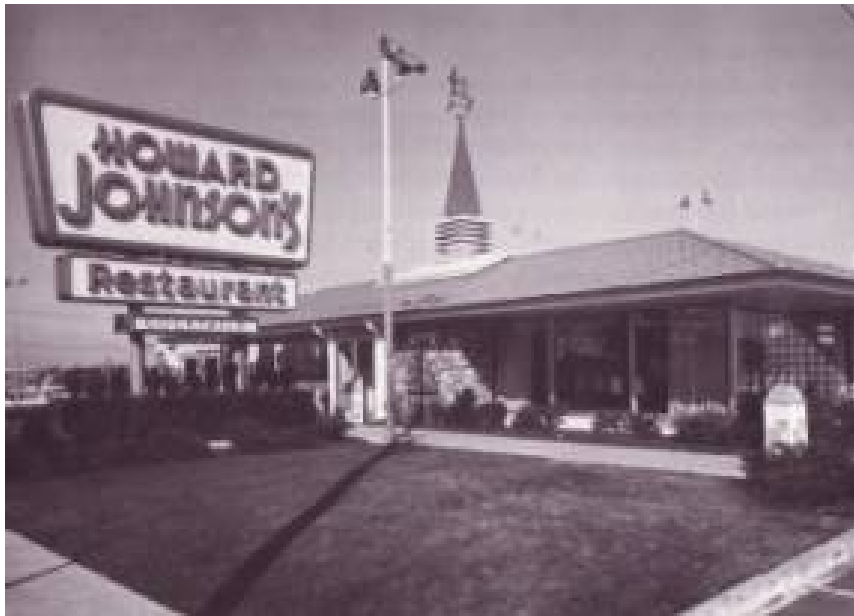
Figure 2. Modern family restaurant. (Image courtesy of Chester H. Liebs as cited in University of Vermont 2021)

Many early restaurant chains from the 1930s used architectural gimmicks, like the windmills, to lure motorists. Colonial Revival architecture was also used quite heavily for roadside restaurants during the 1930s - the cupola being the most character-defining feature. By the 1950s, restaurants were abandoning traditional designs and embracing modernization. The Howard Johnson's restaurant seen below features a low, overhanging hipped roof, large windows, and a stylized, modern cupola (University of Vermont 2021).

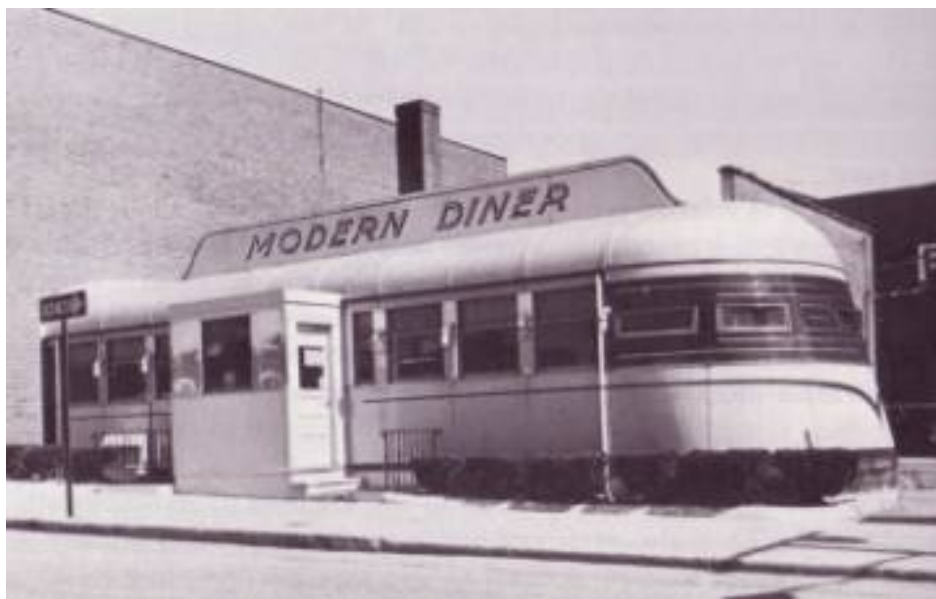
Figure 4. Railroad car diner. (Image courtesy of Chester H. Liebs as cited in University of Vermont 2021)

The diner continued to prosper in the post-WWII years; at this time, the diner began to take on the aesthetics of a railroad car. Along the road they provided truck drivers, businessmen and other travelers with the hearty home-cooked fare that was first served to urban factory workers. As the 1950s drew to a close, the diner began losing business to the fast food chains. As a result, the railroad motif was abandoned in favor of a more family-oriented atmosphere and traditional look. The new diners featured columns, mansard roofs, trellises, and stone cladding; in Los Angeles the space-age Googie style was popular from roughly 1945 to the early 1970s (University of Vermont 2021; Rosin and Bowers 1992:11-12).

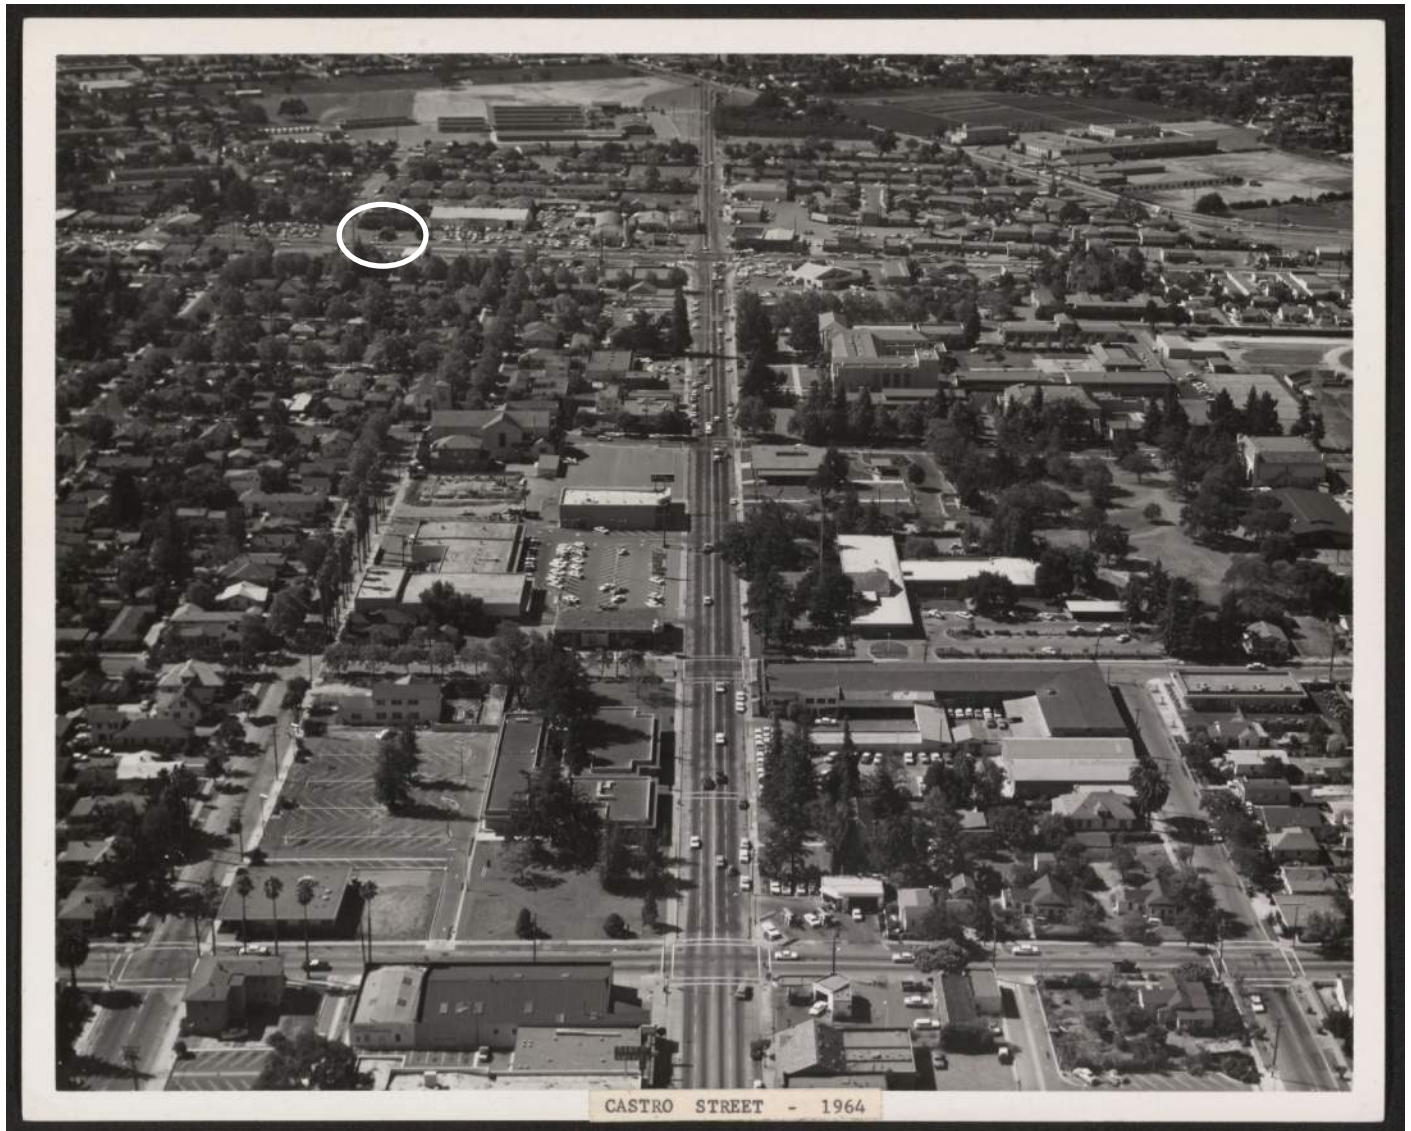
Figure 8. City of Mountain View 1964 historic photograph. (Mountain View Public Library 2021)

While the county tax records and news articles state that Bill Clarke opened Clarke's Charcoal Broiler at this location in 1945, neither the historic photos from the Mountain View library nor online historical aerals confirm this. The 1948 aerial (Figure 5) shows a triangular shape as does the 1950 site photo (Figure 6). The 1956 online historical aerals show the original A-frame building, but the rear addition does not seem to be present; the rear addition is visible in the 1960 historical aerals (Figure 7). The left and right wings were constructed between 1982 and 1987 (Figures 10 and 11).

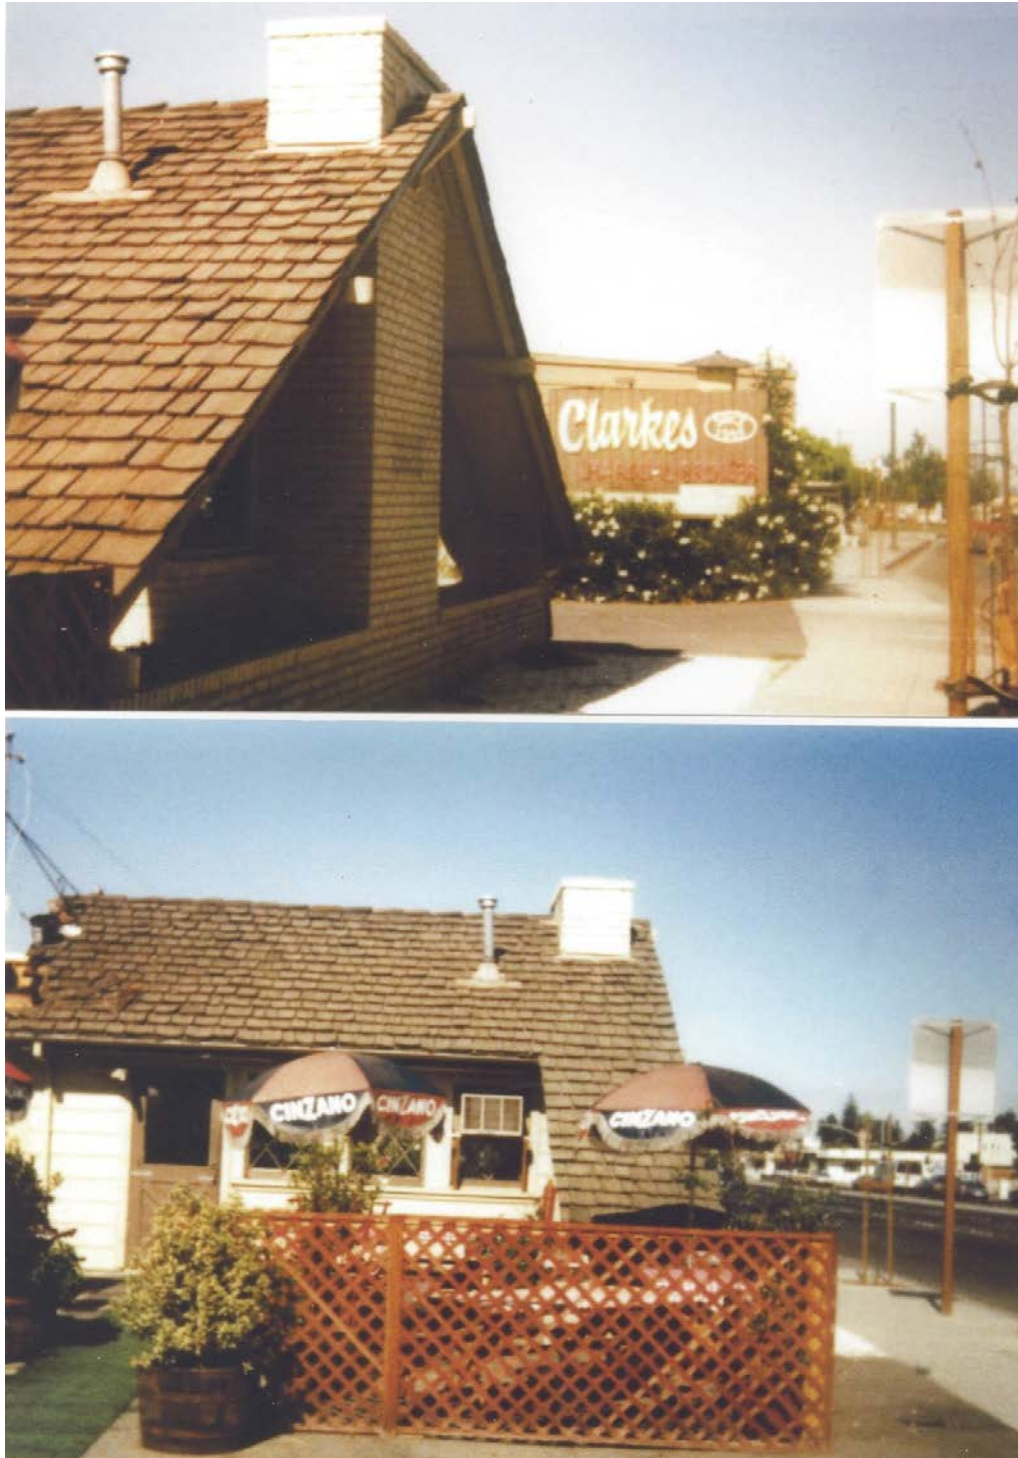
Figure 9. Undated photographs of subject property. Roofline at left of bottom picture seems to have been partially removed. (Clarke's Facebook page)

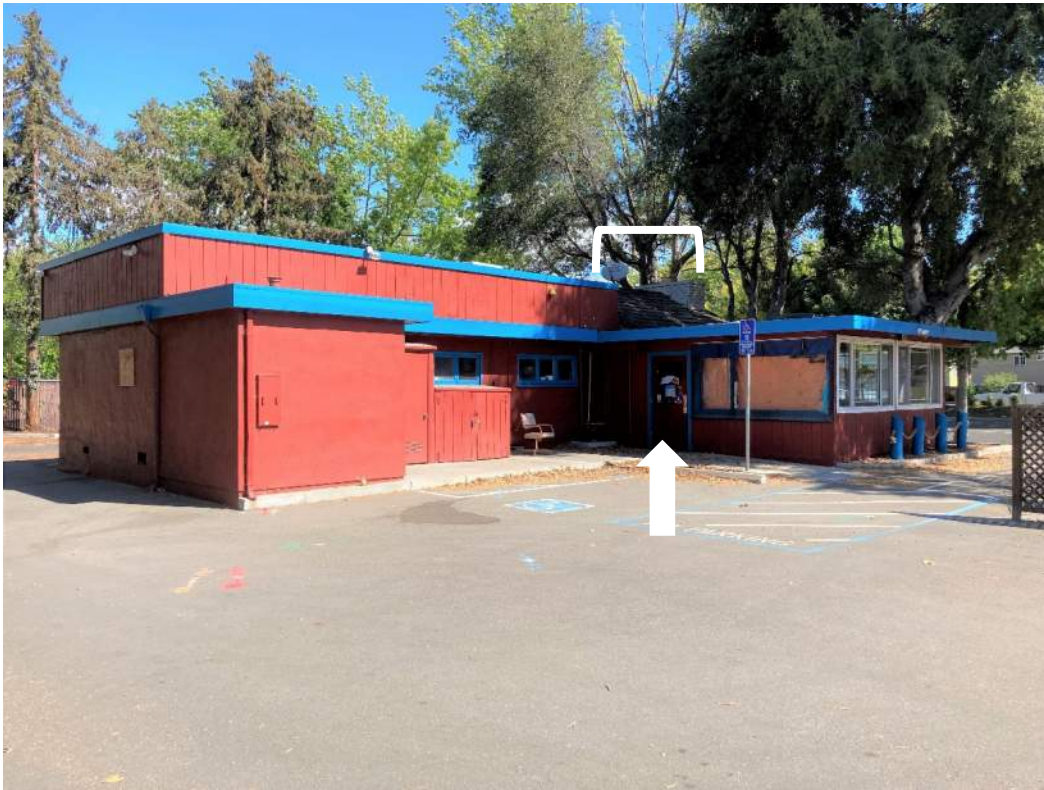
Photo 1. Southeast façade; entrance at arrow. Original building portion at bracket. Photo taken 6/22/2021.

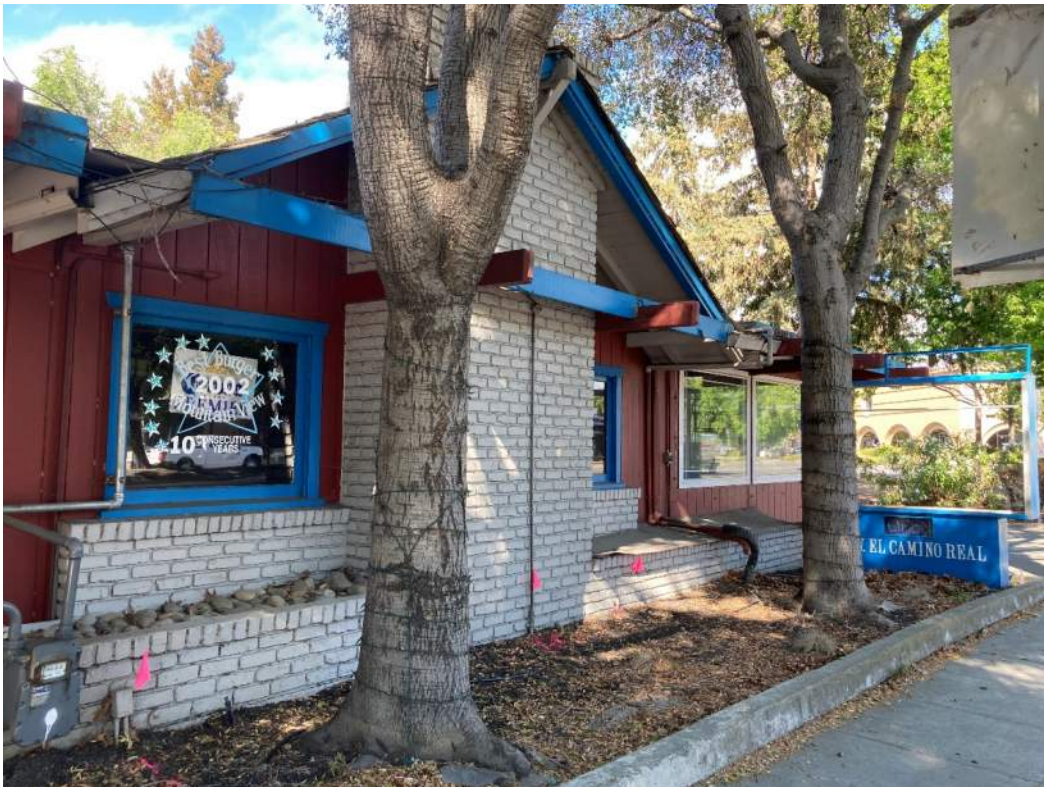
Photo 2. Primary façade showing original section of building. Facing west. Photo taken 6/22/2021.

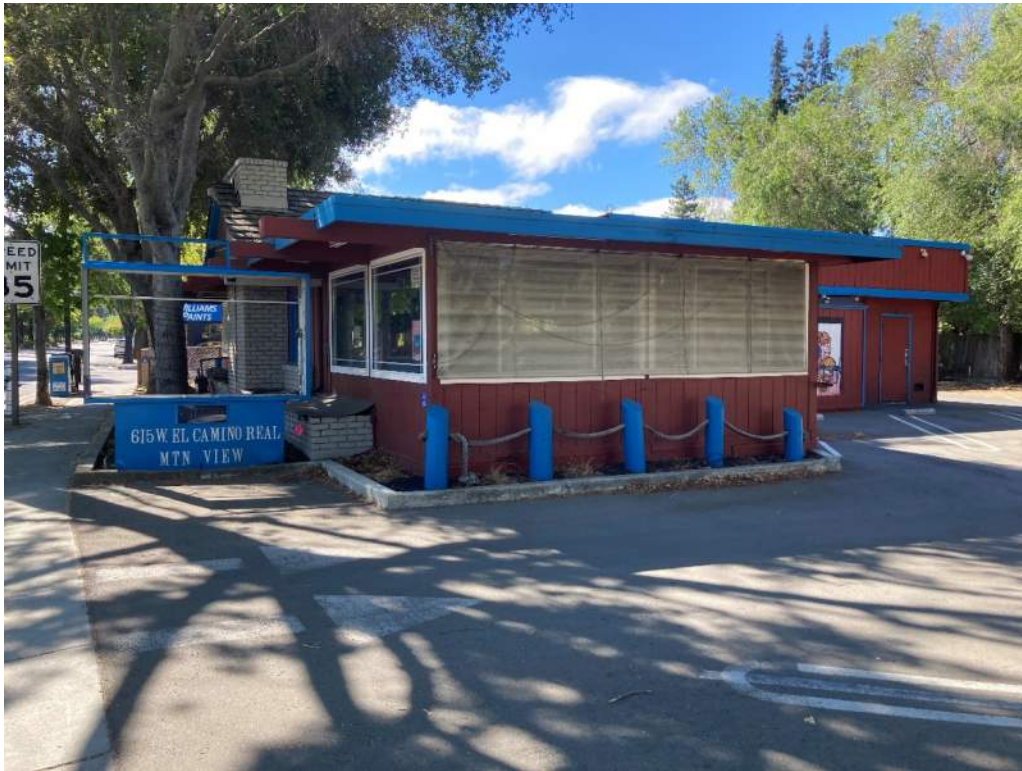
Photo 3. Northwest façade. Wooden posts visible; restaurant sign missing. Photo taken 6/22/2021.

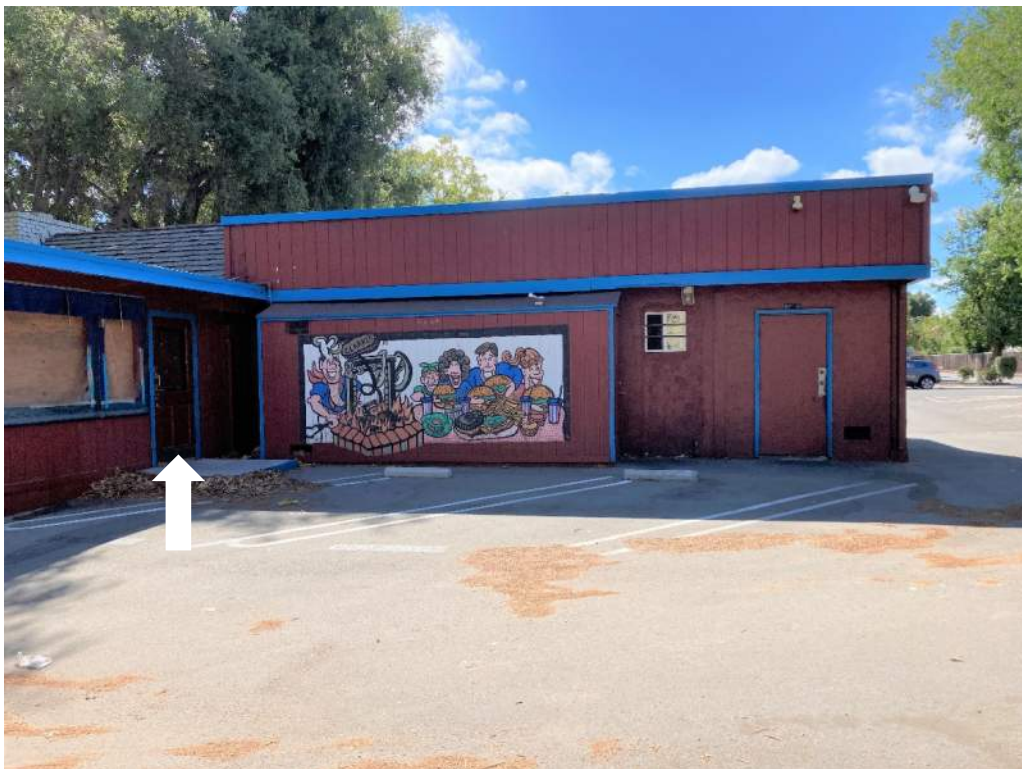
Photo 4. Northwest façade with mural. Entrance at arrow. Facing southeast. Photo taken 6/22/2021.

A planter box of painted white brick extends from the chimney almost the full length of the primary façade. Additional brickwork is located under the wood-framed windows. All brickwork is running bond with a soldier course along the top edge (Photo 2). The two entrances are located at the rear of the left and right wings. Window openings adjacent to the entrances have been boarded up (see Photos 1 and 4).

Both the southeast and northwest facades have shed-roof additions. The one located on the northwest façade has a mural of a barbeque spit and a family enjoying their meal. The southeast façade also features a bump-outs for the restroom (see Photo 5). Wooden posts that have been painted blue are located along the southeast and northwest; the posts are connected by thick nautical rope.

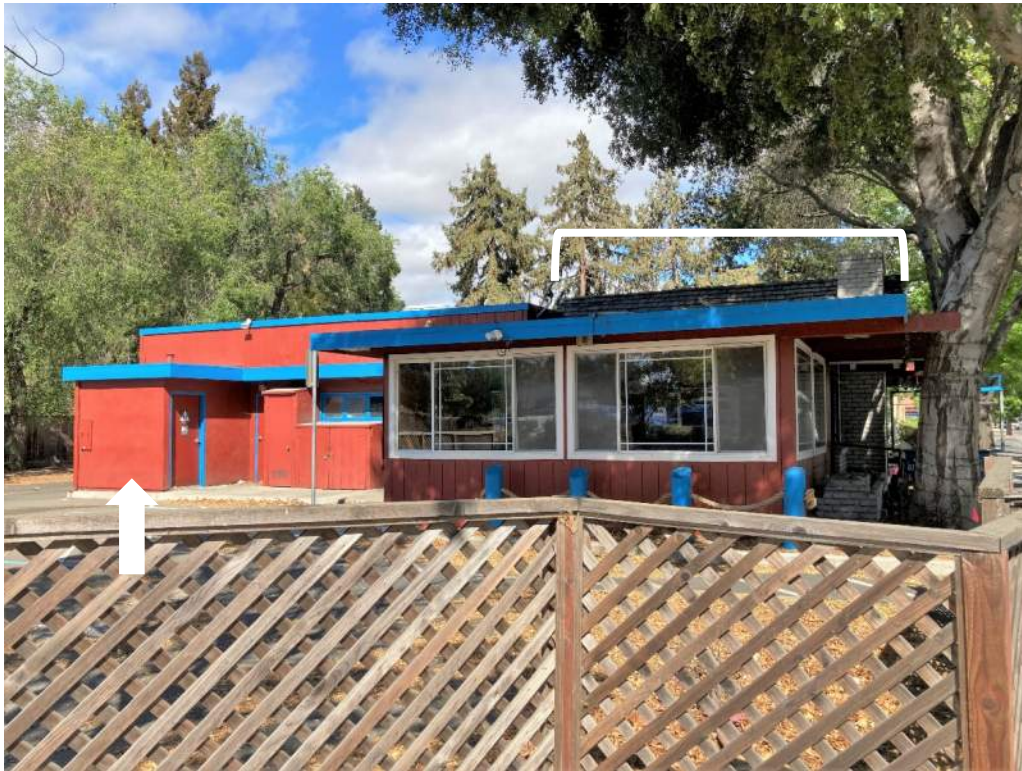
Photo 5. Southeast façade. Bathroom bump out at arrow. Original building portion at bracket. Photo taken 6/22/2021.

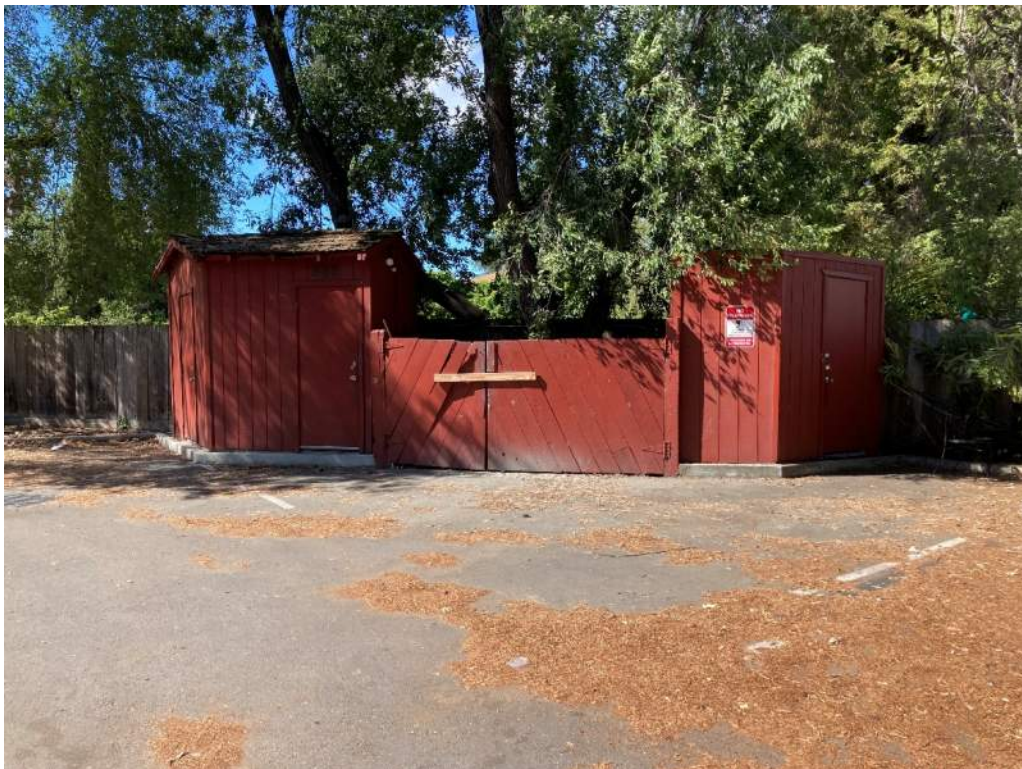
Photo 6. Accessory buildings at rear of parking lot. View to the west. Photo taken 6/22/2021.

Two small accessory buildings are located at the rear of the parking lot. The space between them is enclosed with a wooden fence, likely used for dumpster storage (Photo 6).
