## Attachment D – Biological Resources Letter Report

**Subject: Biological Resources Letter Report for the Tideline Kensho Residential Project**

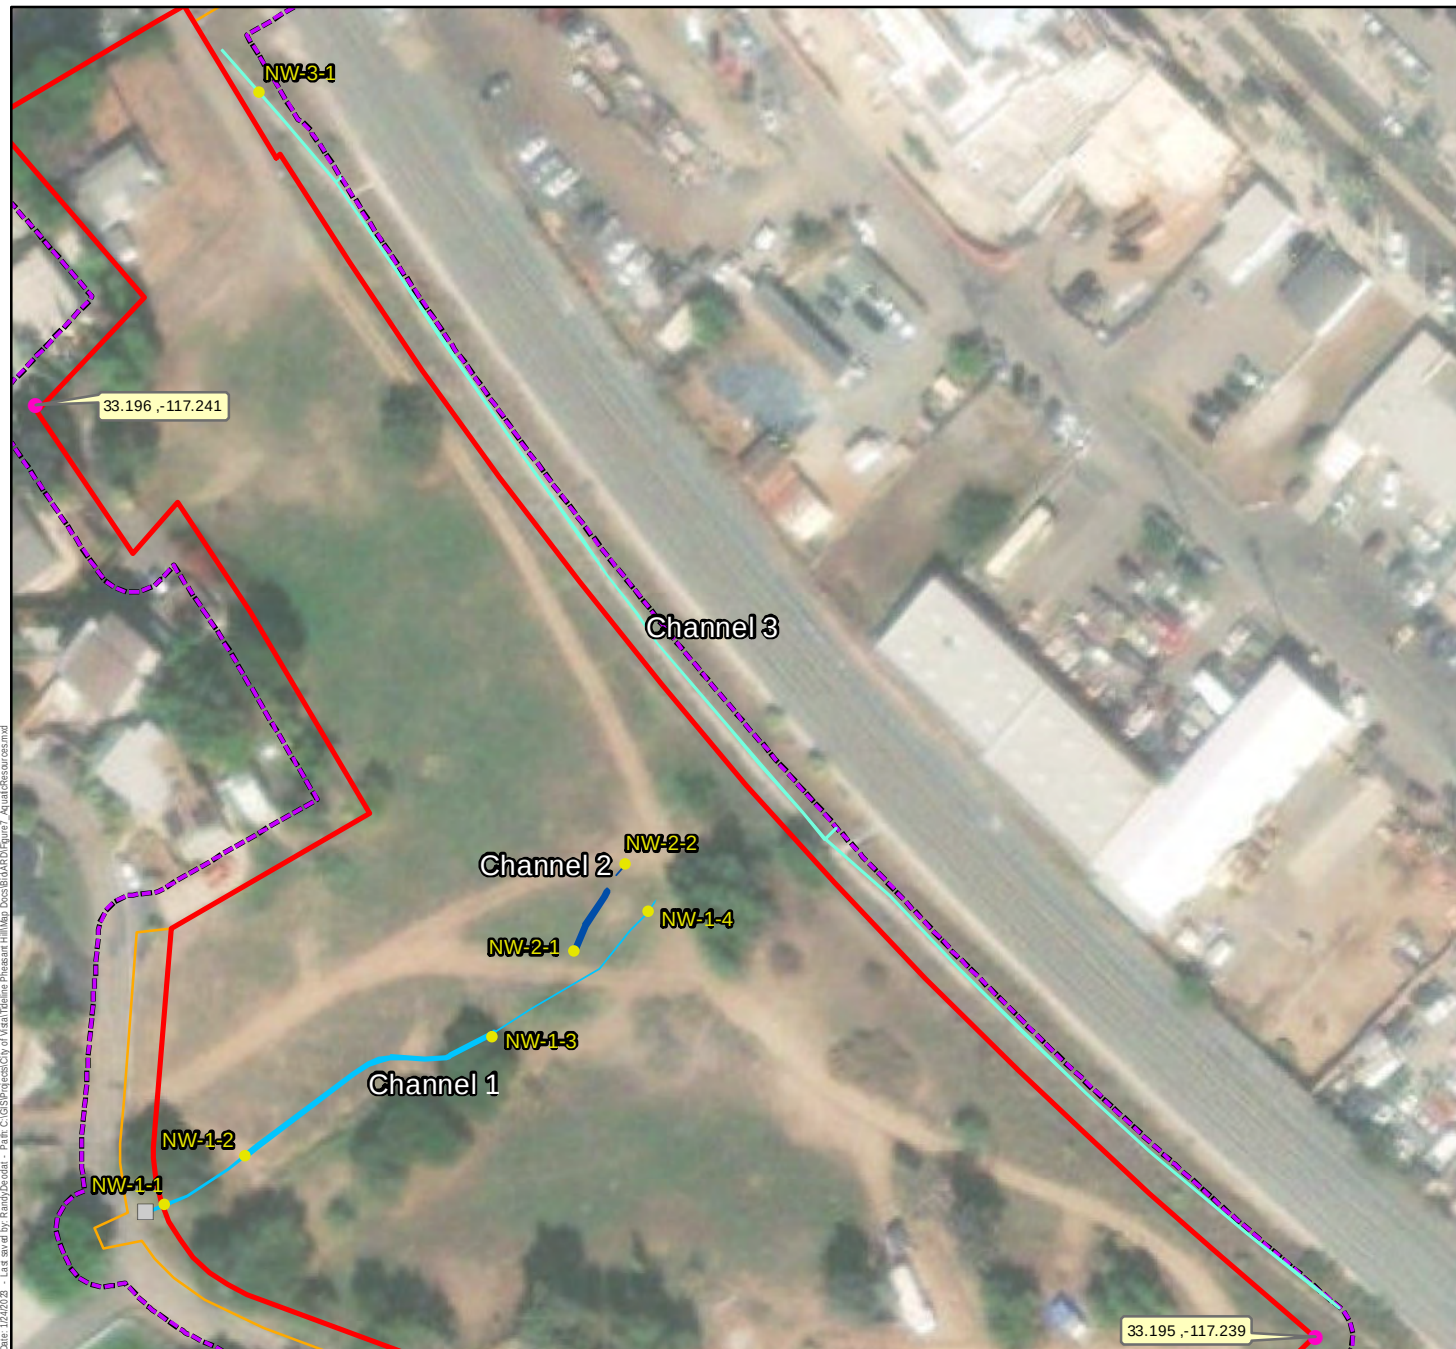
### Figure 7

Three non-wetland water channels were observed on the Project site (Figure 7, Aquatic Resources). One approximately 0.016-acre (309-linear-foot) earthen-bottomed non-wetland water, Channel 1, was observed starting on the western edge of the Project site at the outfall of an approximately two-foot-diameter corrugated metal pipe and extending west to east through the central portion of the Project site where it becomes undefined

as it disappears into a dirt road (Rhoda Lane) that runs along the eastern side of the Project site (Figure 7). One approximately 0.003-acre (43-linear-foot) earthen-bottomed non-wetland water, Channel 2, was observed starting in the disturbed uplands in the central portion of the Project site and extending east where it becomes undefined as it meets with the Rhoda Lane dirt road that runs along the eastern side of the Project site (Figure 7). One approximately 0.02-acre (893-linear-foot) concrete-lined non-wetland water, Channel 3, was observed entering the southeastern corner of the survey area and ending in a disturbed upland area south of Guajome Street (Figure 7). Channel 3 is connected to a larger concrete channel to the east that is directed through a stormwater culvert under Guajome Street.

The non-vegetated earthen-bottom Channels 1 and 2 observed in the center of the survey area and concrete-lined Channel 3 observed along the eastern edge of the survey area during the aquatic resources delineation fieldwork were not identified on the NWI or NHD mapping results (USFWS 2023a; USGS 2023). The two non-vegetated channels appear to have formed as a result of erosion from stormwater flows directed onto the Project site through a corrugated metal stormwater pipe on the western edge of the Project site. Channel 3 is an artificial, concrete-lined channel that was constructed to capture and direct stormwater flows away from the SPRINTER transit right-of-way. No other aquatic resources were identified in the NWI or NHD mapping results or observed in the survey area or off-site improvements area during the survey.

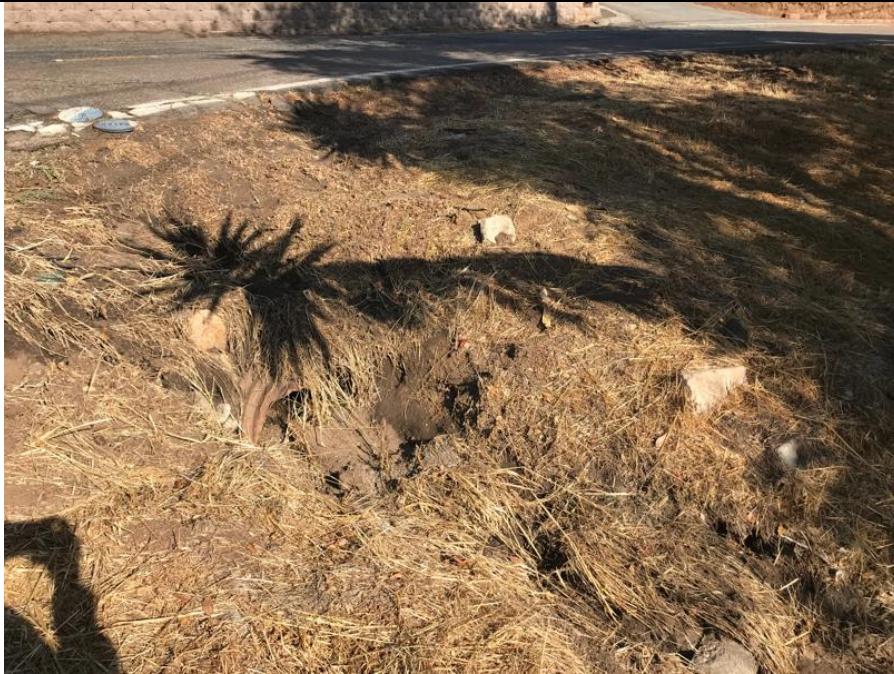
**Photograph 1:** (33.194999 N, -117.240876 W) Northwest-facing view of the western reach of the two-foot-wide Channel 1 in the western portion of the Project site. This photo also shows where the highly eroded channel forms at the outlet of the two-foot-diameter corrugated metal culvert on the western edge of the Project site. This photo shows where Sampling Point NW-1-1 was taken to determine the presence of OHWM indicators. This photo also shows the sediment clogging the corrugated metal culvert and the erosion of the channel at the outlet of the culvert.

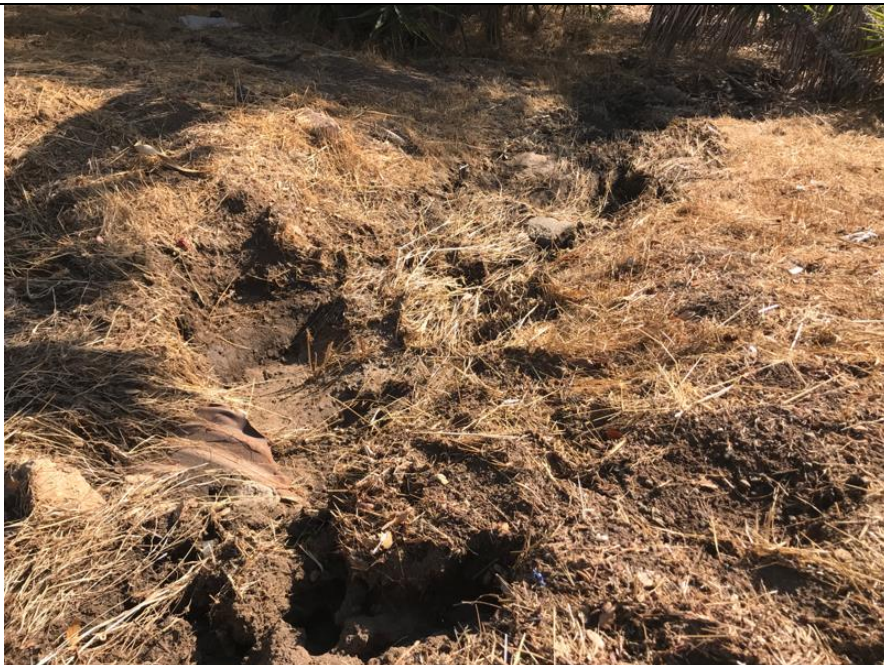
**Photograph 2:** (33.194999 N, -117.240876 W) East-facing view of the western reach of the two-foot-wide earthen-bottom channel in the western portion of the Project site. This photo shows where Sampling Point NW-1-1 was taken to determine the presence of OHWM indicators.

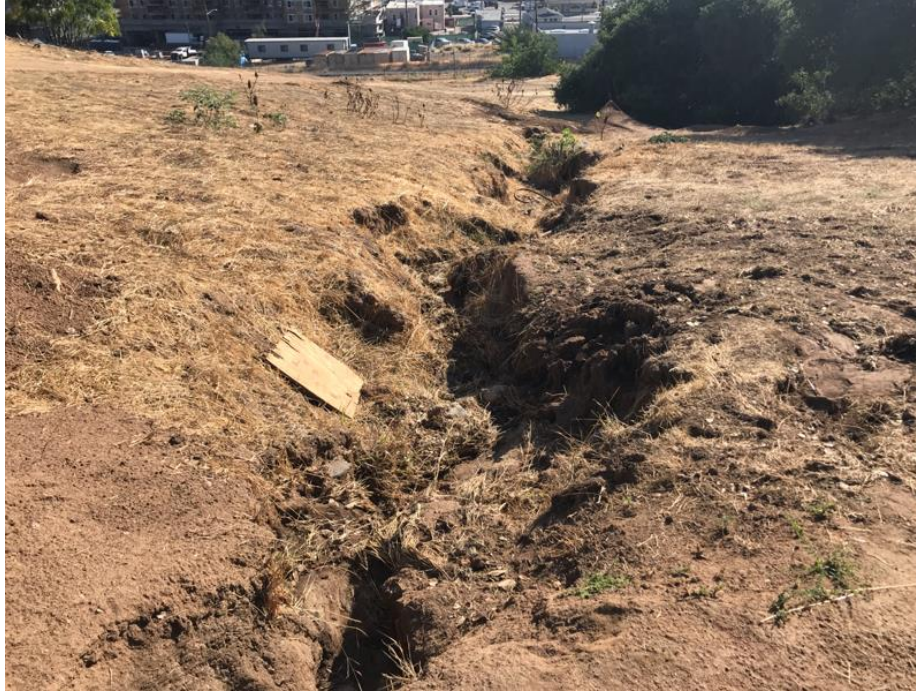
**Photograph 3:** (33.195070 N, -117.240741 W) East-facing view of the three-foot-wide Channel 1 in the western portion of the Project site. This photo shows where Sampling Point NW-1-2 was taken to determine the presence of OHWM indicators.

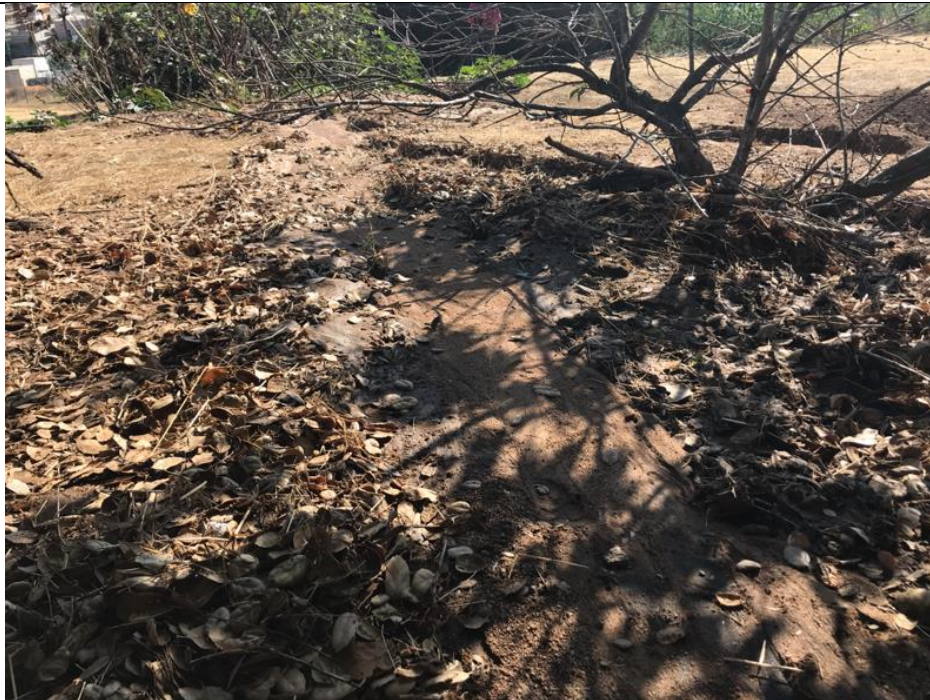
**Photograph 4:** (33.195244 N, -117.240321 W) East-facing view of the one-foot-wide Channel 1 in the central portion of the Project site. This photo shows where Sampling Point NW-1-3 was taken to determine the presence of OHWM indicators. This photo shows where Channel 1 runs through the interior coast live oak woodland in the central portion of the Project site and where Channel 1 becomes shallow and changes soil texture.

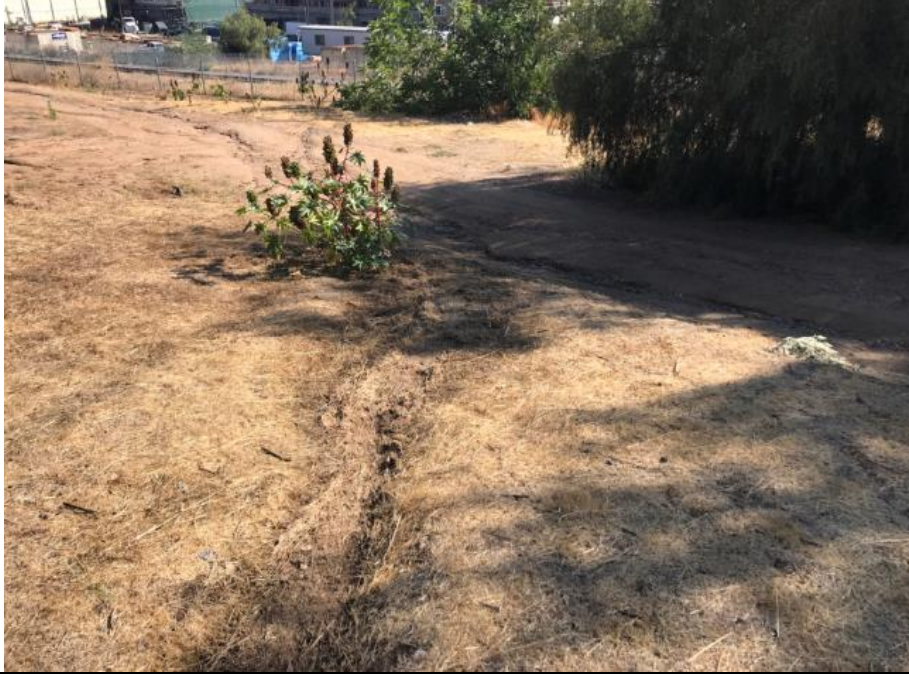
**Photograph 5:** (33.195425 N, -117.240058 W) East-facing view of the 0.5-foot-wide Channel 1 in the eastern portion of the Project site. This photo shows where Sampling Point NW-1-4 was taken to determine the presence of OHWM indicators. This photo also shows where the defined Channel 1 ends and flows into a dirt road on the eastern side of the Project site.

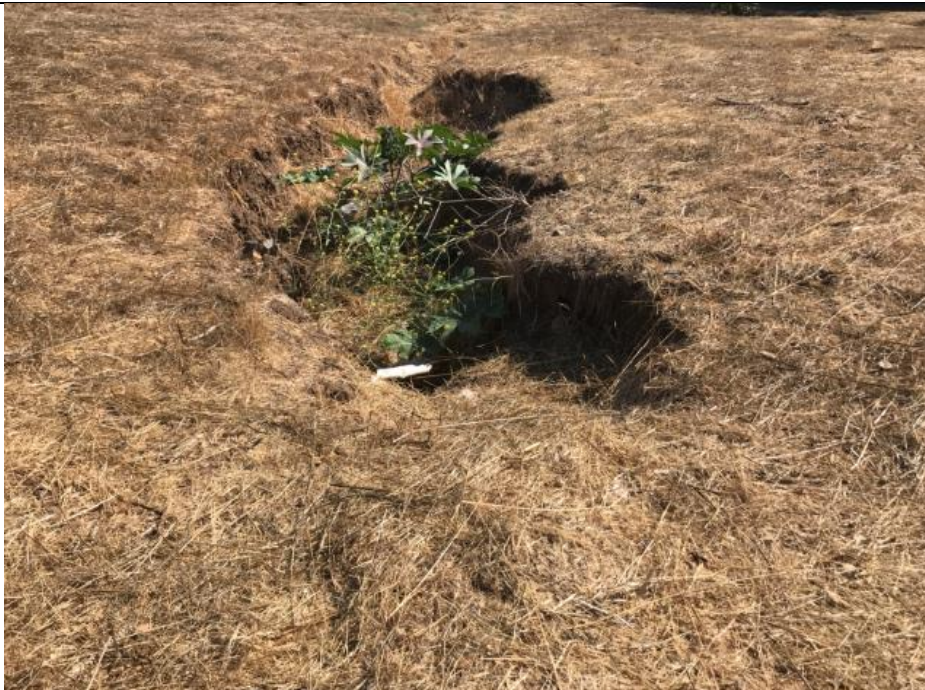
**Photograph 6:** (33.195367 N, -117.240182 W) East-facing view of the 3.5-foot-wide Channel 2 in the central portion of the Project site. This photo shows where Sampling Point NW-2-1 was taken to determine the presence of OHWM indicators. This photo also shows where Channel 2 formed from apparent erosion.

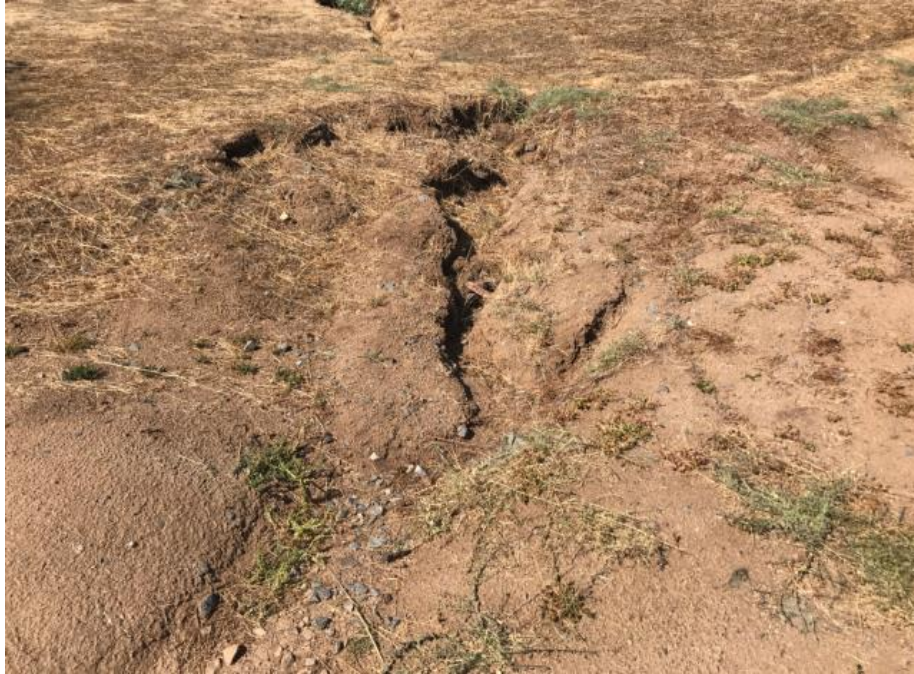
**Photograph 7:** (33.195493 N, -117.240097 W) West-facing view of the one-foot-wide Channel 2 in the eastern portion of the Project site. This photo shows where Sampling Point NW-2-2 was taken to determine the presence of OHWM indicators.

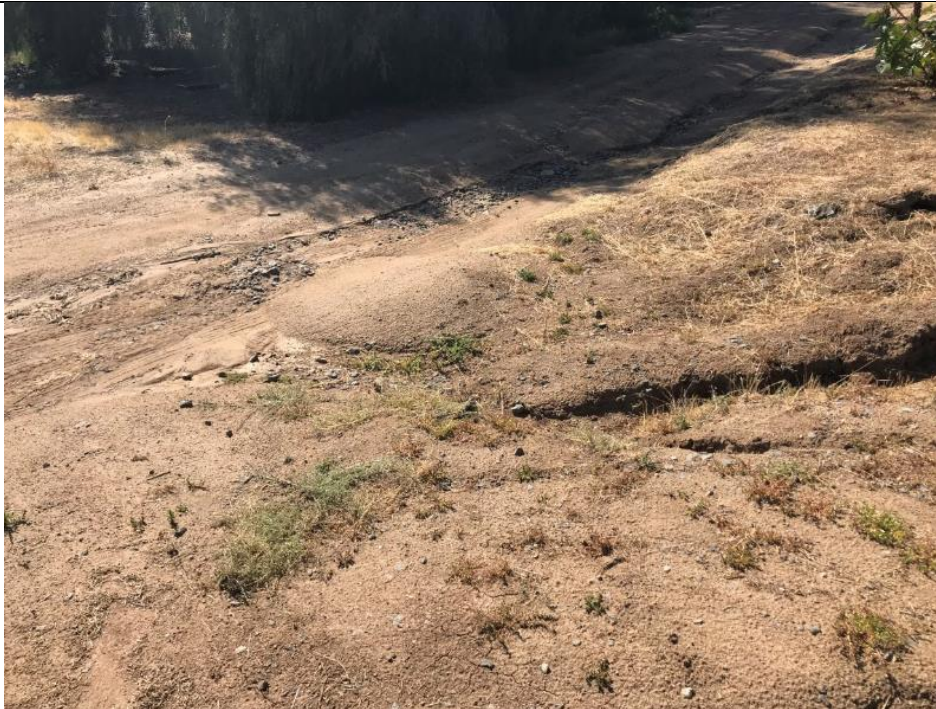
**Photograph 8:** (33.195493 N, -117.240097 W) Southeast-facing view of the one-foot-wide Channel 2 in the eastern portion of the Project site. This photo shows where Sampling Point NW-2-2 was taken to determine the presence of OHWM indicators. This photo shows where the defined Channel 2 ends and flows into the dirt road on the eastern side of the Project site.

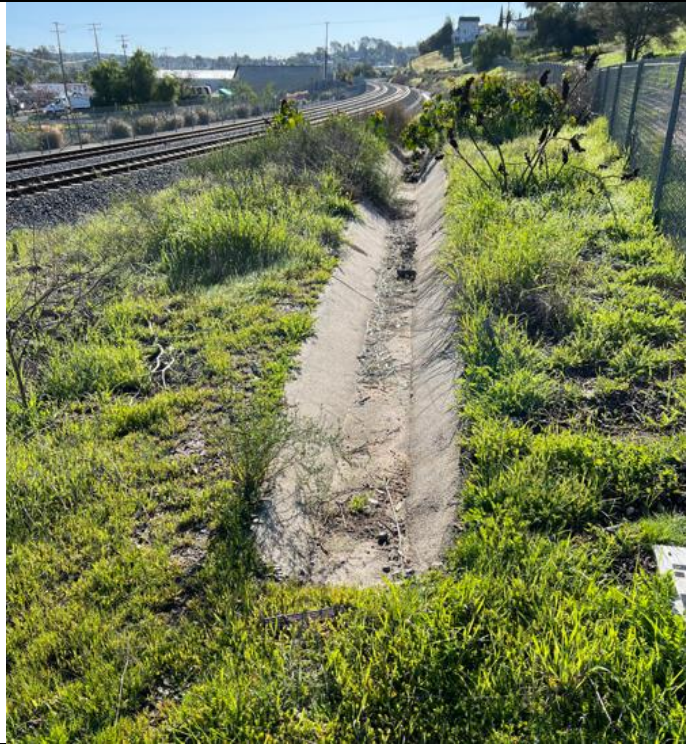
**Photograph 9:** (33.196593 N, -117.240733 W) Southeast-facing view of the one-foot-wide Channel 3 along the eastern edge of the survey area. This photo shows where Sampling Point NW-3-1 was taken to determine the presence of OHWM indicators. The northern extent of the concrete-lined channel is also visible in the lower-half of the photo.

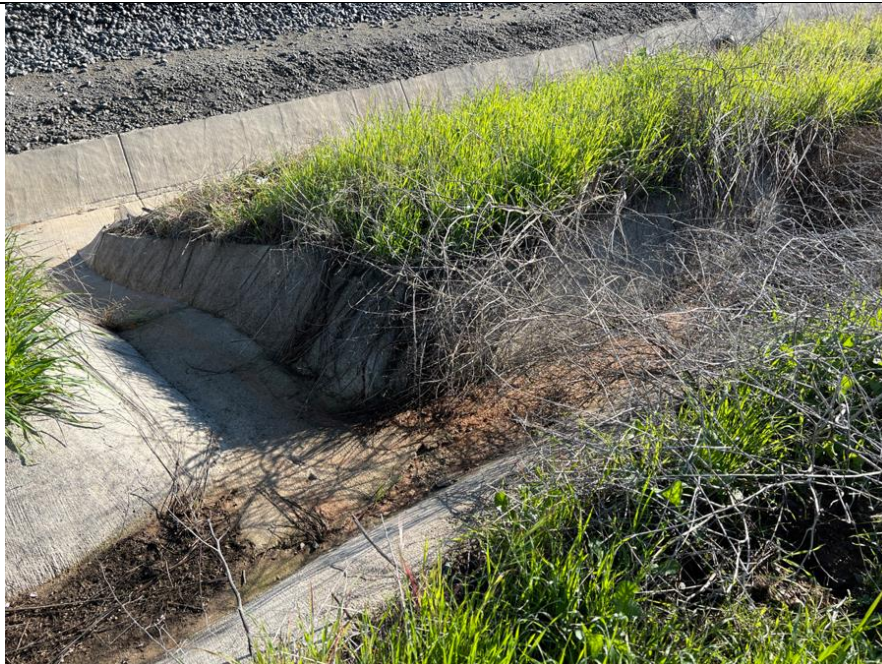
**Photograph 10:** (33.196412 N, -117.240628 W) East-facing view of Channel 3 along the eastern edge of the survey area. This photo shows where Channel 3 connects to another larger concrete-lined channel that runs parallel east of the survey area through the SPRINTER transportation right-of-way.

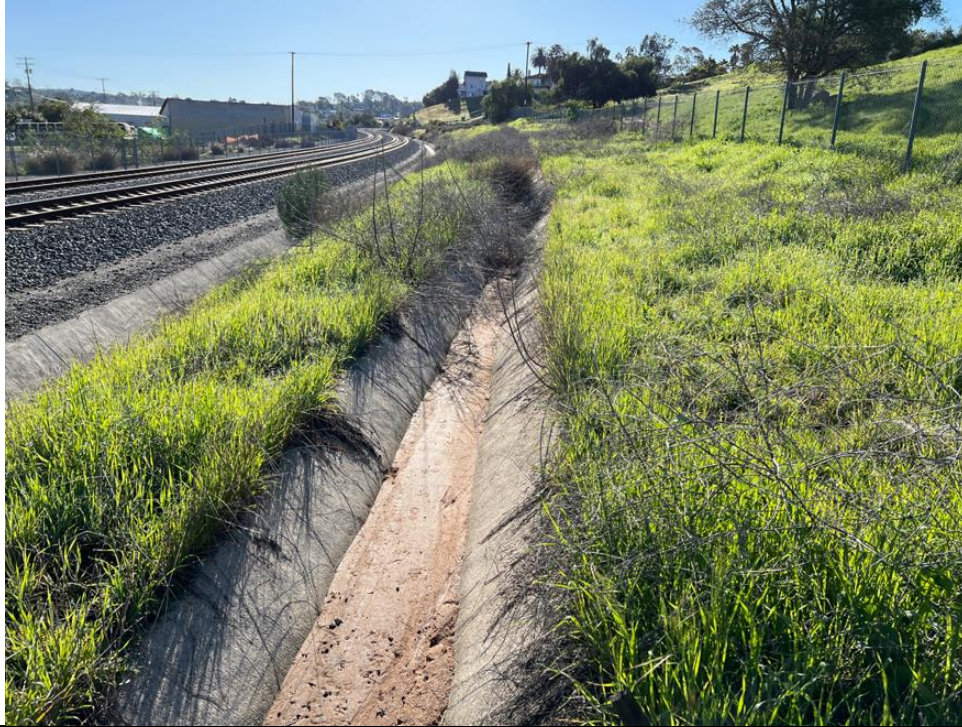
**Photograph 11:** (33.196216 N, -117.240421 W) Southeast-facing view of Channel 3. This photo shows the upland grasses and weeds growing outside of the channel banks. The eastern side of the Project site and the chain-link fence separating it from the eastern portion of the survey area is visible in the upper right-hand-corner of the photograph.

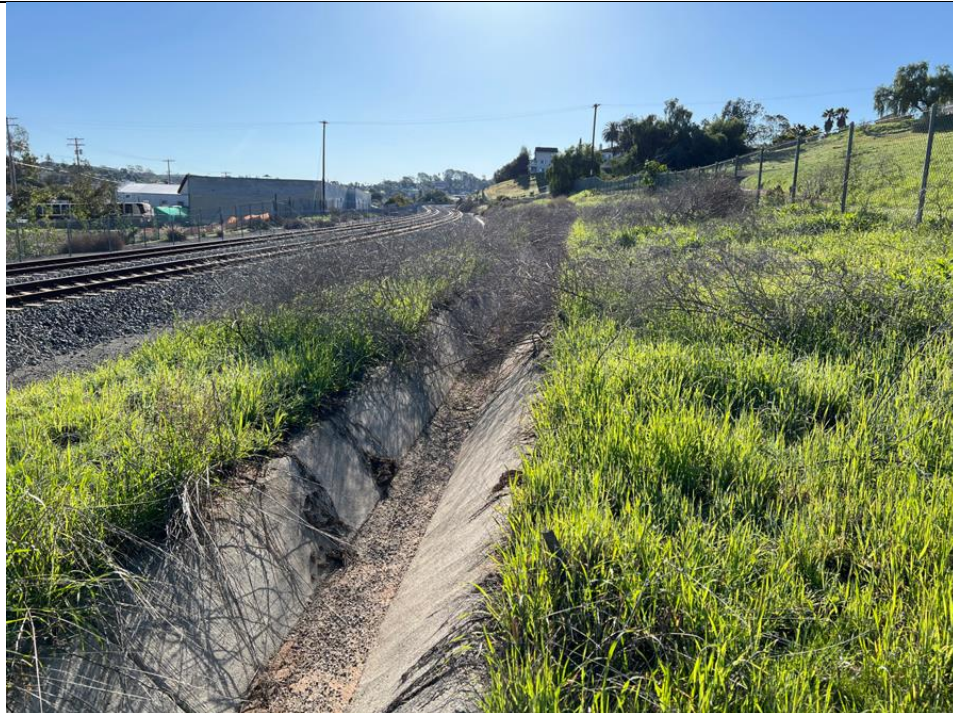
**Photograph 12:** (33.195849 N, -117.240079 W) Southeast-facing view of Channel 3 along the eastern edge of the survey area. Channel 3 continues southeast where it enters the southeastern corner of the survey area.

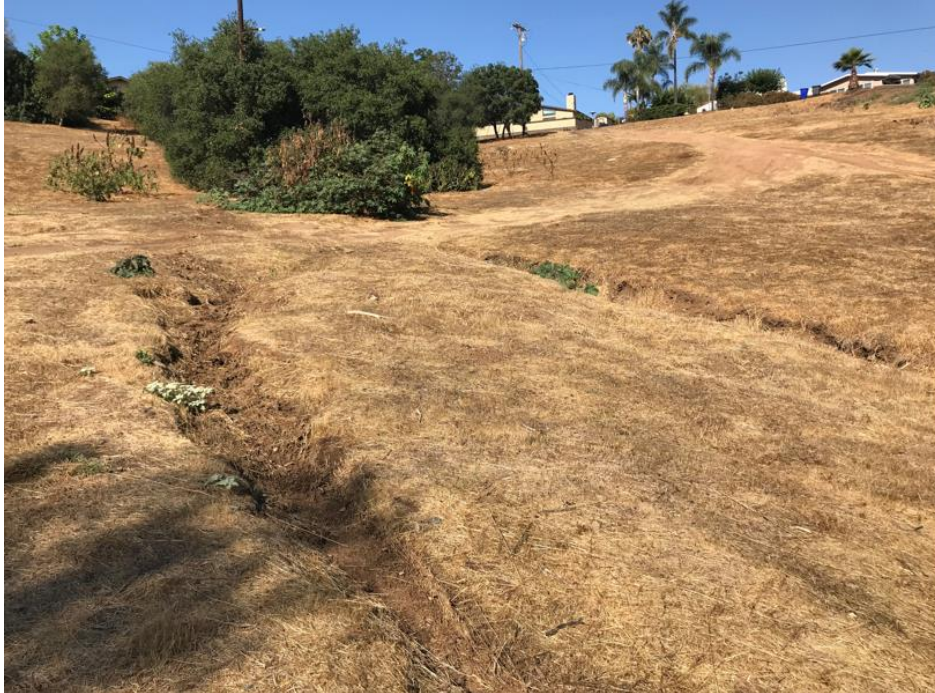
**Photograph 1:** (33.195493 N, -117.240097 W) Southwest-facing and up-slope view of the central and western portions of the Project site. This photo shows the disturbed habitat surrounding the non-vegetated Channels 1 and 2 in the foreground and the coast live oak woodland in the background.

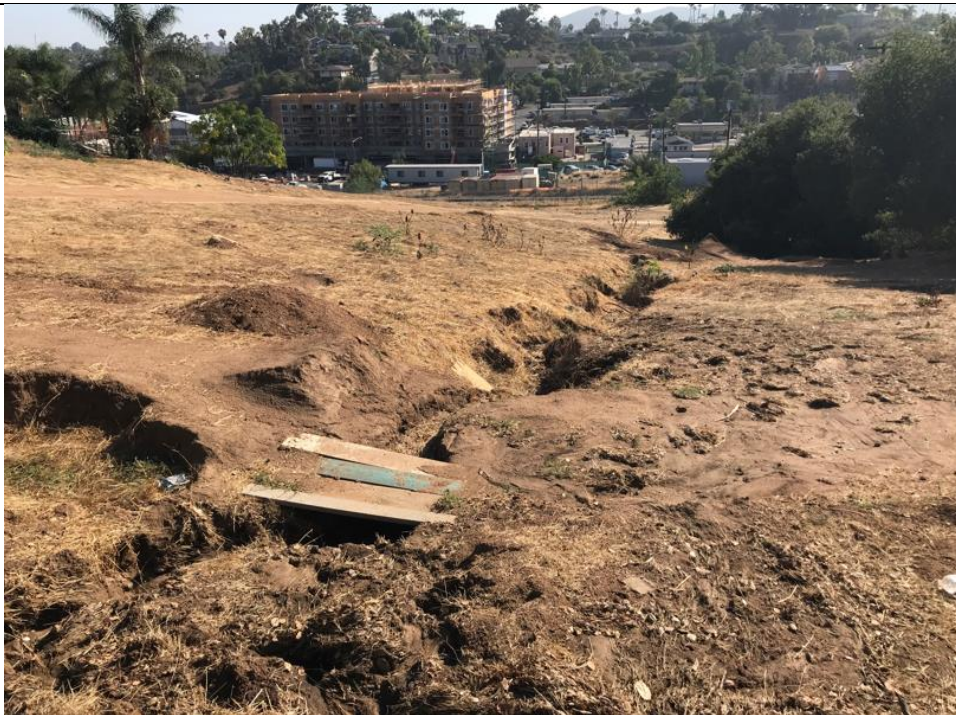
**Photograph 2:** (33.194999 N, -117.240876 W) Northeast-facing and down-slope view of the central and western portions of the Project site. This photo shows the disturbed habitat surrounding the non-vegetated Channel 1 in the foreground and the coast live oak woodland in the right-hand-side background.

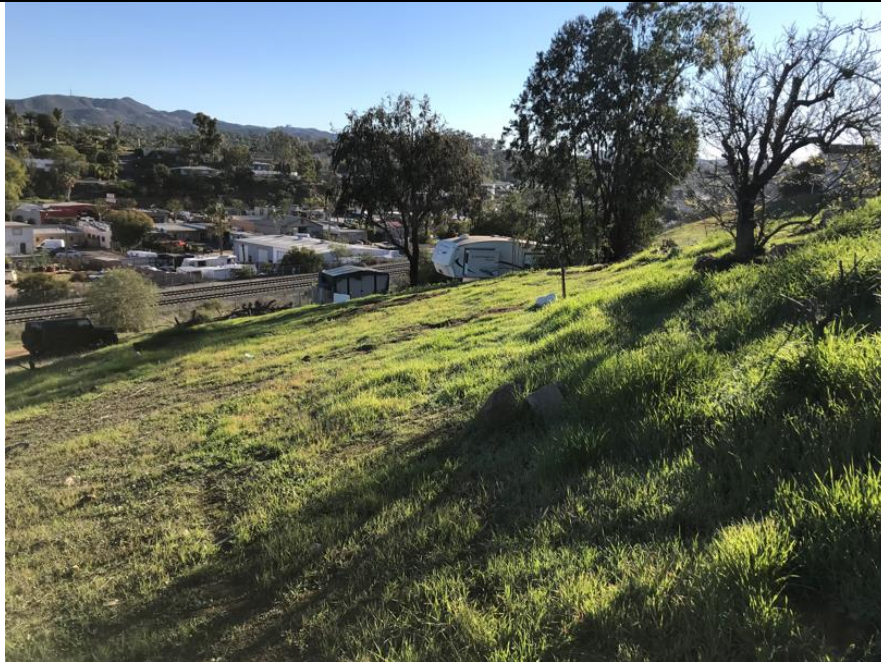
**Photograph 3:** (33.194887 N, -117.239800 W) East-facing view of the southern portion of the Project site. This photo shows the disturbed habitat in the foreground and the recreational vehicle (RV) in the background.

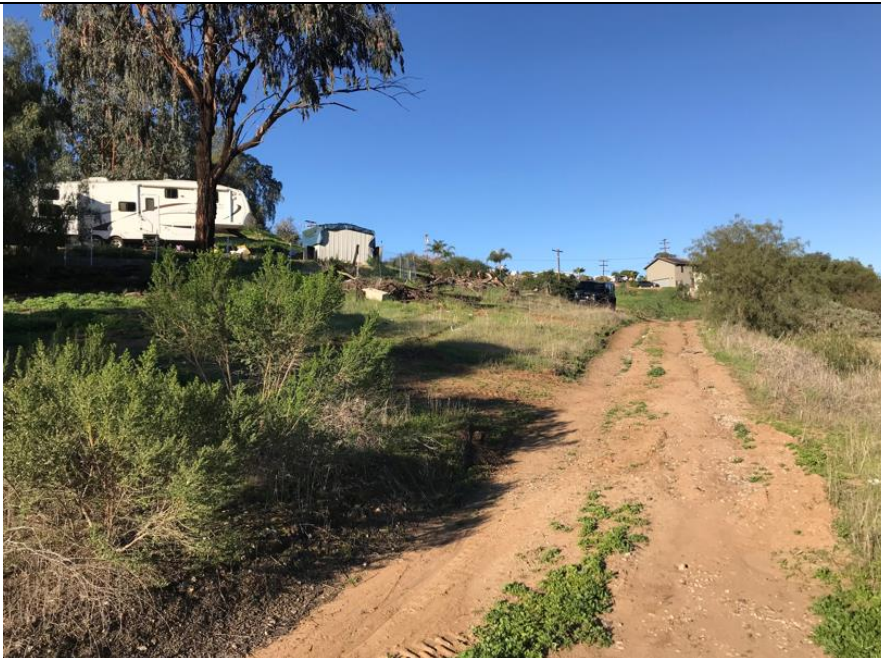
**Photograph 4:** (33.194857 N, -117.239358 W) Northwest-facing view of the southern portion of the Project site. This photo shows the Rhoda Lane dirt road in the foreground, non-native grassland in the right-hand-side background, and the RV and associated storage shed in the left-hand-side background.
