**NOTICE OF EXEMPTION ATTACHMENT**  
**SUPPLEMENTAL INFORMATION AND CONSISTENCY FINDINGS FOR**  
**CLASS 1 CATEGORICAL EXEMPTION**  
**GRASSHOPPER SLOUGH LEVEE MODIFICATIONS PROJECT**

Reclamation District 2103 is proposing to improve a portion of their levee along Grasshopper Slough in Yuba County, California. The Proposed Project includes the repair of waterside streambank erosion, removal and abandonment of decommissioned irrigation pipes, filling a landside ditch, and resurfacing the levee crown in order to meet standards set by FEMA. The levee improvements proposed and described below entail the modifications necessary to ensure long-term levee stability and to meet FEMA levee accreditation requirements.

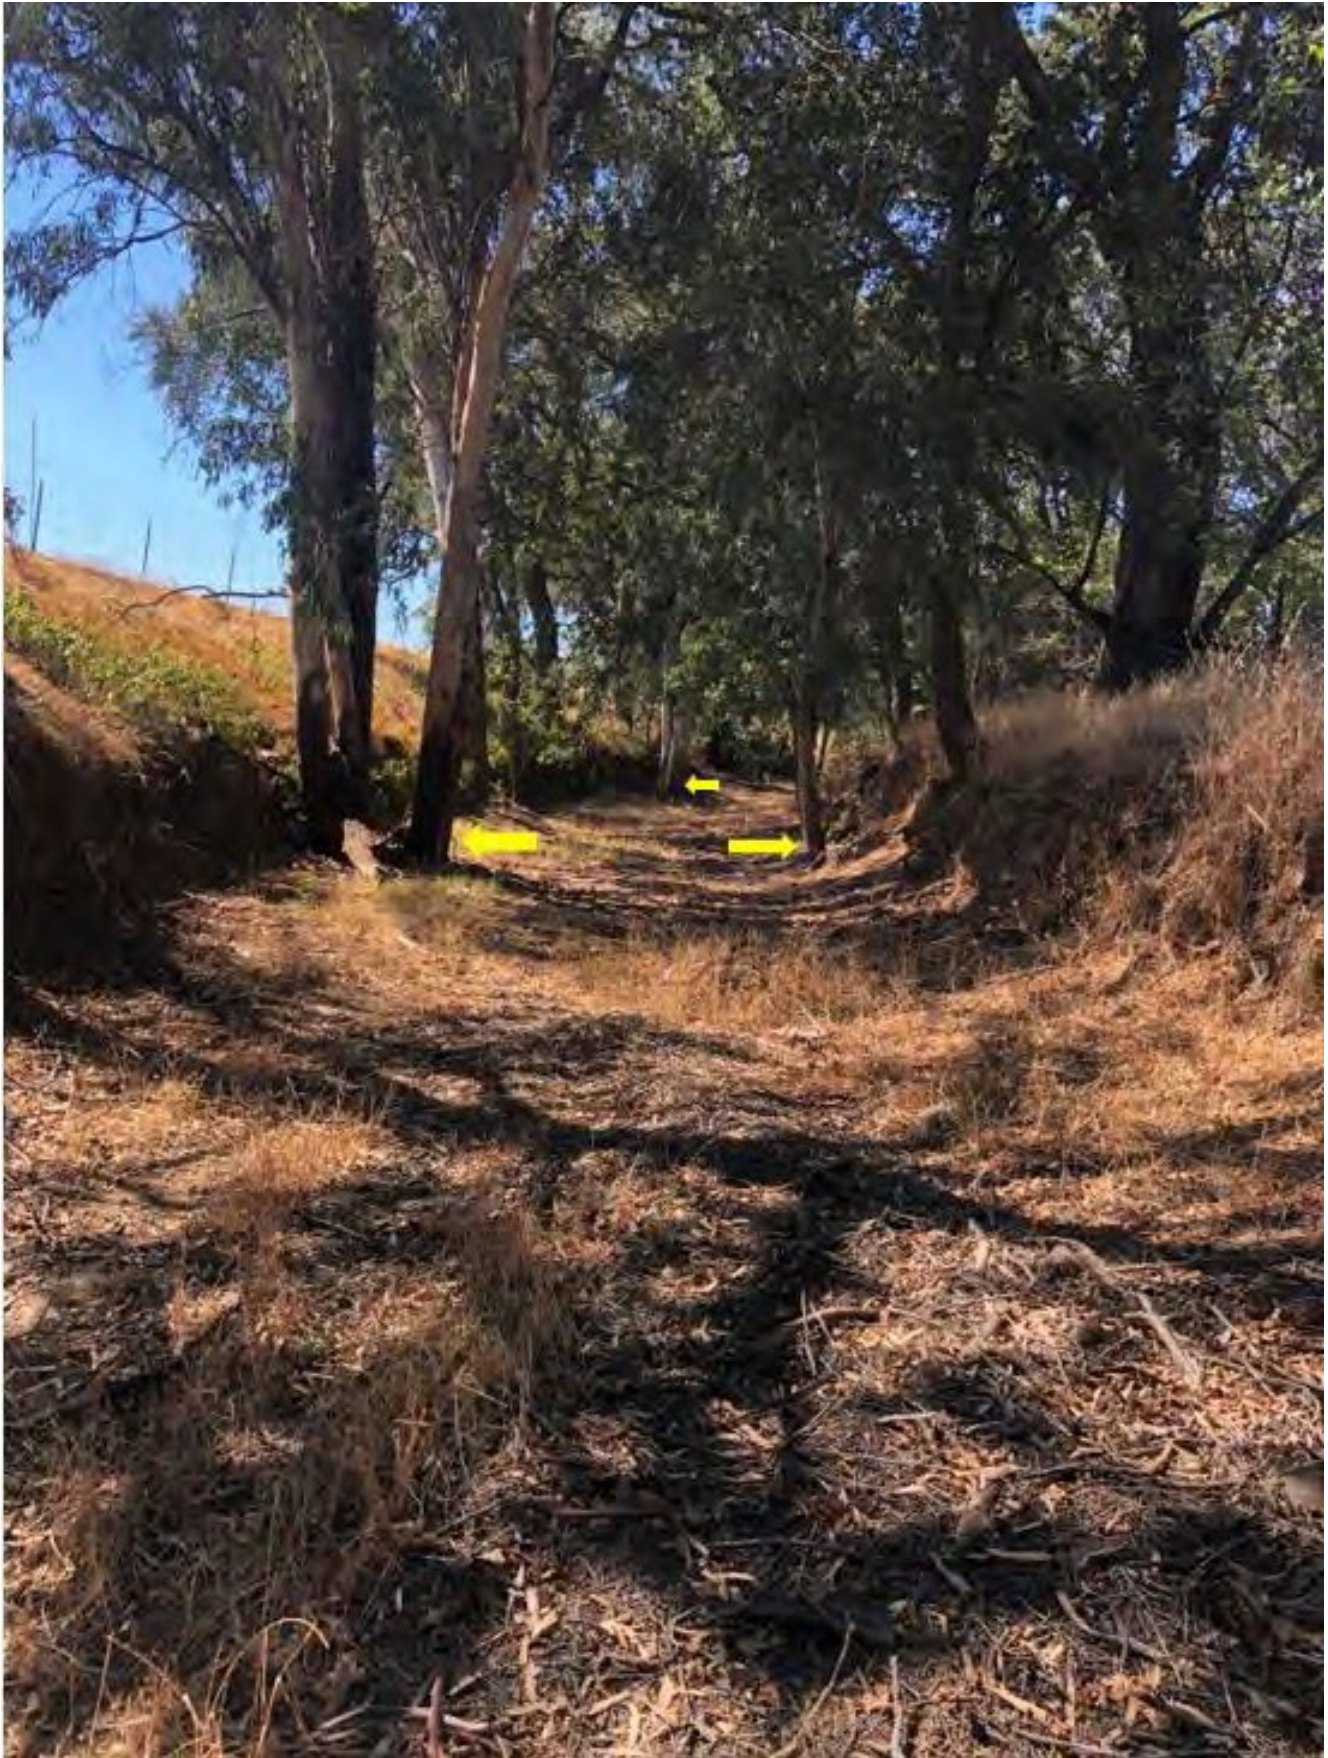
Figure 9. Typical view of Grasshopper Slough channel, non-native trees to be removed in the low flow channel (yellow arrows) and levee erosion repair area on the left.

The project site is located within Grasshopper Slough, an intermittent stream channelized by a levee on the south bank with an incised channel along most of the north bank (**Figure 9**). The topography of the project area includes the Grasshopper Slough channel, the levee, and adjacent agricultural fields (**Figure 11**). Habitat types present include intermittent riverine, riparian, and agriculture fields. Land use for the surrounding region is primarily agriculture.

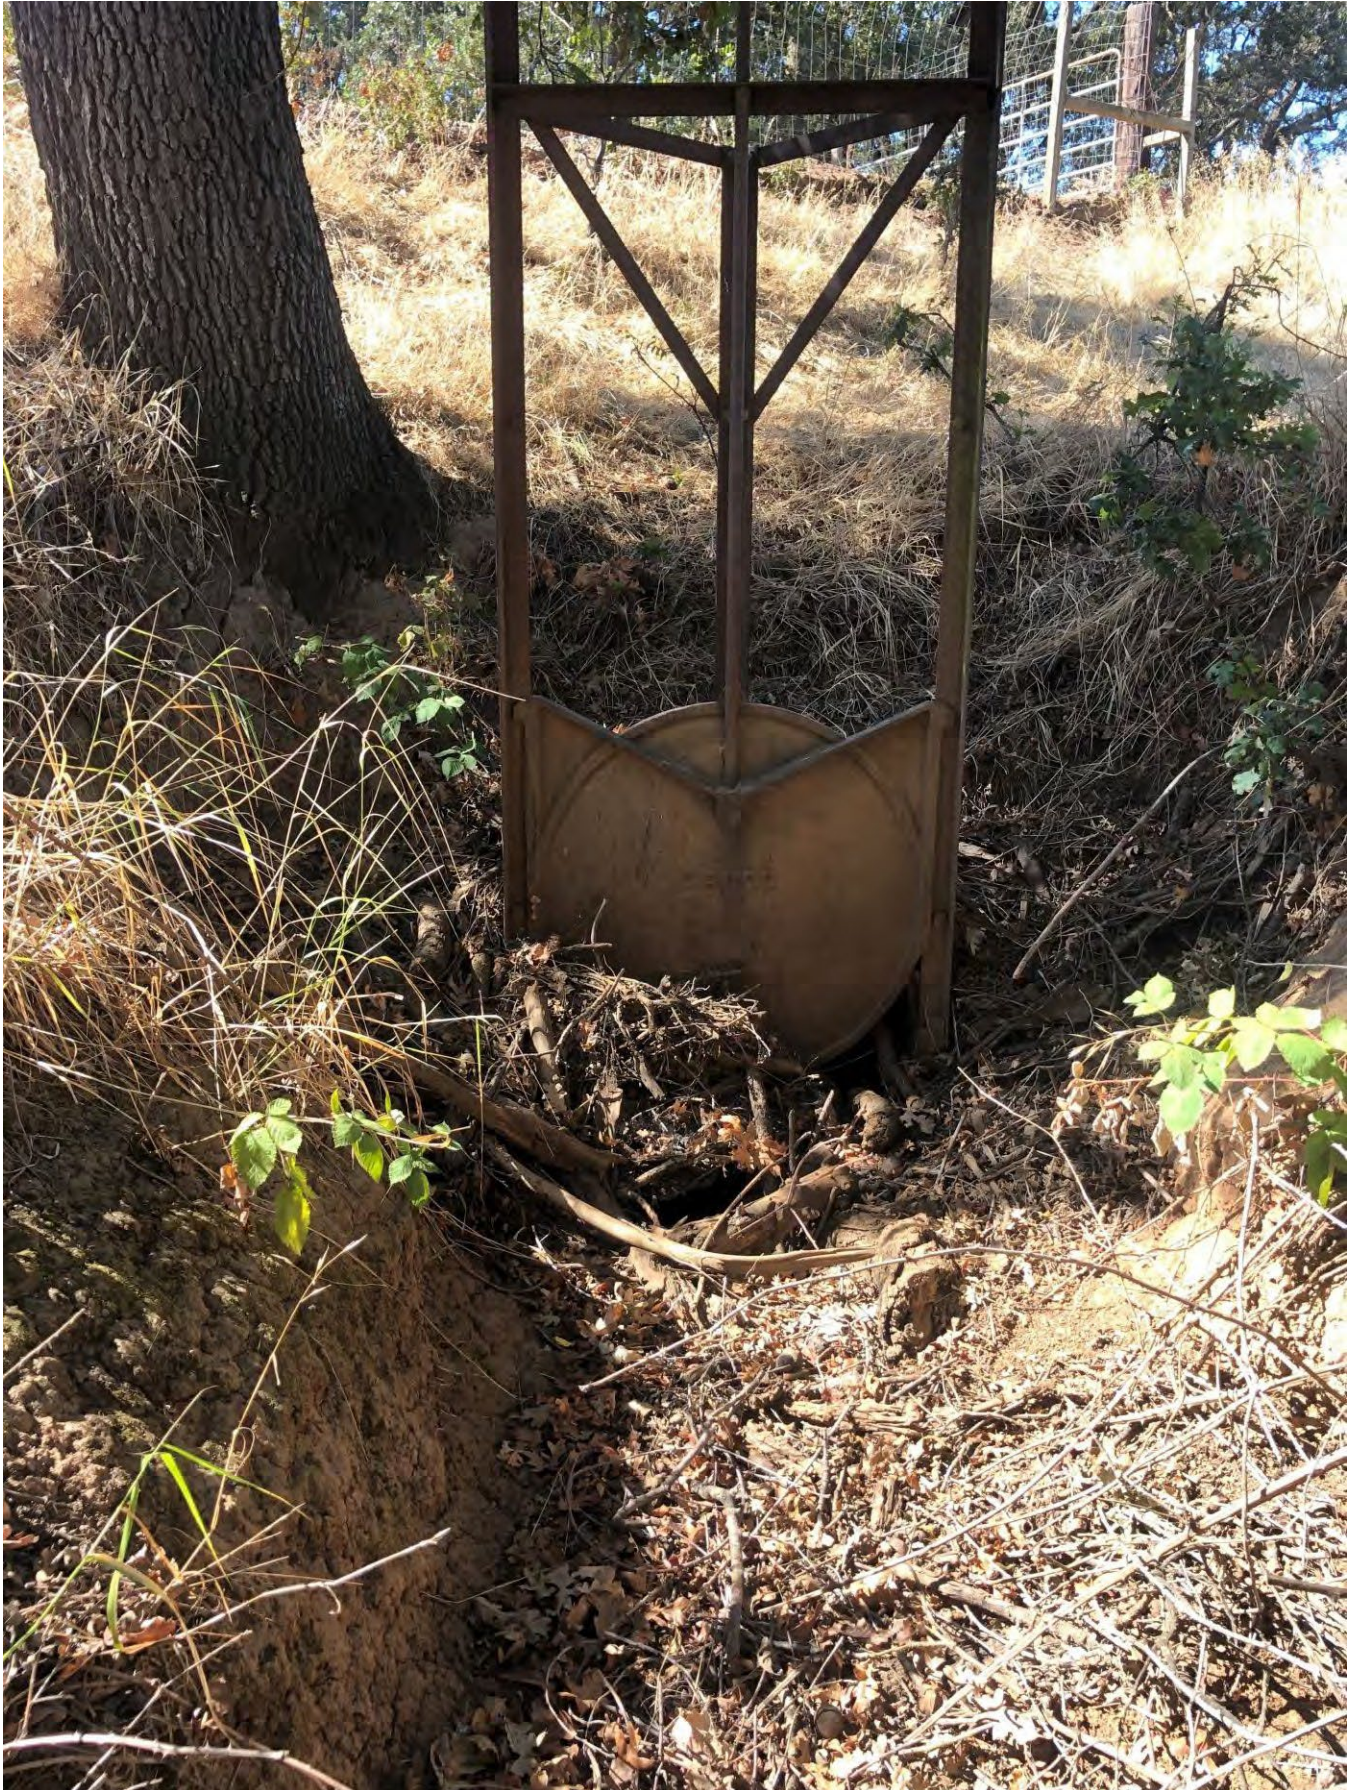
Figure 10. View of a culvert pipe to be abandoned in order to preserve surrounding mature oak trees.

One existing and abandoned irrigation pipe at levee station 1+60, which bisects the levee, would be abandoned-in-place in order to avoid impacts to surrounding native oak trees (**Figure 10**).

The pipe would then be pressure grouted to fill the pipe completely. The grouting process would require approximately 10 yards of cement. The waterside end of the pipe would receive backfill to fill in the drainage channel connecting the pipe to the main channel.

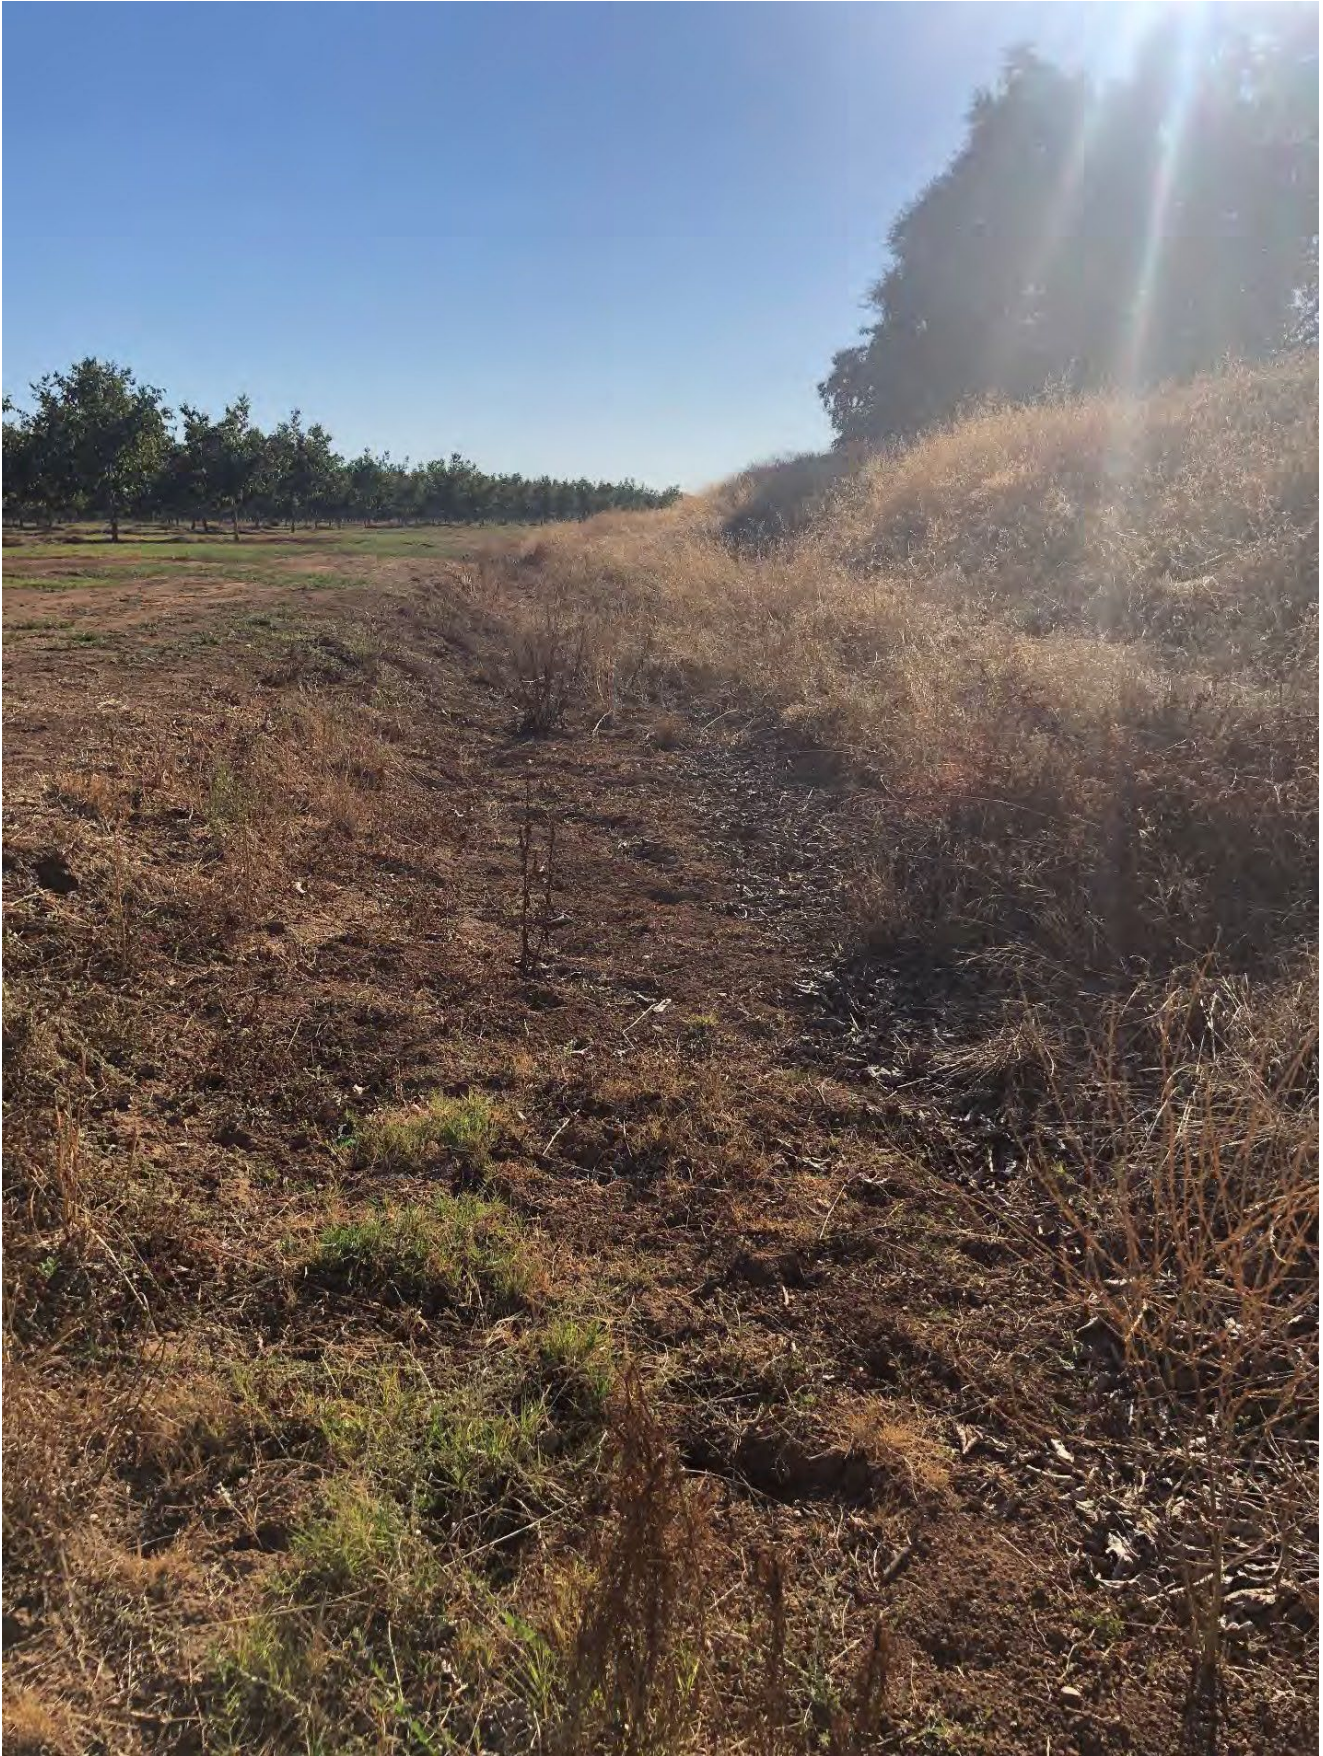
Figure 11. View of irrigation ditch, levee on the right, and agriculture fields to the left.

A decommissioned irrigation ditch at the landside toe of the levee would be filled (**Figure 11**). Approximately 1,425 cubic yards of Type 2 fill material will be placed within the ditch segment. The surface would be finished at a minimum 2% slope to match the existing levee slope (**Figure 2**).
