# Hicks Canyon Channel Restoration Project

## Historic Resources Evaluation Report

January 2023 | 04663.00002.001

Report Title: Historic Resources Evaluation Report the Hicks Canyon Channel Restoration Project, City of Irvine, Orange County, California

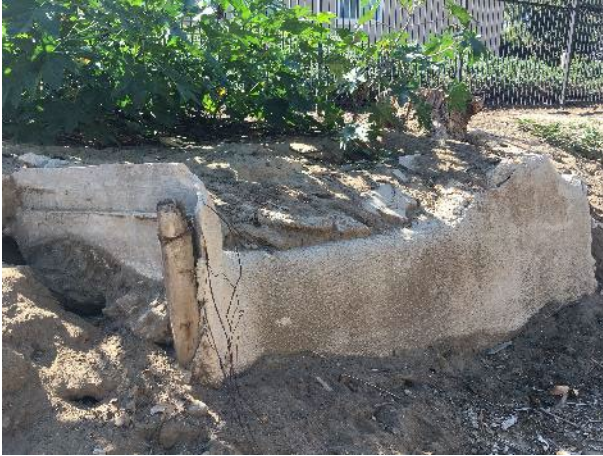
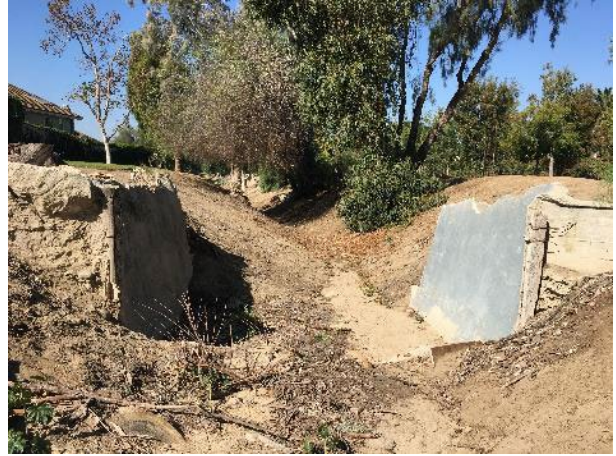
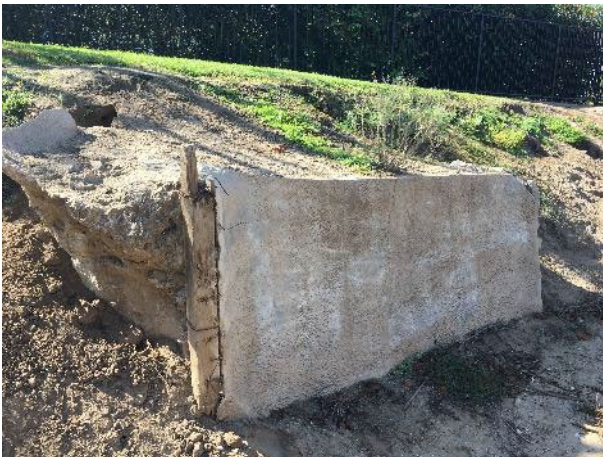
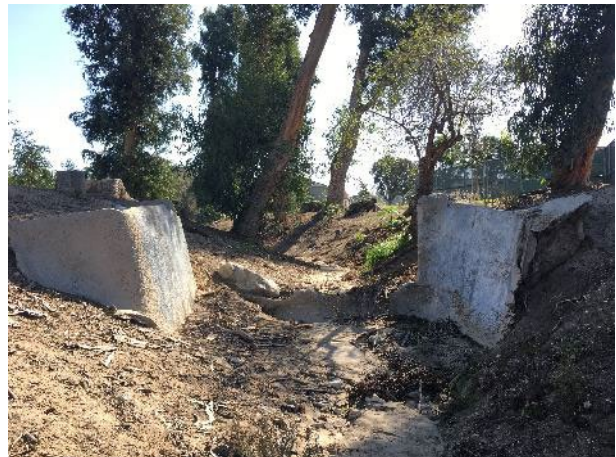
*Plate 7. Guniting channel wall #6  
(southwest perspective)*

*Plate 8. Guniting channel wall #8  
(west perspective)*

*Plate 9. Guniting channel wall #9  
(northeast perspective)*

*Plate 10. Guniting channel wall #12  
(east perspective)*

All 14 fragments of channel walls are significantly damaged: their upper and side edges are chipped and eroded, bottom portions are covered with silt and sediment, and the wall surfaces are bent and partially recede from the earthen slopes.

The exact date of construction of these channel walls is unknown. They are not shown on any of the available archival documents. A U.S. Army Corps of Engineers report mentions that a portion of Hicks Canyon Wash along the plant nursery was improved with guniting, east of the current project area (between Eastwood Path and Jeffrey Road). According to the report, this portion of the channel was badly damaged in the February 1969 flood (U.S. Army Corps of Engineers 1974: 6, 18; Plates 11-12). The type of construction and materials make it possible to date these structures between 1907 and 1964.

Guniting (or shotcrete) is concrete or mortar conveyed through a hose and pneumatically projected at a high velocity onto a vertical surface. It was invented in 1907 by American taxidermist Carl Akeley to repair the crumbling façade of the Field Columbian Museum in Chicago. Since then, it became widely spread to reinforce excavations, tunnel walls, subways, and natural slopes. Guniting is typically reinforced by steel rods, steel mesh, or fibers. The dry sand and cement mixture is blown through a hose using compressed air, with water being injected at the nozzle to hydrate the mixture as it is released. This relatively cheap construction method does not require significant training and allows pouring walls in place following the shape of the surface.

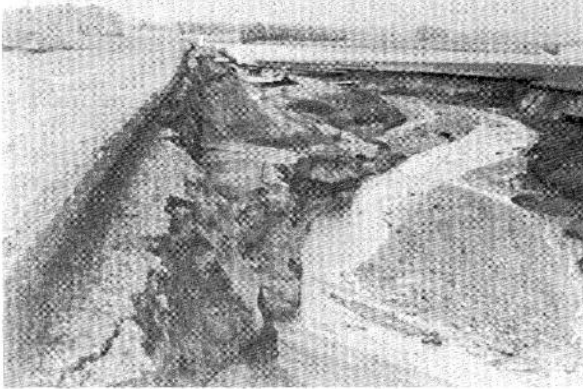
Figure 19 — Extensive channel erosion took place on Hicks Canyon Wash, at Jeffrey Road, during the flood of February 1969. A portion of the improved gunite channel still remains (upper center of photo) several feet above the new channel invert. (Photo courtesy of the Irvine Company.)

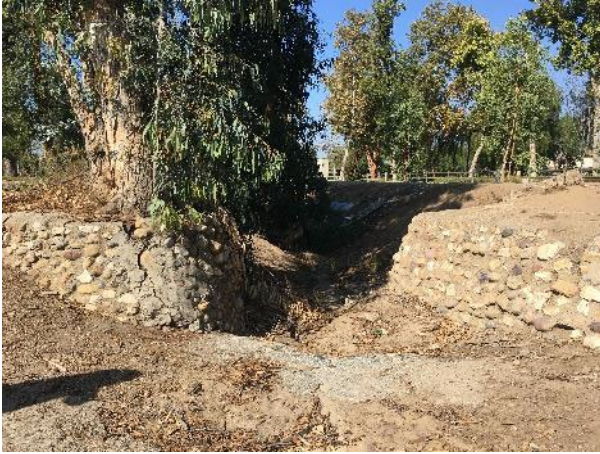
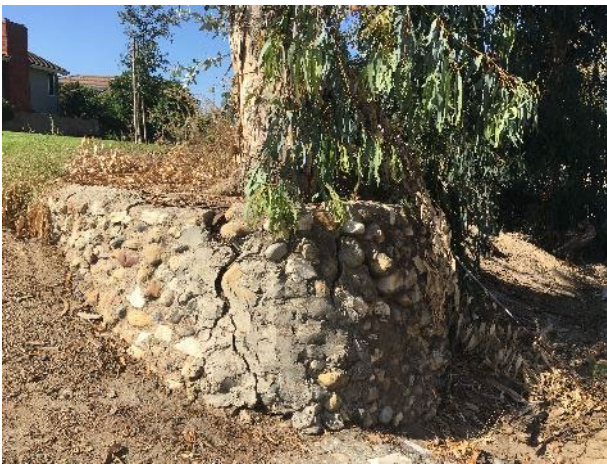
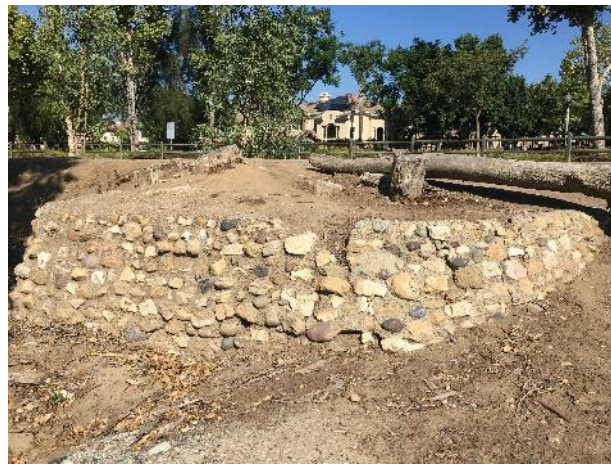
*Plate 15. Creek crossing retaining walls  
(west perspective)*

*Plate 17. Creek crossing retaining walls  
(southwest perspective)*

*Plate 18. Creek crossing retaining walls  
(northwest perspective)*

Northwest and southwest corners of the crossing are improved with curved cobblestone retaining walls. The walls are approximately 5' high and 17' long. Rough cladding includes stones of various sizes and colors, probably brought by the stream and gathered in the surrounding fields, with a few shell inclusions. A concrete patch on the northwest corner exhibits an inscription: "2-2-22 FLS". It may refer to a possible date of the wall construction, February 2, 1922.

The retaining walls are damaged by eucalyptus roots and by flooding. Some stones are missing; mortar with a high volume of gravel has significantly deteriorated. A vertical crack on the southwest corner has been repaired with concrete that did not hold long. The bottom of the walls is covered with sediment.

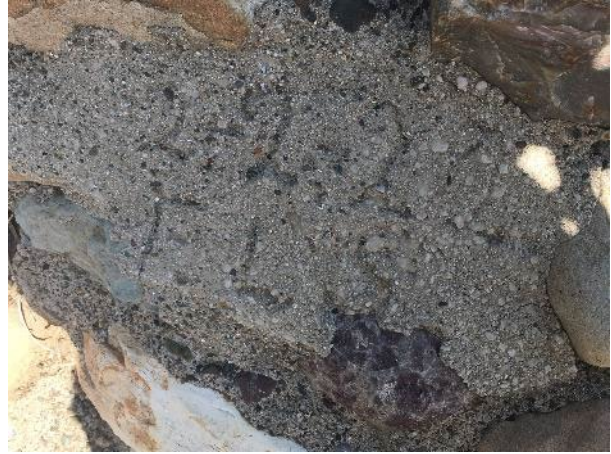
*Plate 16. "2-2-22" inscription  
(northwest perspective)*

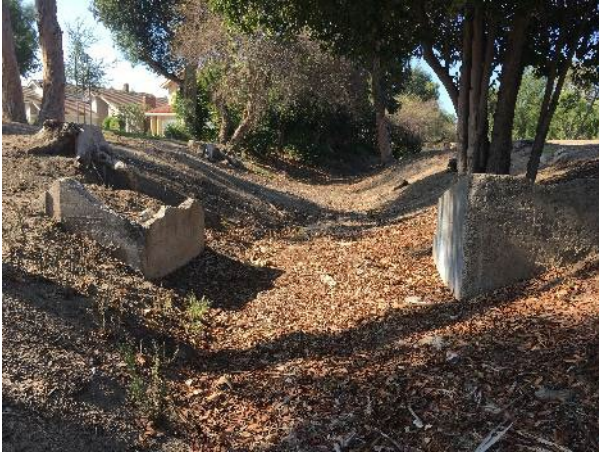
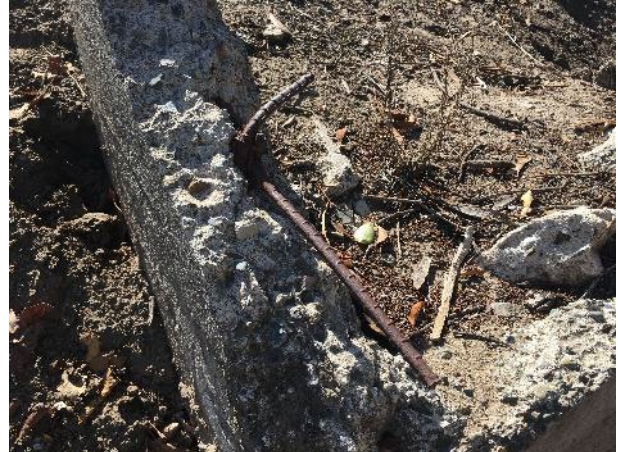
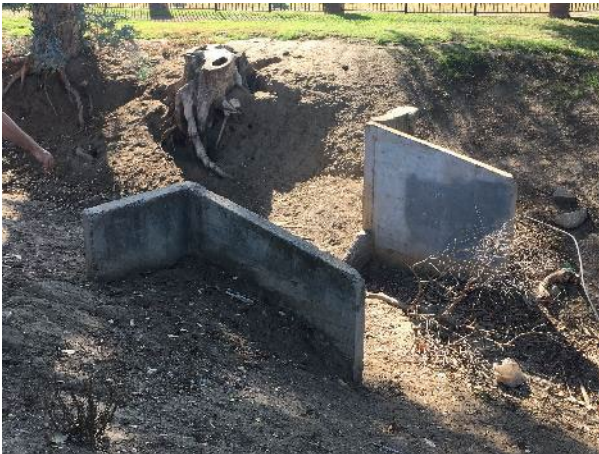
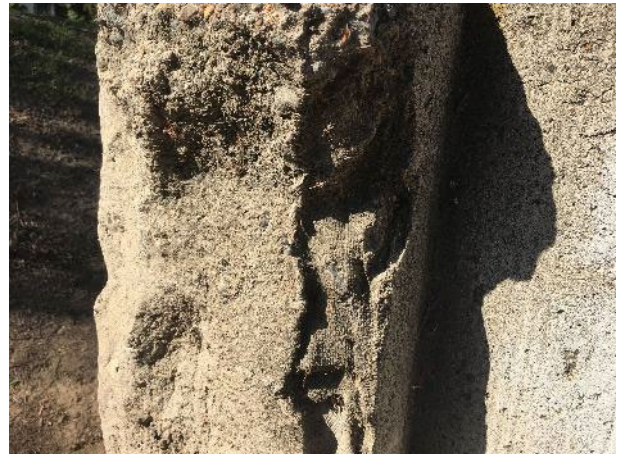
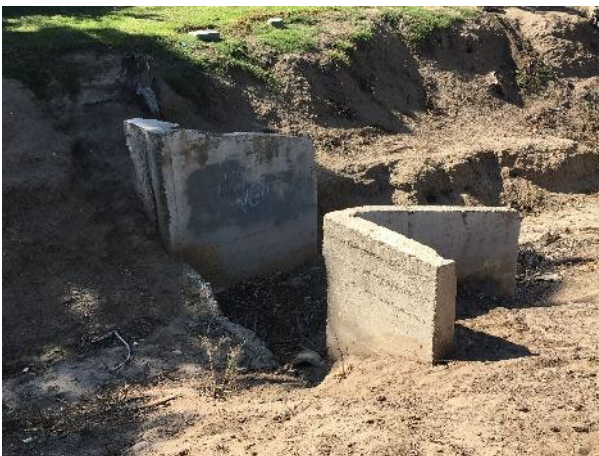
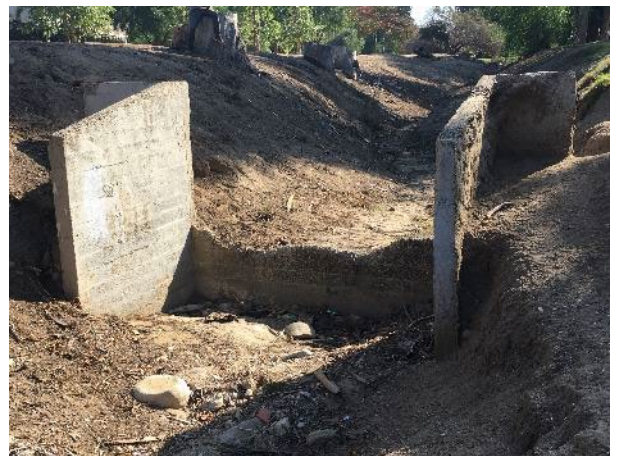
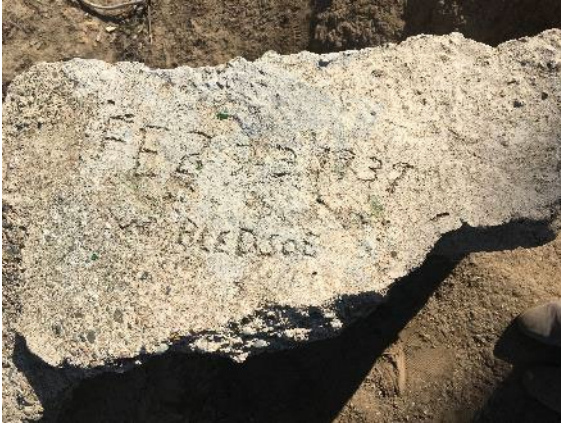
*Plate 20. Check dam # 1  
(west perspective)*

*Plate 21. Check dam # 1, metal rebar  
(southwest perspective)*

*Plate 22. Check dam # 2  
(southeast perspective)*

*Plate 23. Check dam # 2, burlap imprint  
(northwest perspective)*

*Plate 24. Check dam # 3  
(southwest perspective)*

*Plate 25. Check dam # 3  
(northeast perspective)*

Plate 26. Check dam # 3  
(west perspective)

All three check dams are significantly damaged and have not been in use for a long time. The walls are shifted by erosion and dented. Ditch grade walls are partially destroyed. Ditch bottom floors are destroyed or covered with sediment. Metal or wood gate elements are missing.

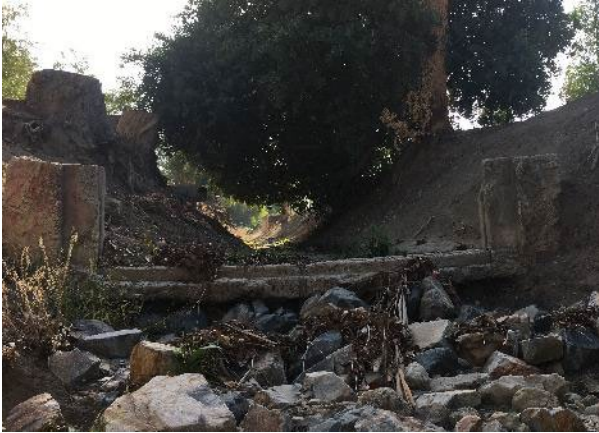
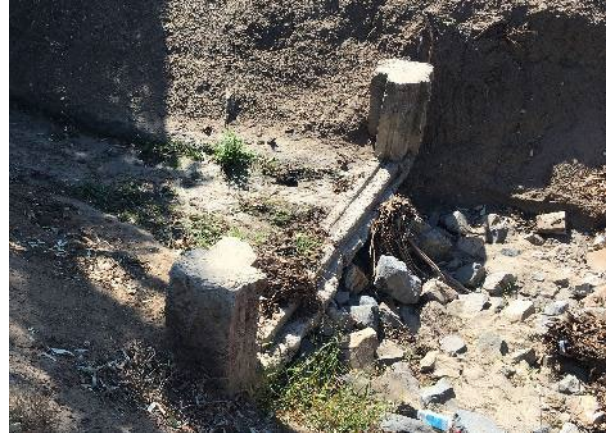
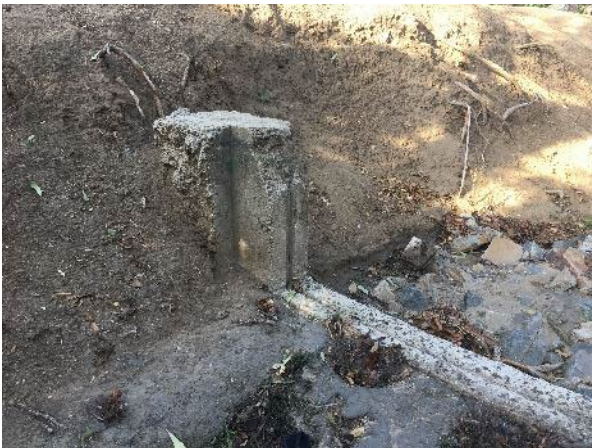
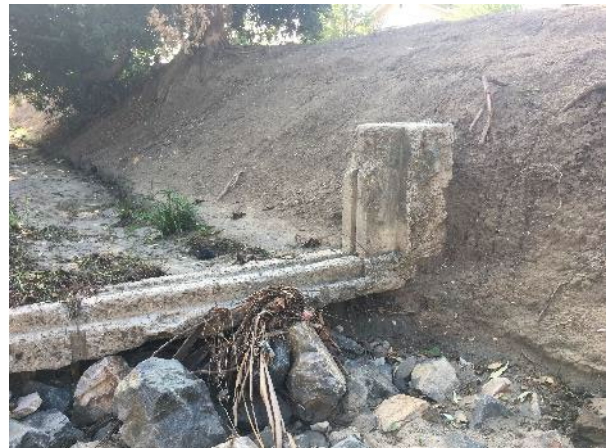
The fourth check dam of a different design is located on the west end of the project area, northeast of the intersection of Seville and Brena Lanes (Plates 28-31). The remaining concrete structure consists of two massive side posts and a stepped horizontal ditch grade beam. The structure is 16’9” wide and 44” high. The inner surfaces of the side posts have slits for the gate doors and traces of the hinges. There is a vertical slit in the middle of the grade beam, probably, for the gate lock. It looks like the posts had extensions in the east and west directions, parallel to the slopes of the channel; however, these extensions have been destroyed. The exact date of construction for Check dam # 4 is unclear.

*Plate 28. Check dam # 4  
(west perspective)*

*Plate 29. Check dam # 4  
(southwest perspective)*

*Plate 30. Check dam # 4  
(northeast perspective)*

*Plate 31. Check dam # 4  
(southwest perspective)*

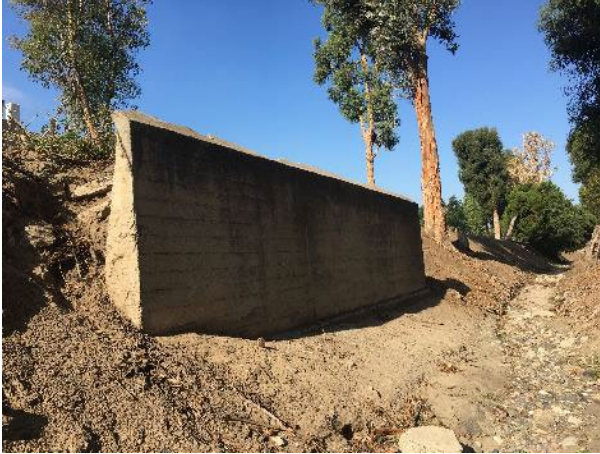
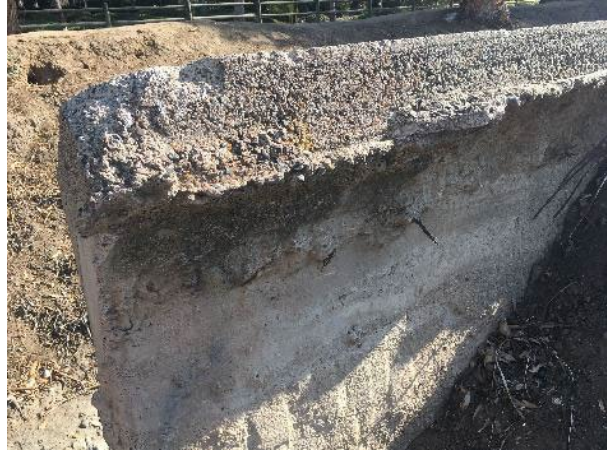
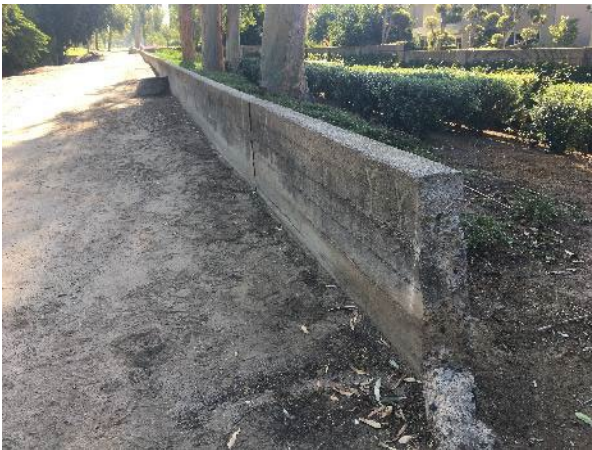
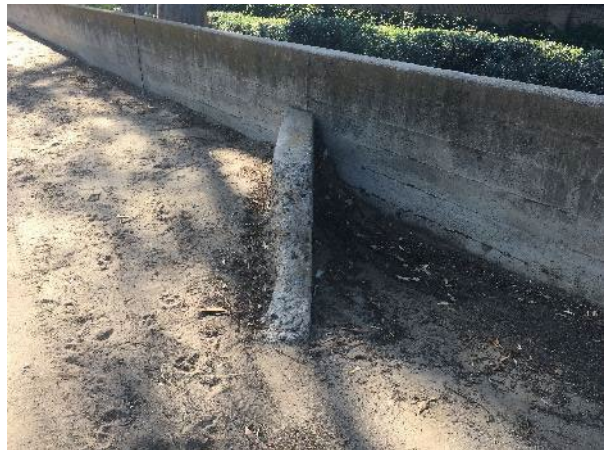
A large fragment of a concrete retaining wall supports the south slope of Hicks Canyon Wash northeast of the intersection of Brillantez and Brena Lanes (Plates 32-33). The wall is constructed of concrete with a high volume of gravel poured into wood board casing and reinforced with metal square rebar, similar to the 1939 check dam structures described above. The wall is 30' long and 7.5' high, with its top portion slightly bending back from the channel. The wall is buttressed: it is 18" thick at the bottom and 7" thick on the top.

The retaining wall is adjacent to an unpaved sidewalk, running from Culver Drive in a southeasterly direction parallel to Brena Lane. The sidewalk is crossed by a remnant of a demolished concrete dividing wall running from the retaining wall at 45 degrees. It connects to a concrete side wall along the south edge of the sidewalk (Plates 34-35). The sidewalk wall is 410' long, 3' high, and 6" thick. It followed the eucalyptus windbreak seen on aerial photographs, now almost completely gone.

*Plate 32. Concrete retaining wall  
(southwest perspective)*

*Plate 33. Concrete retaining wall, fragment  
(northeast perspective)*

*Plate 34. Concrete sidewalk wall  
(southeast perspective)*

*Plate 35. Concrete sidewalk wall, fragment  
(southeast perspective)*

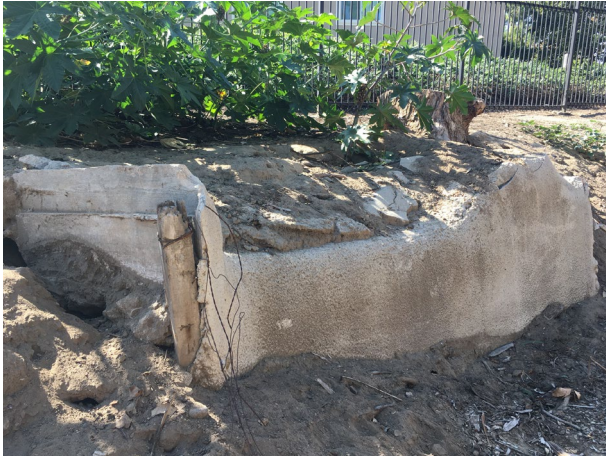
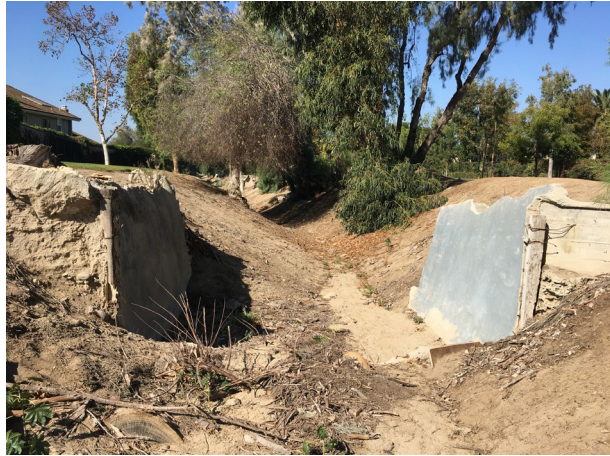
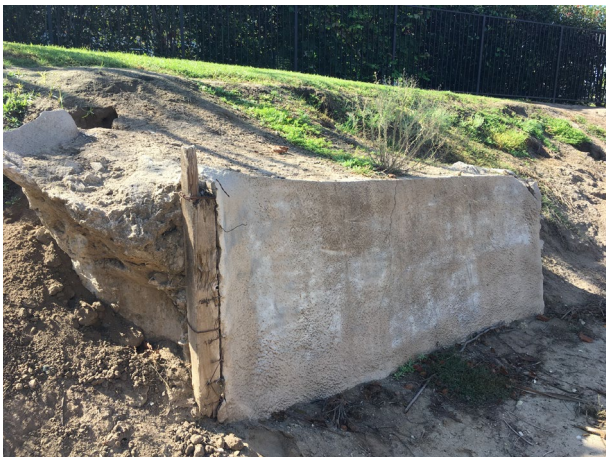
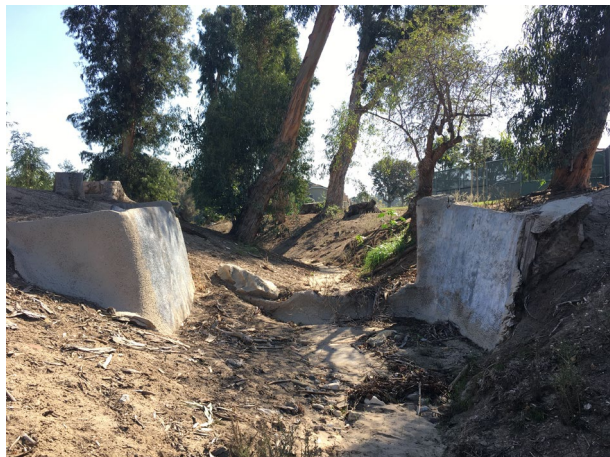
Archival research did not associate these structures with any historically significant events, persons, styles, or masters. All fourteen fragments of channel walls are significantly damaged: their upper and side edges are chipped and eroded, bottom portions covered with silt and sediment, the wall surfaces are bent and partially recede from the earthen slopes. The channel walls exhibit typical rather than distinctive characteristics of their building type and period. They do not retain integrity and do not appear significant at either the state or federal level.

*Gunit channel wall # 6, southwest perspective  
10/28/2022; IMG\_6169*

*Gunit channel wall # 8, west perspective  
10/28/2022; IMG\_6153*

*Gunit channel wall # 9, northeast perspective  
10/28/2022; IMG\_6147*

*Gunit channel wall # 12, east perspective  
10/28/2022; IMG\_6128*

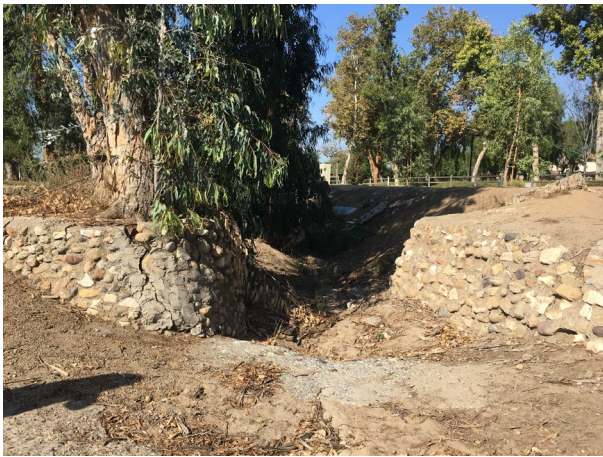
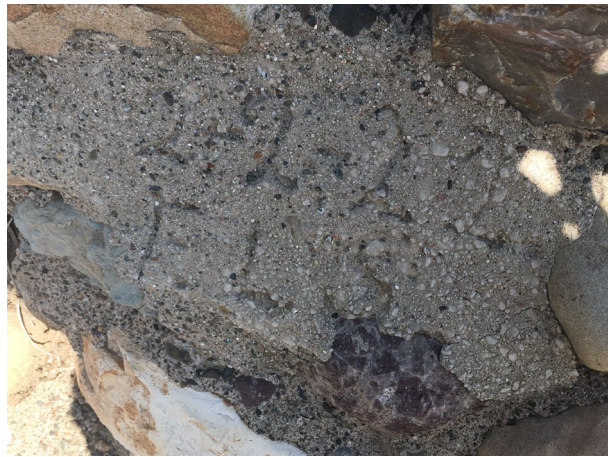
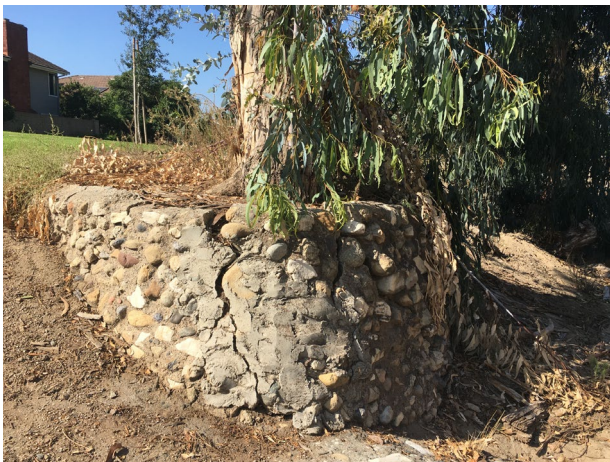
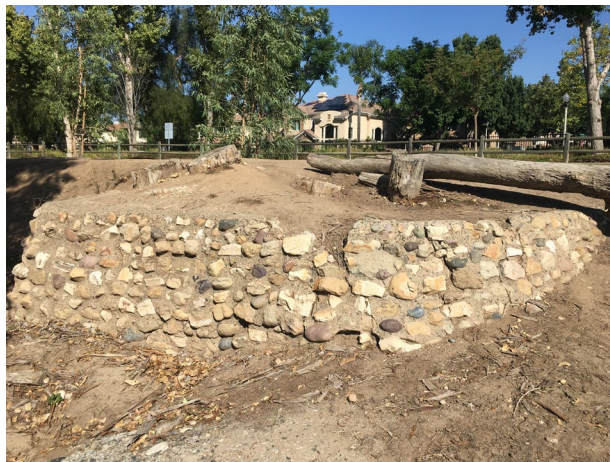
The retaining walls have been damaged by eucalyptus roots and by flooding. Some stones are missing; mortar with a high volume of gravel has significantly deteriorated. A vertical crack on the southwest corner has been repaired with concrete that did not hold long. The bottom of the walls is covered with sediment. The concrete crossing pavement is severely damaged. Archival research did not associate the creek crossing with any historically significant events, persons, styles, or masters. The retaining walls exhibit typical rather than distinctive characteristics of their building type and period. They do not retain integrity and do not appear significant at either the state or federal level.

*Creek crossing retaining walls, west perspective  
10/28/2022; IMG\_6118*

*"2-2-22" inscription, northwest perspective  
10/28/2022; IMG\_6114*

*Creek crossing retaining walls, southwest perspective  
10/28/2022; IMG\_6117*

*Creek crossing retaining walls, northwest perspective  
10/28/2022; IMG\_6116*

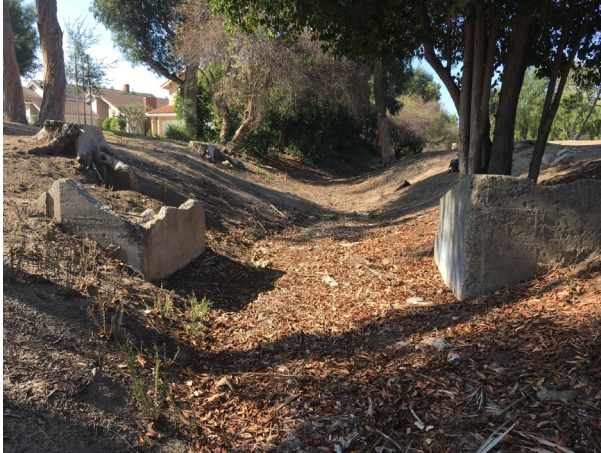
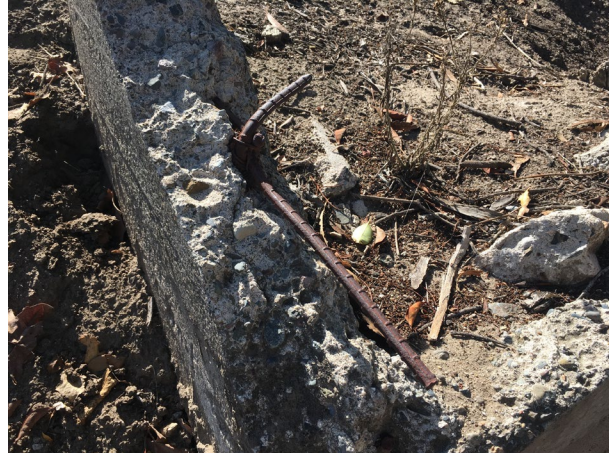
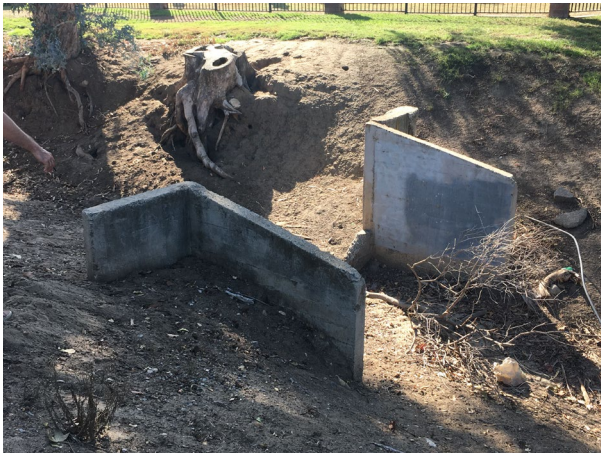
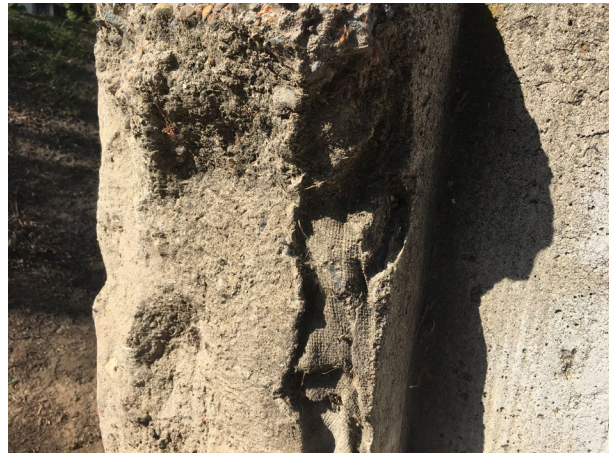
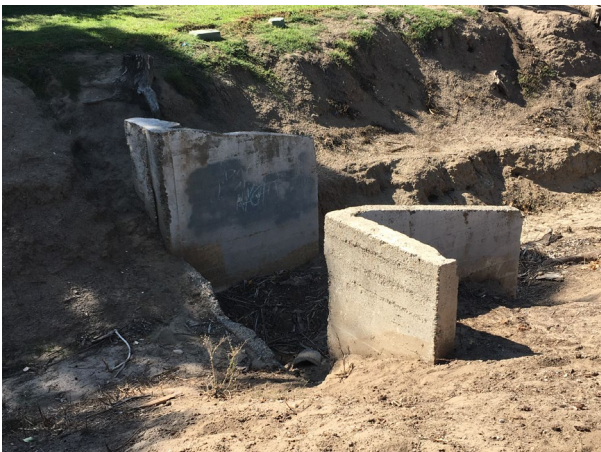
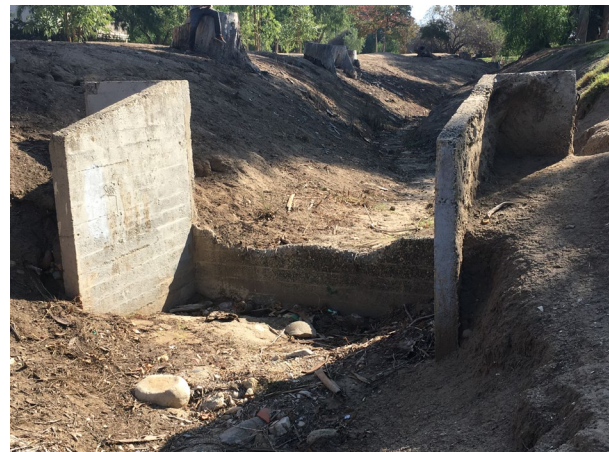
All four check dams are significantly damaged and have not been in use for a long time. The walls are shifted by erosion and dented. Ditch grade walls are partially destroyed. Ditch bottom floors are destroyed or covered with sediment. Metal or wood gate elements are missing. They do not retain integrity and do not appear significant at either the state or federal level.

*Check dam # 1, west perspective  
10/28/2022; IMG\_6108*

*Check dam # 1, metal rebar, southwest perspective  
10/28/2022; IMG\_6107*

*Check dam # 2, southeast perspective  
10/28/2022; IMG\_6095*

*Check dam # 2, burlap imprint, northwest perspective  
10/28/2022; IMG\_6098*

*Check dam # 3, southwest perspective  
10/28/2022; IMG\_6201*

*Check dam # 3, northeast perspective  
10/28/2022; IMG\_6091*

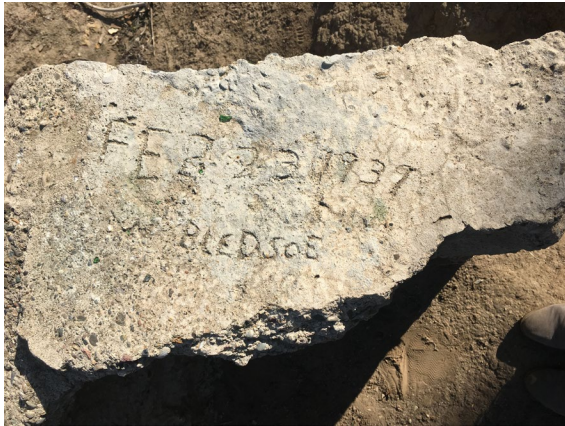
Check dam # 3, west perspective  
10/28/2022; IMG\_6088

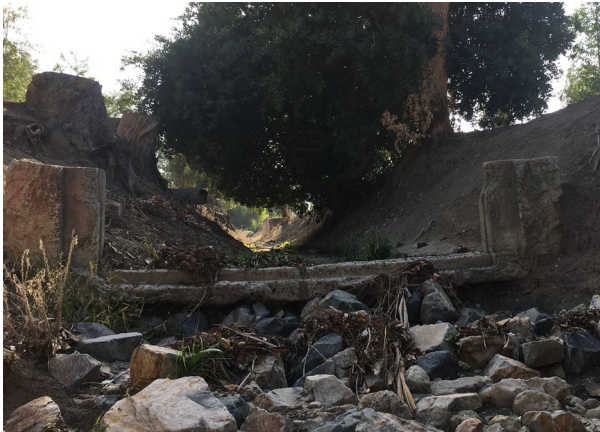
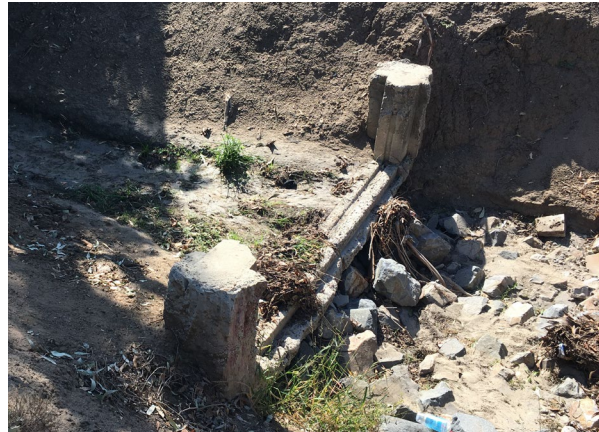
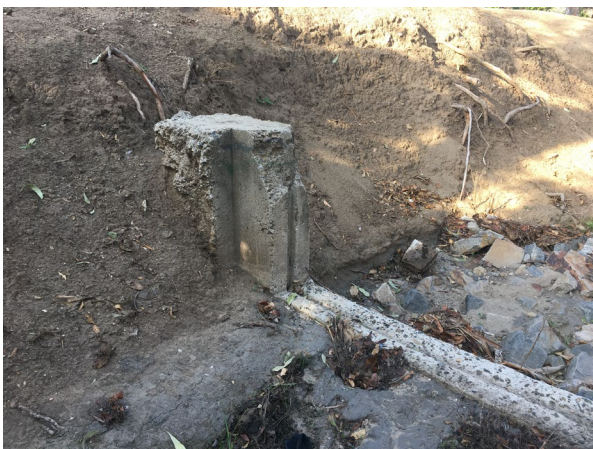
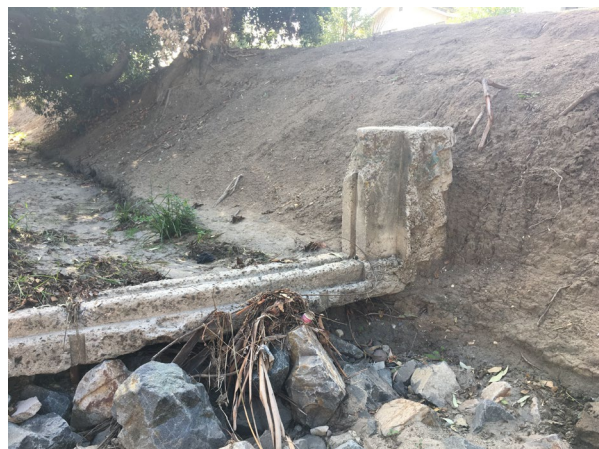
Check dam # 4, west perspective  
10/28/2022; IMG\_6054

Check dam # 4, southwest perspective  
10/28/2022; IMG\_6203

Check dam # 4, northeast perspective  
10/28/2022; IMG\_6058

Check dam # 4, southwest perspective  
10/28/2022; IMG\_6056

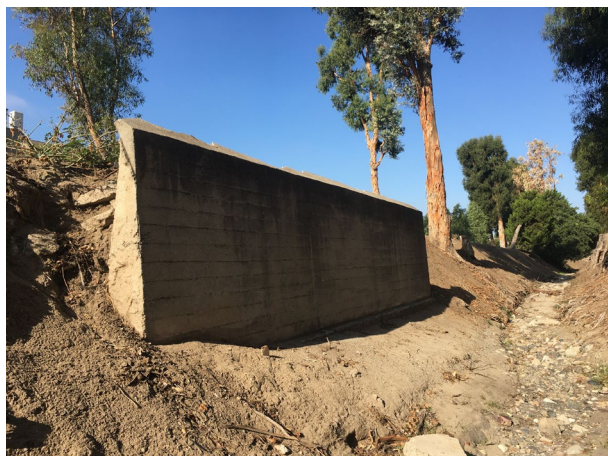
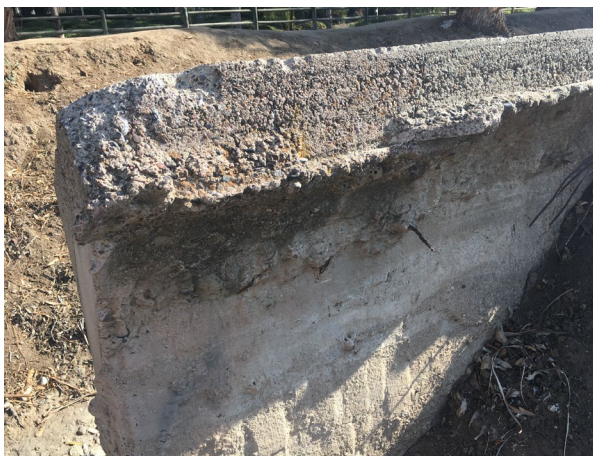
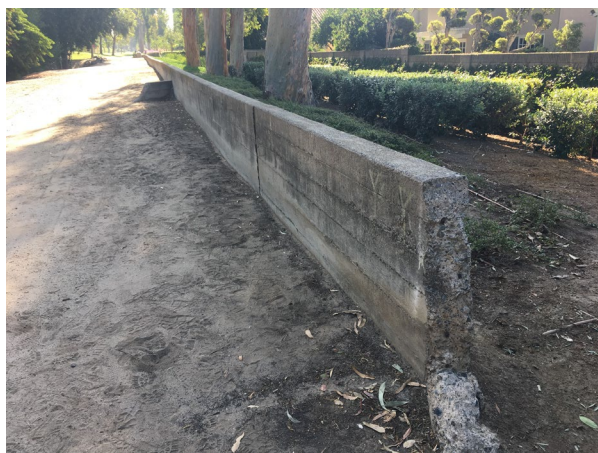
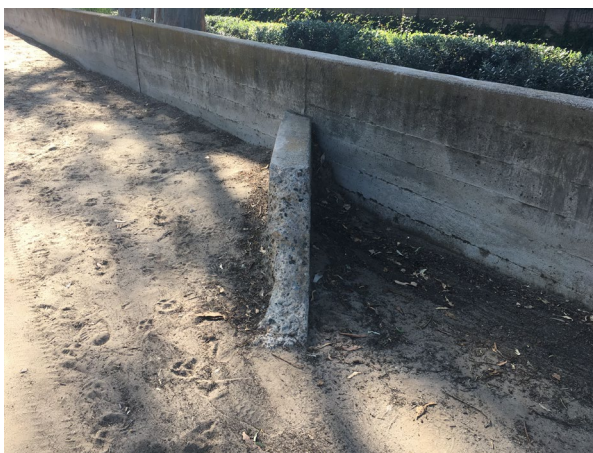
The concrete retaining wall and sidewalk wall were built in the first half of the 20th century as part of the Irvine Ranch / San Joaquin Fruit Company operations. Archival research did not associate these structures with any historically significant events, persons, styles, or masters. The walls exhibit typical rather than distinctive characteristics of their building type and period. They are partially damaged and do not appear significant at either the state or federal level.

*Concrete retaining wall, southwest perspective  
10/28/2022; IMG\_6063*

*Concrete retaining wall, fragment, northeast perspective  
10/28/2022; IMG\_6064*

*Concrete sidewalk wall, southeast perspective  
10/28/2022; IMG\_6073*

*Concrete sidewalk wall, fragment, southeast  
perspective. 10/28/2022; IMG\_6072*
