## EXTENDED PHASE I INVESTIGATION FOR THE COUNTY ROAD 305 OVER WATSON CREEK BRIDGE REPLACEMENT PROJECT, GLENN COUNTY, CALIFORNIA

Federal Aid #: BRL0-5911 (056)

June 2022

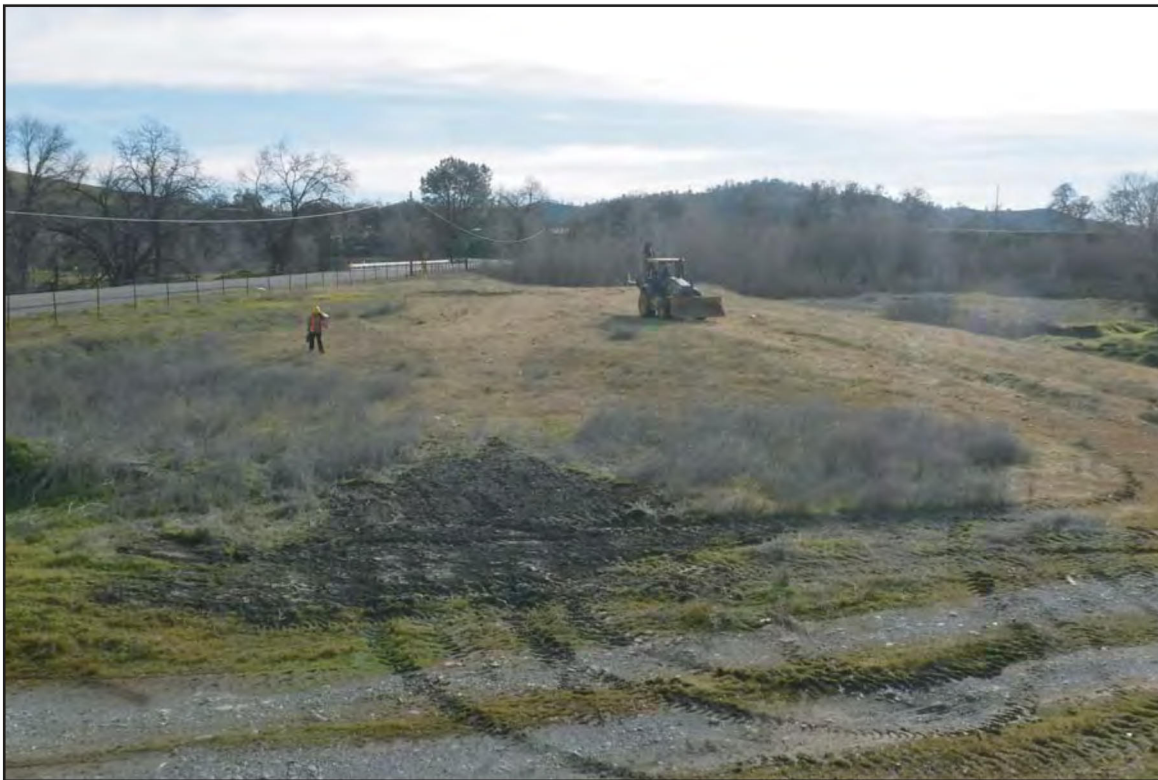
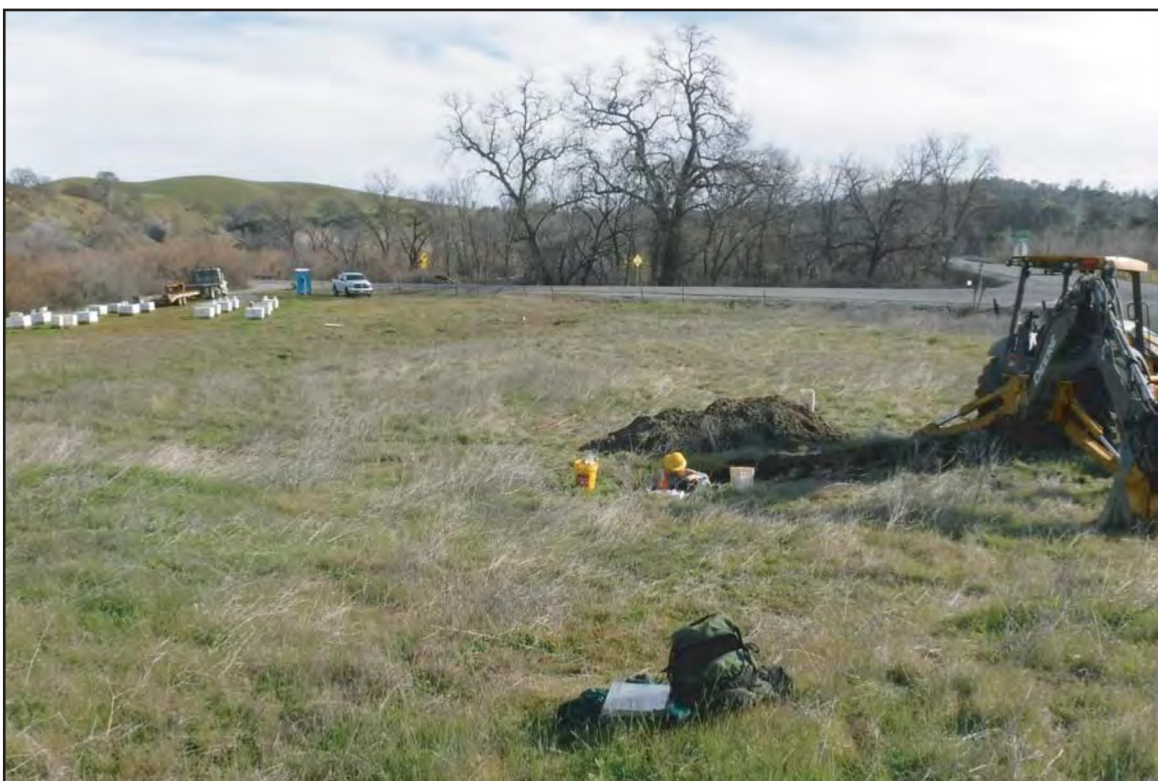
**Figure 3. Overview Photographs of Trenching Operations at Trench 2 (Above) and Trench 4 (Below).**

Pacific Legacy contracted with Pacheco Backhoe Service of Willows, California, to mechanically excavate eight trenches in the APE to search for archaeological deposits. The trenches were excavated by a Deere 310SL tractor-mounted backhoe at an approximate interval spacing of 30 m (98.4 ft) to 50 m (164 ft) in the APE. Such trench spacing has been recommended as an appropriate sampling interval in areas of high and very high sensitivity (Meyer 2013:168) such as the Project APE.

Backhoe trenches measured 0.6 m (2.0 ft) wide and ranged in length from 1.7 to 4.9 m (5.6 to 16.1 ft). Trenches were ramped at one end to allow ingress/egress, with maximum depths ranging from 1.8 to 2.4 m (5.9 to 7.9 ft). Roughly 15.7 m<sup>3</sup> of material was excavated from the trenches, and trench spoils were closely monitored for archaeological deposits. Per California OSHA regulations, no project personnel were allowed to enter sections of an exploratory trench deeper than 1.5 m (5.0 ft) without proper shoring or benching. Where appropriate and safe, at depths up to 1.5 m (5.0 ft), trench sidewalls were also closely examined for cultural materials. When the trench depth surpassed 1.5 m (5.0 ft), the spoils pile continued to be closely examined for archaeological material and changes in soil stratigraphy. Where buried soils were observed, samples of trench spoils were passed through 1/4-inch mesh screen to search for cultural materials. Selected samples consisting of 3 to 5 five-gallon buckets of any suspected buried soils were screened through 1/4" wire mesh to determine presence or absence of cultural material. The location of each trench was recorded with a Trimble GeoXT GPS unit. Digital photographs of trench locations, trench sidewalls, and trenching operations were taken. After documentation, attempts were made to return the excavation area to pre-excavation appearance and grade, including backfilling and compaction. About 44 person-hours were expended during the field portion of the XPI study, including travel and mobilization/demobilization time.

The eight exploratory trenches in the APE were mechanically excavated by a Deere 310SL backhoe operated by Anthony Pacheco of Pacheco Backhoe Services. Approximately 15.7 m<sup>3</sup> of material was excavated from the trenches and inspected for archaeological materials, for an average of about 1.96 m<sup>3</sup> of excavated soil per trench. Barring modern refuse, no cultural materials were identified in the trenches during the XPI investigation. In addition to the eight exploratory trenches, the present study examined an exposed cutbank located approximately 100 m (328 ft) north of the Project's APE. Table 1 lists the characteristics of each trench. Detailed trench and cutbank soil stratigraphic descriptions are provided in Appendix A.

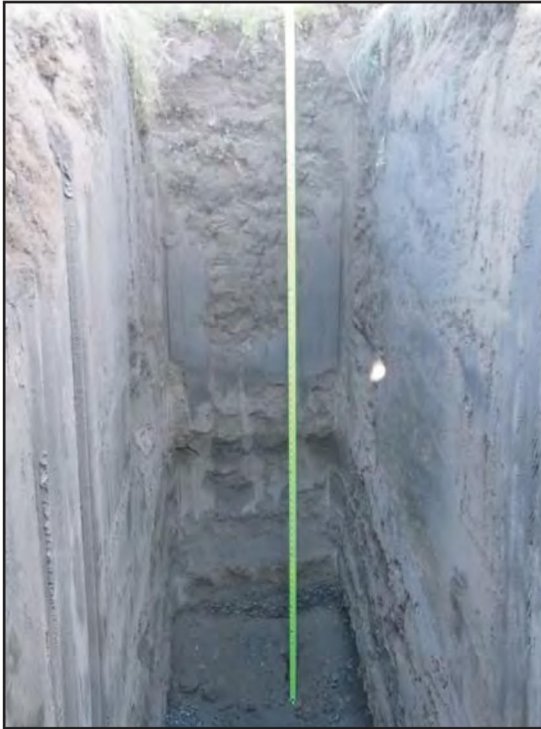
Trench 4 North Wall  
(0-240 cmbs)

Trench 4  
Generalized Profile

**Figure 5. Photographs and Generalized Profiles of Soil Stratigraphy at Trench 4 (top) and Trench 6 (bottom).**

floodplain, and based on the degree of soil development, are interpreted as being late Holocene in age (<4,000 years old). As demonstrated in Trench 4, these deposits are underlain by the Great Valley Sequence of California, which formed between the Late Jurassic and Cretaceous Period. There are four strata documented in this landform, as depicted in Trench 4 (Figure 5).

Stratum I is characterized by dark grey decomposing bedrock of the Great Valley Sequence of California. Stratum I was identified in Trench 4 between 222 and 240 cmbs, and along an exposed cutbank to the west of the trench. Fossil shells were observed within the deposit, confirming the stratum's advanced antiquity.

Stratum II is characterized by coarse-grained (coarse sand, coarse gravel, river cobbles) alluvium lacking soil development. Depths to Stratum II range from 84 cmbs in Trench 1 and Trench 8 to 200 cmbs in Trench 4 and the stratum ranges in thickness from 22 cm in Trench 4 to 96 cm in Trench 8. Stratum II consists of a single C horizon, as typified in Trench 4 (Figure 5). The color associated with Stratum II is dark gray.

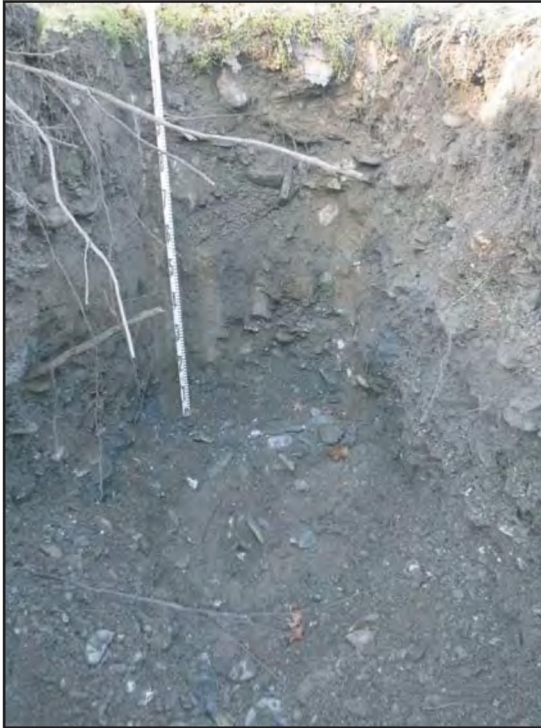
Trench 6 West Wall  
(0-140 cmbs)

Trench 6  
Generalized Profile

The majority of trenches (Trenches 2, 5, 6, and 7) and the exposed cutbank represent modern/Historic Era floodplain deposits associated with Watson and Grindstone Creeks. There are two strata documented in this landform, as depicted in Trench 6 (Figure 5).

Stratum I is characterized by gray coarse-grained (coarse sand, coarse gravel, river cobbles) alluvium lacking soil development. Depths to Stratum I range from 20 cmbs in the exposed cutbank to 103 cm in Trench 5, and the stratum ranges in thickness from 130 cm in the cutbank to 80 cm in Trench 6. Stratum II consists of a C horizon, as exhibited in Trench 6 (Figure 5).
