**Notice of Exemption****Appendix E**

Project Title: Daugherty Hill Wildlife Area Maintenance

**Subject: PG&E Access Road Maintenance on Daugherty Hill Wildlife Area**

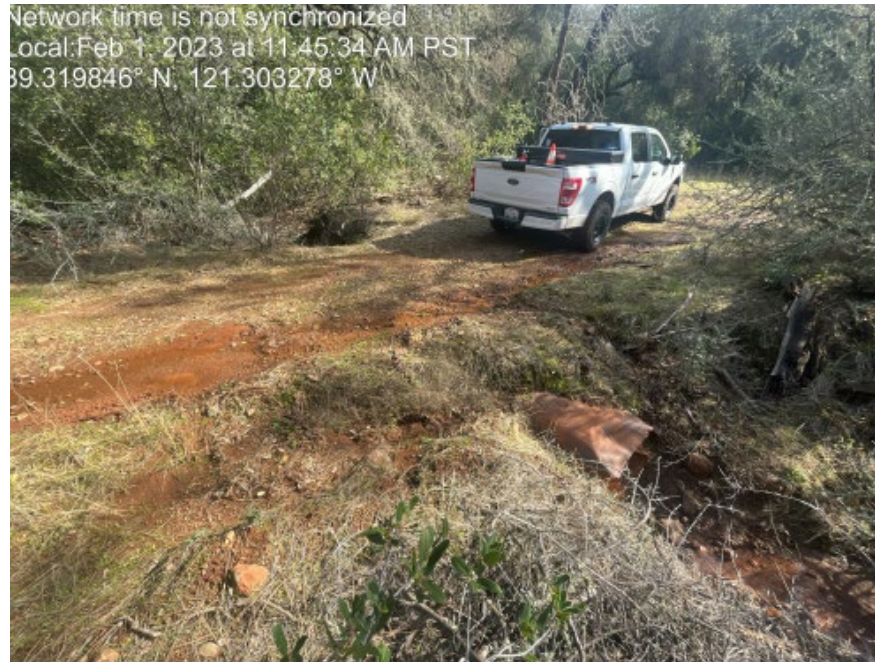
**Location 1:** 24" steel culvert. Culvert is clear but shows erosion on the outlet side above culvert. During site visit, we established no work will occur in 2023. Further scope of work at this location will be determined in Spring 2024.

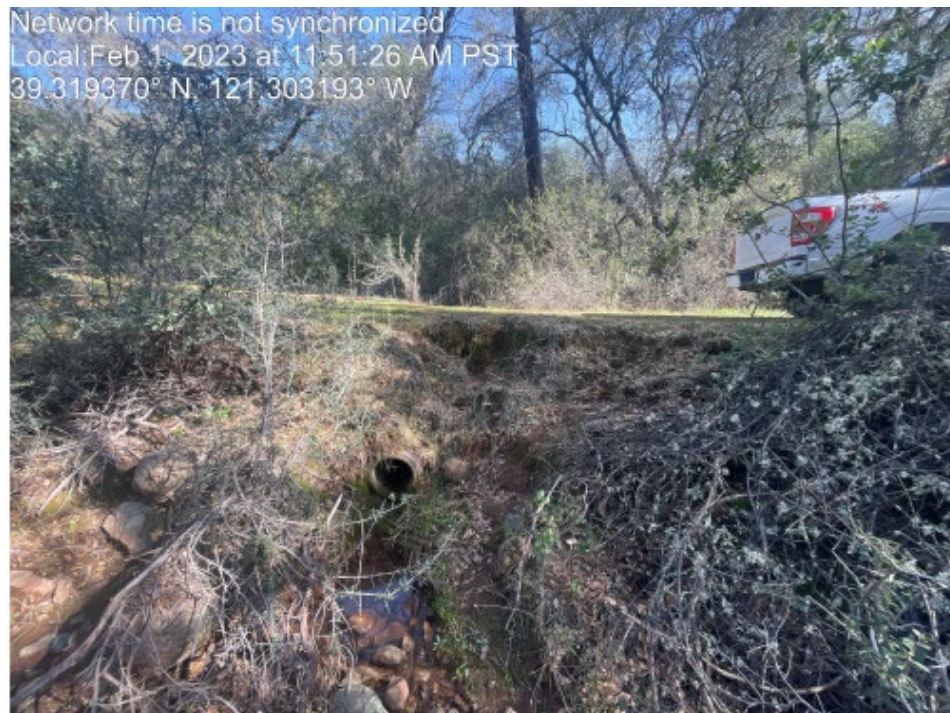
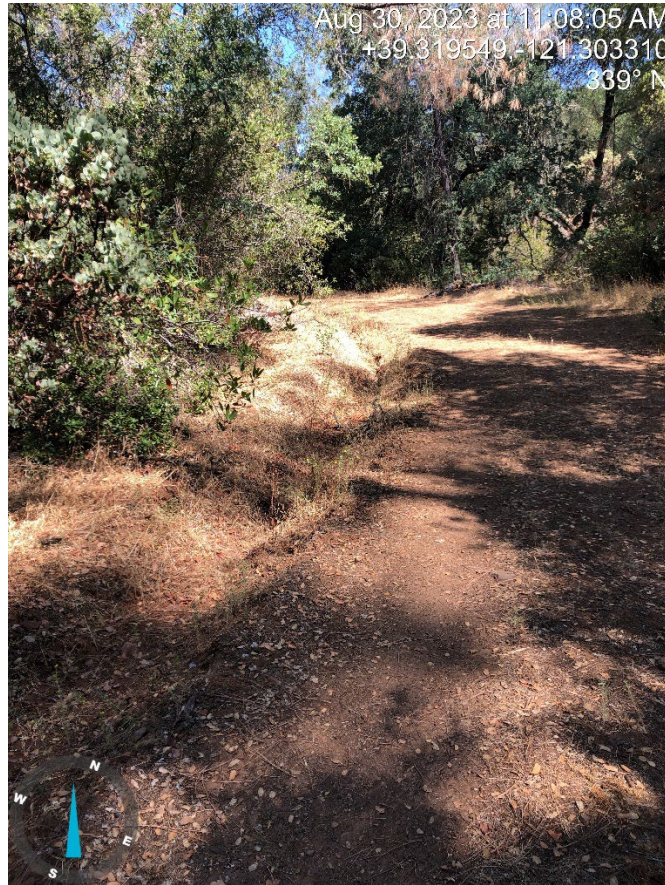
**Location 2:** 12" concrete culvert. Culvert is clear but shows erosion on the outlet side above culvert. During site visit, we established no work will occur in 2023. Further scope of work at this location will be determined in spring 2024.

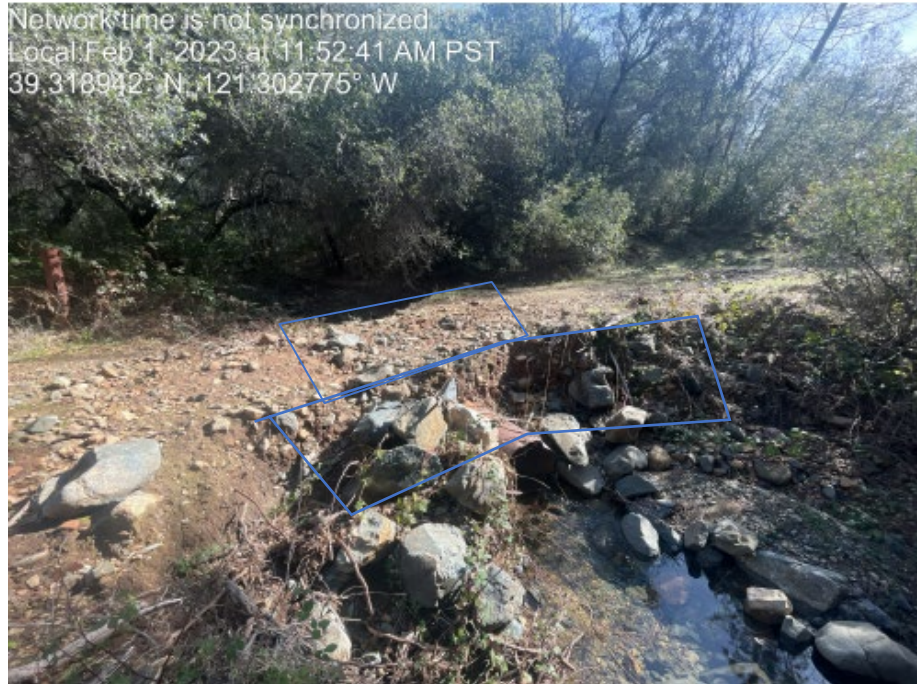
**Location 3:** 30" steel culvert. The culvert itself seems to be flowing and functioning however the outlet side of the culvert is eroding away. Use large rip rap to armor edge of road way cap over the culvert outlet (area in blue polygon). Rock will be placed within road prism with smaller 3x5 rip rap to avoid future erosion. Crews will use hand tools to remove vegetation growing above culvert outlet. Work to occur during Phase 1. Phase 2 work will include a plan for a more long-term stable solution.

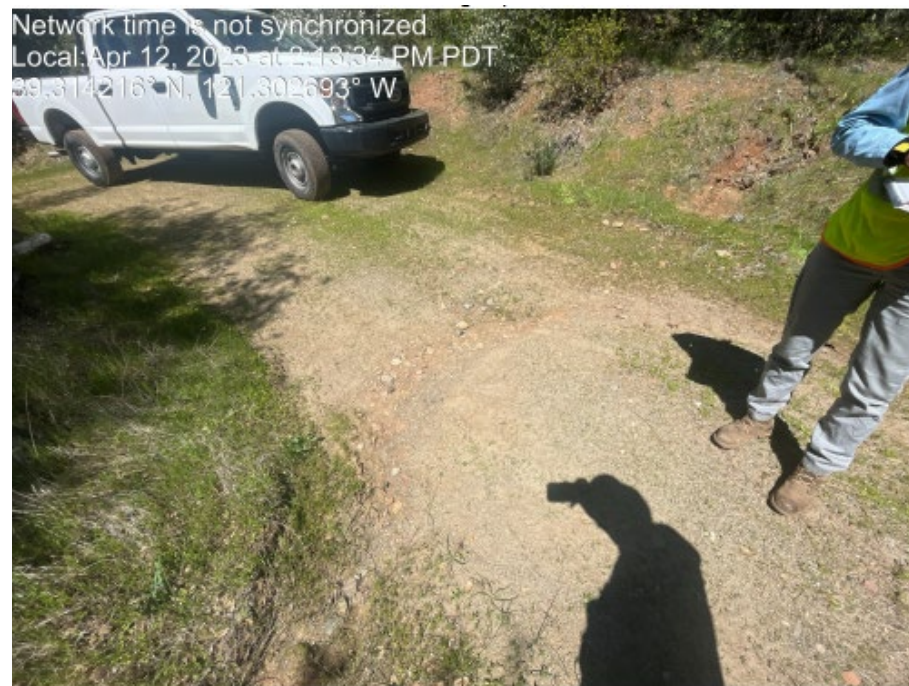
**Location 4:** Just above crossing 3, during storm event this area had a lot of water flow that was running down the road and into the culverted area, this could have been the cause of some of the erosion at the culvert. Create swale/rolling dip and armored lead out with 3x5 rock. Work to occur during Phase 1.

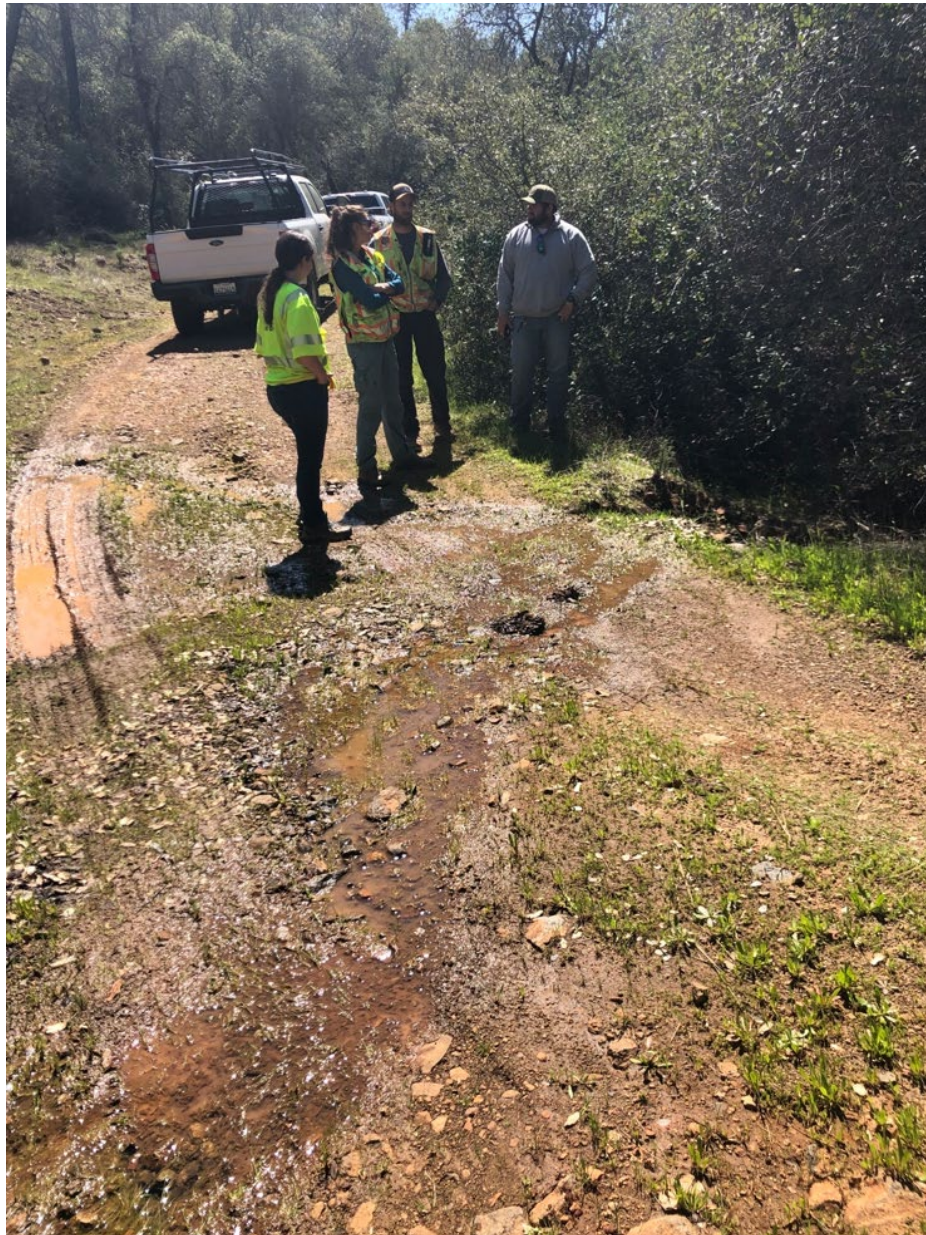
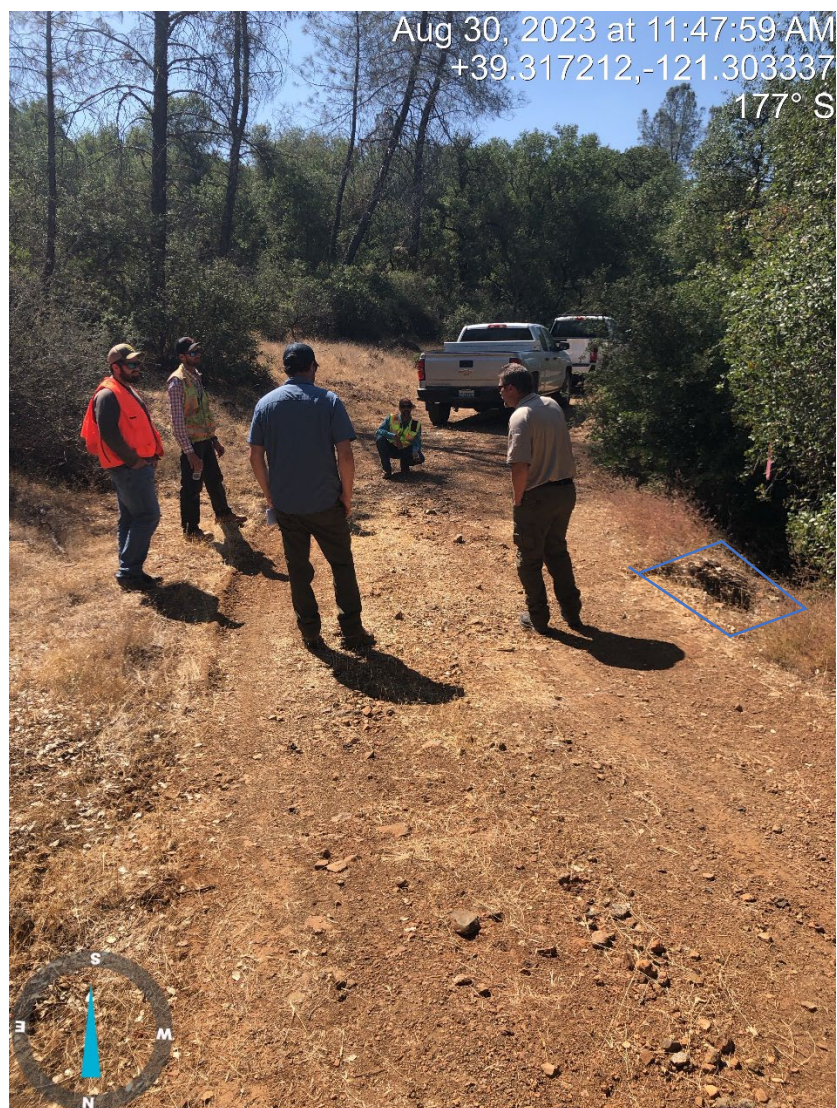
**Location 5:** Low point in road that stays wet after rain events. For Phase 1, rock will be hand stacked to an eroded area on the edge of the road (area in blue polygon). Phase 2 work will include a plan for a more long-term stable solution.

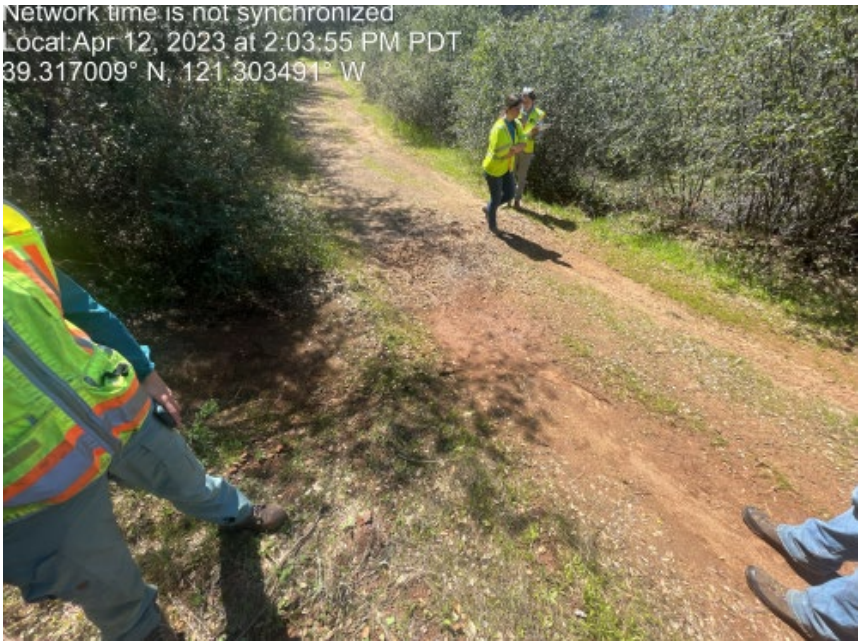
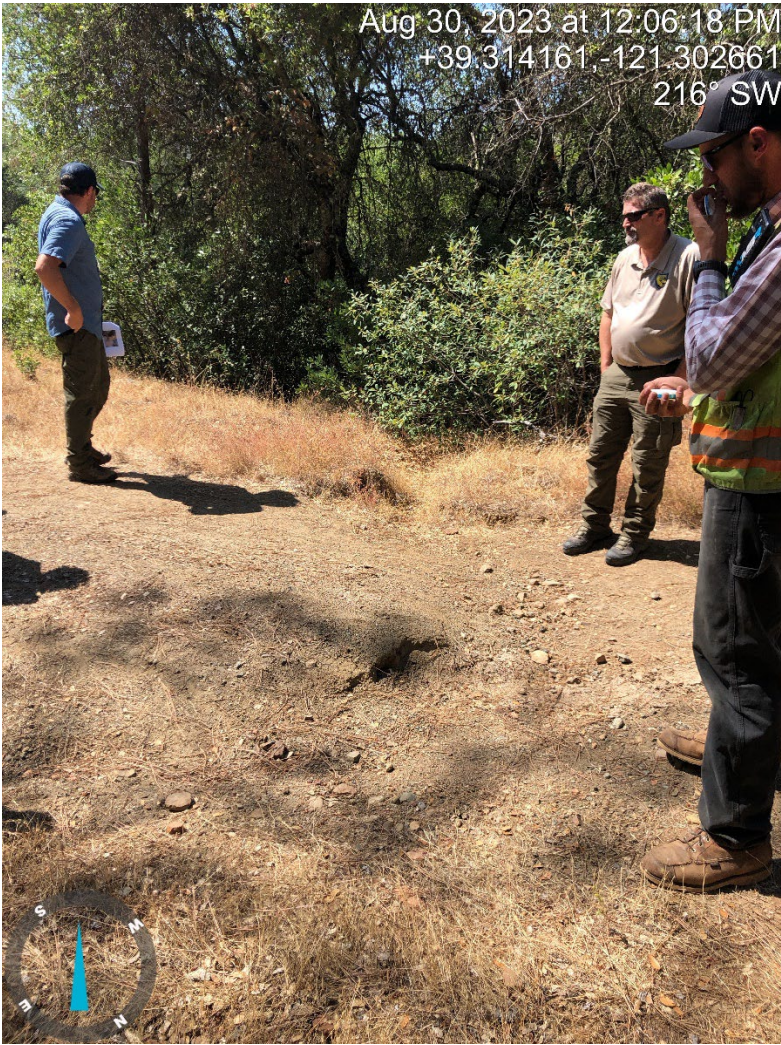
**Location 6:** Low point drain that is causing a little bit of erosion on the fill side of the road. No work for Phase 1. Phase 2 work will include a plan for a more long-term stable solution in spring 2024.

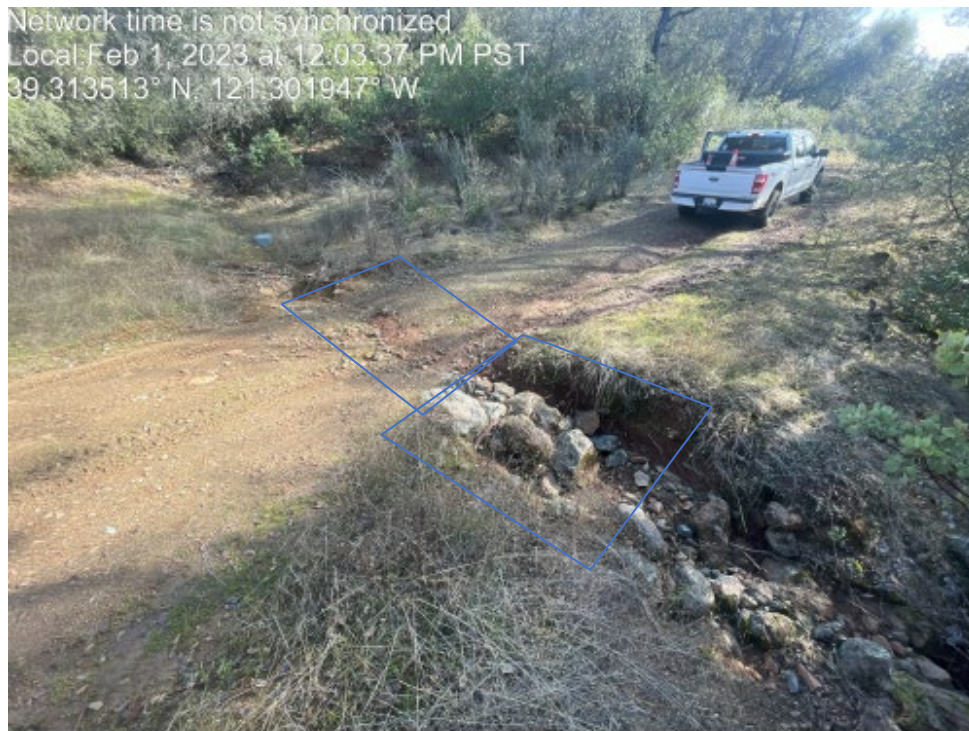
**Location 7:** Small channel running across road. Erosion on the outlet side has created a large hole. Phase 1, install large rip rap to fill hole and prevent further erosion (area in blue polygons). Add additional rock to road prism. No grading. Phase 2 work will include a plan for a more long-term stable solution in spring 2024.

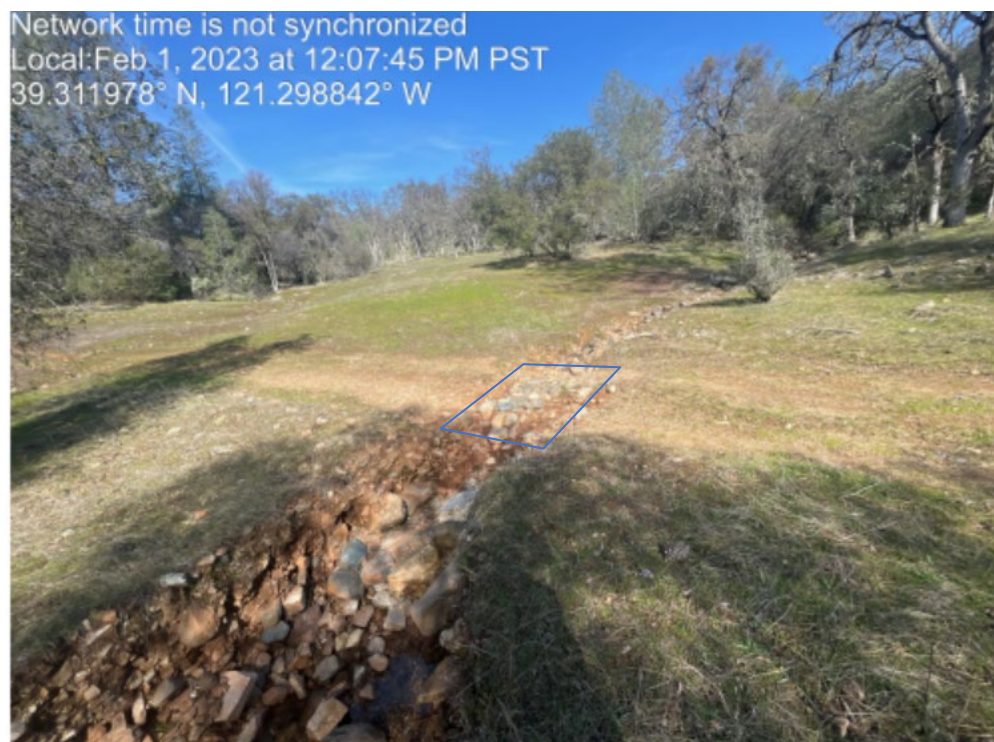
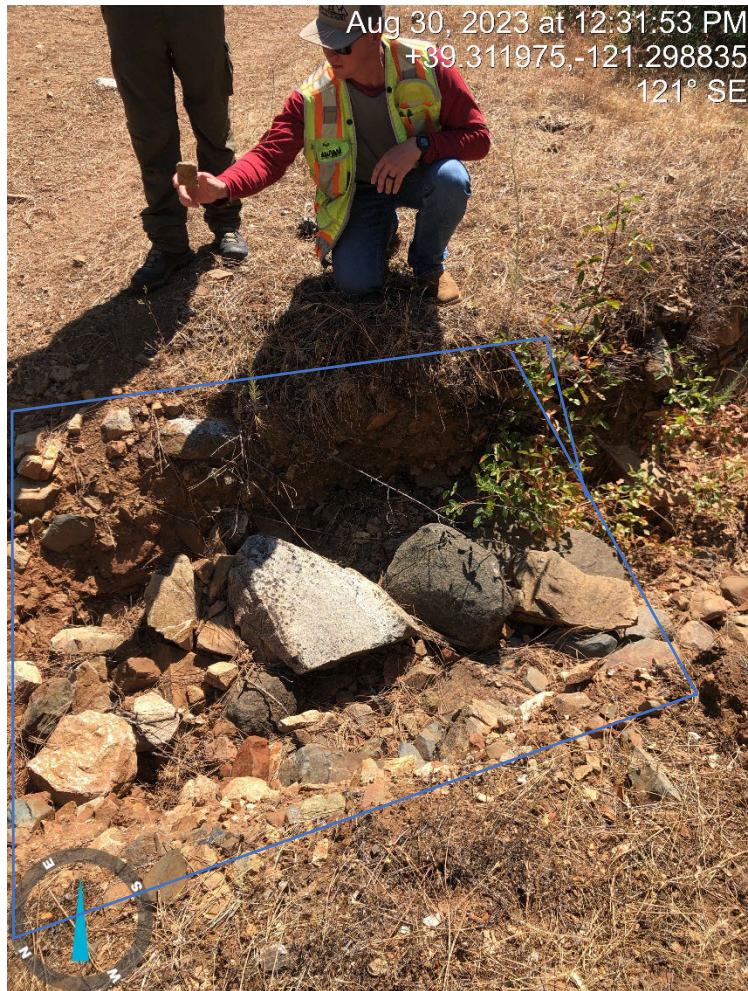
**Location 8:** Native rocky crossing thru road that has eroded away the fill side of road. Phase 1, install large rip rap armoring to fill in erosion and cap with smaller rock to prevent further erosion (area in blue polygons). No grading or keying in rock will occur.

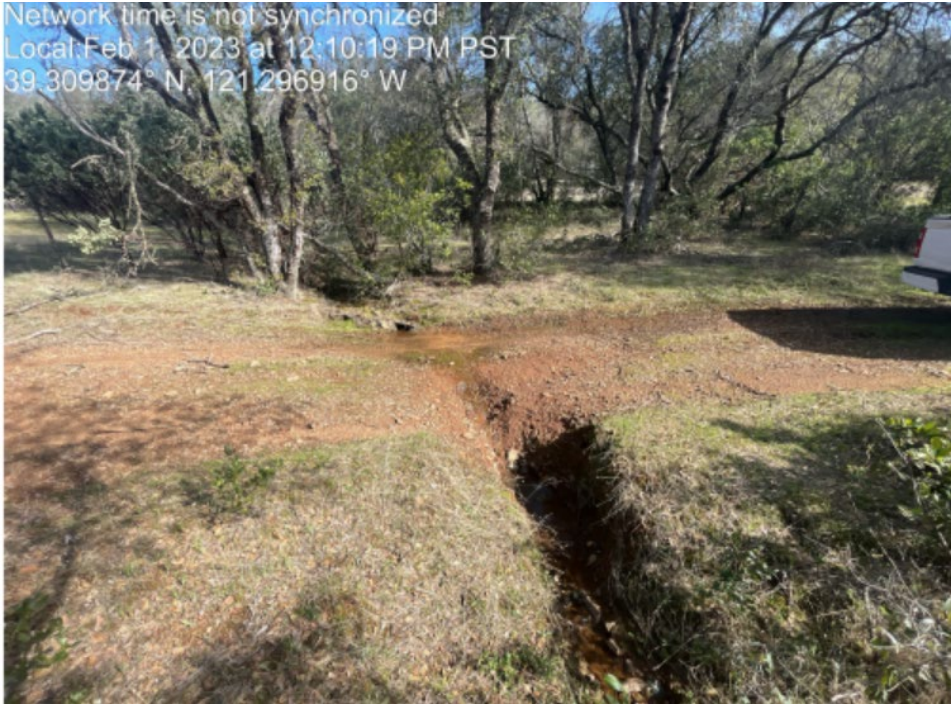
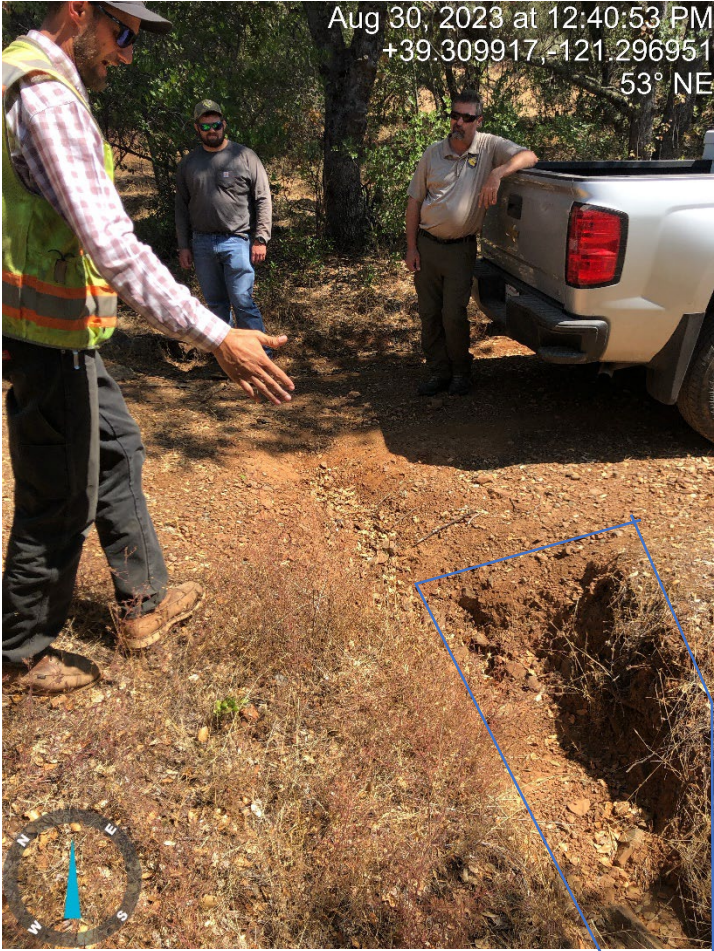
**Location 9:** native crossing is eroding the roadbed. Phase 1, use large rip rap to fill in erosion on fill side of road (area in blue polygon).

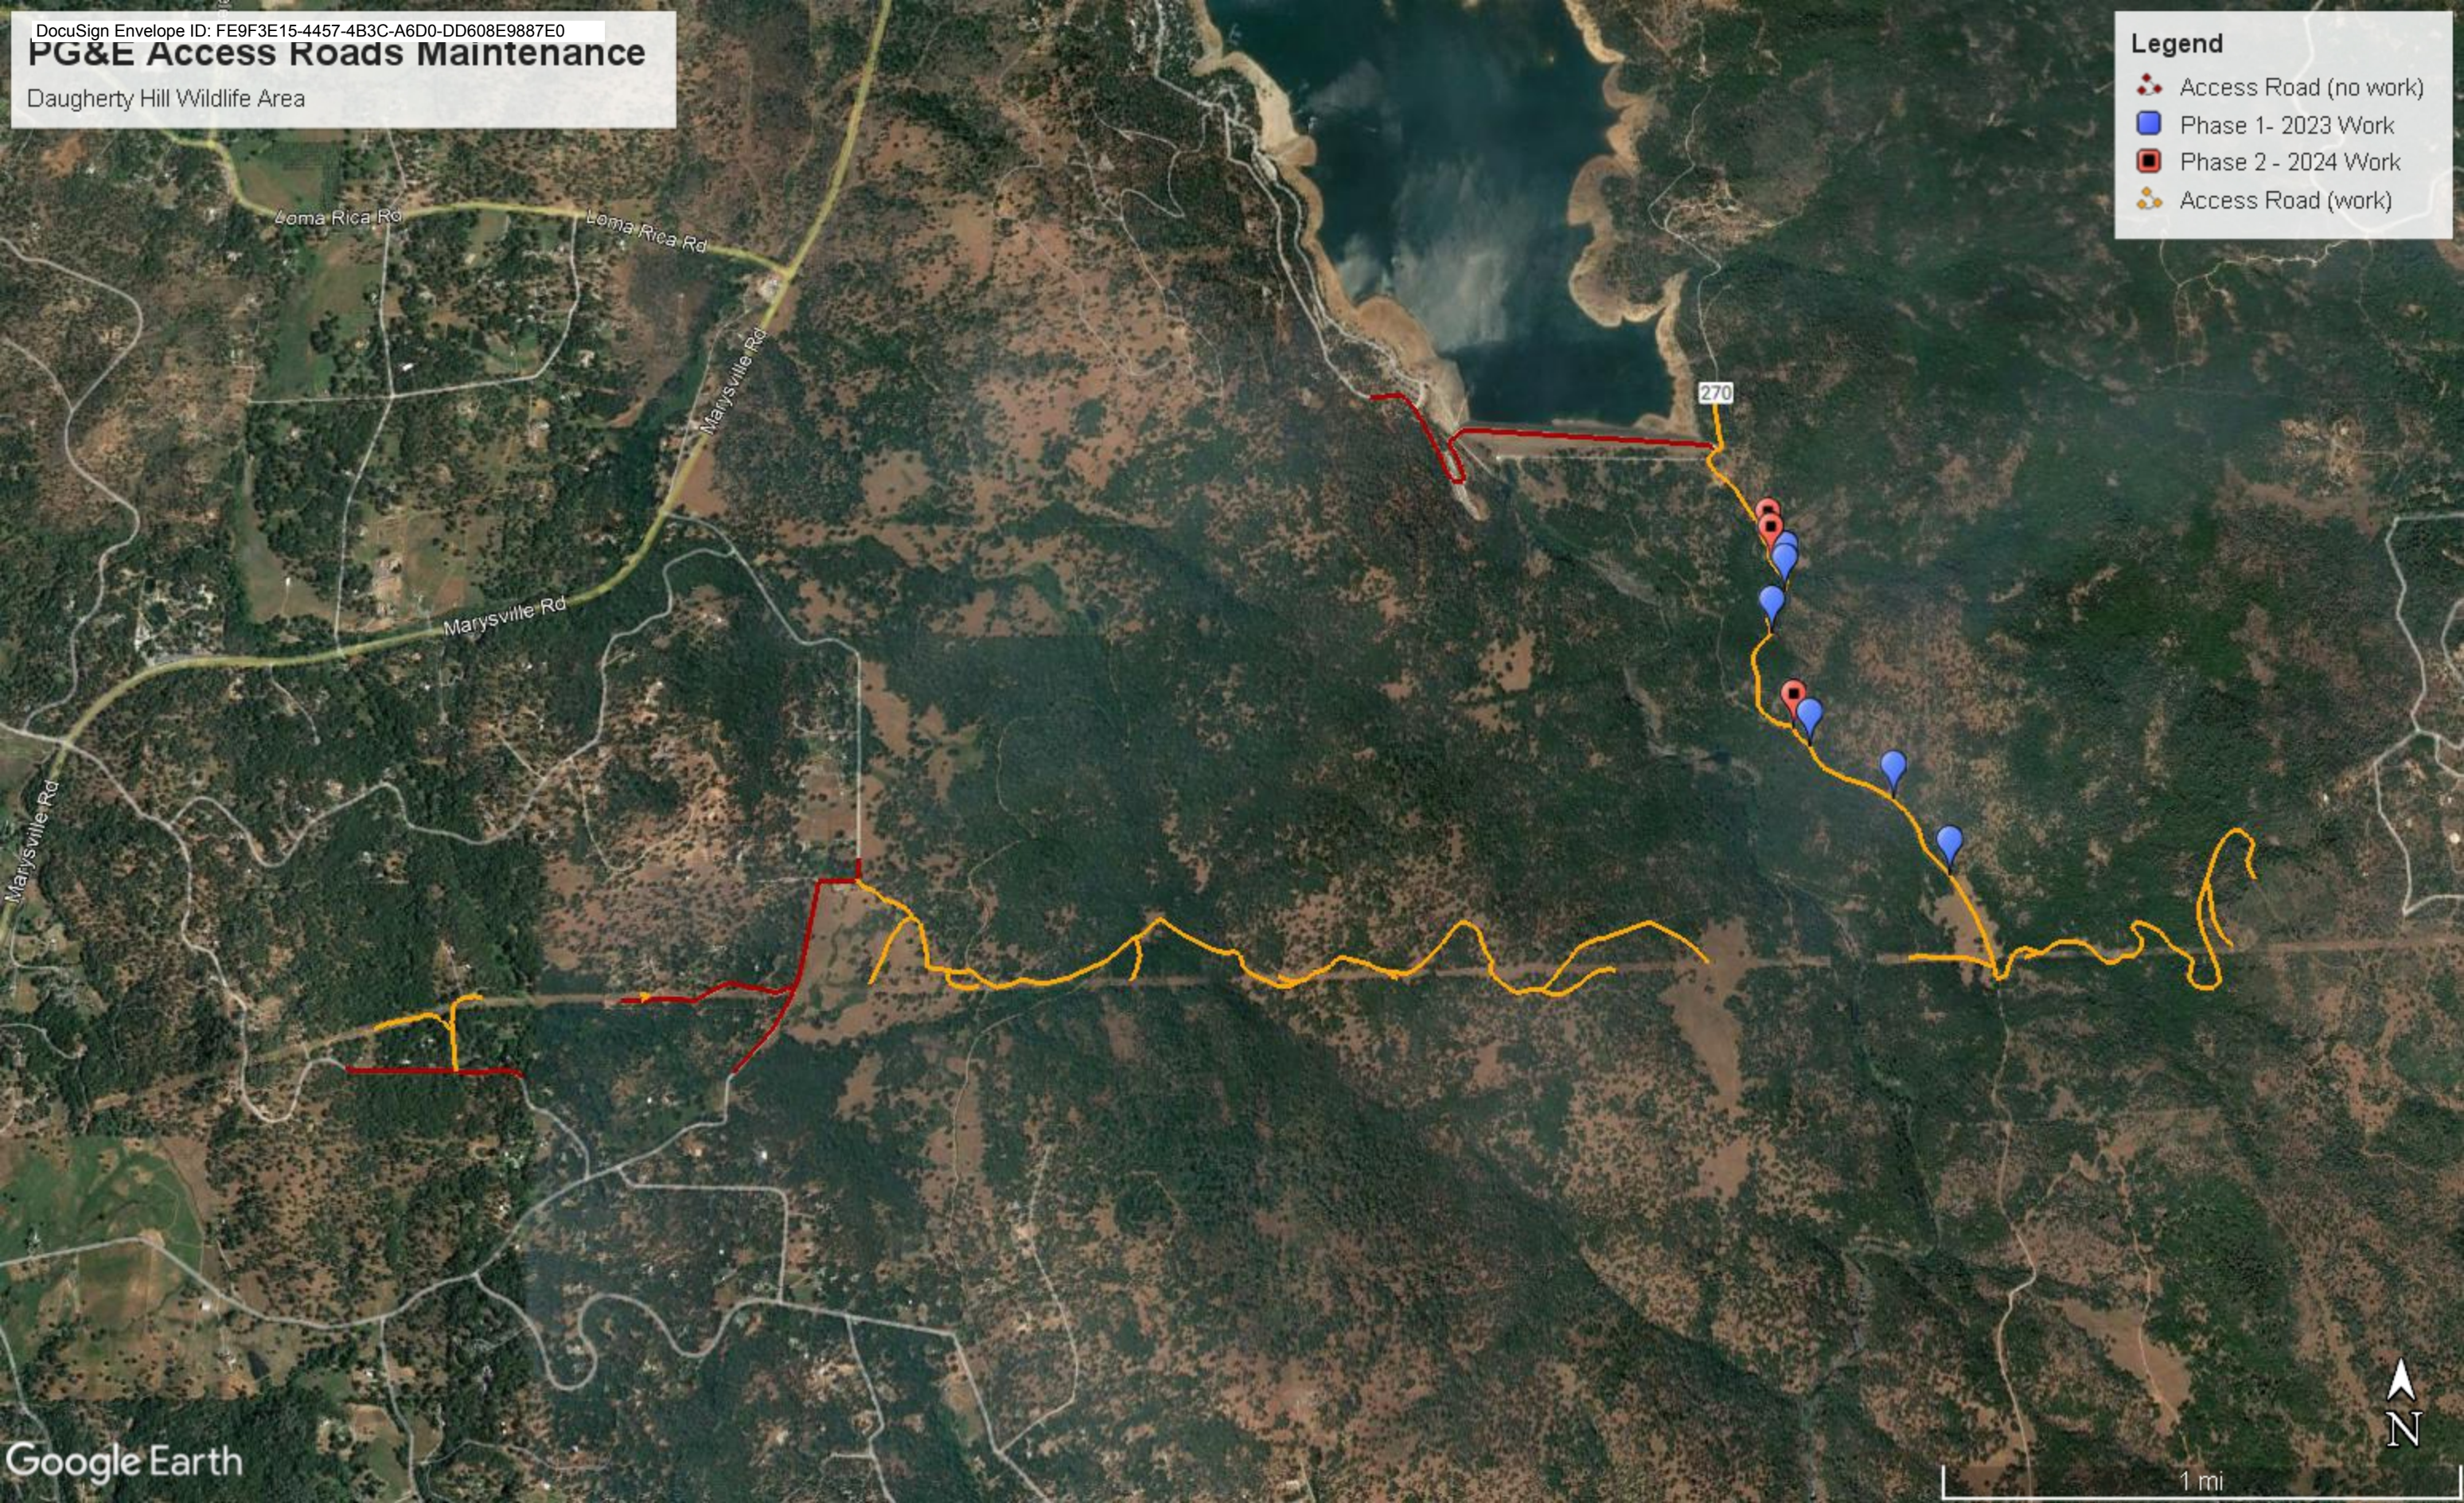
# PG&E Access Roads Maintenance

Access Road (no work)
-

Phase 1- 2023 Work
-

Phase 2 - 2024 Work
-

Access Road (work)
