**TREE REPORT**

The Tree Resource,  
Protected Tree Report, 1600 S. Flower St. & 1611 S. Hope St., Los Angeles, CA 90015,  
May 9, 2018

# PROTECTED TREE REPORT

1600 S Flower St. & 1611 S. Hope St.

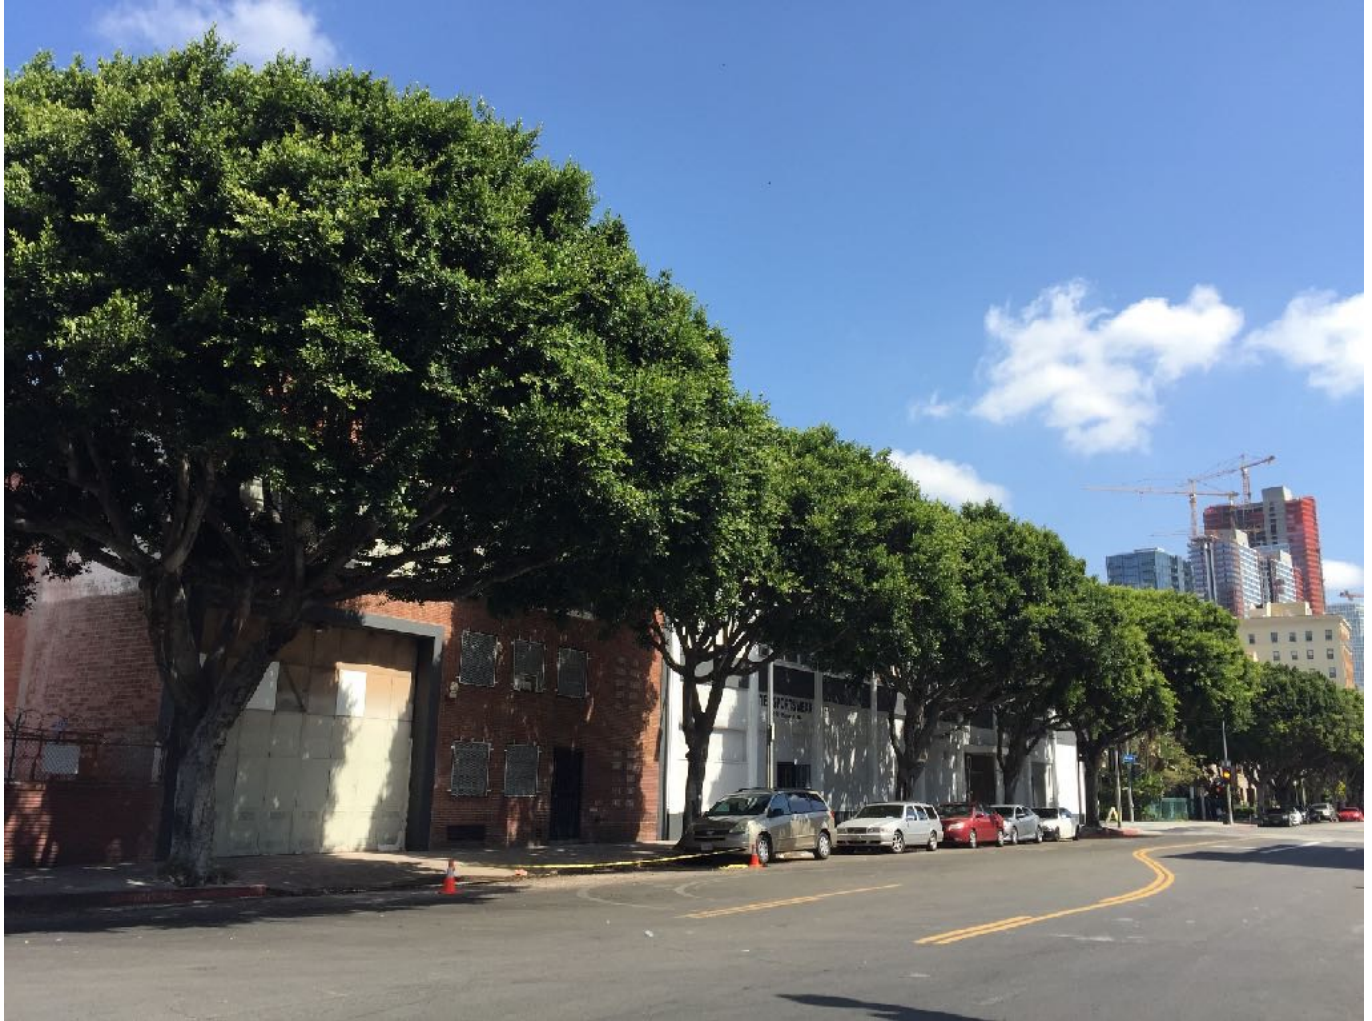
**PHOTO 1** - Shows Indian laurel fig (*Ficus microcarpa nitida*) street trees #1 - 5 adjacent to the subject property on Hope Street. These trees will be significantly impacted by the required street improvements and are recommended for removal.

The proposed construction for this project will require the installation of new sidewalks and right-of-way improvements. The seven (7) street trees adjacent to the site will be significantly impacted by the sidewalk repair and are recommended for removal and replacement at a two-to-one (2:1) ratio, to the satisfaction of the Urban Forestry Division.

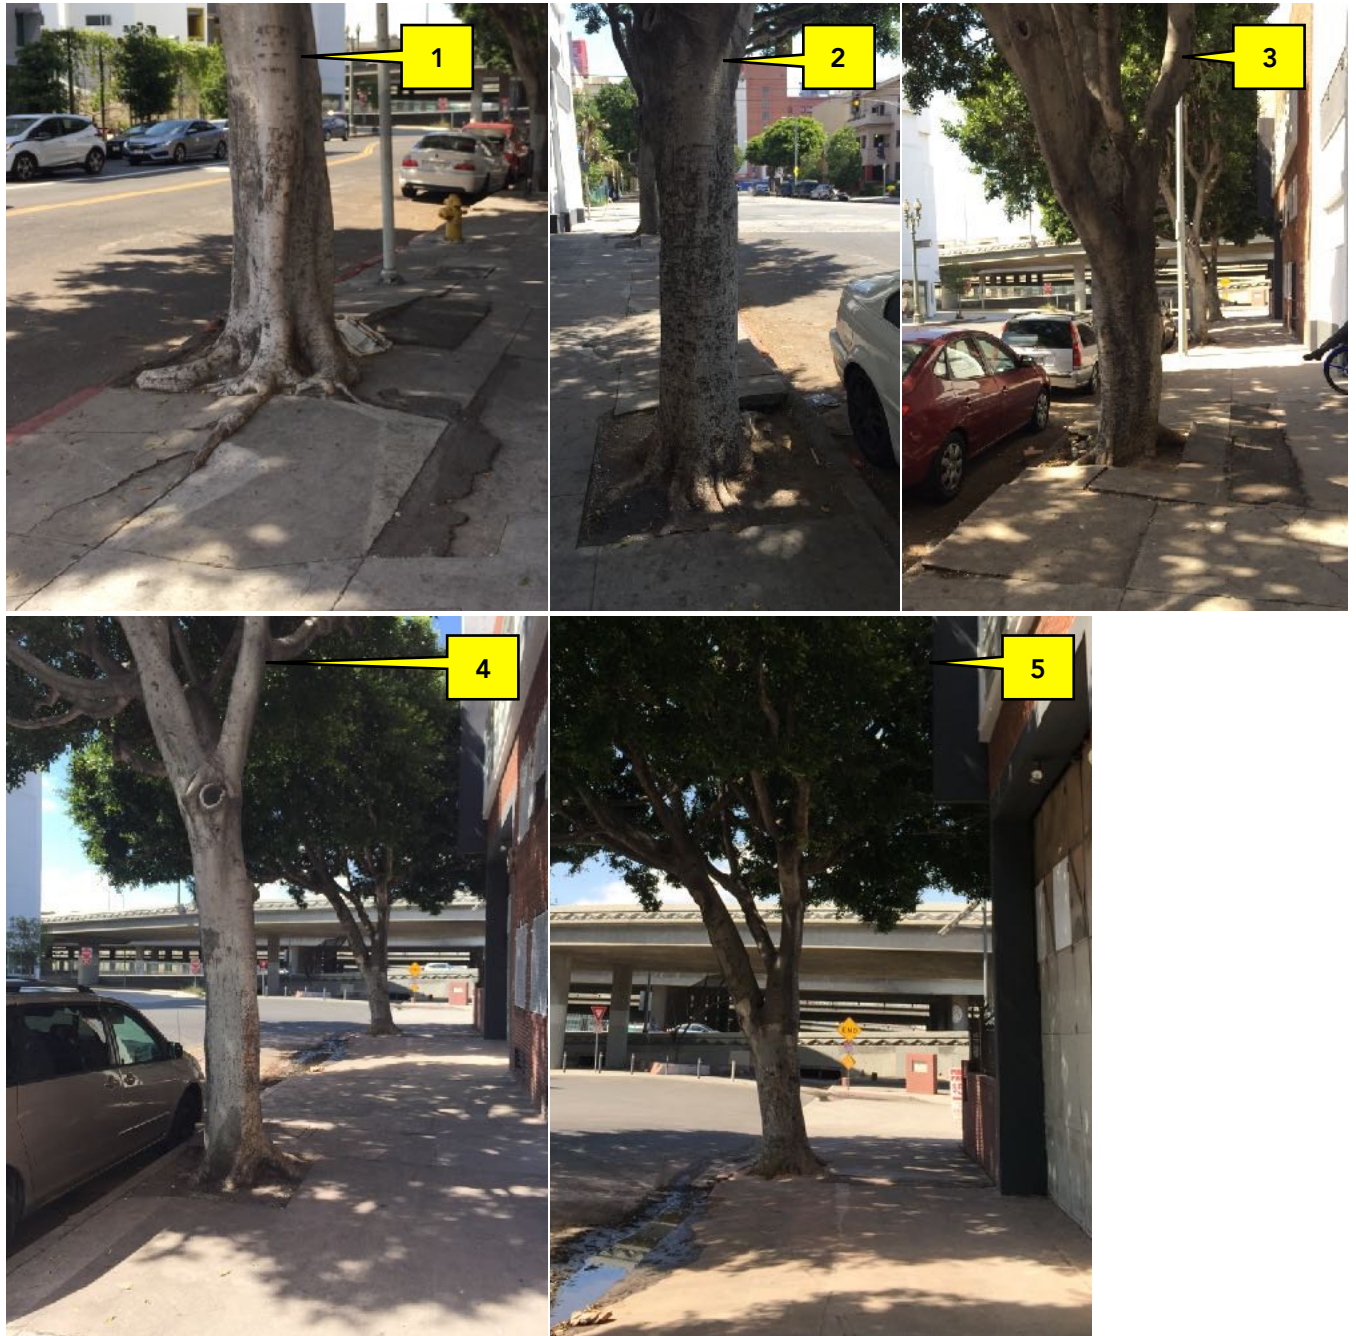
**PHOTO 2** - Shows close ups of lifted pavement at the base of Indian laurel fig (*Ficus microcarpa nitida*) street trees #1 - 5.

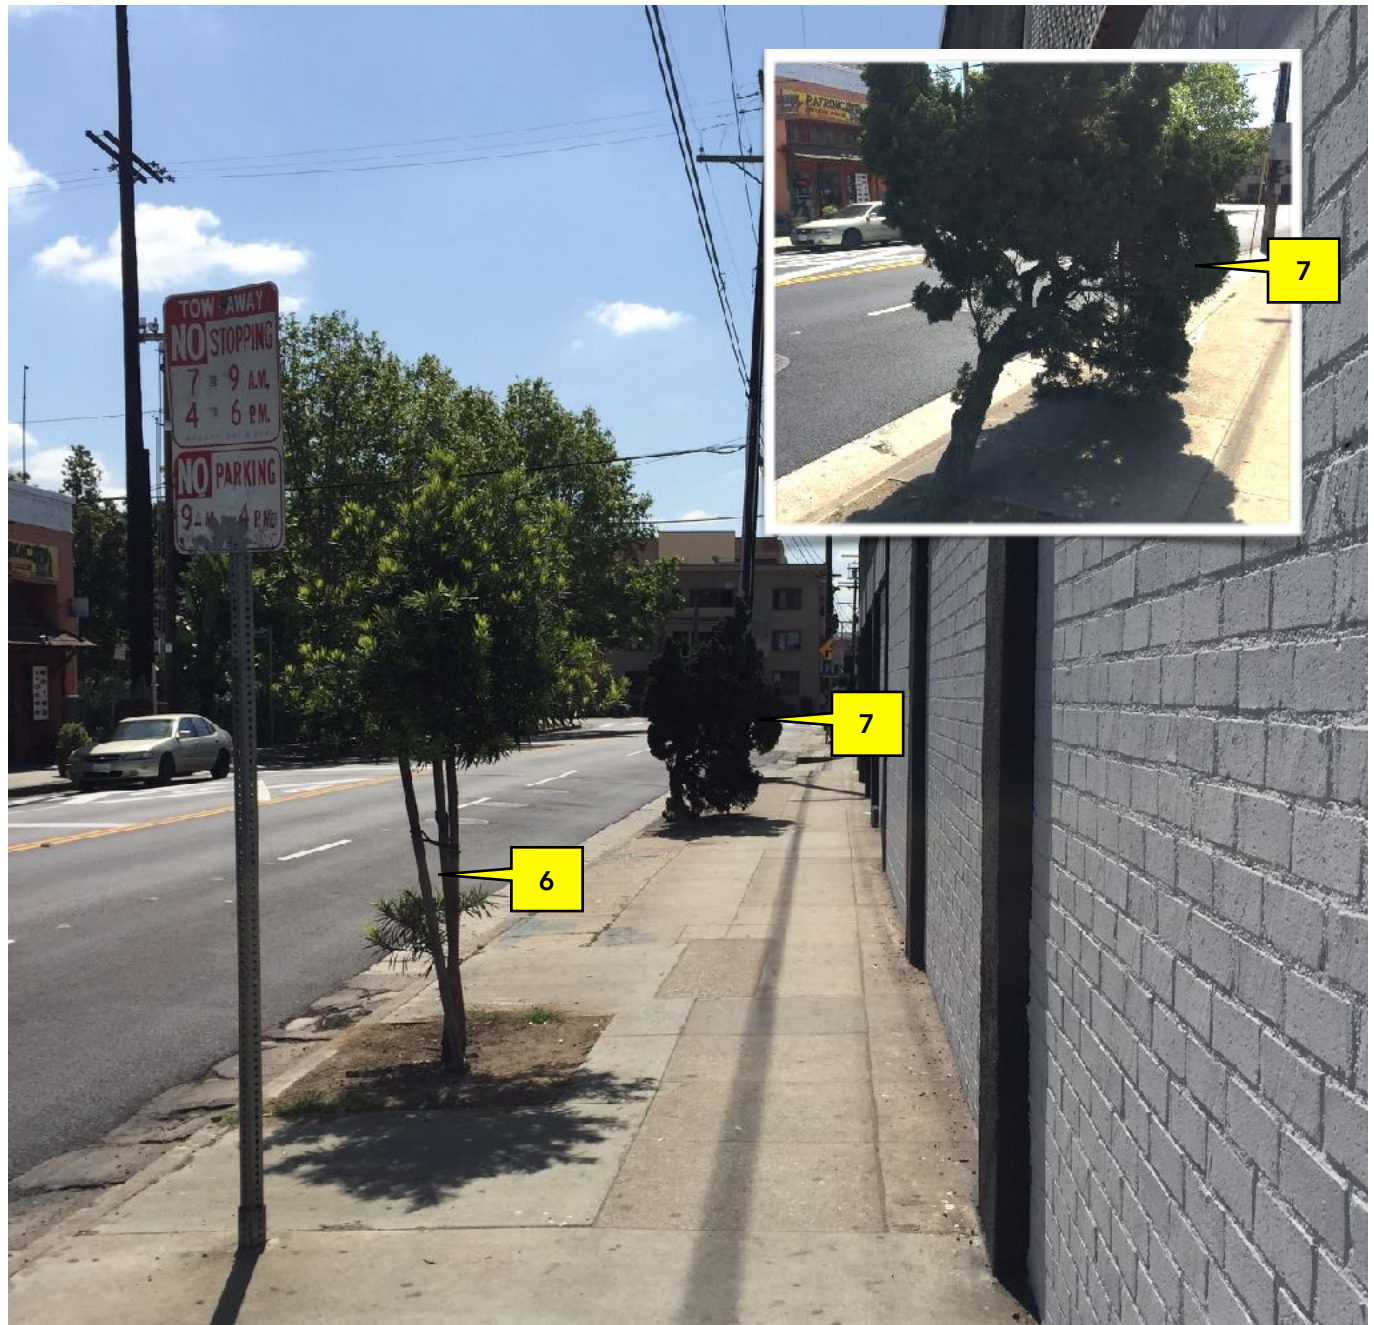
**PHOTO 3** - Shows street trees #6 and #7 installed along Venice Boulevard. These trees will be significantly impacted by the required street improvements and are recommended for removal.

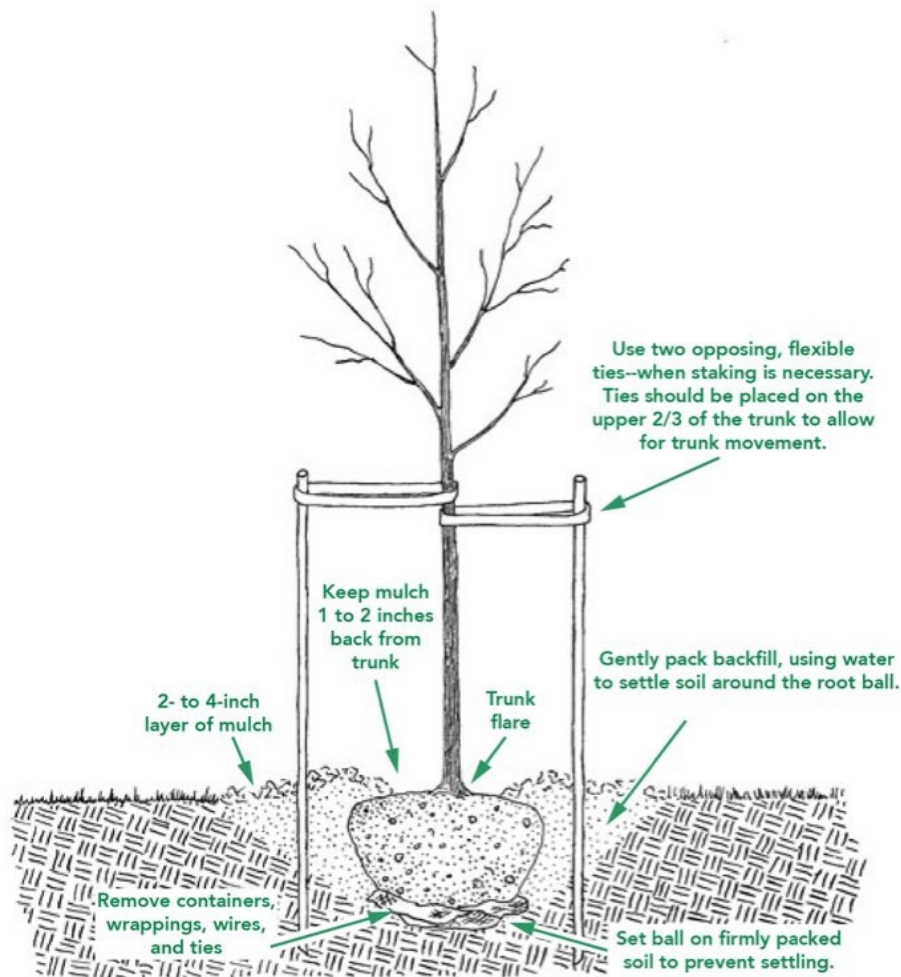
**2. Identify the trunk flare.** The trunk flare is where the roots spread at the base of the tree. This point should be partially visible after the tree has been planted (see diagram). If the trunk flare is not partially visible, you may have to remove some soil from the top of the root ball. Find it so you can determine how deep the hole needs for proper planting.

**7. Stake the tree, if necessary.** If the tree is grown properly at the nursery, staking for support will not be necessary in most home landscape situations. Studies have shown that trees establish more quickly and develop stronger trunk and root systems if they are not staked at the time of planting. However, protective staking may be required on sites where lawn mower damage, vandalism, or windy conditions are concerns. If staking is necessary for support, there are three methods to choose among: staking, guying, and ball stabilizing. One of the most common methods is staking. With this method, two stakes used in conjunction with a wide, flexible tie material on the lower half of the tree will hold the tree upright, provide flexibility, and minimize injury to the trunk (see diagram). Remove support staking and ties after the first year of growth.
