PRELIMINARY GEOTECHNICAL REPORT

Skyline Quarry Development
Susanville, Lassen County, California

Prepared by:
Bajada Geosciences, Inc.

May1, 2023
Project No. 2001.0114

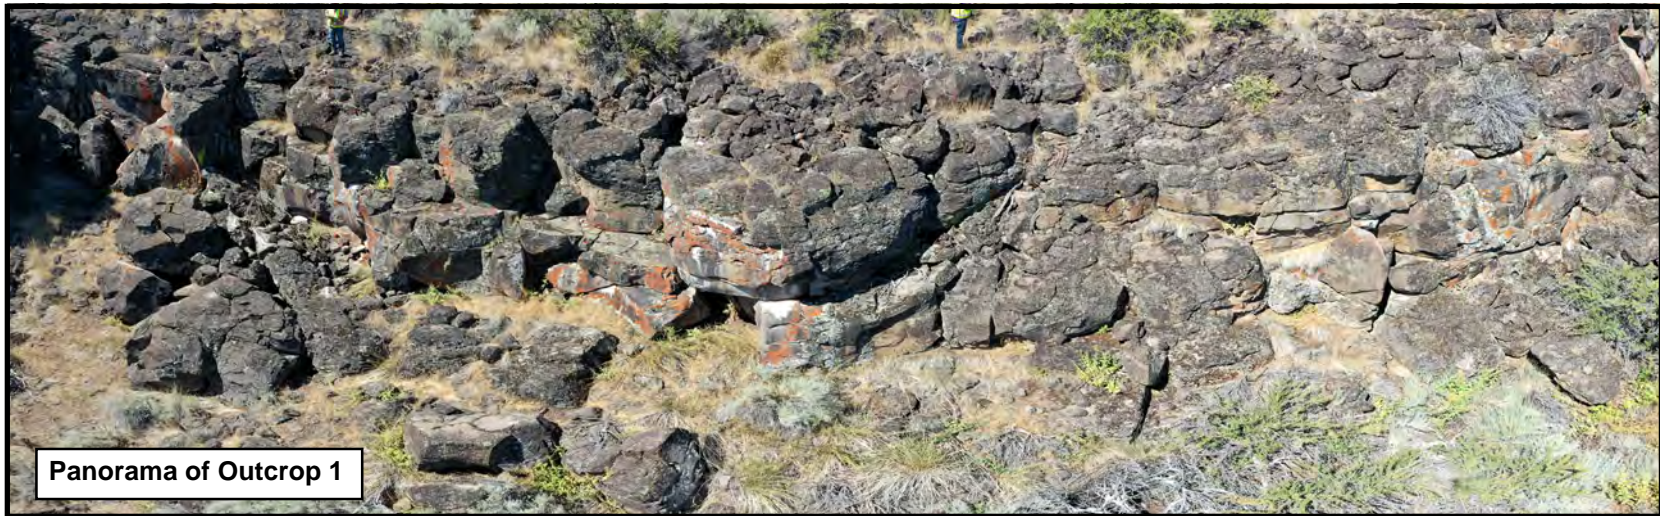
PHOTOGRAMMETRICALLY MEASURED DISCONTINUITY PLANES

PREDOMINANT DISCONTINUITY ORIENTATIONS			
Plane No.	Strike	Dip Direction	Dip
1	N42°E	72°	9°
2	N30°E	79°	84°
3	N01°W	269°	89°
4	N24°W	66°	66°

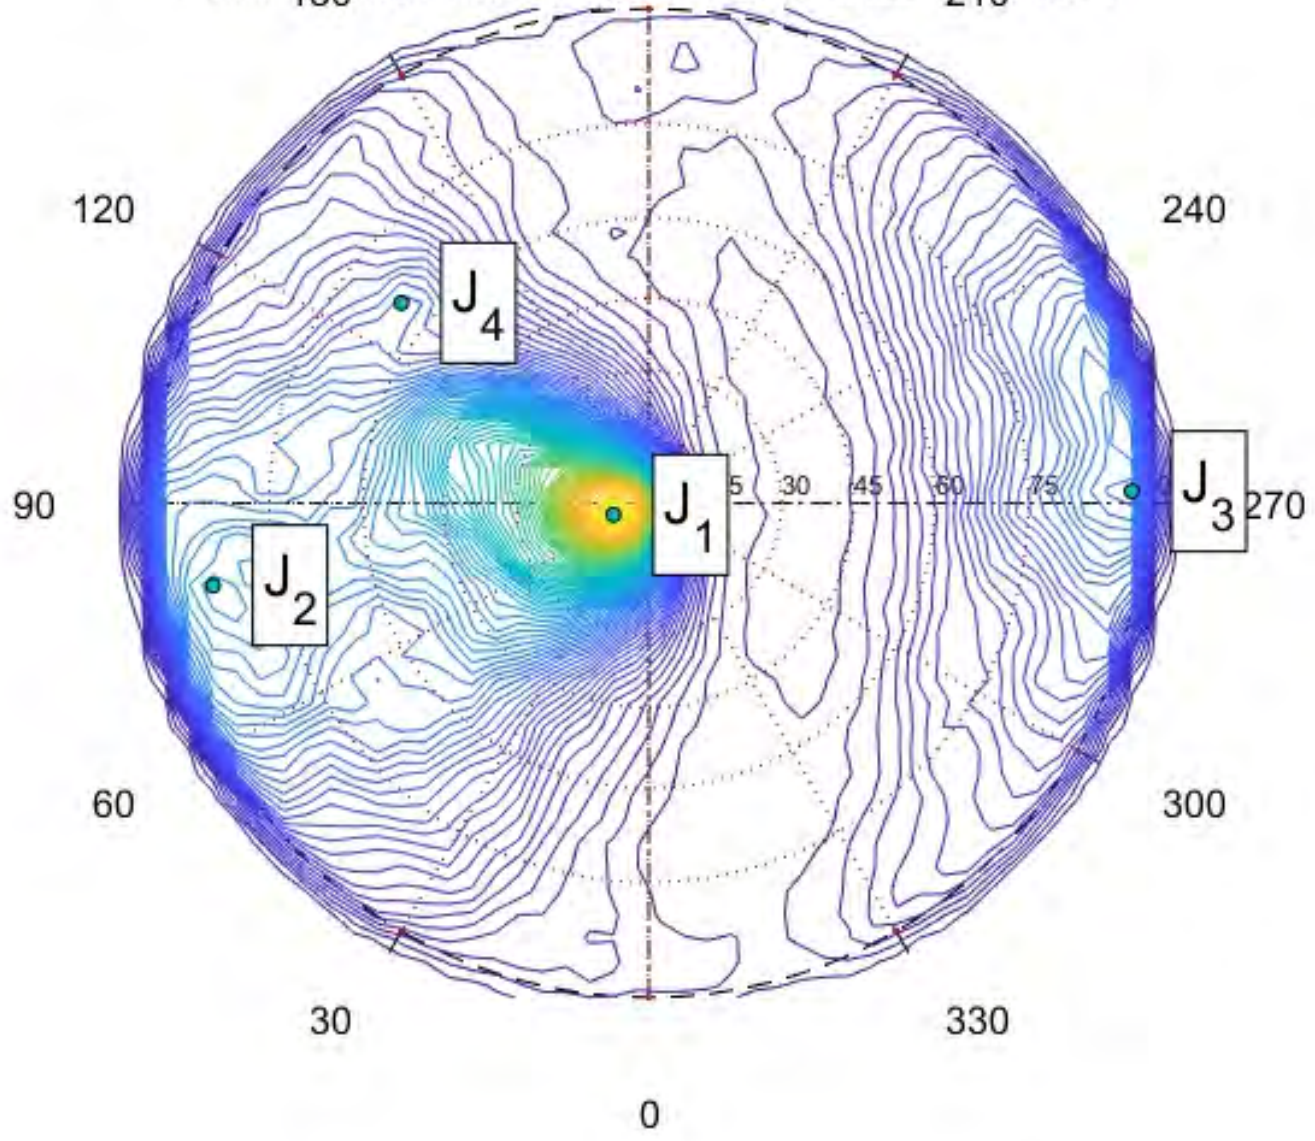
PREDOMINANT DISCONTINUITIES	
Skyline Quarry Preliminary Geotechnical Study Hat Creek Construction Susanville Area, Lassen Co., CA	Plate No. 10

180
Poles Density Plot, Principal Poles. Isolines each 1.25%

Dip dir (°)	Dip (°)	Density	%
1	71.7075	8.6046	2.2658	19.72
2	79.3010	83.7549	0.8019	21.29
3	268.5918	88.6367	0.6865	14.76
4	128.9989	65.5120	0.4874	15.24

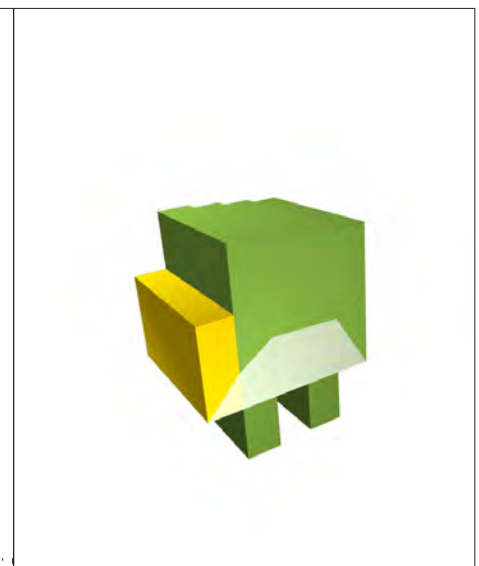
RESULTS OF TOPPLE ANALYSES	
Skyline Quarry Preliminary Geotechnical Study Hat Creek Construction Susanville Area, Lassen Co., CA	Plate No.
	13
