**PRELIMINARY GEOTECHNICAL AND  
GEOHAZARDS TECHNICAL REPORT  
ETIWANDA COMMERCE CENTER  
PROJECT  
BLACK CREEK INDUSTRIAL  
ACQUISITIONS LLC  
RANCHO CUCAMONGA, CALIFORNIA**

**PROJECT NO. 24001666.002A**

**FEBRUARY 2, 2024**

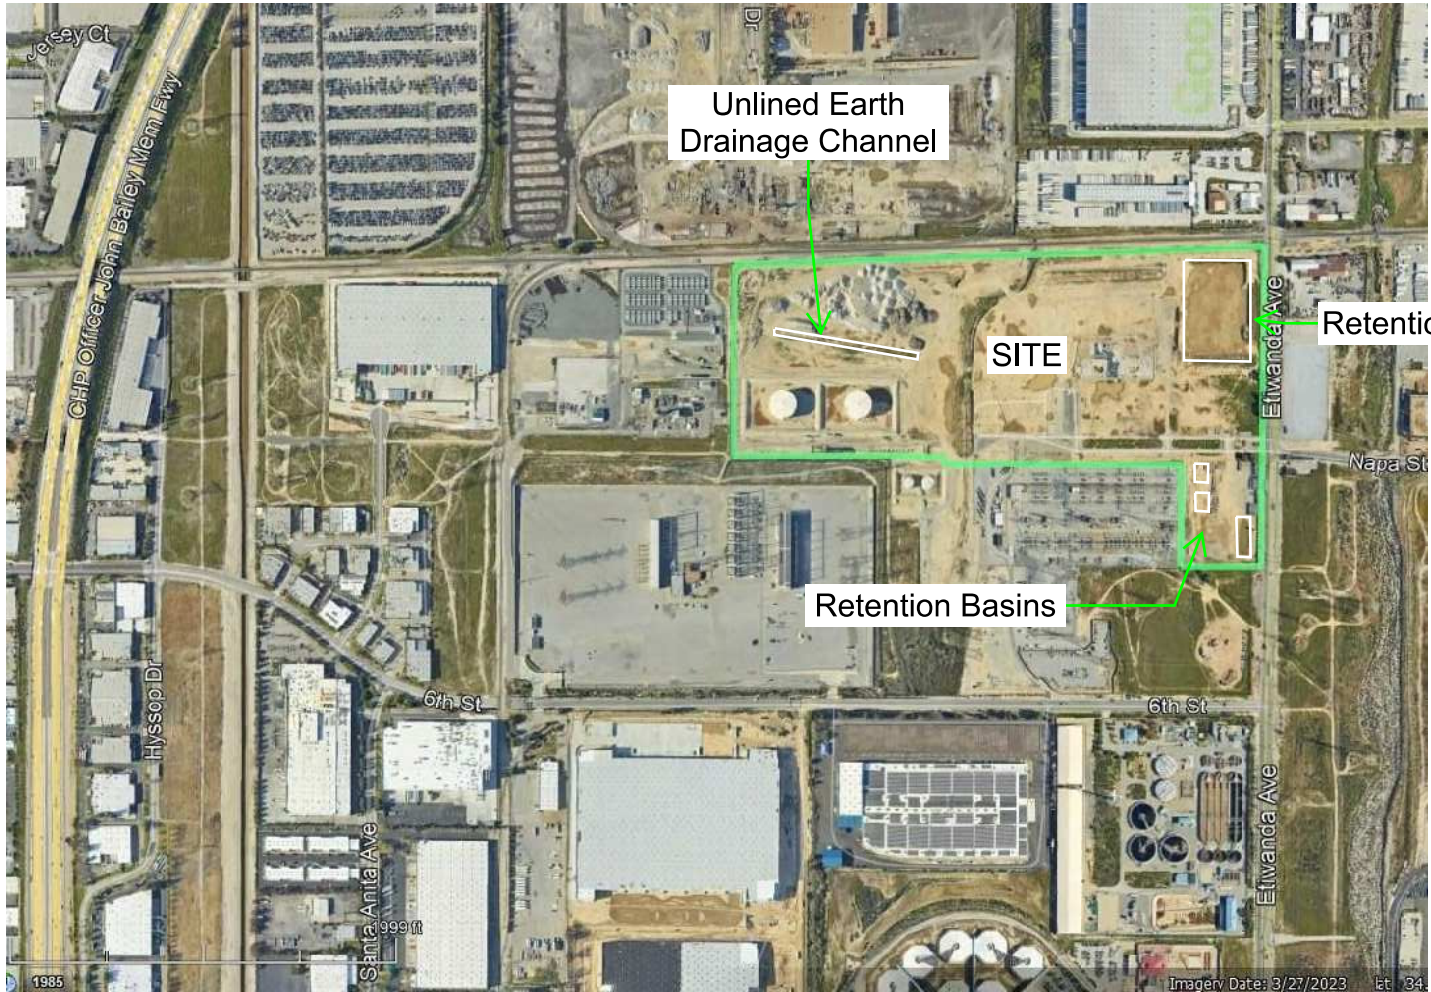
**2**

A dry retention pond, shown on Figure 2, was observed on the northeast corner of the site with above grade earth berms approximately 10 feet high, and an unlined earth drainage channel was observed running east west on the west side of the project site. Three stormwater retention basins were located within the southeast portion of the site area. Two of the retention basins, located in the southeast corner of the site near the offsite SCE substation have been partially backfilled with fill soil. The third and largest retention basin, located in the southeast corner along Etiwanda Avenue, is open and approximately 10 feet deep.

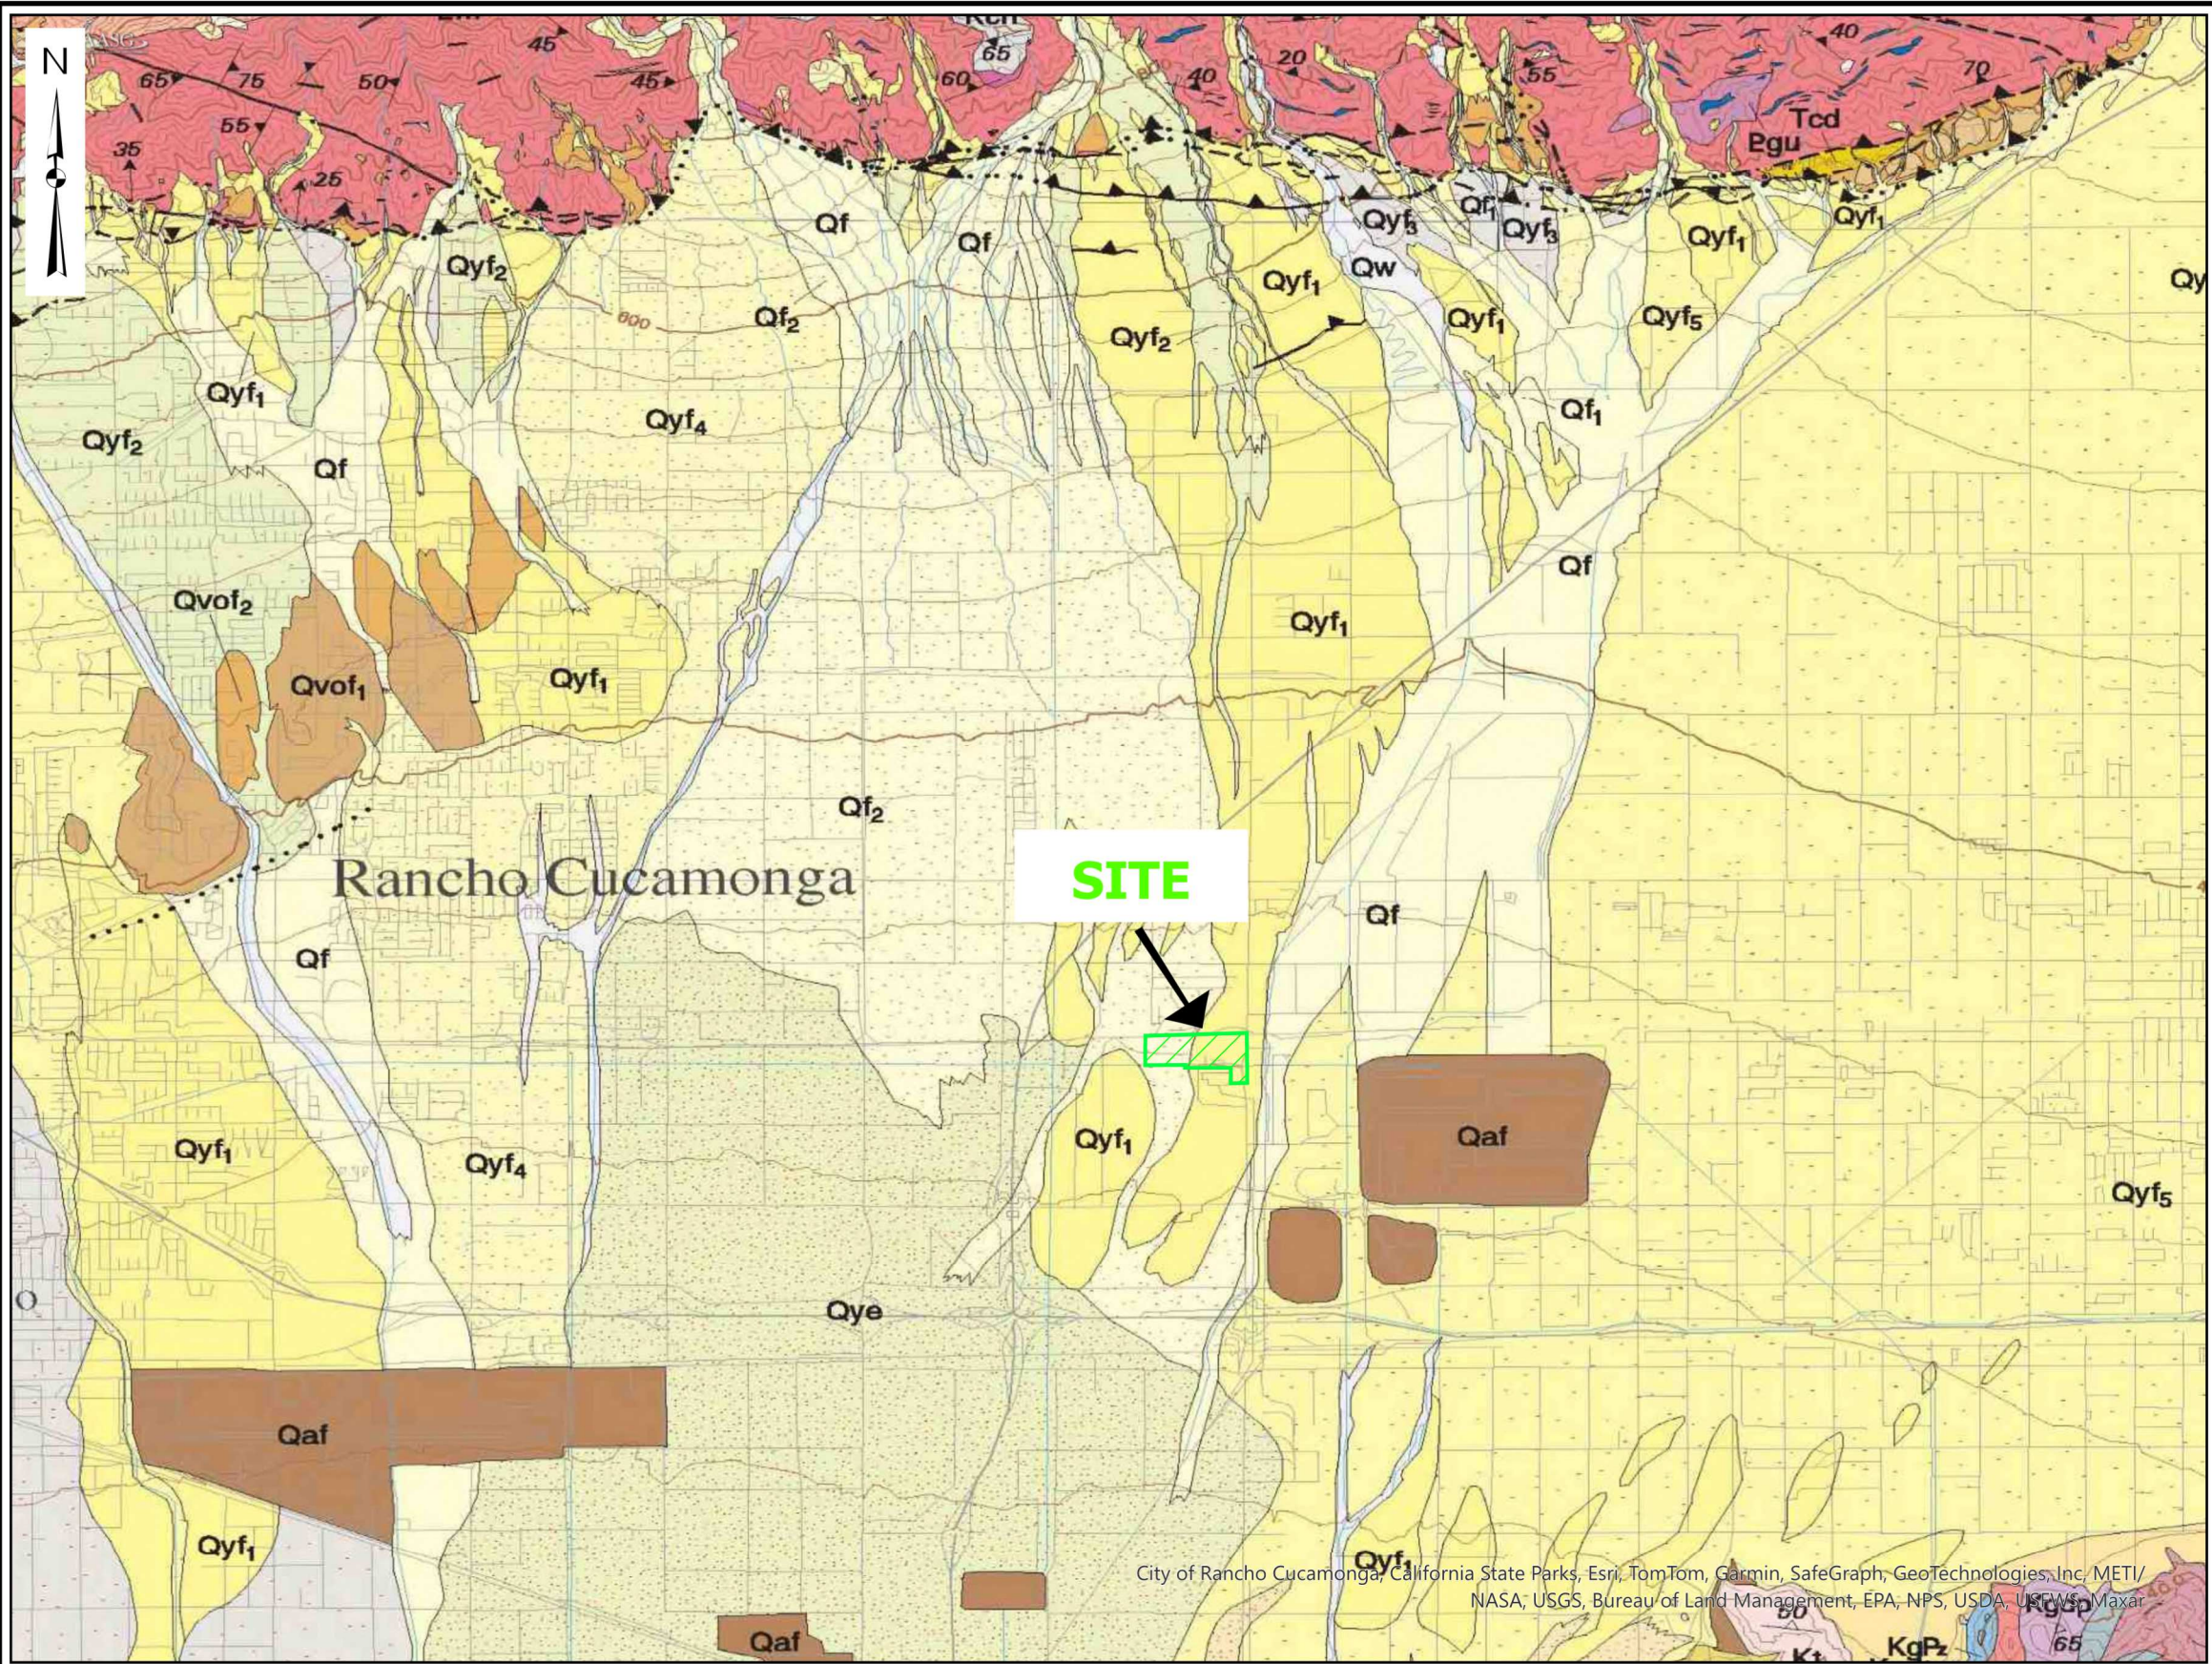
The project site is situated within the Chino Valley at the northern end of the Perris block along the northern boundary of the Peninsular Ranges geomorphic province of California (Norris and Webb, 1990). The geology of the region is presented on a referenced geologic map by Morton and Miller (2006) Figure 3 – Regional Geologic Map.

- Artificial Fill (late Holocene) - Sand, gravel, and bedrock
- Very Young Wash Deposits (late Holocene) - Unconsolidated sand and gravel deposits
- Very Young Alluvial-Fan Deposits (late Holocene) - Unconsolidated deposits of sand, gravel, and boulders

The site is underlain by late-Holocene age alluvial-fan deposits (Qyf<sub>1</sub>, Qf<sub>2</sub>) (Morton and Miller, 2006). Native alluvial soils are estimated to be 1,000 to 1,100 feet thick beneath the site (Fife, 1976). Surficial deposits observed by SCG consist of fill soils ranging in thickness from approximately 2.0 to 8.5 feet bgs (SCG, 2020) over alluvial fan deposits to the maximum depth explored of 30 feet bgs. These fill soils generally consisted of medium dense to dense fine sands with little silt, and silty fine sands with varying medium to coarse sand and fine gravel content. Some of the fill soils contained trace amounts of slag debris.
