**APPENDIX B2**  
**JURISDICTIONAL DELINEATION**

June 29, 2022

JN 189002

**SUBJECT: Delineation of State and Federal Jurisdictional Waters for the proposed Coronado Condos Project – City of Menifee, County of Riverside, California**

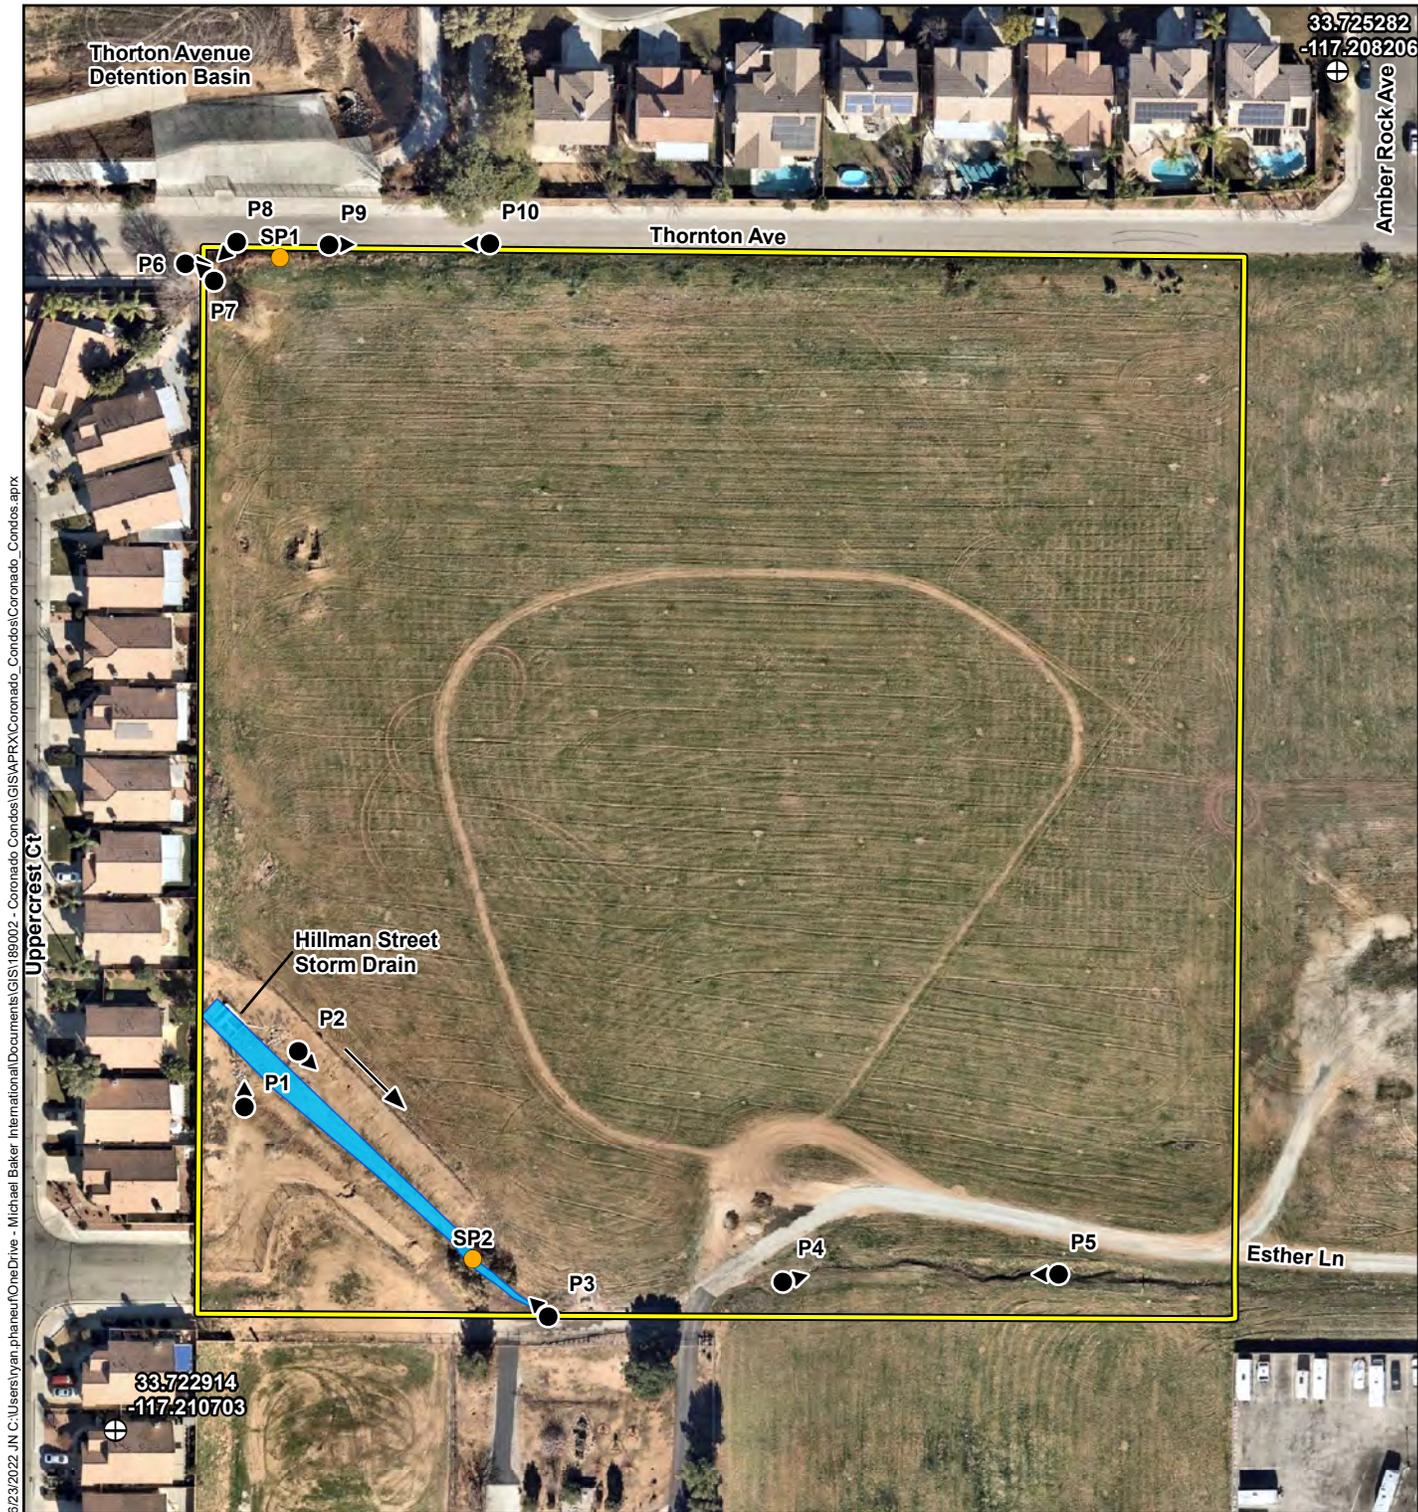
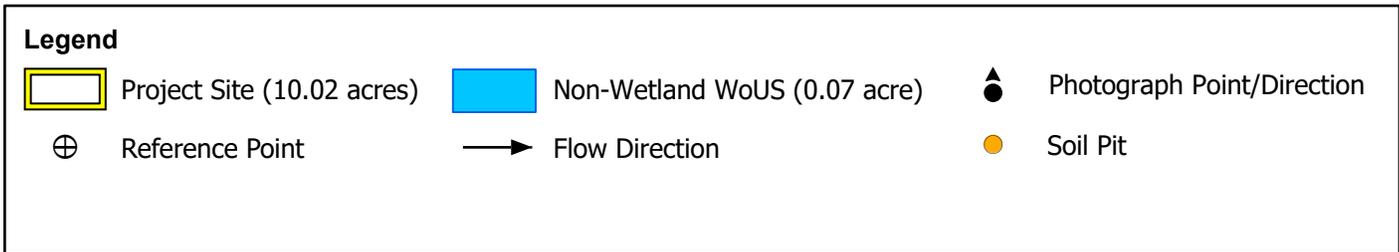
Figure 4

CORONADO CONDOS PROJECT  
 DELINEATION OF STATE AND FEDERAL JURISDICTIONAL WATERS  
**USACE/RWQCB Jurisdiction**

The HSSD Channel occurs within the southwest portion of the project site and exhibits a surface hydrologic connection to the Salt Creek Channel (Relatively Permanent Water) and ultimately Canyon Lake (Traditional Navigable Water). Therefore, the HSSD Channel would qualify as WoUS and fall under the regulatory authority of the USACE, RWQCB, and CDFW. Based on the results of the field delineation, approximately 0.07 acre (285 linear feet) of USACE/RWQCB jurisdiction (non-wetland WoUS) and approximately 0.19 acre (285 linear feet) of CDFW jurisdiction (streambed) occurs within the project site (refer to Table 1 below).

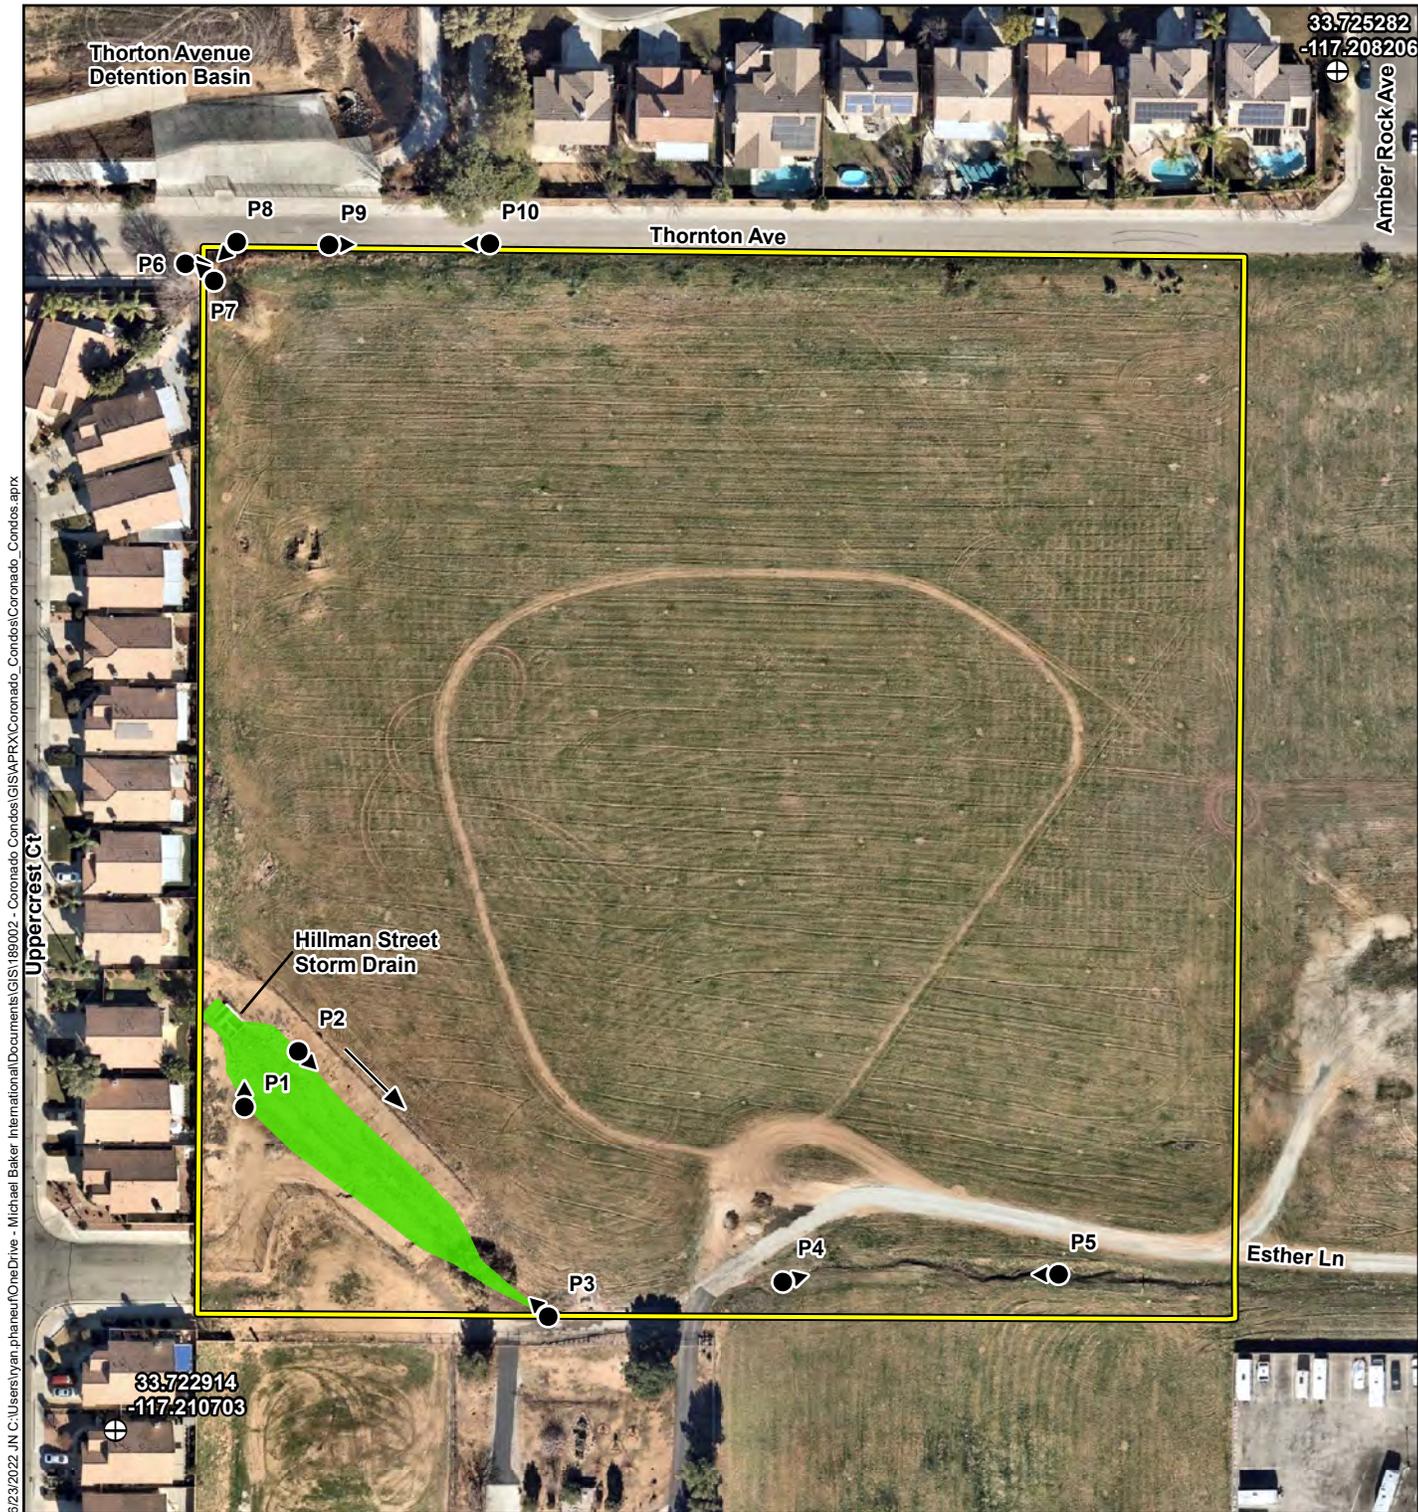
Figure 5

Streambed (0.19 acre)

CORONADO CONDOS PROJECT  
 DELINEATION OF STATE AND FEDERAL JURISDICTIONAL WATERS  
**CDFW Jurisdiction**

The CDFW regulates alterations to lakes, streambeds, and riparian habitats pursuant to Section 1600 *et seq.* of the CFGC. Based on a review of the conceptual site plan, approximately 0.19 acre (285 linear feet) of CDFW jurisdiction (streambed) occurs within the project site and would potentially be impacted by the proposed project. Therefore, it would be necessary for the project proponent to obtain a Section 1602 Streambed Alteration Agreement (SAA) from the CDFW prior to impacts occurring within CDFW jurisdictional areas.

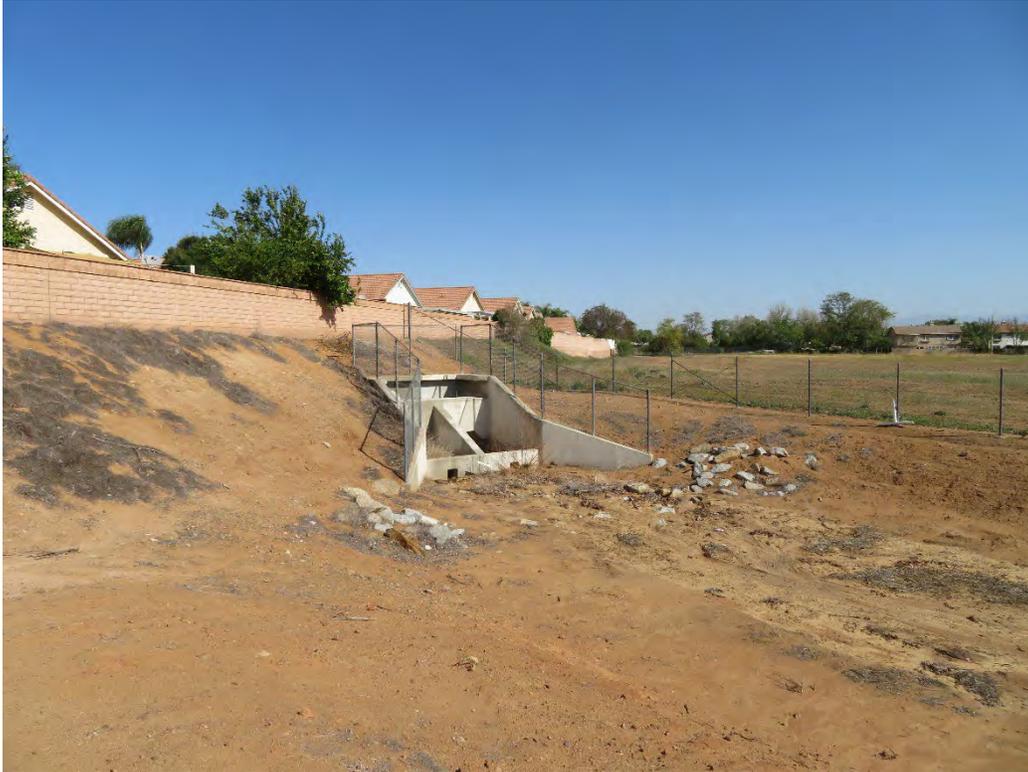
**Photograph 1:** View of the Hillman Street Storm Drain (HSSD) outlet located near the western boundary of the project site, facing north (upstream).

The HSSD collects/transportes municipal stormwater from the adjacent residential development and surrounding foothills before discharging into an earthen flood control channel located near the western boundary of the project site (refer to Attachment E, *Site Photographs*). The HSSD Channel is maintained by the Riverside County Flood Control & Water Conservation District (RCFCD) and extends in a northwest to southeast direction for approximately 285 linear feet through the southwest corner of the project site before terminating at Esther Lane. Based on the results of the field survey, surface water exiting the HSSD Channel appears to flow along/across Esther Lane as unconfined/overland sheet flow and ultimately fanout and infiltrate on the southern portion of the project site. No surface water was observed within the channel during the field survey. However, evidence of an OHWM was observed via a natural line impressed on the bank, change in particle size distribution, presence of a wrack line, and shelving.

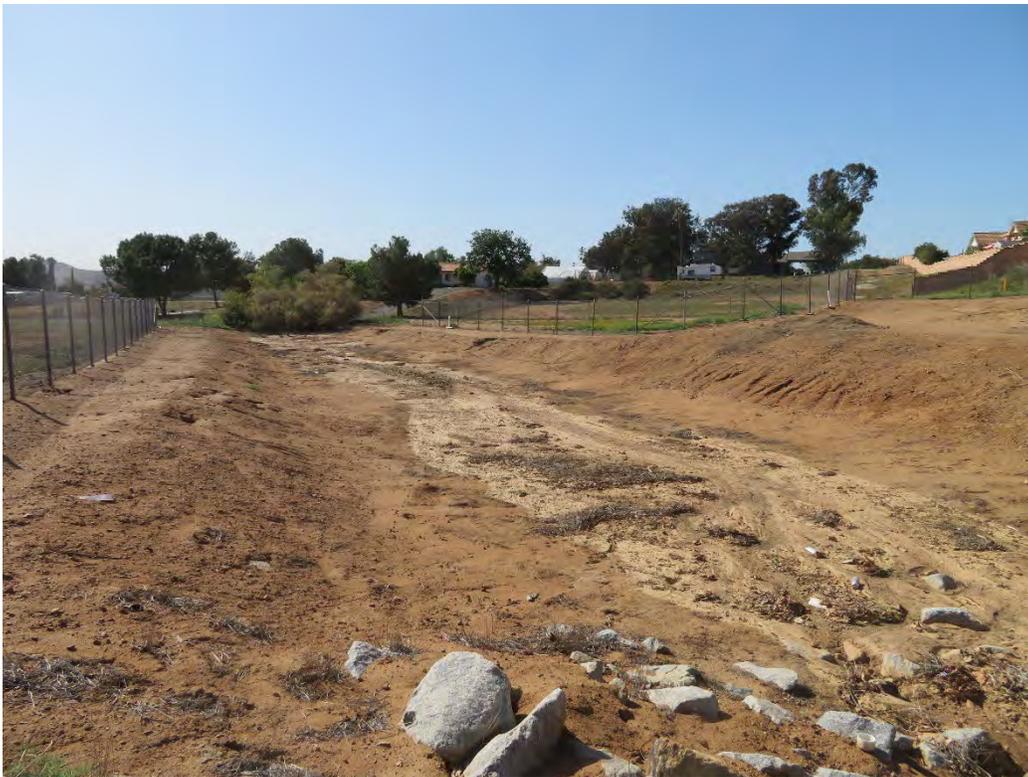
**Photograph 2:** View from northern slope/bank of HSSD Channel in the southwest corner of the project site, facing southeast (downstream).

Due to ongoing maintenance by RCFCD, a majority (approximately 75%) of the channel is devoid of vegetation and consists of heavily compacted soils. However, there are some areas at the downstream end of the channel that appear to not be maintained which has allowed some vegetation to establish/persist. Plant species observed within the downstream portion of the channel were mostly non-native and included short-pod mustard (*Hirschfeldia incana*, UPL), London rocket (*Sisymbrium irio*, UPL), common fiddleneck (*Amsinckia menziesii*, UPL), bicolor lupine (*Lupinus bicolor*, UPL), foxtail barley (*Hordeum murinum*, FACU), red brome (*Bromus rubens*, UPL), ripgut brome (*Bromus diandrus*, UPL), wild oats (*Avena fatua*, UPL), as well as a small patch (4 individuals) of African sumac (*Searsia lancea*, NI), Mexican fan palm (*Washingtonia robusta*, FACW), salt cedar (*Tamarix ramosissima*, FAC), and Goodding's black willow (*Salix gooddingii*, FACW).

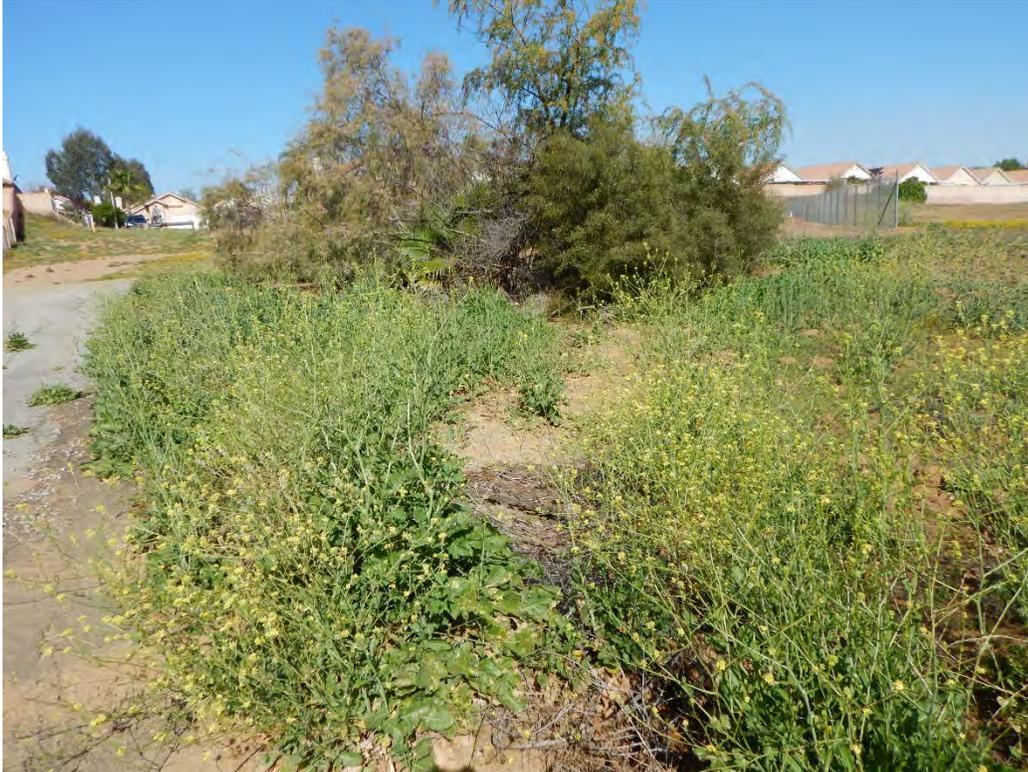
**Photograph 3:** View of downstream terminus of the HSSD Channel and patch of non-native trees (i.e., tamarisk, African sumac), facing northwest (upstream).

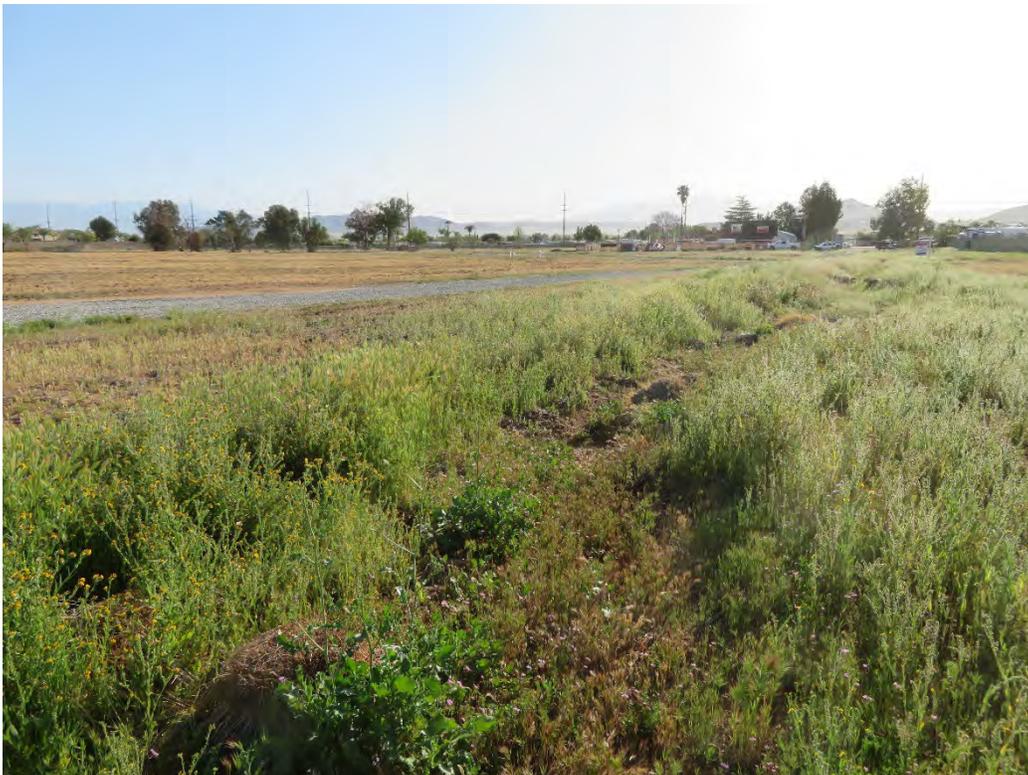
**Photograph 4:** View of swale feature to the east/south of Esther Lane that lacked evidence of a continuous OHWM or defined bed and bank, facing east.

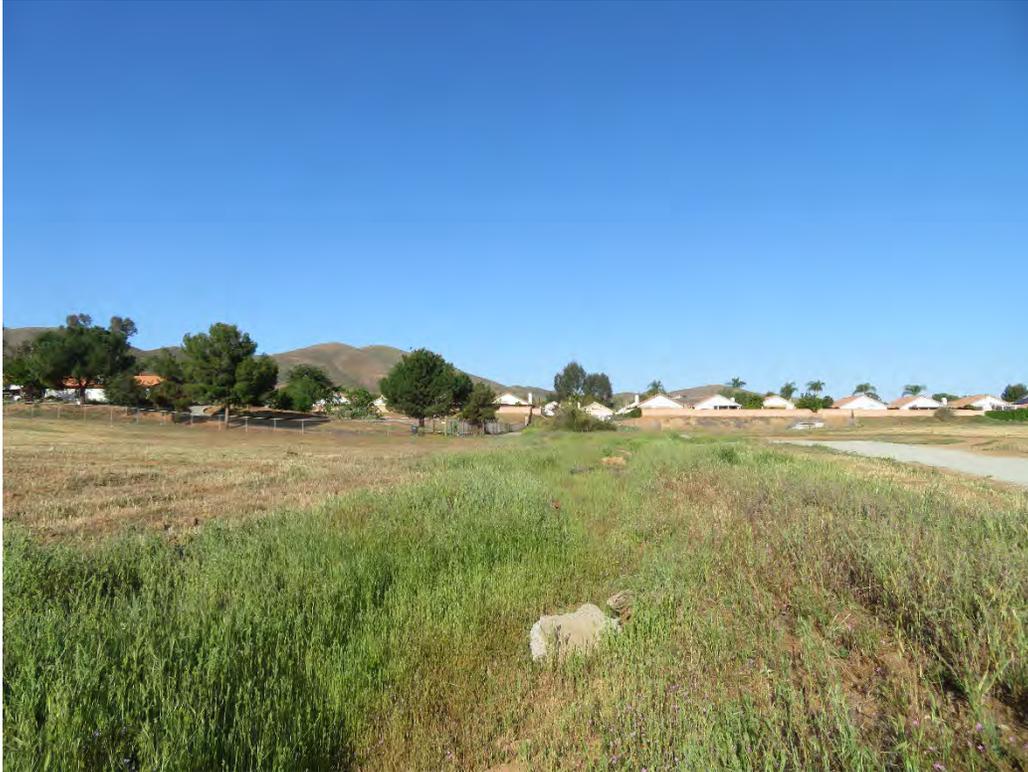
**Photograph 5:** View of non-native grasses and other upland plant species near the southeast corner of the project site, facing west.

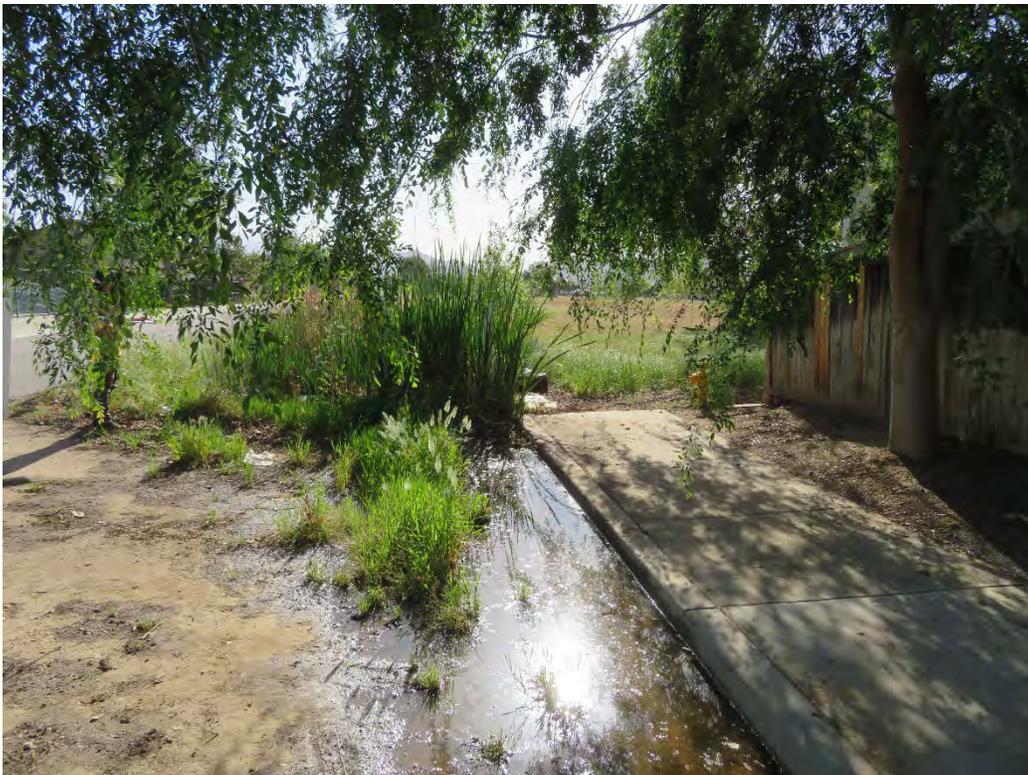
**Photograph 6:** View of surface water flowing east along Thornton Avenue to the northwest corner of the project site where flows pond/infiltrate, facing east.

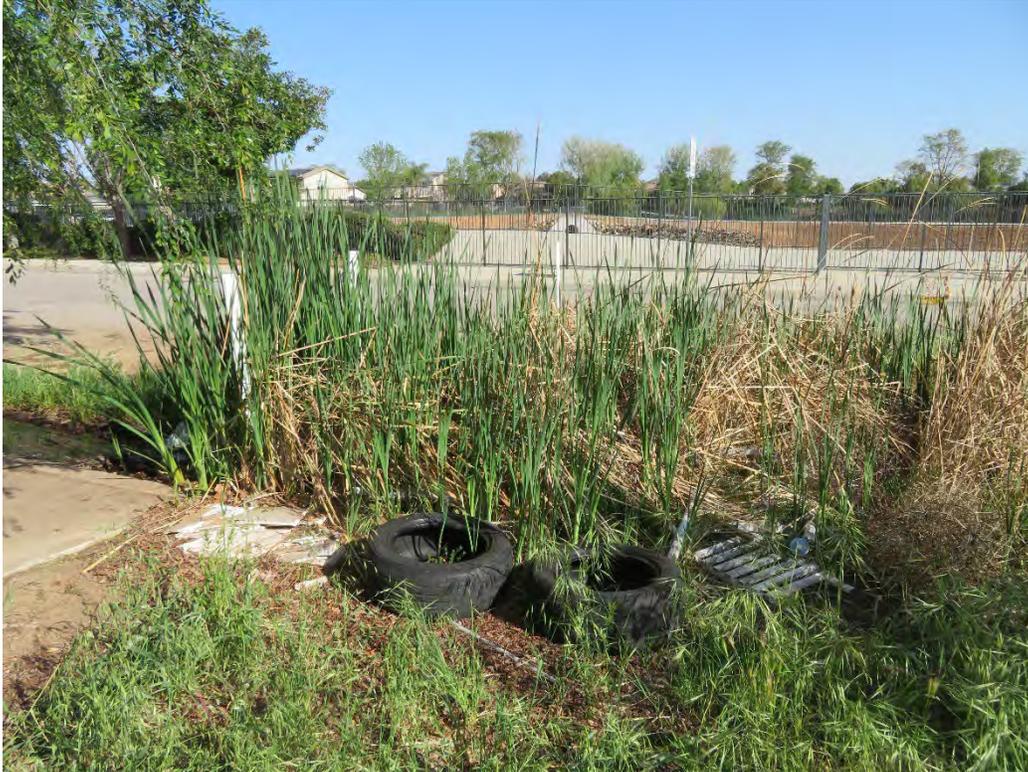
**Photograph 7:** View of hydrophytic vegetation observed in the northwest corner of the project site due to urban runoff from Thornton Avenue, facing northwest.

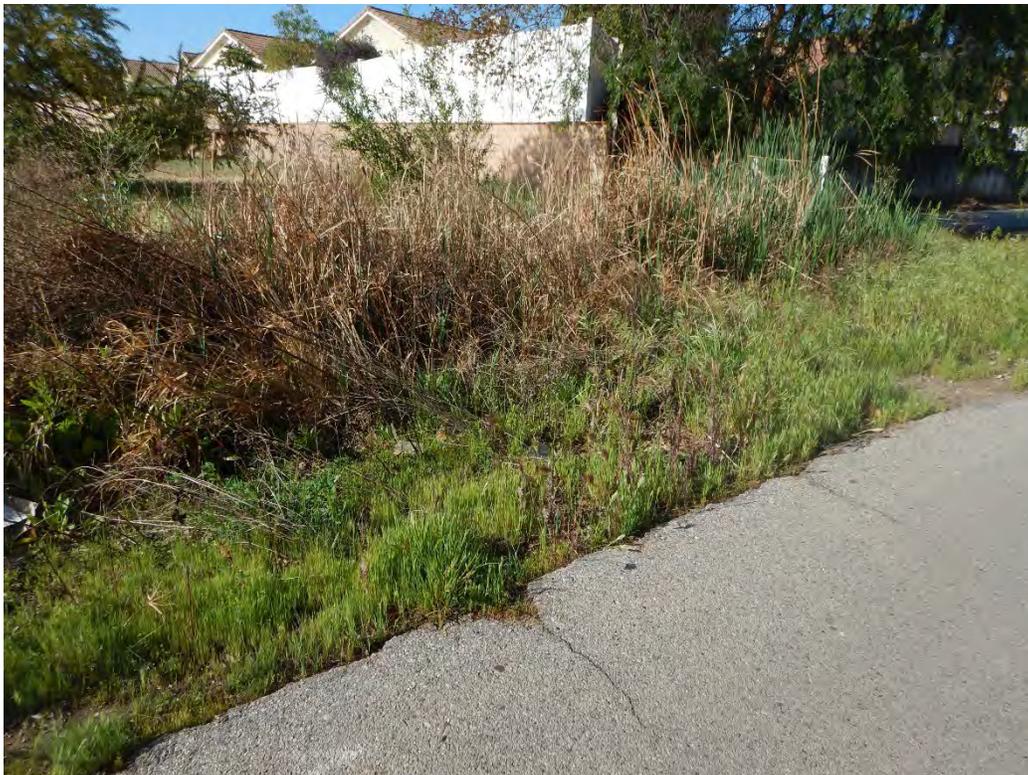
**Photograph 8:** View of small strip of hydrophytic vegetation along the northern boundary of the project site where it meets Thornton Avenue, facing southwest.

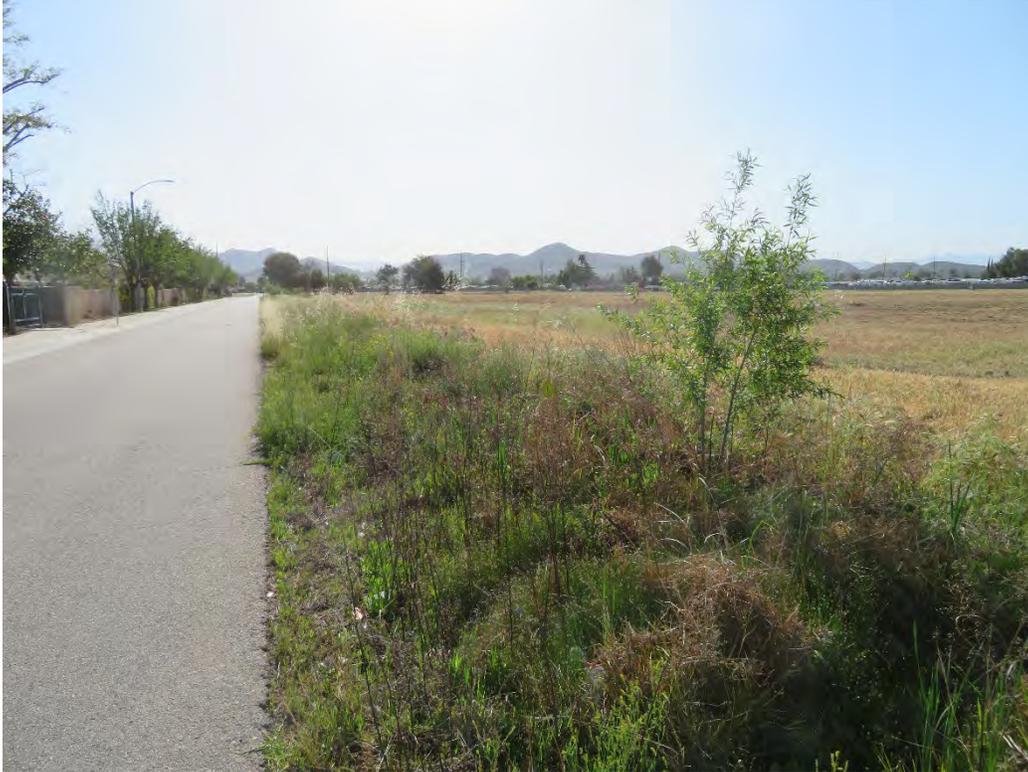
**Photograph 9:** View of along the northern boundary of the project site and absence of hydrophytic vegetation, facing east.

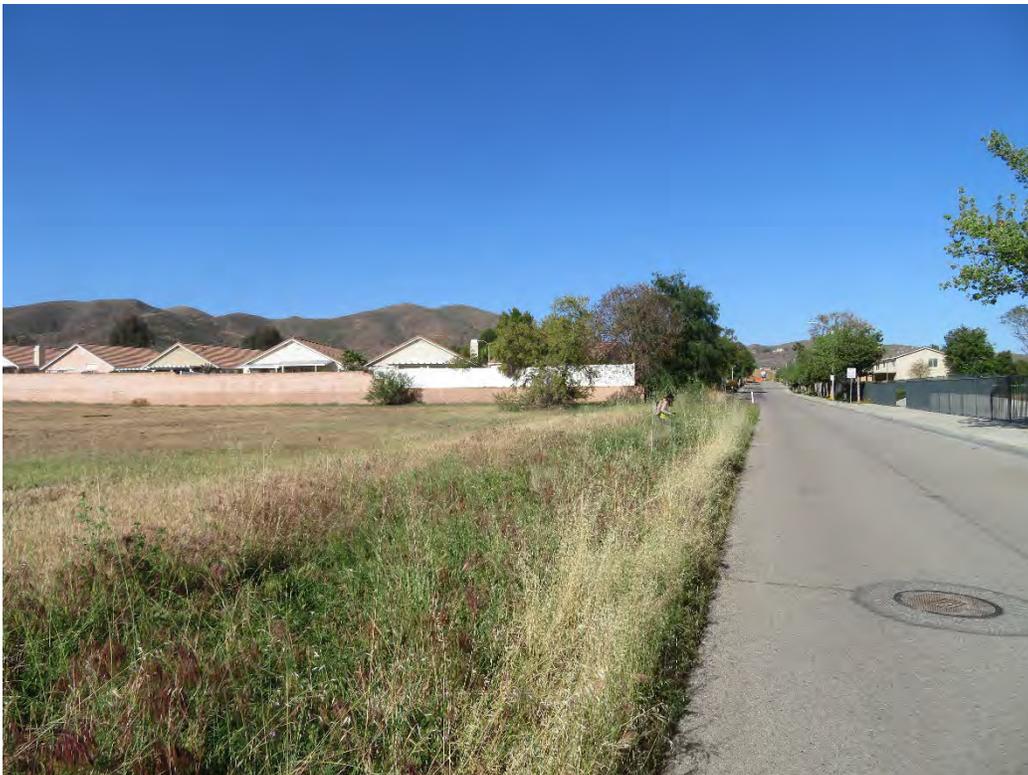
**Photograph 10:** View of non-native grasses and other upland plant species along the northern boundary of the project site and Thornton Avenue, facing west.

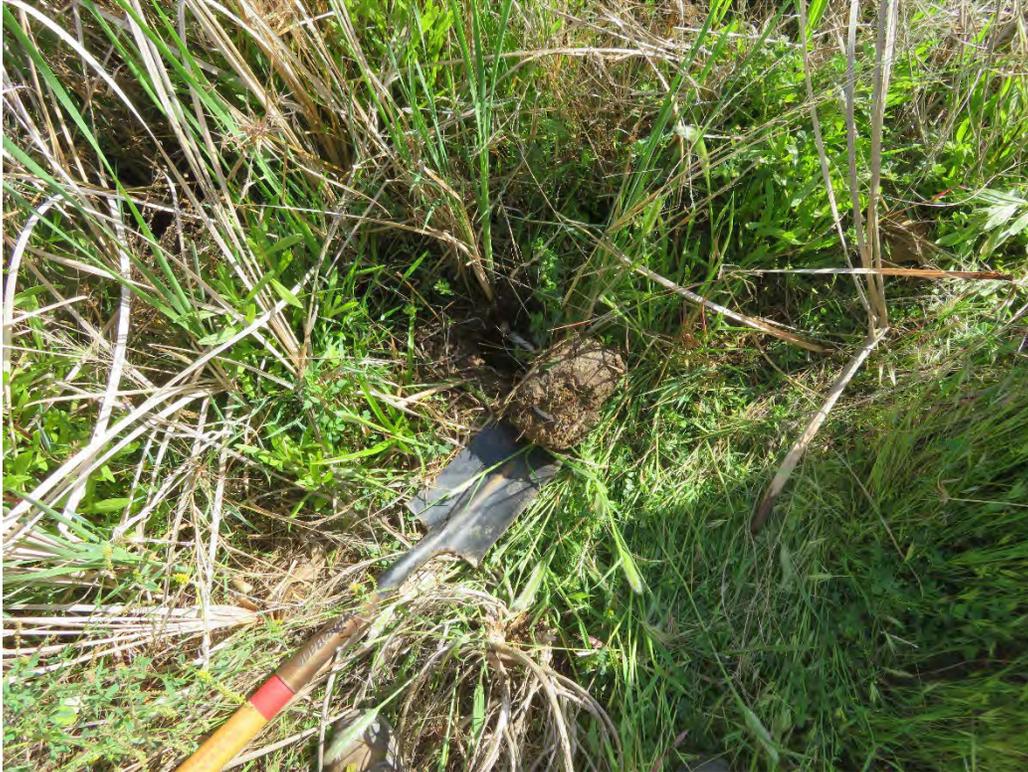
Remarks:  
 Single layer of soil, consistent throughout. Redox concentrations visible throughout entire matrix. Soil formed a long ribbon in the hand and felt gritty.

**Photograph F-1:** View of SP1 soil pit taken within the northwest corner of the project site.

FACW), and tall flatsedge (*Cyperus eragrostis*, FACW). SP1 was excavated to a depth of approximately 7 inches; suspected concrete or bedrock below the terminal point of the pit made it difficult to excavate further. Soils exhibited a loamy/clayey texture and displayed a matrix color of 10YR 3/4 when moist. Redoximorphic features displaying a color of 7.5YR 4/4 were observed consistently throughout the entire matrix confirming the presence of hydric soils. However, due to the absence of hydrophytic vegetation, it was determined that SP1 two (hydric soils and wetland hydrology) of the three required parameters, and thus did not qualify as a wetland (refer to Attachment F, *Wetland Determination Data Forms*).

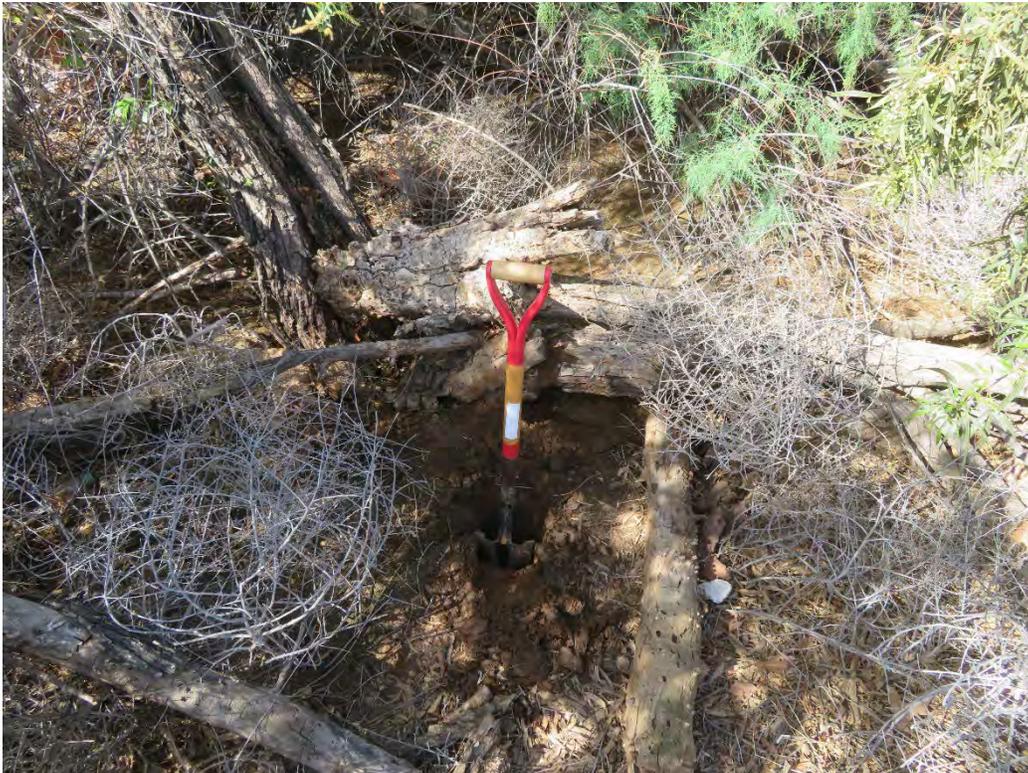
Remarks:  
Single soil layer consistent throughout. Tree roots encountered around 12.5" but dug around. Soil failed to form a ball in hand when wet. No evidence of redox features, hydrogen sulfide, or other hydric soil indicators observed.

**Photograph F-2:** View of SP2 soil pit taken within invert of the Hillman Street Storm Drain (HSSD) Channel.

SP2 was located within the HSSD Channel due to the presence of Goodding’s black willow (FACW) and Mexican fan palm (FACW) and both primary and secondary hydrology indicators (i.e., surface soil cracks, sediment deposits, drift deposits, saturation visible on aerial imagery). SP2 was excavated to a depth of approximately 16 inches. Soils exhibited a sandy texture and displayed a matrix color of 10YR 3/3 when moist with no redoximorphic features observed. Due to the absence of hydric soils, it was determined that SP2 only met two (hydrophytic vegetation and hydrology) of the three required parameters, and thus did not qualify as a wetland (refer to Attachment F, *Wetland Determination Data Forms*).
