Project/Site: Janus Solar	oject/Site: Janus Solar City/County:Colusa					
Applicant/Owner: RWE Solar Development, LLC		State:CA	Sampling Point:1-1a up			
Investigator(s): Daniel Berg, Monique O'Conner	Section, Township	Section, Township, Range: 1-3, 25, 26, 29, 30, 35; 14N, 15N; 3W				
Landform (hillslope, terrace, etc.): Plain	Local relief (conca	ive, convex, none):None	Slope (%):0			
Subregion (LRR):C - Mediterranean California	Lat:Refer to Map	Long:Refer to Map	Datum:N/A			
Soil Map Unit Name: Capay clay loam		NWI classifi	cation:None			
Are climatic / hydrologic conditions on the site typical for this tir	me of year? Yes 💿 🛛 N	lo 🔿 (If no, explain in F	Remarks.)			
Are Vegetation X Soil X or Hydrology sign	ificantly disturbed?	Are "Normal Circumstances"	present? Yes 💿 No 🔿			
Are Vegetation Soil or Hydrology natu	Irally problematic? (If needed, explain any answe	ers in Remarks.)			
SUMMARY OF FINDINGS - Attach site map sho	owing sampling poir	nt locations, transects	, important features, etc.

Janus Solar Project Colusa County, CA Paleontology Technical Memorandum Figure 2: Project Site

Tesla Megapack 2/XL | Hazard Mitigation Analysis

Janus Solar Project Colusa County, CA Noi

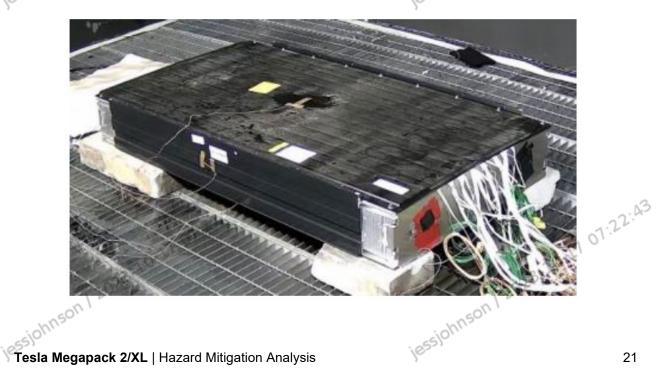
Table 3-2 - Module Level Test Gas Analysis

Gas Name	Chemical Structure	Measurement Peak (ppm)	Detection Method
	Carbon Monoxide	CO	204.84	FTIR
	Carbon Dioxide	CO ₂	6720.62	20FTIR
hnso	Methane	CH₄	67.83	on FTIR
	Acetylene	C_2H_2	17.115	FTIR
	Ethene	C_2H_4	Not Detected	FTIR
	Ethane	C ₂ H ₆	Not Detected	FTIR
	Propane	C_3H_8	Not Detected	FTIR
F	Butane	C_3H_4	Not Detected	FTIR
	Pentane	C ₃ H ₆	Not Detected	FTIR
	Benzene	C_6H_6	9.01	FTIR
	Hexane	C ₇ H ₁₄	Not Detected	FTIR
	Hydrofluoric Acid	N3 HF	Not Detected	FTIR
	Hydrogen Chloride	HCL	Not Detected	FTIR
	Hydrogen Cyanide	HCN	Not Detected	FTIR J
ľ	Hydrogen	H ₂	446	Hydrogen Sensor
~0	Total Hydrocarbons	(Propane Equivalent)	246.53	FID
Fi	gure 3-3 - Highlights of I	Nodule Testing	jessjohns	·
