# PHASE I ENVIRONMENTAL SITE ASSESSMENT

# A PORTION OF KINGS COUNTY ASSESSOR'S PARCEL NUMBER 014-260-078-000 HANFORD, CALIFORNIA

BSK PROJECT E00000330

July 14, 2022

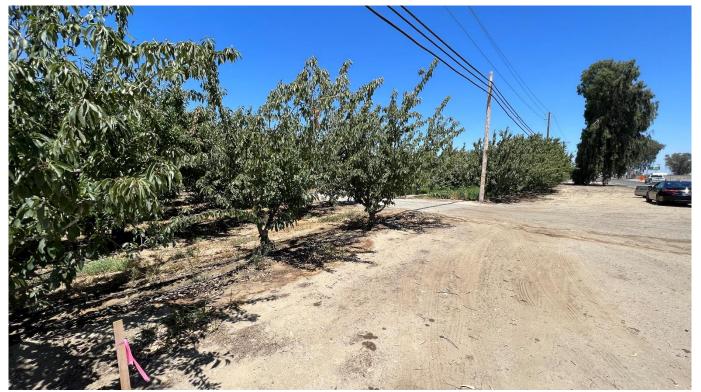
Photo 1: View of Subject Property from the southwest corner looking northeast. Note overhead utilities.

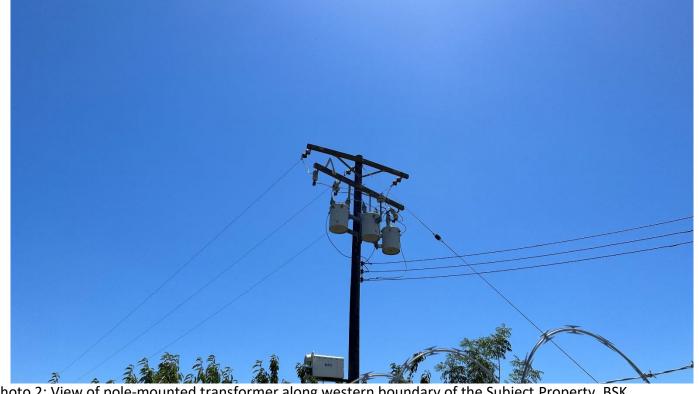
Photo 2: View of pole-mounted transformer along western boundary of the Subject Property. BSK did not see evidence of staining or release from the pole-mounted transformer.

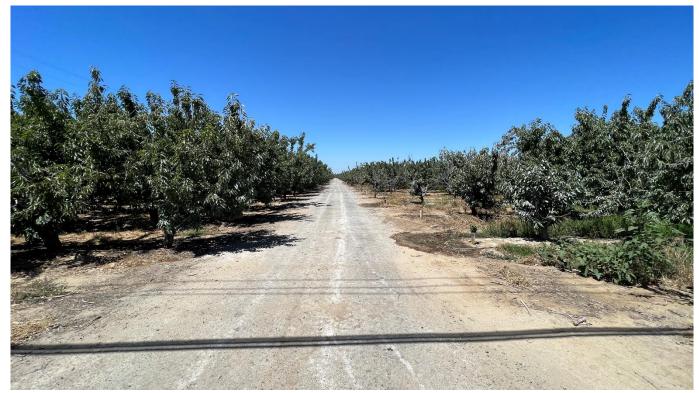
Photo 3: View of access road near western boundary of the Subject Property looking north.

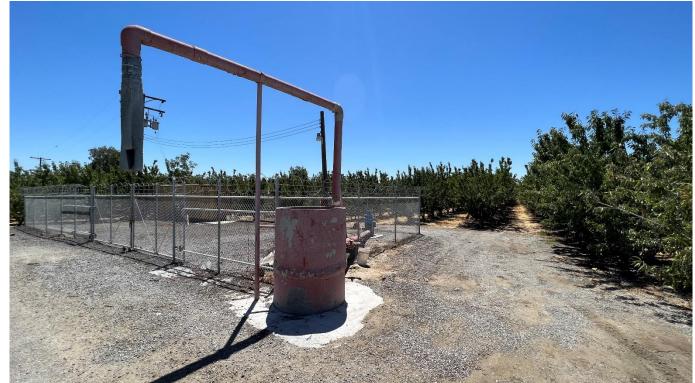
Photo 4: Fenced well area and irrigation standpipe along western boundary of the Subject Property. This area is a potential chemical mixing area.

- 1. Past agricultural operations (including a potential agricultural chemical mixing area).
- 2. Former drainage area
- 3. Stained soil adjacent west of well area.

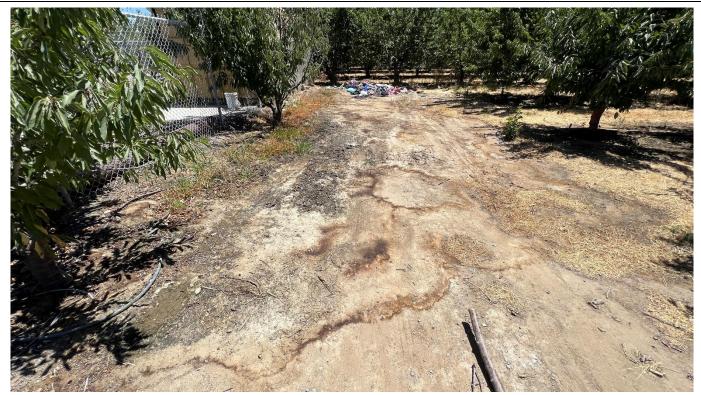
Photo 5: View of clothing pile and burn area along western boundary of the Subject Property. Note soil staining in foreground. This soil staining qualifies as an **on-Subject Property REC**.

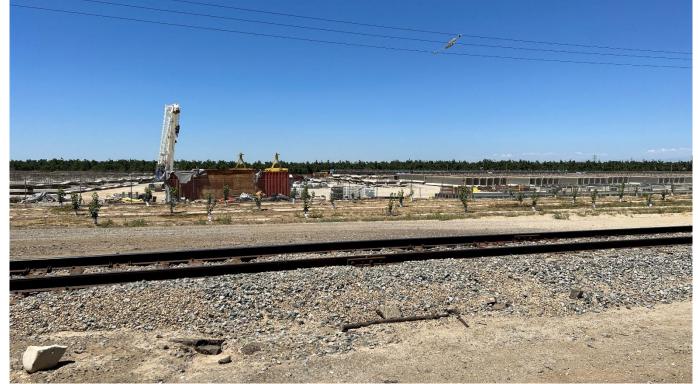
Photo 6: View of railroad (foreground) and California High-Speed Rail staging area (background) adjacent north of the Subject Property. This railroad qualifies as an **off-Subject Property REC**.

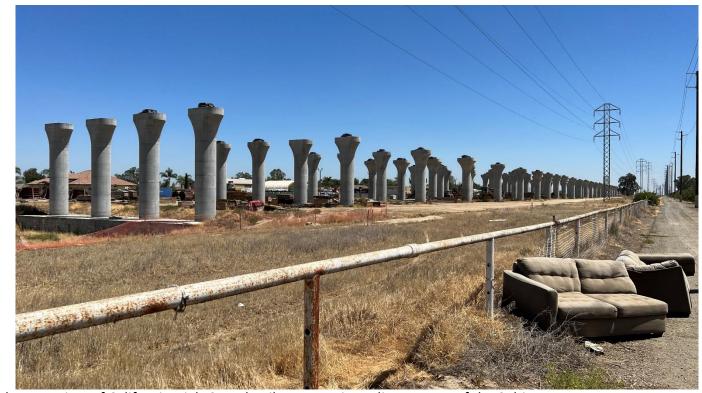
Photo 7: View of California High-Speed Rail construction adjacent east of the Subject Property.

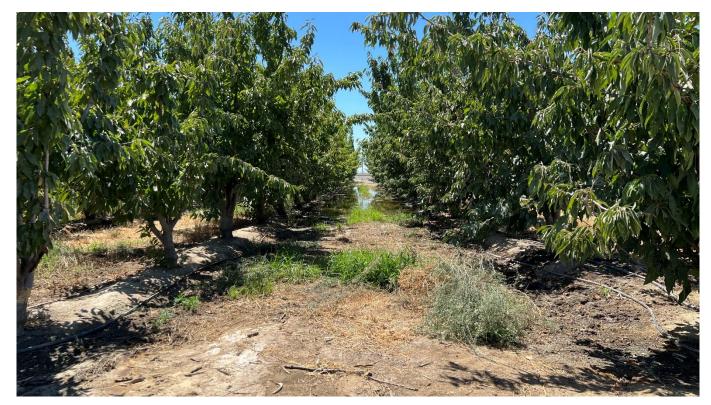
Photo 8: View of interior of orchard with standing irrigation water far in the background.
