# Appendix A

Air Quality, Greenhouse Gas  
Emissions, and Energy Calculations

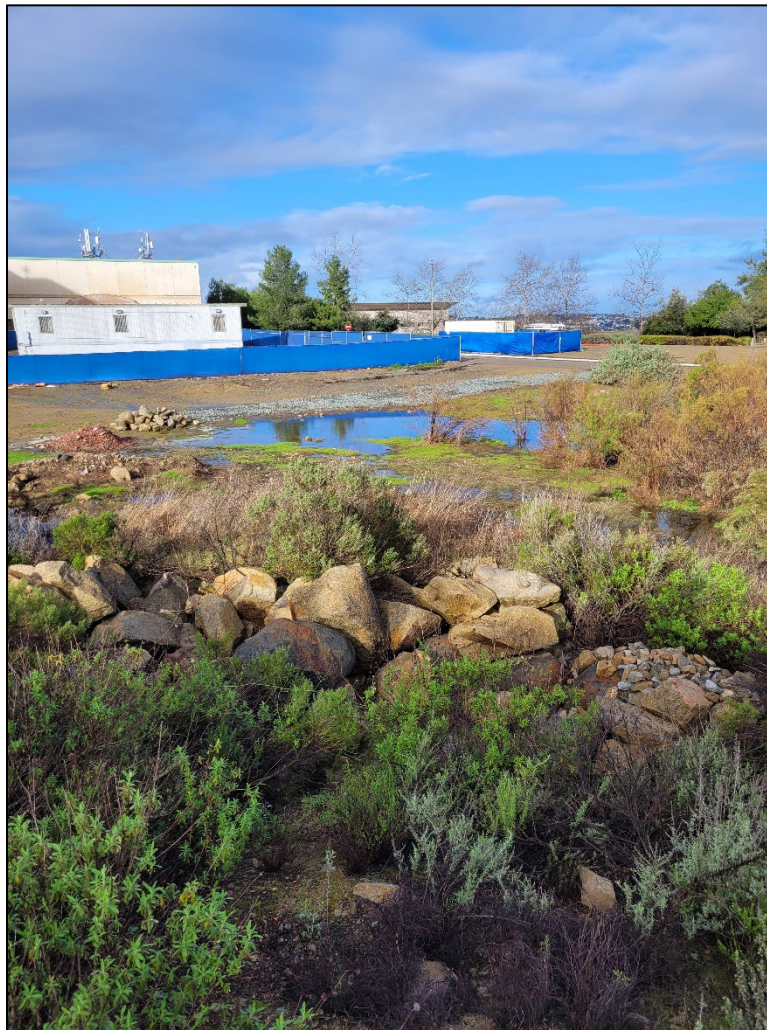
Figure 4. View of the Project area from the east side, facing west, showing base of the hillside vegetation, grading construction activities, and adjacent development.

An intensive-level pedestrian survey of the Project area was conducted on February 9, 2024, by ASM Associate Archaeologist Lucas Piek. Mr. Piek surveyed the entire project area in transects spaced approximately 15 m apart wherever possible. Saving Sacred Sites Native American monitor Banning Taylor assisted in the survey. Ground surface visibility within the project area was good in the areas developed as a part of CSUSM and fair on the eastern side of the Project area, where it overlaps with the base of an undeveloped hillside covered in Mule Fat, Deerweed, and Coastal Sage Scrub. Mr. Piek noted that the survey area was extremely disturbed from past grading construction activities. The portion of the Project area containing the off-site utility tunnel is currently paved. No artifacts were identified during the survey. The project area is currently surrounded by modern development, including university buildings, residential development at the top of the eastern hill, and surface parking lots. The hillside east of the project, below the residential development, is undeveloped. No new cultural resources were identified by survey in the Project area.
