# *Arborist Draft Report*

for  
Silicon Valley Power – 115 kV T-line NRS-KRS Project  
Santa Clara, California

Revised July 8, 2024

*Silicon Valley Power – NRS to KRS 115 kV Transmission  
Line Project*

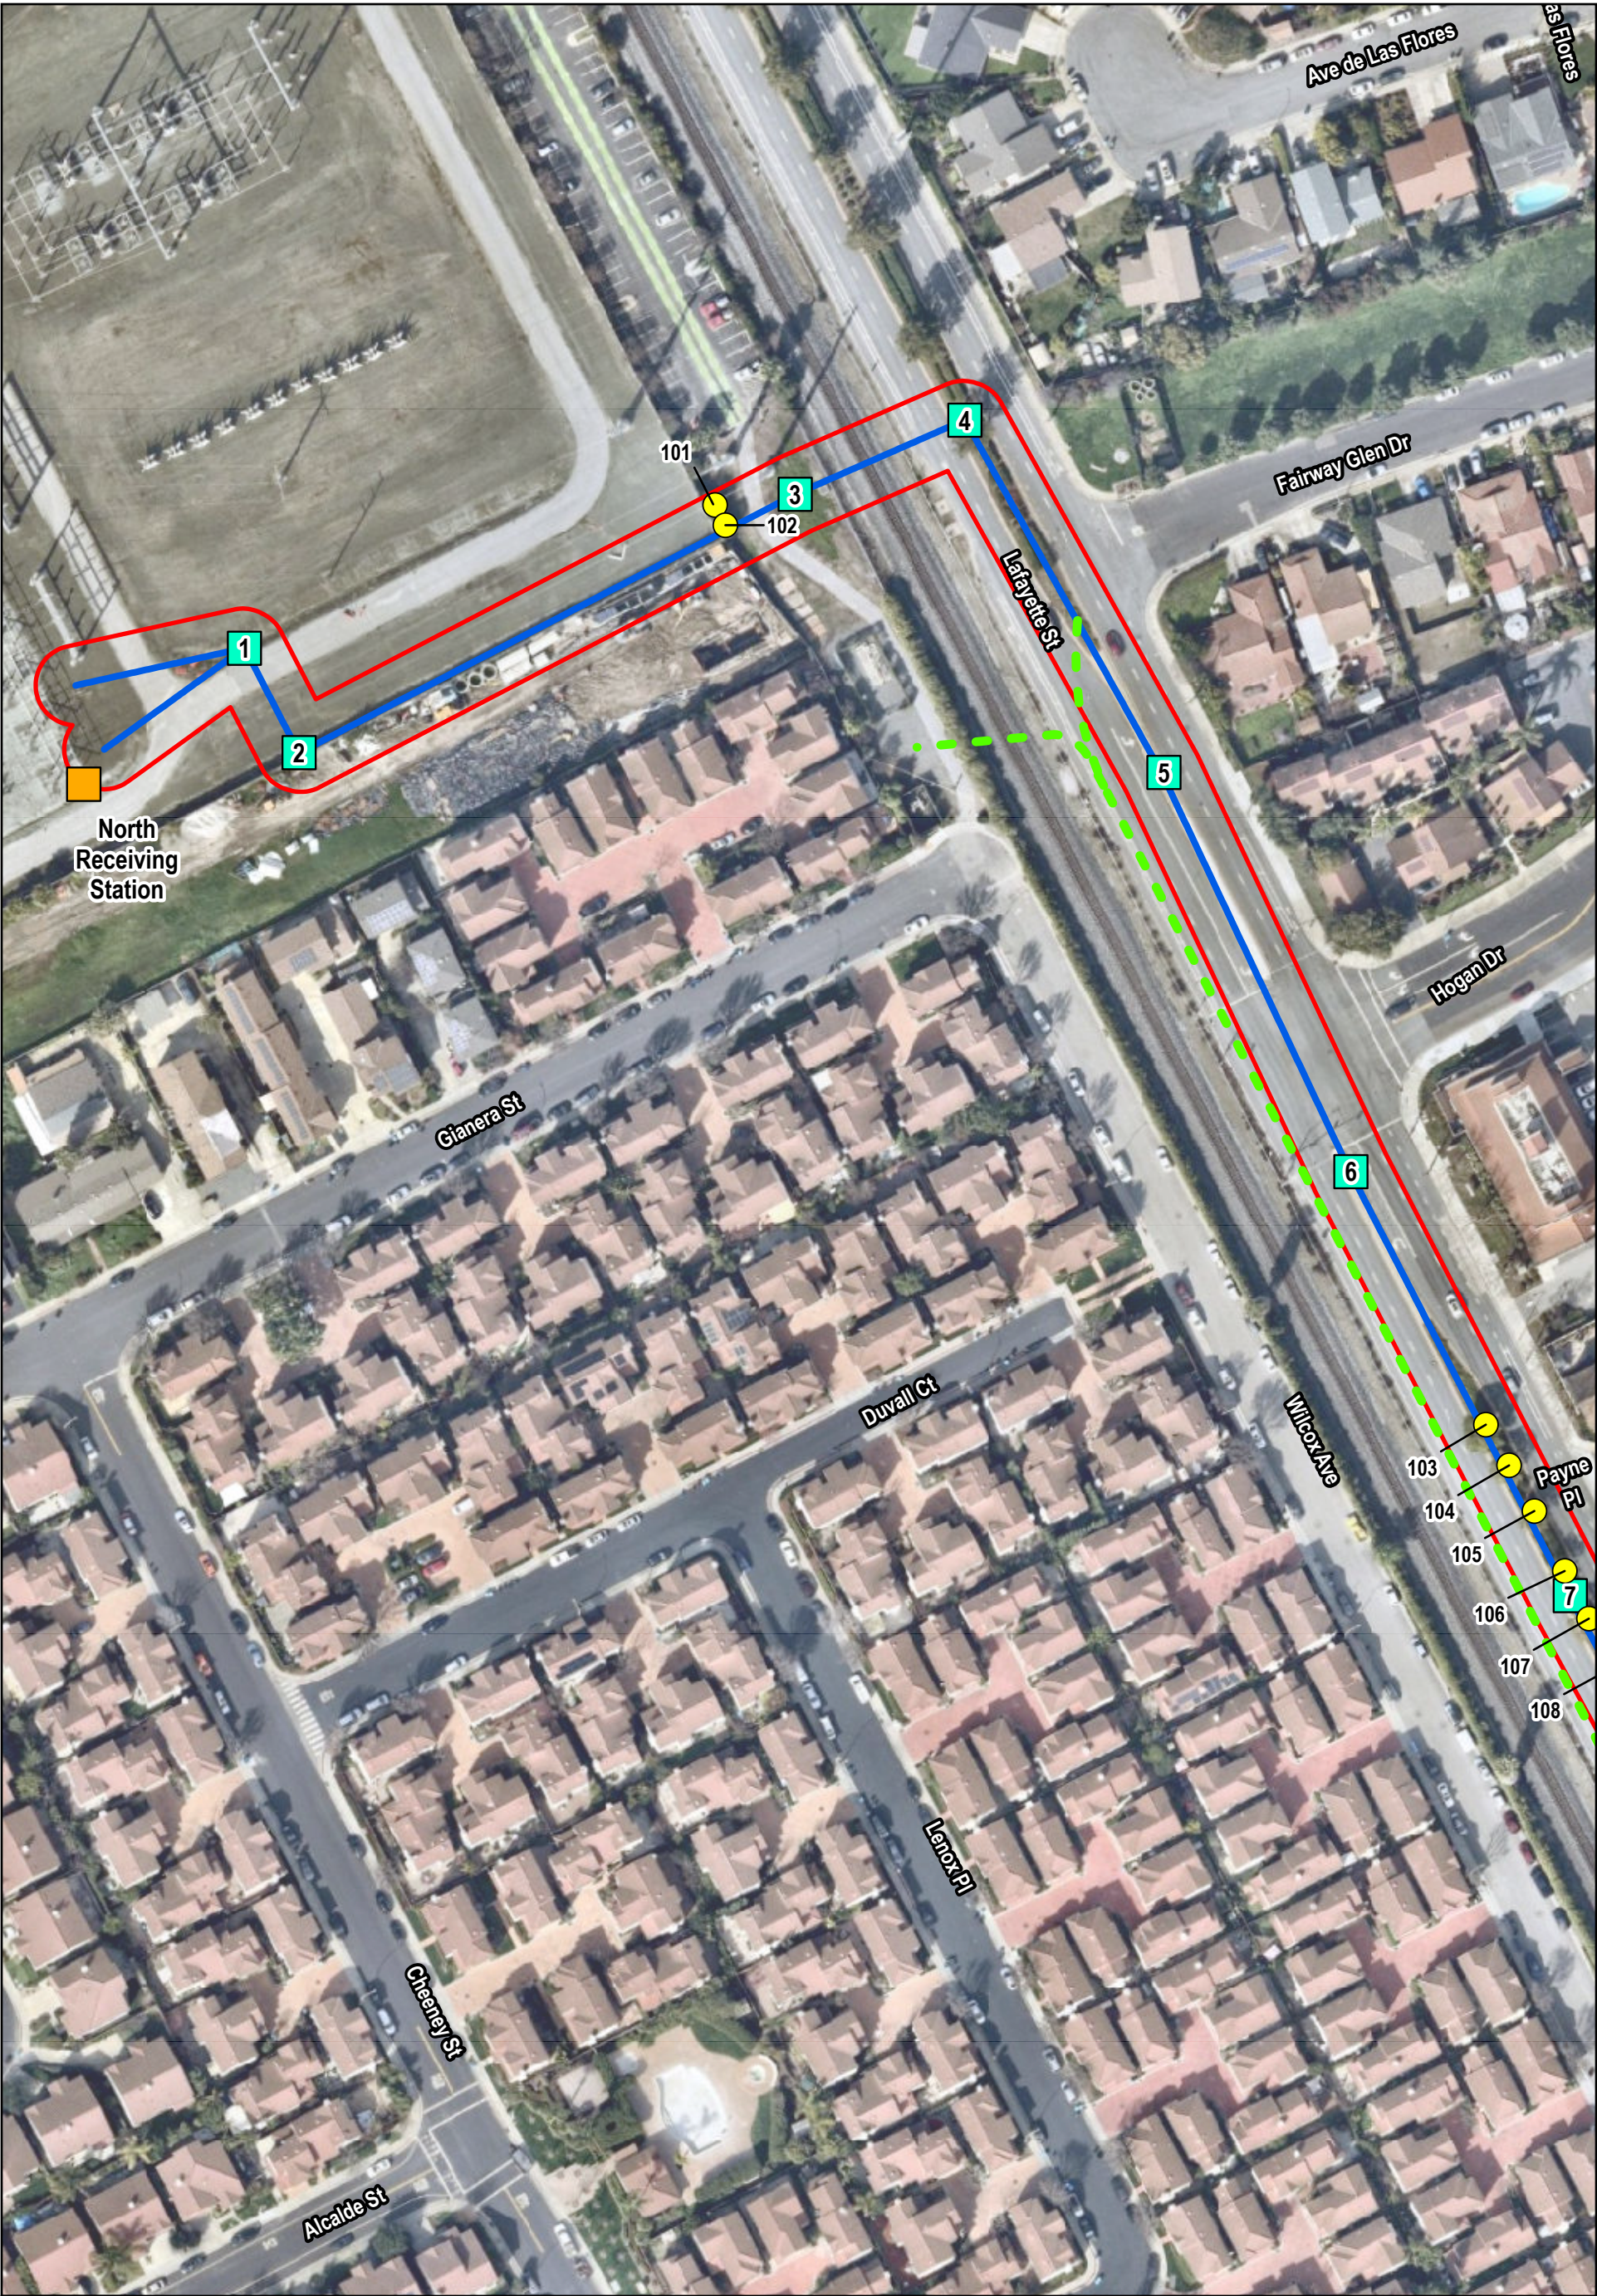
**Tree Survey Results**  
Page 1 of 9  
Sources: Aspen, 2024; Esri, 2024; NearMap, 2024.

Approximate tree locations along the transmission alignment are shown on aerial maps 1-9 provided with this report as [Attachment B](#).
