HISTORIC RESOURCE EVALUATION FOR THE PROPOSED CROIX ESTATE WINERY PROJECT LOCATED AT 1406 WOOD ROAD, FULTON, SONOMA COUNTY, CALIFORNIA

updated February 7, 2019

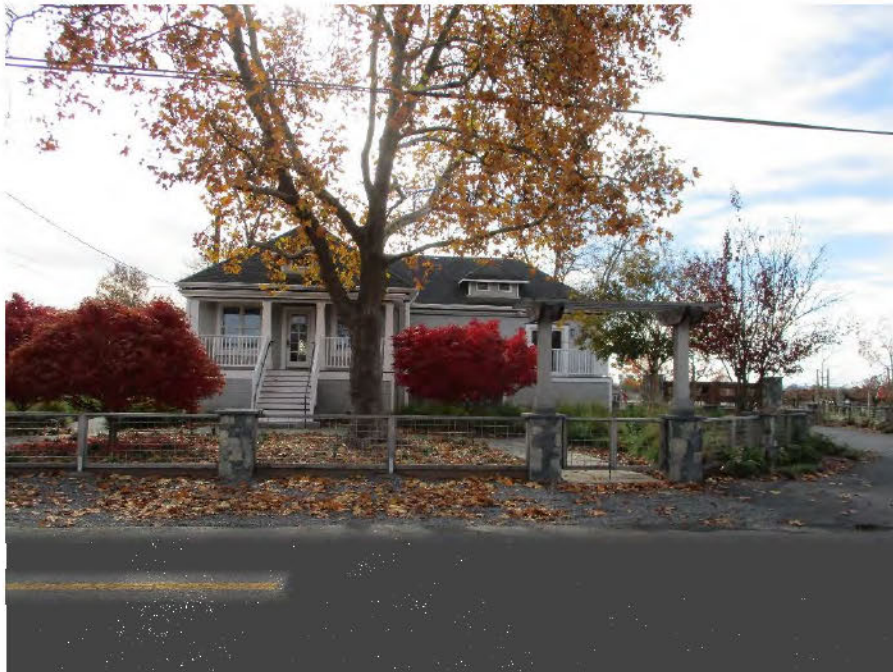
The ca. 1910 house is designed in the Queen Anne architectural style and laid-out in a side-facing T-shaped plan. The building is set back from Wood Street and situated along the northeast corner of the 10-acre property (Figure 17 and Figure 18). The primary façade (north elevation) consists of a raised first floor, dominant hipped roof, and secondary hipped roof addition, each with one hipped roof dormer. The roof has a slight eave overhang and is clad in asphalt shingles. The house is clad in horizontal, channel wood siding that is not original and recently replaced the original narrow, horizontal redwood boards. There is a full-width front porch that has been skirted with channeled siding that is not original. The current porch railings and slanted side columns recently replaced the original turn-post columns, and the decorative lace-like brackets were removed, which are traditional to the Queen Anne architectural style. The front porch ceiling consists of narrow horizontal boards that appear to original to the house (Figure 19). The front porch stairs and railings

Figure 17. Photo showing primary façade (north elevation), facing south.

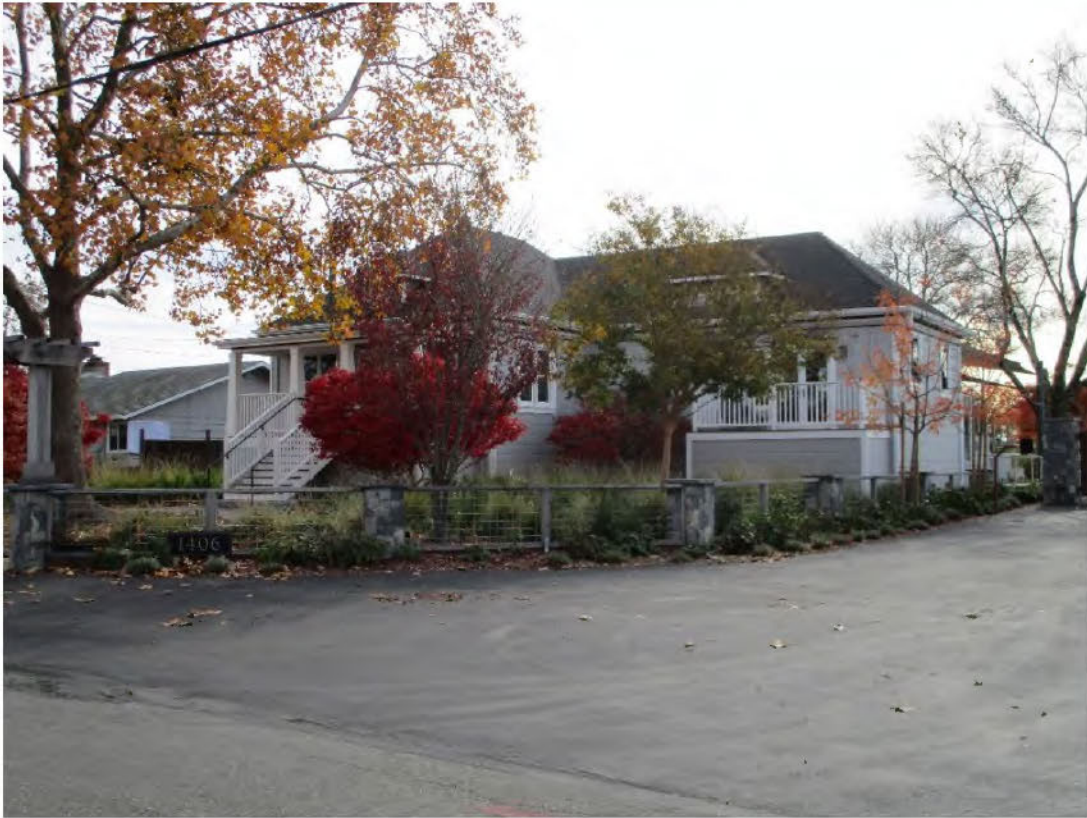
Figure 18. Photo showing primary façade (north elevation), facing south/southeast.

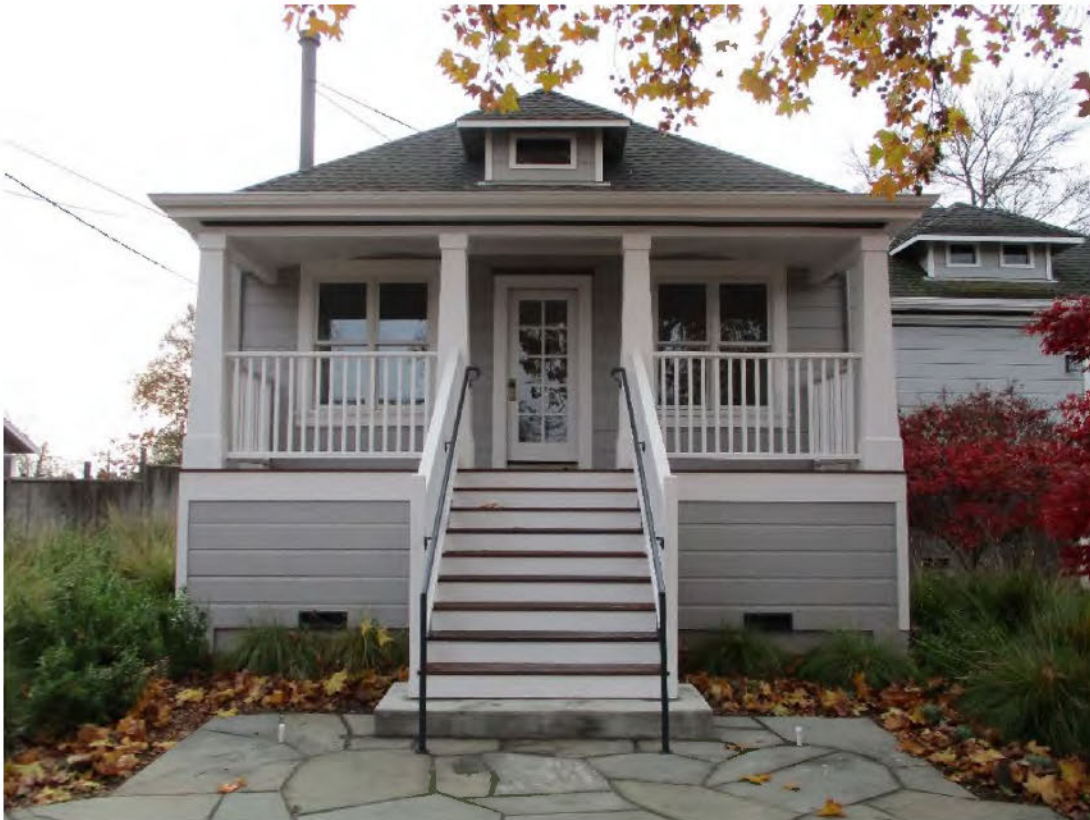
are not original and were recently replaced with simple wood railings and stairs. There is a centered multi-light front door that is flanked by two pairs of windows. The window opening to the right of the door was recently enlarged from an original single-window opening that housed a double-hung wood window, and replaced with a pair of double-hung vinyl windows (Figure 20). The window opening to the left of the front door consists of what appears to be the original window opening, with the original window casings and window sill; however, the design originally consisted of a fixed center window flanked by two narrow double-hung windows. This window has been removed and replaced with a pair of vinyl double-hung windows (Figure 21). There is a raised deck along a portion of the secondary hipped roof addition and French doors that are not original to the house.

Figure 19. Photo showing primary façade (north elevation), facing south

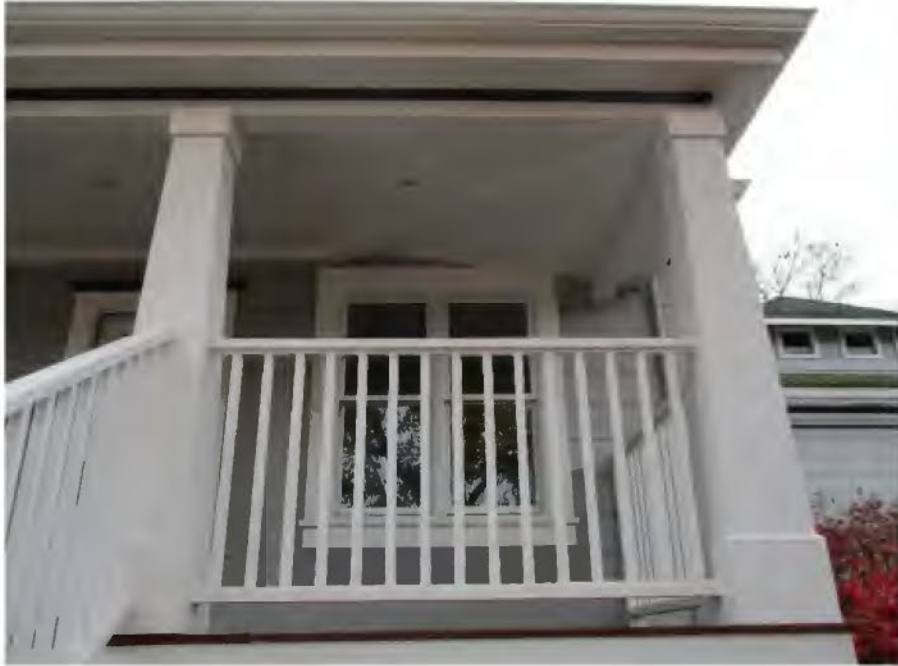
Figure 20. Photo showing a pair of vinyl windows, set inside an enlarged window opening.

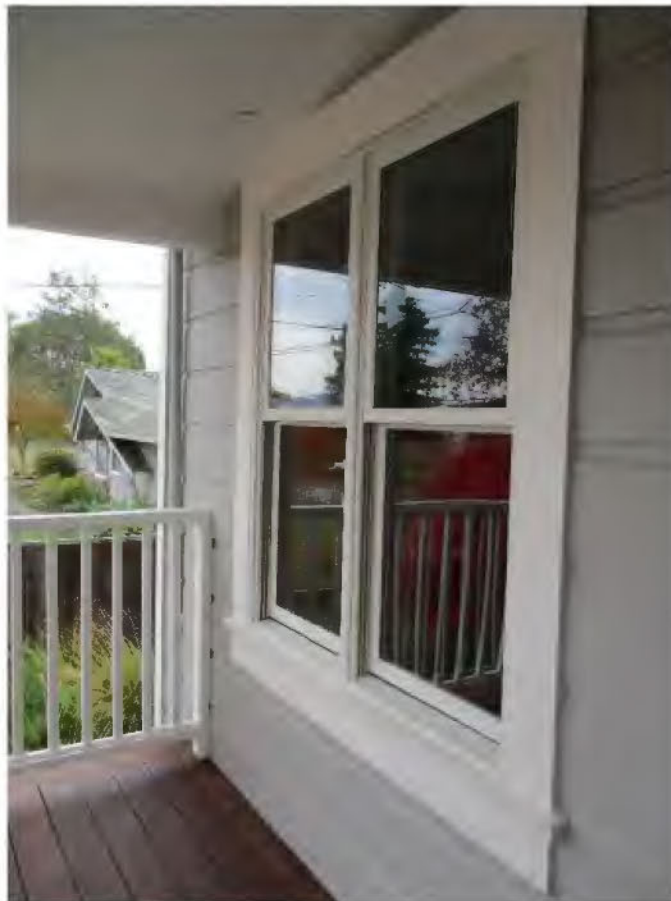
Figure 21. Photo showing the new pair of vinyl windows, facing east.

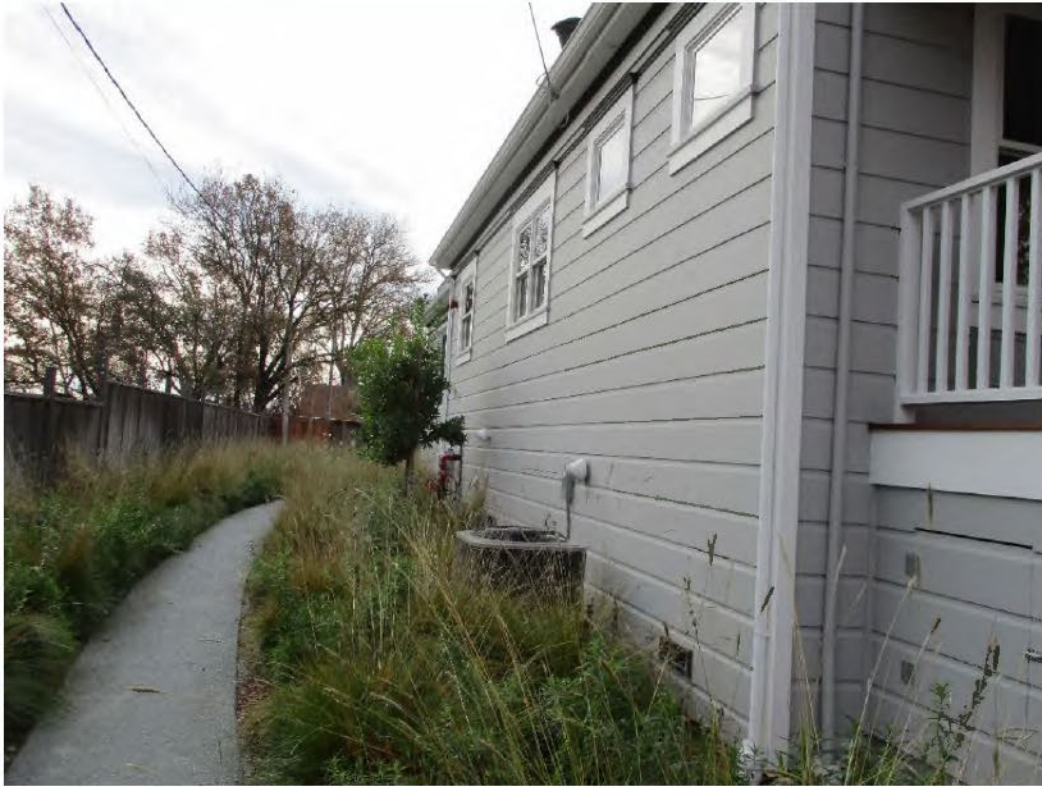
Figure 22. Photo showing the east elevation, facing south.

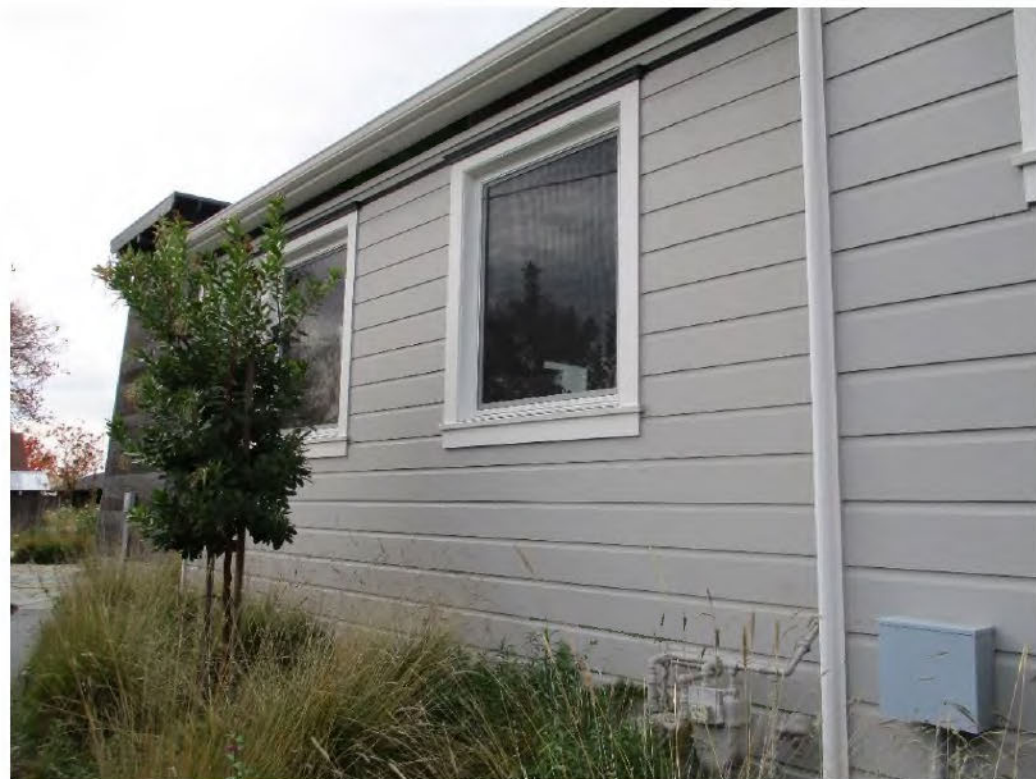
Figure 23. Photo showing the east elevation, near the southeast corner of the house, facing south.

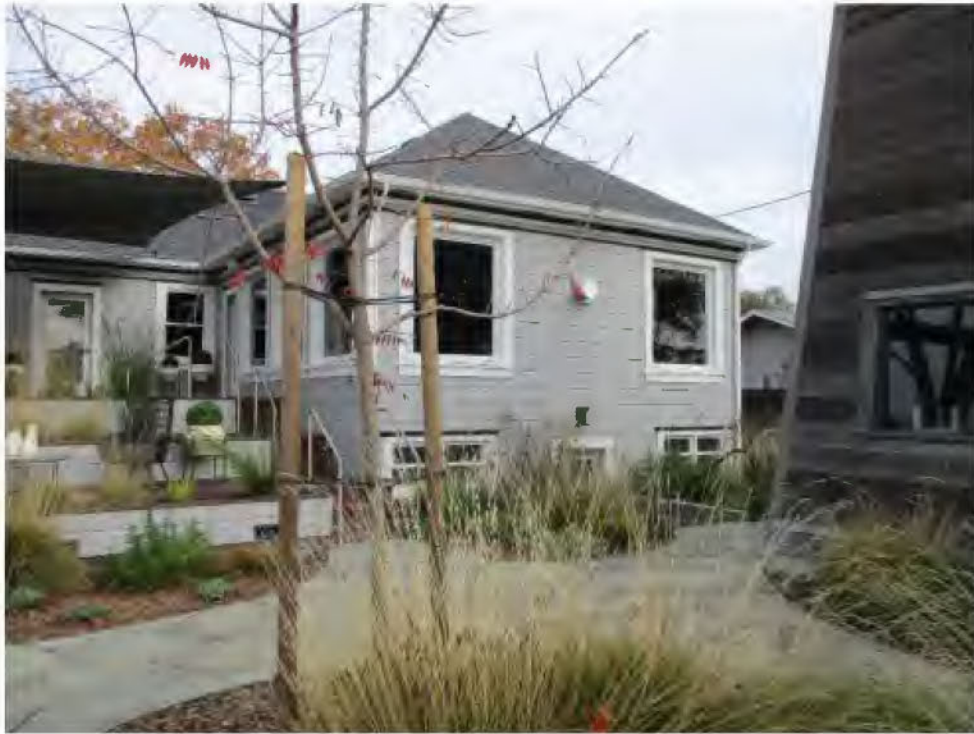
Figure 24. Photo showing the south elevation, facing north/northeast.

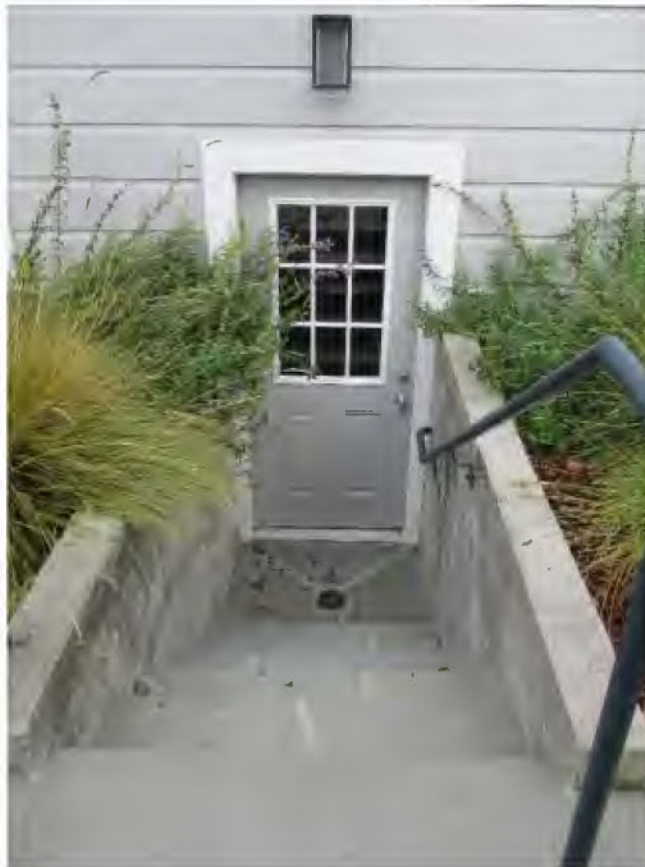
The **south elevation** consists of horizontal, channel wood siding that is not original to the house. There are two large fixed windows, one double-hung vinyl window, two pairs of double-hung vinyl windows and a framed solid glazed rear door (Figure 24). There is a half-width tiered patio deck along the rear elevation with integrated wood planters and a contemporary modern railing. There is a full-height basement situated below the rear hipped addition that consists of a pair of narrow, double-hung windows, and a contemporary basement door that is accessed via concrete stairs (Figure 25).

Figure 25. Photo showing the rear basement entry stairs and door.

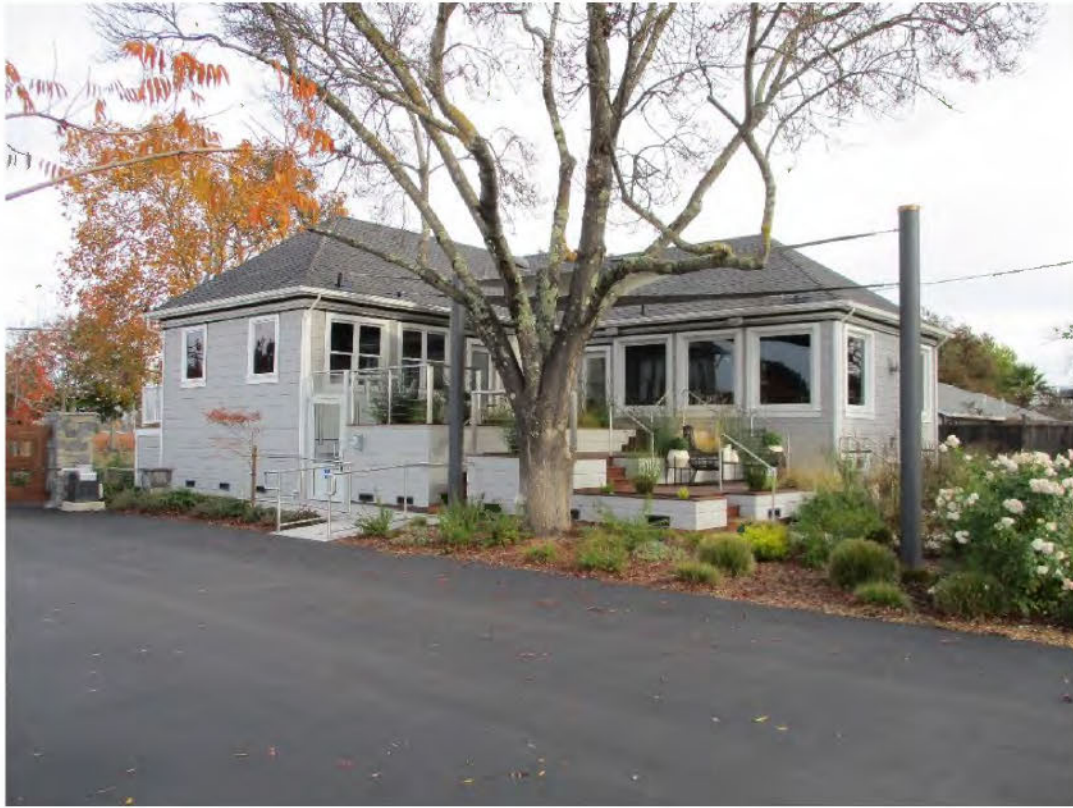
The **west elevation** consists of horizontal, channel wood siding that is not original to the house, and two fixed windows that were recently added during the 2018 alterations, and replaced what appear to have been two contemporary windows (Figure 26).

Figure 26. Photo showing the west elevation, facing north/northeast.

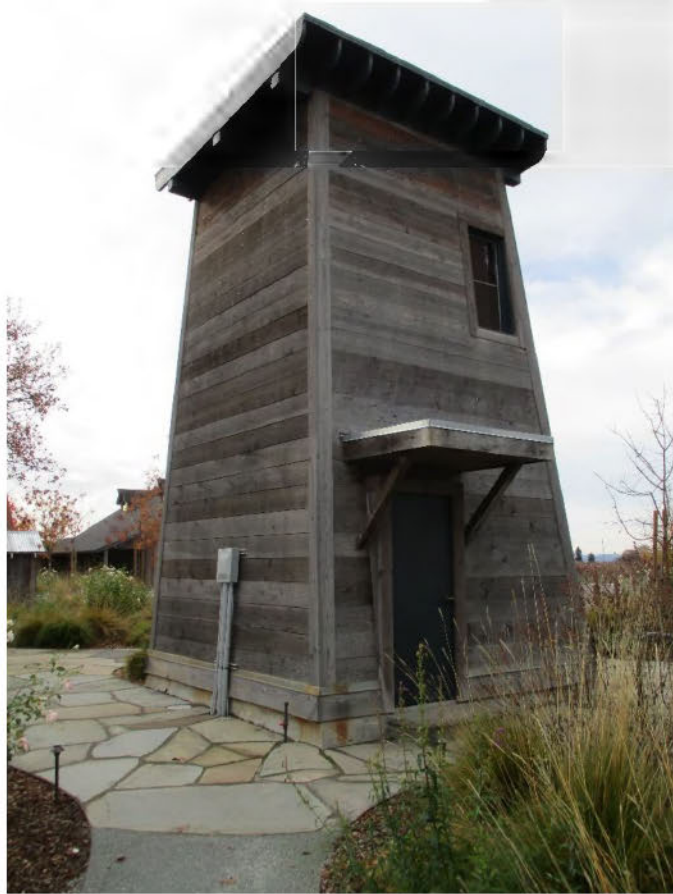
The water tower (aka tank house) consists of original horizontal, redwood boards. There is a door along the lower level north elevation that allows access to the lower-level interior (Figure 27). There is door along the second level south elevation that previously allowed access to the platform and the water tank; however, the staircase was recently removed (Figure 28). There are two wood-framed windows, one along the second story of the north elevation, and one along the first story of the west elevation. There is a flat roof with exposed rafter tails. The top of the flat roof is where the water tank was originally located. The interior of the building consists of exposed redwood framing and elements of old knob and tube electrical, which was mainly used in the U.S. from the 1880s to the late 1930s, although all the wiring has been removed there are a few knobs that remain.

Figure 27. ca. 1910 water house, showing the north elevation door, facing south.

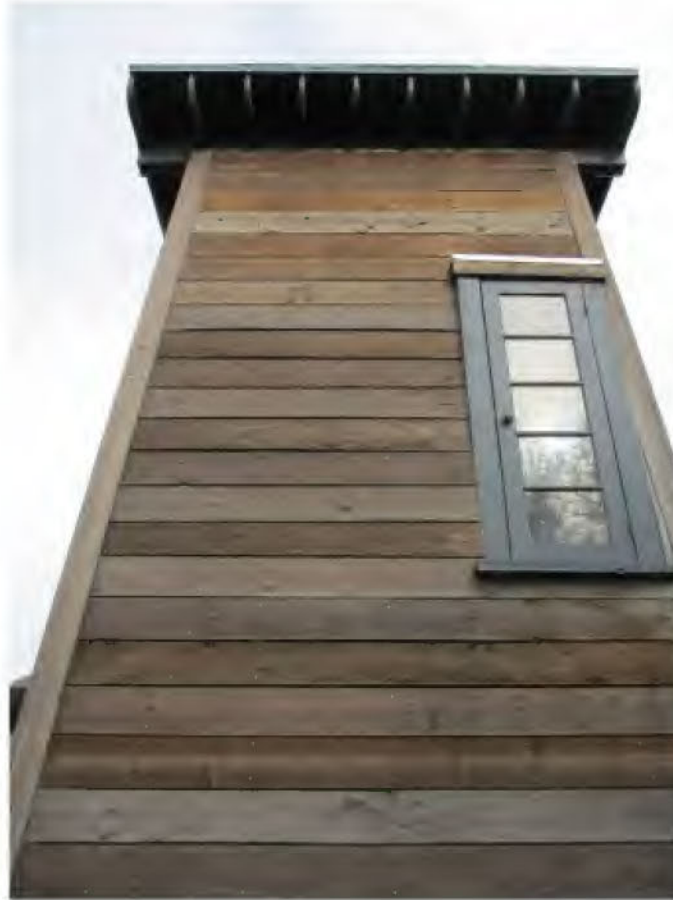
Figure 28. ca. 1910 water tower, showing the upper level, south elevation door.

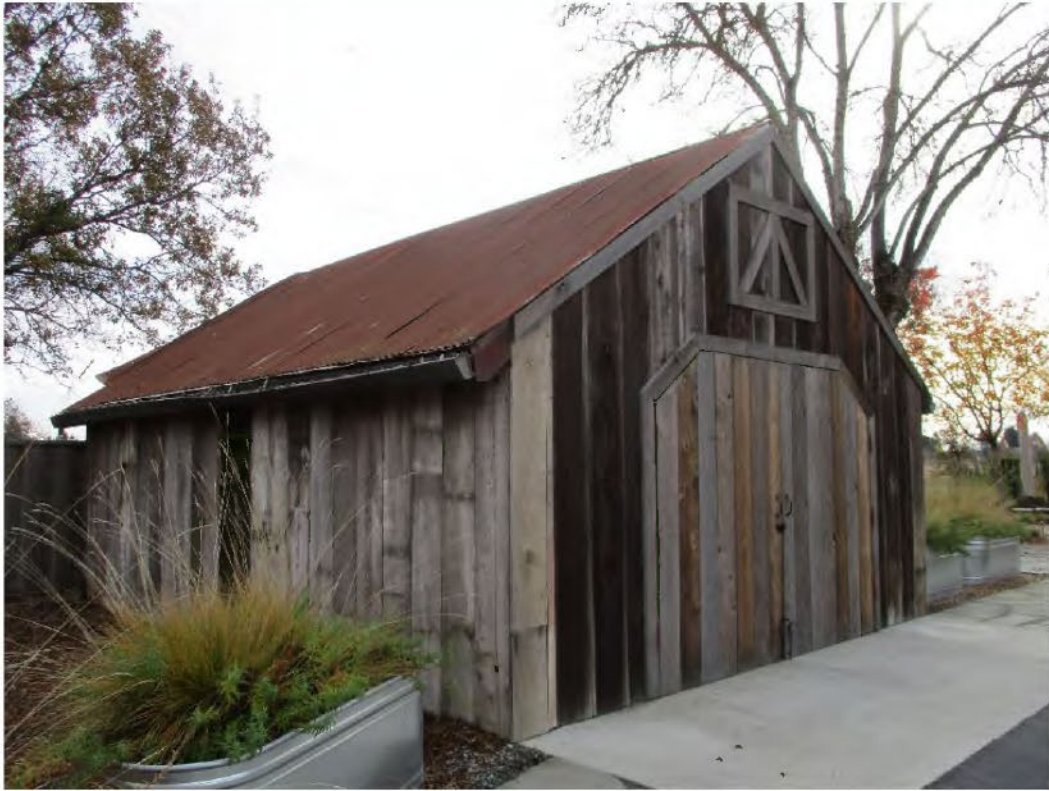
The ca. 1910 barn is a front gable barn, clad in vertical redwood boards. The **west elevation** consists of a decorative wood framing that uses a cross-buck design to mimic a hay loft door, and two wide barn doors with contemporary hardware (Figure 29 and Figure 30). The moderate pitched, gabled roof is clad in corrugated steel with moderate roof eaves that extend along the north and south elevations.

Figure 29. Photo showing the ca. 1910 barn, north and west elevation, facing south/southeast.

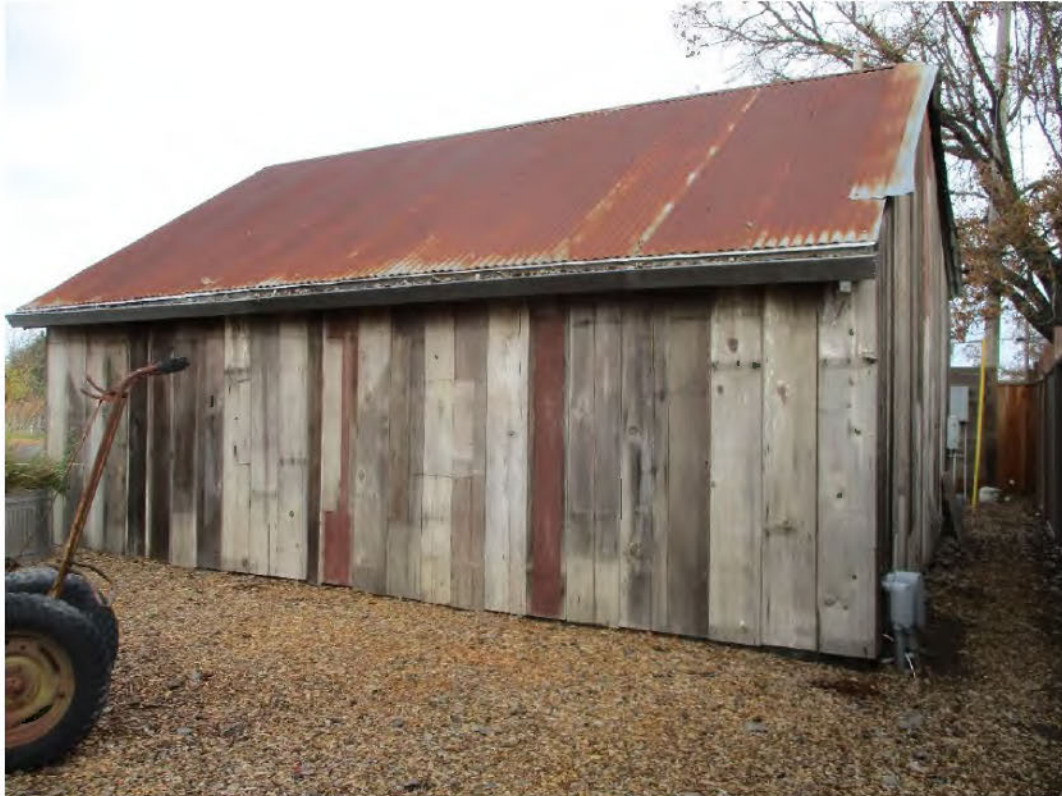
Figure 30. Photo showing north elevation, facing south.

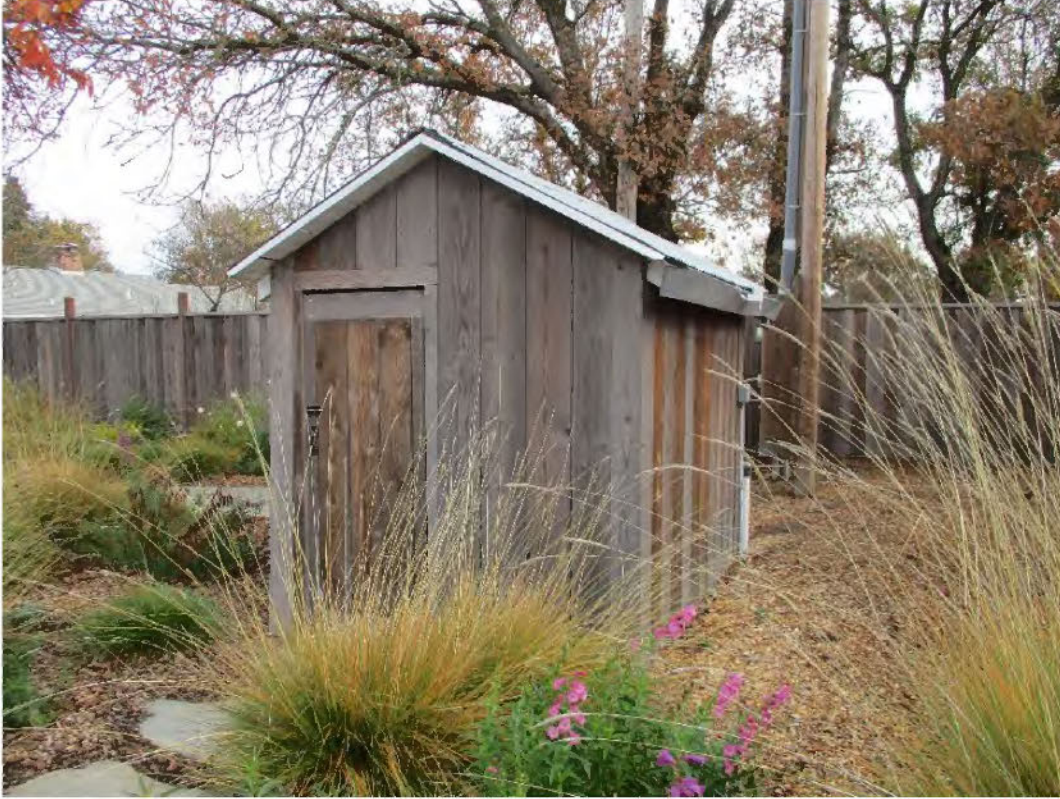
The ca. 1910 pump house is a small, front-gabled building with a moderate pitched roof that is clad in corrugated metal sheets (Figure 31). The building is clad in vertical redwood boards and there is a single entry door along the west elevation. The north and east elevations consist of metal and PVC pipe.

Figure 31. Photo showing the ca. 1910 pump house, facing east.

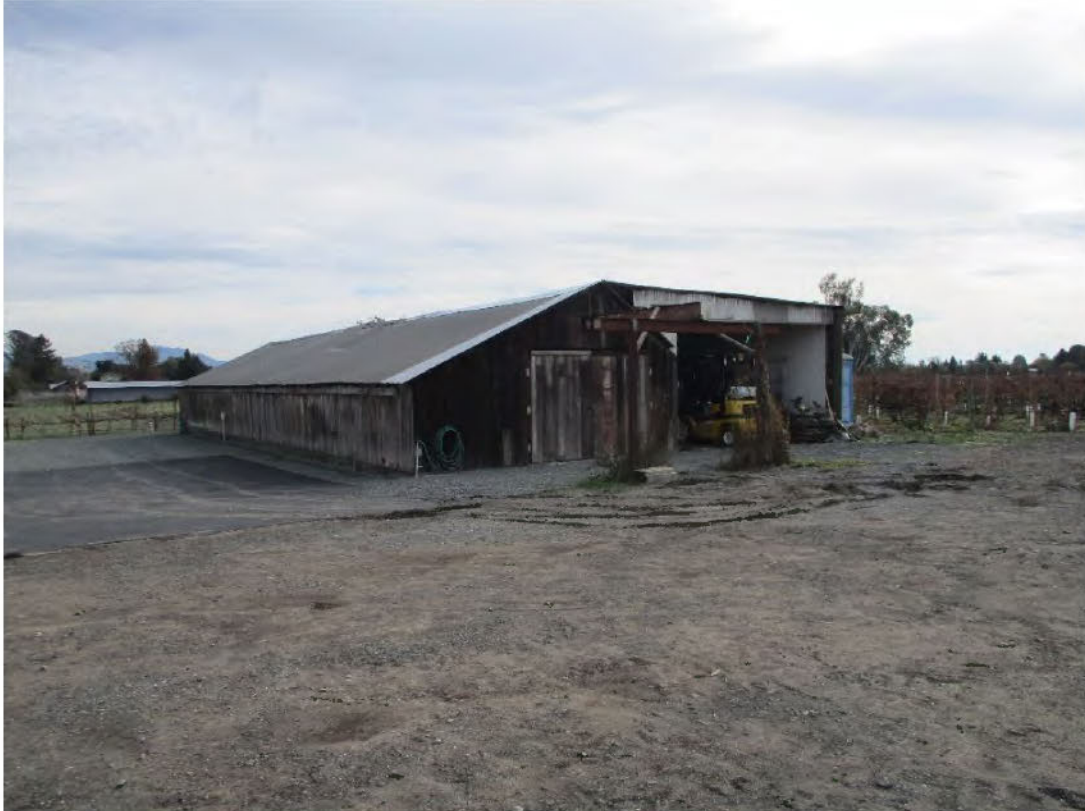
The ca. 1910 egg-washing barn consists of a rectangular planned building with a low-pitched shed roof and a nearly flat-roofed addition along the south elevation, which was likely added in the 1970s (Figure 32 and Figure 33). The egg-washing barn is clad in vertical redwood siding and the roof is clad in corrugated metal sheets. There is a large overhead steel hoist in front of the barn with a steel beam that is attached and centered above the barn doors (Figure 34). The steel hoist, which is weathered and showing signs oxidation, is likely associated with grape production as these types of hoists are typically used to move large vats of freshly picked grapes to crushing machines.

Figure 32. Photo showing the ca. 1910 egg-washing barn, facing east.

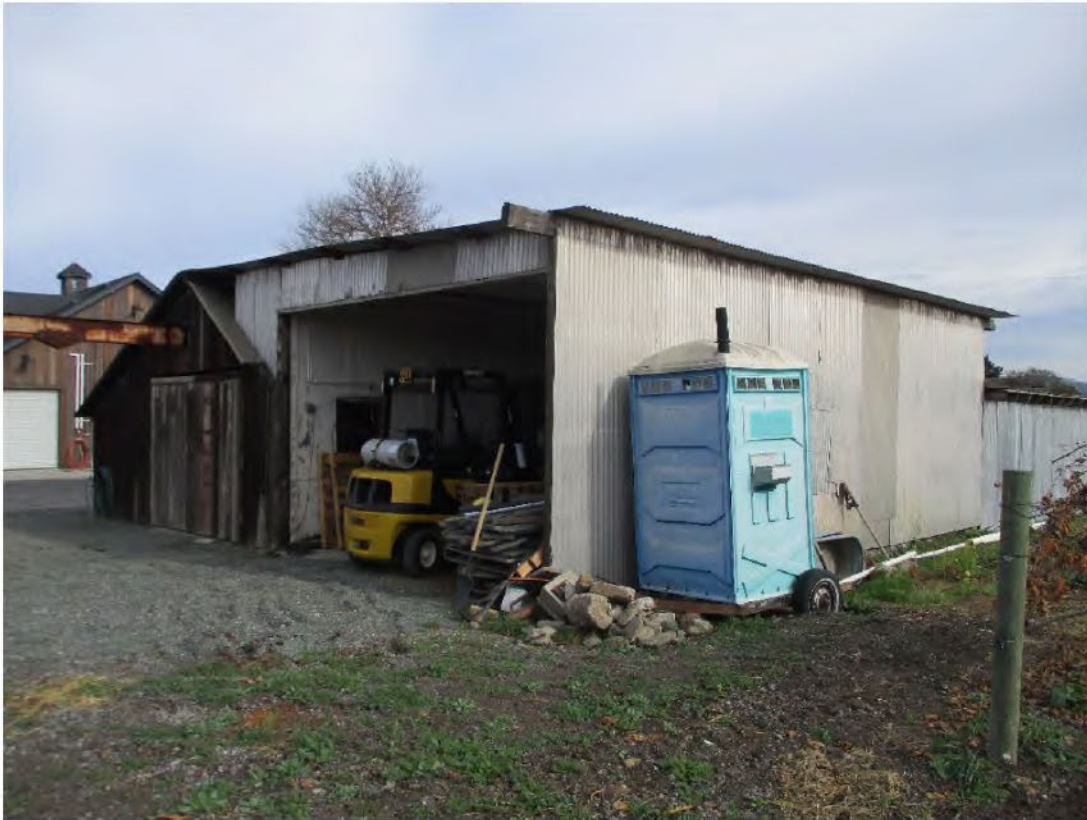
Figure 33. Photo showing the flat roof addition, facing north/northeast.

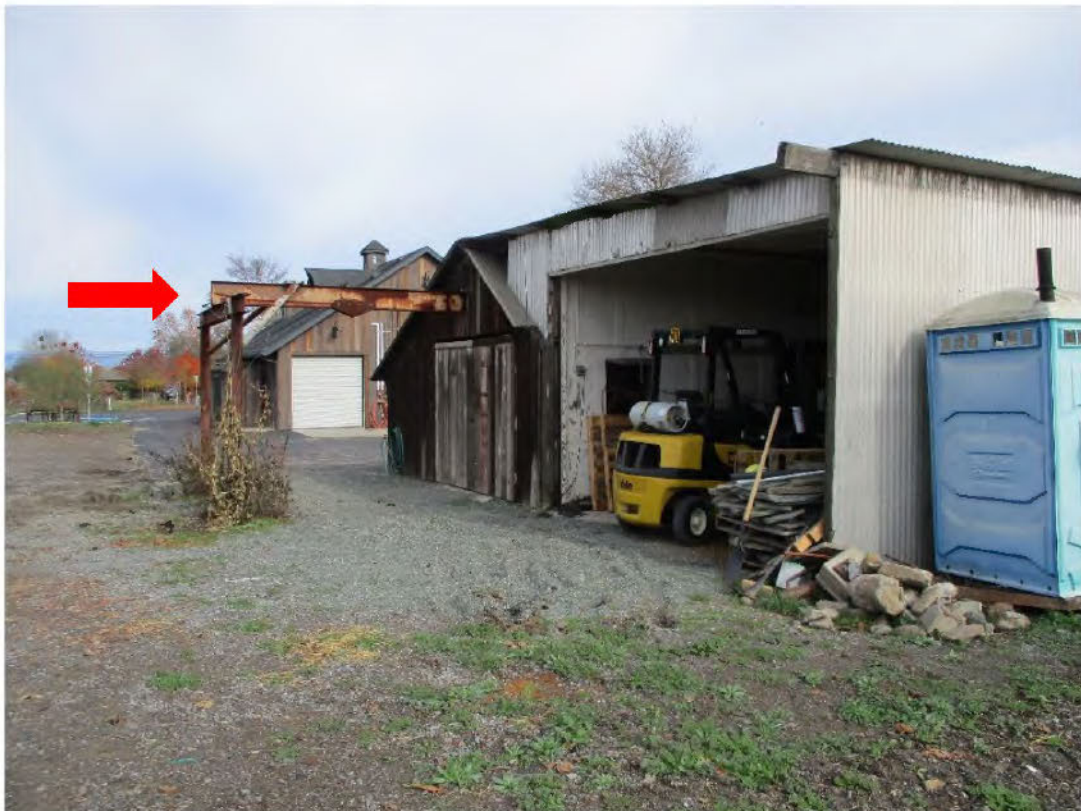
Figure 34. Photo showing overhead steel hoist, facing north.

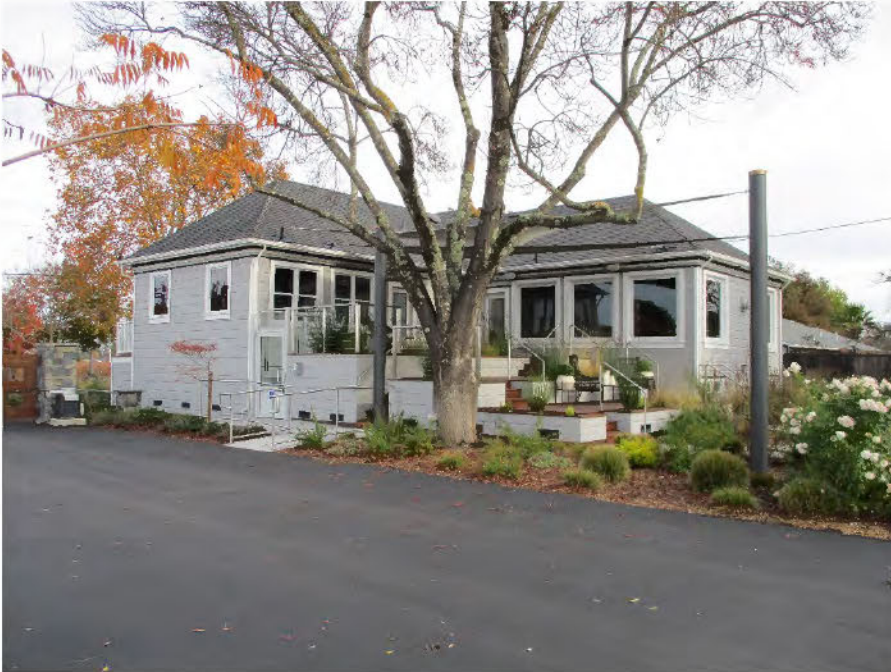
The **west elevation** consists of horizontal, channel wood siding that is not original to the house, and two fixed windows that were recently added during the 2018 alterations, and replaced what appear to have been two contemporary windows.

Photo showing the west elevation, facing north/northeast.

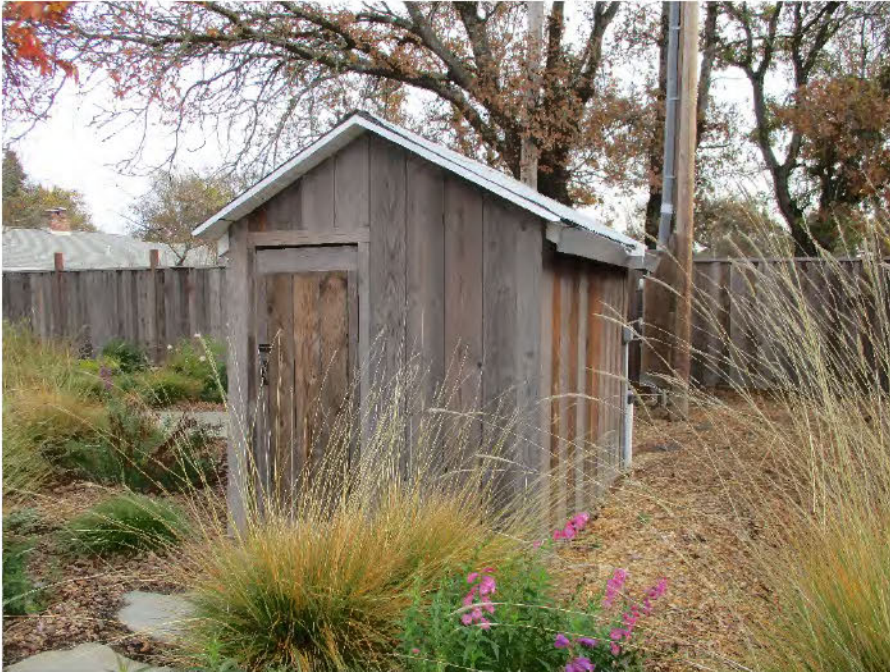
The ca. 1910 pump house is a small, front-gabled building with a moderate pitched roof that is clad in corrugated metal sheets. The building is clad in vertical redwood boards and there is a single entry door along the west elevation. The north and east elevations consist of metal and PVC pipe.

Photo showing the ca. 1910 pump house, facing east.

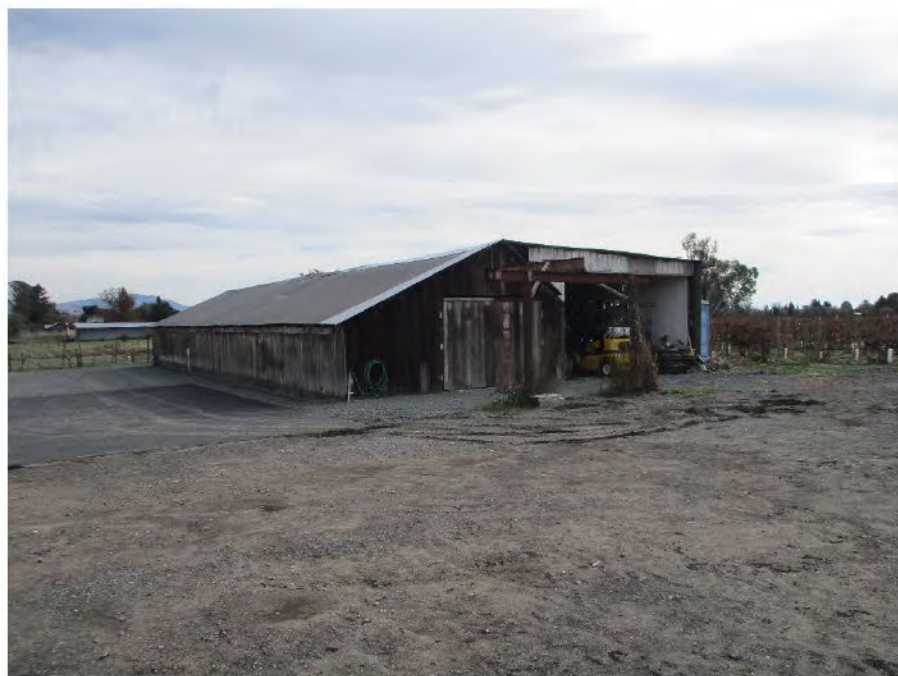
The ca. 1910 egg-washing barn consists of a rectangular planned building with a low-pitched shed roof and a nearly flat-roofed addition along the south elevation, which was likely added in the 1970s. The egg-washing barn is clad in vertical redwood siding and the roof is clad in corrugated metal sheets. There is a large overhead steel hoist in front of the barn with a steel beam that is attached and centered above the barn doors. The steel hoist, which is weathered and showing signs oxidation, is likely associated with grape production as these types of hoists are typically used to move large vats of freshly picked grapes to crushing machines. .

Photo showing the ca. 1910 egg-washing barn, facing east.
