SANTA MARIA RIVER LEVEE TRAIL

Wallace Group Project No: 1105-0003

Date: October 3, 2024
To: Stuart Poulter, EMC Planning Group Inc.
From: Jorge Aguilar, P.E.
Subject: Bonita School Road Crossing

Date: October 3, 2024
To: Stuart Poulter, EMC Planning Group Inc.
From: Matt Wilkins, PLA, ASLA, APA / Jorge Aguilar, P.E.
Subject: Farmland Conflict Avoidance Planning

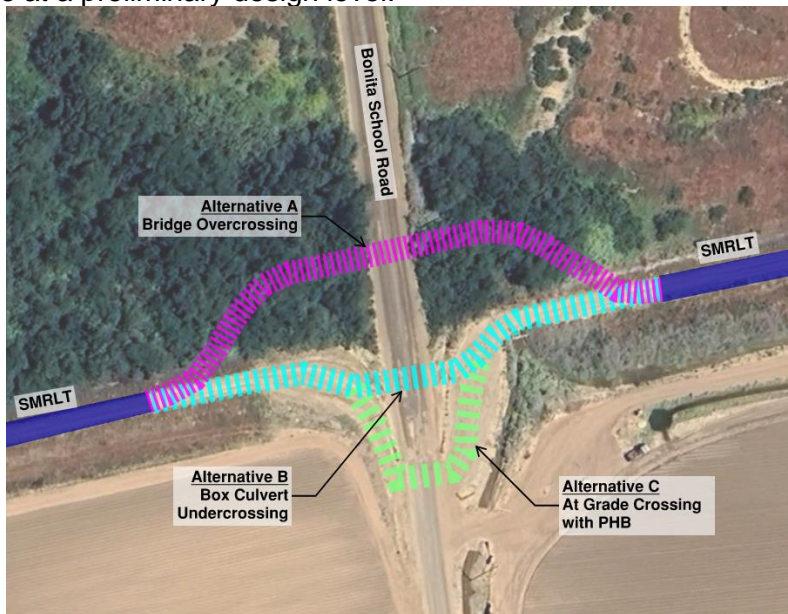
Figure 1: Crossing Alternatives

A conceptual trail bridge alignment over Bonita School Road is shown in pink on Figure 1, and an example installation of a trail bridge with switchbacks is shown in Figure 2. A bridge over the roadway would provide a fully separated roadway crossing but that would require significant switchbacks to achieve the vertical clearance over the roadway. This bridge would need to be designed to accommodate all trail user mobility types and adhere to ADA standards. These switchbacks could prove to be a hindrance to many users who might try to avoid the added vertical climb and length by crossing the roadway at-grade south of the embankment. A trail bridge over the roadway might be considered to enhance the vistas the trail users' experience but would also be visible to the passing public which would create a visual impact as it would not be consistent with the surrounding area.

A box culvert undercrossing in a roadway embankment alternative is shown in cyan on Figure 1, and an example is depicted in Figure 3. Similar to the overcrossing alternative, the box culvert would provide a fully separated roadway crossing experience that would provide safer, uninterrupted trail use. It would also be a benefit to roadway users, as it would allow uninterrupted traffic flow, reducing risks and potential accidents. The grade differential for the trail to drop under the roadway is much less than what is needed for the overcrossing alternative, particularly when the

The at grade crossing alternative is shown as green in Figure 1, and an example with a Pedestrian Hybrid Beacon (PHB) is depicted in Figure 4. Of the three alternatives, the at grade crossing with a PHB is the least expensive, with an estimated construction cost of approximately \$500k. Assuming no alterations to the levee, this alternative would include trail connections to an at-grade roadway crossing point. A key need for this alternative is to be

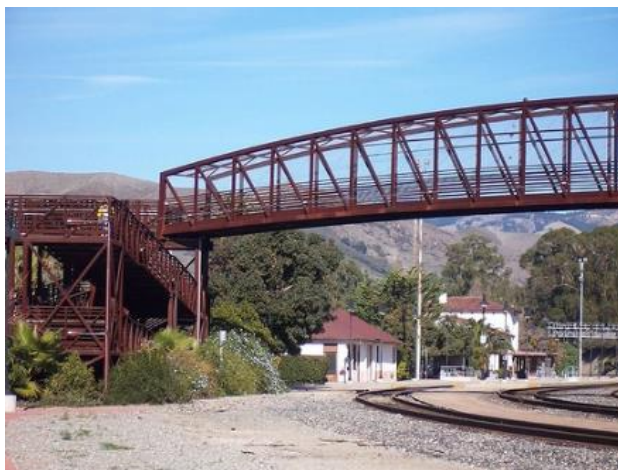
Figure 2: Trail Bridge Example

A trail bridge has significant challenges. The County's Bonita School Road bridge profile will be elevated ~ 8' above the current levee elevation. The minimum vertical clearance for a pedestrian bridge is 17' (2' greater than the 15' min of a roadway bridge). This means that the trail would need to ramp up 25' plus the thickness of the structure or supporting elements below the deck profile using ADA compliant slopes. There are significant environmental challenges for an overcrossing alternative due to the visual impact, adjacent riverbed and riparian area. On top of these concerns, the design and construction costs for a trail bridge overcrossing of the roadway will be substantially more expensive than the other two alternatives. Costs are estimated in the \$7M to \$12M range.

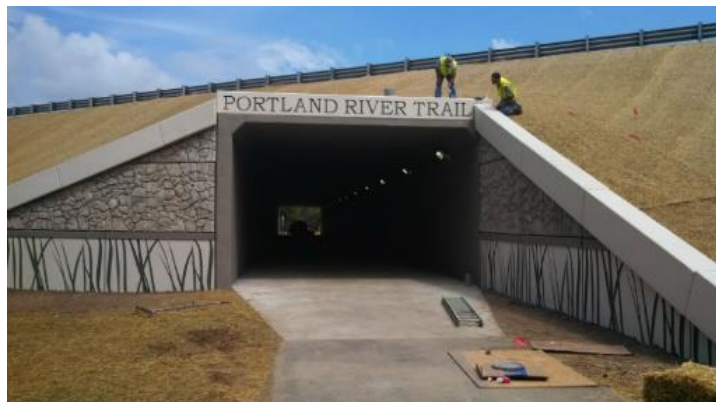
Figure 3: Example Trail Box Culvert Crossing

roadway profile is also being raised approximately 8'. According to Chapter 1000 of the Caltrans Highway Design Manual, a trail requires 8' minimum vertical clearance; however, 10' is desirable. Including the thickness of the box culvert top and clearance for the roadway structural section, the total grade differential is approximately 4'-5'--much less than the overcrossing

alternative. This results in lower impacts and costs and is more accessible to users of all abilities. Box culvert undercrossings are typically made of reinforced concrete and other durable materials which make it a lower maintenance option. These facilities are typically low profile and blend with the surrounding embankment.

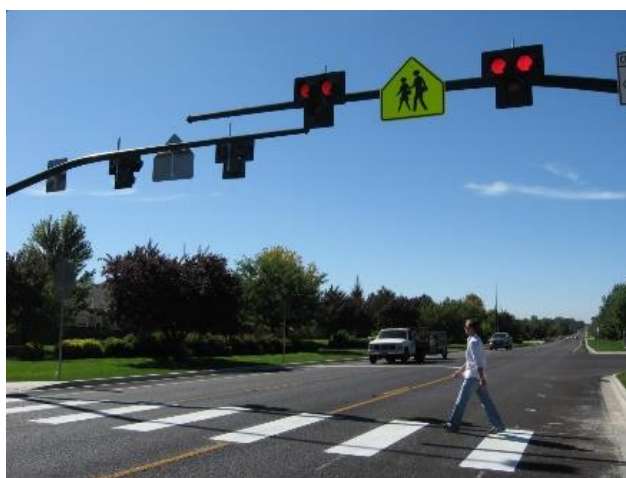
Figure 4: Example PHB Installation

While PHBs are proven safety countermeasures for use at crosswalks, an at-grade crossing still puts the pedestrians and vehicles in conflict and relies on drivers to obey the signs, markings, and beacons to avoid collisions with vulnerable trail users. The design speed of Bonita School Road approaching from the south is 55 mph, and an at grade crossing with a PHB would be unusual and unexpected to drivers in this rural, agricultural context, which introduces additional compliance concerns. Of the three alternatives, the at grade crossing has the highest vehicle-pedestrian conflict risk. Vehicles are required to stop when the crossing is activated, which will cause some delay to drivers on Bonita School Road.

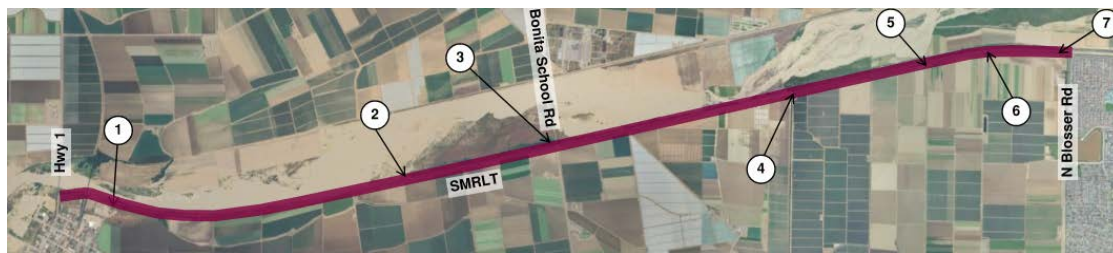
Figure 1: Farm Access Crossings of the SMRLT

This memorandum discusses options to minimize potential conflicts between trail users, agricultural operators, and landowners along the proposed Santa Maria River Levee Trail (SMRLT). Between Highway 1 and North Blosser Road, there are seven crossings of the SMRLT as shown in Figure 1 and listed below:

1. Peralta Street
2. Farmland Crossing
3. Bonita School Road Crossing
4. Stormwater Crossing
5. Farmland Crossing
6. Stormwater Crossing
7. Farmland Crossing

Treatments at Peralta Street and Bonita School Road are discussed in separate memorandums and are therefore not included in this memorandum; however, treatments discussed herein could also have overlap with those to be applied at those crossings if needed. Figure 1 is a large scale overview of the setting for the SMRLT, there are agricultural fields along the southern edge of the trail for the entire length of the project, and there are also many on the north side of the southerly levee as well as north of the river corridor with some agricultural access crossings at the locations noted. There is fencing along the majority, but not all, of the northern limits of the agricultural fields just south of the southern levee. The trail will avoid direct impacts to the agricultural fields by remaining on top of the existing levee and it is anticipated that the steepness of the levee slopes will discourage access to the fields. However, at the existing crossings the access roads are much more traversable so this

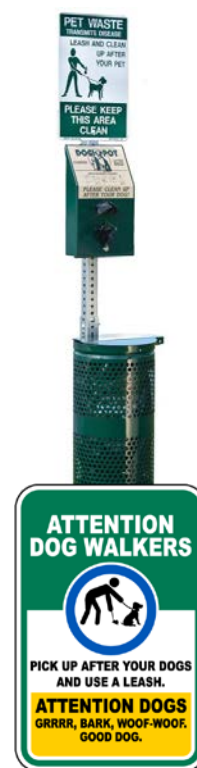
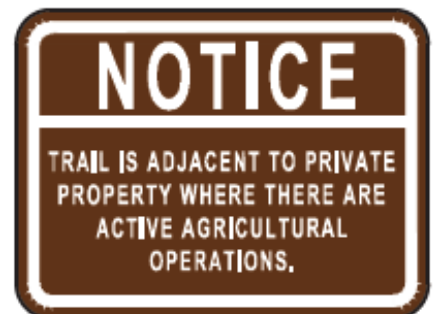
Example Trailhead Signage

Informational, regulatory, and warning signs should be strategically located at trailheads, as well as along the trail, to inform trail users of agricultural considerations, rules, and etiquette. Trail users should be advised to stay on the trail and be alert to operating machinery and equipment near the trail. Signs noting on-going agricultural activities should be posted at entrances to the trail, stating that the trail user agrees to use of the trail at their own risk and that intermittent closures are to be expected due to agricultural activities. Signage should note that the trail may be subject to closure without notice to accommodate agricultural operations which may include pesticide spraying, agricultural dust and debris, and burning activities in accordance with State and local laws and ordinances. It is also recommended to post signs at the trailhead stating the legal ramifications for trespassing on adjacent properties or using the trail while closed.

Example trailhead signage for these considerations are shown below:

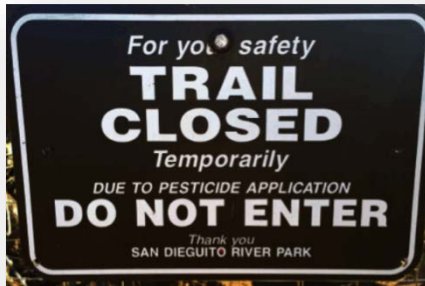
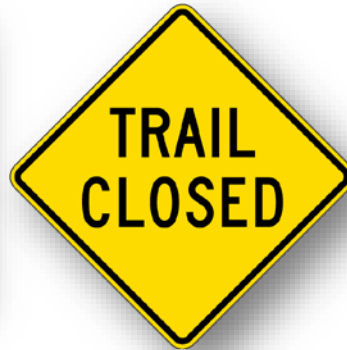
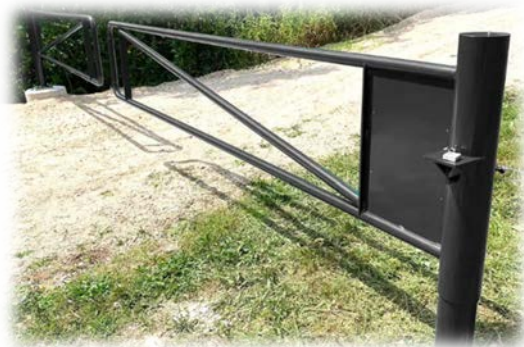
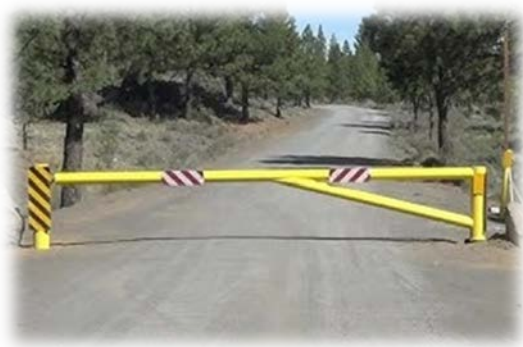
The trail should be designed with the ability for its physical closure of isolated segments. The County would need to establish a plan for receiving notices of impending spraying activity from the farmers with follow-up actions, as appropriate, and the responsibility for ensuring that temporary closure and reopening of trail gates would be delegated to County Park Rangers. Example trail closure signage and gates are shown below.

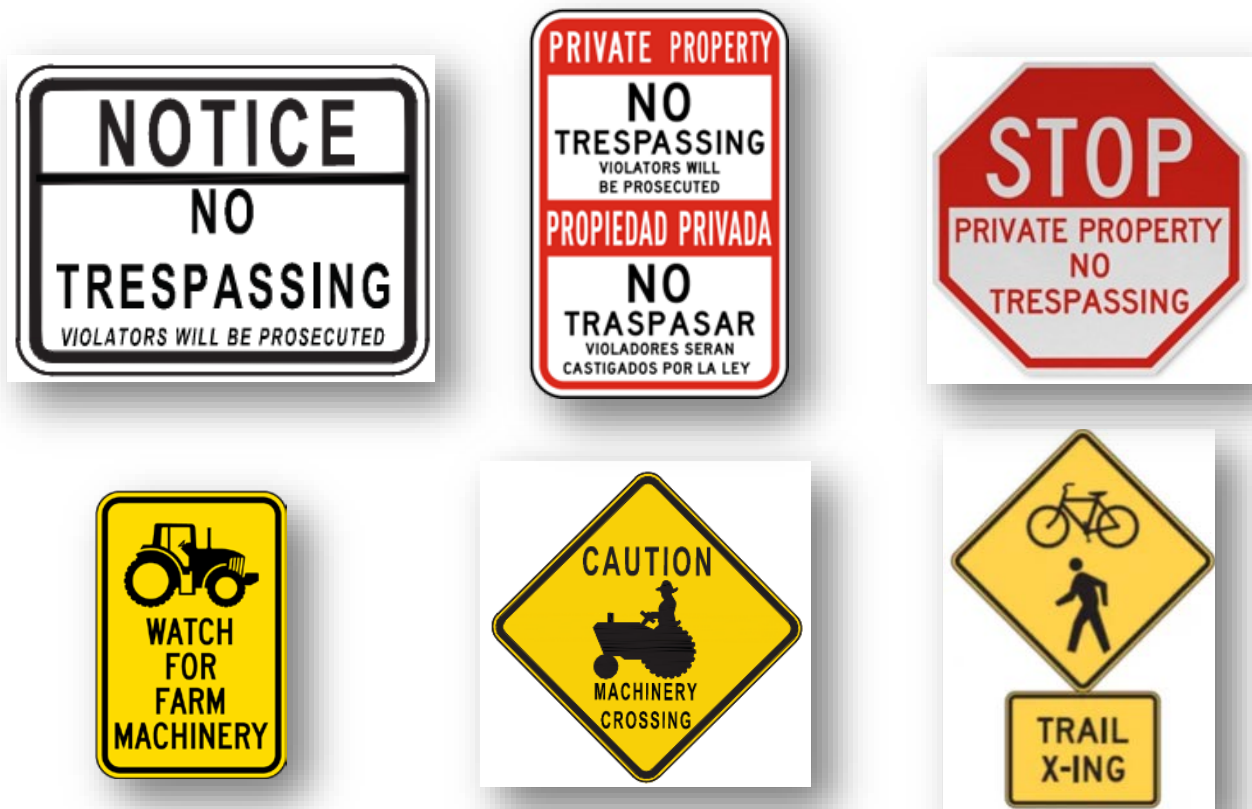
Warning signs for both the trail user and agricultural operators should be provided to alert the upcoming crossing area. Regulatory "no trespassing" signs should also be placed along the trail and on the gates to notify the trail users to stay on the trail. Example signs are shown below.

Access roads to the farmland should have lockable gates, and fencing should extend along the trail at least 50' on each side of the access road to encourage trail users to stay on the trail. The gates should be set back from the edge of the trail to provide space for the agricultural equipment to move off the trail while opening and closing the gate without blocking the trail. Types of fencing and gates are expected to depend on the adjacent land use negotiations.
