### **GEOTECHNICAL REPORT**

**GEOTECHNICAL ENGINEERING STUDY  
SAN ANDREAS DEVELOPMENT  
236 - 300 EAST SAINT CHARLES STREET  
APNS: 042-030-014-000 & 042-031-017-000  
SAN ANDREAS, CALIFORNIA**

**September 15, 2022  
Condor Project No. 8897**

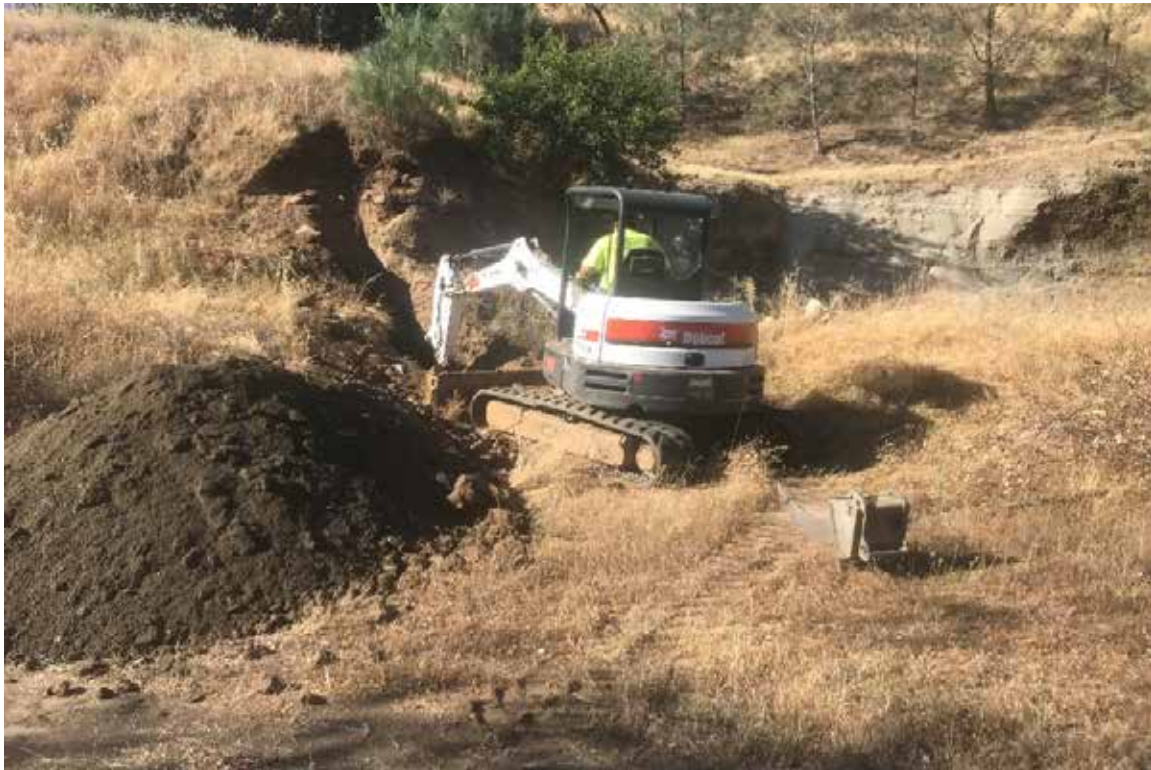
**Test Pit No:** TP – 1  
**Total Depth:** 7 feet  
**Date Excavated:** 07/18/22  
**Elevation:** 1,135', Topo  
**Logged by:** M. Crum

| DEPTH | USCS | DESCRIPTION |
|---|---|---|
| 0-2' | CL | RESIDUAL SOIL: Sandy Lean Clay, grayish red, slightly moist, very stiff to hard (4.5TSF), fine to medium sand generally medium. Mineralogy: rhyolite, andesite, quartz, biotite, muscovite<br>Trace roots at sharp contact with: |

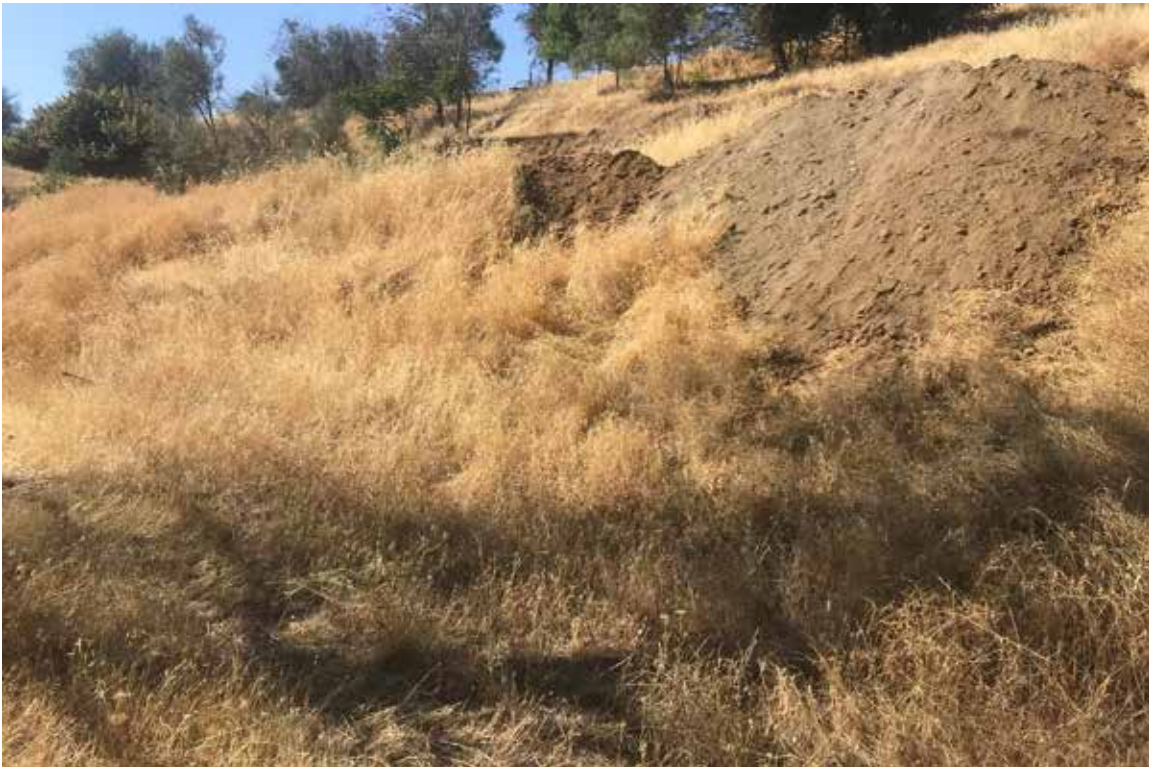
**Test Pit No:** TP – 2  
**Total Depth:** 10 feet  
**Date Excavated:** 07/18/22  
**Elevation:** 1,135', Topo  
**Logged by:** M. Crum

| DEPTH | USCS | DESCRIPTION |
|---|---|---|
| 0-2' | CL | RESIDUAL SOIL: Sandy Lean Clay, grayish red, slightly moist, very stiff to hard (4.5TSF), fine to medium sand generally medium. Mineralogy: rhyolite, andesite, quartz, biotite, muscovite<br>Sharp contact with: |

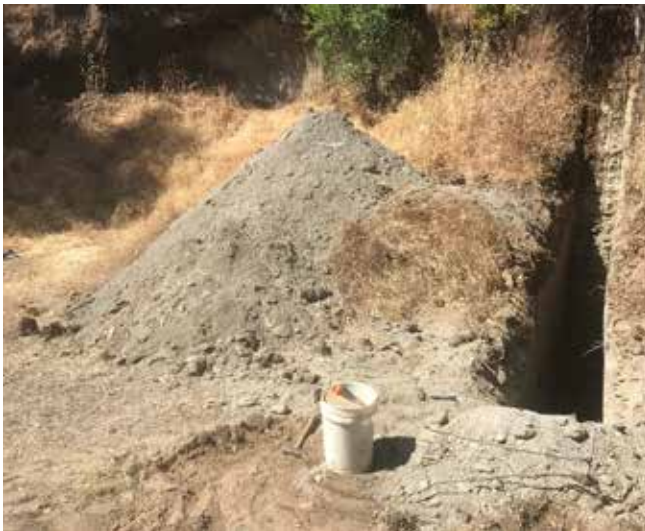
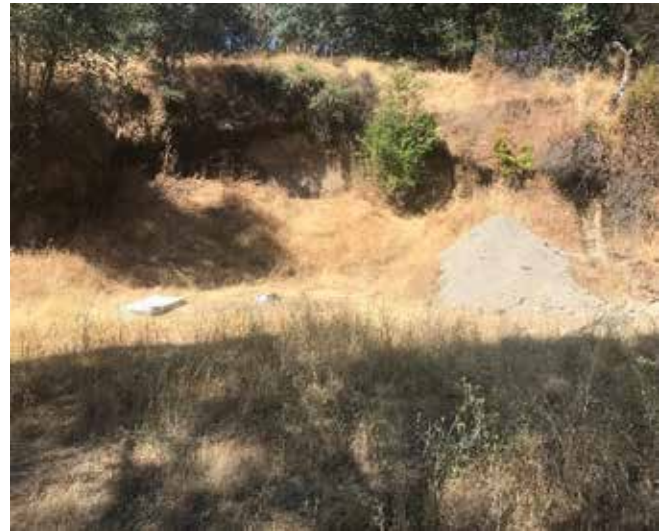
**Test Pit No:** TP – 3  
**Total Depth:** 11 feet  
**Date Excavated:** 07/18/22  
**Elevation:** 1,120', Topo  
**Logged by:** M. Crum

| DEPTH | USCS | DESCRIPTION |
|---|---|---|
| 0-3' | CL | RESIDUAL SOIL: Sandy Lean Clay, grayish red, slightly moist, very stiff to hard (4.5TSF), fine to medium sand generally medium. Mineralogy: rhyolite, andesite, quartz, biotite, muscovite<br>Sharp contact with: |

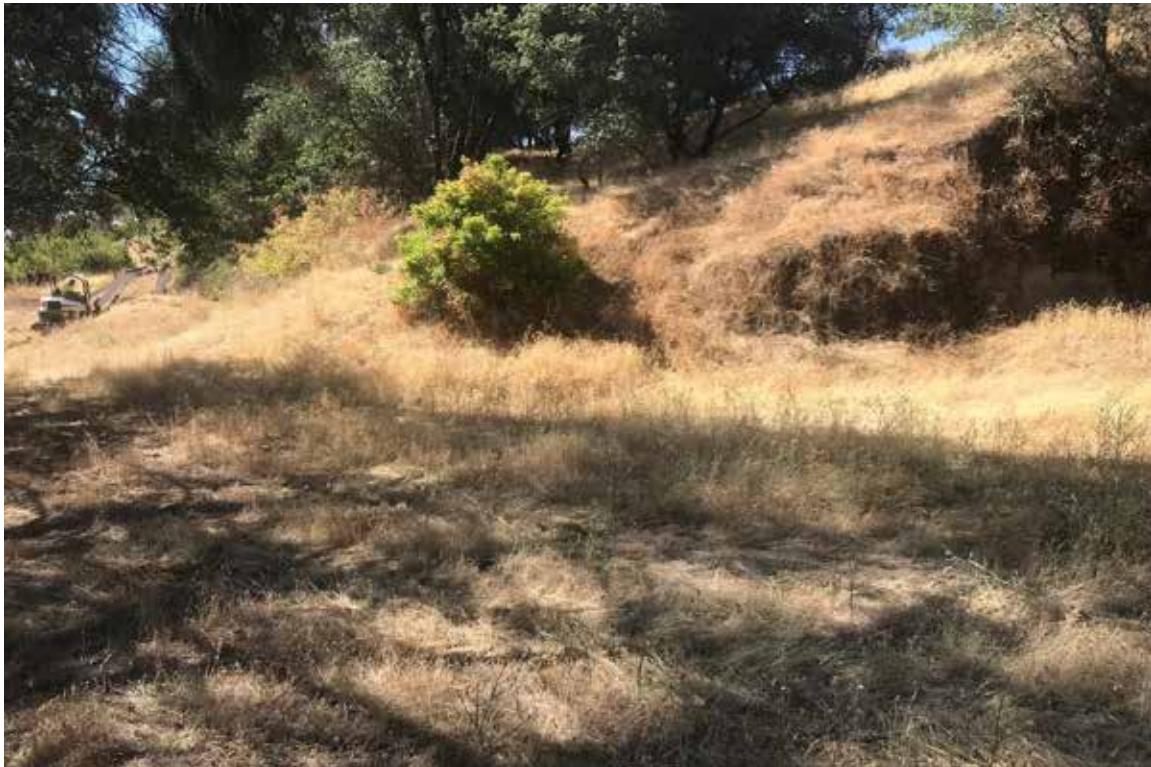
**Test Pit No:** TP – 4  
**Total Depth:** 7 feet  
**Date Excavated:** 07/18/22  
**Elevation:** 1,130', Topo  
**Logged by:** M. Crum

| DEPTH | USCS | DESCRIPTION |
|---|---|---|
| 0-2' | CL | RESIDUAL SOIL: Sandy Lean Clay, grayish red, slightly moist, very stiff to hard (4.5TSF), fine to medium sand generally medium. Mineralogy: rhyolite, andesite, quartz, biotite, muscovite<br>Trace roots at sharp contact with: |

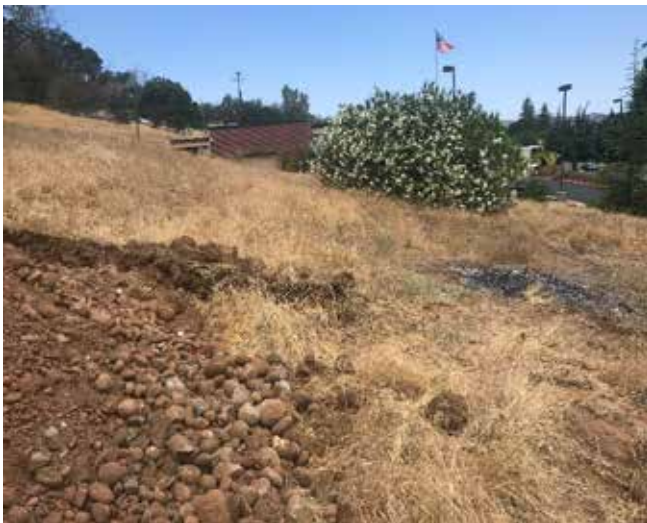
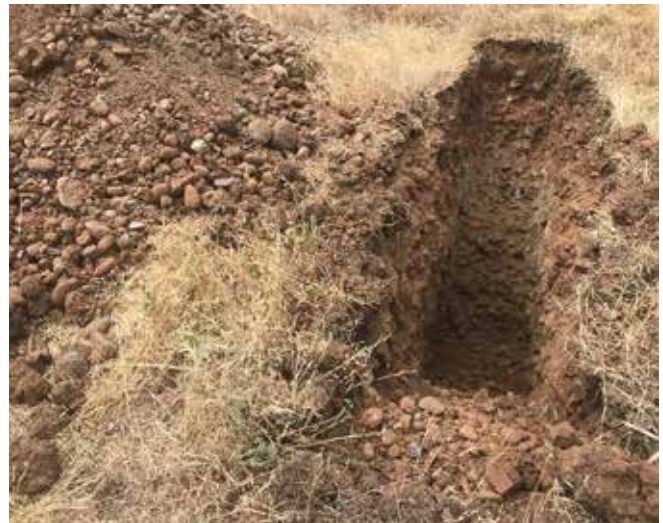
**Test Pit No:** TP – 5  
**Total Depth:** 6.5 feet  
**Date Excavated:** 07/18/22  
**Elevation:** 1,060', Topo  
**Logged by:** M. Crum

| DEPTH | USCS | DESCRIPTION |
|---|---|---|
| 0-0.75' | CL | RESIDUAL SOIL: Sandy Lean Clay, grayish red, slightly moist, very stiff to hard (4.5TSF), fine to medium sand generally medium. Mineralogy: rhyolite, andesite, quartz, biotite, muscovite<br>sharp contact with: |

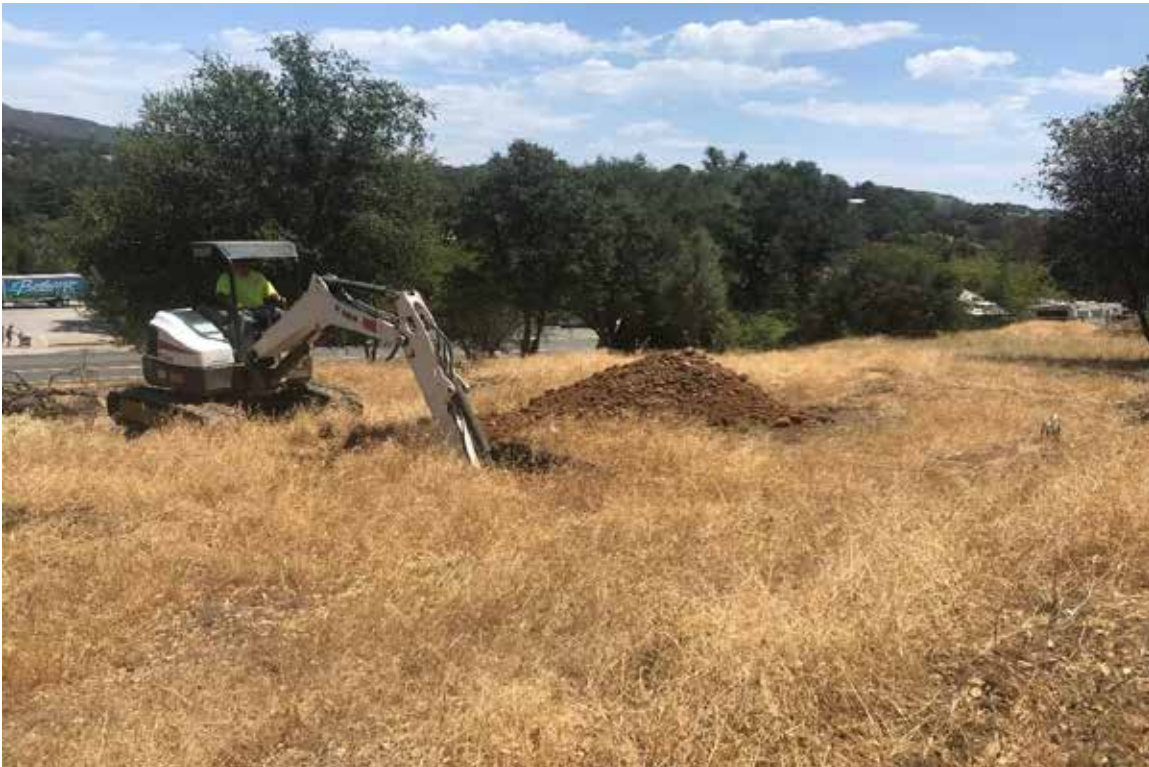
**Test Pit No:** TP – 8  
**Total Depth:** 5.5 feet  
**Date Excavated:** 07/18/22  
**Elevation:** 1,070', Topo  
**Logged by:** M. Crum

| DEPTH | USCS | DESCRIPTION |
|---|---|---|
| 0-1.3' | CL | RESIDUAL SOIL: Sandy Lean Clay, grayish red, slightly moist, very stiff to hard (4.5TSF), fine to medium sand generally medium. Mineralogy: rhyolite, andesite, quartz, biotite, muscovite<br>sharp contact with: |

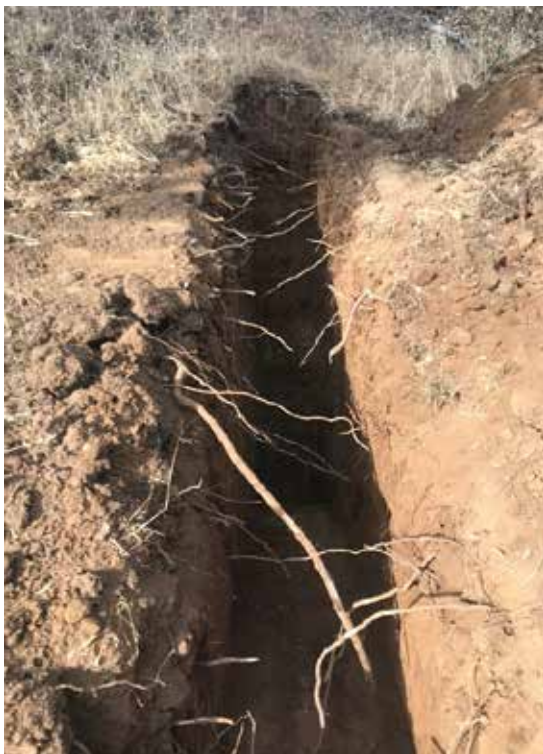
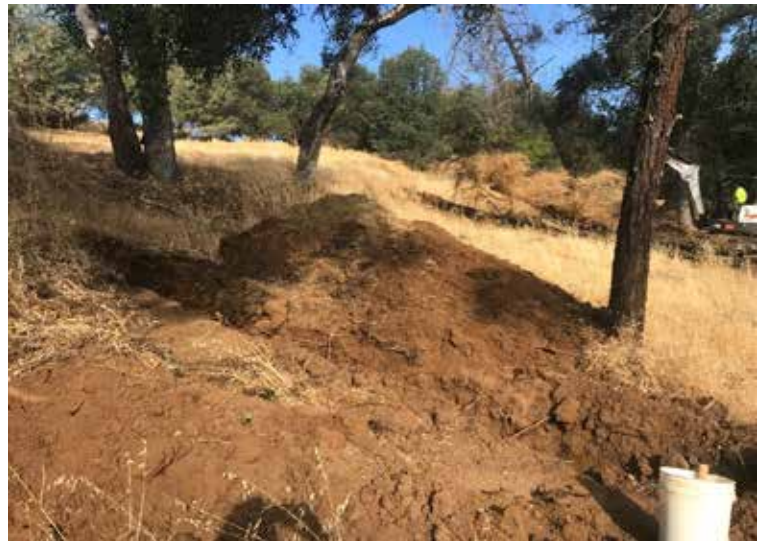
**Test Pit No:** TP – 11  
**Total Depth:** 11 feet  
**Date Excavated:** 07/18/22  
**Elevation:** 1,095', Topo  
**Logged by:** M. Crum

| DEPTH | USCS | DESCRIPTION |
|---|---|---|
| 0-4' | CL | RESIDUAL SOIL: Sandy Lean Clay, grayish red, slightly moist, very stiff to hard (4.5TSF), fine to medium sand generally medium. Mineralogy: rhyolite, andesite, quartz, biotite, muscovite, abundant roots<br>Sharp contact with: |

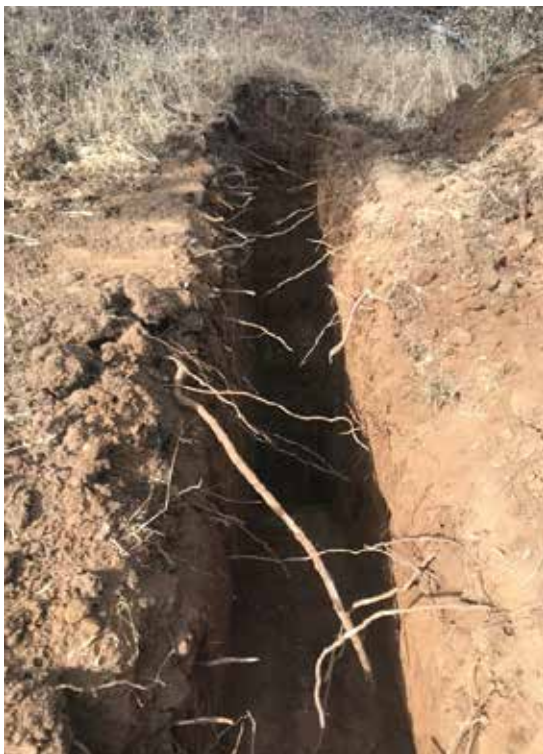
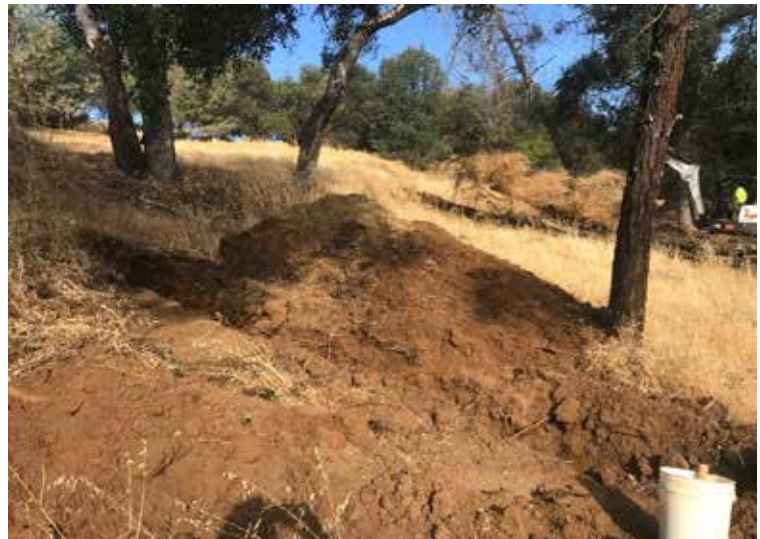
**Test Pit No:** TP – 12  
**Total Depth:** 11 feet  
**Date Excavated:** 07/19/22  
**Elevation:** 1,100', Topo  
**Logged by:** M. Crum

| DEPTH | USCS | DESCRIPTION |
|---|---|---|
| 0-3' | CL | RESIDUAL SOIL: Sandy Lean Clay, grayish red, slightly moist, very stiff to hard (4.5TSF), fine to medium sand generally medium. Mineralogy: rhyolite, andesite, quartz, biotite, muscovite, abundant roots<br>Sharp contact with: |

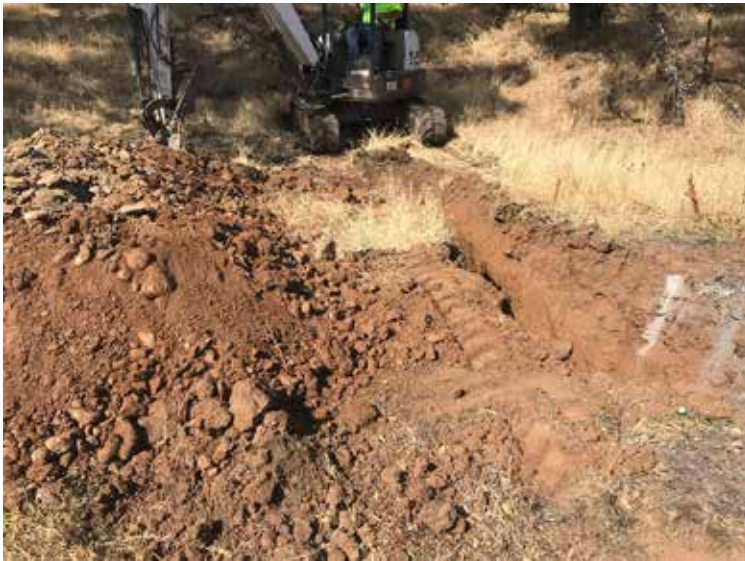
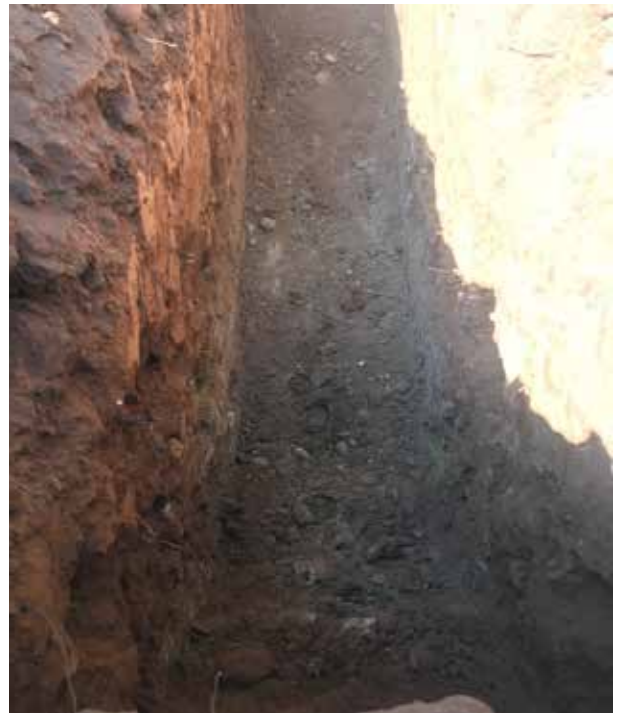
**Test Pit No:** TP – 14  
**Total Depth:** 6 feet  
**Date Excavated:** 07/19/22  
**Elevation:** 1,075', Topo  
**Logged by:** M. Crum

| DEPTH | USCS | DESCRIPTION |
|---|---|---|
| 0-4' | CL | RESIDUAL SOIL: Sandy Lean Clay, grayish red, slightly moist, very stiff to hard (4.5TSF), fine to medium sand generally medium. Mineralogy: rhyolite, andesite, quartz, biotite, muscovite<br>sharp contact with: |
