August 22, 2024

Re: Biological Report for Franklin Creek Exposed Sewer Line Project  
City of Paso Robles, California

**City of Paso Robles**  
**Exposed Trunk Sewer Line - Franklin Creek**  
 Map Center: 35.61182°N 120.675°W  
 Paso Robles, San Luis Obispo County

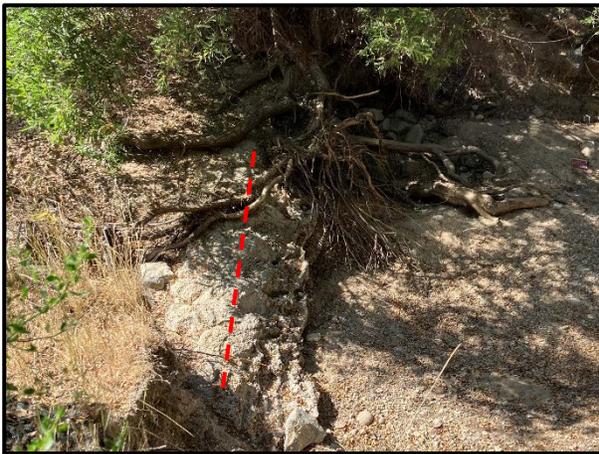
Photo 1. Franklin Creek exposed sewer line, August 7, 2024, view from top of bank (northwest).

An exposed 21-inch diameter trunk sewer line was recognized by City staff on September 14, 2023. The sewer line crossing is in an area that eroded immediately downstream from the sewer, exposing the line. The sewer line is in a location that is at risk of continued bed and bank erosion and is vulnerable to failure pending the upcoming rainy season. The City proposes to protect the

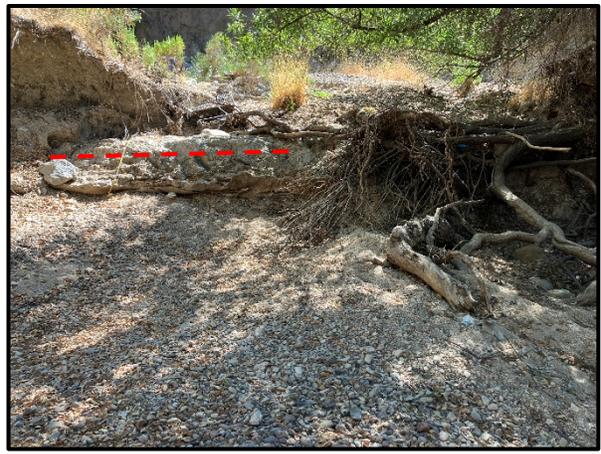
Photo 2. Franklin Creek exposed sewer line, August 7, 2024, view upstream (southwest).

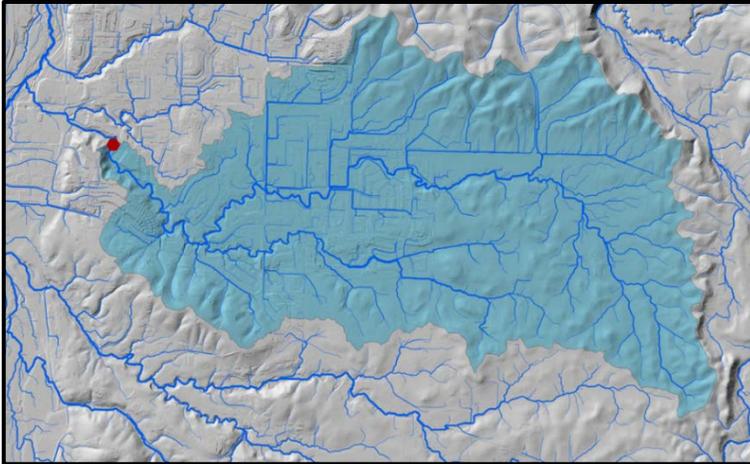
Exhibit 1. Exposed sewer line feature indicated by a star and above watershed indicated in light blue.

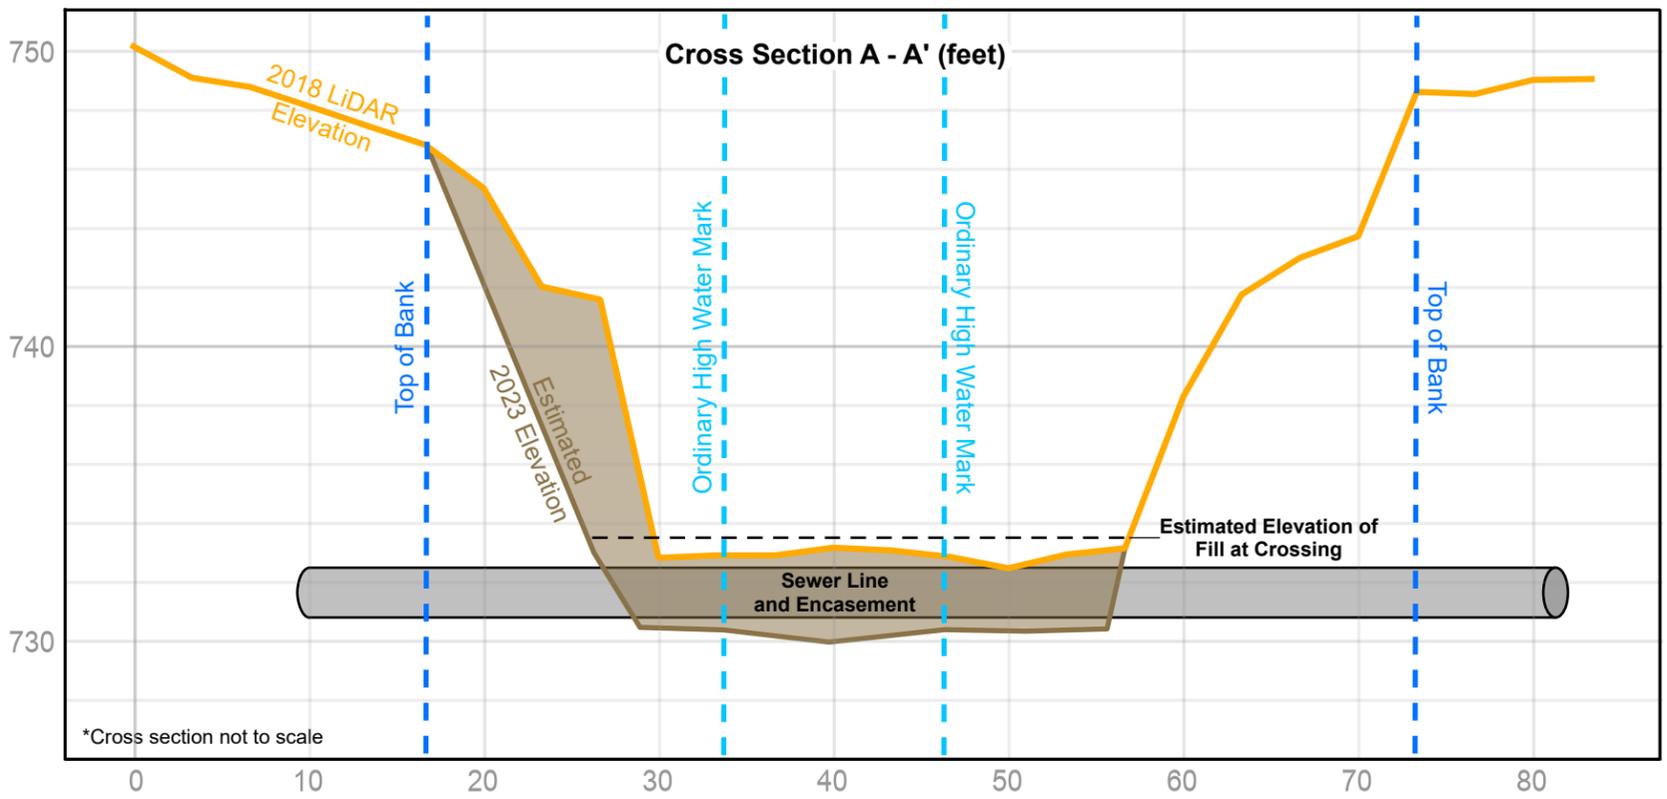
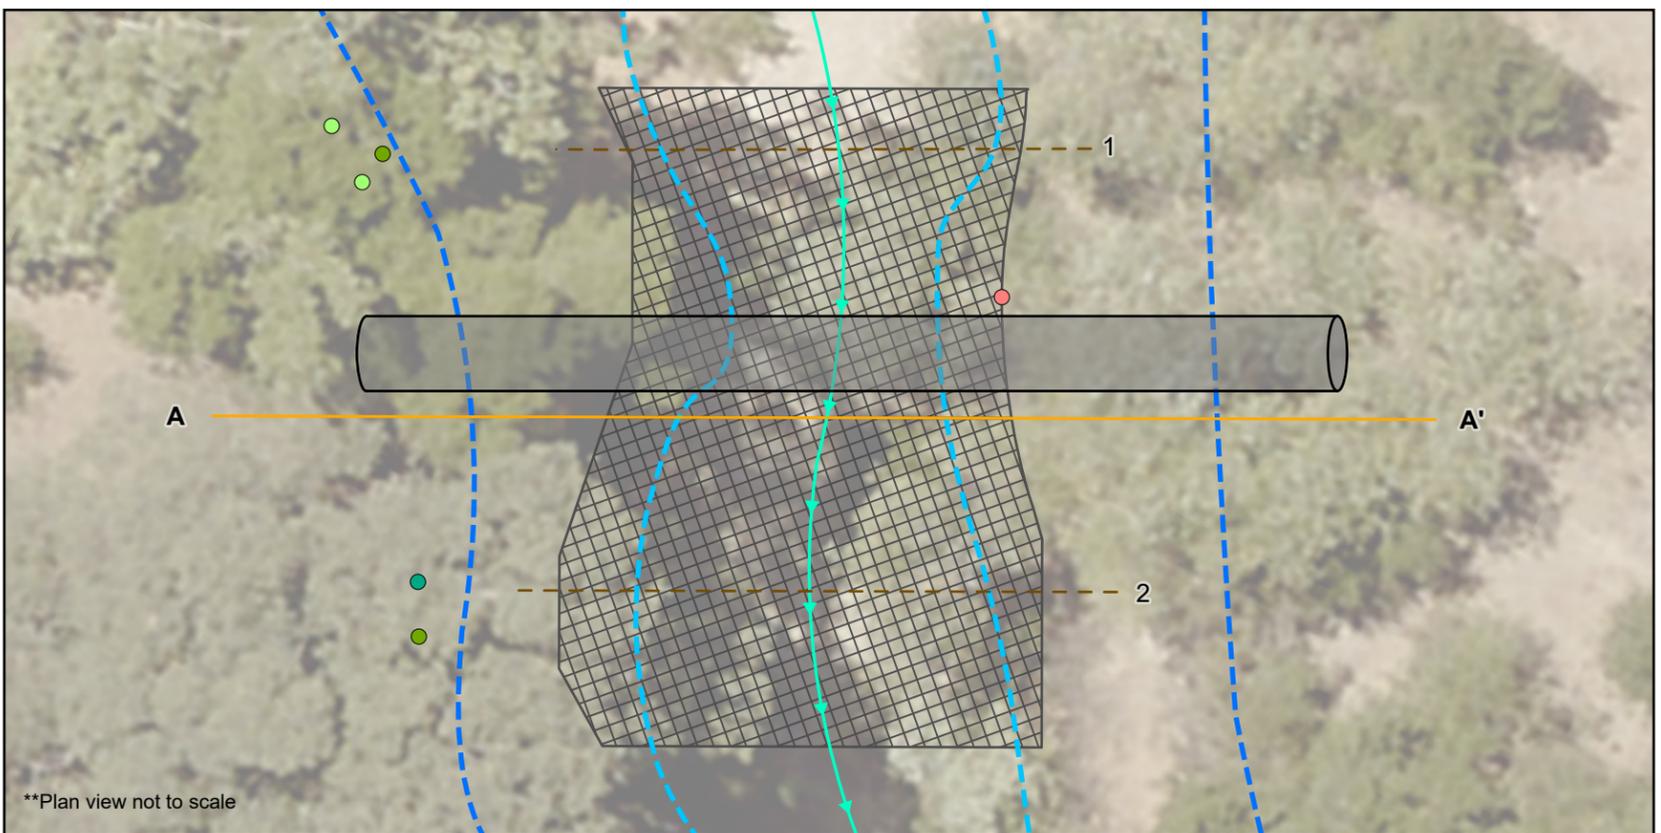
**Figure 5. Cross Section**

- Top of Bank
- Ordinary High Water Mark
- Estimated Sewer Line and Encasement
- Proposed Riprap
- Franklin Creek
- Cross Section\*
- Cross-section location, see Appendix F datasheets
- Tree Species**
- Blue oak
- Coast live oak
- Red willow
- Valley oak

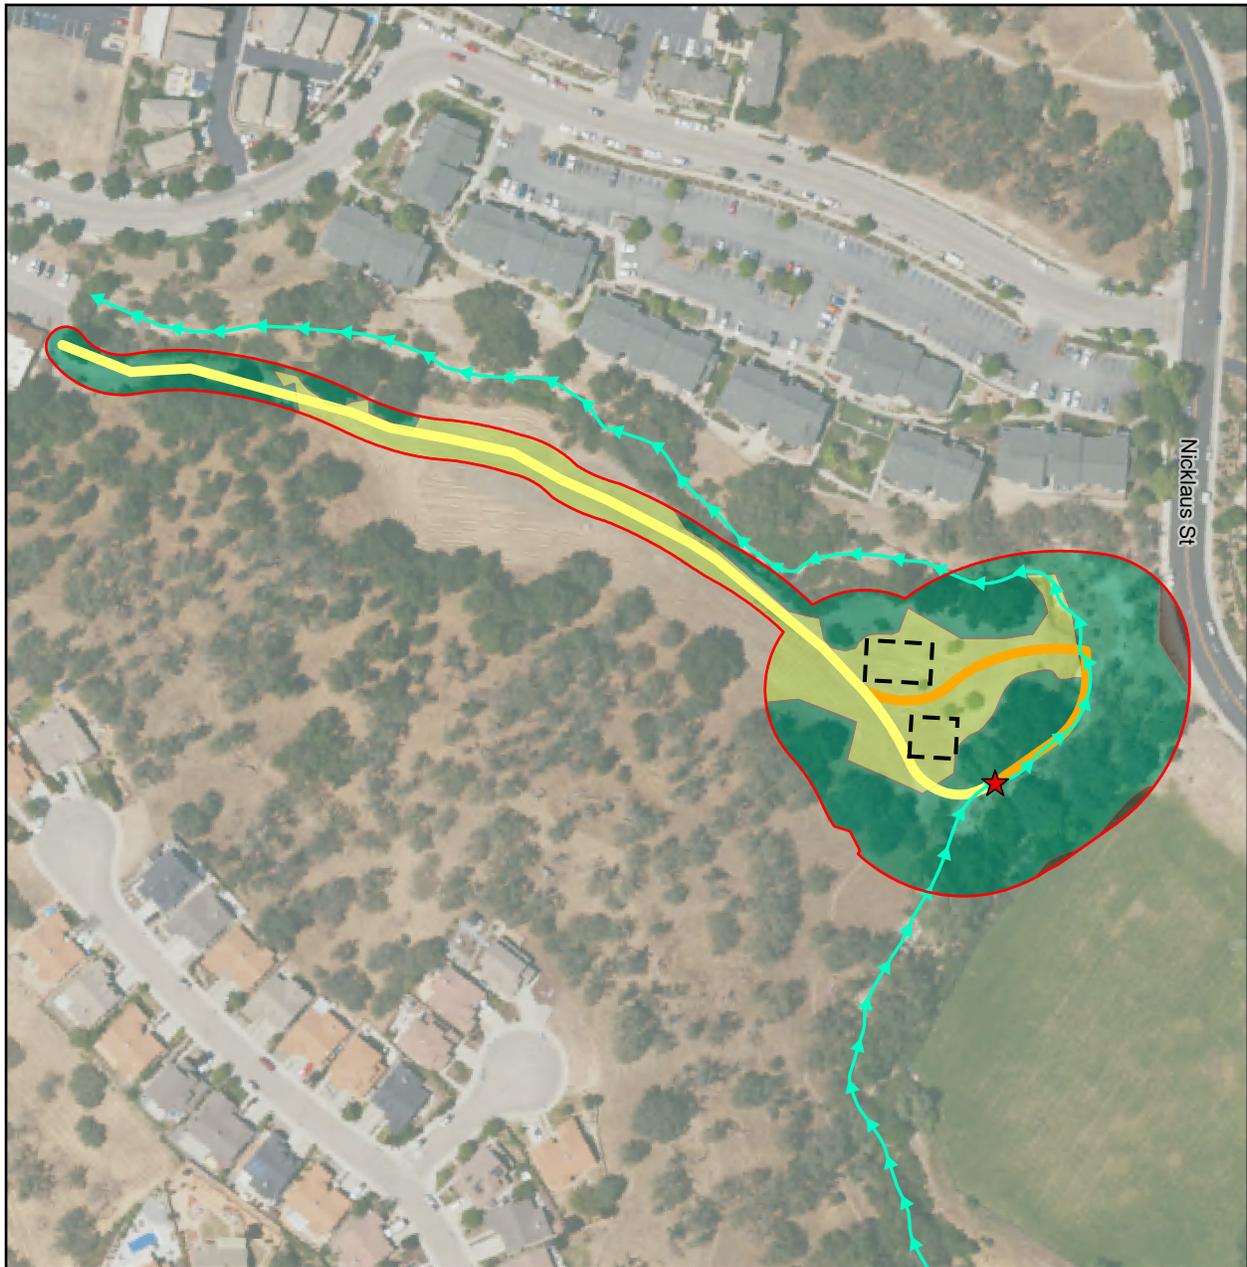
**Figure 8. Impact Map**

\*\*Impact from 0.1-acre staging and 0.01-acre creek access point.

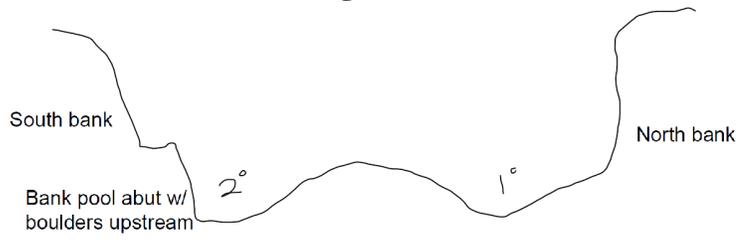
**Cross section drawing:**

OHWM 32' wide

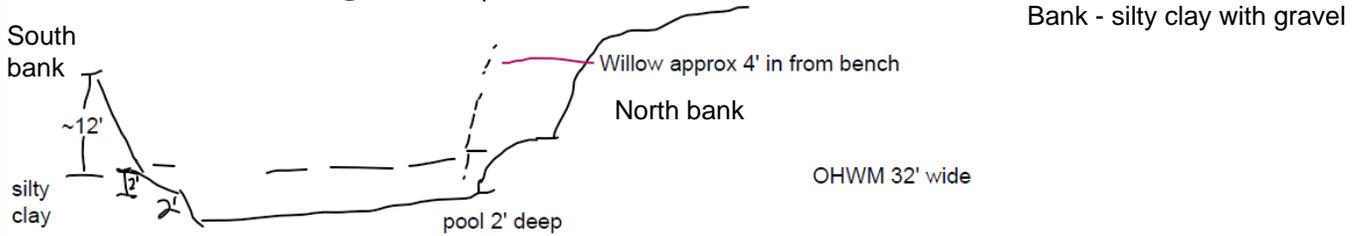
**Cross section drawing:** View upstream

**OHWM**

GPS point: 35.611500 N, -120.675111 W

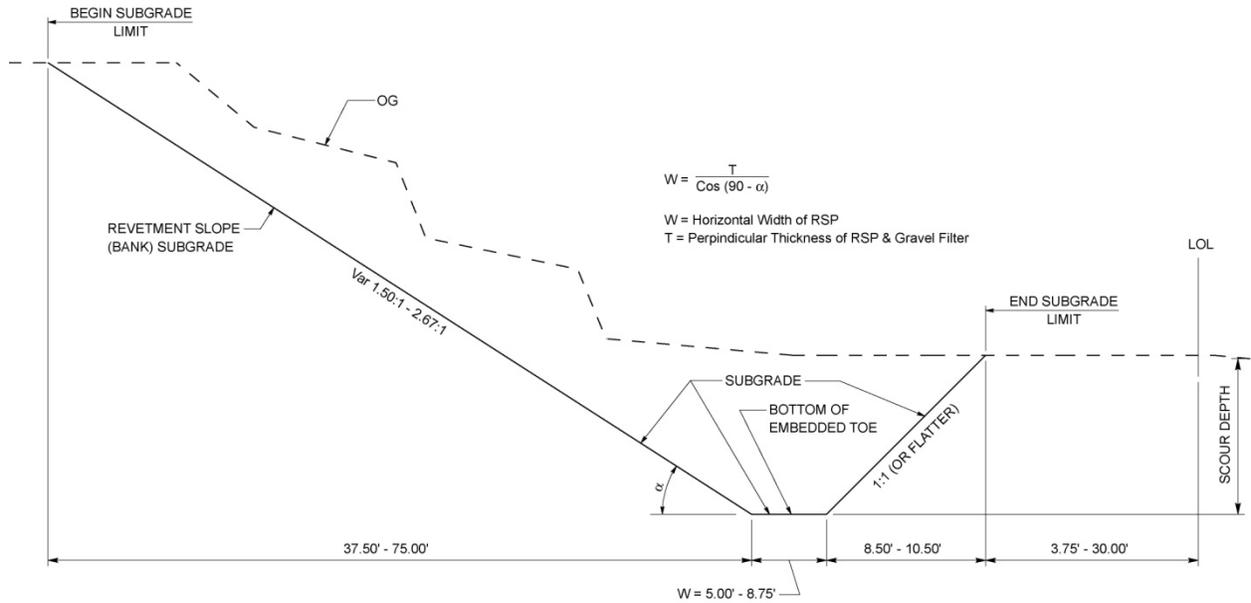
**Figure 15- Subgrade Cross Section**

All grading for the hybrid revetment will be performed by the civil engineer. Grading is discussed in *Section 72-2.03A General* of the *Standard Specifications*, and its payment is included in cost per cubic yard or ton of RSP.

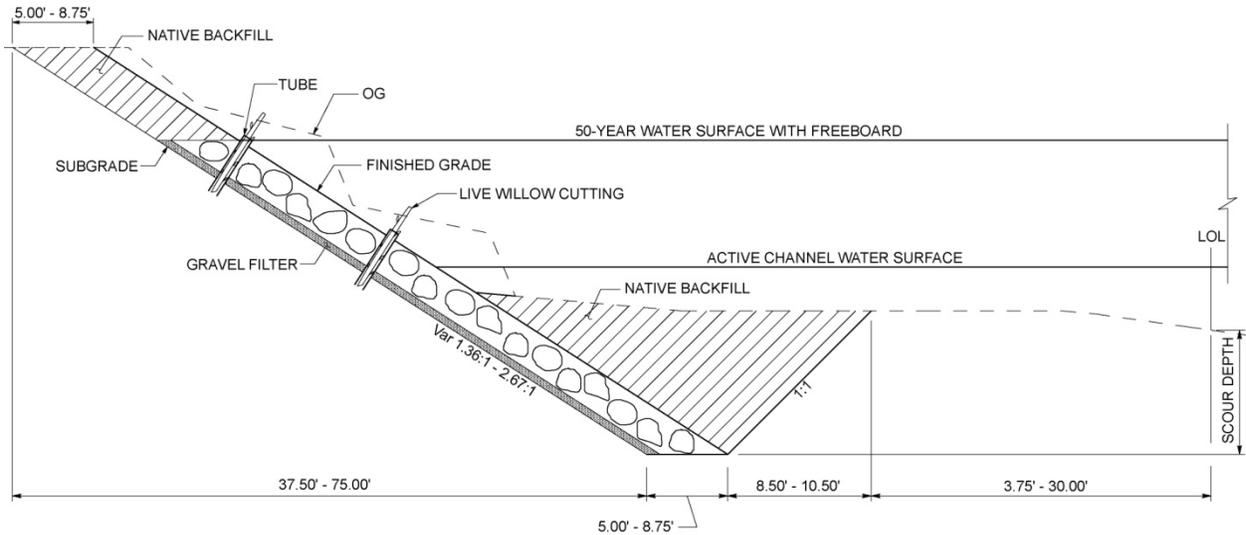
**Figure 16- Hybrid Revetment Cross Section**

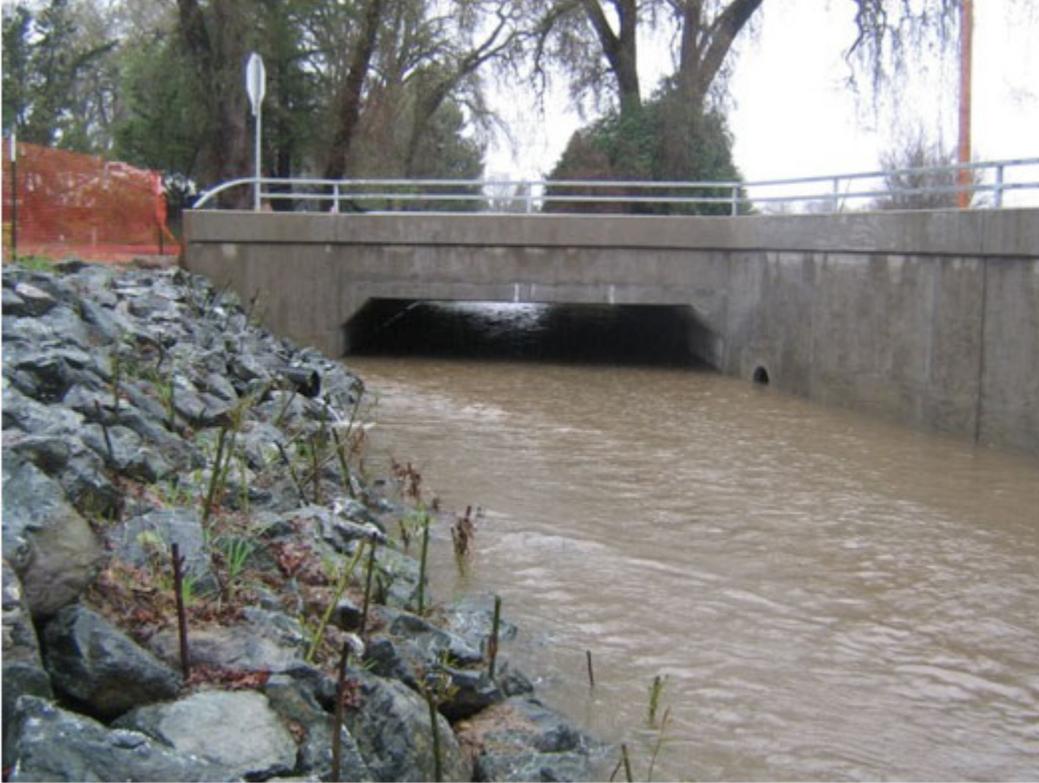
**Figure 17- Gibson Creek, Cuttings through RSP (Right After Installation, Fall 2010)**

their success rate, ease of harvesting and planting, as well as their vast availability, willow cuttings have been chosen to be the vegetation component in hybrid revetments. The predominant species of willow within a 5 to 7 mile radius of the project site should be used as the source for the cuttings. For areas where willows may not be prolific and plentiful, such as in arid climates, the landscape architect may recommend comparable vegetation alternatives to the civil engineer. See Figures 17 and 18 for an example of live willow cuttings incorporated into RSP in an effort to protect a streambank.

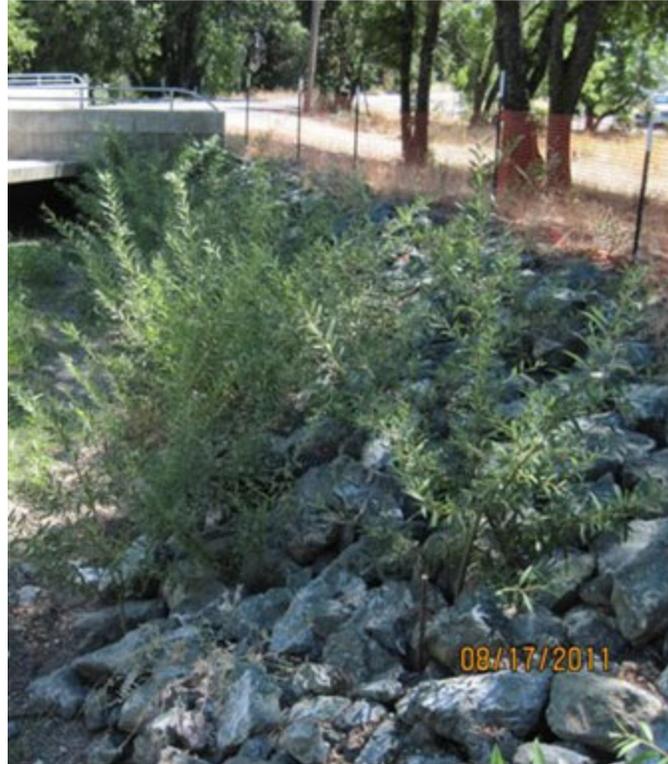
**Figure 18- Gibson Creek, Cuttings through RSP (Summer 2011)**

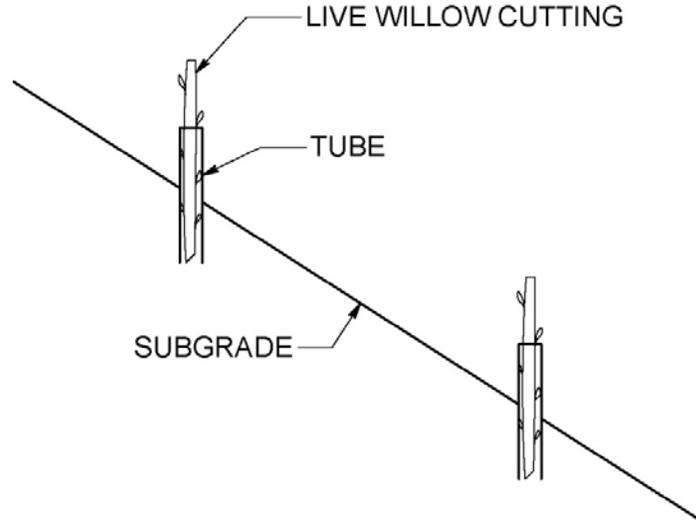
**Figure 19- Live Cutting Vertical Orientation**

The willow cuttings may be planted into the streambank with either a vertical or perpendicular orientation. See Figures 19 and 20 for orientation illustration. The cuttings will be planted into the revetment subgrade and must be long enough to extend through the RSP and gravel filter layers, which are placed at a thickness perpendicular to the streambank. As seen in Figure 21, the total cutting length is the sum of the cutting embedment depth (A), the RSP layer(s) and gravel filter thickness (B), where the “B” dimension depends upon cutting orientation with streambank, and the cutting protrusion length from the RSP outer layer (C+D). Normally, the embedment depth and protrusion length are influenced by existing vegetation and soil conditions at the project site.

An advantage of the vertical orientation is that the amount of vegetation projection and encroachment into the main channel at maturity is minimized lessening potential stream hydraulic impacts from the perpendicular cutting orientation that would have greater tendency to project into the main channel, however a disadvantage of the vertical orientation is that the required cutting length is increased. When a cutting is placed vertically and completely through the RSP and gravel filter, the thickness dimension of these layers is skewed or lengthened because the rock and gravel are placed to their specified thickness measured perpendicular to the streambank slope. Due to the skewed thickness, the cutting length must be longer to penetrate completely through the RSP and gravel filter. For example, a 2.5:1 streambank slope receiving ½T (½Ton) (Method A Placement), Backing No. 1, and gravel filter, considering 1-foot subgrade soil embedment and 2-foot protrusion length from RSP outer layer, would require a cutting length equal to 9.4 feet having vertical orientation, while the perpendicular orientation length is 8.7 feet.

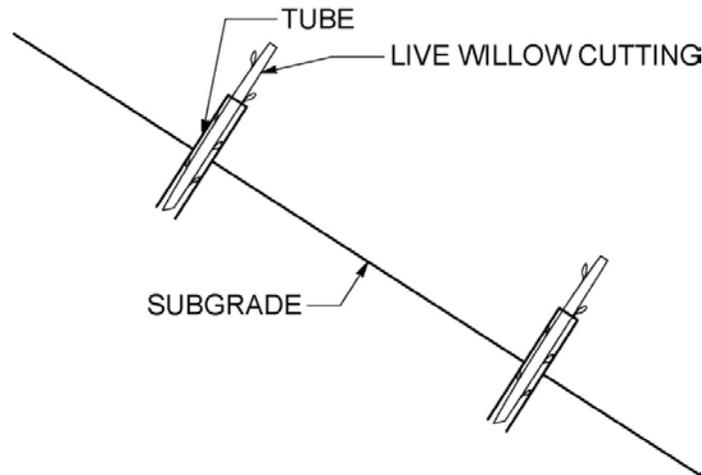
**Figure 20- Live Cutting Perpendicular Orientation**

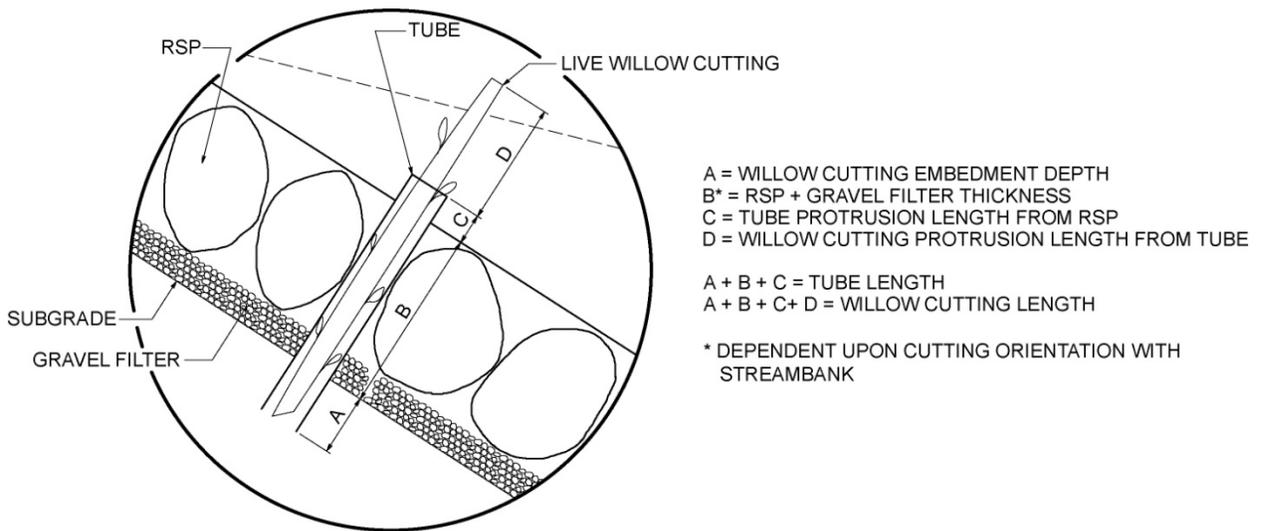
**Figure 21- Live Cutting Detail**

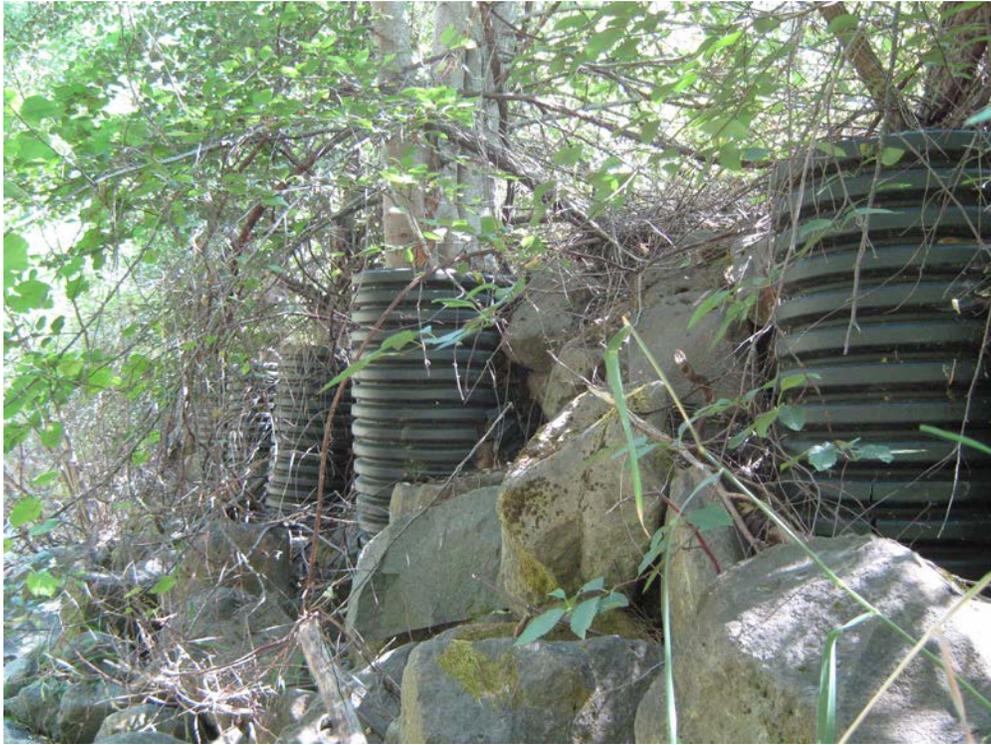
**Figure 22- Weaver Creek (2012), Mature Vegetation in Plastic Tubes**

prevent damage when placing rock. An example site using tubes is shown in Figures 22 and 23 where vegetation is planted through corrugated plastic tubes within RSP. As previously stated, degradable cardboard tubes are recommended instead of plastic.

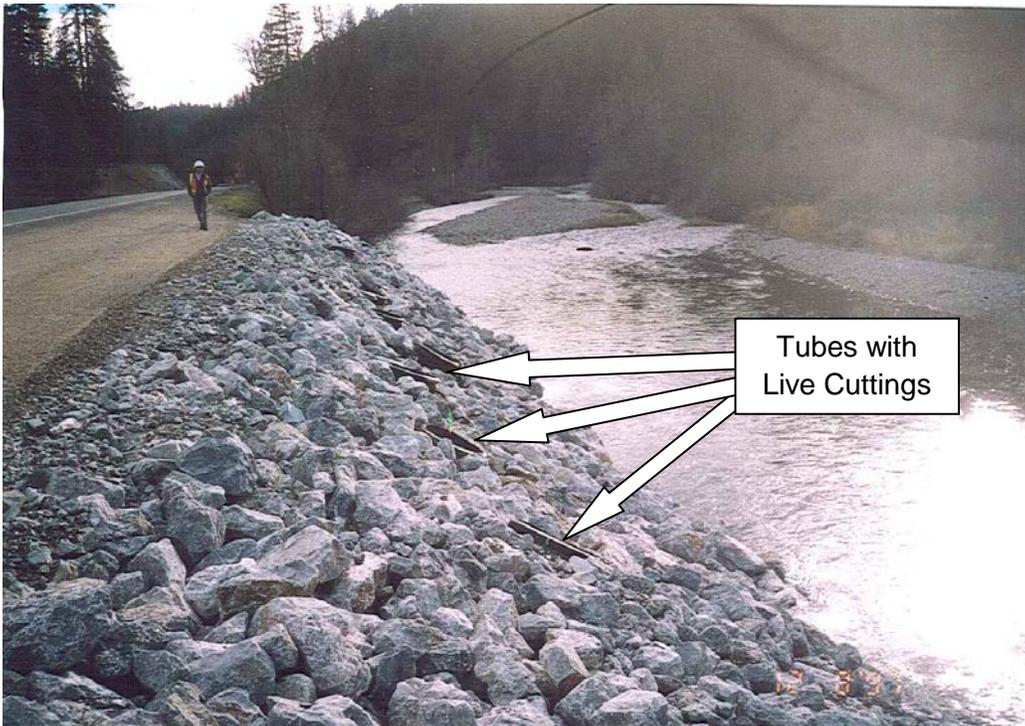
**Figure 23- Weaver Creek (1997), Cuttings in Plastic Tubes Just After Installation**

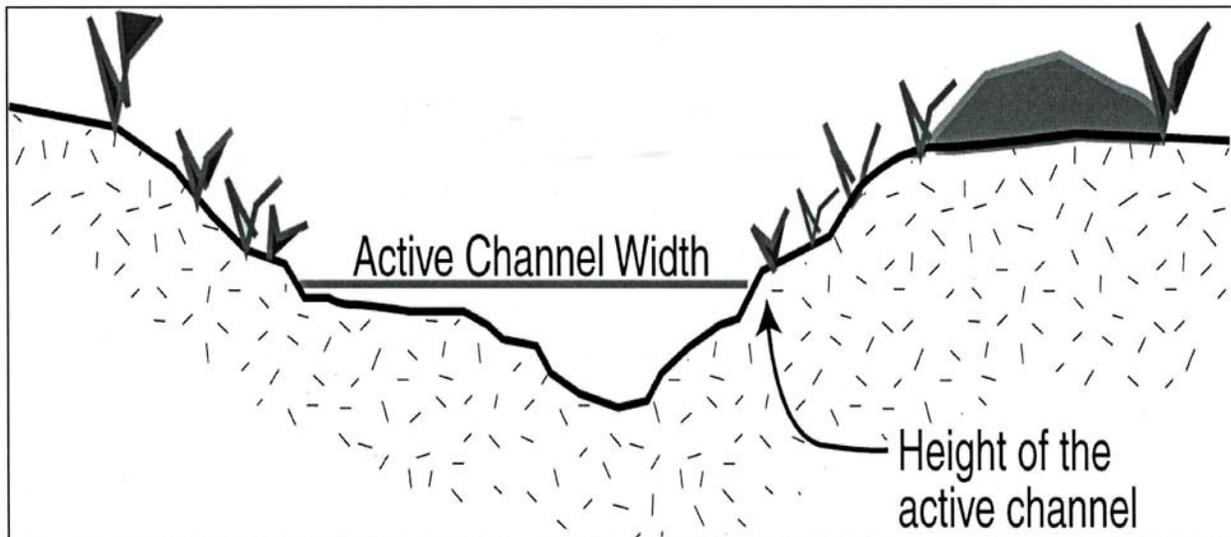
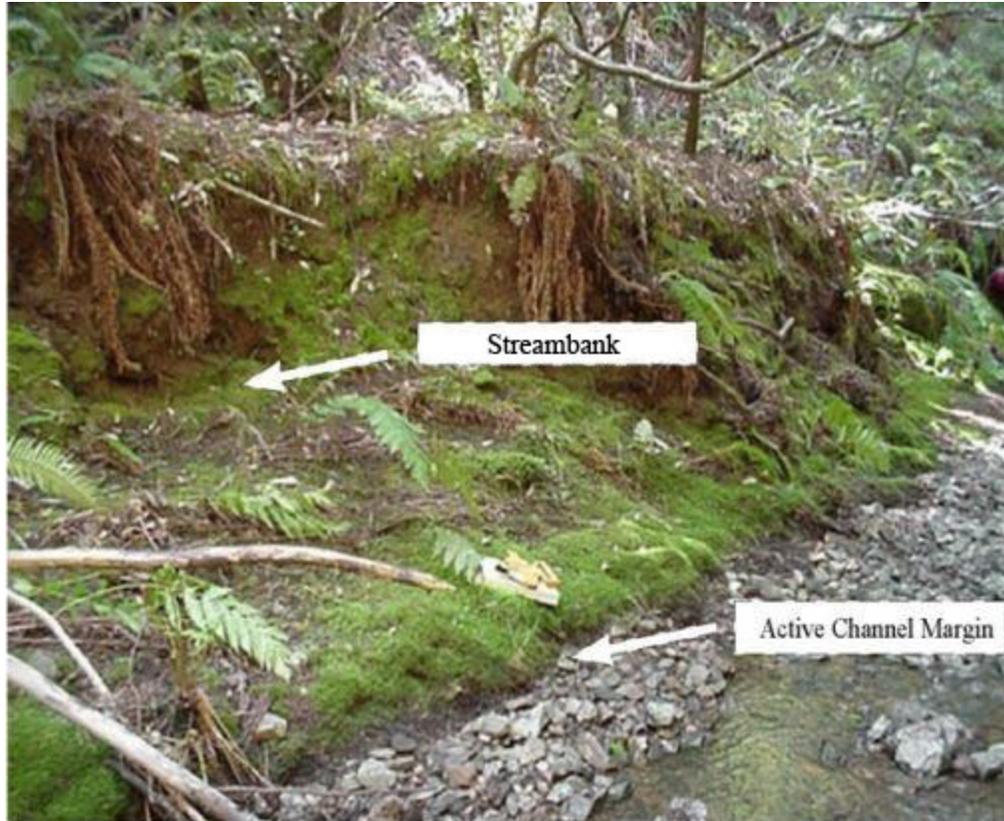
**Figure 24- Active Channel Delineation (adapted from CDFW (2004))**

In Figure 24, a schematic depiction of active channel margin is shown in cross section and a stream photograph is marked with the active channel margin. CDFW (2002) defines active channel as *the ordinary high water level elevation delineating the highest water level maintained for a sufficient period of time to leave evidence on the landscape, such as the point at which cleanly scoured substrate of the stream ends and terrestrial vegetation begins*. The active channel height and limit should be located in the field by the civil engineer and plotted on the hybrid revetment typical cross section for reference.
