APPENDIX A

AIR QUALITY MODELING RESULTS

Self-Storage Facility on Corporate Way Custom Report

Phase I Environmental Site Assessment

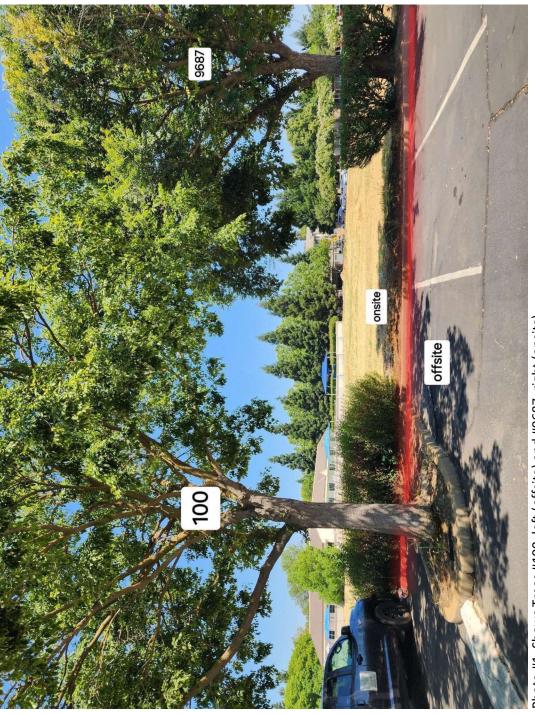
Photo #1, Shows Trees #100, left (offsite) and #9687, right (onsite)

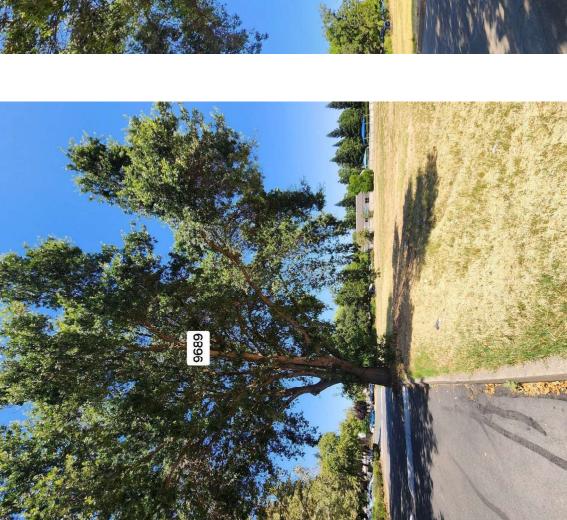
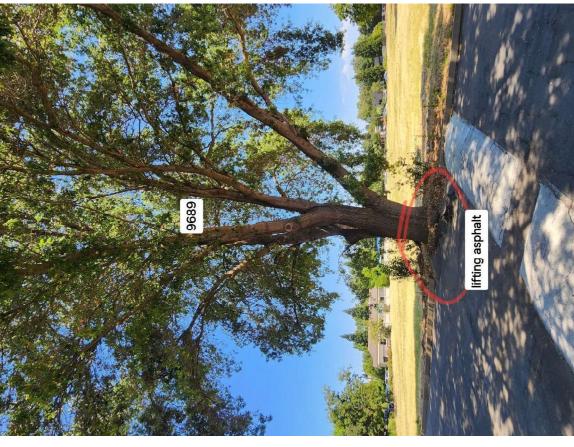
Photo #4, Shows Heritage Tree #9689, lifting asphalt

Photo #3, Shows Heritage Tree #9689

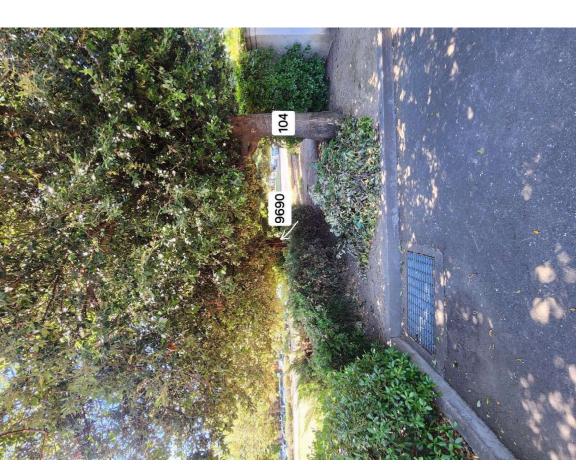
Photo #5, Shows Tree #9690, left (possibly offsite) and Tree #104, right

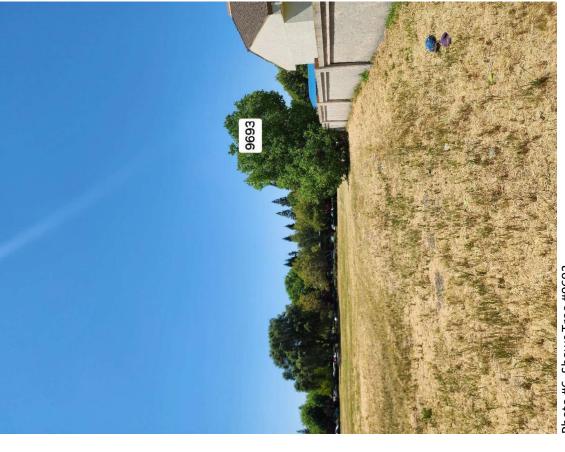
Photo #6, Shows Tree #9693

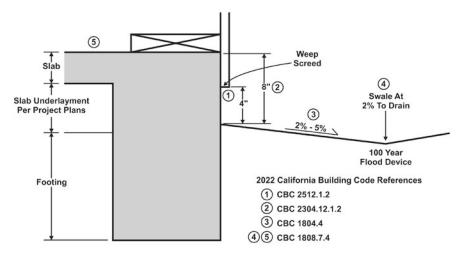
Typical 2022 California Building Code Drainage Requirements

All grades should provide rapid removal of surface water runoff; ponding water should not be allowed on building pads or adjacent to foundations or other structural improvements (during and following construction). All soils placed against foundations during finish grading should be compacted to minimize water infiltration. Finish and landscape grading should include positive drainage away from all foundations. Section 1808.7.4 of the 2022 California Building Code (CBC) states that for graded soil sites, the top of any exterior foundation shall extend above the elevation of the street gutter at the point of discharge or the inlet of an approved drainage device a minimum of 12 inches plus 2 percent. If overland flow is not achieved adjacent to buildings, the drainage device should be designed to accept flows from a 100-year event. Grades directly adjacent to foundations should be no closer than 8 inches from the top of the slab (CBC 2304.12.1.2), and weep screeds are to be placed a minimum of 4 inches clear of soil grades and 2 inches clear of concrete or other hard surfacing. From this point, surface grades should slope a minimum of 2 percent away from all foundations for at least 5 feet but preferably 10 feet, and then 2 percent along a drainage swale to the outlet (CBC 1804.4). Downspouts should be tight piped via an area drain network and discharged to an appropriate non-erosive outlet away from all foundations.

The above referenced elements pertaining to drainage of the proposed structures is provided as general acknowledgement of the California Building Code requirements, restated and graphically illustrated for ease of understanding. Surface drainage design is the purview of the Project Architect/Civil Engineer. Review of drainage design and implementation adjacent to the building envelopes is recommended as performance of these improvements is crucial to the performance of the foundation and construction of rigid improvements.

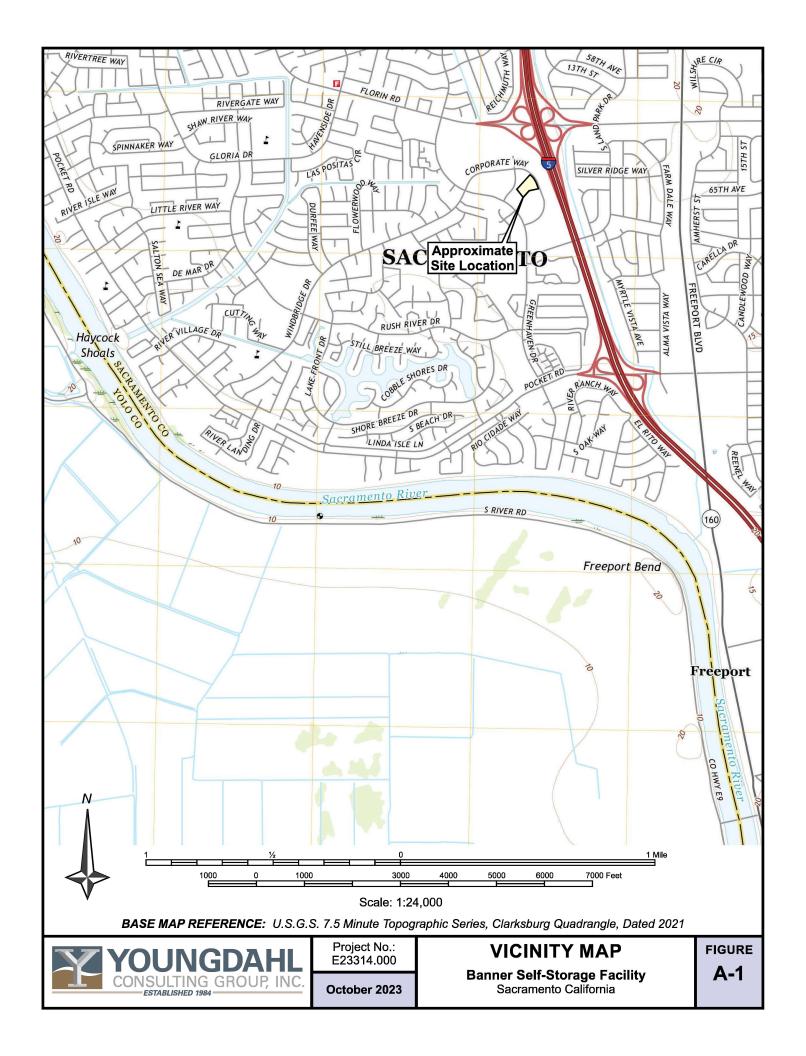
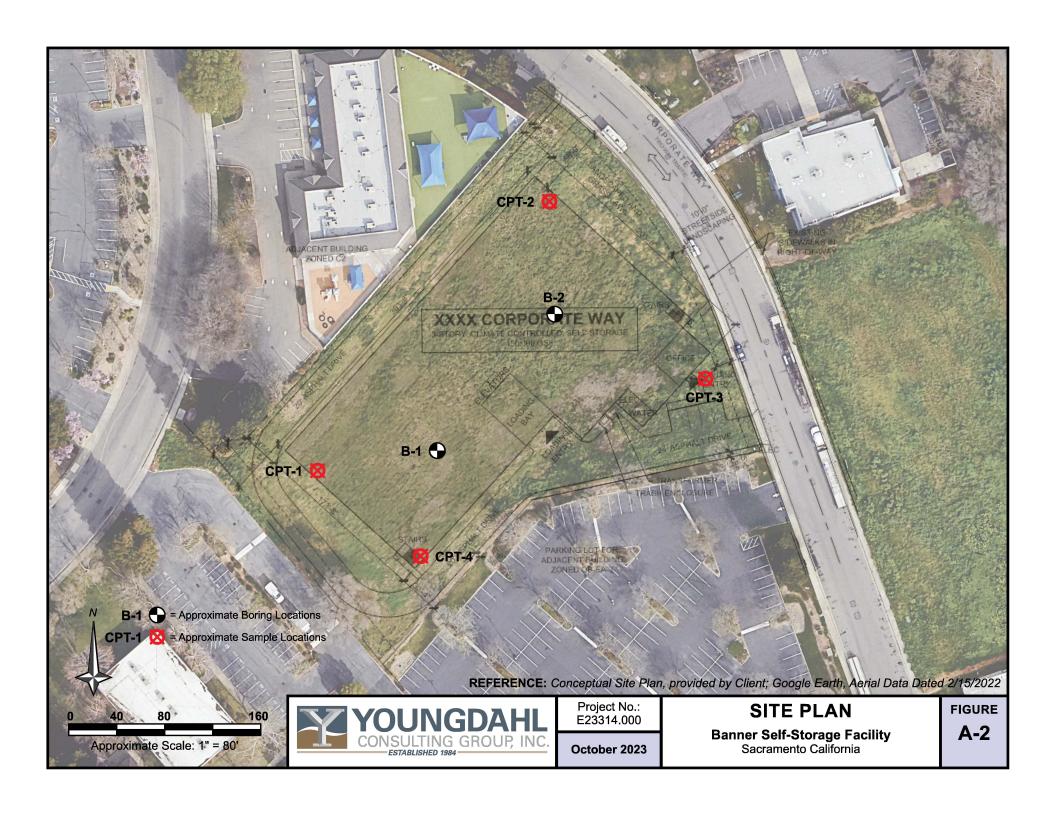
Lat / Lon: N 38.491872° / W 121.517478° Boring No. Logged By: ITK Date: 8 September 2023 **B-1** Equipment: CME 55 Drill Rig - 4" Solid Stem Auger / Mud Rotary Elevation: ~ **Ground Water** Depth (Feet) Graphic Log **Blow Counts** Pocket Pen (tsf) Dry Density (pcf) **Geotechnical Description Tests & Comments** & Unified Soil Classification Grey to olive brown CLAY (CL), medium stiff to stiff, Bulk B-1 slightly moist @ 0' - 5' Partial Recovery EI = 108 (high) 2 3 Grades moist 10 2.5 5 Grades very soft, moist to wet 6 3 모 <.25 Grades wet Switch to Mud Rotary 8 9 10 Grades olive grey, fine grained, sandy <.25 LL = 43, PI = 20 11 83.2 36.7 4 12 13 14 15 <.25 16 3 <.25 17 18 19 20 Olive grey SILT (ML) with sand, very soft, wet <.25 94.4 30.1 72.5% < No. 200 21 2 Olive grey CLAY (CL), very soft, wet 90.9 32.5 22 23 24 25 Boring Continued on Figure A-3b

Note: The boring log indicates subsurface conditions only at the specific location and time noted. Subsurface conditions, including groundwater levels, at other locations of the subject site may differ significantly from conditions which, in the opinion of Youngdahl Consulting Group, Inc., exist at the sampling locations. Note, too, that the passage of time may affect conditions at the sampling locations.

The soils encountered were logged during this provide the basis for the "Exploratory Boring Logs", Figures A-3 and A-4, this Appendix. This log shows a graphic representation of the soil profile, the location, and depths at which samples were collected.

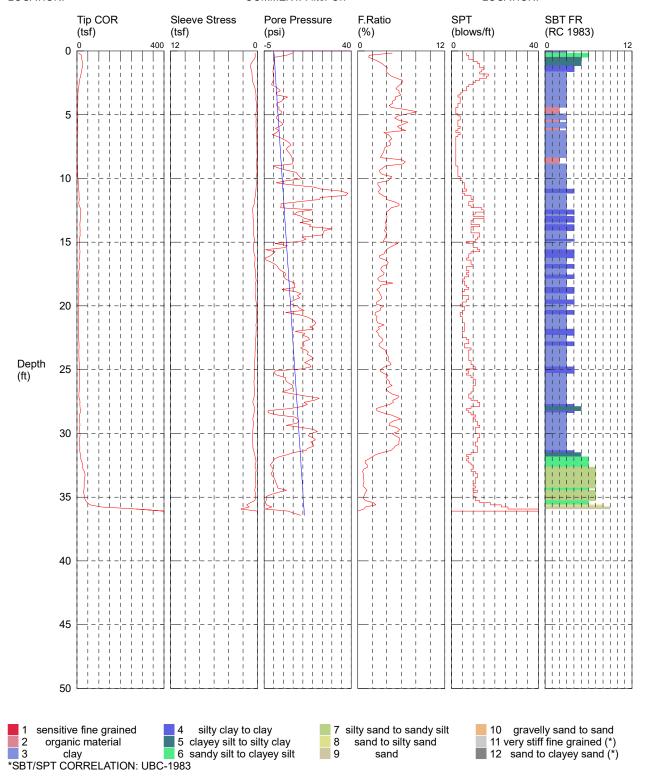
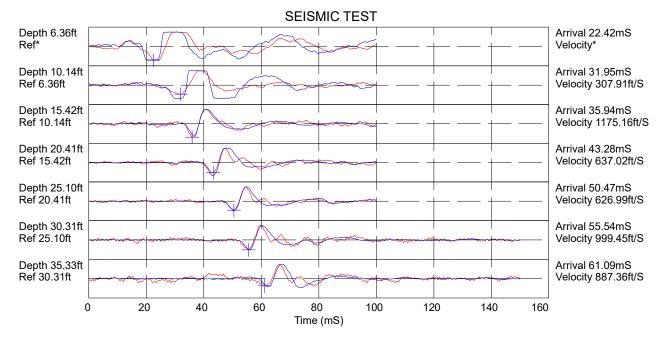
SOUNDING CUSTOMER: Taber Drilling OPERATOR: David CONE ID: DDG1570 LOCATION: JOB NUMBER: HOLE NUMBER: CPT-1 TEST DATE: 9/8/2023 8:01:01 AM COMMENT: Auto Enhance On COMMENT: Filter On COMMENT: GPS (LAT,LON,ALT): 0.00,0.00,0.0 LOCATION: LOCATION: LOCATION:

The CPT data collected are provided in this section following Figure A-6. The enclosed CPT data describes the vertical sequence of soil behavior which was encountered during exploration based on cone resistance, sleeve friction, and pore water pressure.

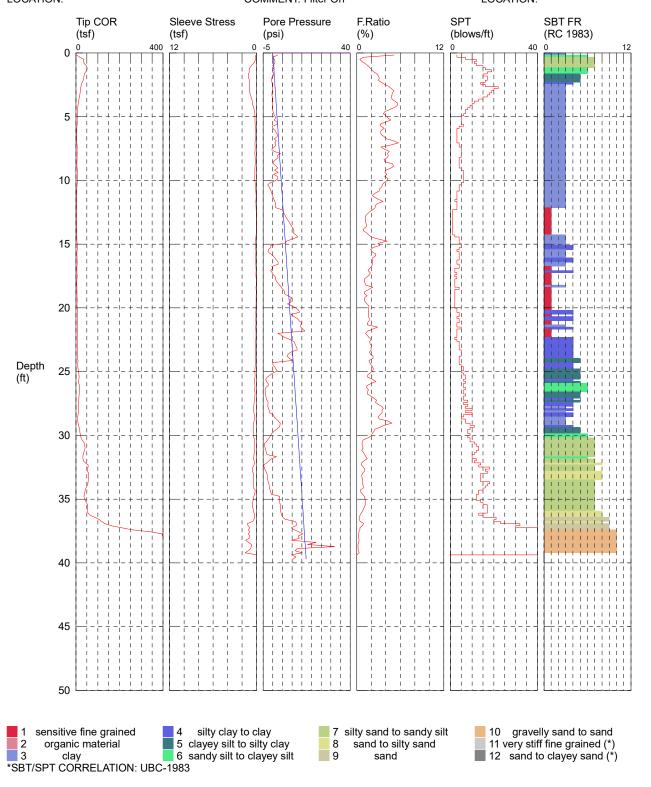
SOUNDING CUSTOMER: Taber Drilling OPERATOR: David CONE ID: DDG1570 LOCATION: JOB NUMBER: HOLE NUMBER: CPT-2 TEST DATE: 9/8/2023 9:20:12 AM COMMENT: Auto Enhance On COMMENT: Filter On COMMENT: GPS (LAT,LON,ALT): 0.00,0.00,0.0 LOCATION: LOCATION: LOCATION:

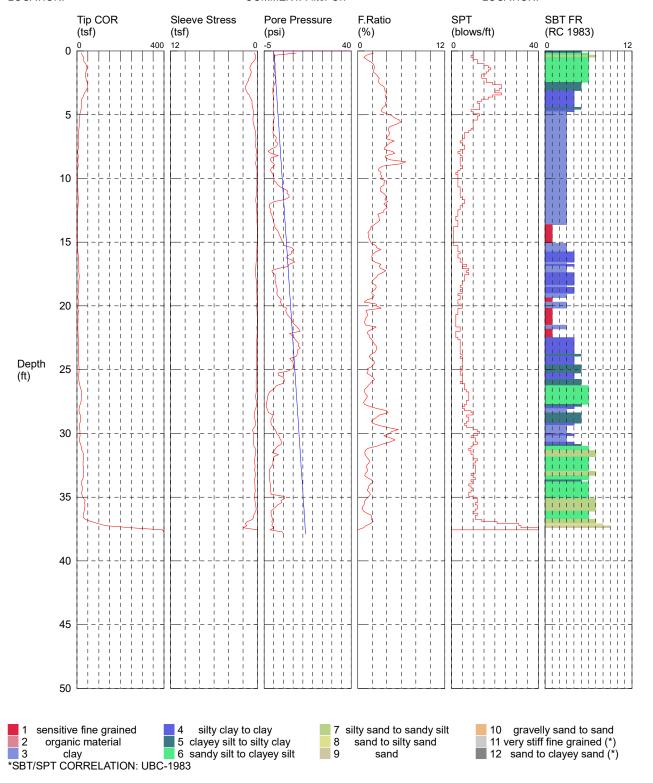
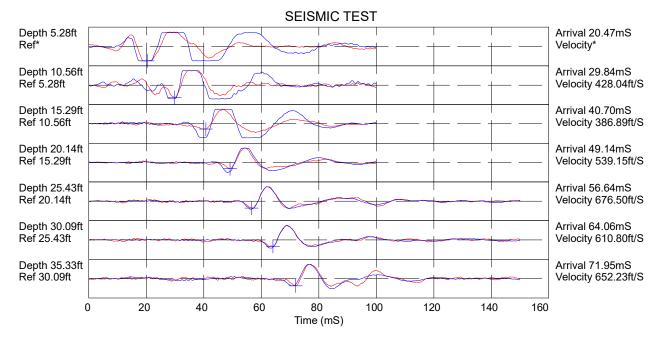
SOUNDING CUSTOMER: Taber Drilling OPERATOR: David CONE ID: DDG1570 LOCATION: JOB NUMBER: HOLE NUMBER: CPT-3 TEST DATE: 9/8/2023 10:31:38 AM COMMENT: Auto Enhance On COMMENT: Filter On COMMENT: GPS (LAT,LON,ALT): 0.00,0.00,0.0 LOCATION: LOCATION: LOCATION:

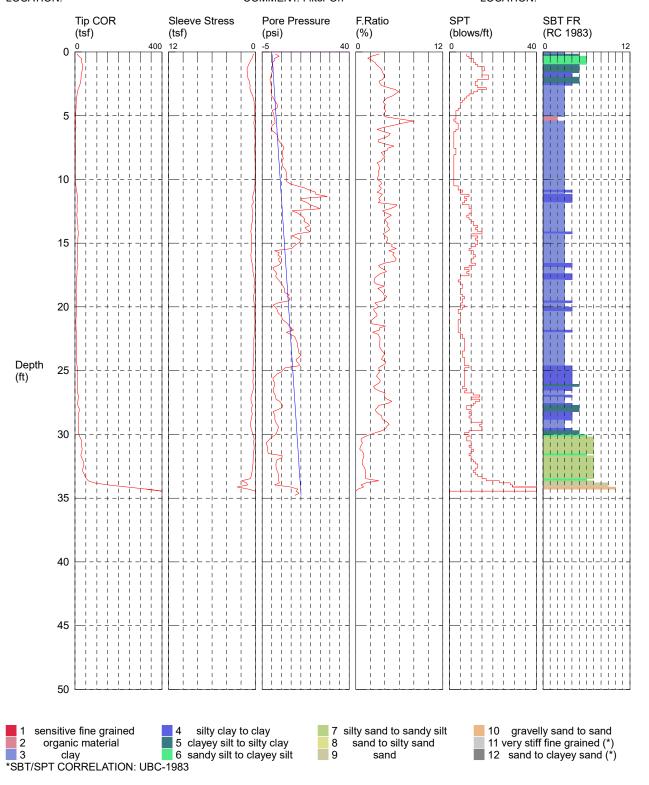
SOUNDING CUSTOMER: Taber Drilling OPERATOR: David CONE ID: DDG1570 LOCATION: JOB NUMBER: HOLE NUMBER: CPT-4 TEST DATE: 9/8/2023 11:28:49 AM COMMENT: Auto Enhance On COMMENT: Filter On COMMENT: GPS (LAT,LON,ALT): 0.00,0.00,0.0 LOCATION: LOCATION: LOCATION:

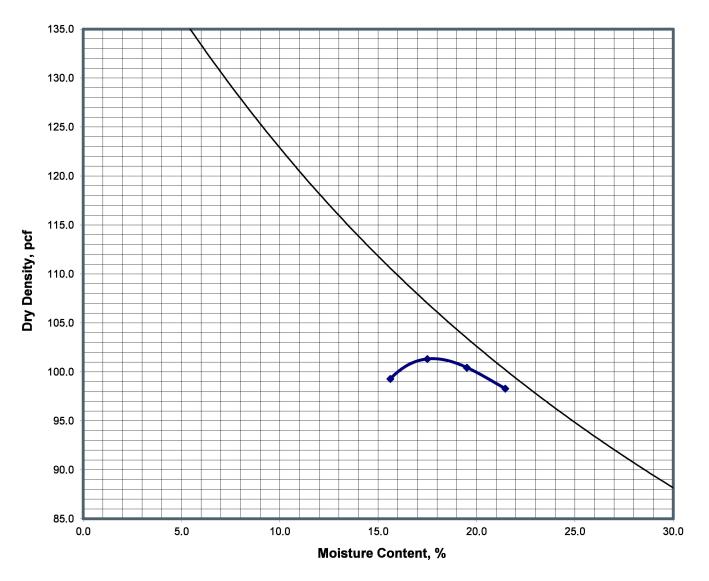
Laboratory Compaction Characteristics of Soil Using Modified Effort (56,000 If-Ibf/ft3), ASTM D1557, Method A

Zero Air Voids Curve at 100% Saturation;
Specific Gravity Estimated at: 2.45

Maximum Dry Density, pcf: 101.3 Optimum Moisture Content, %: 17.8

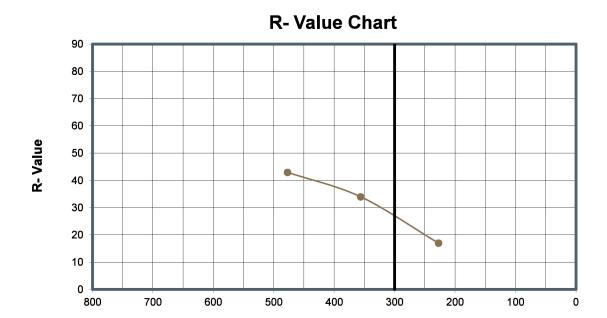
Resistance "R" Value of Soil and Soil-Aggregate Mixtures, CTM 301

Test Specimen No.:	1	2	3
Moisture Content at Test, %	19.5	21.7	22.8
Dry Density at Test, pcf	105.7	103.1	101.5
Expansion Pressure, psf	1173	450	398
Exudation Pressure, psi	477	356	227
Resistance "R" Value	43	34	17
"R" Value at 300 psi Exudation	27

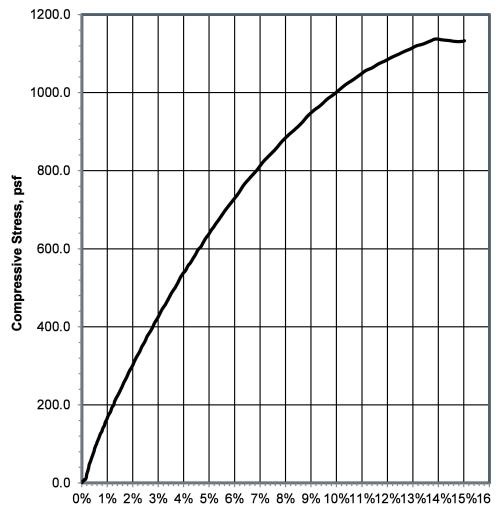
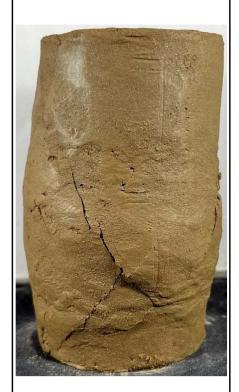
Unconfined Compressive Strength of Cohesive Soil, ASTM D2166

Image of Failed Specimen

ied sion s	Compression Strength	1137.5 psf
Unconfined compression Results	Shear Strength	568.75 psf
Un Con	Failure Strain, %	13.9 %

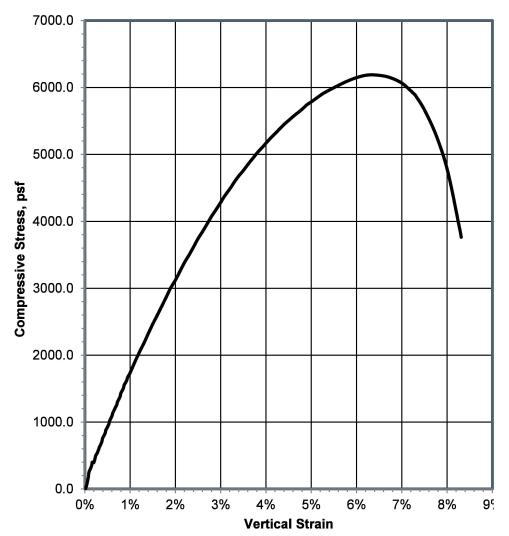
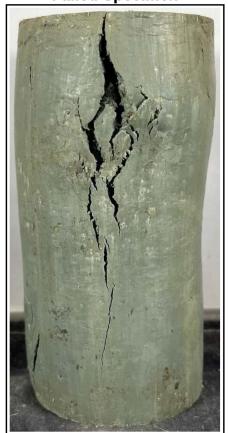
Unconfined Compressive Strength of Cohesive Soil, ASTM D2166

Image of Failed Specimen

Compression Strength	6185.5 psf
Shear Strength	3092.75 psf
Failure Strain, %	6.3 %

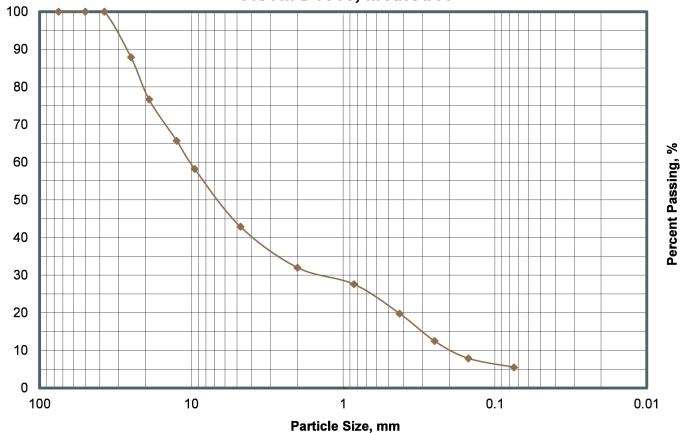
Particle-Size Distribution (Gradation) of Soils Using Sieve Analysis, ASTM D6913, Method A

U.S. Standard Sieve Size	Combined % Passing	U.S. Standard Sieve Size	Combined % Passing
3 Inch (75 mm)	100	No. 4 (4.75 mm)	43
2 Inch (50 mm)	100	No. 10 (2 mm)	32
1 1/2 Inch (37.5 mm)	100	No. 20 (850 μm)	28
1 Inch (25 mm)	88	No. 40 (425 μm)	20
3/4 Inch (19 mm)	77	No. 60 (250 µm)	12
1/2 Inch (12.5 mm)	66	No.100 (150 μm)	8
3/8 Inch (9.5 mm)	58	No. 200 (75 μm)	5.5

Material Description: Olive Gray Sandy GRAVEL

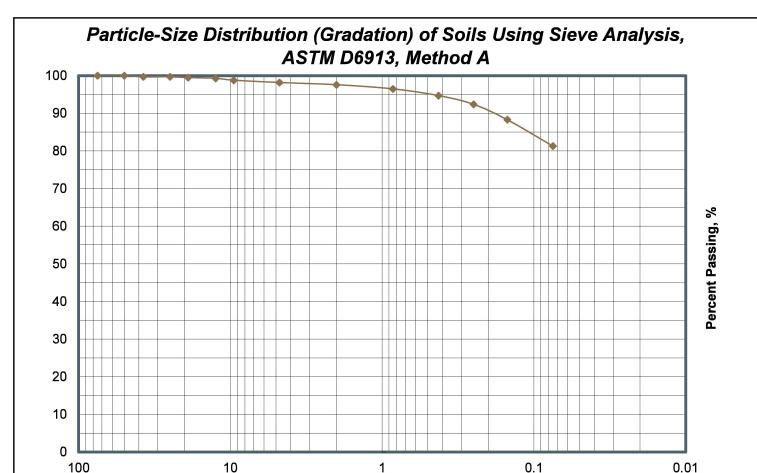
U.S. Standard Sieve Size	Combined % Passing	U.S. Standard Sieve Size	Combined % Passing
3 Inch (75 mm)	100	No. 4 (4.75 mm)	98
2 Inch (50 mm)	100	No. 10 (2 mm)	98
1 1/2 Inch (37.5 mm)	100	No. 20 (850 μm)	96
1 Inch (25 mm)	100	No. 40 (425 μm)	95
3/4 Inch (19 mm)	100	No. 60 (250 μm)	92
1/2 Inch (12.5 mm)	99	No.100 (150 μm)	88

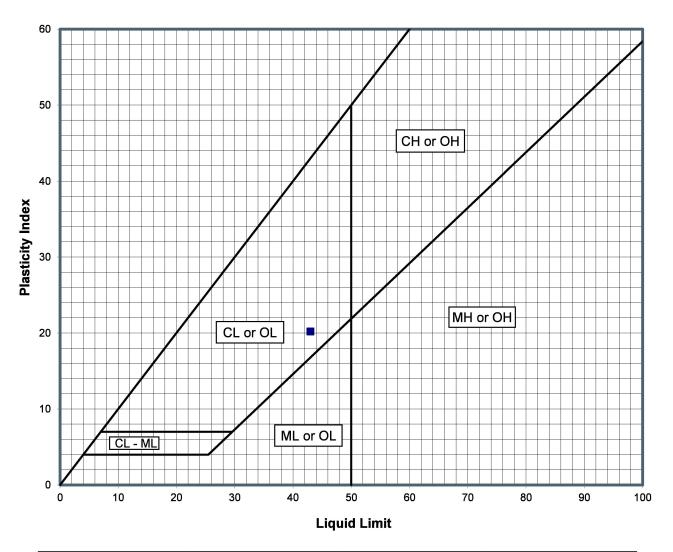
Liquid Limit, Plastic Limit, and Plasticity Index of Soils, ASTM D4318, Method A

Liquid Limit	Plastic Limit	Plasticity Index	Unified Soil Classification, ASTM D2487
43	23	20	CL

Material Description: Gray Lean CLAY with Sand

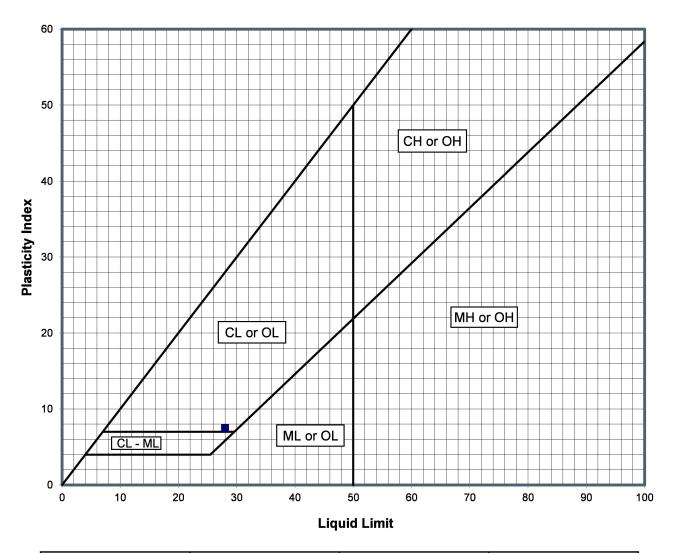
Liquid Limit, Plastic Limit, and Plasticity Index of Soils, ASTM D4318, Method A

Liquid Limit	Plastic Limit	Plasticity Index	Unified Soil Classification, ASTM D2487
28	21	8	CL

Material Description: Brown Lean CLAY with Sand

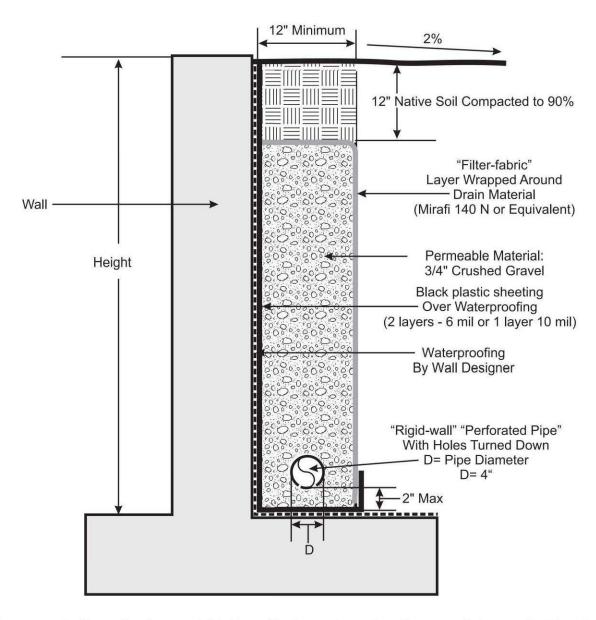
(Typical Cross Section)

- 1. Slope footing and "rigid-wall" pipes along flow line parallel to wall at least 1% gradient to drain to an appropriate outfall area away from residence.
- 2. Use "sweeps" for directional changes in pipe flow (do not use 90°elbows).
- 3. Provide periodic "clean-outs".
- 4. Washed clean permeable material.
