Aquatic Resource Delineation Report for the  
Riverford Road Roundabouts Project  
San Diego County, California

RECON Number 9009-30A  
December 15, 2023

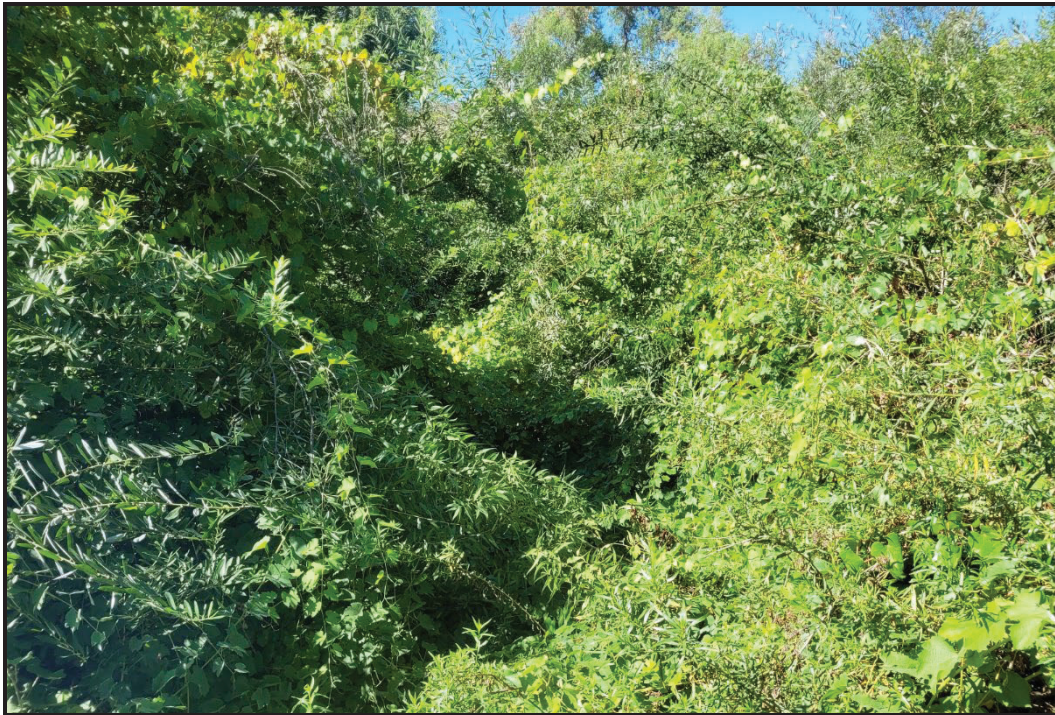
PHOTOGRAPH 1

View of Southern Cottonwood-willow Riparian Forest in the Northern Portion of the Review Area along the San Diego River, Facing North

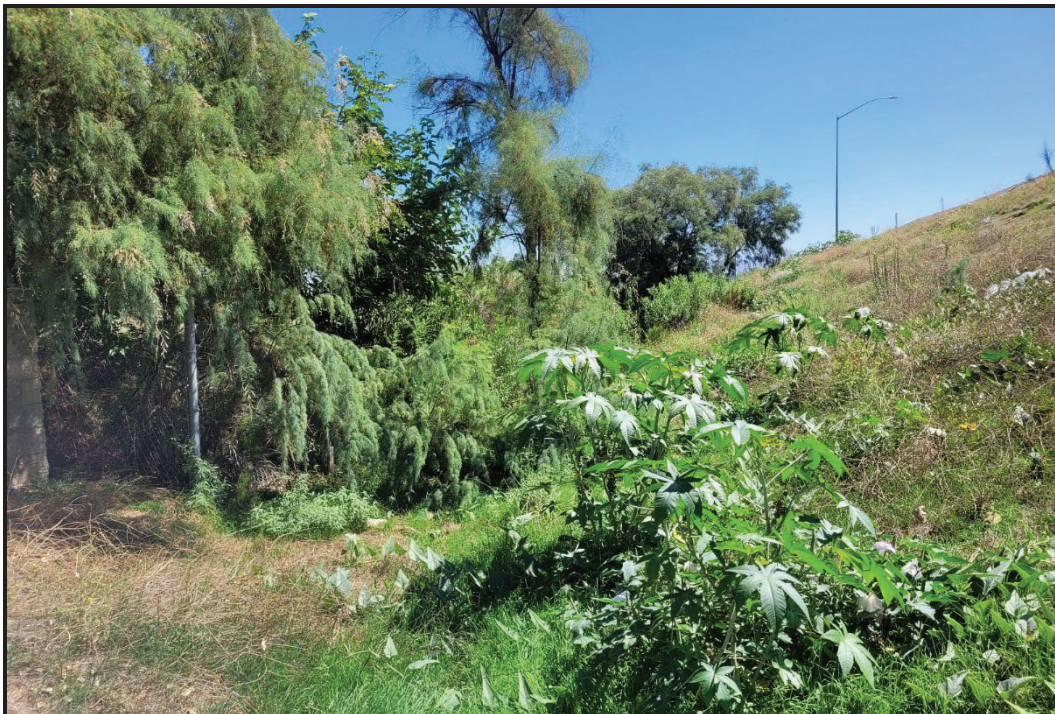
PHOTOGRAPH 2

View of Patch of Disturbed Southern Cottonwood-willow Riparian Forest in the Northeastern Portion of the Review Area, Facing East

Disturbed southern cottonwood-willow riparian forest habitat occurs in the north and northeast portions of the Review Area (Photograph 2). This vegetation community is dominated by Fremont cottonwood and mule fat, but contains non-native saltcedar (*Tamarix ramosissima*), with an understory dominated by non-native grasses.

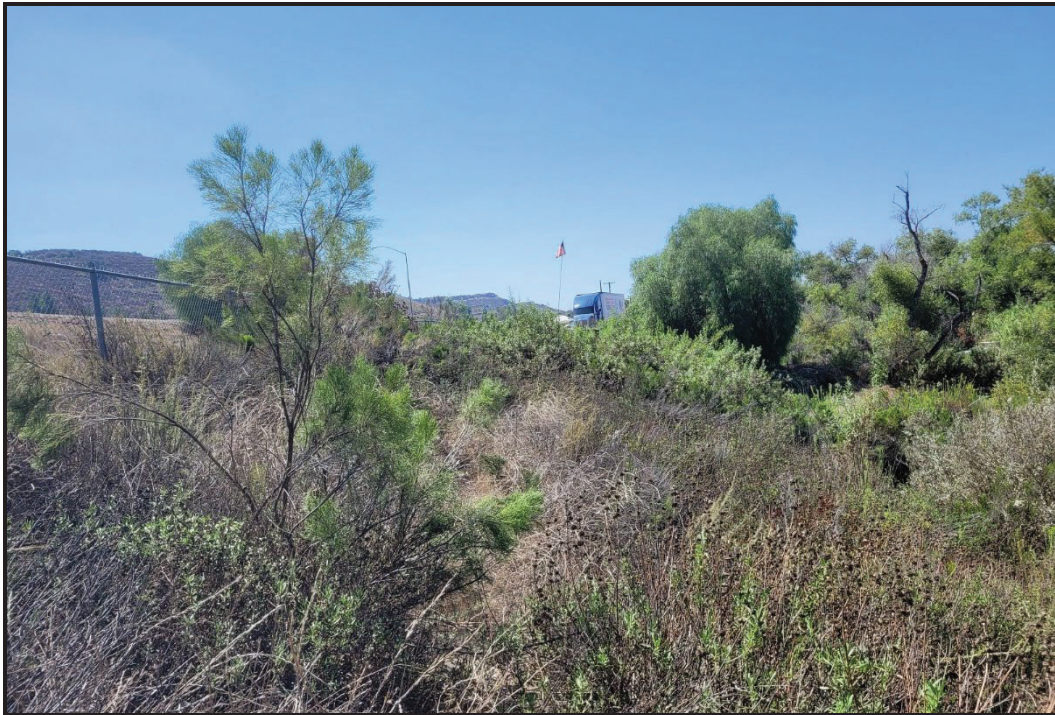
PHOTOGRAPH 3

View of Diegan Coastal Sage Scrub in the Western Portion of the Review Area on Sloped banks of the San Diego River, Facing West

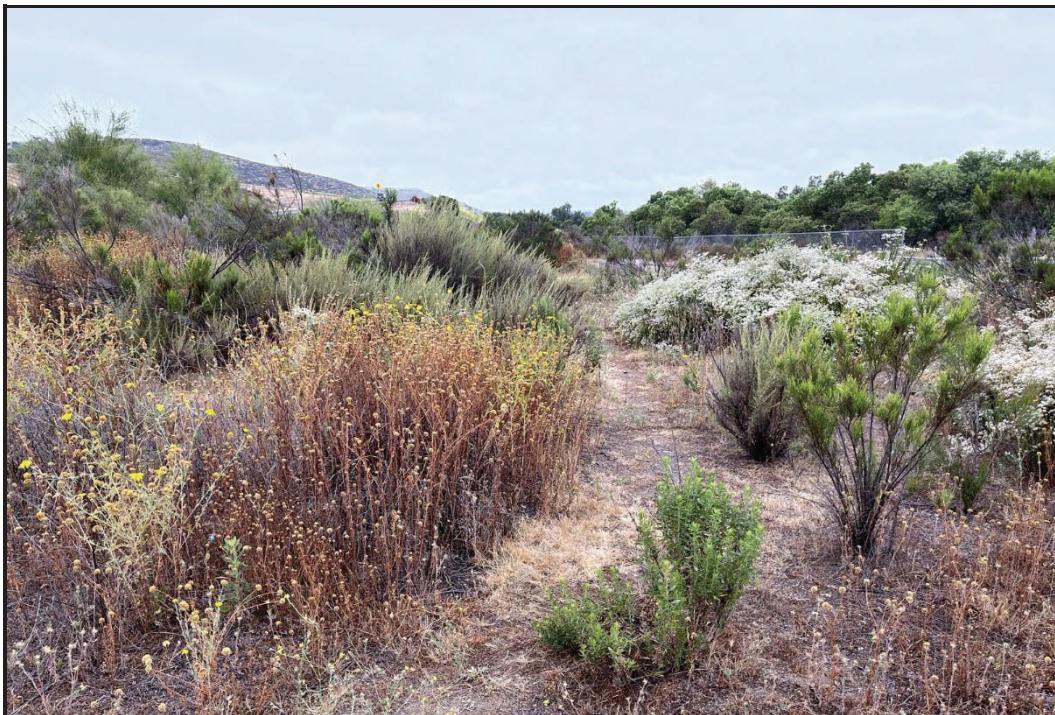
PHOTOGRAPH 4

View of Disturbed Diegan Coastal Sage Scrub in the North-central Portion of the Review Area, Facing Northwest

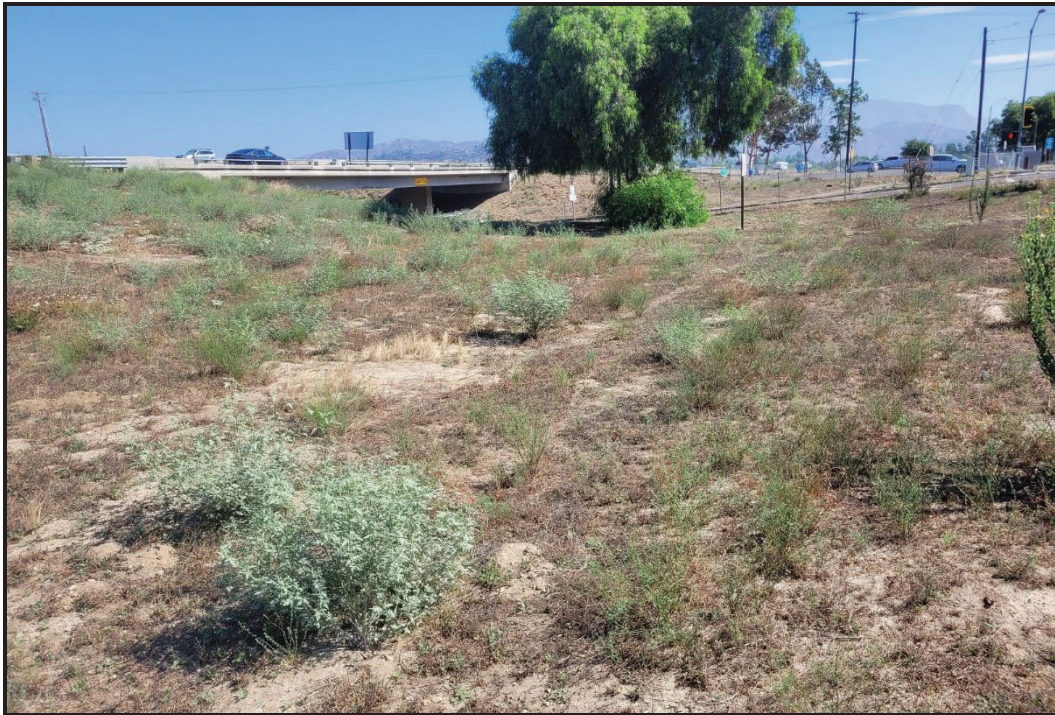
PHOTOGRAPH 5

View of Disturbed Habitat in the South-central Portion of the Review Area,  
Facing East

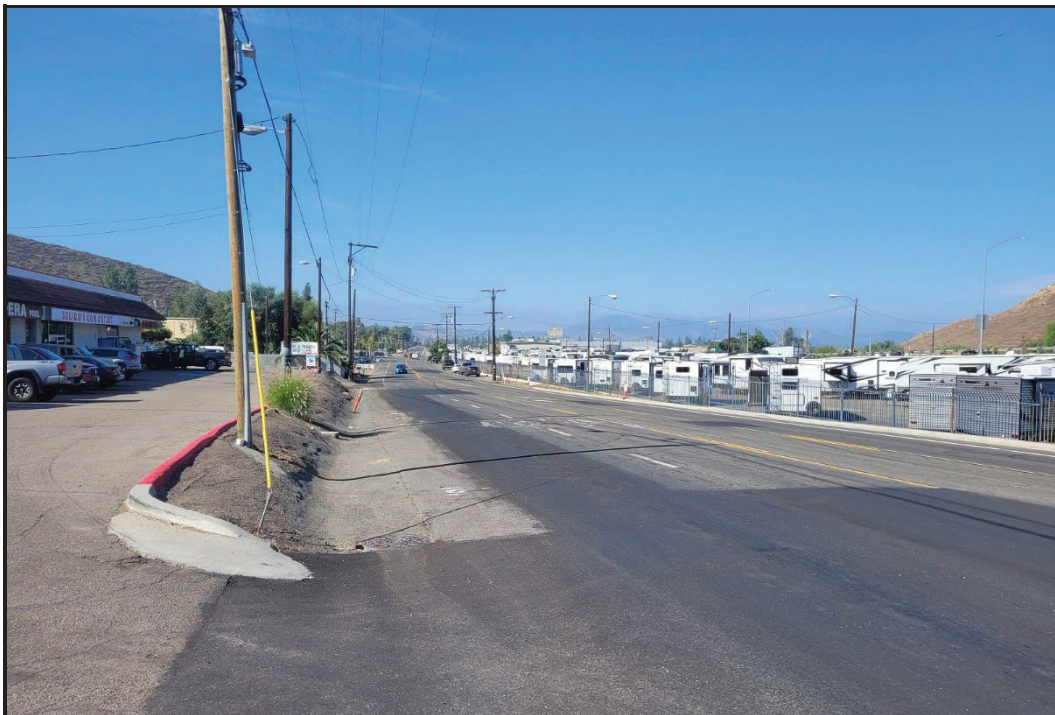
PHOTOGRAPH 6

View of Urban/Developed Land in the Southwestern Portion of the  
Review Area, Facing Southwest

Urban/developed consists of areas that have been constructed upon or otherwise physically altered to an extent that native vegetation is no longer supported (Oberbauer et al. 2008). Urban/developed occurs as the dominant land cover type within the Review Area (Photograph 6). Urban/developed includes paved roads and highways, such as SR-67, Riverford Road, Woodside Avenue, North Woodside Avenue, and Woodside Terrace, as well as residences, commercial developments, and associated ornamental vegetation (Figure 6 and Photograph 6).

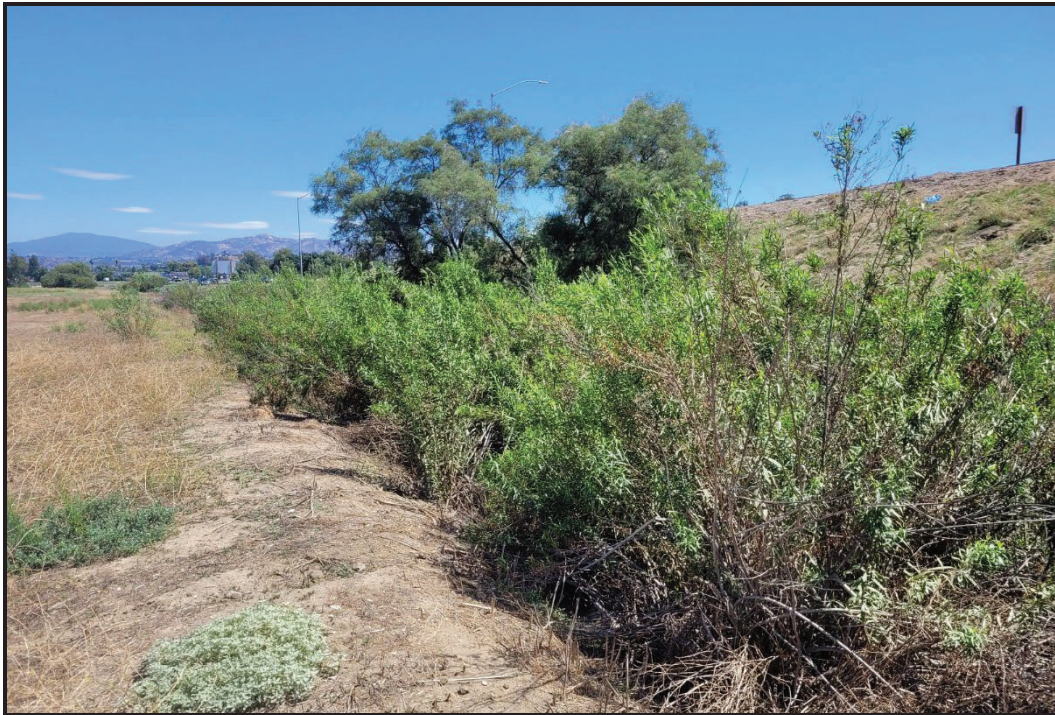
PHOTOGRAPH 7

View of Patch of Disturbed Southern Cottonwood-willow Riparian Forest in the  
Northeastern Portion of the Review Area, Facing East

Within the northwestern portion of the Review Area, the floodplain of the San Diego River contains undulating topography that has resulted in a floodplain swale that was found to support standing water at the time of the survey. This long and narrow swale feature supports southern cottonwood-willow riparian forest like the surrounding areas that are slightly elevated above this swale. A small patch of the disturbed form of this habitat occurs approximately 120 feet south of the river, on the other side of an elevated and graded berm. This disturbed form supports one large Fremont cottonwood (FAC), scattered saltcedar (FAC), and a shrub layer dominated by mule fat (FAC; Photograph 7).

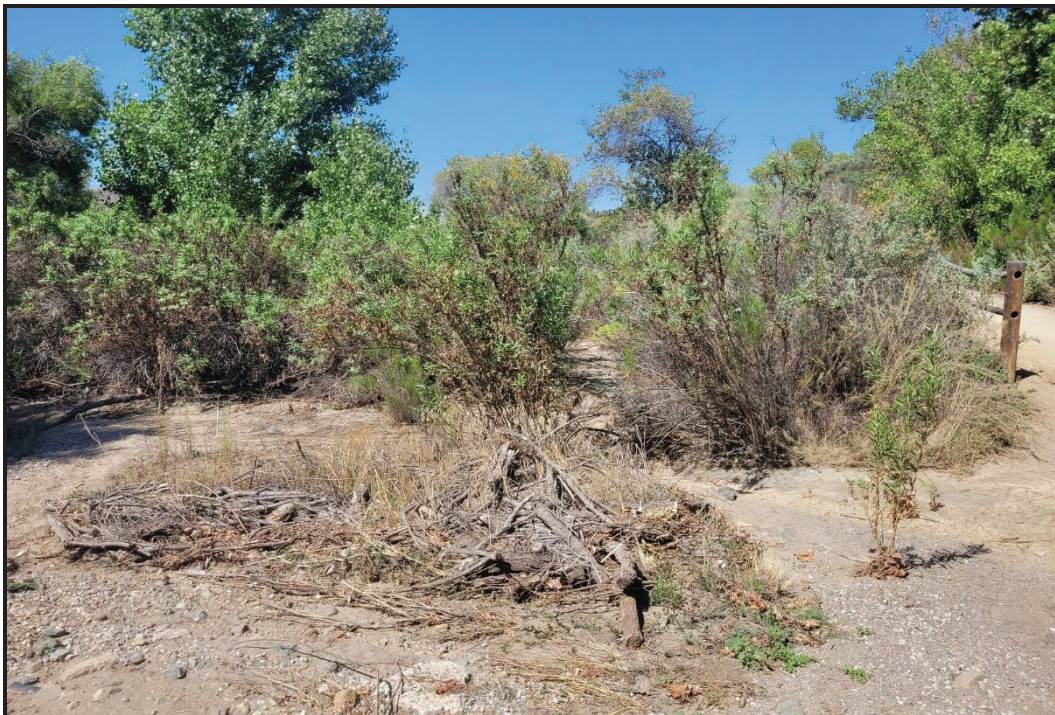
PHOTOGRAPH 8

View of Wracking and Change in Sediment Texture OHWM Indicators within  
Northern Portion of the Review Area in the San Diego River Active Floodplain,  
Facing West

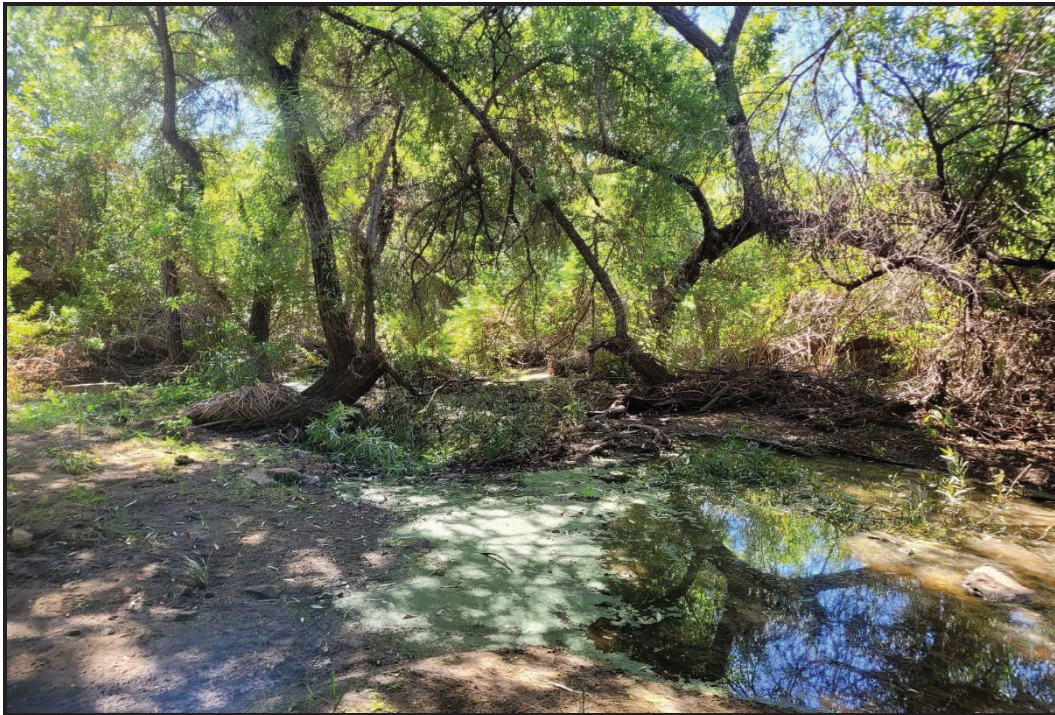
PHOTOGRAPH 9

View of Surface Water within Low-flow Channel of San Diego River in Northern Portion of the Review Area, Facing West

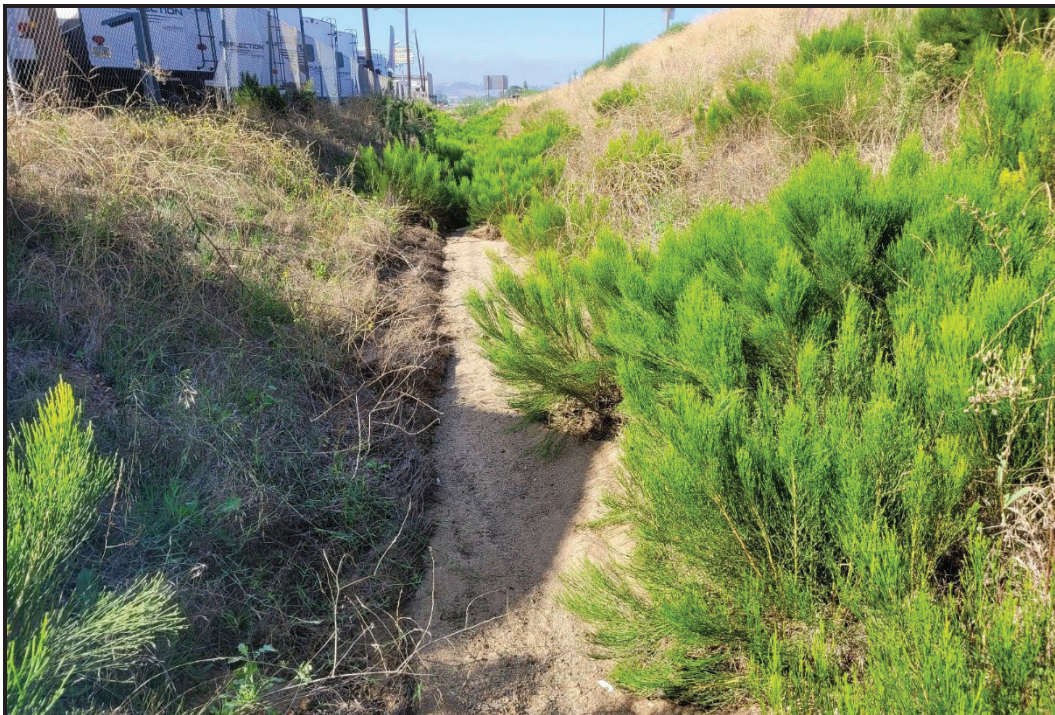
PHOTOGRAPH 10

View of Break in Slope, Change in Sediment Texture, and Wracking OHWM Indicators in Small Channel in Southwestern Portion of the Review Area, Facing Southwest

The lateral extent of the ordinary high water mark (OHWM) was delineated along the on-site drainages, including the San Diego River and a small channel in the southwestern portion of the Review Area, using the observed hydrology indicators in accordance with *A Field Guide to the Identification of the Ordinary High Water Mark (OHWM) in the Arid West Region of the Western United States* (Lichvar and McColley 2008). The OHWM sample locations are depicted on Figure 5 and the OHWM data forms are included as Attachment 6. Indicators observed and used to determine the extent of the OHWM include change in average sediment texture, change in vegetation species and cover, a break in bank slope, and ancillary indicators, such as wracking and water staining (Photograph 8). The distribution and abundance of observed indicators varied between those within the San Diego River active floodplain and those along the small channel in the southwestern portion of the Review Area. The river supports a diverse suite of OHWM indicators that were abundant and consistent throughout the active floodplain (see Attachment 6: OHWM sheet #2). The river contained flowing water within the observed low-flow channel at the time of the survey (Photograph 9). While the small channel contained fewer indicators, those observed were consistent throughout, including a break in slope, change in sediment texture, and wracking, resulting in a consistently observed OHWM (Photograph 10; see Attachment 6: OHWM sheet #1).

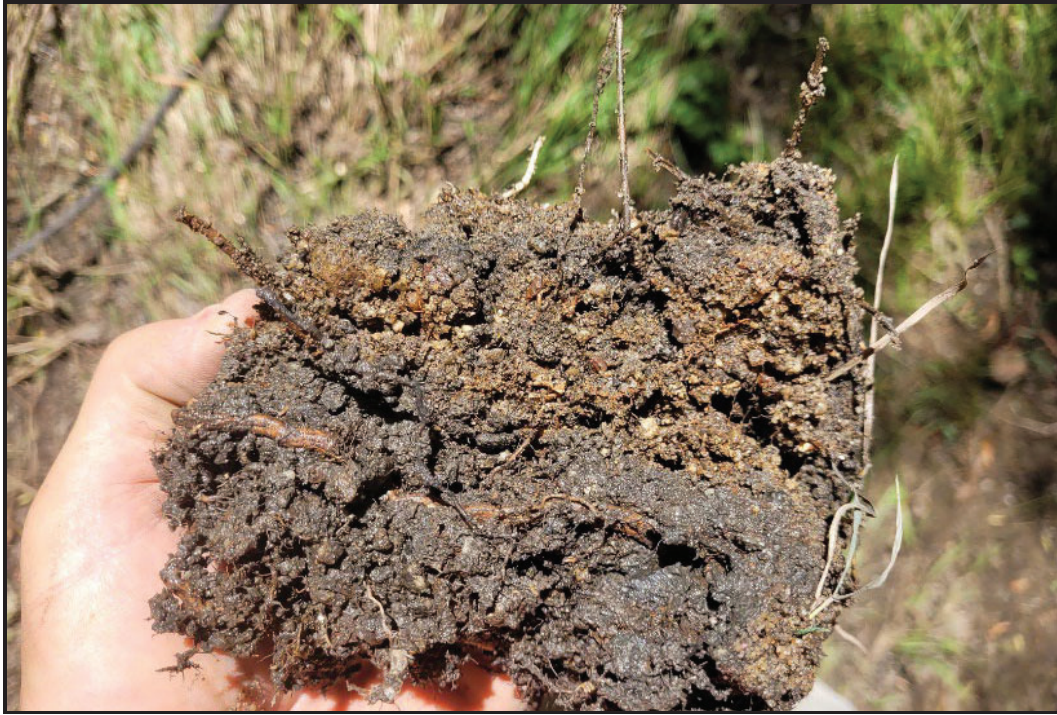
PHOTOGRAPH 11  
Downward-facing View of Sandy Redox Hydric Soil at  
Wetland Sample Point 4

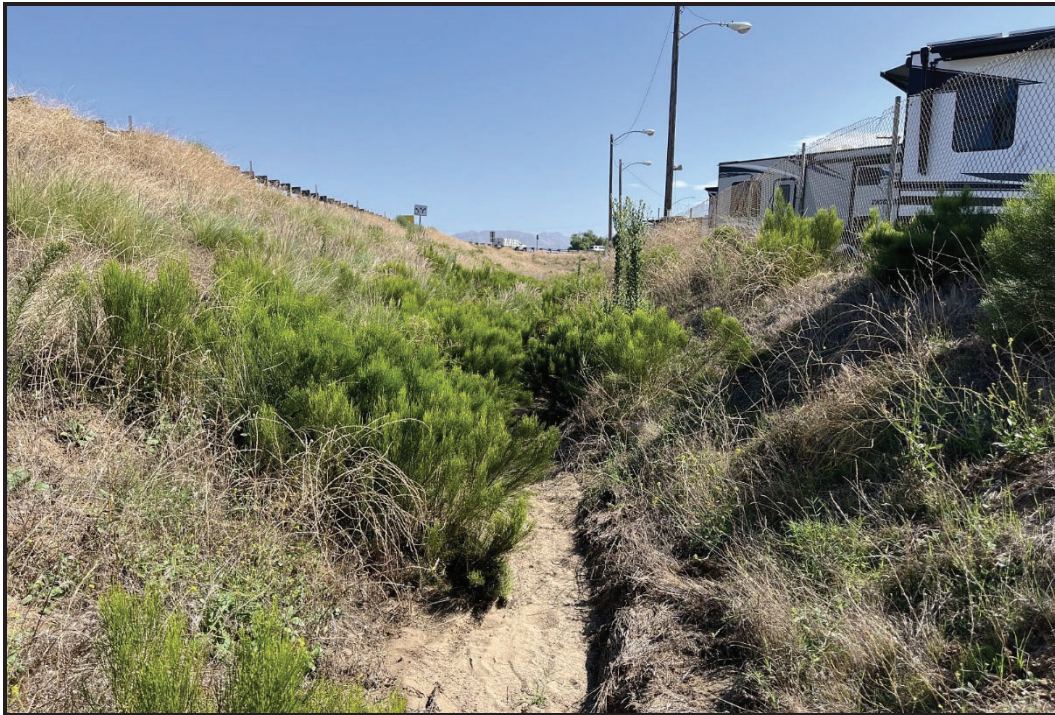
PHOTOGRAPH 1

Upstream View of Break in Slope, Change in Sediment Texture, and Wracking OHWM Indicators in Small Channel in Southwestern Portion of the Review Area, Facing Northeast

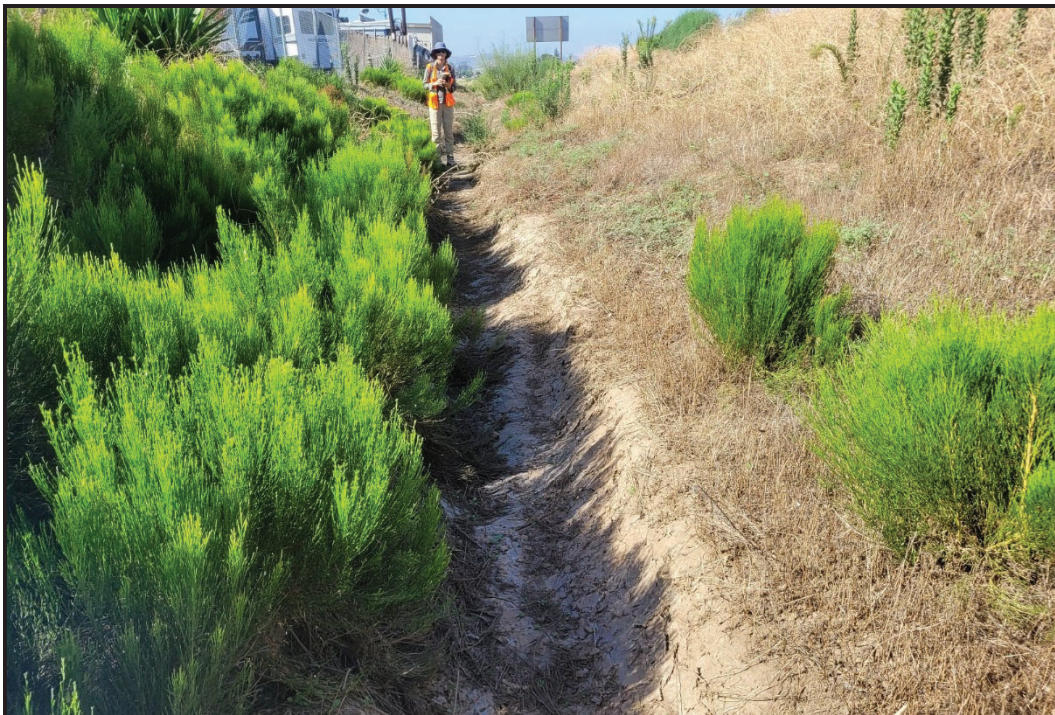
PHOTOGRAPH 2

Downstream View of Break in Slope, Change in Sediment Texture, and Mudcracks OHWM Indicators in Small Channel in Southwestern Portion of the Review Area, Facing Southwest

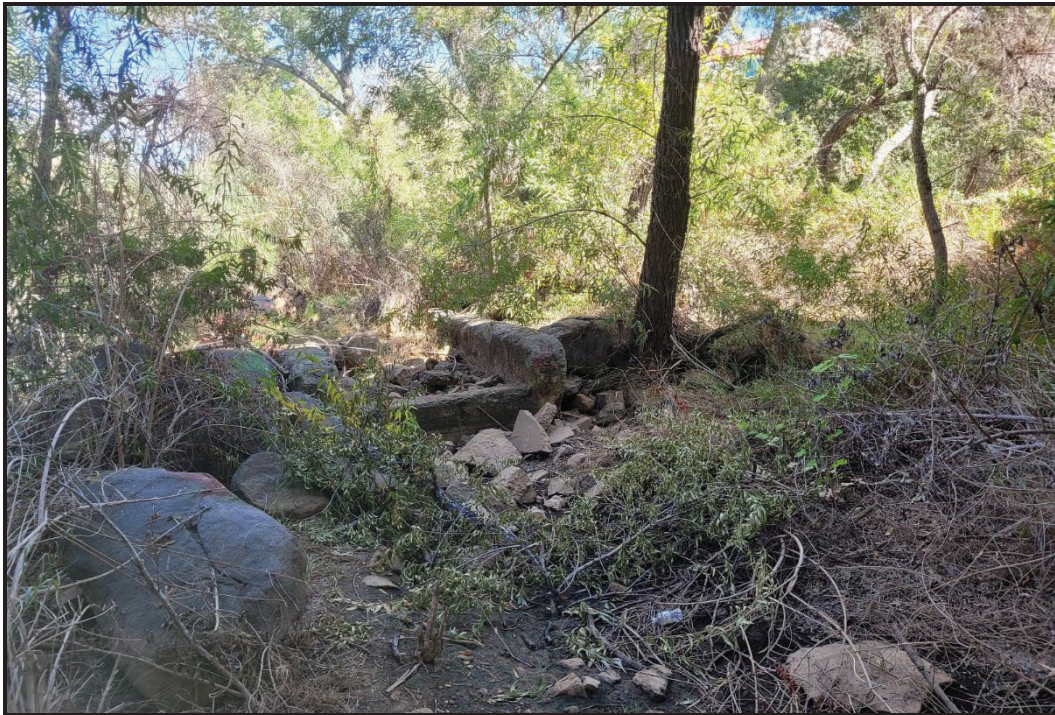
PHOTOGRAPH 1

Upstream View of Vegetated Channel Bar and Ancillary Indicators within  
San Diego River, Facing East

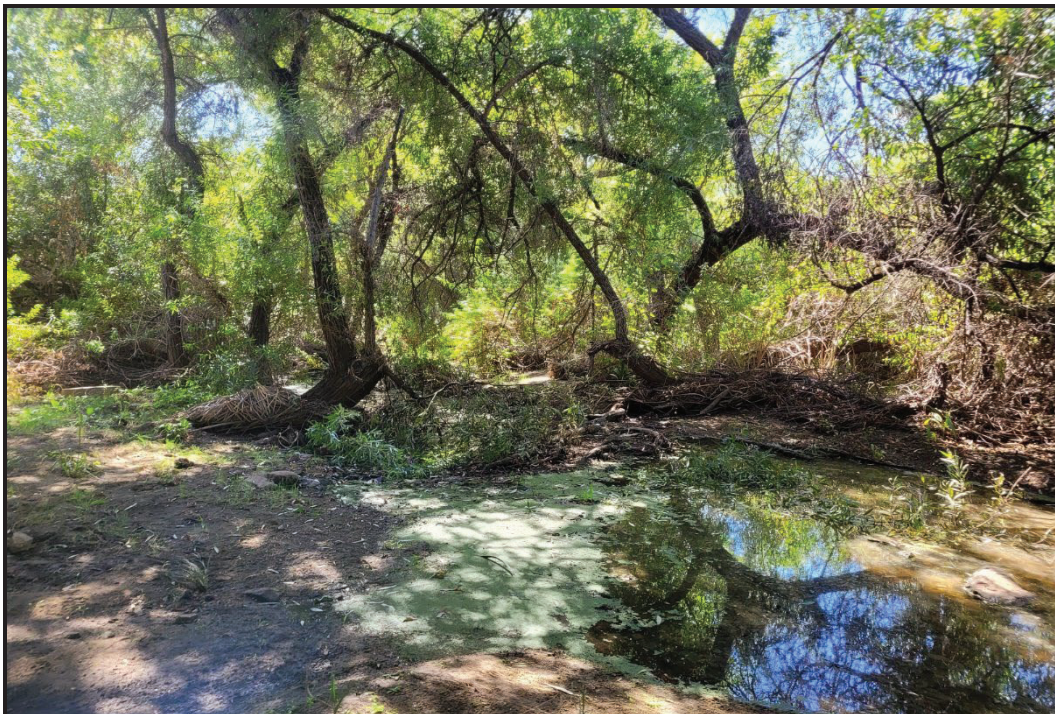
PHOTOGRAPH 2

Downstream View of Surface Water within Low-flow Channel of  
San Diego River, Facing West

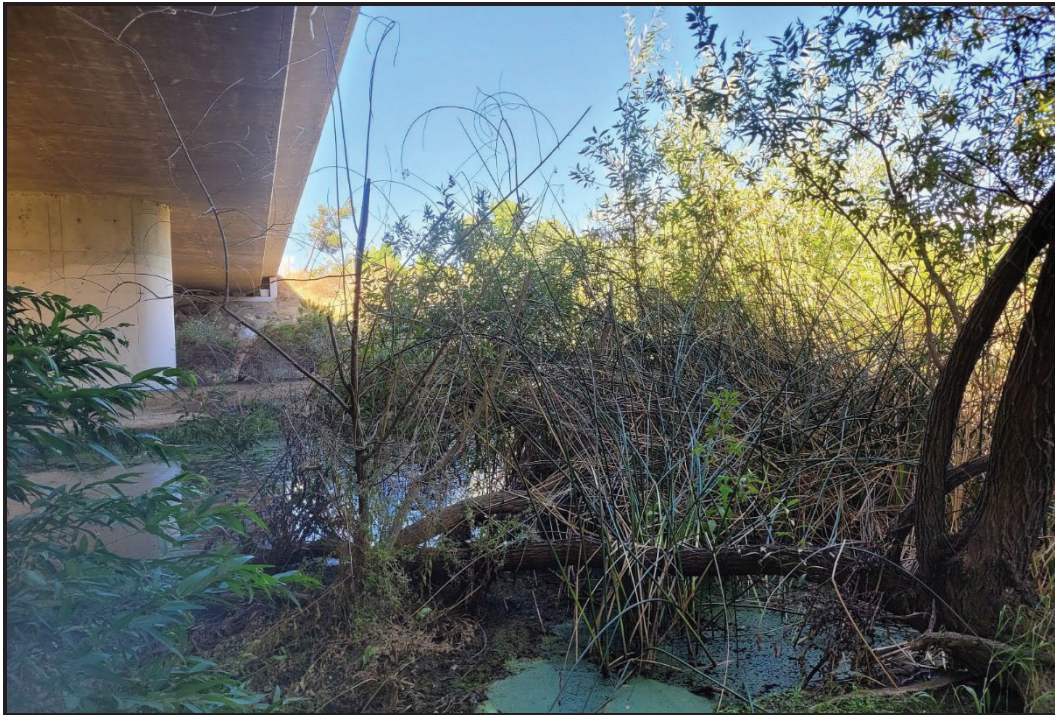
PHOTOGRAPH 3

North-facing View across San Diego River Floodplain with Wetland Vegetation and Wracking

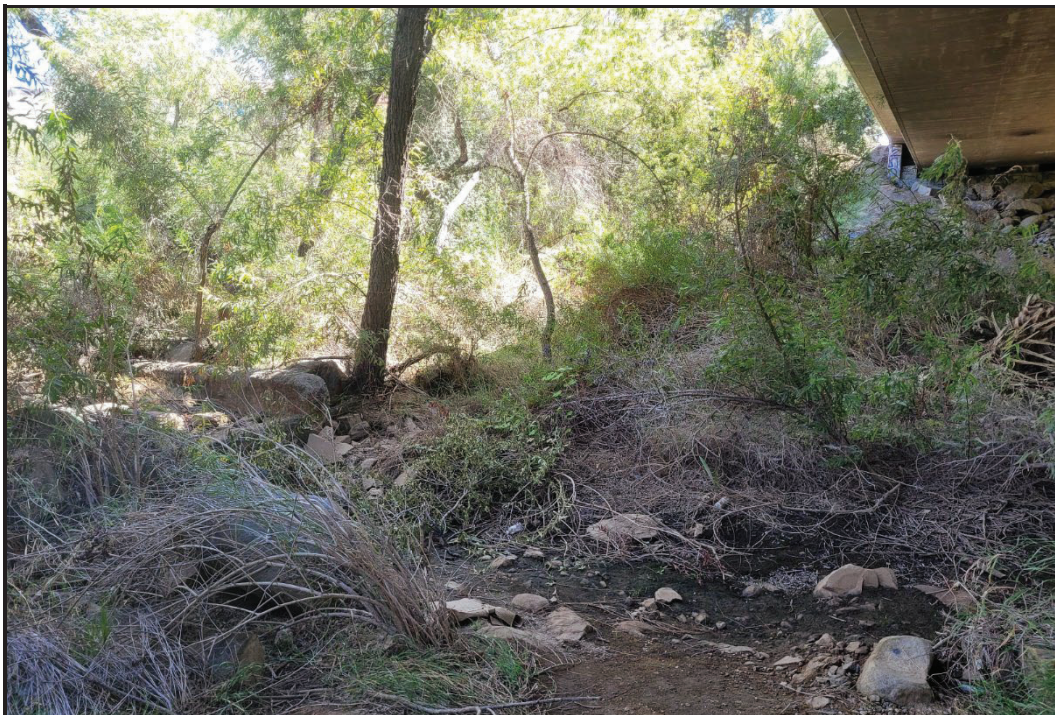
PHOTOGRAPH 4

South-facing View of Southern Bank of San Diego River with Break in Slope, Change in Sediment, Wracking, and Leaf Litter Washed Away
