Phase I Environmental Site Assessment

Phase 1 Environmental Site Assessment Two Undeveloped 40 Acre Parcels of Land North Side of Twenty Mule Team Road Barstow, California

Two Undeveloped 40 Acre Parcels of Land North Side of Twenty Mule Team Road Barstow, California

Project 22-5572

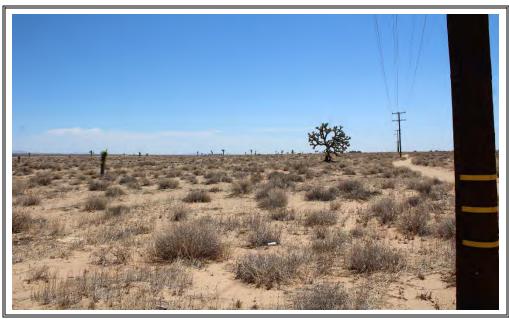
1. View of the Southwestern Portion of the Subject Property Looking Northeast Showing the Power Lines

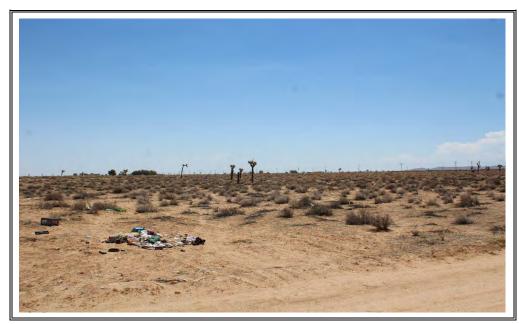
The Subject Property consists of two undeveloped 40 acre parcels of land. On the day of the inspection, no use or storage of hazardous materials were observed, as can be seen in Photographs 1 - 12 in Appendix C. Scattered debris was observed along the northern side of the Subject Property, some of which can be seen in Photograph 6. No containers were observed among the debris.

6. View of the North-Central Portion of the Subject Property Looking Southeast Showing Scattered Debris

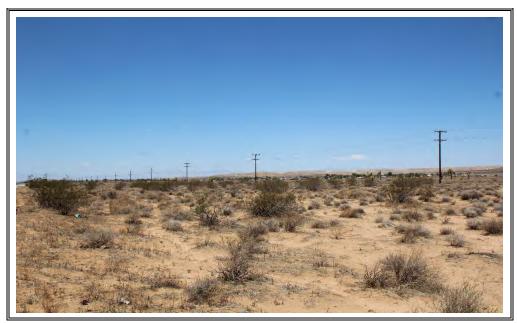
9. View of the Southeastern Portion of the Subject Property Looking Northwest Showing the Area of Interconnection to the Power Grid

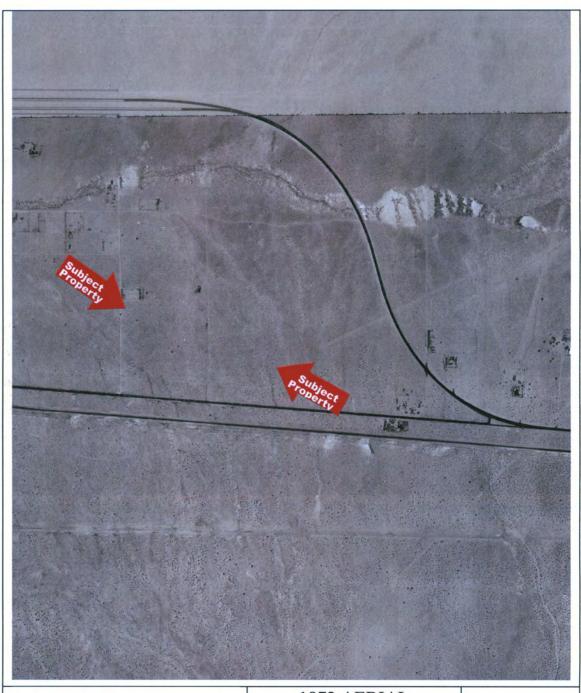
Hayden Environmental	1972 AERIAL PHOTOGRAPH Subject Property: Sunrise Road Solar Project on Twenty Mule Team Road; Barstow, California	↑ NORTH
JOB NUMBER:	Date:	FIGURE:
22-5572	7/22/22	C-2

- An aerial photograph taken in 1972 showed the Subject Property and adjoining property to the east to be undeveloped, with no evidence of activity observed. What appeared to be stables were shown in the western portion of the adjoining area to the north, with the majority of the area to the north shown to be undeveloped. The adjoining area to the south of the Subject Property, across Twenty Mule Team Road, was undeveloped with railroad tracks shown further to the south. The adjoining area to the west, across an unpaved road, was shown to be undeveloped. Route 58 was shown to the northeast. What appeared to be landing strips were shown to the east. Small structures, likely residences, were shown to the east, southeast, north and northwest. An unnamed creek was shown to the north. A copy of this aerial photograph can be seen as Figure C-2 in Appendix C.

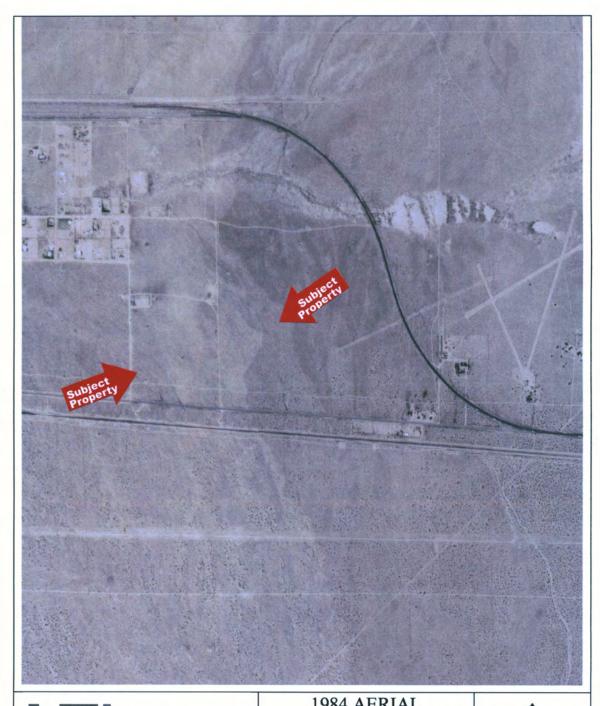
Hayden Environmental	PHOTOGRAPH Subject Property: Sunrise Road Solar Project on Twenty Mule Team Road; Barstow, California	↑ NORTH
JOB NUMBER:	Date:	FIGURE:
22-5572	7/22/22	C-3

- An aerial photograph taken in 1984 showed the Subject Property to be undeveloped, with unpaved roads observed in the southern and central areas. What appeared to be stables were shown in the western portion of the adjoining area to the north, with the majority of the area to the north shown to be undeveloped. The adjoining property to the east was shown to be undeveloped, with no evidence of activity observed. The adjoining area to the south of the Subject Property, across Twenty Mule Team Road, was undeveloped with railroad tracks shown further to the south. The adjoining area to the west, across an unpaved road, was shown to be undeveloped. Route 58 was shown to the northeast. What appeared to be landing strips were shown to the east. Small structures, likely residences, were shown to the east, southeast, north and northwest. An unnamed creek was shown to the north. A copy of this aerial photograph can be seen as Figure C-3 in Appendix C.

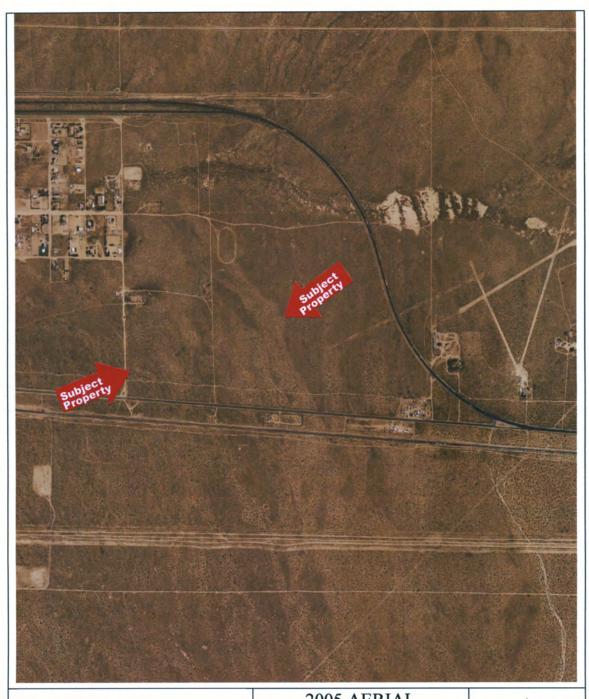
Hayden Environmental	2005 AERIAL PHOTOGRAPH Subject Property: Sunrise Road Solar Project on Twenty Mule Team Road; Barstow, California	↑ NORTH
JOB NUMBER:	Date:	FIGURE:
22-5572	7/22/22	C-5

- An aerial photograph taken in 2005 showed the Subject Property to be undeveloped, with unpaved roads observed in the southern and central areas. What appeared to have been stables were shown in the western portion of the adjoining area to the north, with the majority of the area to the north shown to be undeveloped. The adjoining property to the east was shown to be undeveloped, with no evidence of activity observed. A small structure was shown in the eastern portion of the adjoining area to the south of the Subject Property, across Twenty Mule Team Road, with the balance of the adjoining area to the south shown to be undeveloped. Railroad tracks were shown further to the south. The adjoining area to the west, across an unpaved road, was shown to be undeveloped. Route 58 was shown to the northeast. An oval was shown to the north and what appeared to be landing strips were shown to the east. Small structures, likely residences, were shown to the east, southeast, north and northwest. An unnamed creek was shown to the north. A copy of this aerial photograph can be seen as Figure C-5 in Appendix C.
