**PHASE 1
ENVIRONMENTAL SITE
ASSESSMENT**

**Undeveloped 80 Acre Parcel of Land
East Side of Lear Avenue
Twentynine Palms, California**

February 2022

Project 22-717

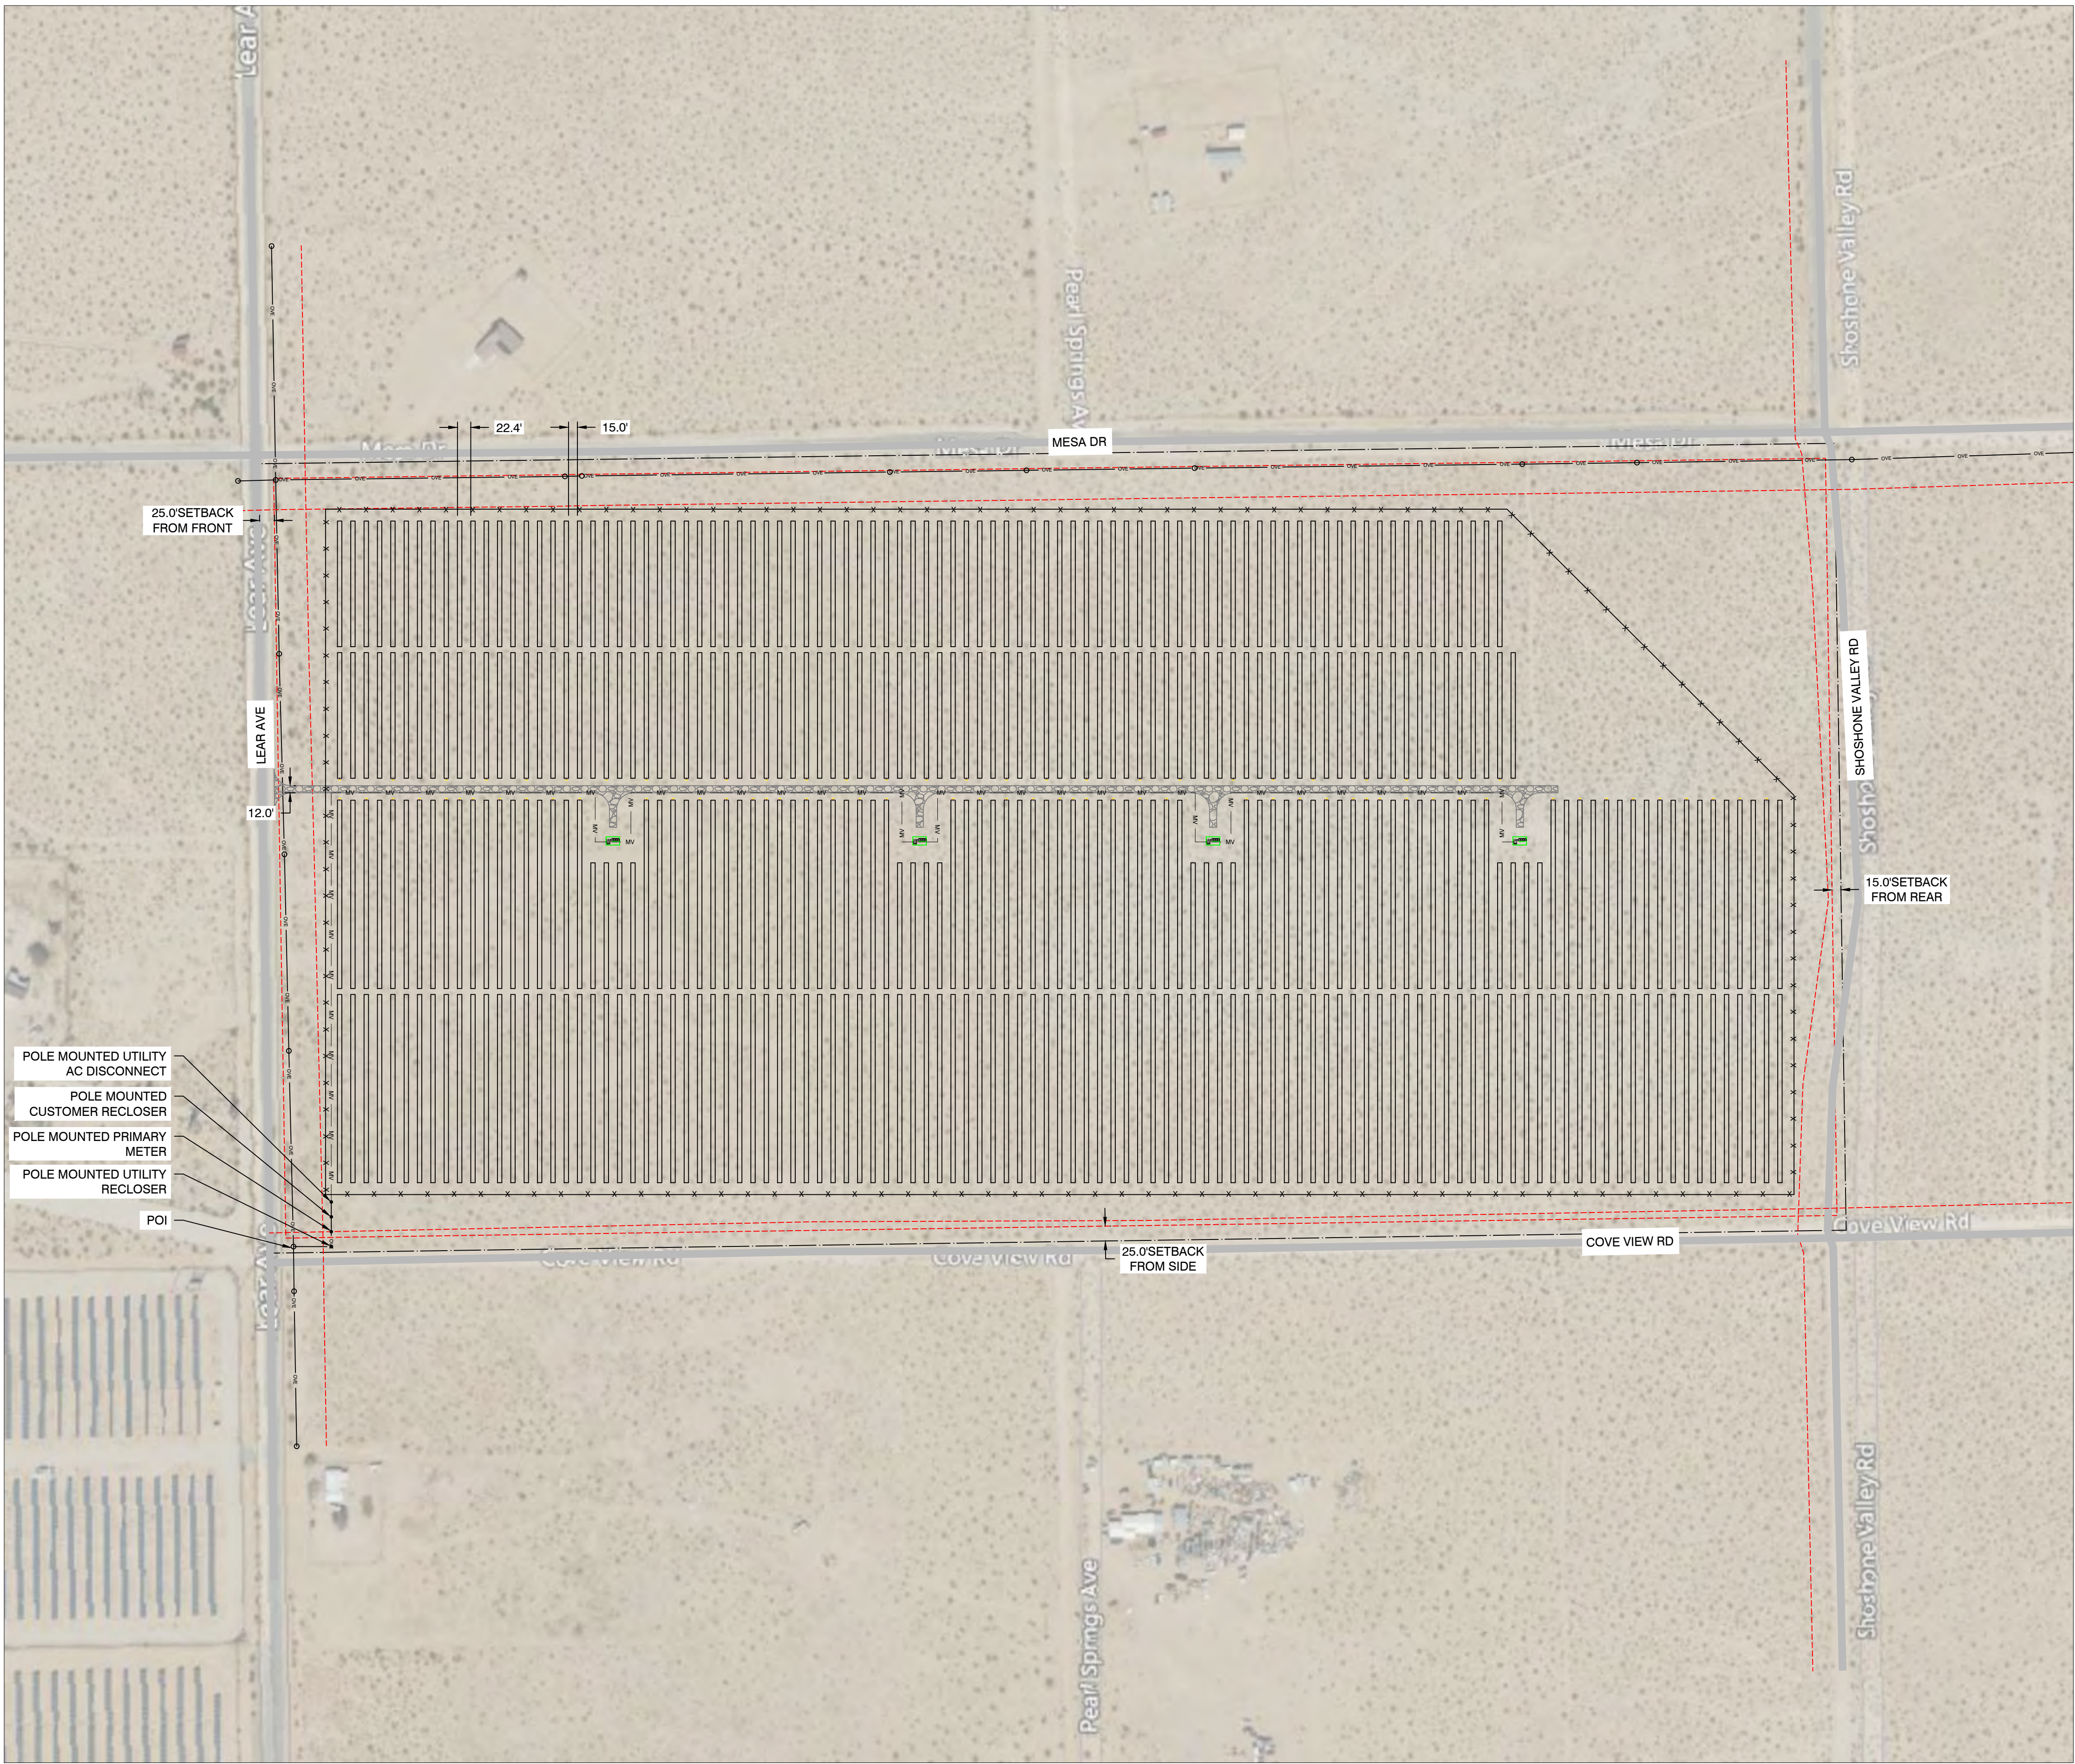
PV-100

1 ARRAY LOCATION
SCALE: 1"=150'

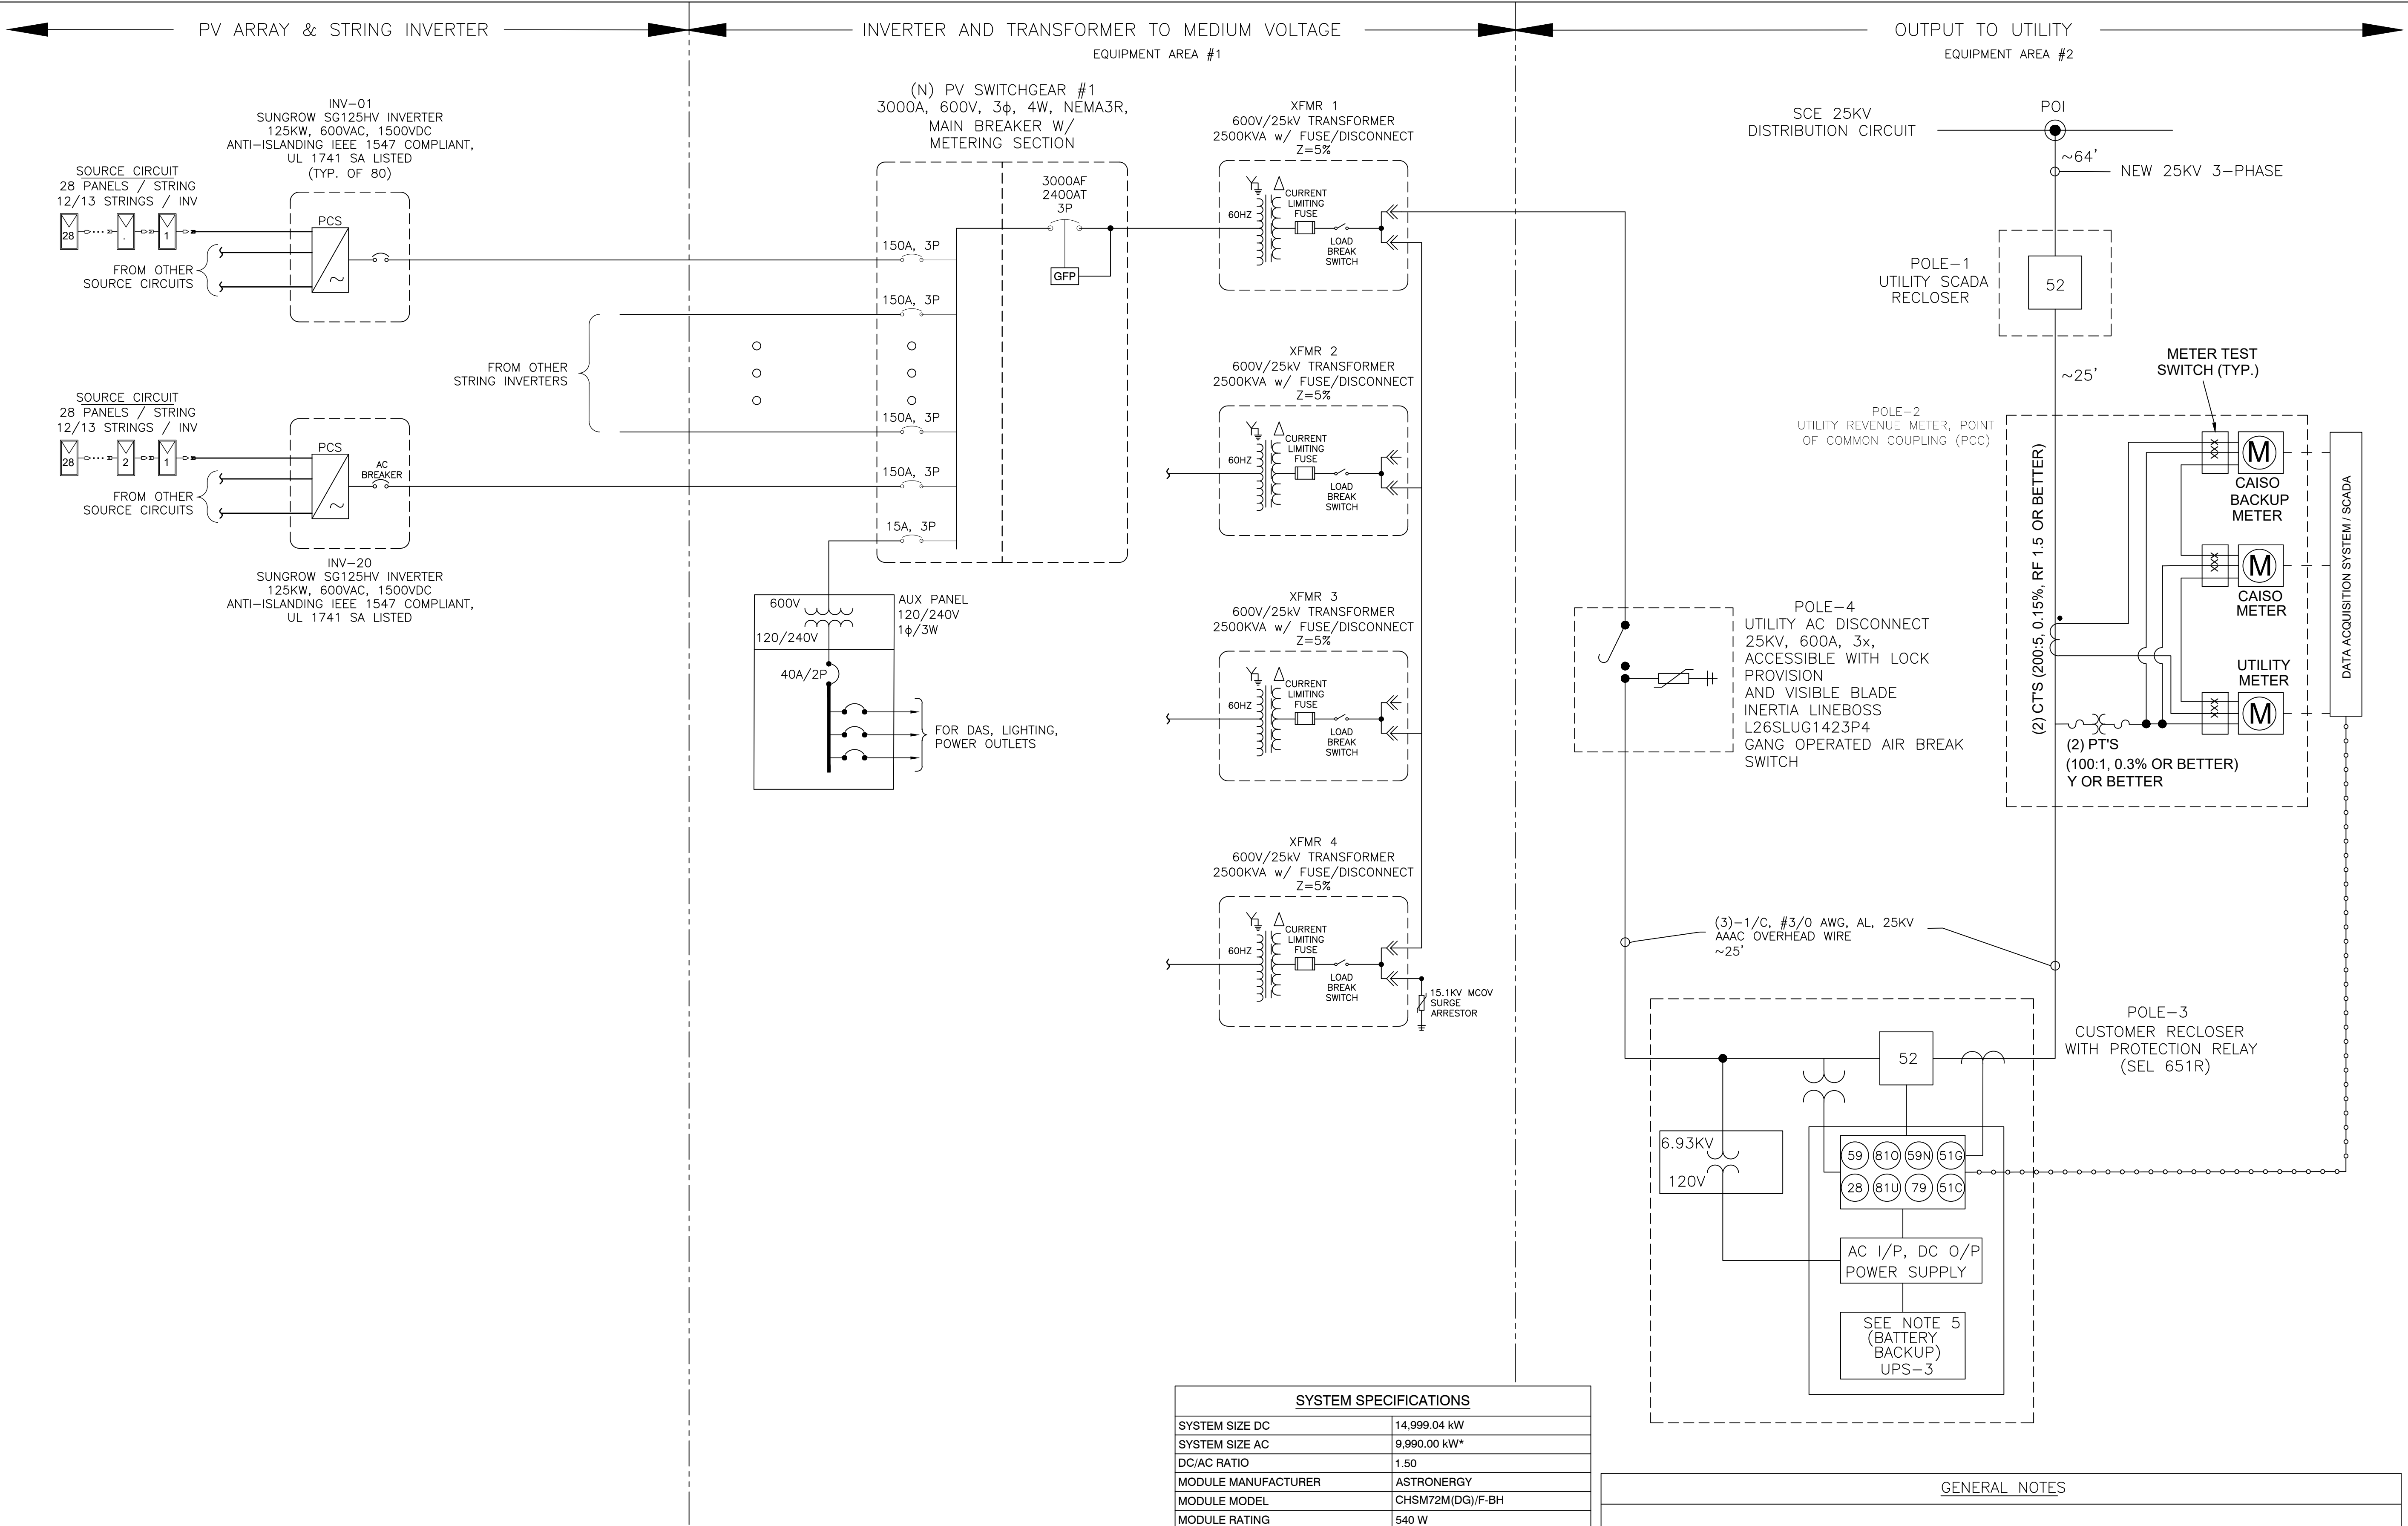
1 SINGLE LINE DIAGRAM

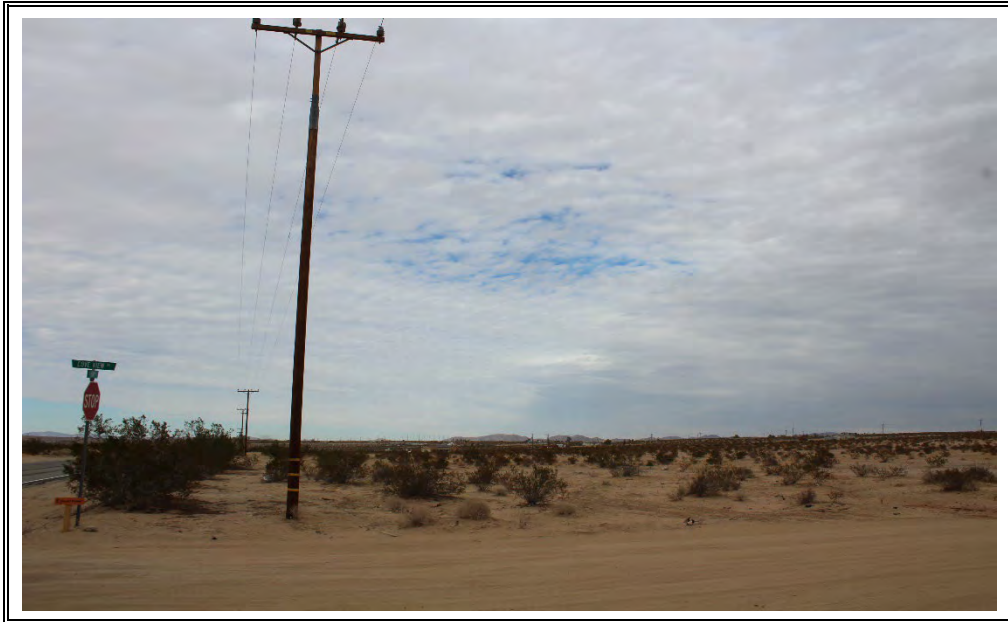
1. View of the Western Portion of the Subject Property Looking North Showing the Point of Interconnection to the Electrical Grid

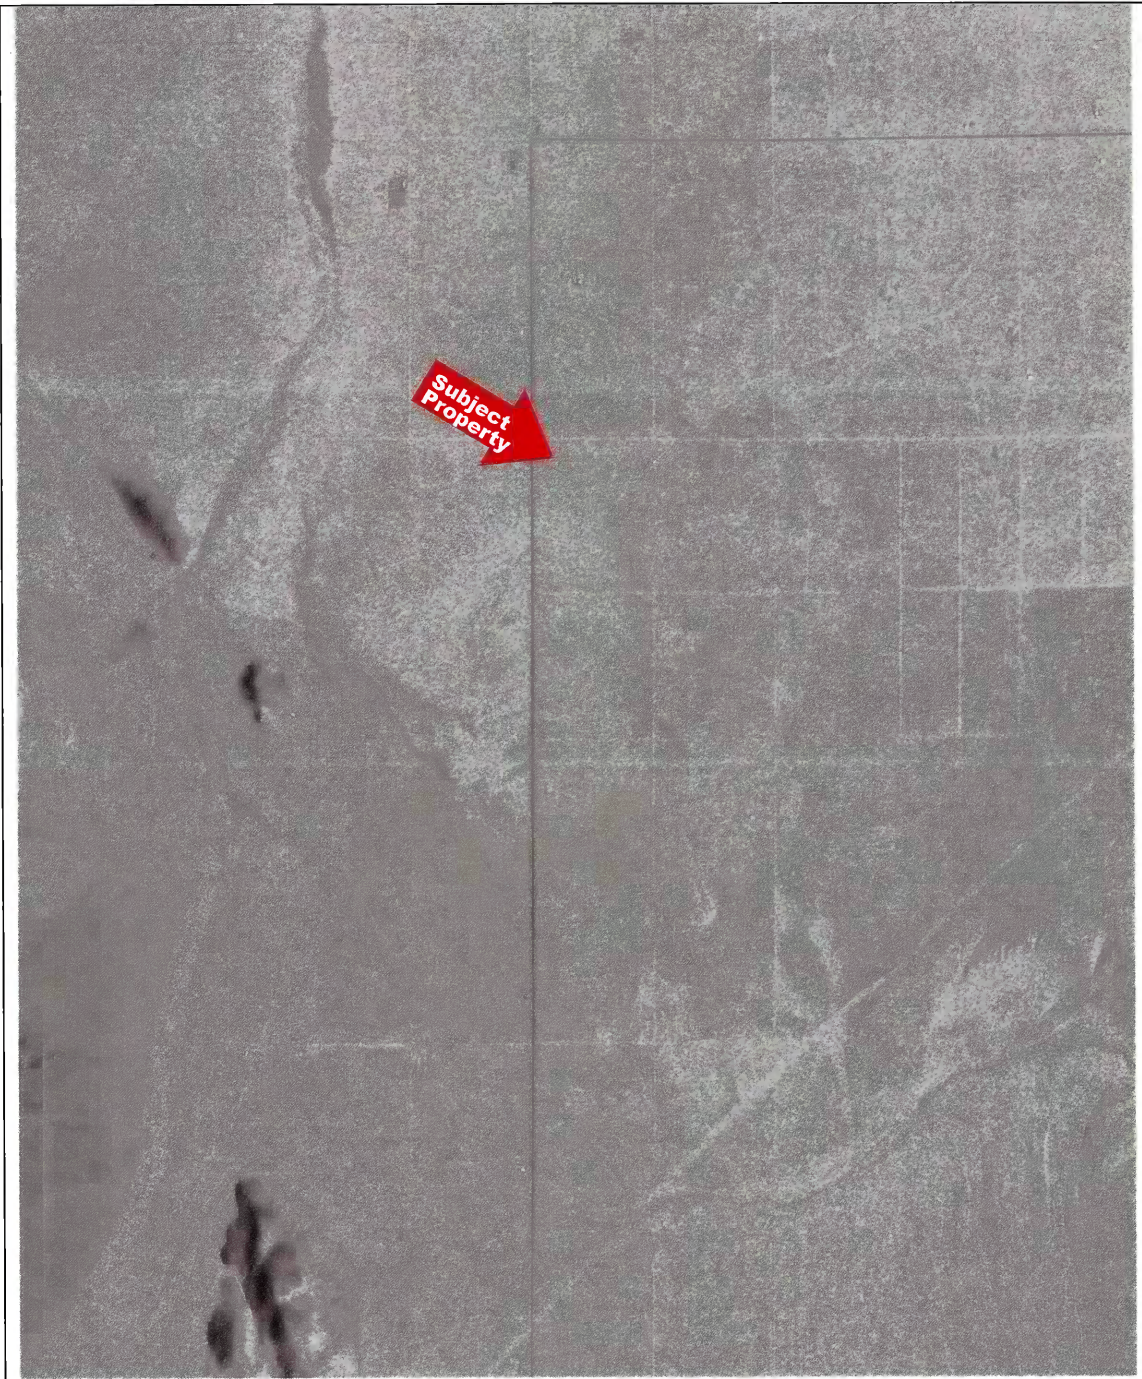
NORTH
JOB NUMBER: 22-717	Date: 2/16/22	FIGURE: C-1

- An aerial photograph taken in **1970** showed the Subject Property and adjoining property to the east to be undeveloped, with no evidence of activity observed. A trail was shown to cross the western portion of the Subject Property. The adjoining area to the north, across an unpaved Mesa Drive, was shown to be undeveloped. The adjoining area to the south, across an unpaved Cove View Road, was shown to be undeveloped. The adjoining area to the west, across Lear Avenue, was shown to be undeveloped. Dry creek beds were shown to the south and west. Small structures that appeared to be residences were observed to the north, northeast and southwest. A copy of this aerial photograph can be seen as Figure C-1 in Appendix C.

Hayden Environmental	1970 AERIAL PHOTOGRAPH Subject Property: Lear Avenue Solar; Twentynine Palms, California

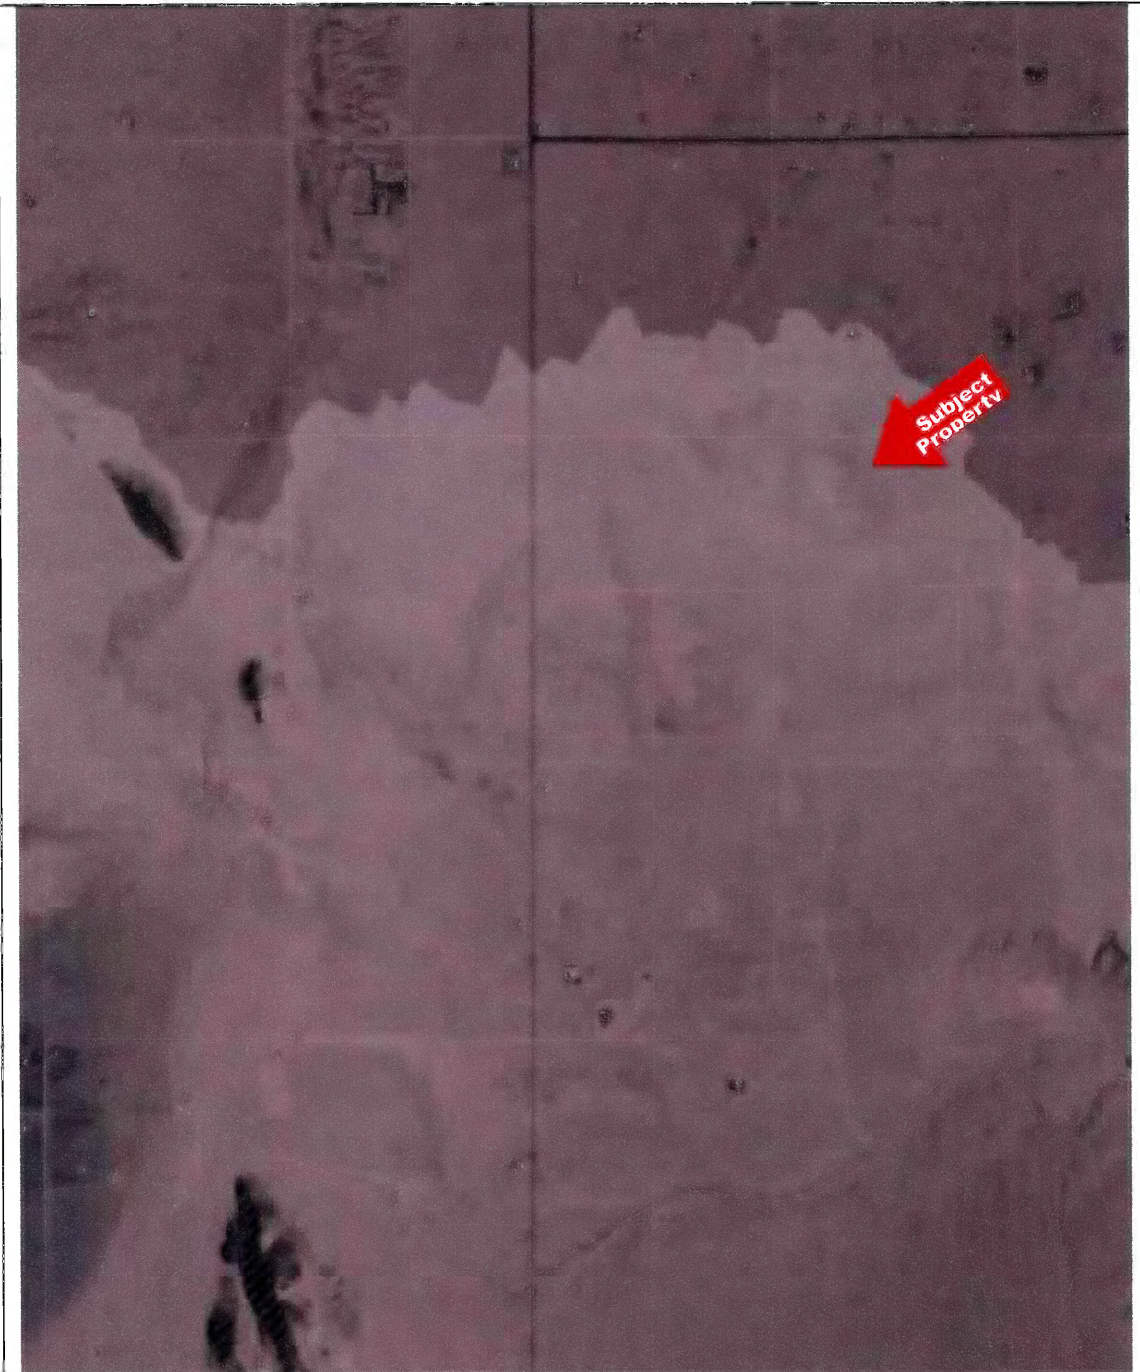
NORTH
JOB NUMBER: 22-717	Date: 2/16/22	FIGURE: C-2

- An aerial photograph taken in **1983** showed the Subject Property and adjoining property to the east to be undeveloped, with no evidence of activity observed. A trail was shown to cross the western portion of the Subject Property. The adjoining area to the north, across an unpaved Mesa Drive, was shown to be undeveloped. The adjoining area to the south, across an unpaved Cove View Road, was shown to be undeveloped. The adjoining area to the west, across Lear Avenue, was shown to be undeveloped. Dry creek beds were shown to the south and west. Small structures that appeared to be residences were observed in the areas to the north and south. A copy of this aerial photograph can be seen as Figure C-2 in Appendix C.

HEI Hayden Environmental	1983 AERIAL PHOTOGRAPH Subject Property: Lear Avenue Solar; Twentynine Palms, California

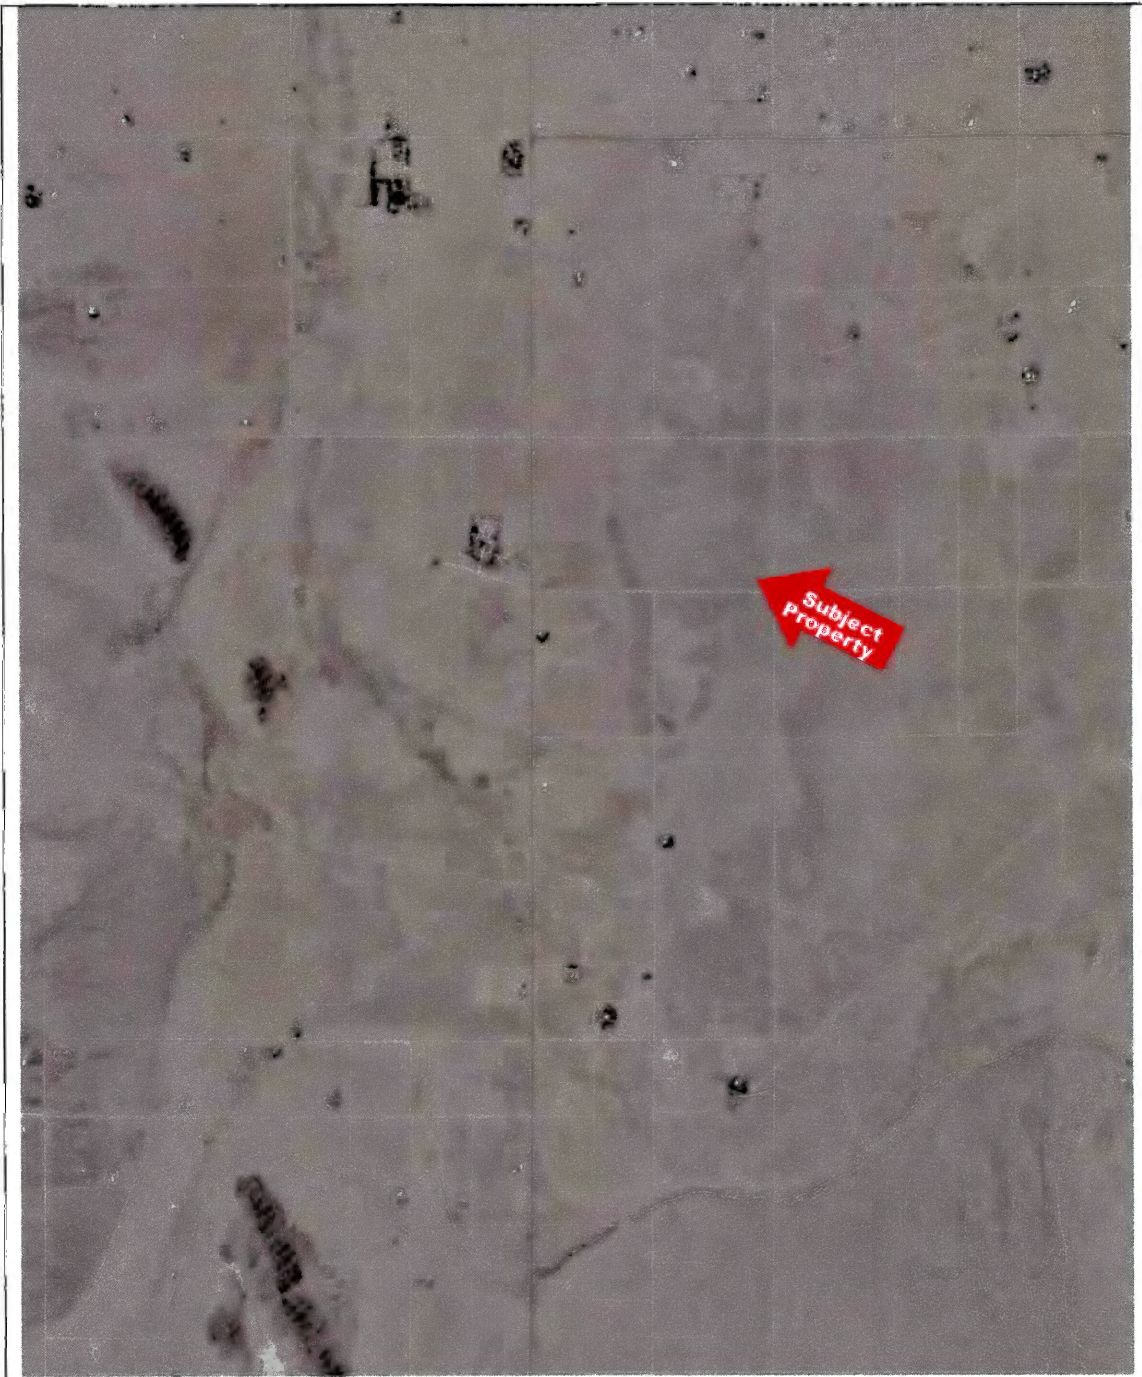
NORTH
JOB NUMBER: 22-717	Date: 2/16/22	FIGURE: C-3

- An aerial photograph taken in **1994** showed the Subject Property and adjoining property to the east to be undeveloped, with no evidence of activity observed. A trail was shown to cross the western portion of the Subject Property. The adjoining area to the north, across an unpaved Mesa Drive, was shown to be undeveloped. Most of the adjoining area to the south, across an unpaved Cove View Road, was undeveloped; with residence shown in the western portion of the adjoining area to the south. Adjoining to the west, across Lear Avenue, was a residence. Dry creek beds were shown to the south and west. Small structures that appeared to be residences were observed in the areas to the north and south. A copy of this aerial photograph can be seen as Figure C-3 in Appendix C.

Hayden Environmental	1994 AERIAL PHOTOGRAPH Subject Property: Lear Avenue Solar; Twentynine Palms, California

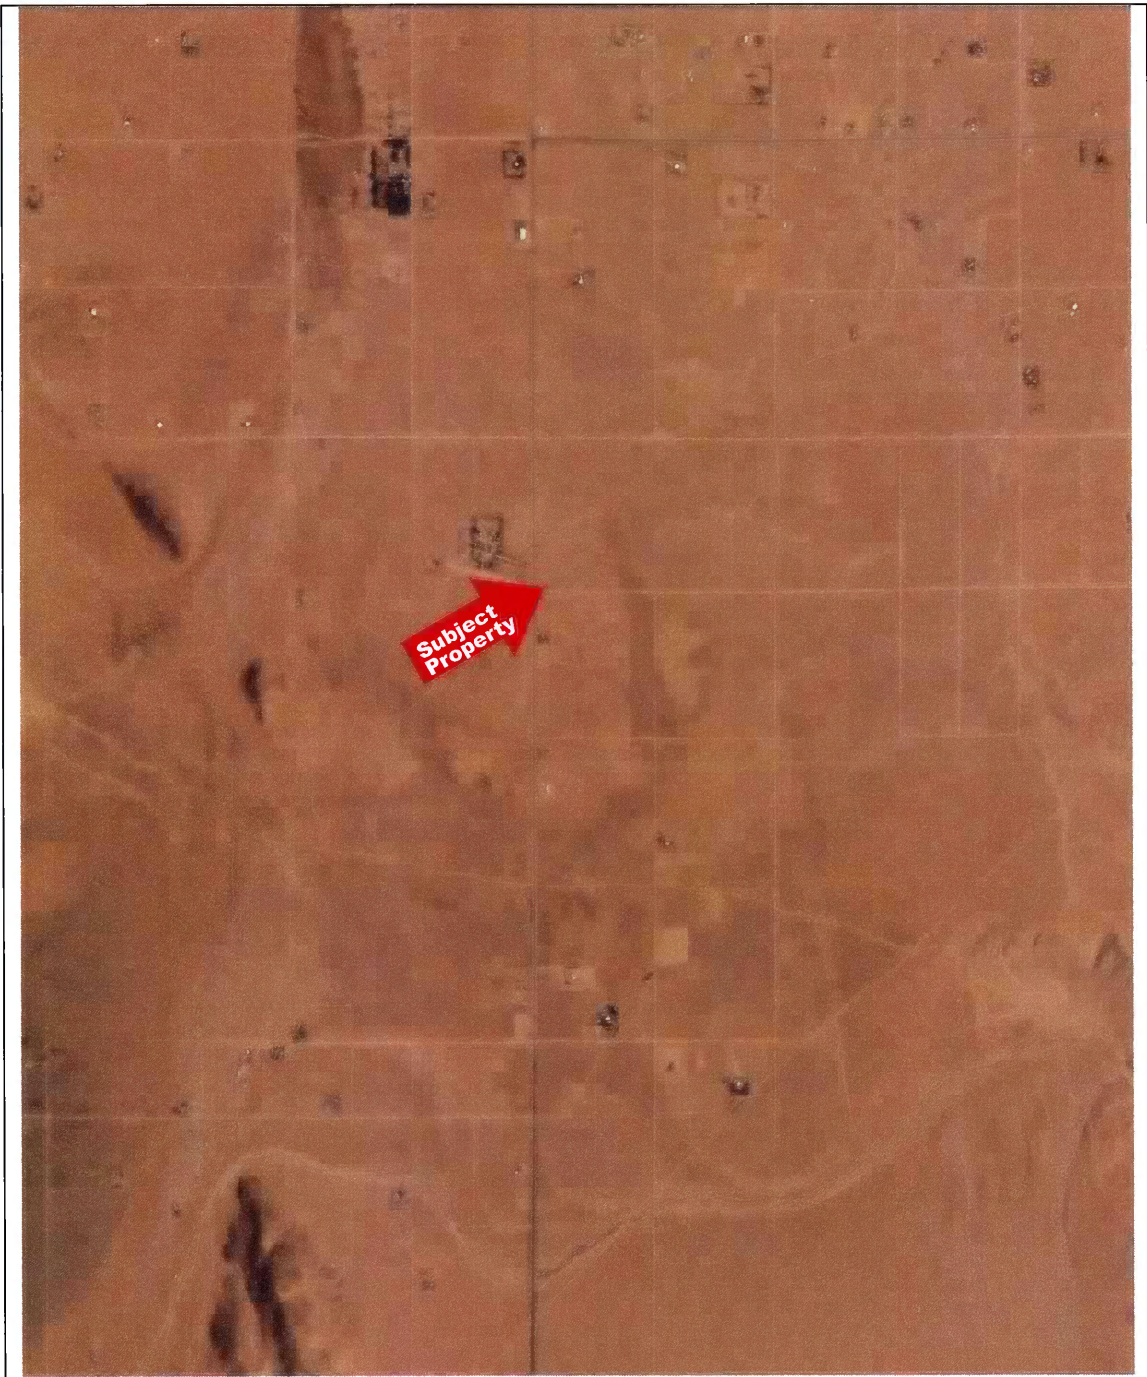
NORTH
JOB NUMBER: 22-717	Date: 2/16/22	FIGURE: C-4

- An aerial photograph taken in **2005** showed the Subject Property and adjoining property to the east to be undeveloped, with no evidence of activity observed. A trail was shown to cross the western portion of the Subject Property. The adjoining area to the north, across an unpaved Mesa Drive, was shown to be undeveloped. Two residences were shown in the adjoining area to the south, across an unpaved Cove View Road, with most of this area shown to be undeveloped. Adjoining to the west, across Lear Avenue, was a residence. Dry creek beds were shown to the south and west. Small structures that appeared to be residences were observed in the areas to the north and south. A copy of this aerial photograph can be seen as Figure C-4 in Appendix C.

HEI Hayden Environmental	2005 AERIAL PHOTOGRAPH Subject Property: Lear Avenue Solar; Twentynine Palms, California

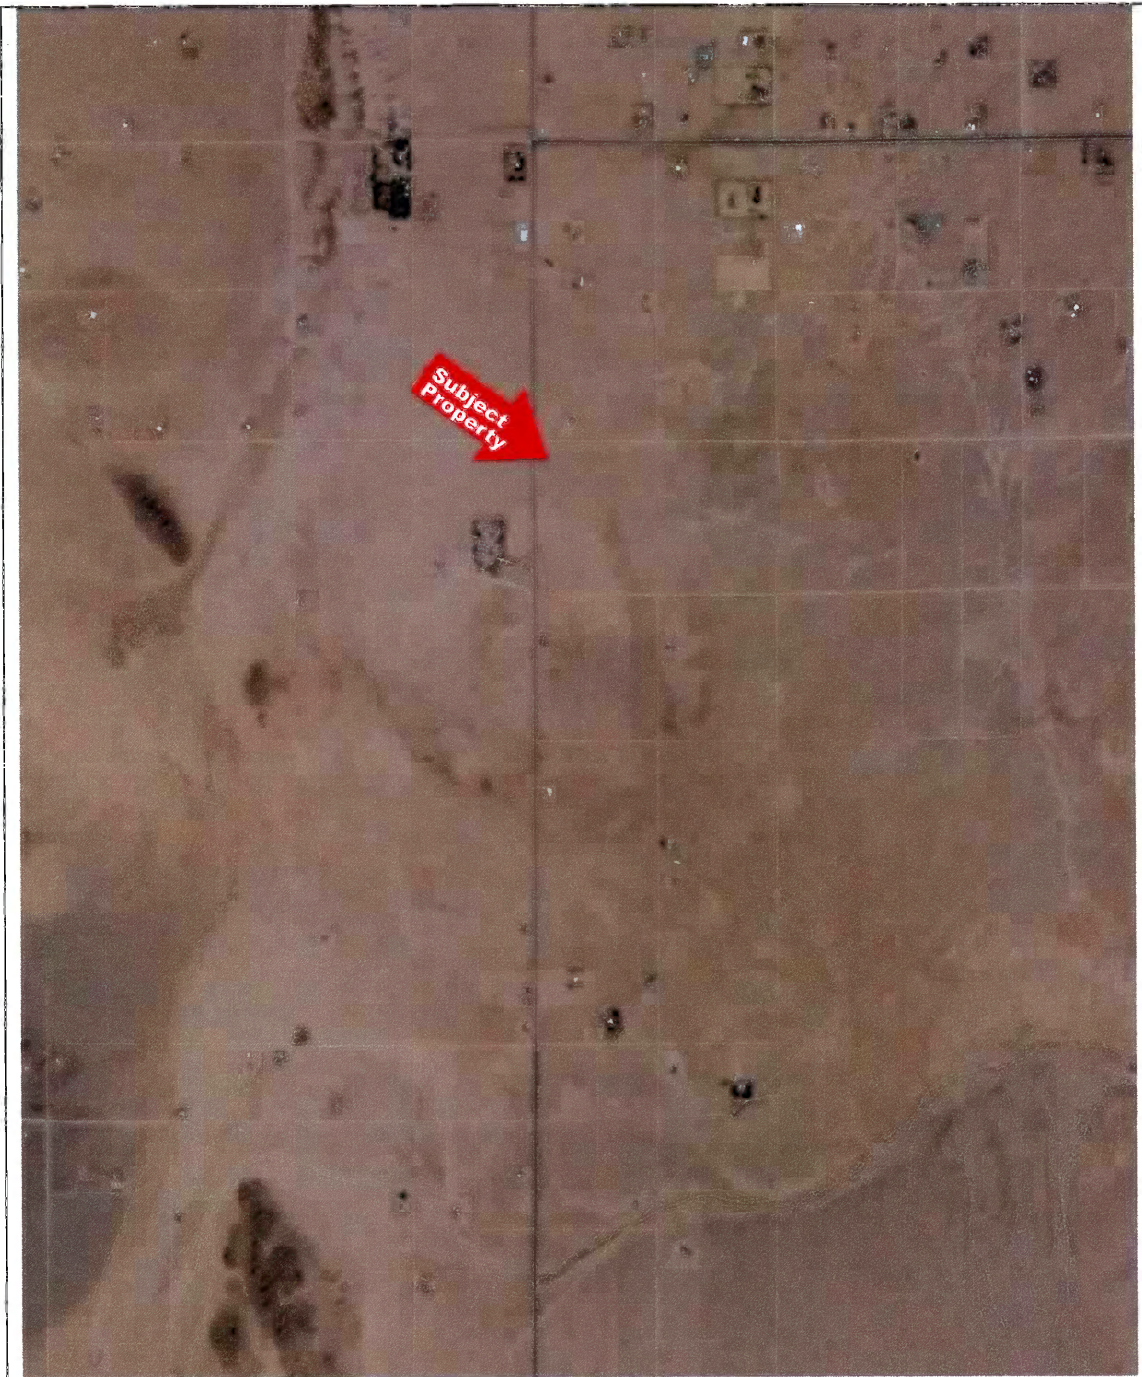
NORTH
JOB NUMBER: 22-717	Date: 2/16/22	FIGURE: C-5

- An aerial photograph taken in **2010** showed the Subject Property and adjoining property to the east to be undeveloped, with no evidence of activity observed. A trail was shown to cross the western portion of the Subject Property. A residence was observed in the western portion of the adjoining area to the north, across an unpaved Mesa Drive, with the balance of this area shown to be undeveloped. Two residences were shown in the adjoining area to the south, across an unpaved Cove View Road, with most of this area shown to be undeveloped.

Adjoining to the west, across Lear Avenue, was a residence. Dry creek beds were shown to the south and west. Small structures that appeared to be residences were observed in the areas to the north and south. A copy of this aerial photograph can be seen as Figure C-5 in Appendix C.

HEI Hayden Environmental	2010 AERIAL PHOTOGRAPH Subject Property: Lear Avenue Solar; Twentynine Palms, California

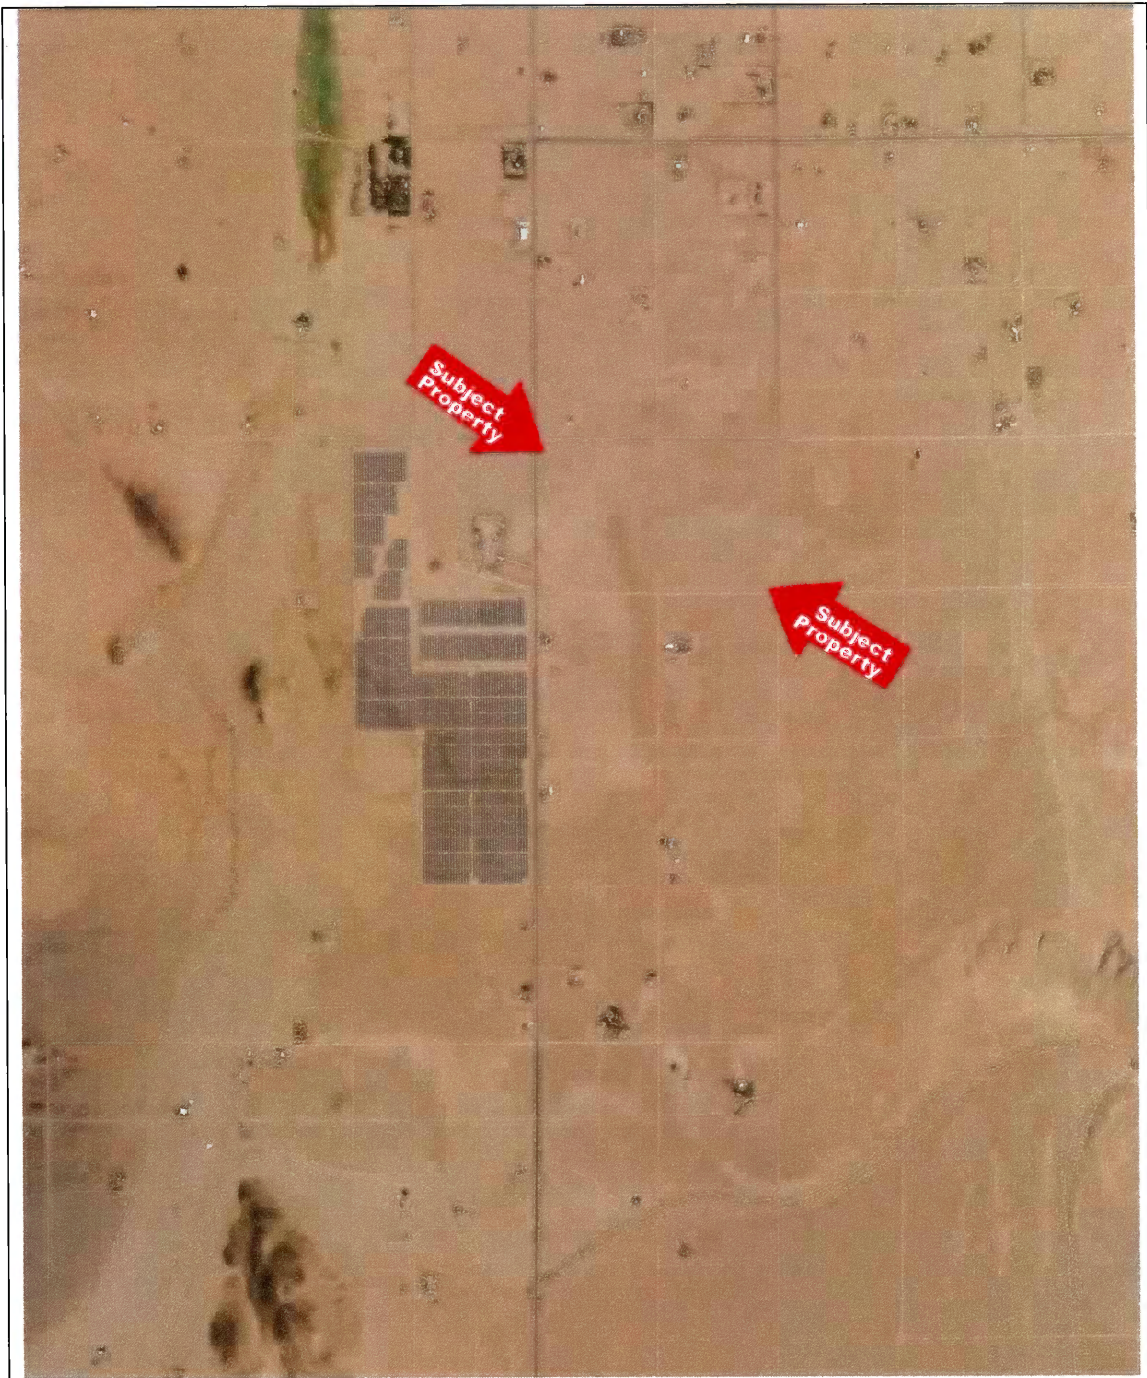
- An aerial photograph taken in **2018** showed the Subject Property and adjoining property to the east to be undeveloped, with no evidence of activity observed. A trail was shown to cross the western portion of the Subject Property. A residence was observed in the western portion of the adjoining area to the north, across an unpaved Mesa Drive, with the balance of this area shown to be undeveloped. Two residences were shown in the adjoining area to the south, across an unpaved Cove View Road, with most of this area shown to be undeveloped. Adjoining to the west, across Lear Avenue, was a residence. A large solar array was shown to the southwest and west, across Lear Avenue. Dry creek beds were shown to the south and west. Small structures that appeared to be residences were observed in the areas to the north and south. A copy of this aerial photograph can be seen as Figure C-6 in Appendix C.

**2018 AERIAL
PHOTOGRAPH**
