Re: CITADEL Project No. 7109.1095.0
Phase I Environmental Site Assessment Report
Former Sperling Nursery Site
24460 Calabasas Road
Calabasas, California 91302

# Phase I Environmental Site Assessment Report

Citadel Project Number 7109.1095.0

Former Sperling Nursery Site 24460 Calabasas Road Calabasas, California 91302

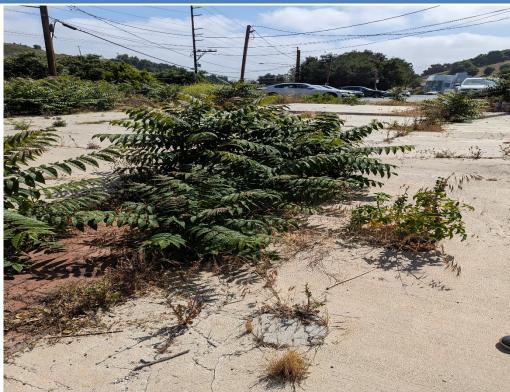
Several drains were observed in the most northern area of the Site. Drains can act as conduits and provide pathways for spills or releases of pesticides and chemicals to enter the subsurface, representing an environmental concern.

PHOTO 3: View of drainage or old well, looking East.

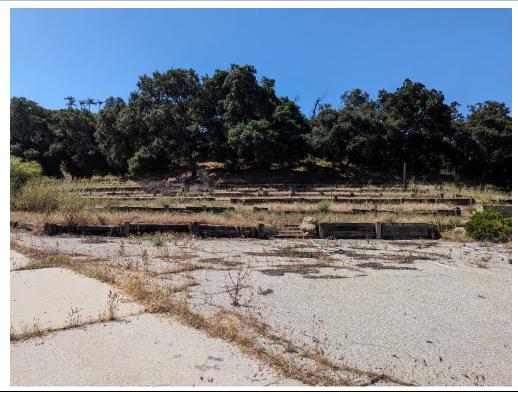
PHOTO 7: View of terraces, looking North.

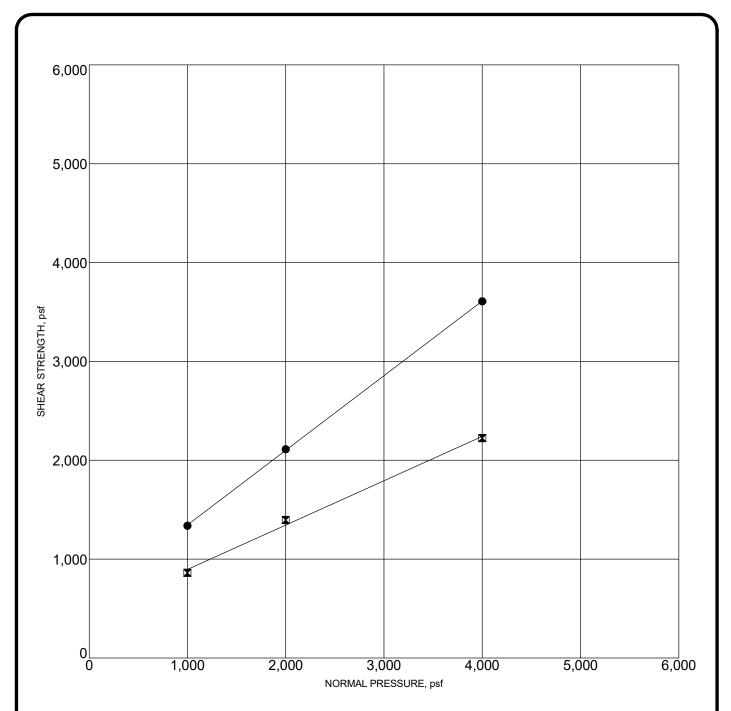
• PEAK STRENGTH
Friction Angle= 37 degrees
Cohesion= 590 psf

■ ULTIMATE STRENGTH
Friction Angle= 24 degrees
Cohesion= 448 psf

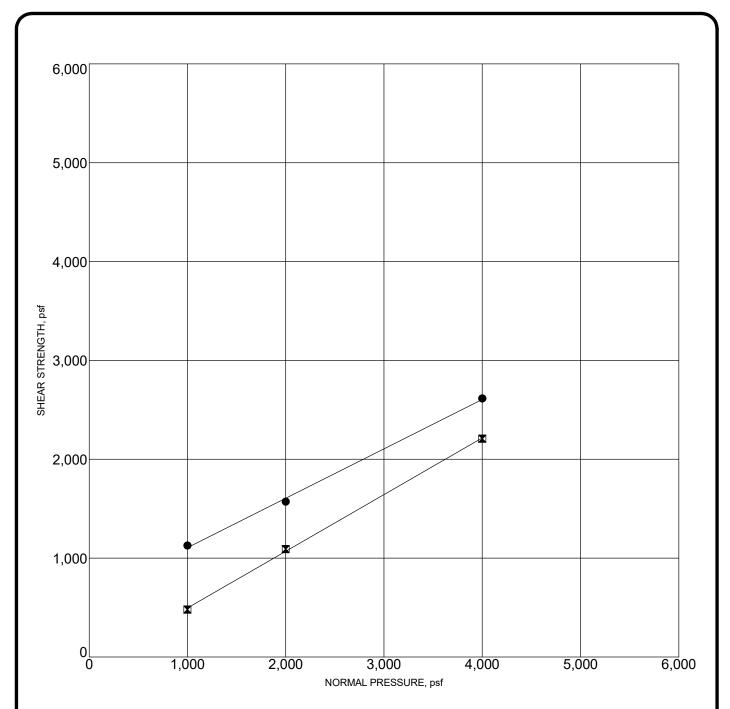
PEAK STRENGTH
 Friction Angle= 27 degrees
 Cohesion= 606 psf

■ ULTIMATE STRENGTH Friction Angle= 29 degrees Cohesion= 0 psf

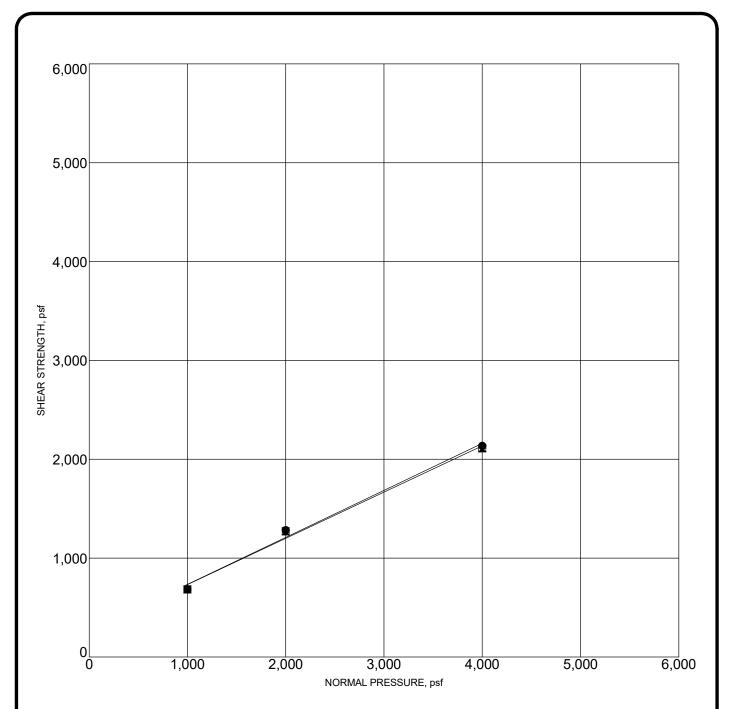
PEAK STRENGTH
 Friction Angle= 25 degrees
 Cohesion= 258 psf

■ ULTIMATE STRENGTH
Friction Angle= 25 degrees
Cohesion= 264 psf

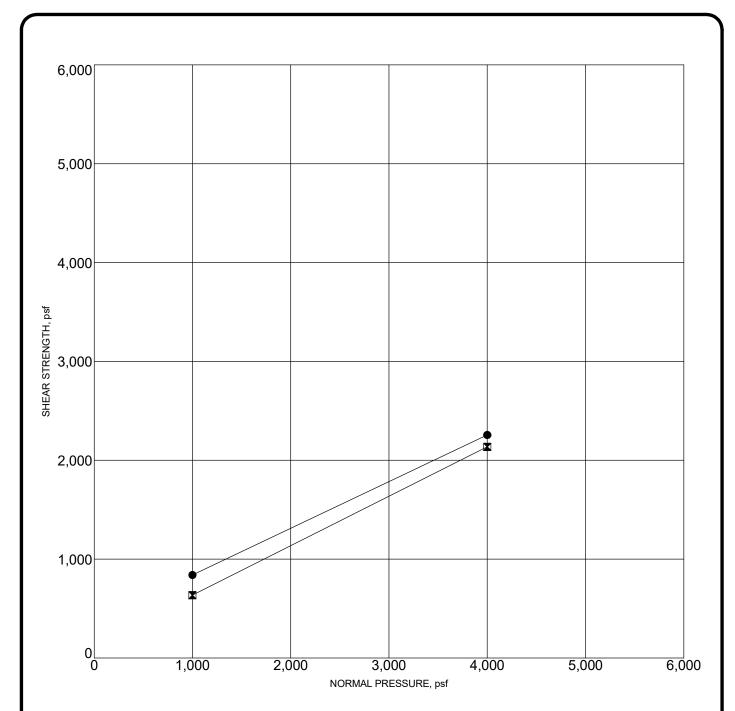
• PEAK STRENGTH
Friction Angle= 25 degrees
Cohesion= 368 psf

■ ULTIMATE STRENGTH
Friction Angle= 27 degrees
Cohesion= 136 psf

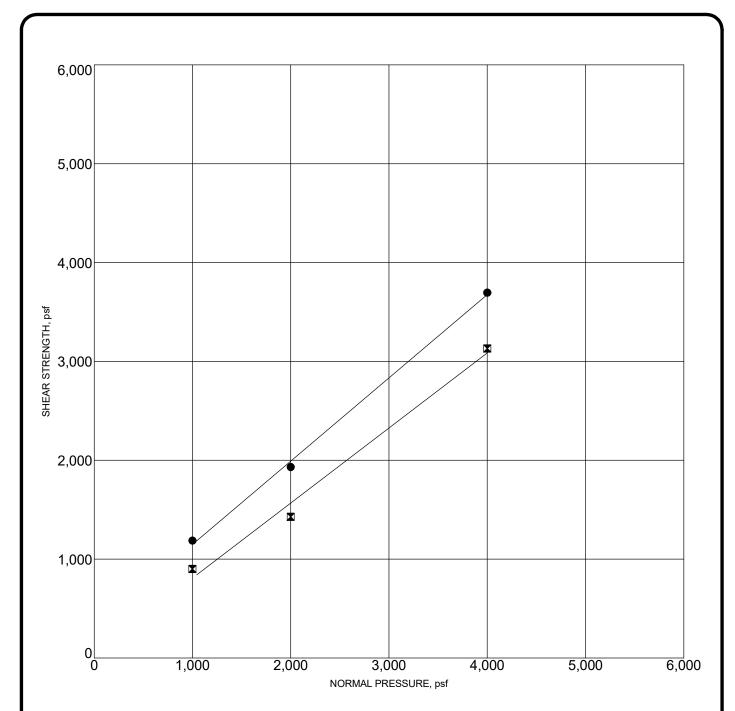
• PEAK STRENGTH
Friction Angle= 40 degrees
Cohesion= 306 psf

■ ULTIMATE STRENGTH
Friction Angle= 37 degrees
Cohesion= 48 psf

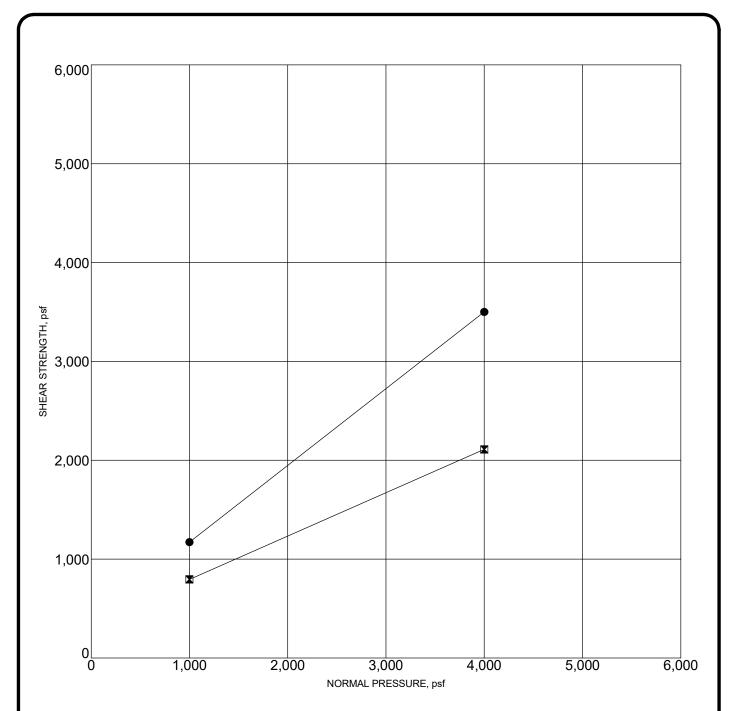
• PEAK STRENGTH
Friction Angle= 38 degrees
Cohesion= 396 psf

■ ULTIMATE STRENGTH
Friction Angle= 24 degrees
Cohesion= 357 psf

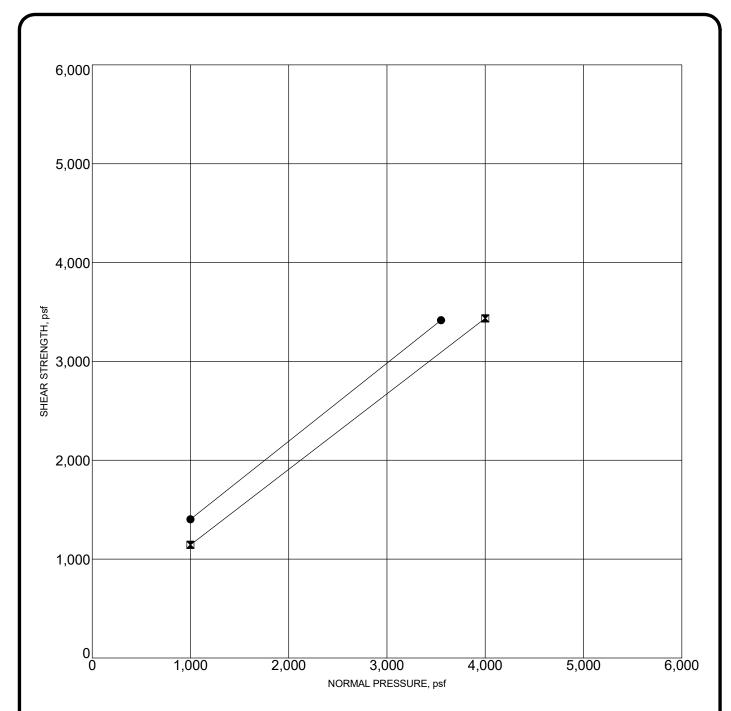
• PEAK STRENGTH
Friction Angle= 38 degrees
Cohesion= 613 psf

■ ULTIMATE STRENGTH
Friction Angle= 37 degrees
Cohesion= 381 psf

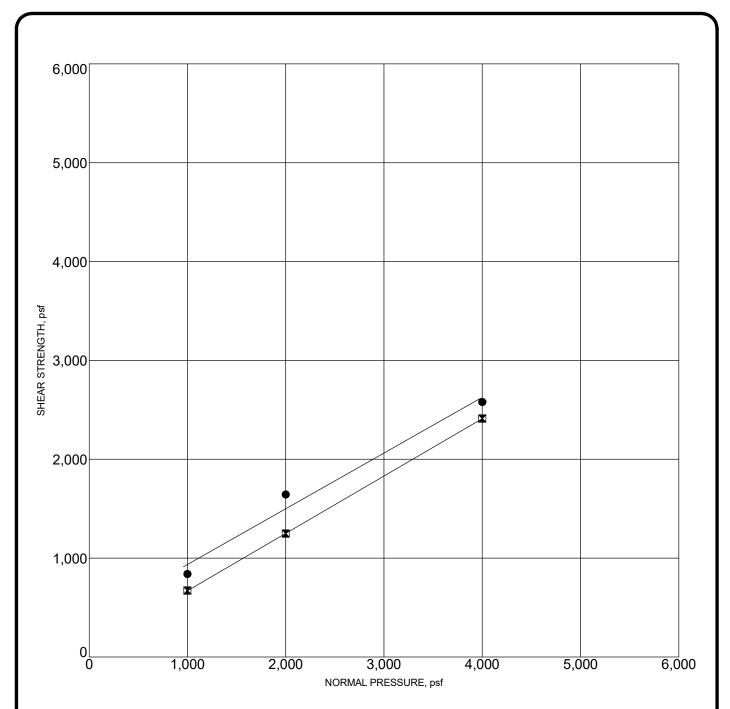
• PEAK STRENGTH
Friction Angle= 29 degrees
Cohesion= 372 psf

■ ULTIMATE STRENGTH
Friction Angle= 30 degrees
Cohesion= 90 psf

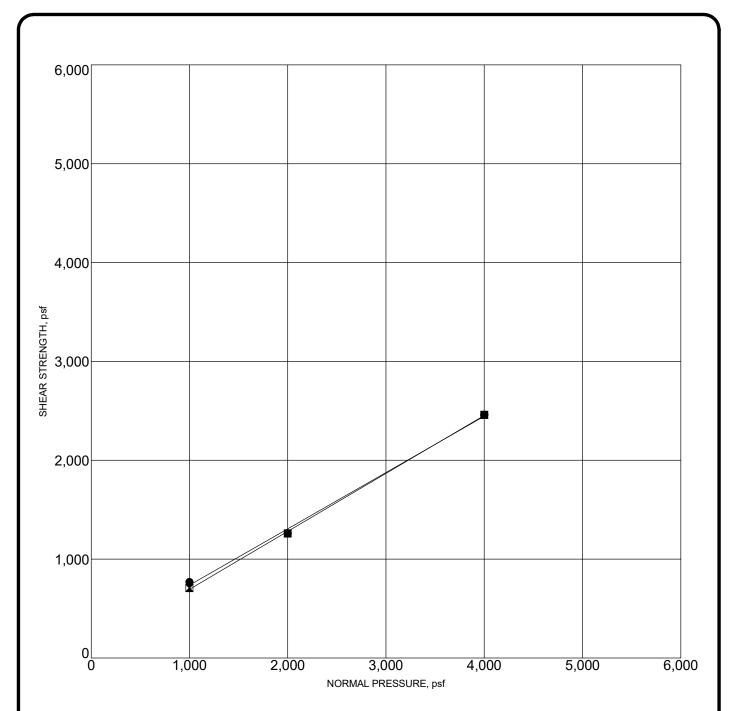
• PEAK STRENGTH
Friction Angle= 30 degrees
Cohesion= 168 psf

■ ULTIMATE STRENGTH
Friction Angle= 30 degrees
Cohesion= 108 psf
