Project Specific Water Quality Management Plan (Preliminary)

For: Maverik Fueling & Convenience Store Golf Central Parkway & Avenue 45 Indio, CA 92201

SDC, Inc. Mehdi Keshmiri , PE 245 East Third St. Long Beach, CA 90802 mkeshmiri@sdcollaborative.net 1-949-310-7567

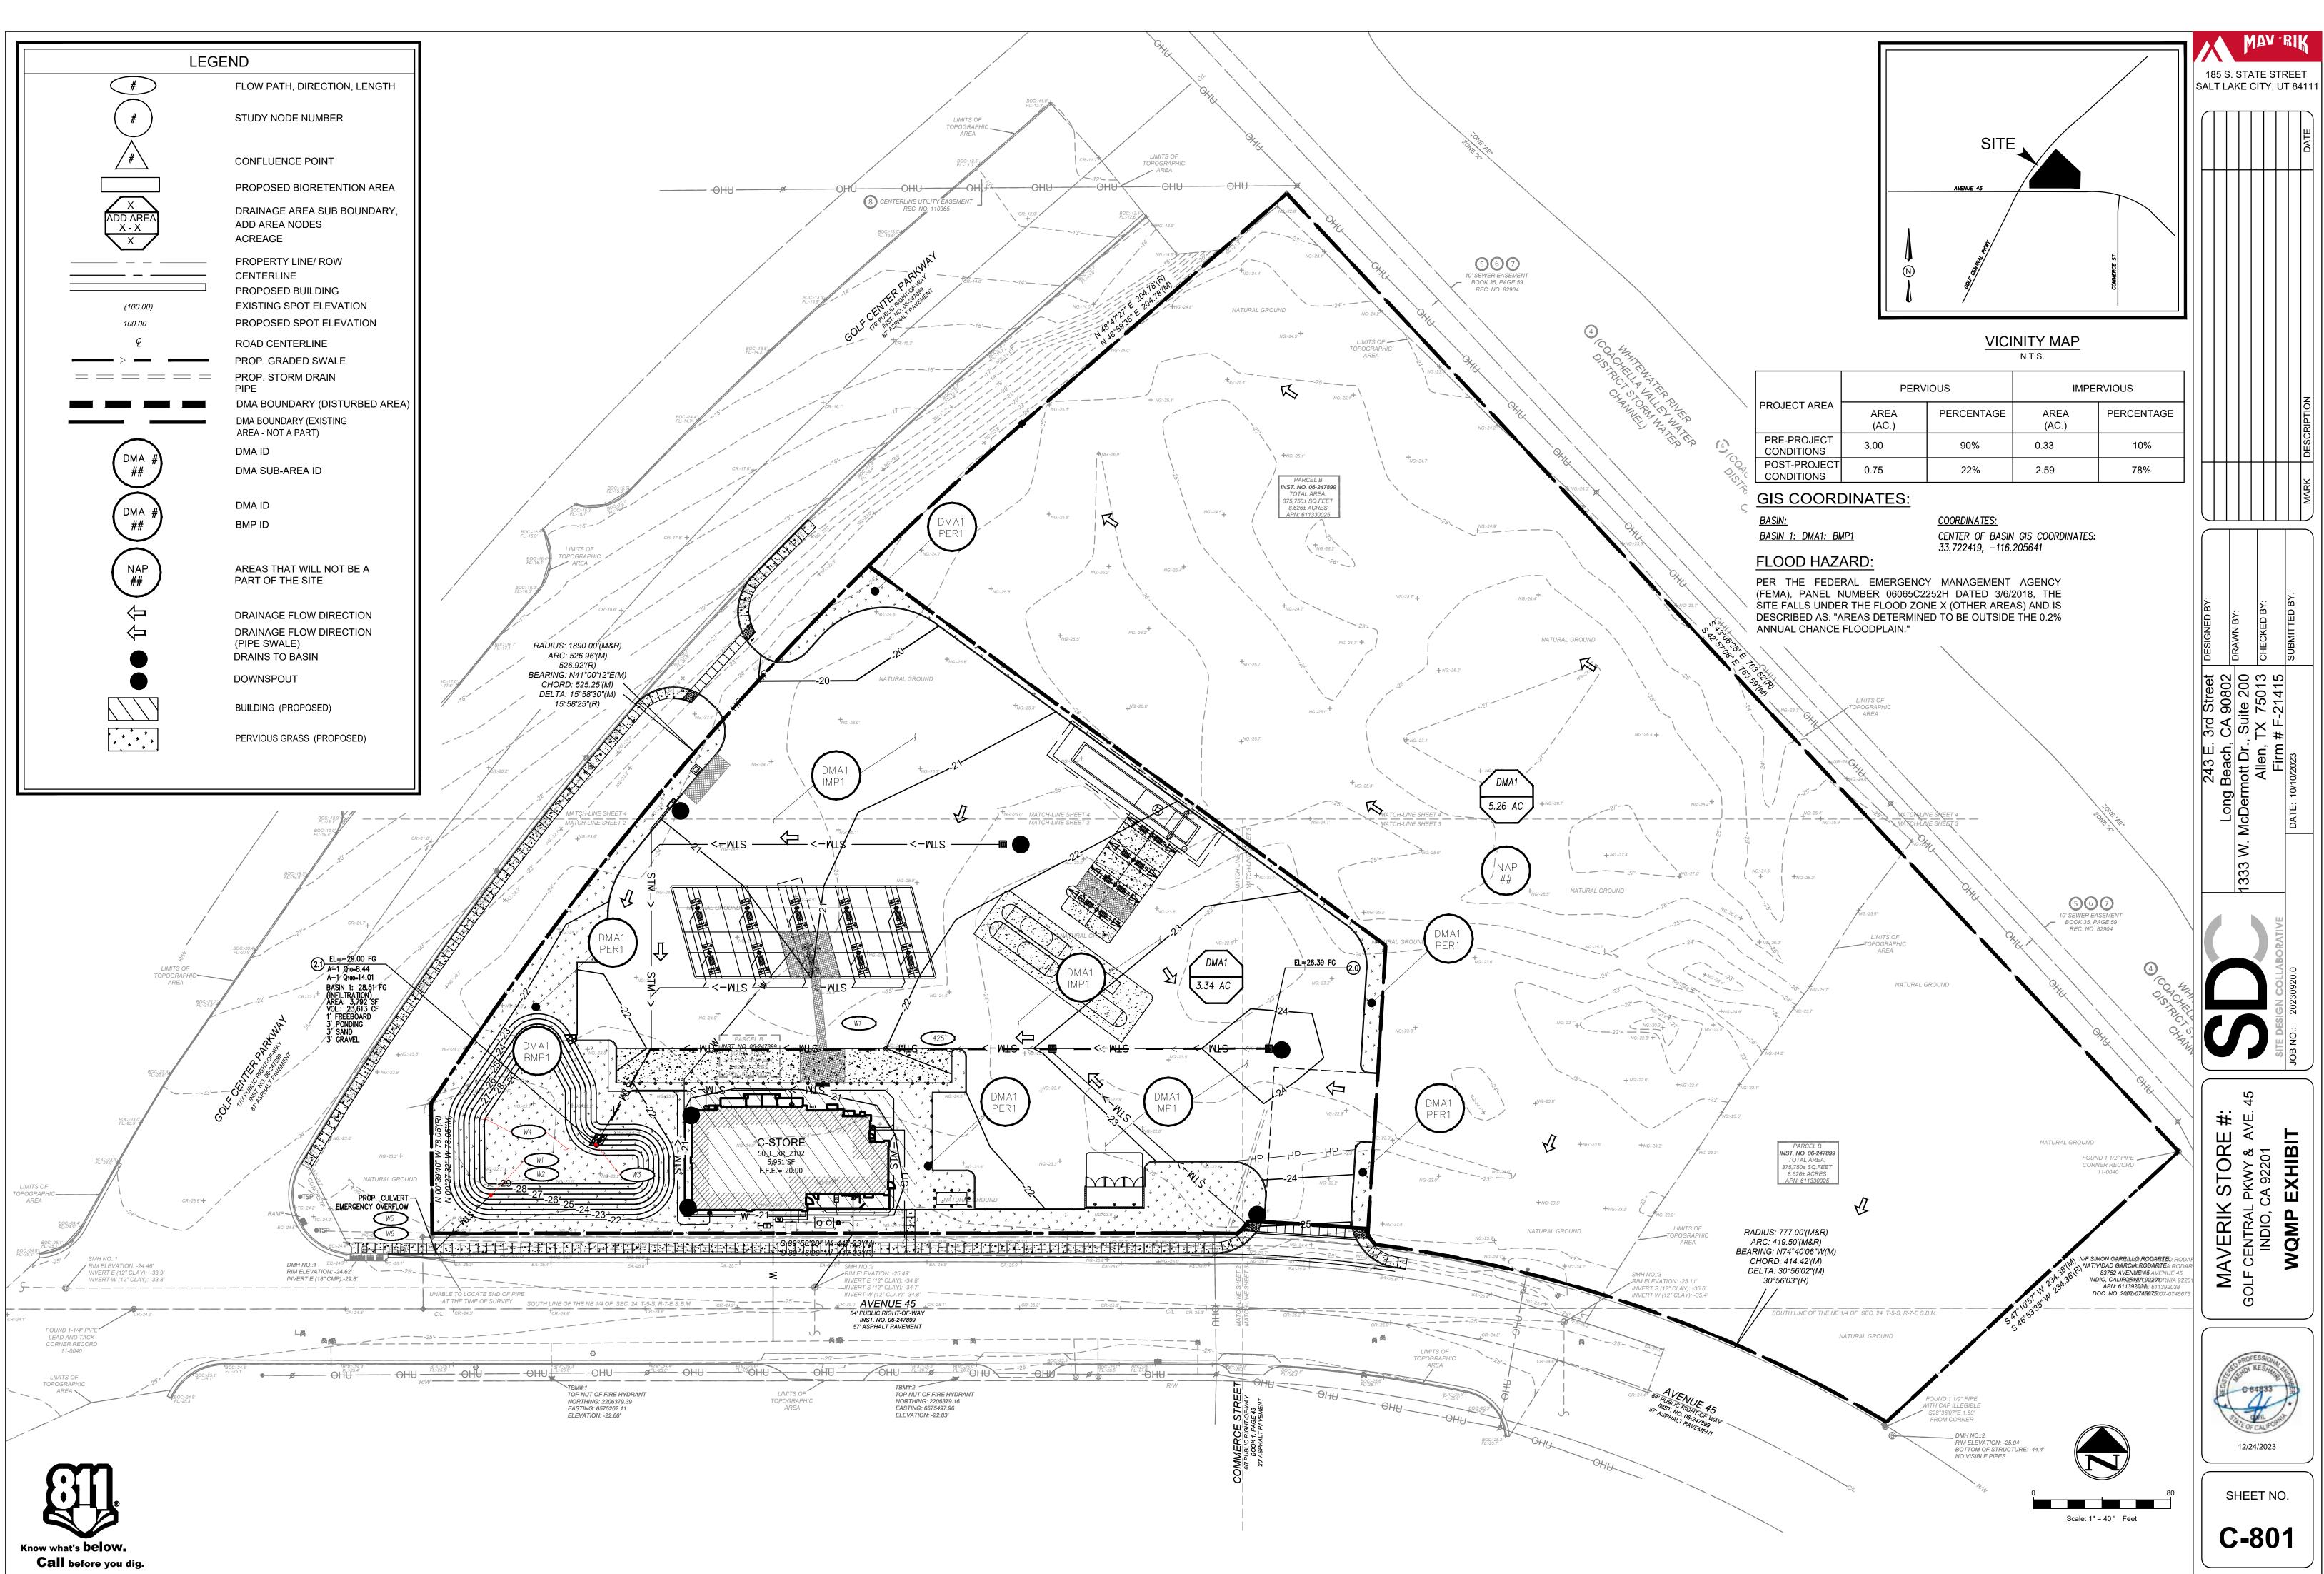
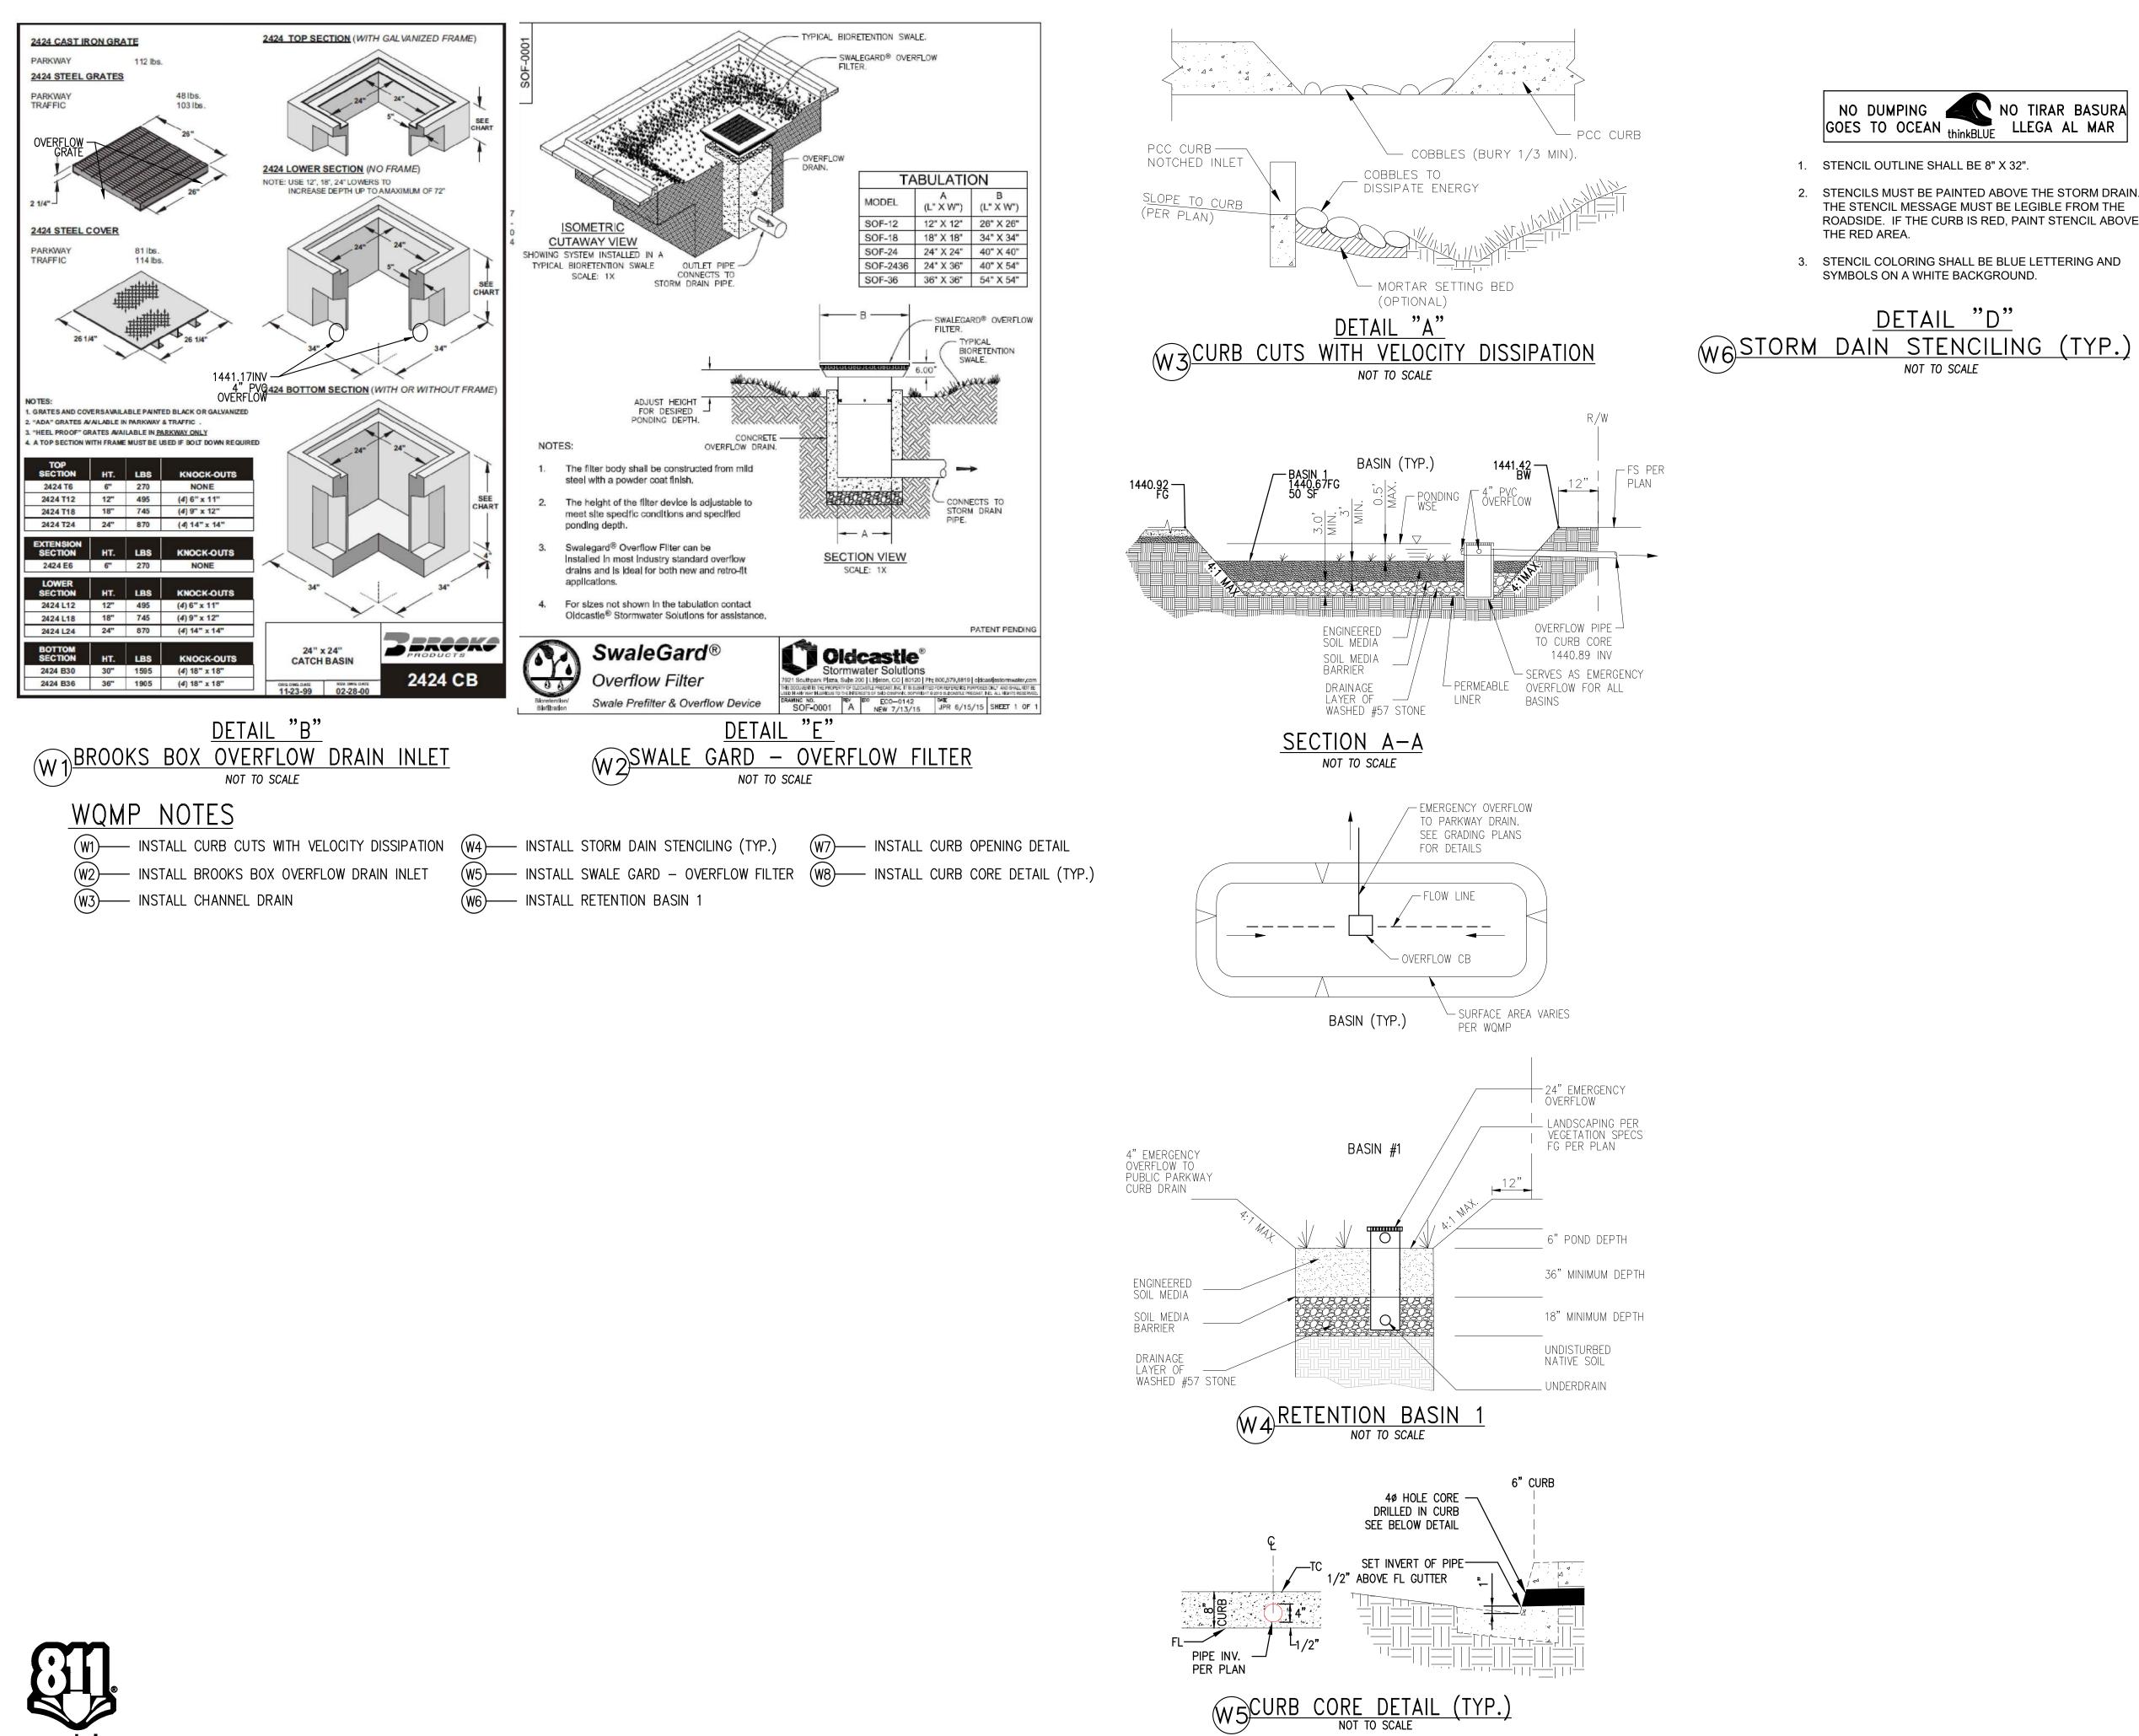
OFFSITE FLOW NOTE: THERE ARE NO OFFSITE FLOWS DISCHARGING THROUGH THE SITE IN EXISTING OR PROPOSED CONDITIONS.

THE PROJECT SITE CLASSIFIED AS: INFILTRATION

The project site design BMP consists of a bio-retention basin (infiltration) located at the south west corner of the project site where all water will flow to during a storm event and will be treated.

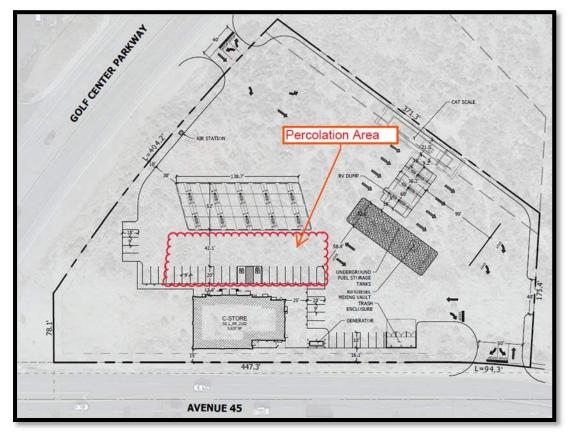
Figure 1 Preliminary Site Plan Showing Assumed Percolation Area

This soil percolation report for proposed seepage pits has been prepared for the proposed commercial development. The commercial development is located northeast corner of the intersection of Avenue 45 and Golf Center Parkway (APN # 611-330-025-9), Indio, California. We understand the site development will include a 5,600 square foot gas station store, fueling canopy, underground fuel storage tanks, biodiesel mixing vault, air station, trash enclosure, generator, RV dump area, cat scale, two drive entrances, parking area, and truck route, see Figure 1 below. Site-specific Permanent Best Management Practice (BMP) for storm water treatment improvements are not understood at this time. An Onsite Wastewater Treatment System (OWTS) is proposed for this project. The proposed commercial site location is shown on Plate 1 in Appendix A. The locations of the proposed seepage pits are shown on Plate 2. Inlet depths are assumed to be generally 4 feet below grades or shallower.

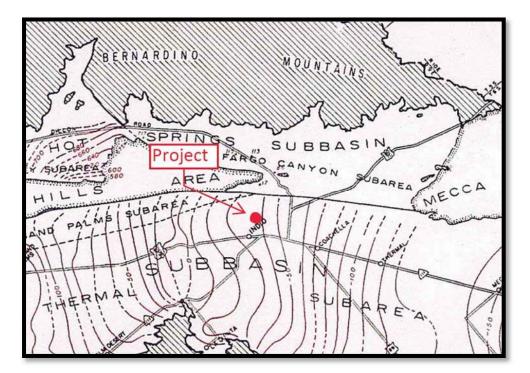
Figure 2 Historic Groundwater Map

<u>Historic Groundwater Information</u>: From observation of a 1961 Ground Water Basin Subdivisions and Contours of Ground Water Levels Map (see Figure 2 below), published by the Resources Agency of California Department of Water Resources Southern District (Department of Water Resources Bulletin 108), the historic groundwater contour nearest the project is between contour -30 and -40. Using an elevation of -38 feet near the site, the historic groundwater is at a depth of approximately 10 feet below the ground surface; however, mottling could indicate a potential depth of 7½ feet.

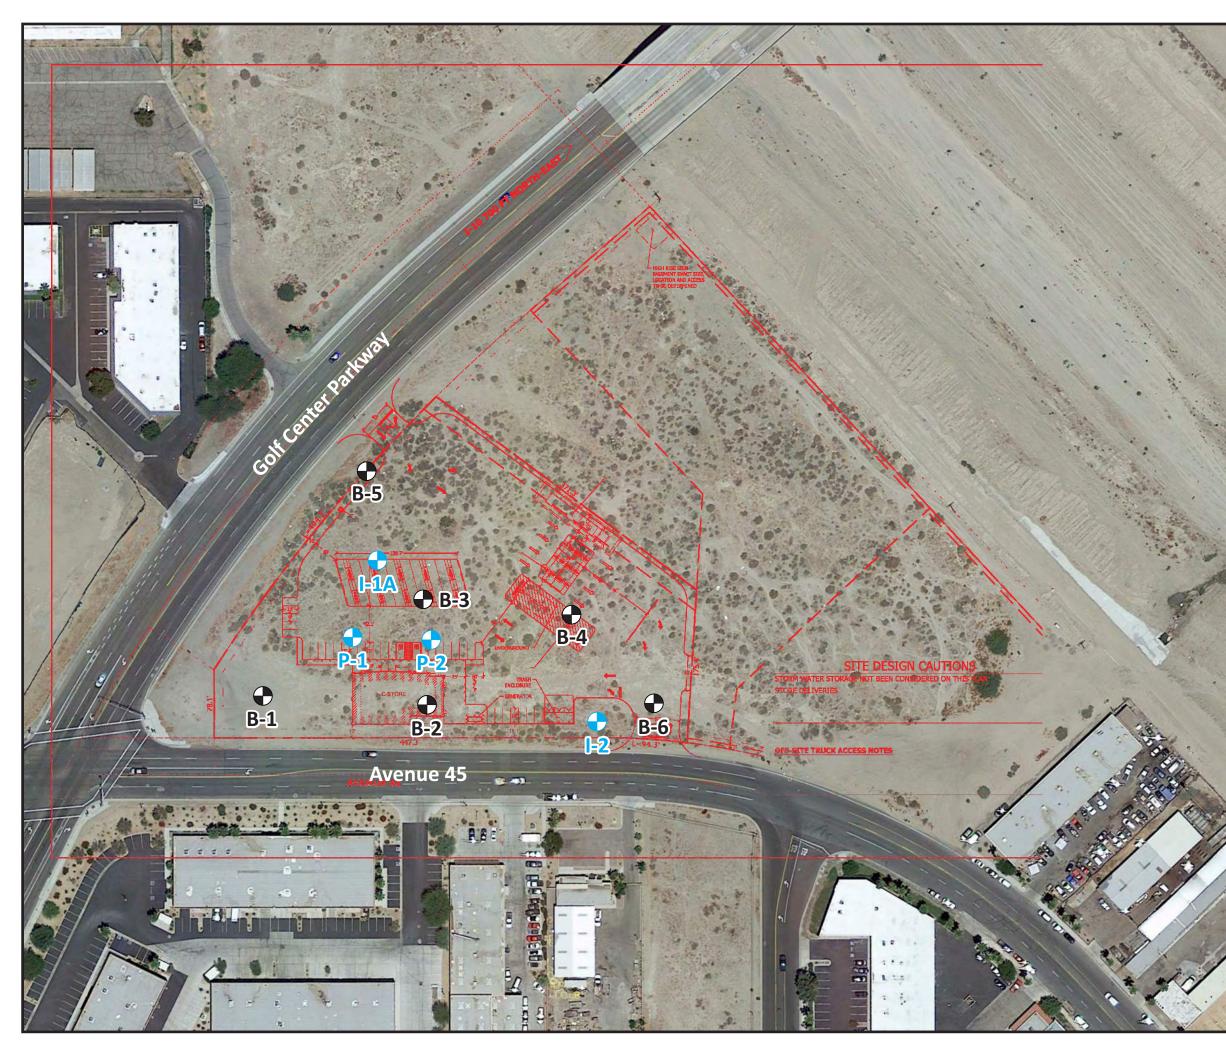
- **B-6** Approximate Exploration Locations
- ₽-2 Approximate Percolation Test Locations
- ← I-2 Approximate Infiltration Test Locations
