Historical Resource Assessment Report

115, 125, 133 and 135 N. Pennsylvania Ave

July 2020

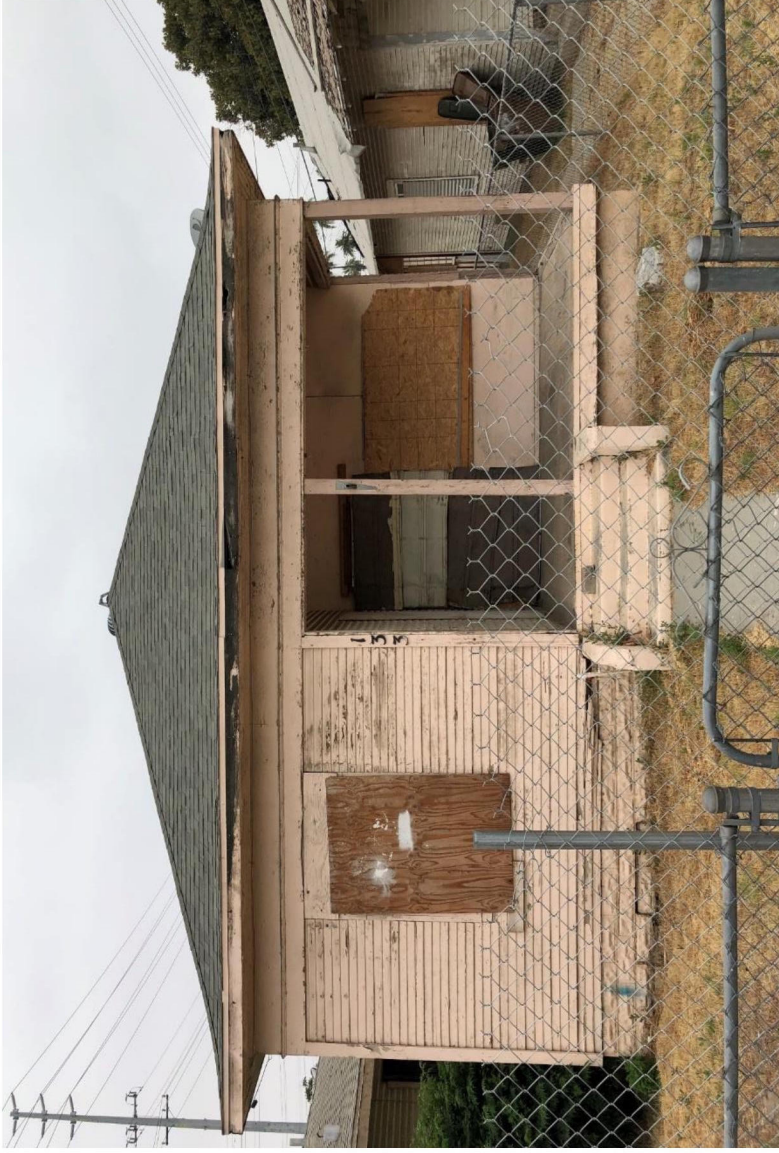
The home at 133 North Pennsylvania Avenue is sited on the large central parcel which contains one additional single-family residence slightly to the south. Constructed in 1901, 133 North Pennsylvania Avenue has a rectangular footprint and appears to rest on a concrete foundation although plyboard and corrugated metal panels cover much of the foundation like skirting. Its hipped roof has shallow, closed eaves and is clad with composite shingles. The home is sheathed with a variety of original and replacement materials including horizontal channel siding, narrower clapboard siding, vertical wooden siding, plyboard, and what appears to be vertical wood panels. Its primary entry, on the eastern façade, is accessed via concrete steps leading to a partial-width, recessed porch which is supported by square wooden posts. Panels have been nailed over the primary entry door for security reasons (Figure 5). The west elevation exhibits considerable alteration which appears to be an enclosure of the porch and an addition across the rear of the home (Figure 6). The addition is topped by a shed roof clad with composite shingles, and a roof overhang shelters an entry door and concrete steps. The addition's exterior is clad with various types of siding, including vertical wooden boards of different widths and plyboard (Figure 7). Windows are currently covered with plyboard. Where siding is missing, wall studs and portions of the building interior are exposed (Figure 8). The home's quality of materials is poor and it is in severe disrepair.

Figure 5 133 North Pennsylvania Avenue, Eastern Façade, View West

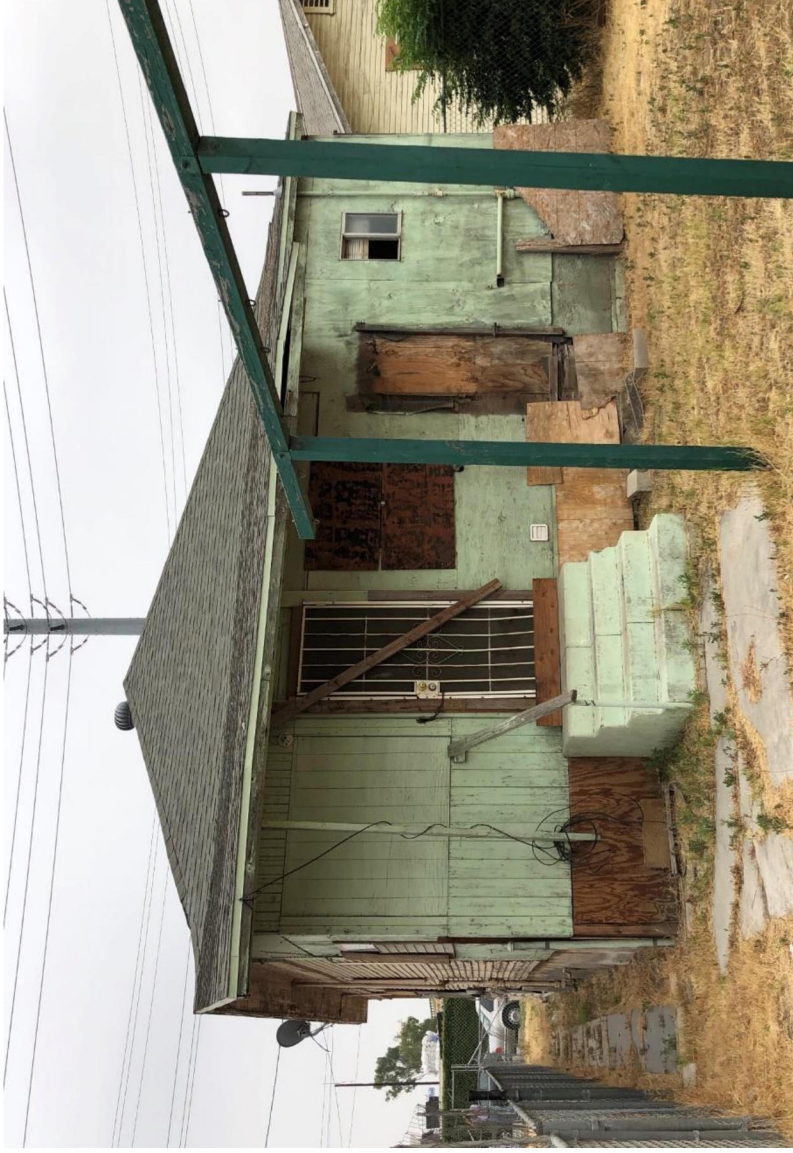
Figure 6 133 North Pennsylvania Avenue, West (Rear) Elevation, View Southeast

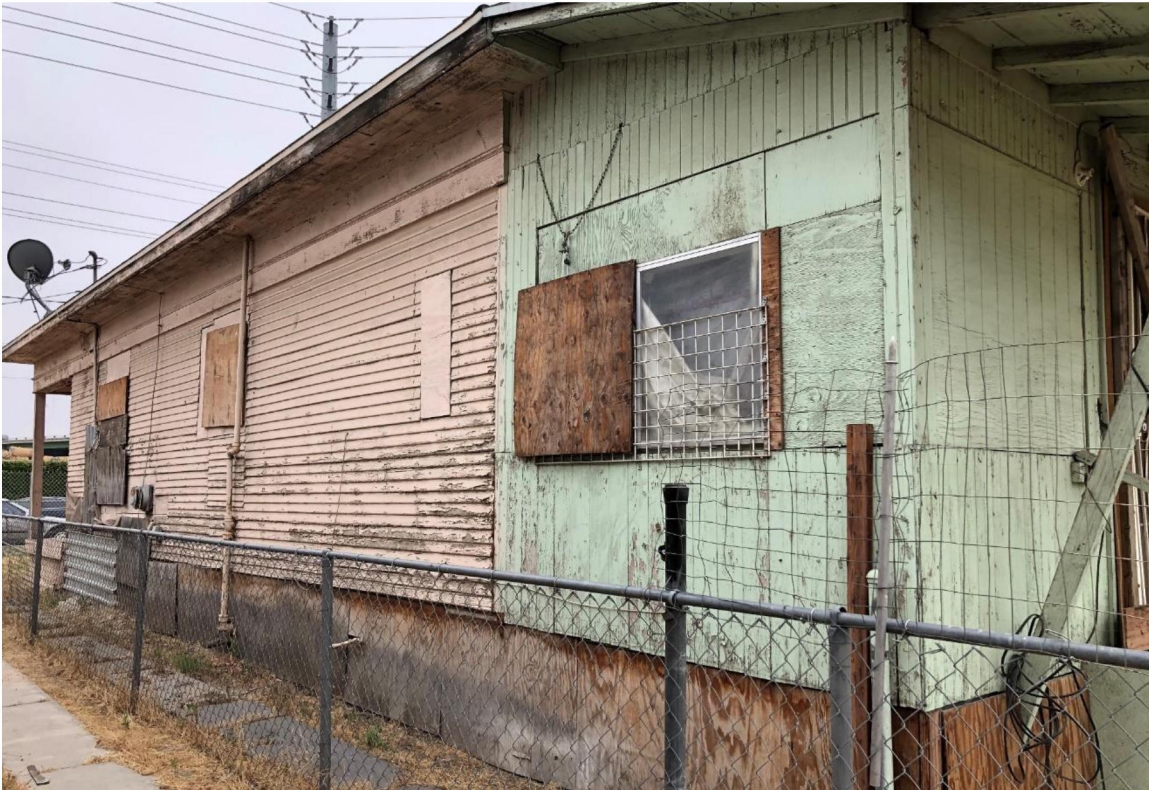
Figure 7 133 North Pennsylvania Avenue, North Elevation, View Southeast

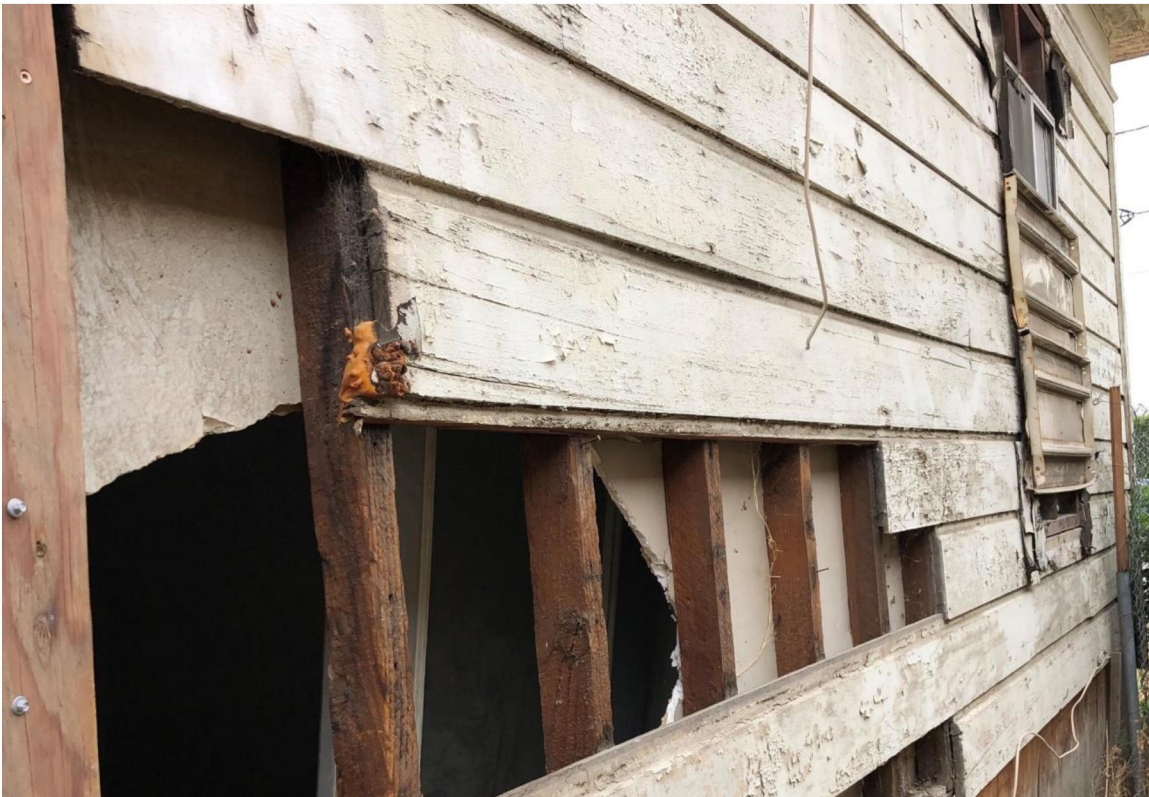
Figure 8 133 North Pennsylvania Avenue, Closeup of Siding

Although City staff did not locate any building permit records for the property, visual observation demonstrates extensive alterations have been made to the home as previously described above. This includes the porch enclosure and addition at the rear of the home, addition of plyboard and corrugated metal panels around the base/foundation, replacement of areas of original siding, and areas of missing siding which expose studs and the building's interior.

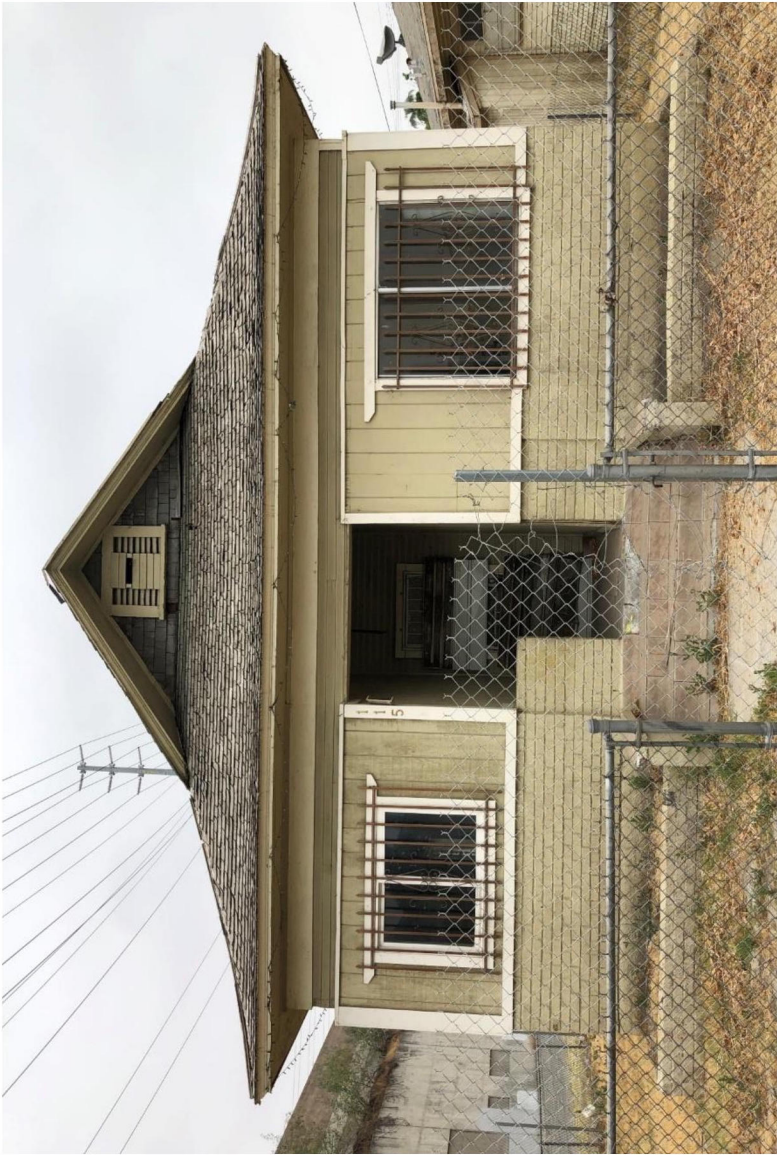
The home at 115 North Pennsylvania Avenue is situated on the southernmost parcel adjacent to J Street. Constructed between 1907 and 1910, 115 North Pennsylvania Avenue has a rectangular footprint and rests on a concrete and concrete block foundation. It is topped by a gable-on-hip roof with shallow, closed eaves, and is covered with composite shingles. Slatted vents are located on the east and west gables. Smaller gables, similar to dormers, are located on the north and south sides of the home, and contain similar vents. The home is sheathed in a variety of replacement and original siding including horizontal channel siding, narrower clapboard siding, vertical wooden siding, plyboard, and what appears to be vertical wood panels. The home's primary entry, on the eastern façade, is deeply recessed due to the original full-width porch being enclosed (Figure 11). As a result, the façade has brick construction on the lower portion of the walls and wide vertical siding or wood panels on the upper portion of the walls (Figure 12). The entry stoop and steps have been covered with large, non-original tile. A metal security door obscures view of the front entry door, and additionally, ridged metal panels have been nailed over the door for security reasons. A secondary entry is located on the rear (west) elevation, which is accessed by a set of concrete steps with a metal railing. The door is obscured by a metal security door and additionally, ridged metal panels have been nailed over it for security reasons. Attached to the northwest corner of the home is a small shed roof covered with tar paper and supported by wooden posts. In this area, the home's exterior shows various types of siding indicating replacement or alteration (Figure 13). Windows have been replaced throughout the home and currently include aluminum and vinyl-sash sliders. Window size/openings have also been altered (Figure 14). Some windows have iron grilles applied over them for security reasons and some windows are currently covered with plyboard. The home's quality of materials is poor and it is in disrepair.

Figure 11 115 North Pennsylvania Avenue, Eastern Façade, View West

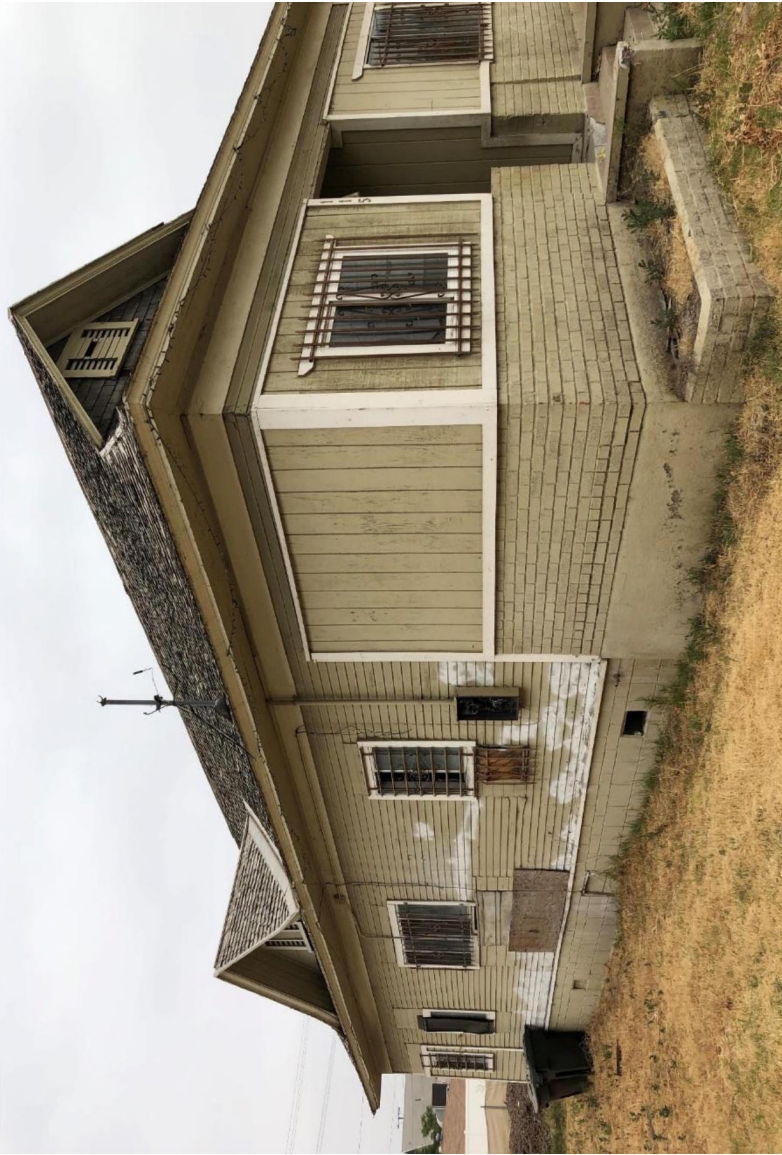
Figure 12 115 North Pennsylvania Avenue, East and South Elevations, View Northwest

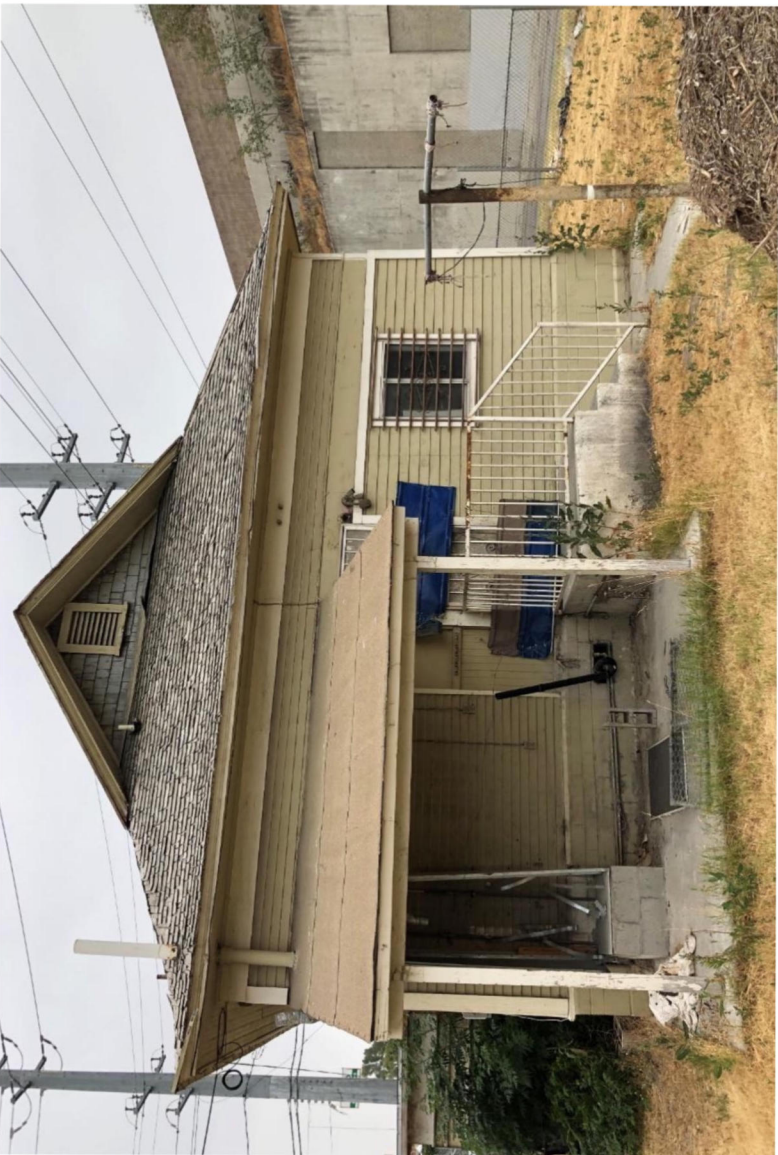
Figure 13 115 North Pennsylvania Avenue, West (Rear) Elevation, View Southeast

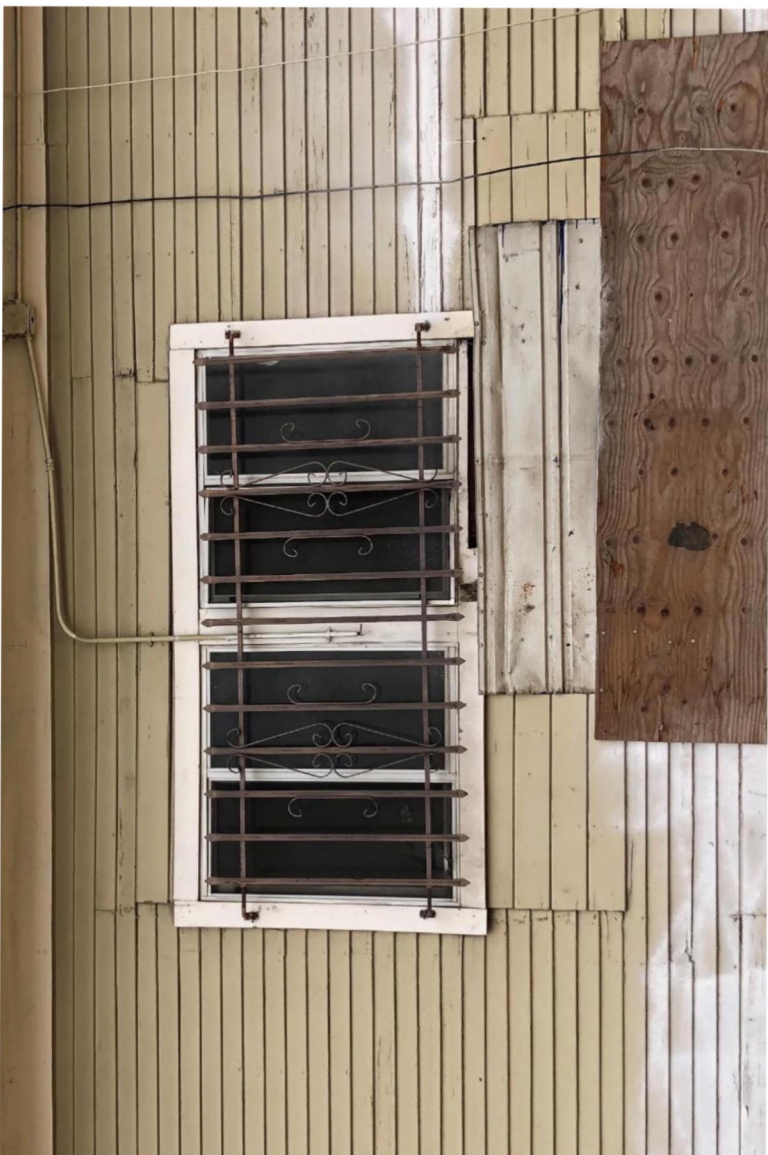
Figure 14 115 North Pennsylvania Avenue, Closeup of Window and Siding Alterations

Although City staff did not locate any building permit records for the property, visual observation indicates considerable alterations have been made to the home as previously described above. This includes replacement of the original windows, alteration of windows size/openings, addition of a shed roof on the rear (west) elevation, replacement of areas of original siding, enclosure of the original full-width front porch which created a deeply recessed primary entrance, and non-original tile on the entry stoop and steps.

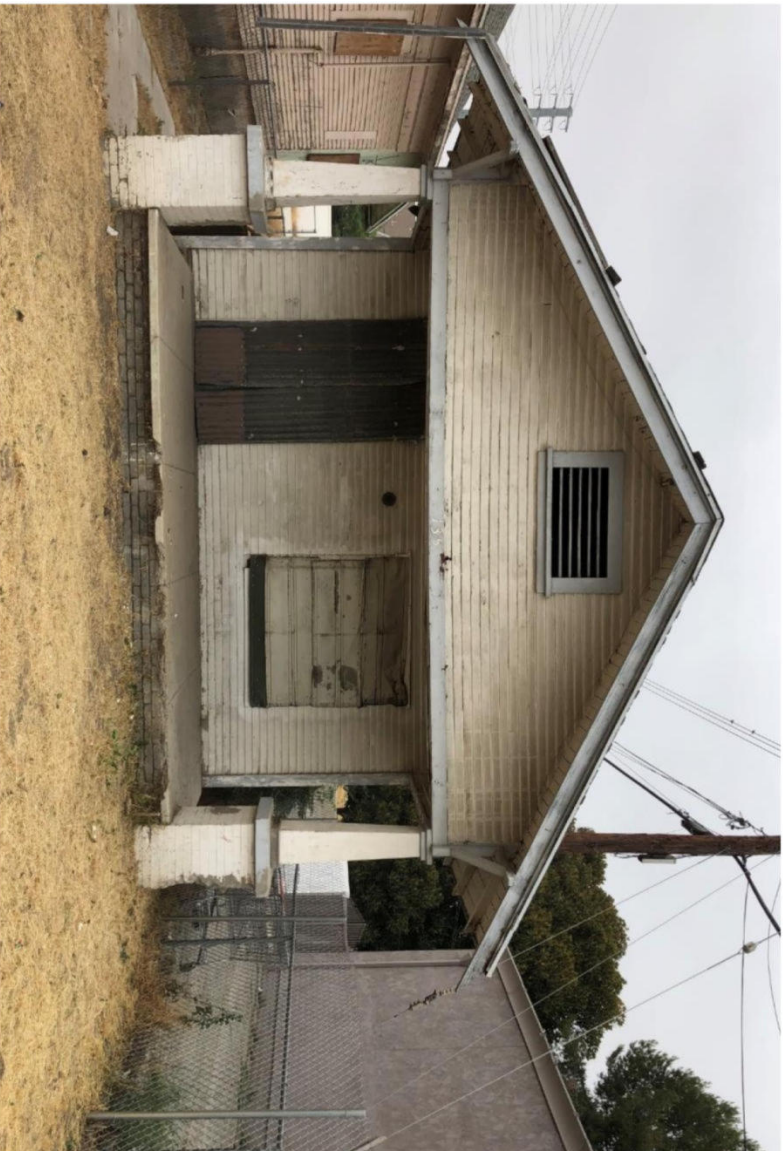
The home at 135 North Pennsylvania Avenue is situated on the northernmost parcel adjacent to the alley. Built in 1922 as a modest Craftsman-inspired bungalow, the home has a rectangular footprint and a moderately-pitched gabled roof with overhanging eaves and exposed rafter tails (Figure 16). The roof is covered with rolled roofing material. Resting on a concrete and brick foundation, the home is sheathed in horizontal clapboard and has slatted vents on the front and rear gables. Its primary entry, on the eastern façade, is accessed via a full-width, recessed porch which is supported by two tapered wooden posts resting on square brick pillars. Concrete steps are located on the south end of the porch. The primary entry door is obscured by corrugated metal panels that have been applied over it for security reasons. An addition was constructed cross the west (rear) elevation (Figure 17). It is topped by a shed roof clad with rolled roofing material, and its roof overhang creates a porch supported by square wooden posts. The addition's exterior is sheathed

Figure 16 135 North Pennsylvania Avenue, Eastern Façade, View West

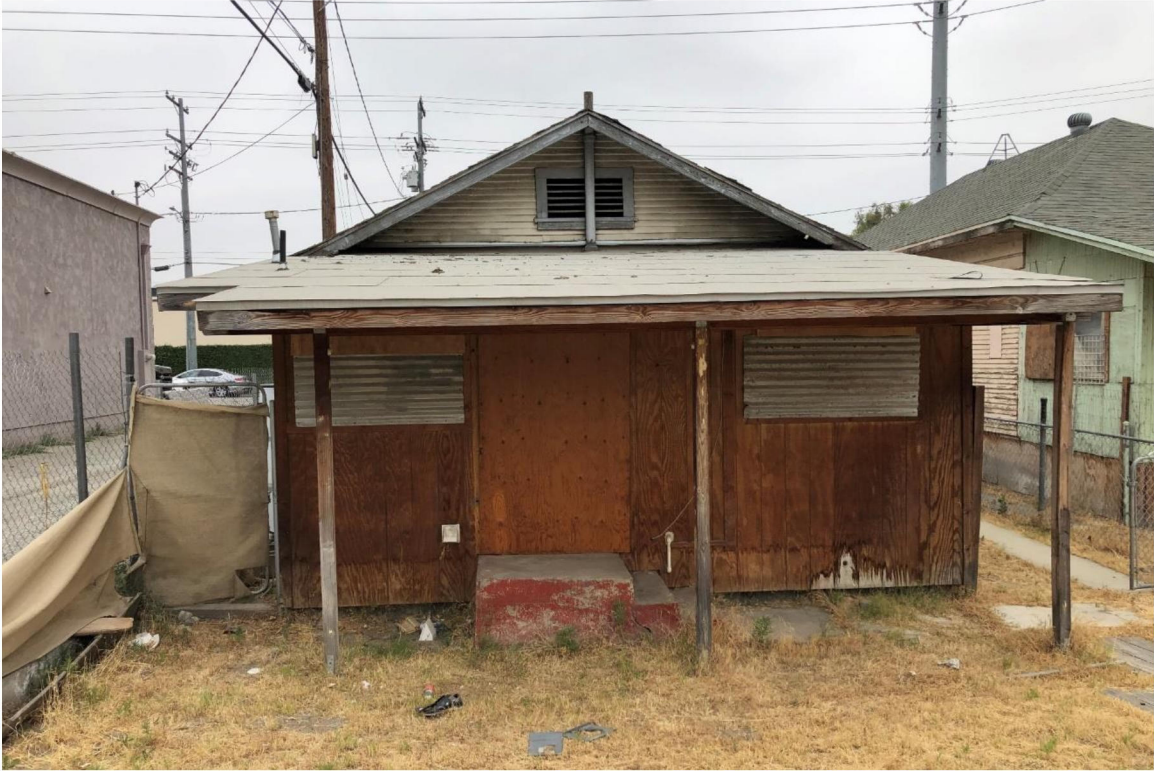
Figure 17 135 North Pennsylvania Avenue, Western (Rear) Elevation, View East

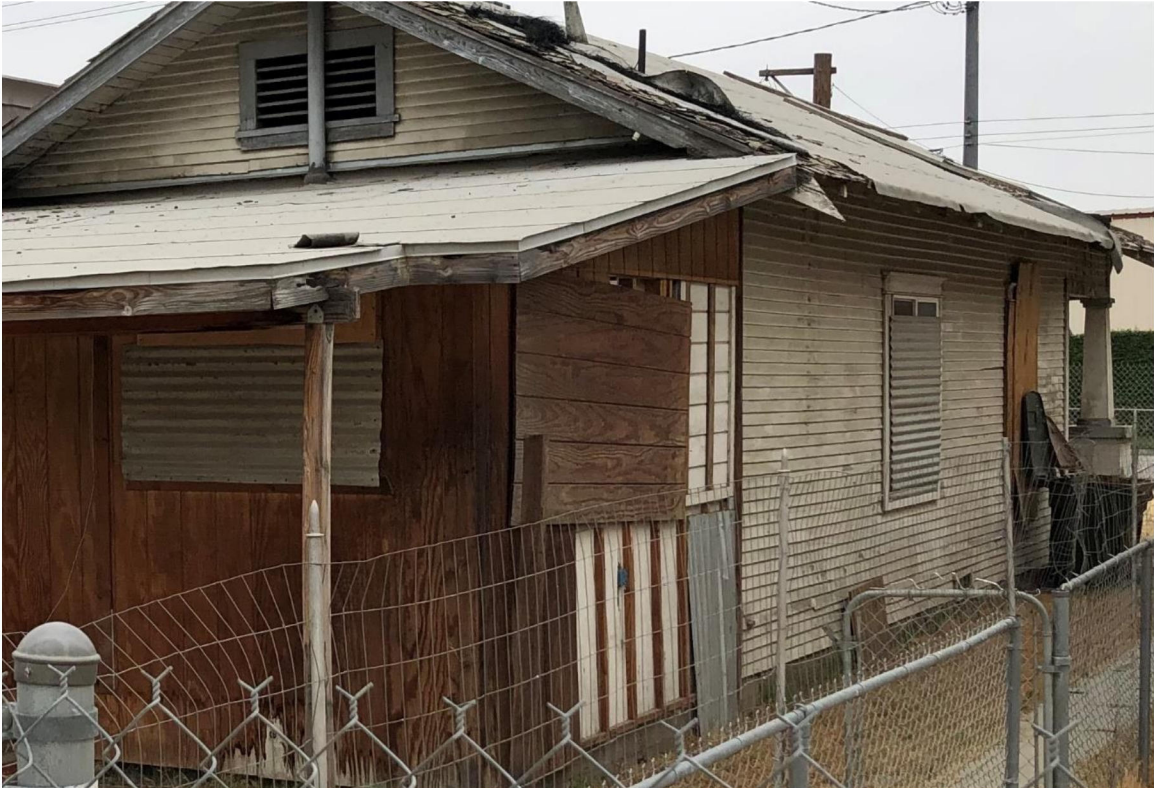
with various types of siding, including what appears to be wood panel siding, board-and-batten, and plywood (Figure 18). A secondary entry door, which is accessed via concrete steps, is covered by plywood. In some areas, vinyl-sash sliders and some of the original window surrounds are visible; however, windows are covered with ridged metal panels, corrugated metal panels and plywood for security reasons. The home's quality of materials is poor and it is in disrepair.

Figure 18 135 North Pennsylvania Avenue, Closeup of Alterations, View Northeast

Only two building permits for the property were located by City staff, one of which was to replace all the original windows in 2008. A water heater was replaced that same year (City of Colton, various). Visual observation demonstrates additional alterations were made to the home. As described above, this includes an addition at the rear of the building which is constructed with an assortment of materials.

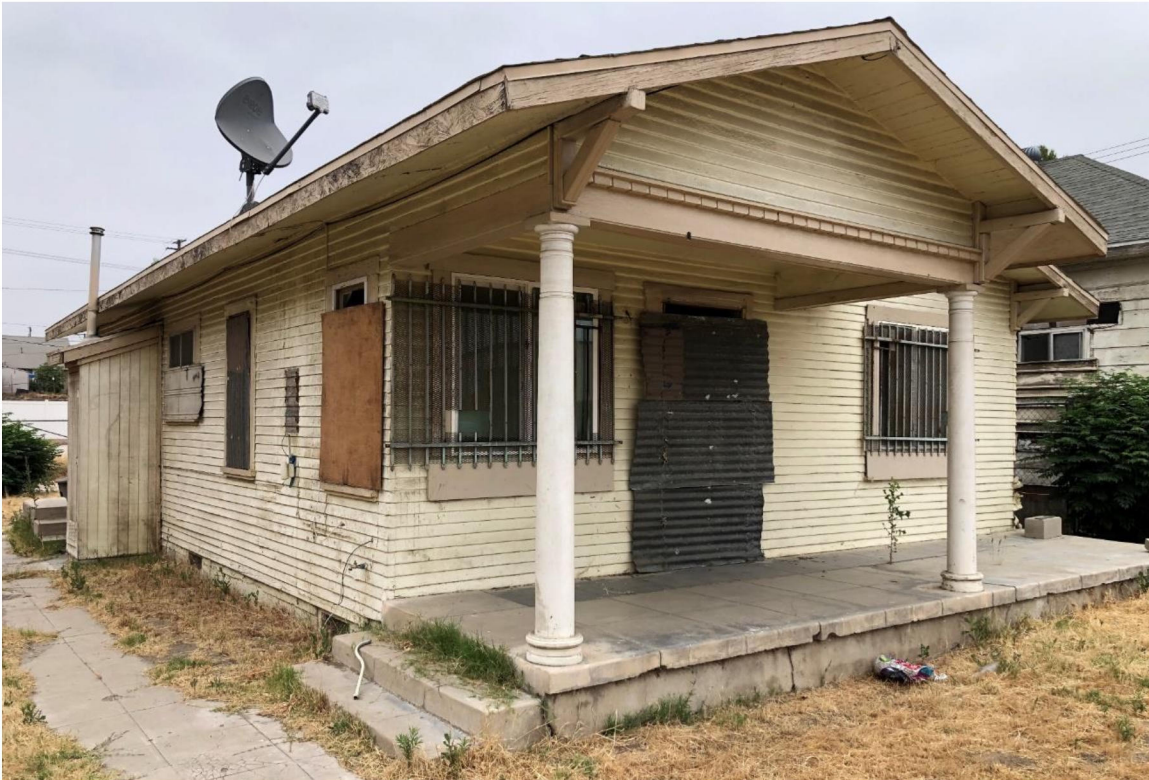
The home at 125 North Pennsylvania Avenue is situated on the central parcel which also includes 133 North Pennsylvania Avenue to the north. Built in 1926, the home has a L-shaped footprint and rests on a concrete foundation (Figure 20 and Figure 21). Its moderately-pitched gabled roof has overhanging, closed eaves and appears to be clad with composite shingles. The home is sheathed primarily in horizontal clapboard. Slatted vents are located on the east and west gables. Its primary entry, on the eastern façade, is accessed via a partial-width, projecting porch supported by Ionic columns which are likely not original. The entry door is covered by corrugated metal panels for security reasons. A secondary entry is located near the southwest corner; in this area vertical wood paneling which differs from the rest of the home indicates alteration (Figure 22). Windows include vinyl-sash sliders; some show the original wood casing. Windows are covered with metal grilles, wooden boards, corrugated metal panels and plyboard for security reasons. The home's quality of materials is poor and it is in disrepair.

Figure 20 125 North Pennsylvania Avenue, Eastern façade and South Elevation, View Northwest

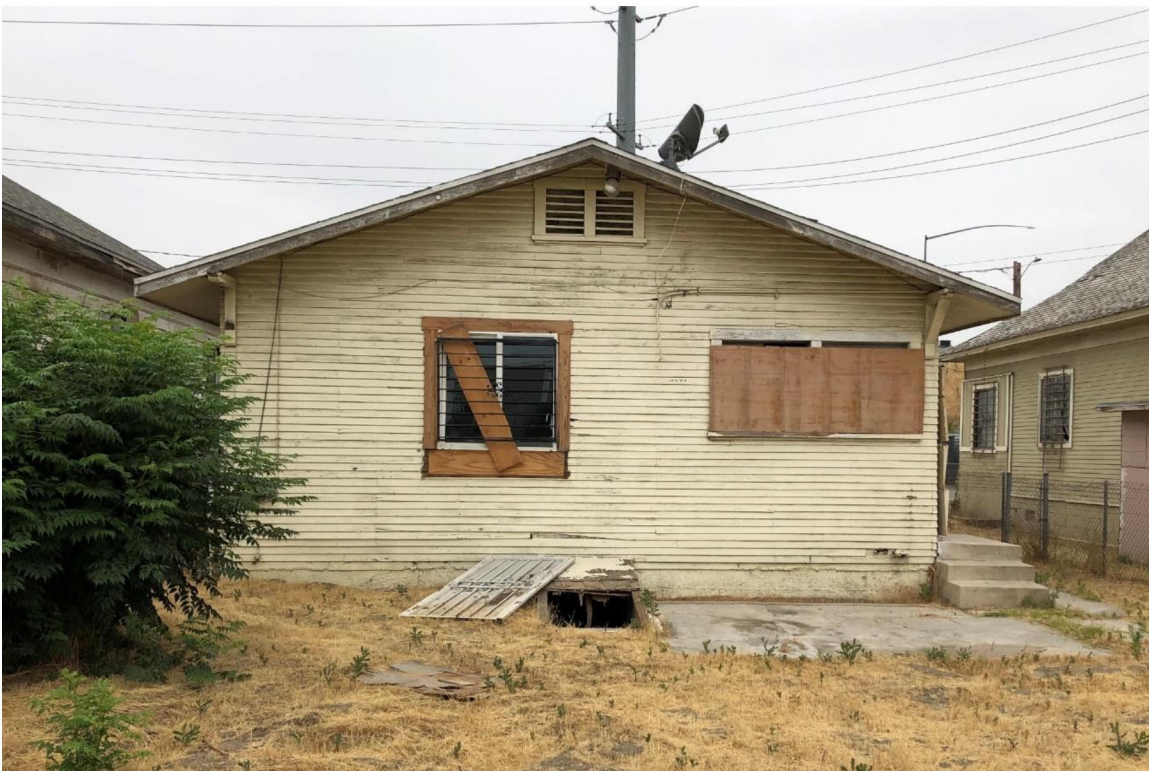
Figure 21 125 North Pennsylvania Avenue, West (Rear) Elevation, View East

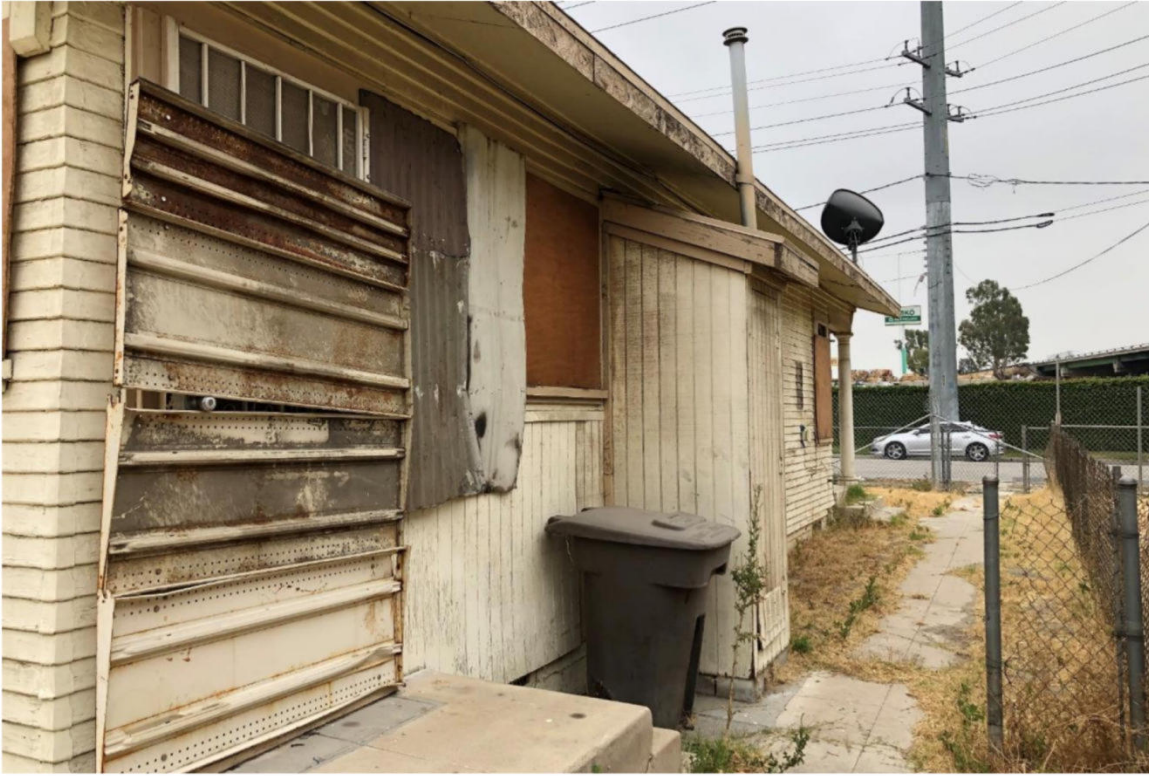
Figure 22 125 North Pennsylvania Avenue, Closeup of Alterations on South Elevation

The home at 125 North Pennsylvania Avenue was constructed in 1926 (San Bernardino County Assessor). It was the last of the four homes built on the large parcel spanning between J Street and the alley and was originally addressed as 125 North 5th Street. City staff did not locate any building permit records, and the original property owner and builder were not ascertained. However, visual observation demonstrates alterations have been made to the home as previously described above. These include: replacement vinyl-sash windows, replaced exterior siding and porch columns. Doors and windows have been covered with metal grilles, wooden boards, corrugated metal panels and plywood.

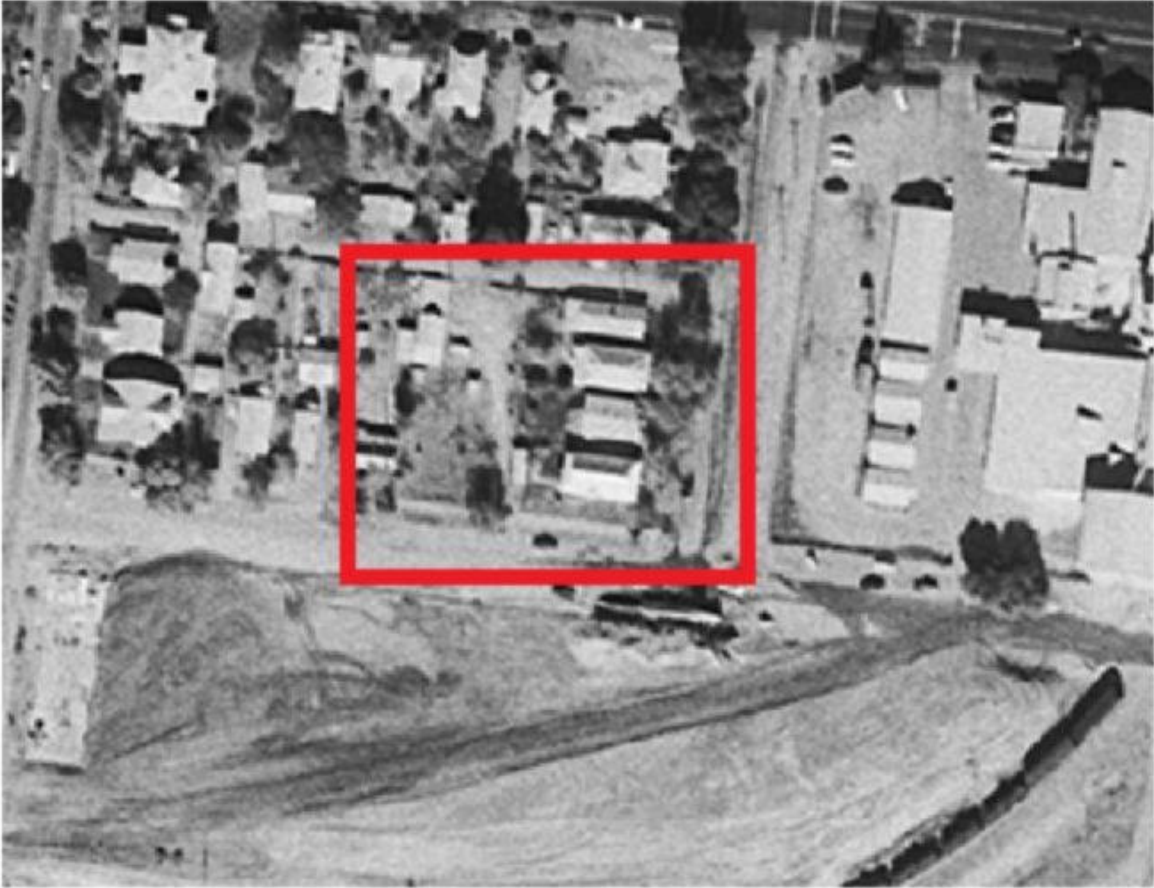
Since the time of the four homes' construction, various changes have occurred to the property and surrounding setting (Figure 23). The once larger parcel was formally subdivided into four smaller parcels at an unknown time. The various ancillary buildings and automobile garages once located to the rear (west) of the four homes were removed or demolished by the 1960s (NETRonline 1959 and 1966). Considerable changes to the properties' setting have occurred - between 1955 and 1959 Interstate 10 was constructed in close proximity to the south (approximately 60 to 175 feet away, depending on the residence), resulting in the demolition of many properties in the area of J Street (U.C. Santa Barbara Map & Imagery Lab 1955; NETRonline 1959). In addition, properties slightly to the north along I Street between 5th and 4th streets appear to have been redeveloped between 1955 and 1980 (U.C. Santa Barbara Map & Imagery Lab 1955; NETRonline 1980). More recently, in 2005, a residence at 529 West J Street was constructed 1 ½ blocks to the west as infill within the Terrace Historic District (San Bernardino County PIMS). Numerous other properties throughout The terrace District boundaries show evidence of having been altered with replacement windows, exterior stucco and additions.

Figure 23 115-135 N. Pennsylvania Ave and Ancillary Buildings on a 1955 Aerial Photo
