INITIAL STUDY/

MITIGATED NEGATIVE DECLARATION

CHARTWELL SCHOOL EXPANSION PROJECT

January 2025

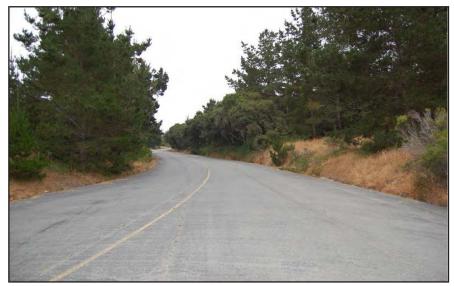
Photo #3: South facing view of Numa Watson Road from Normandy Road. (Source: BASIN, 2024)

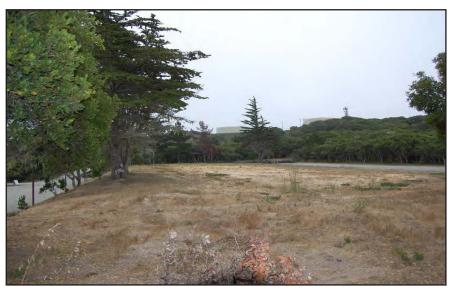
Photo #4: Southeast facing view of High School site. (Source: BASIN, 2024)

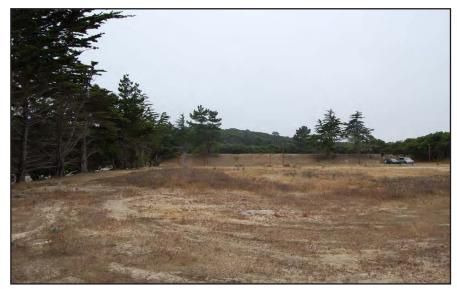
Photo #7: Southwest facing view of High School site from northwest parcel boundary. (Source: BASIN, 2024)

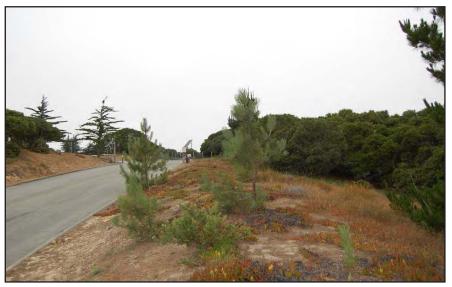
Photo #8: West facing view of future Mid-Campus parking area. (Source: BASIN, 2024)

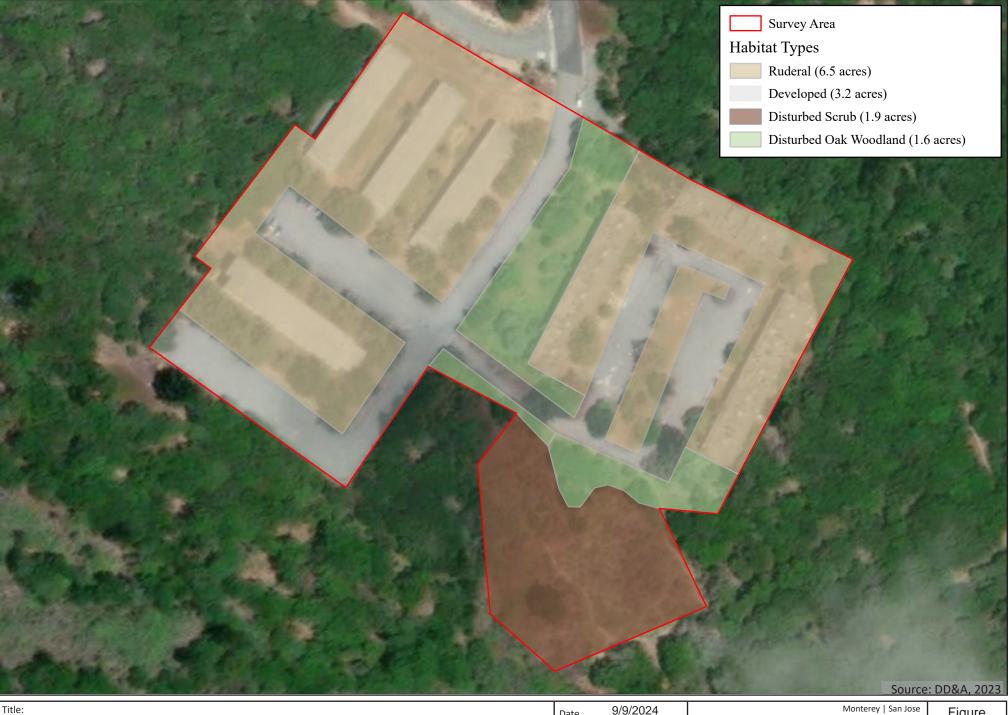
10

<u>Disturbed Scrub</u>: The structure of plant associations that comprise scrub habitat typically consist of low to moderate-sized shrubs with sclerophyllous leaves, flexible branches, semi-woody stems growing from a woody base, and a shallow root system. The scrub habitat within the survey area is highly disturbed due to the presence of non-native species, primarily iceplant and jubata grass (*Cortaderia jubata*). Non-dominant species present within this habitat type include coyote brush, California sagebrush (*Artemisia californica*), and poison oak. The southeast portion of this habitat type is situated in a topographical bowl which is lower than the surrounding topography on the southern, eastern, and western sides and tapers into the existing topography on the northern side. This area is dominated by jubata grass and supports two clusters of arroyo willow (*Salix lasiolepis*). The remaining vegetation within this area is consistent with the scrub vegetation described above. Approximately 1.9 acres of disturbed scrub habitat occur within the survey area (**Figure 10**).
