# **Water Tank 1 (Cunningham Tank) Replacement Project**

## **IS/MND Appendices**

**SUBJECT: Cunningham Water Tank Replacement Project Construction Health Risk Assessment**

### **GEOTECHNICAL DATA REPORT**

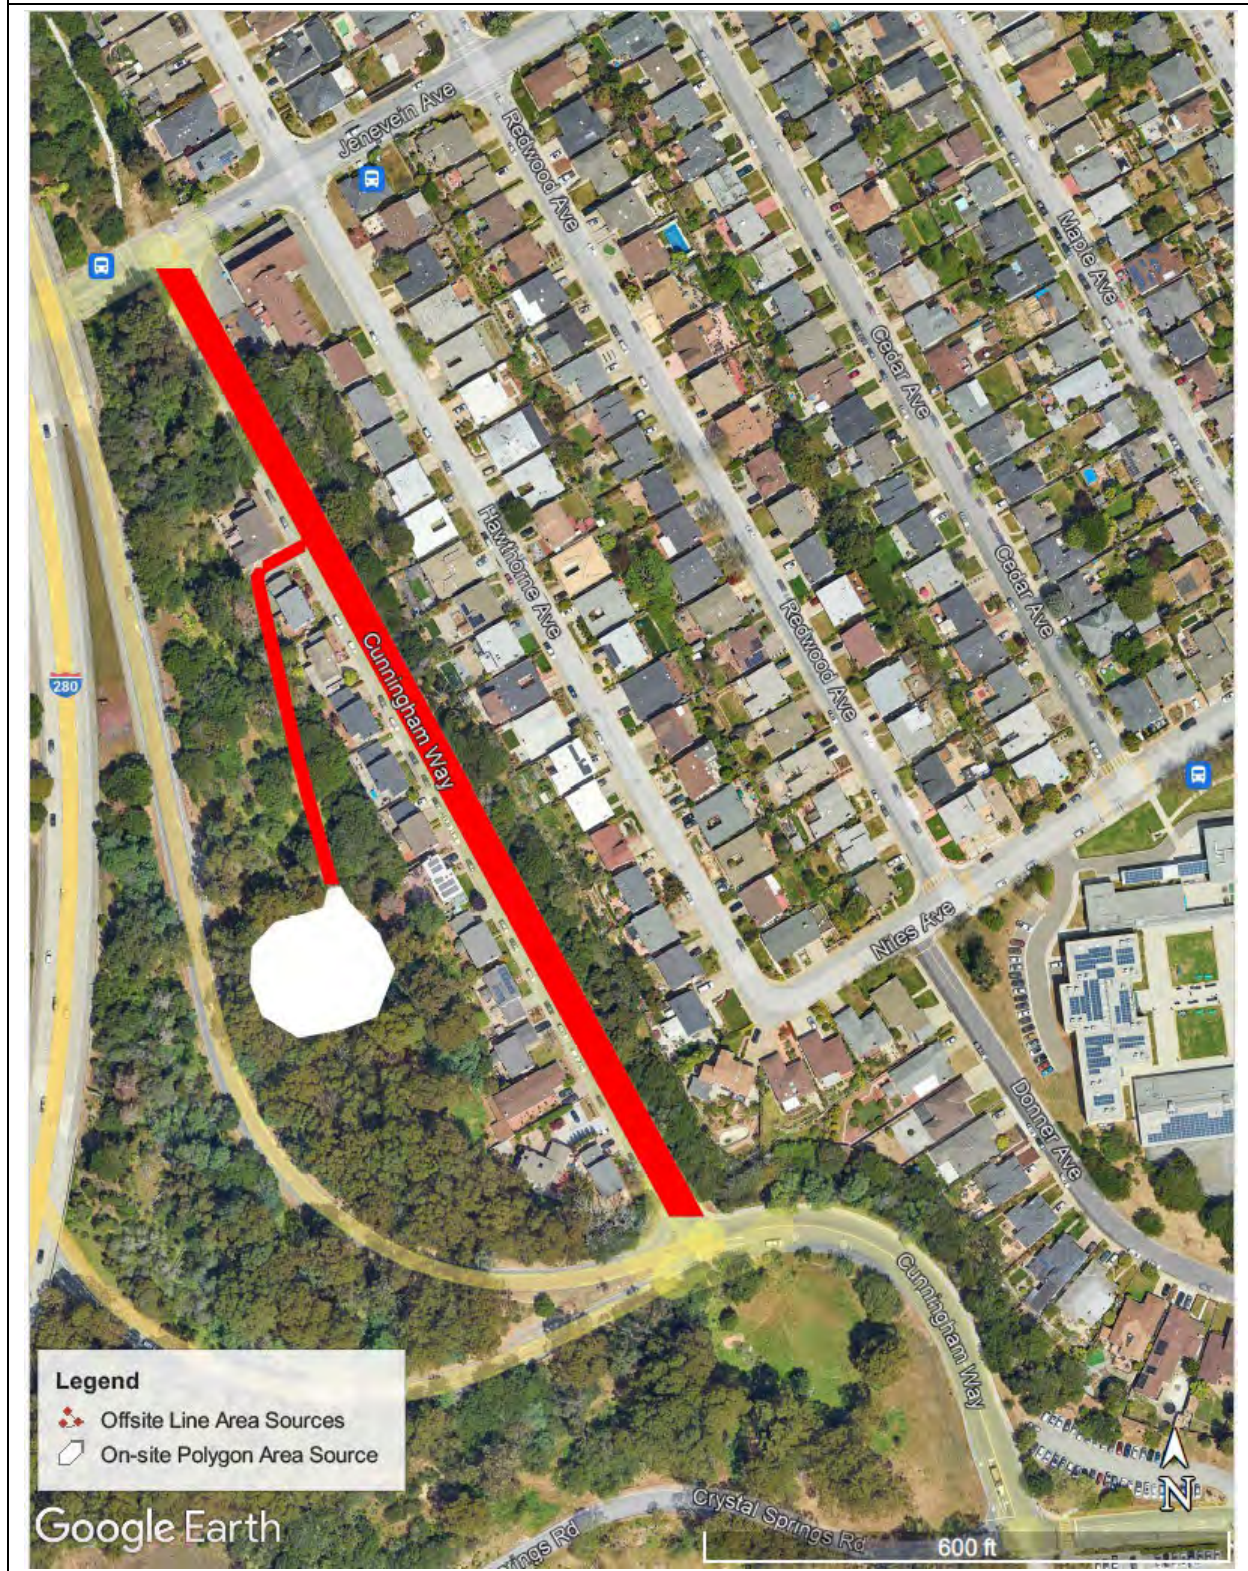
**Figure 1: Modeled Construction Emissions Sources**

On-site DPM emissions were modeled as a series of polygon area sources. Two area sources were modeled for the construction activity area, which reflect construction activities occurring at the project site during Year 1 and Year 2, respectively. The Sacramento Metro Air Quality Management District (SMAQMD) recommends a release height of 5 meters for construction equipment. Since the BAAQMD does not have a recommended release height for PM<sub>2.5</sub> exhaust emissions generated by construction equipment, the SMAQMD's release heights have been used instead (SMAQMD 2013). Two percent of the CalEEMod estimated off-site emissions were added to each polygon area source in order to account for any on-site truck idling during construction activity.

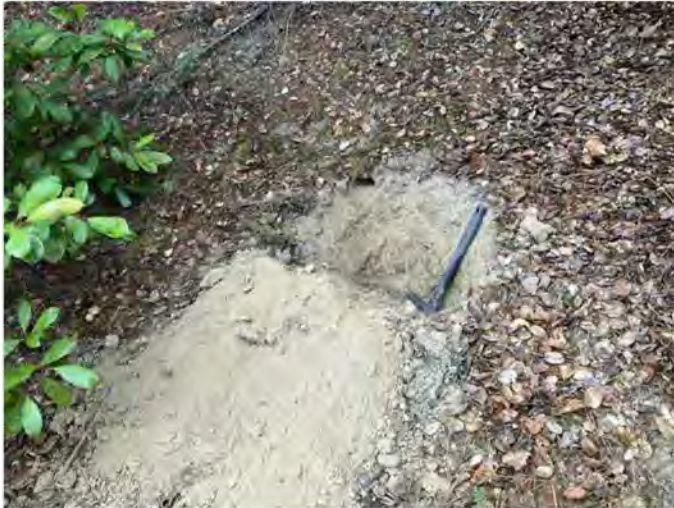
#### Test Pit TP1

Elevation 223 ft

0-1.5 ft Grey to mottled yellow-brown SILTY CLAY with sand (CL-SM), very stiff to stiff, dry, occasional hard greenstone gravels, porous, rootlets. (Colluvium).

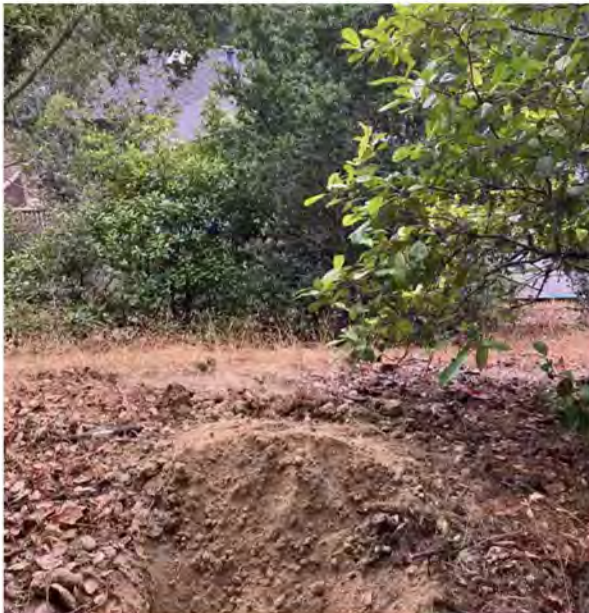
#### Test Pit TP2

Elevation 220 ft

0-1.0 ft Light brown to tan silty SANDSTONE, friable, moderately weathered, dry, fine grained, massive with no relic bedding, minor rootlets (Colma Formation), [consistency of silty sand]

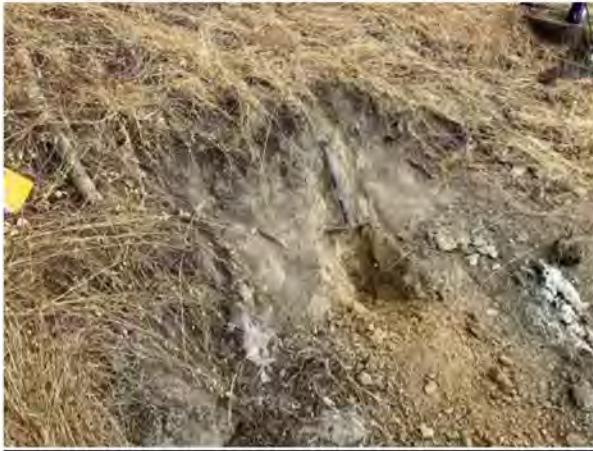
Test Pit TP3 (coincident with ENGEO boring 1-B1)

Elevation 198 ft

0-1.5 ft Light grey to brown sandy SILTY CLAY (CL), stiff to very stiff, dry, fine grained sand with minor rootlets

1.5-2.0 ft Yellow brown SILTSTONE , weak to friable, low hardness, moderately weathered, abundant iron oxide coatings. (Colma Formation)

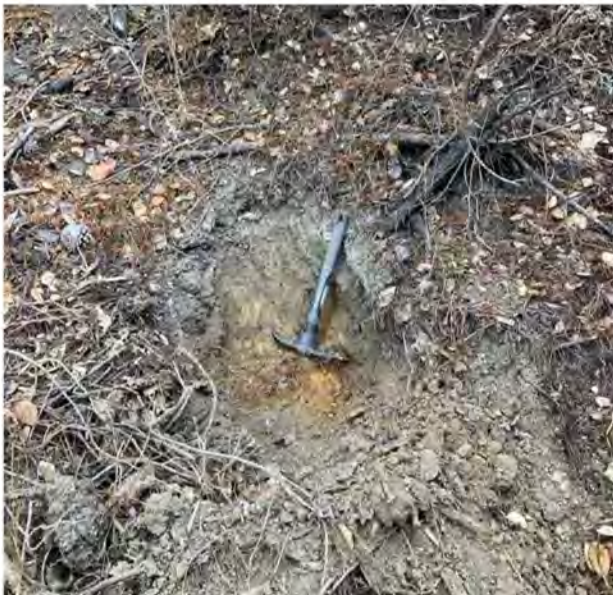
Test Pit TP4

Elevation 206 ft

0-0.5 ft Light grey SILTY CLAY (CL), very stiff, dry (colluvium?)

0.5 to 1.5 ft Orange to red brown SANDSTONE , weak to moderately hard, moderately weathered, fine to medium grained, rootlets (Colma Formation, Qc)

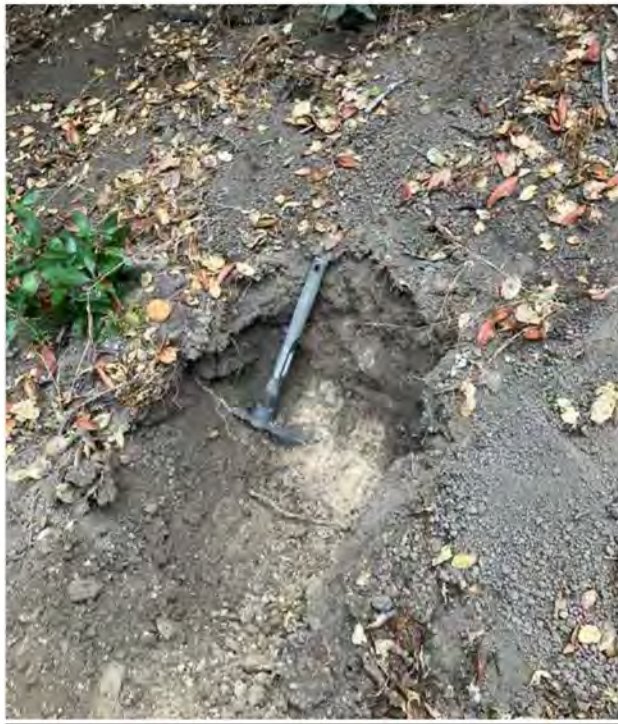
Test Pit TP5

Elevation 225 ft

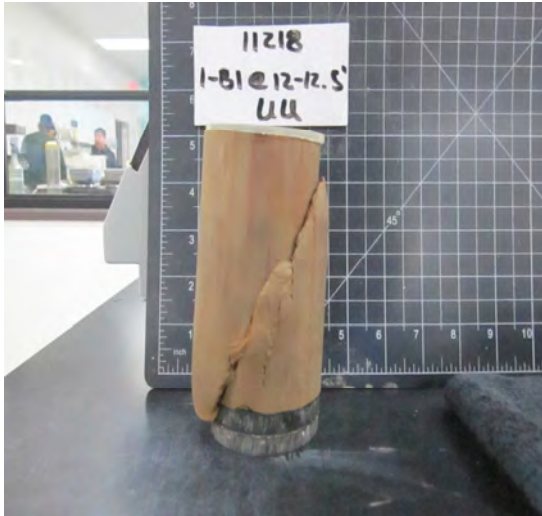
# ISOTROPIC UNCONSOLIDATED UNDRAINED TRIAXIAL REPORT

## ASTM D2850

**CLIENT:** Lee & Ro, Inc.  
**PROJECT NAME:** Cunningham Tank No. 1 Truck Turn  
**PROJECT NO:** 11218.001.000 PH001  
**PROJECT LOCATION:** San Bruno, CA  
**REPORT DATE:** 6/27/2023  
**TESTED BY:** O. Espinoza  
**REVIEWED BY:** W. Miller
