**REVISED JURISDICTIONAL DELINEATION WITH  
LEAST ENVIRONMENTALLY DAMAGING PRACTICAL ALTERNATIVE FOR THE CITY OF  
MONROVIA HIGHLAND DESILTING BASIN AND 3 RESIDENTIAL UNITS**

±7.8 Acre Property, ±7.8 Acres Surveyed

AIN 8503-013-004, City of Monrovia, Sections 22 & 23, Township 1 North,  
Range 11 West, USGS Mount Wilson 7.5' Topographic Quadrangle Map

**Report Date:** September 11, 2019, Updated May 15 2024

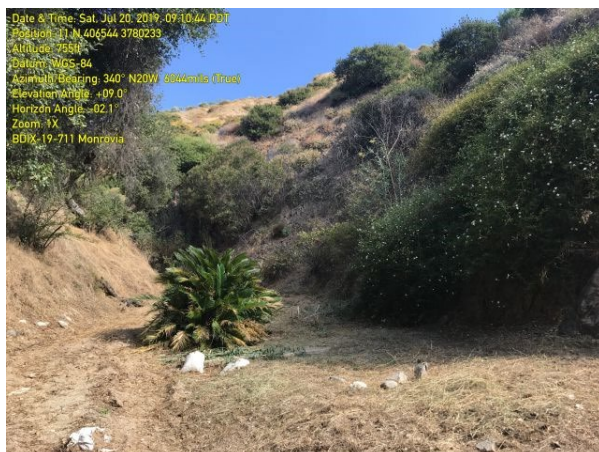
Photo 11: (904) Photo from the outbuilding facing NNW. View up a natural small canyon and drainage. No banks and beds visible. Steep slopes of chaparral visible.

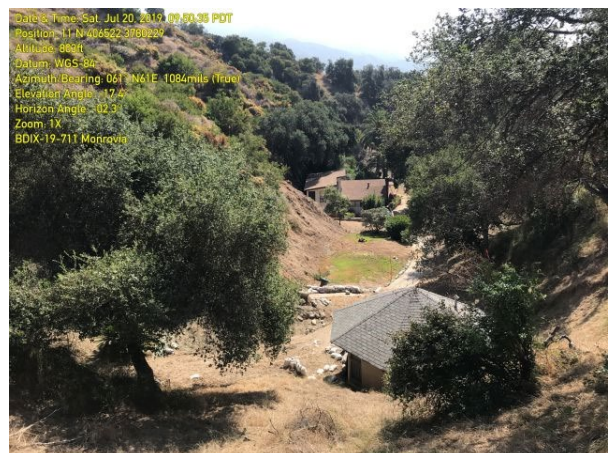
Photo 13b: (916) Photo from the SW project area facing ENE. Showing the very steep terrain and mix of oaks and chaparral.
