# PHASE I ENVIRONMENTAL SITE ASSESSMENT AND SUBSURFACE INVESTIGATION

**3315 SIERRA ROAD**  
**SAN JOSE, CALIFORNIA**

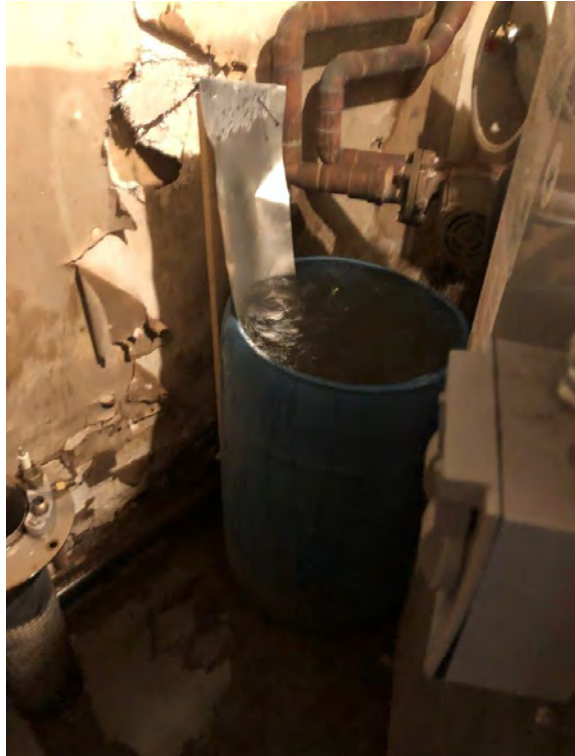
Photo 11: View of water damage and a 55-gallon drum full of condensate water located behind the boiler.

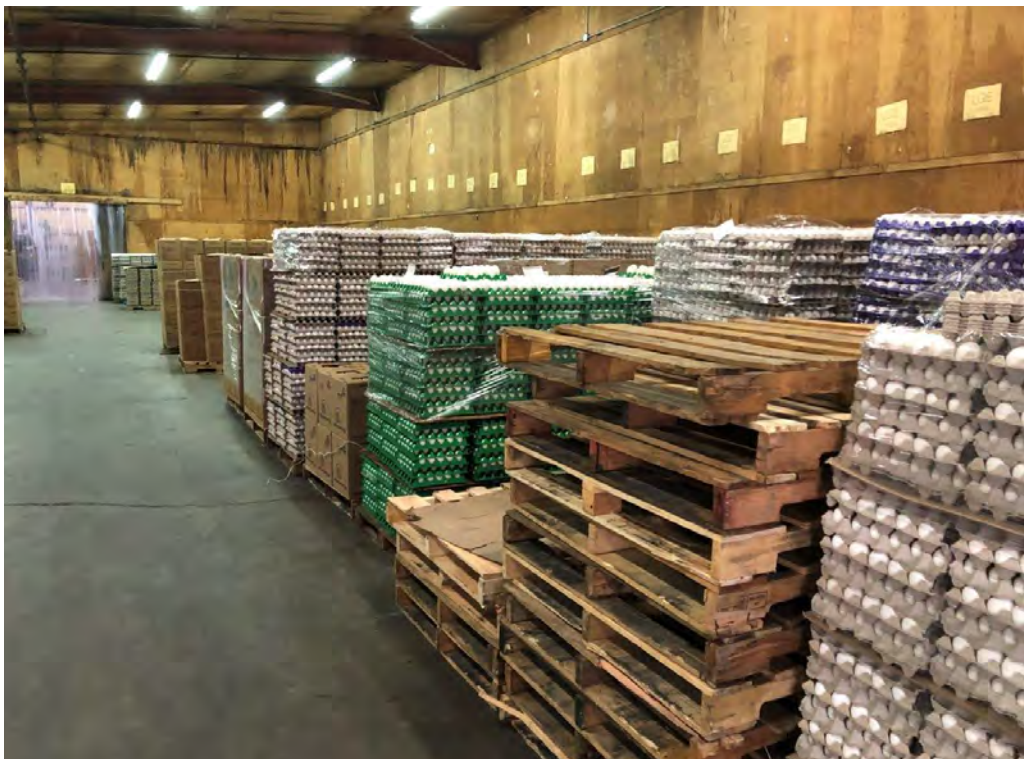
Photo 12: View inside of the largest refrigeration room located in the eastern portion of the processing warehouse.

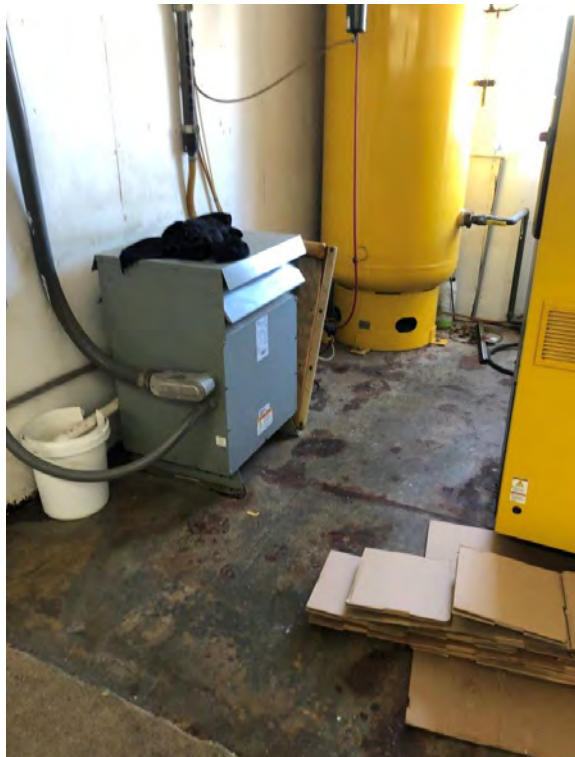
Photo 18: Air compressor room includes an air-compressor water separator, condensate bucket, and hydraulic oil storage. Note floor staining.

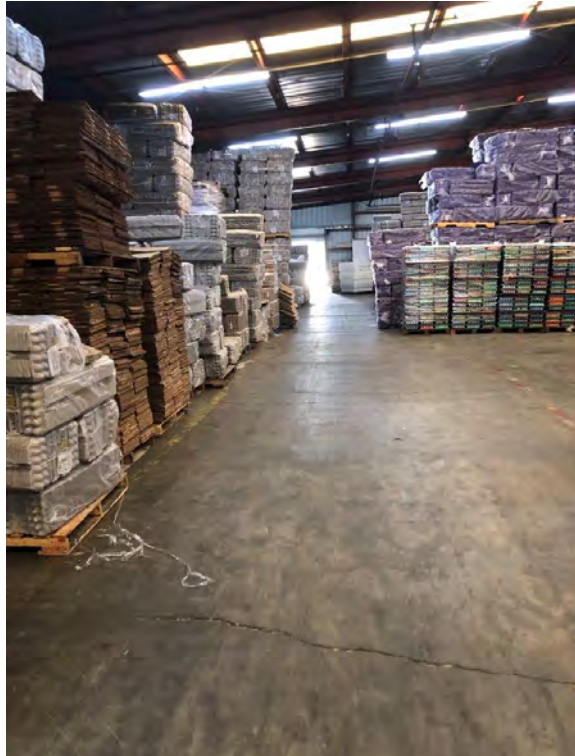
Photo 19: View inside of egg carton and miscellaneous storage area located in the northern portion of the processing warehouse.

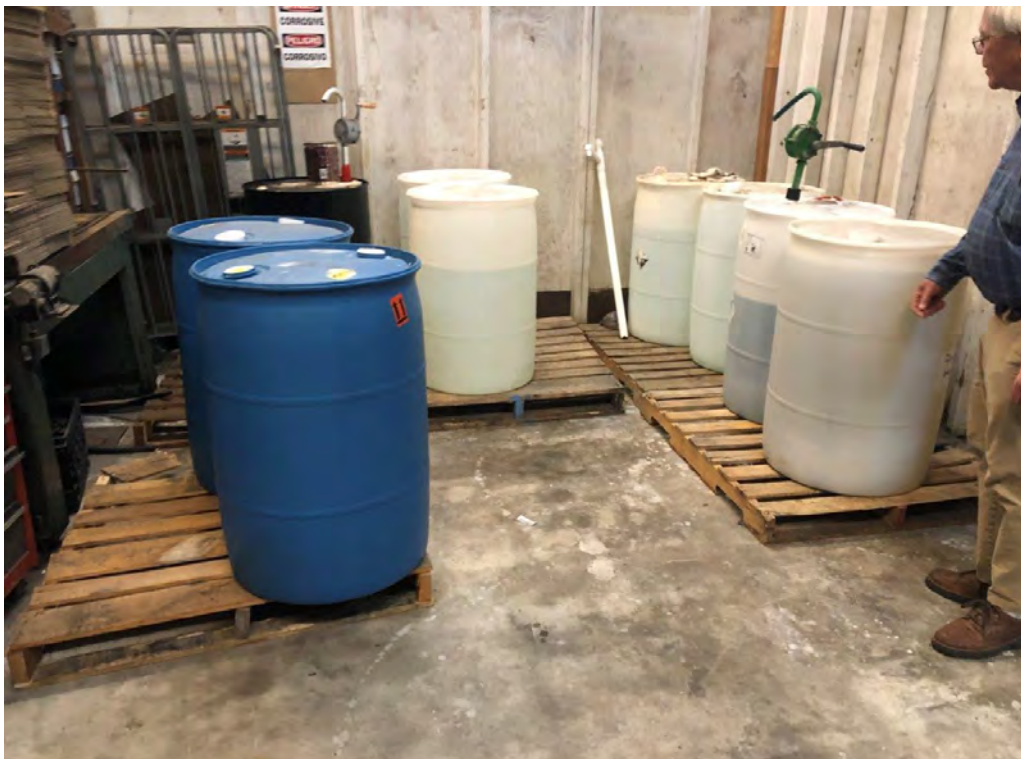
Photo 20: Hazardous materials storage area located in the northeast portion of the processing warehouse. Materials stored in 55-gallon drums include acid-wash, bleach, mineral oil, and hydraulic oil.

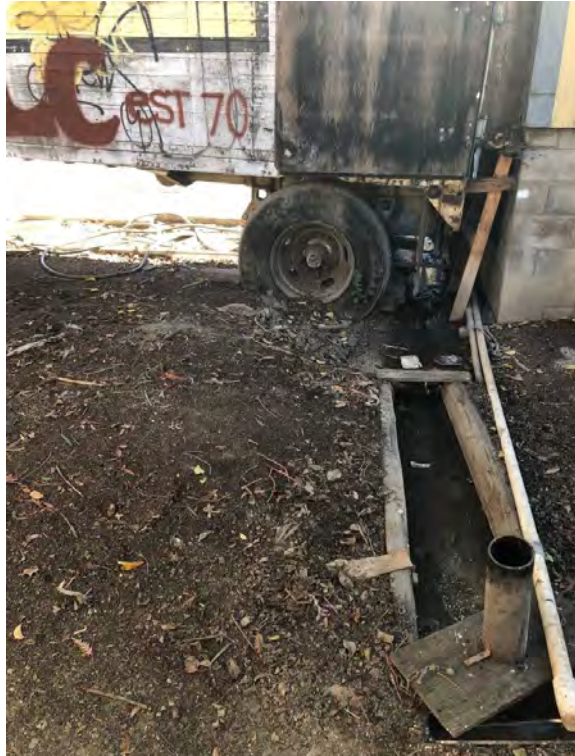
Photo 21: View of loading dock drain, reportedly to the sanitary sewer, located at the northern corner of the processing warehouse.

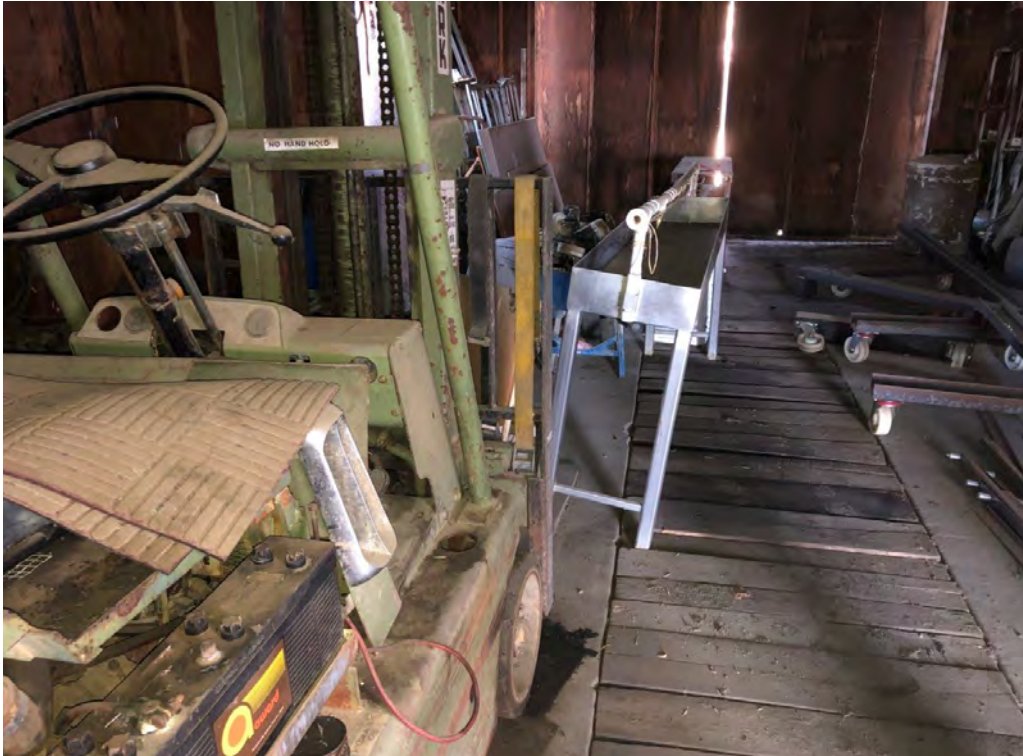
Photo 23: View inside of the former vehicle maintenance building. Note the wooden boards over the concrete oil change pit and the forklift with a minor leak to the concrete floor.

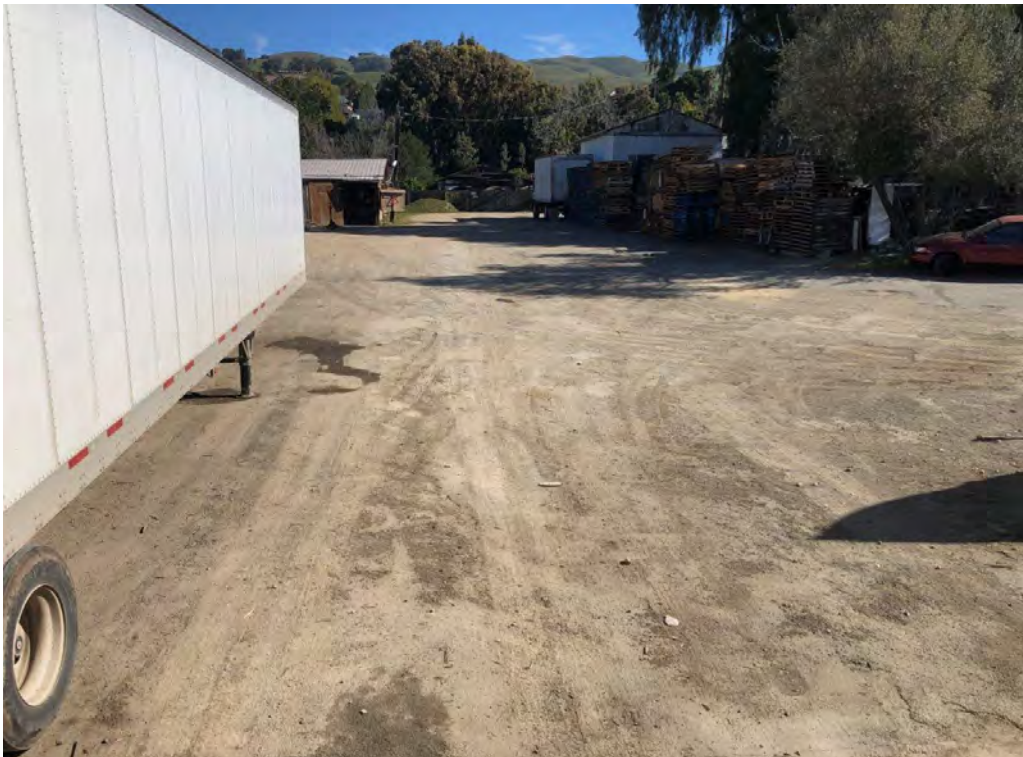
Photo 24: View looking east from the loading dock.

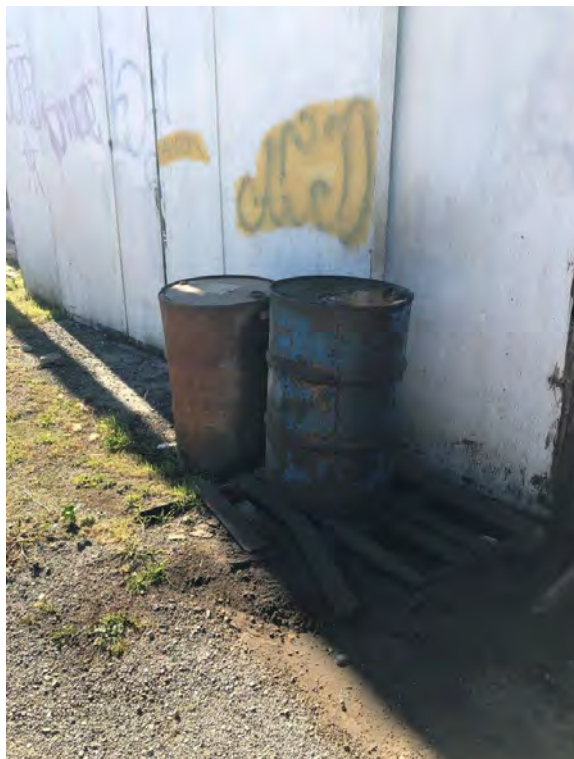
Photo 30: View of deteriorated drums storing unknown contents located adjacent to the former vehicle maintenance building.

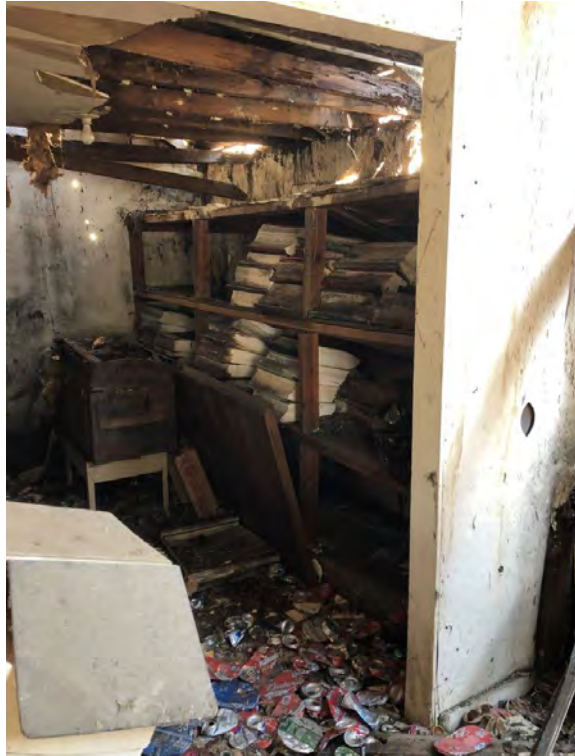
Photo 31: View inside the former file storage building, note the extensive water damage and debris.

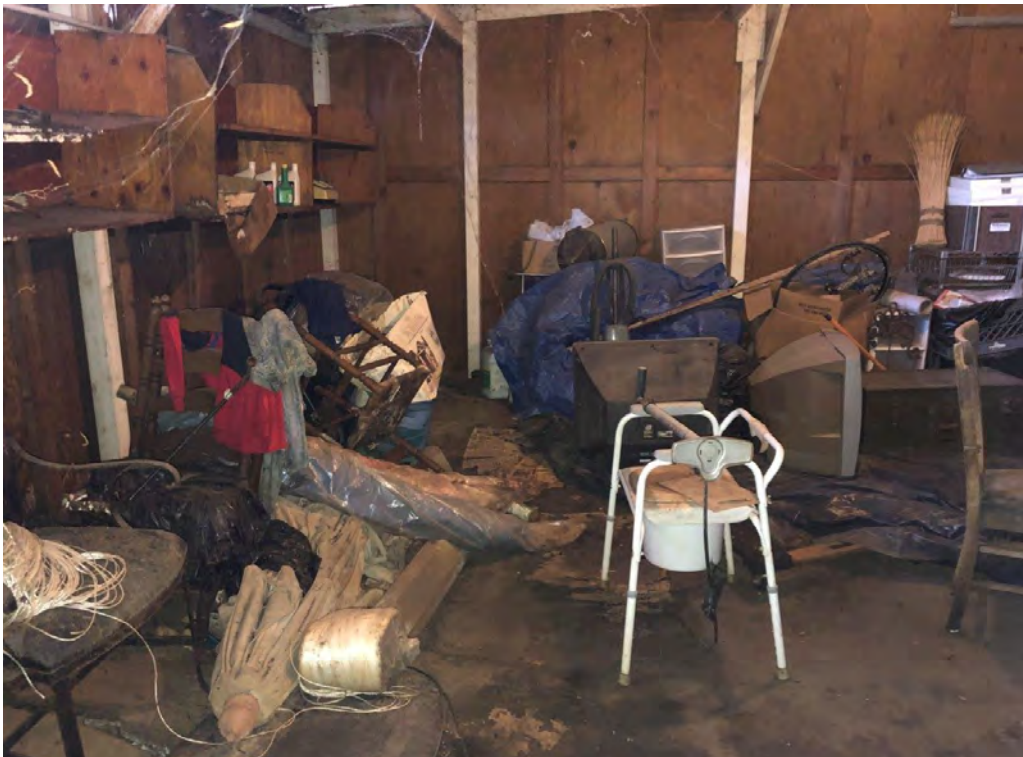
Photo 32: View of miscellaneous storage in the garage in the residence. Note floor staining.

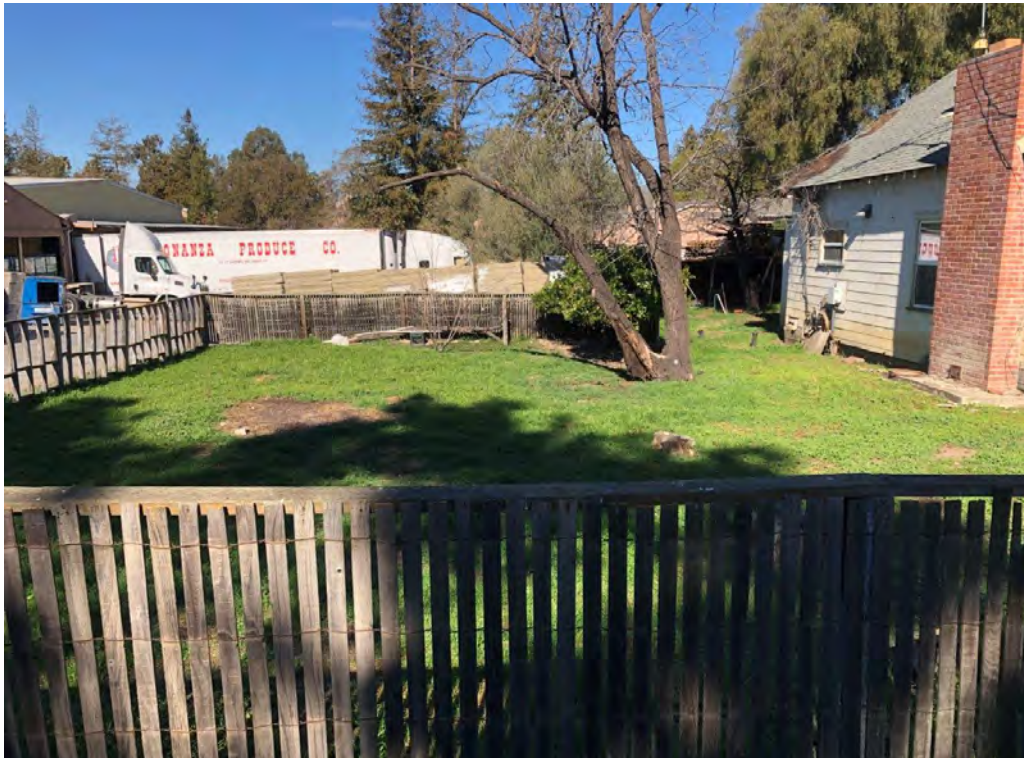
Photo 33: Approximate location of the septic tank, adjacent to the large tree. Note the vent pipes on the right of the photo.
