**Appendix A:**  
**Air Quality/Greenhouse Gas Modeling Data**

# 1000 Palms Channel Detailed Report

# Biological Resources Assessment Thousand Palms Channel Improvement Project

MAY 2023, REVISED JUNE 2024

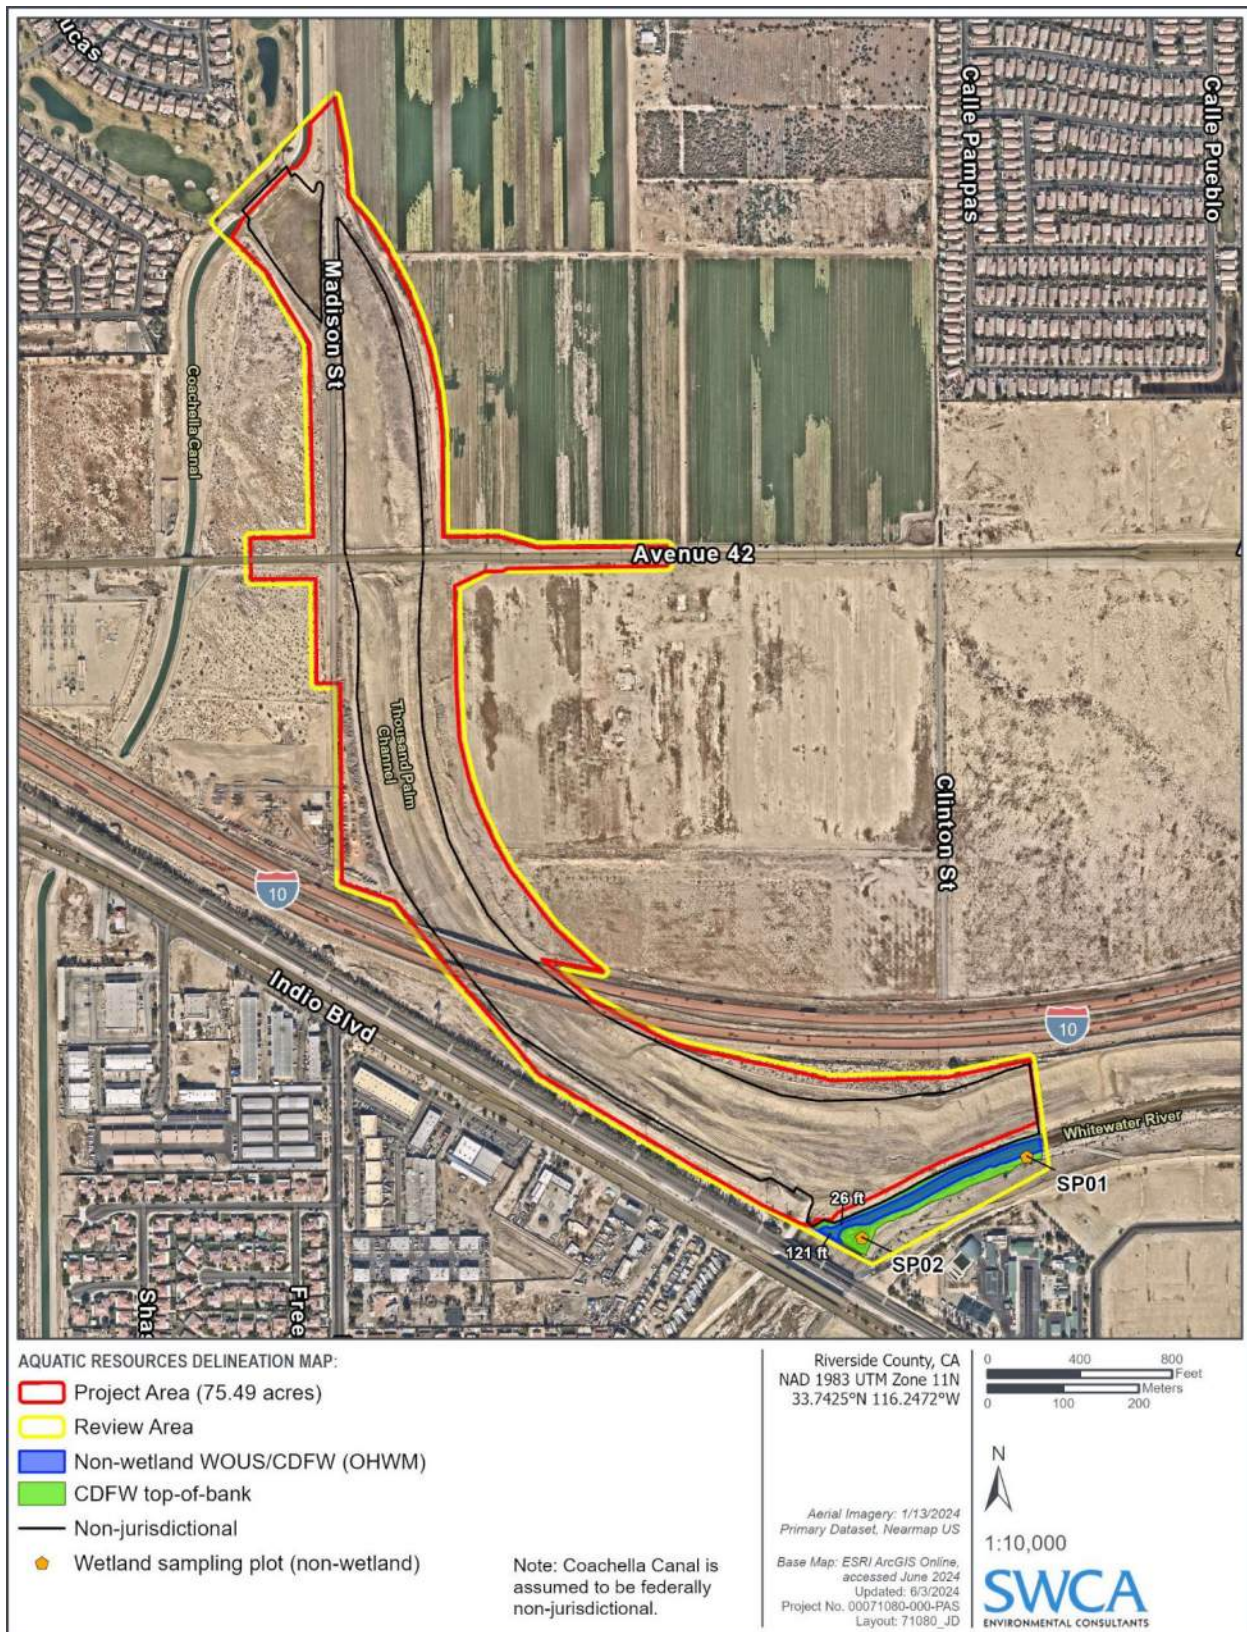
Figure 4. Aquatic resources inventory within Review Area and Project Area, and wetland sampling plots.

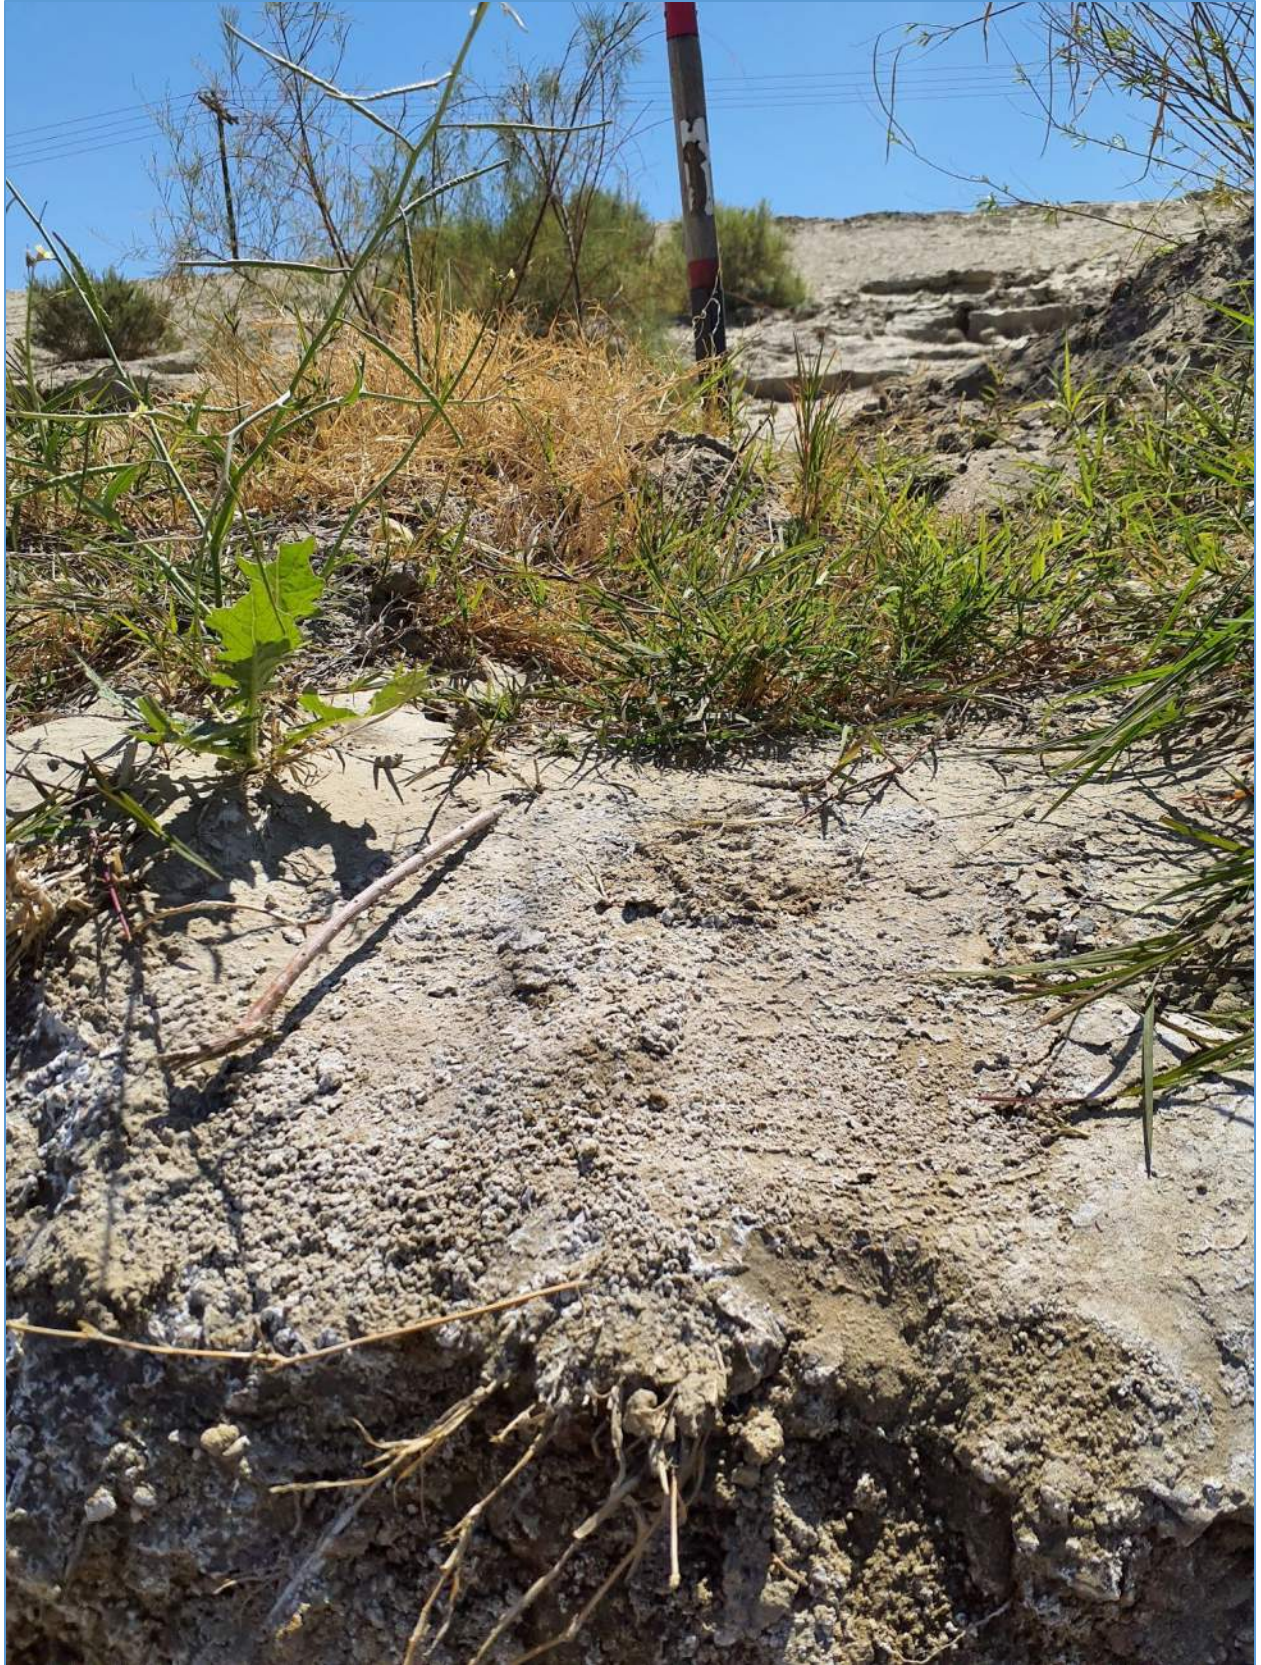
**Photo 26. Salt crust at SP01 plot, view facing southeast.**

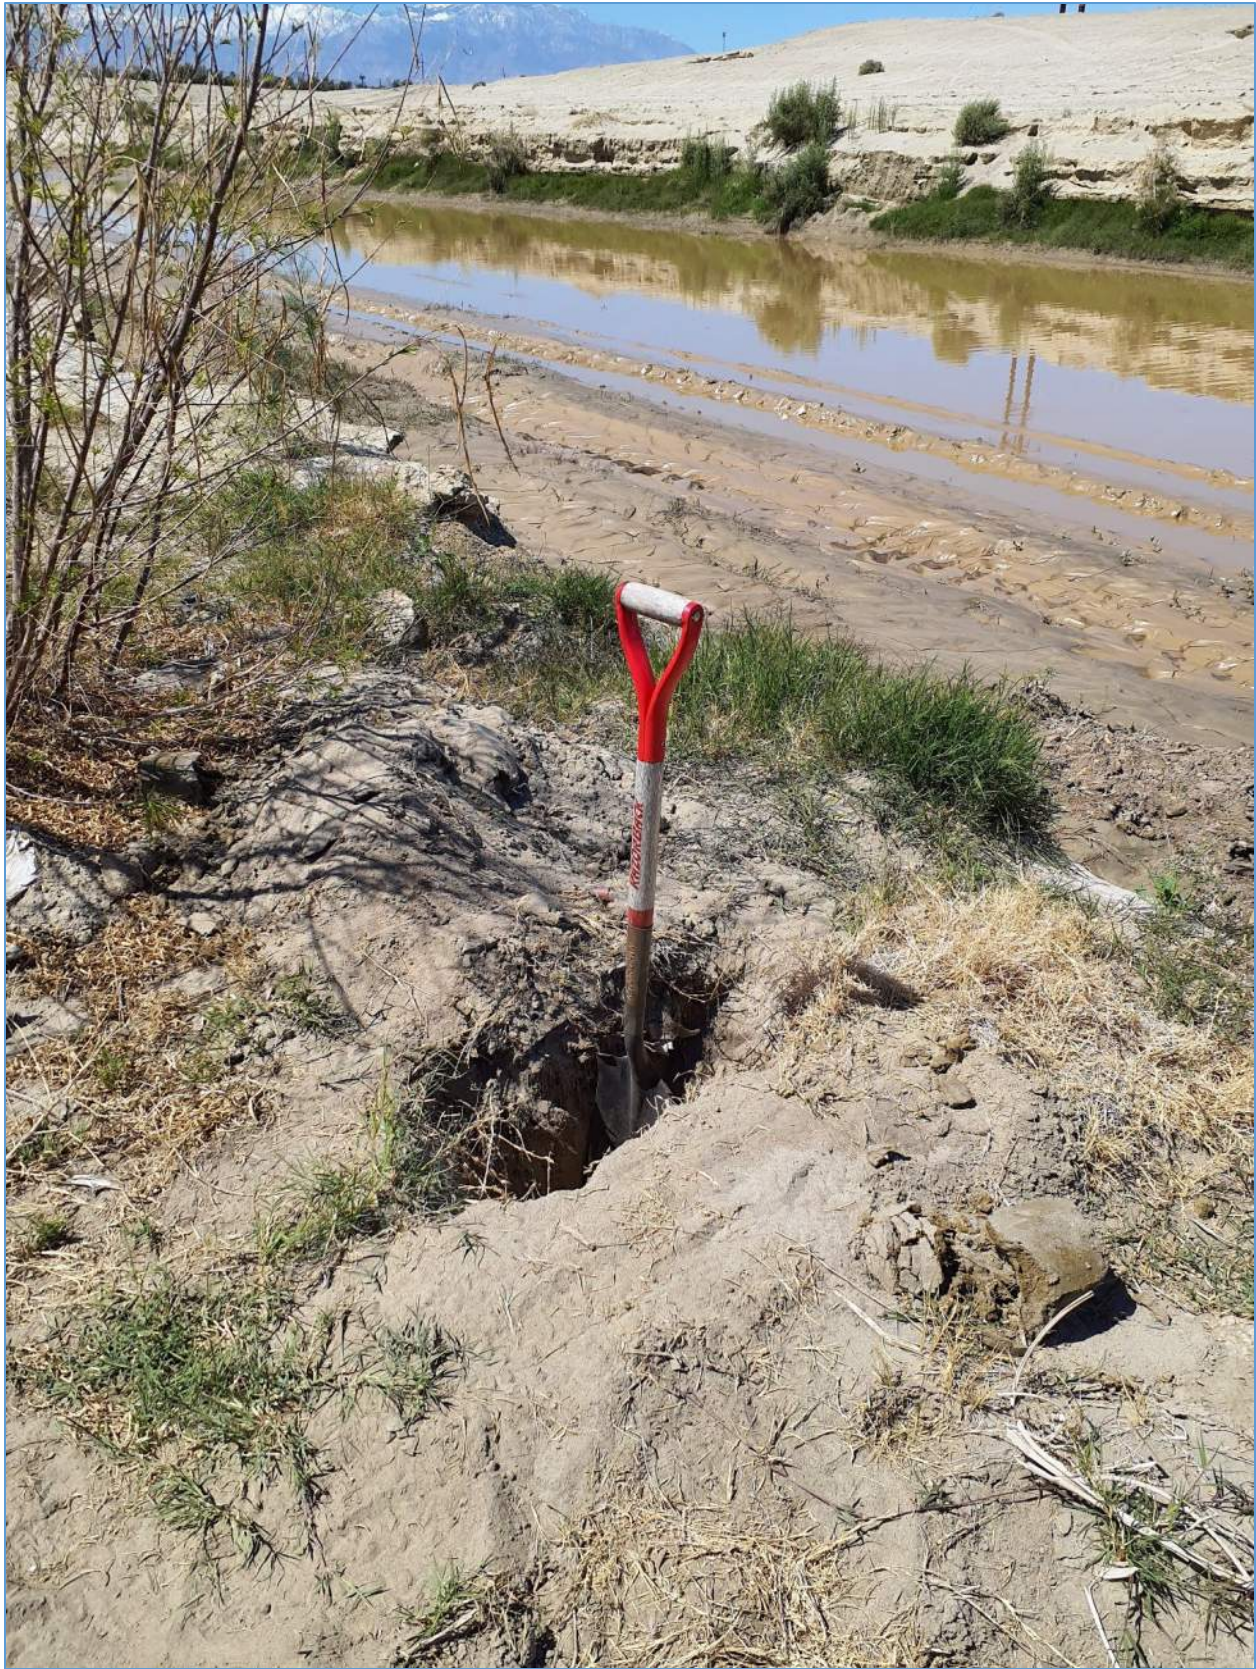
**Photo 27. SP01 soil test pit overview, facing northwest.**

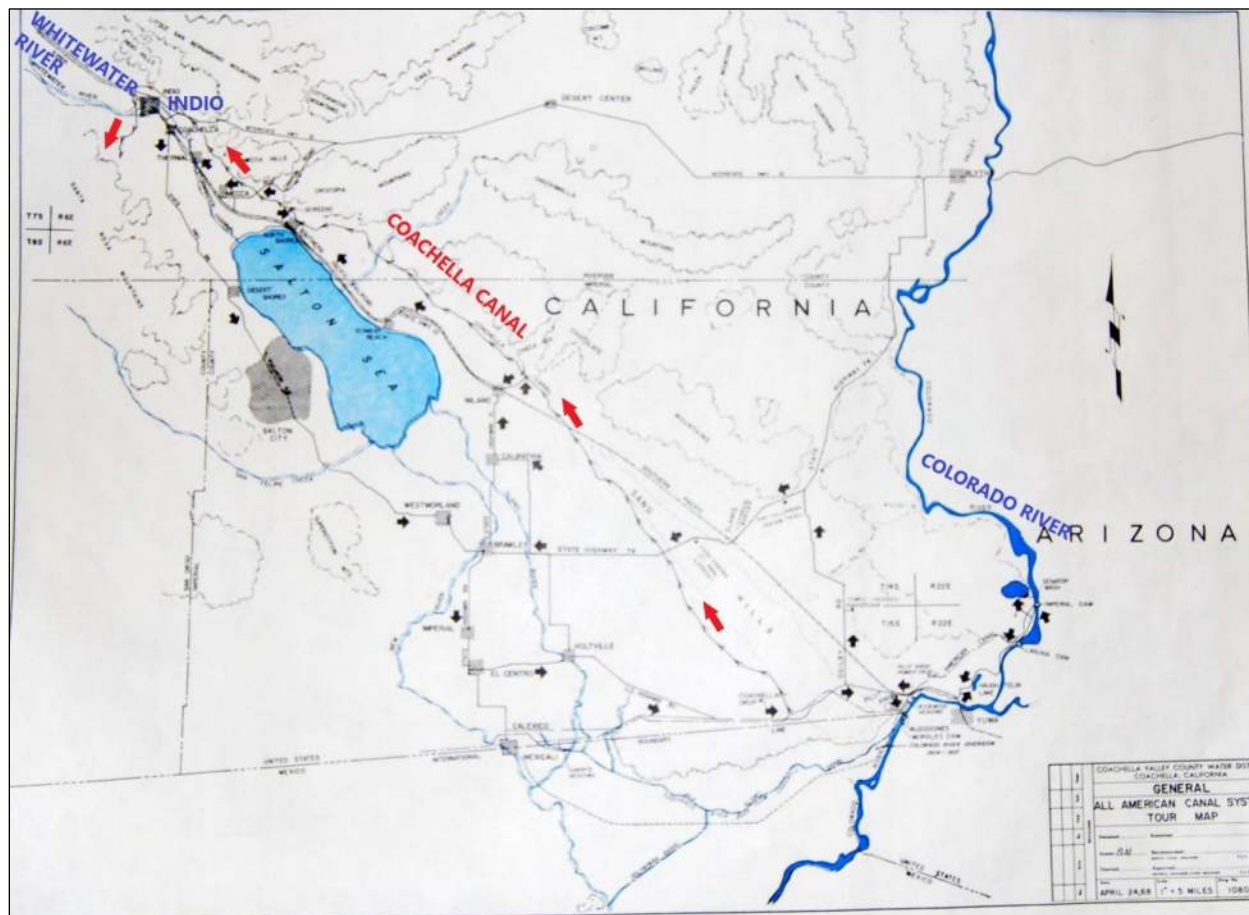
**Figure 6. All-American Canal System Map dated 1968. Red arrows depict the Coachella Canal traveling to Indio and then curving toward southwest (Source: CVCWD 1968).**

In order to deliver water to valley farms, an underground distribution system was built between 1948 and 1954 consisting of 500 miles of concrete pipelines. Nearly 80,000 acres were reached through a system of 80 distribution laterals. The system was “the first of its type and magnitude constructed by the Bureau of Reclamation” (CVWD 2018). Agriculture continued to grow in the Coachella Valley during the time the All-American Canal and distribution system were being constructed, but in the years immediately after the canal’s completion, the amount of irrigated acreage dramatically increased. Area farmers also benefitted from a drainage system developed in the 1950s and 1960s which carried away salts found in shallow groundwater; too much salt buildup would make the soil unusable. This drainage system consisted of a network of pipelines which, as of 2018, totaled approximately 2,500 miles in length (CVWD 2018).

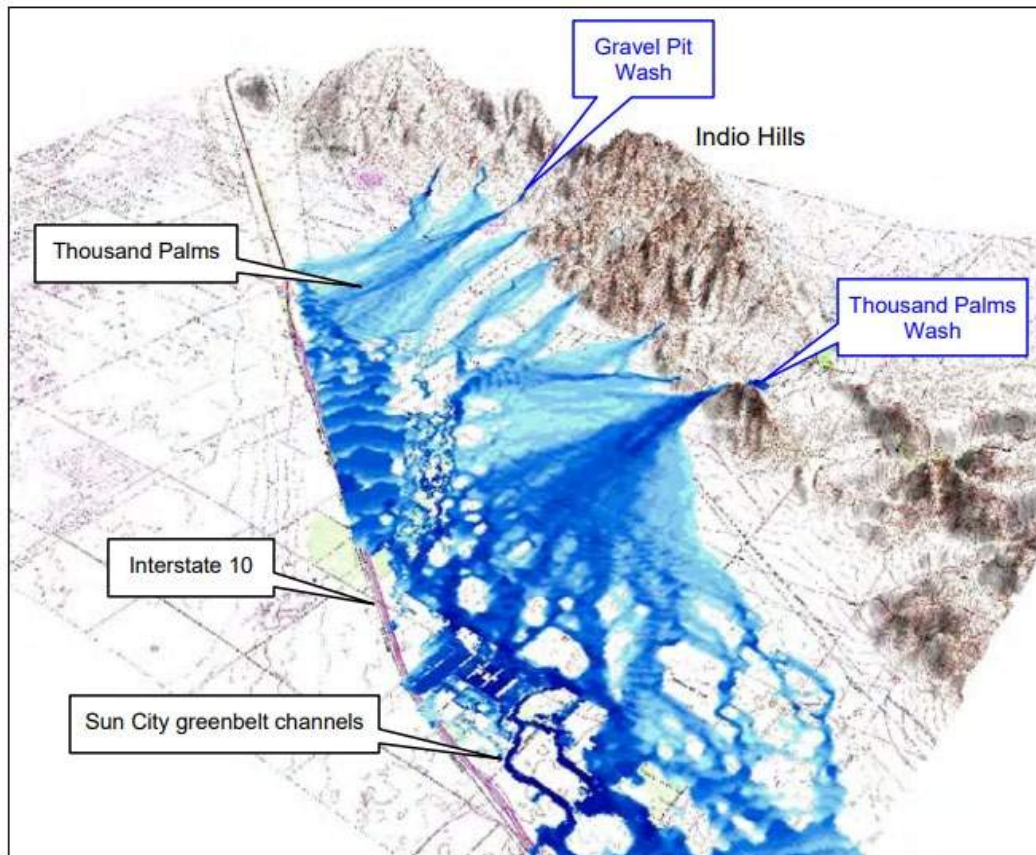
**Figure 7. Thousand Palms Wash (far right) between the Indio Hills and I-10, shown in a simulation of 100-year flood event inundation limits (Source: Shvidchenko et al. 2006).**

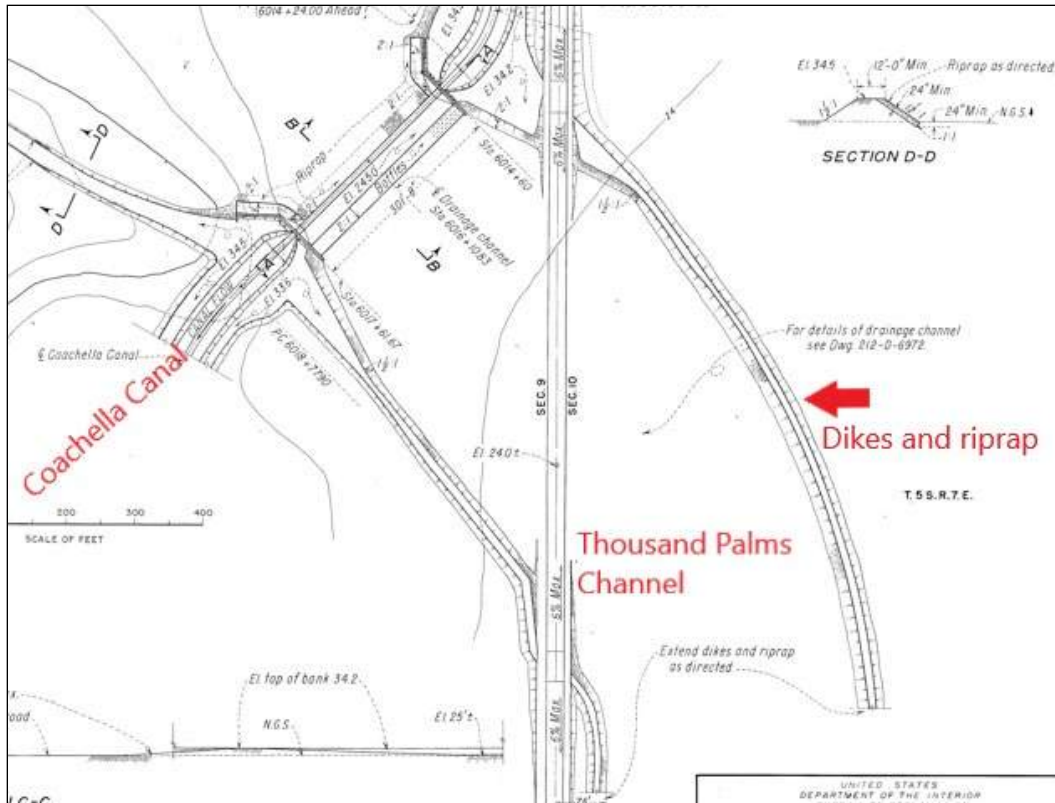
Figure 9. A 1946 design drawing for the Coachella Canal siphon shows modifications to the Thousand Palms Channel (generally called a drainage channel), included extending dikes and riprap along the channel edges (Source: Reclamation 1946a).

It appears the features constructed in the wash/Thousand Palms Channel itself were relatively minor. The wash was graded and riprap was installed on the north side of the siphon. Energy-dissipating concrete blocks (baffle) were installed on the south side of the siphon (Camacho 2022; U.S. Bureau of Reclamation 1946a, 1946b) (Figure 10). Aerial photographs show other human-made features present on the channel bottom by 1949, likely earthen energy-dissipating dikes (Environmental Data Resources [EDR] 2022) (Figure 11). It appears the dikes wore down over the years; they are barely discernible amidst vegetation growth in the channel on a 1965 aerial photograph. Subsequently, maintenance completed by the early 1970s cleared the vegetation from the channel bottom (EDR 2022). In 1985, the channel's outlet to the CVSC was modified; it appears the curve of the outlet was angled farther north and new dikes were created along the channel edges (CVWD 1985).

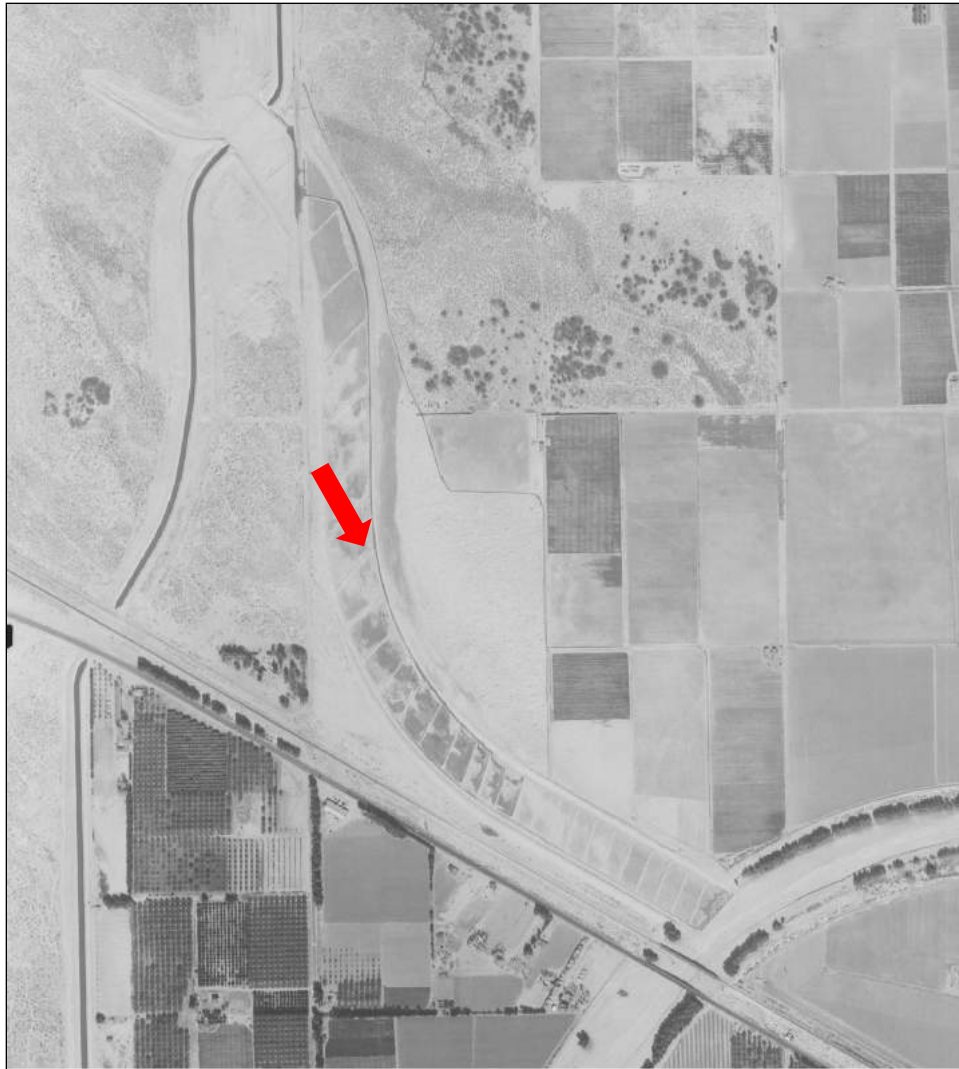
**Figure 11. A 1949 aerial photograph shows what appear to be energy-dissipating dikes along the Thousand Palms Channel bottom, indicated by red arrow (Source: EDR 2022).**

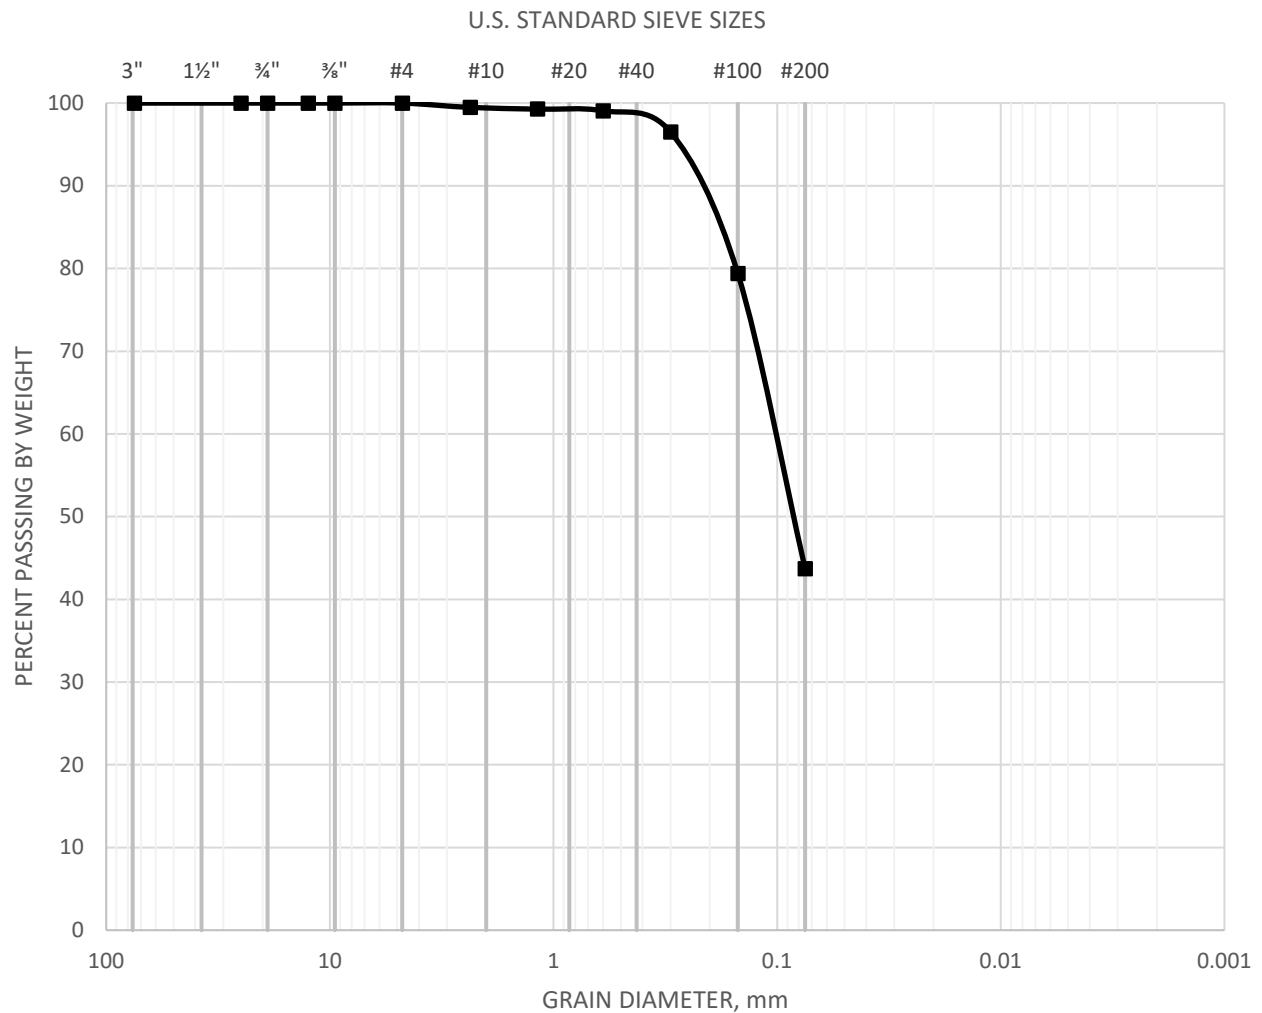
SAMPLE	CLASSIFICATION	D60	D30	D10
B1@2.5'	silty SAND (SM), olive gray

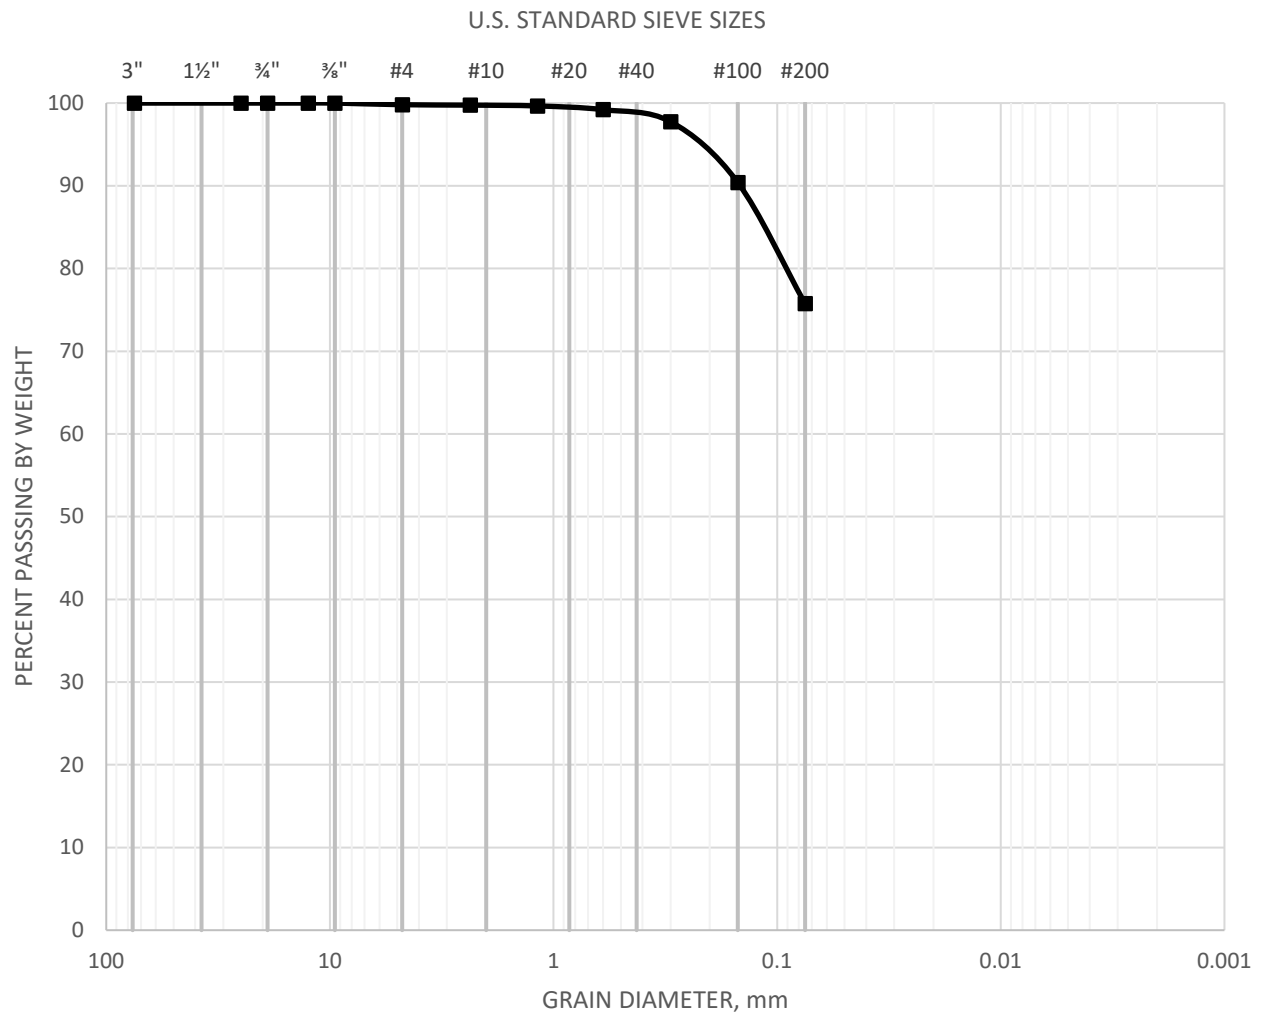
SAMPLE	CLASSIFICATION	D60	D30	D10
B1@10'	Sandy SILT (ML), olive gray

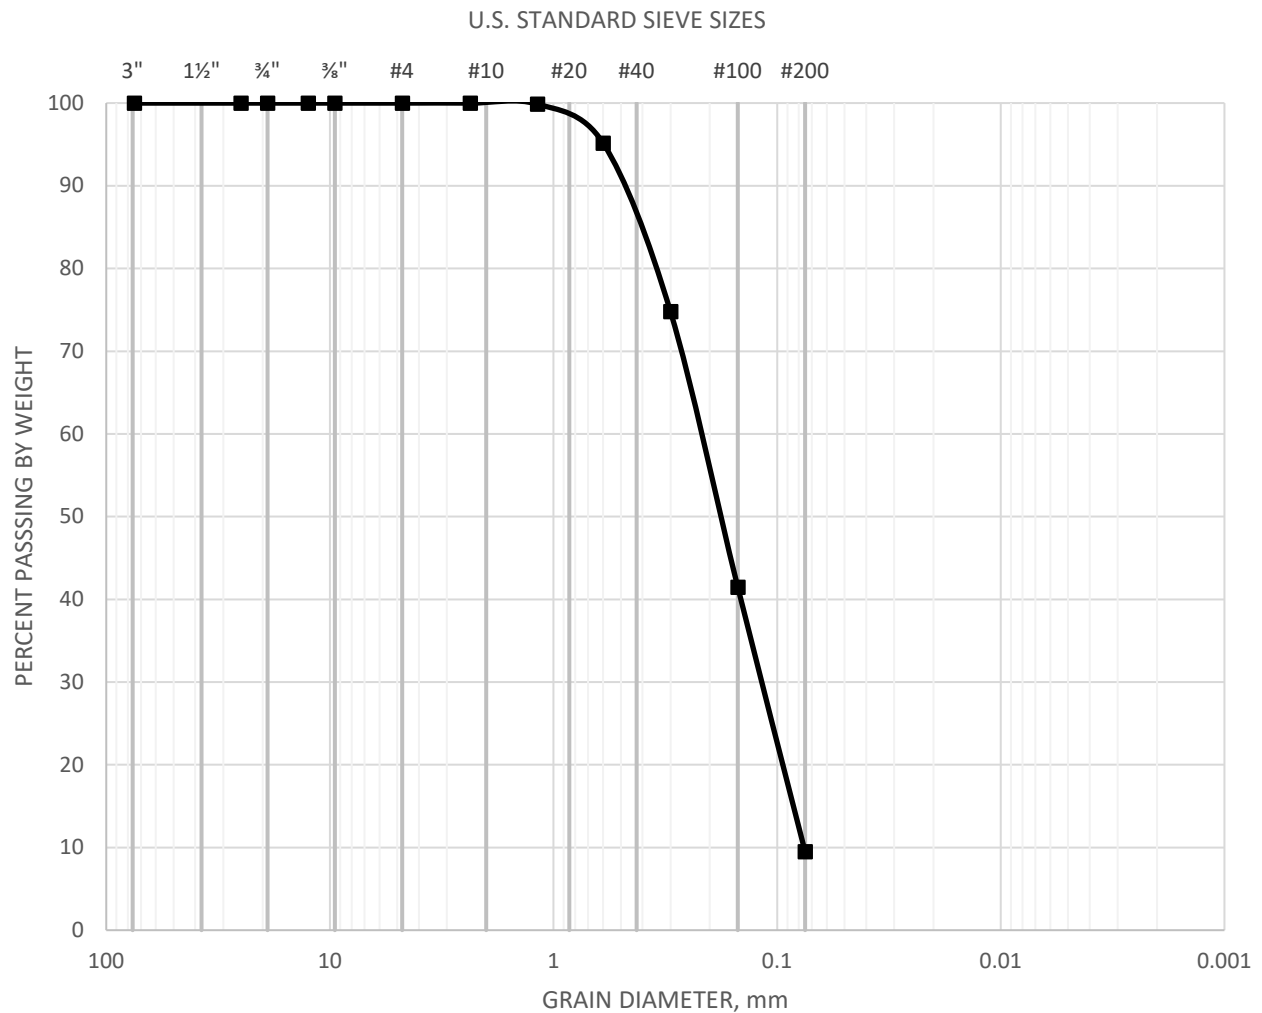
SAMPLE	CLASSIFICATION	D60	D30	D10
B2@2.5'	poorly-graded SAND with silt (SP-SM), grayish brown	0.22	0.12	0.075

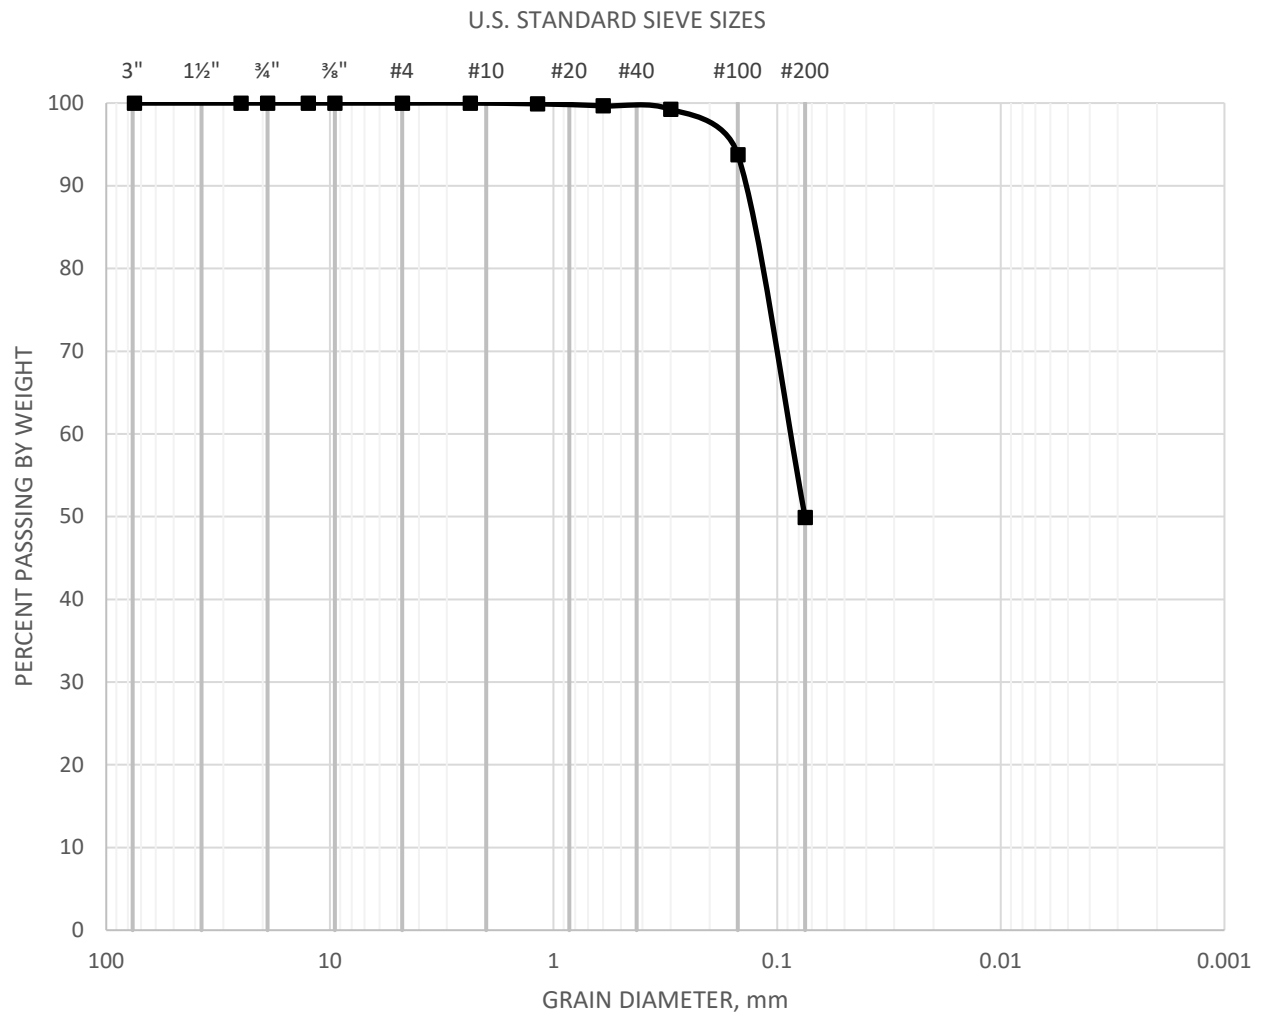
SAMPLE	CLASSIFICATION	D60	D30	D10
B2@5'	Silty SAND (SM), olive gray	0.09

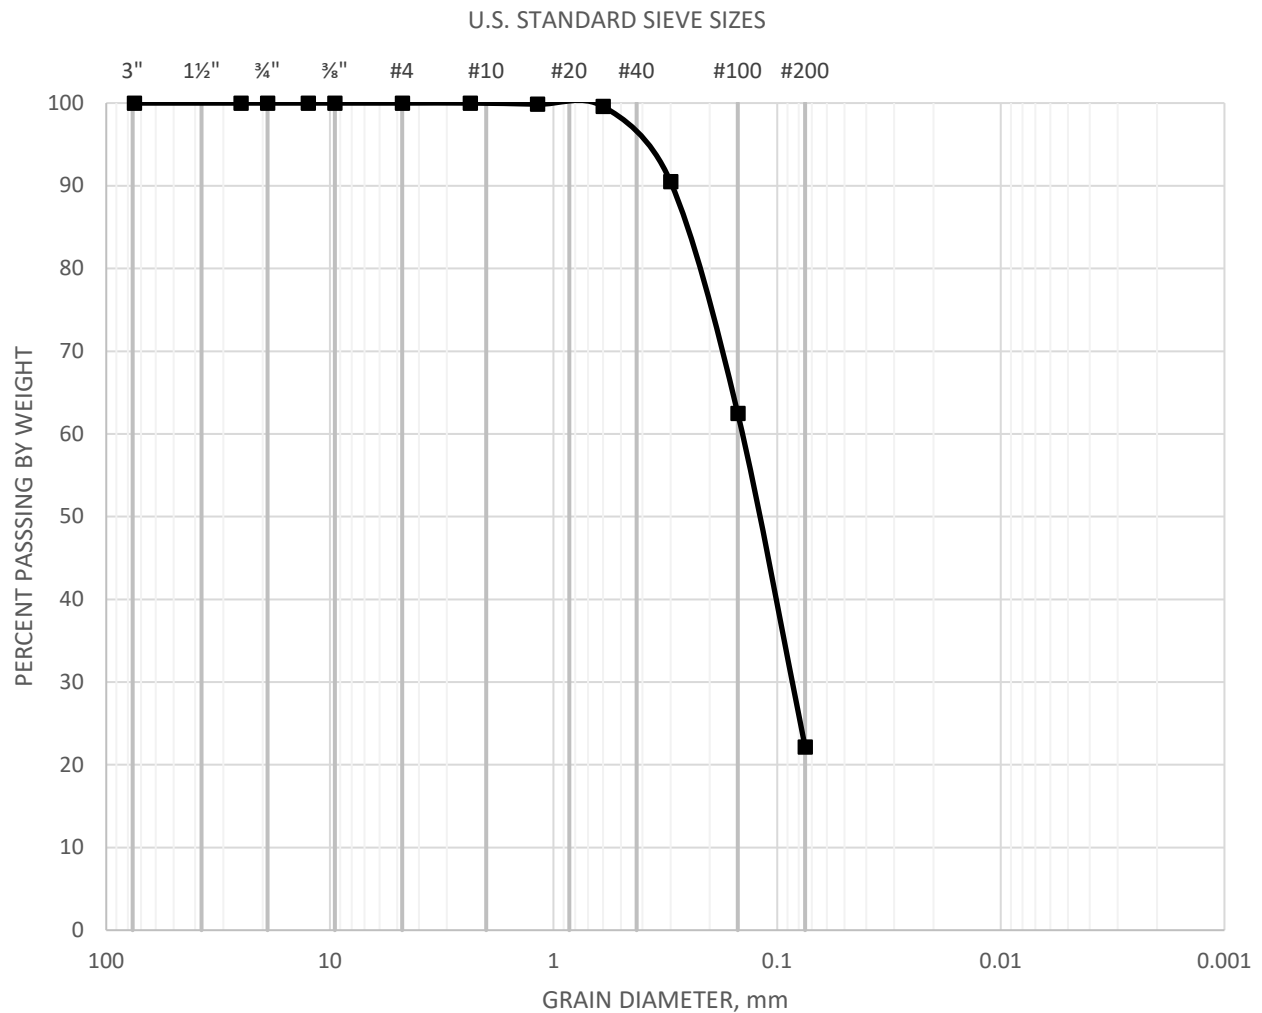
SAMPLE	CLASSIFICATION	D60	D30	D10
B3@2.5'	Silty SAND (SM), olive gray	0.13	0.083

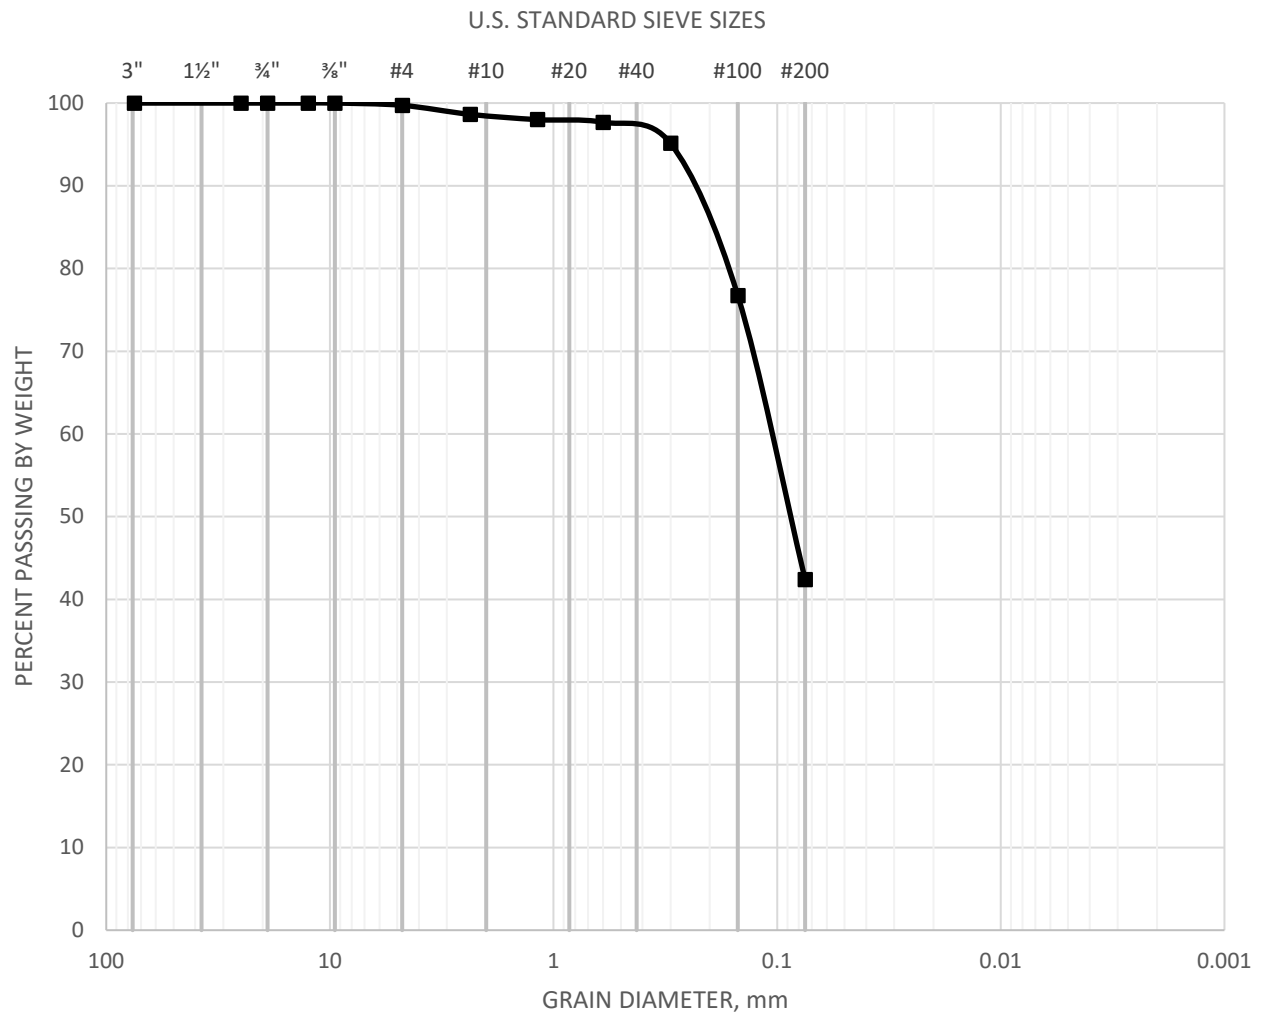
SAMPLE	CLASSIFICATION	D60	D30	D10
B3@5'	silty SAND (SM), gray	0.1

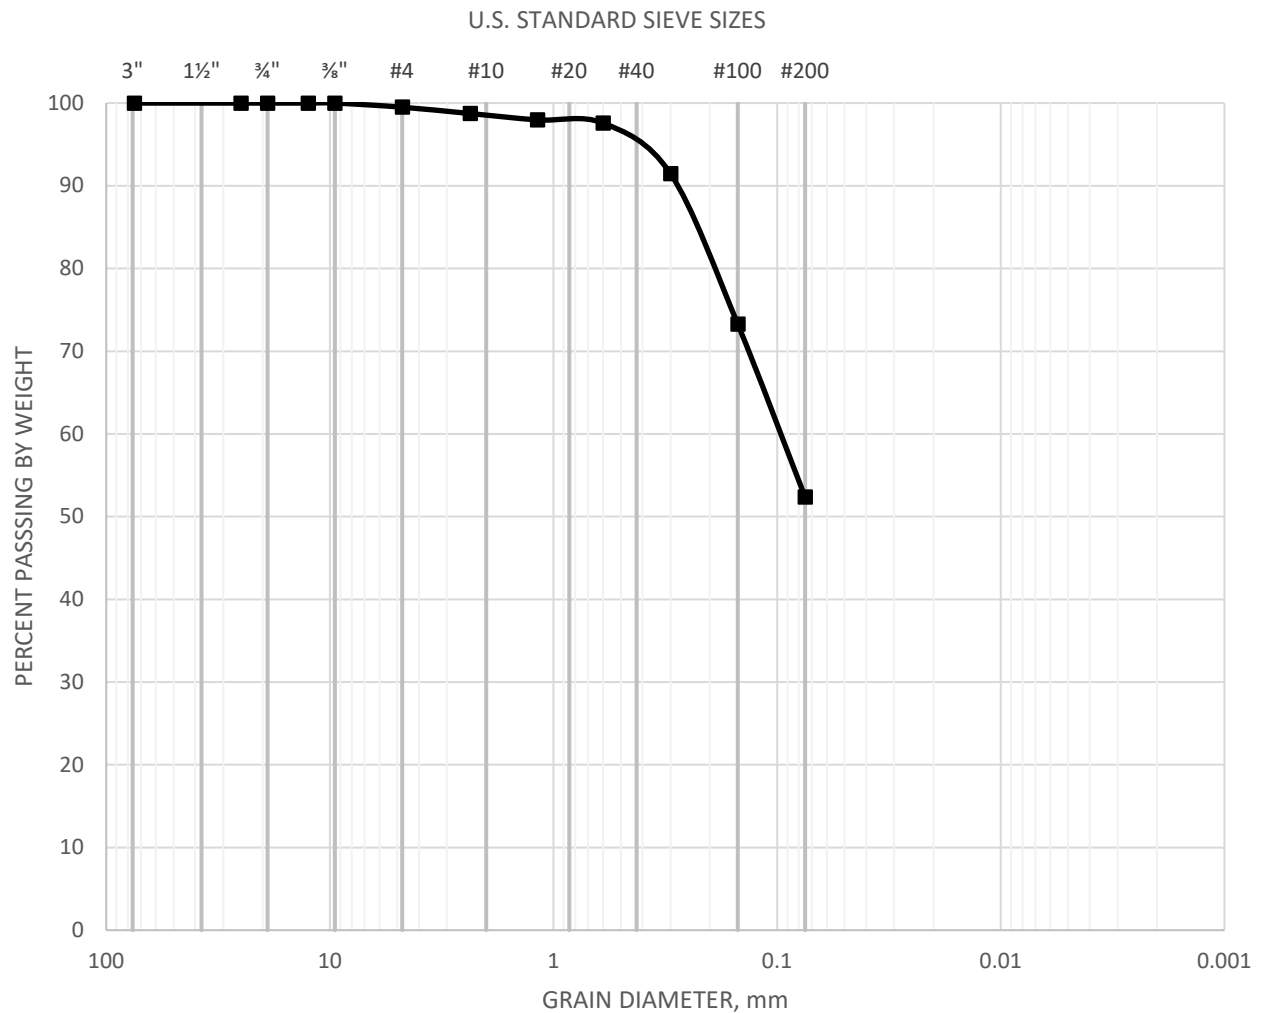
SAMPLE	CLASSIFICATION	D60	D30	D10
B4@2.5'	Sandy SILT (ML), gray	0.1

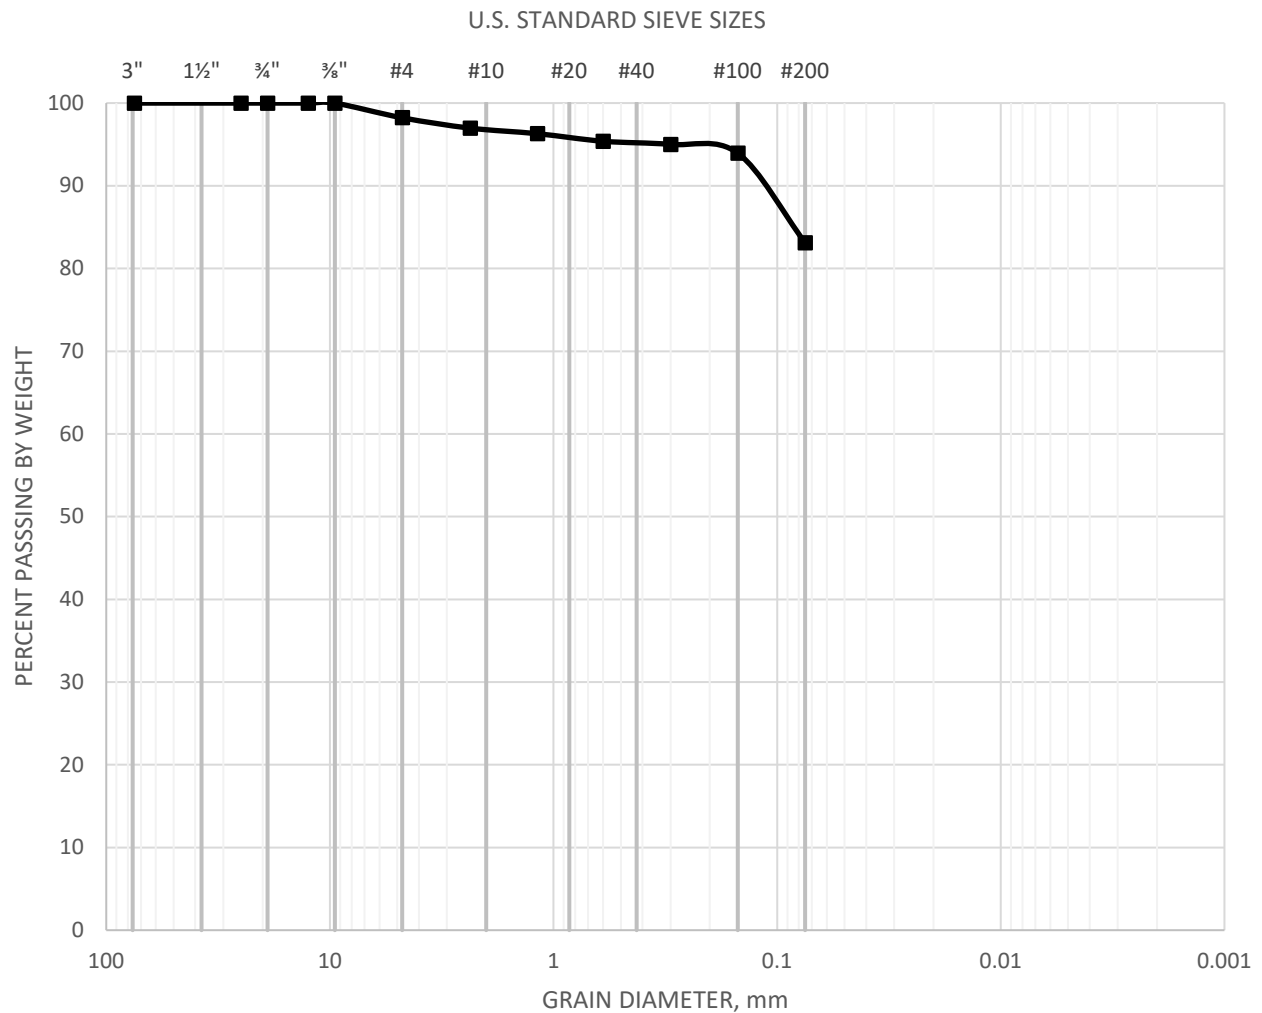
SAMPLE	CLASSIFICATION	D60	D30	D10
B4@10	Sandy SILT (ML), pale yellow

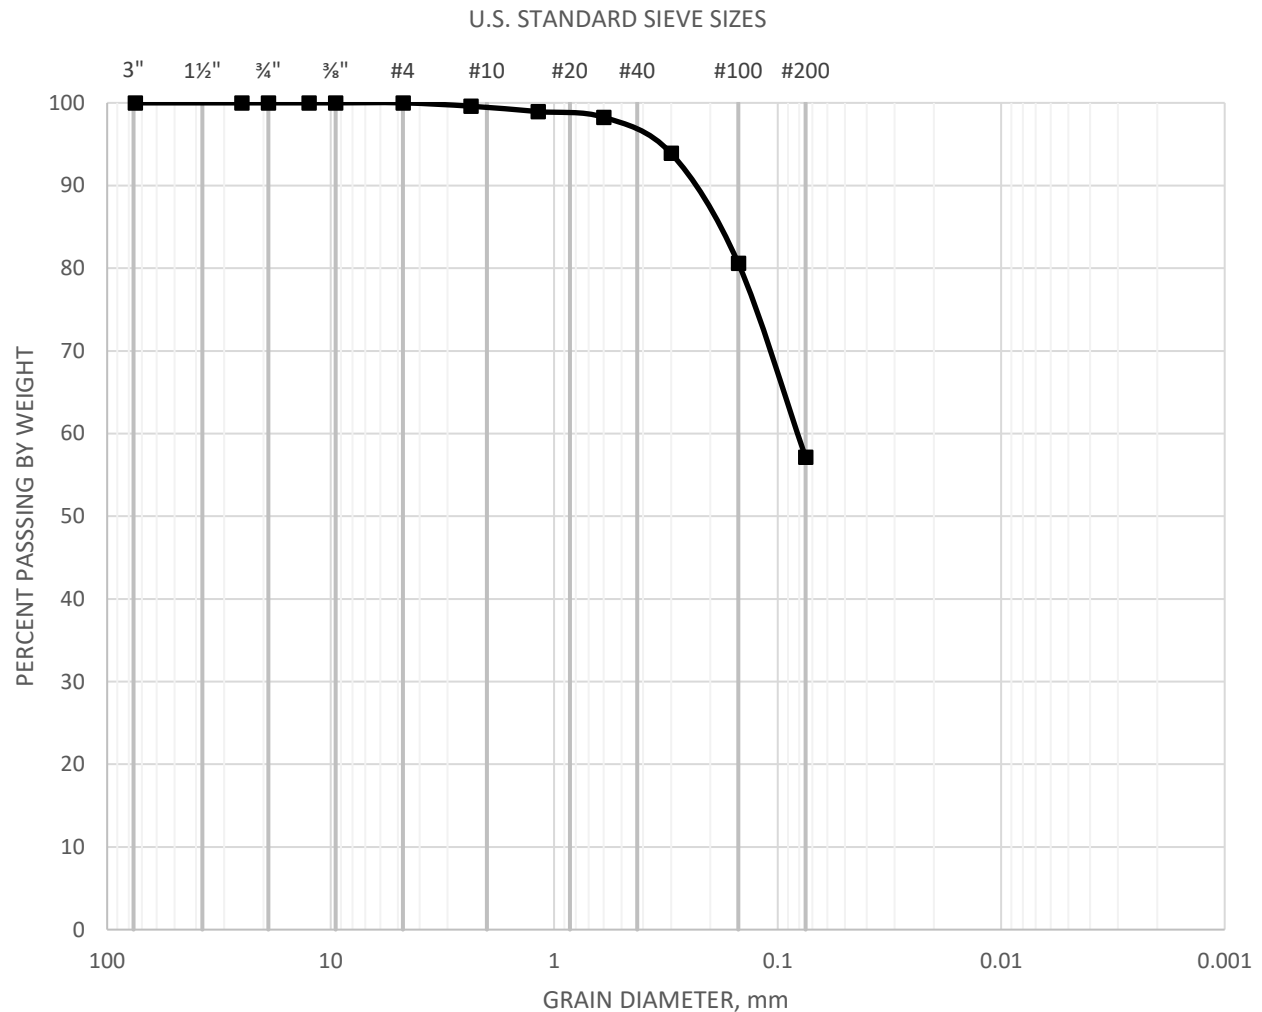
SAMPLE	CLASSIFICATION	D60	D30	D10
B5@5'	SILT with Clay (CL-ML), gray	0.08	0.073	0.073
