**Appendix A:**  
**Air Quality/Greenhouse Gas Modeling Data**

# 1000 Palms Channel Detailed Report

# Biological Resources Assessment Thousand Palms Channel Improvement Project

MAY 2023, REVISED JUNE 2024

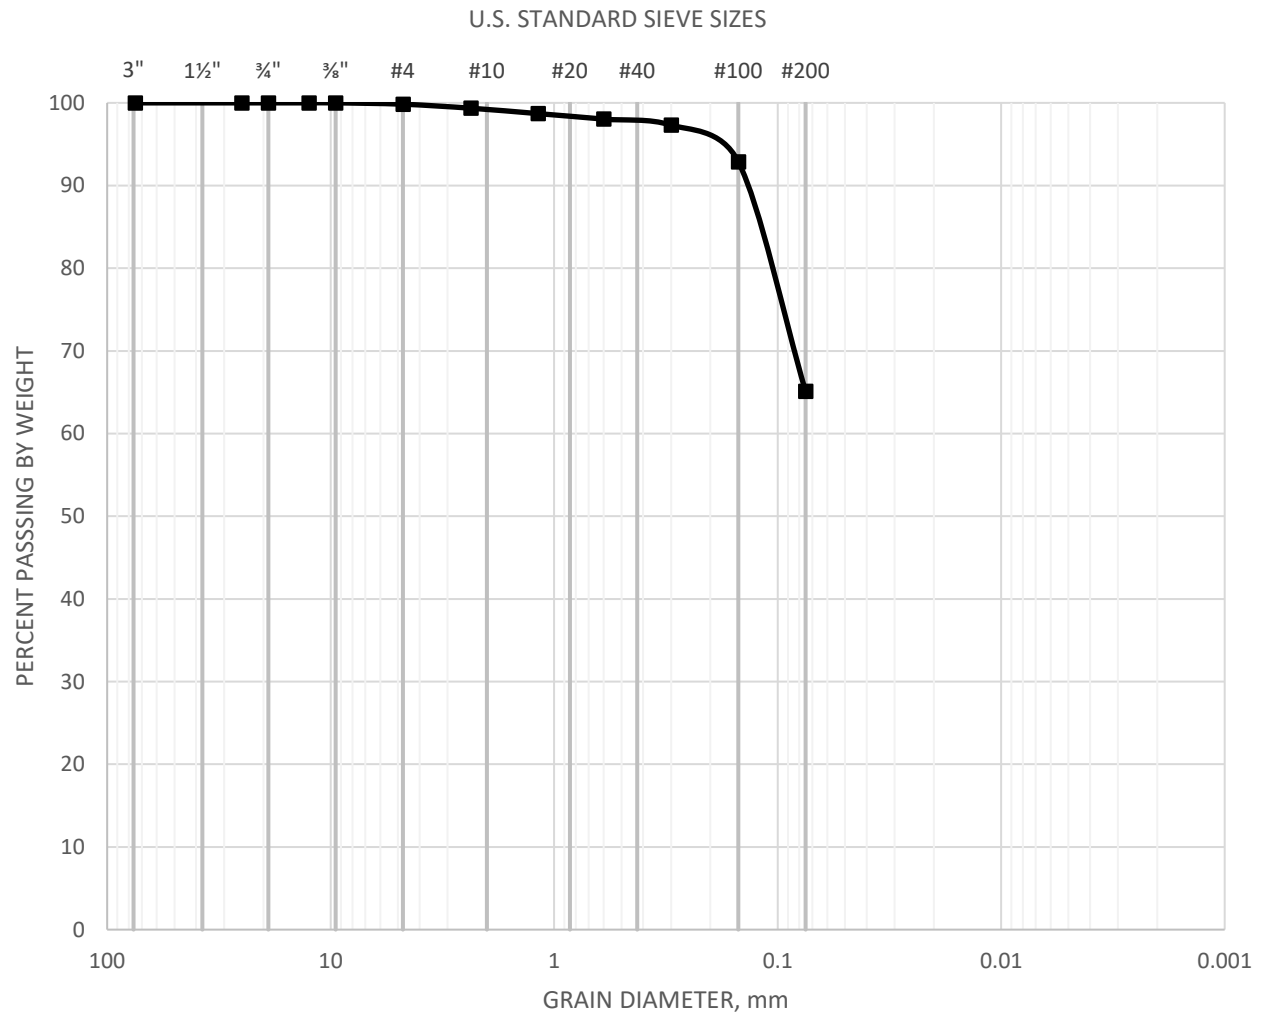
SAMPLE	CLASSIFICATION	D60	D30	D10
B9@25'	SILT with Clay (CL-ML), gray	0.075	0.075	0.075

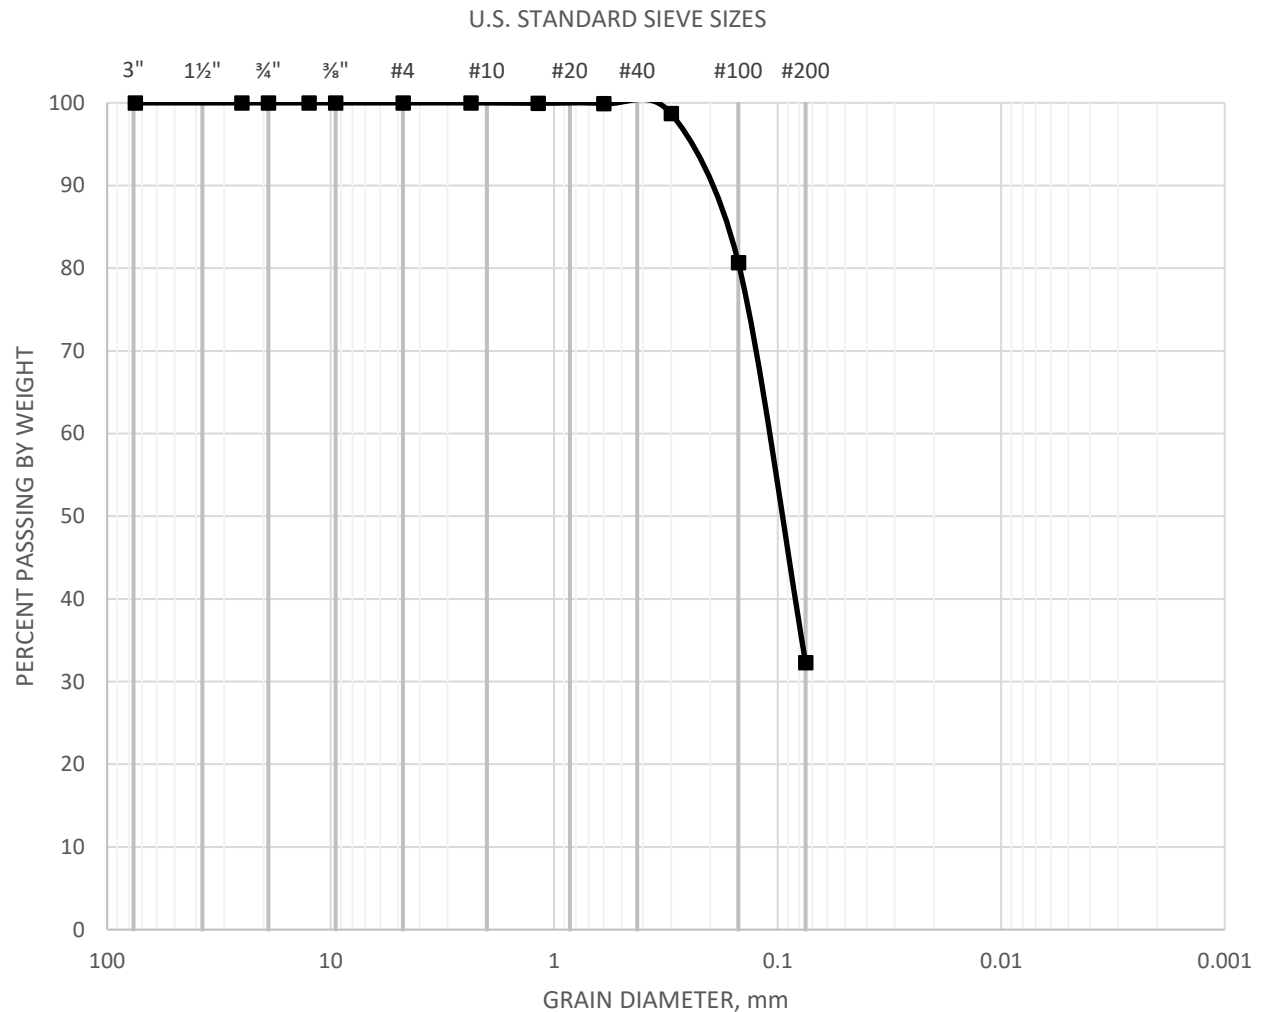
SAMPLE	CLASSIFICATION	D60	D30	D10
B9@35'	SILT with Clay (CL-ML), gray	0.11	0.075	0.075

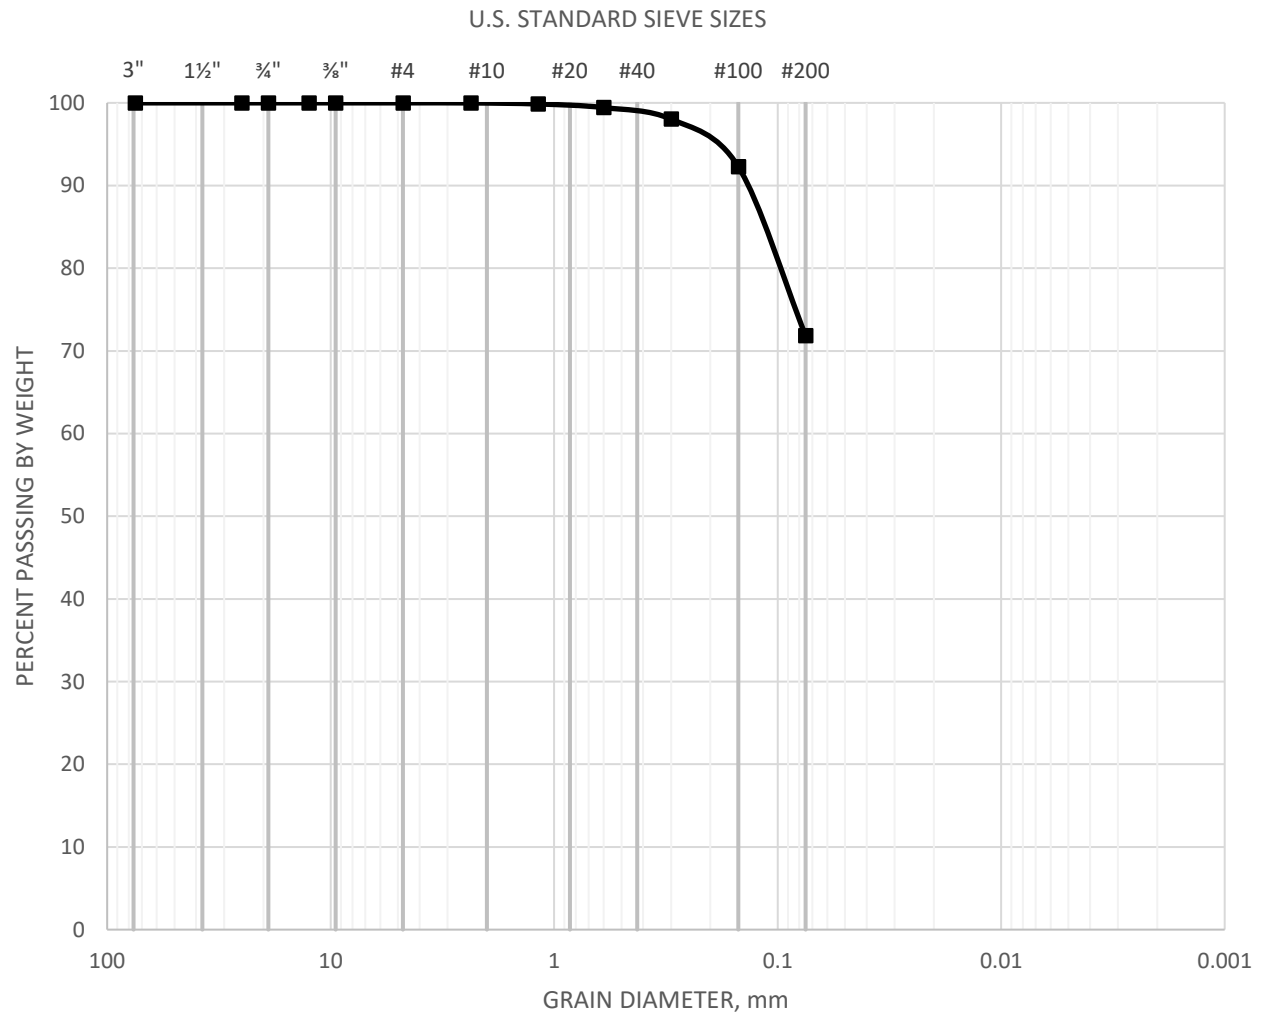
SAMPLE	CLASSIFICATION	D60	D30	D10
B13@40'	SILT with Clay (CL-ML), gray	0.075	0.075	0.075

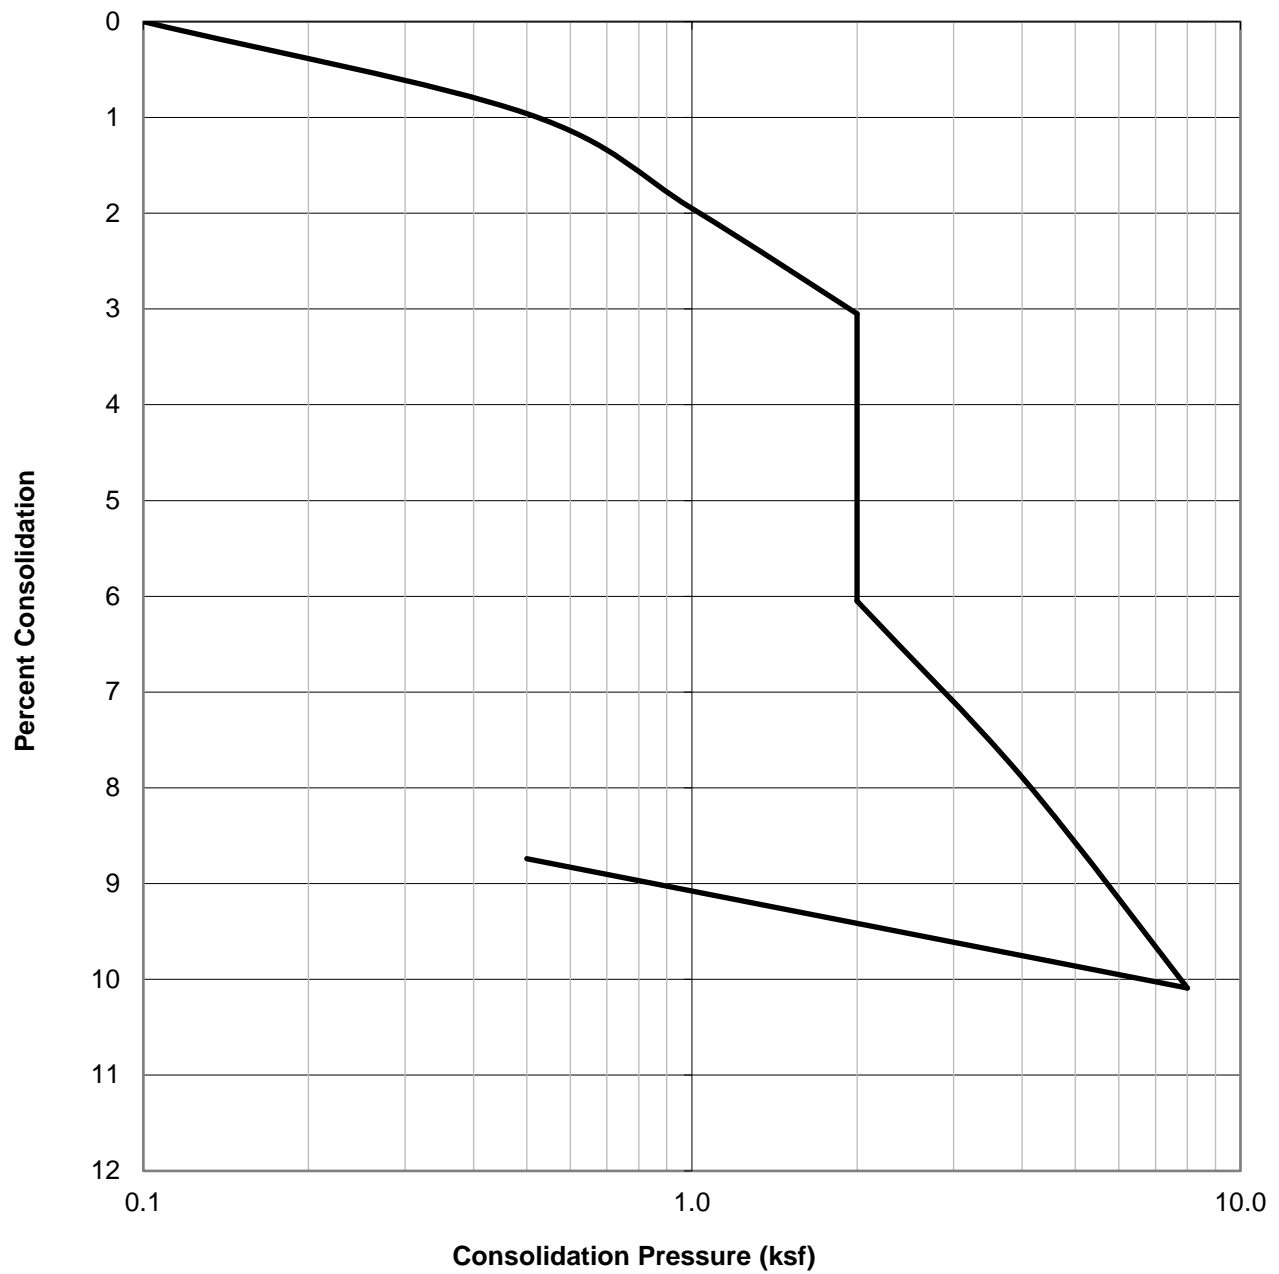
# WATER ADDED AT 2.0 KSF

SAMPLE ID.	SOIL TYPE	DRY DENSITY (PCF)	INITIAL MOISTURE (%)	FINAL MOISTURE (%)
B1@2.5	Silty SAND (SM), olive gray	97.5	3.2	23.3

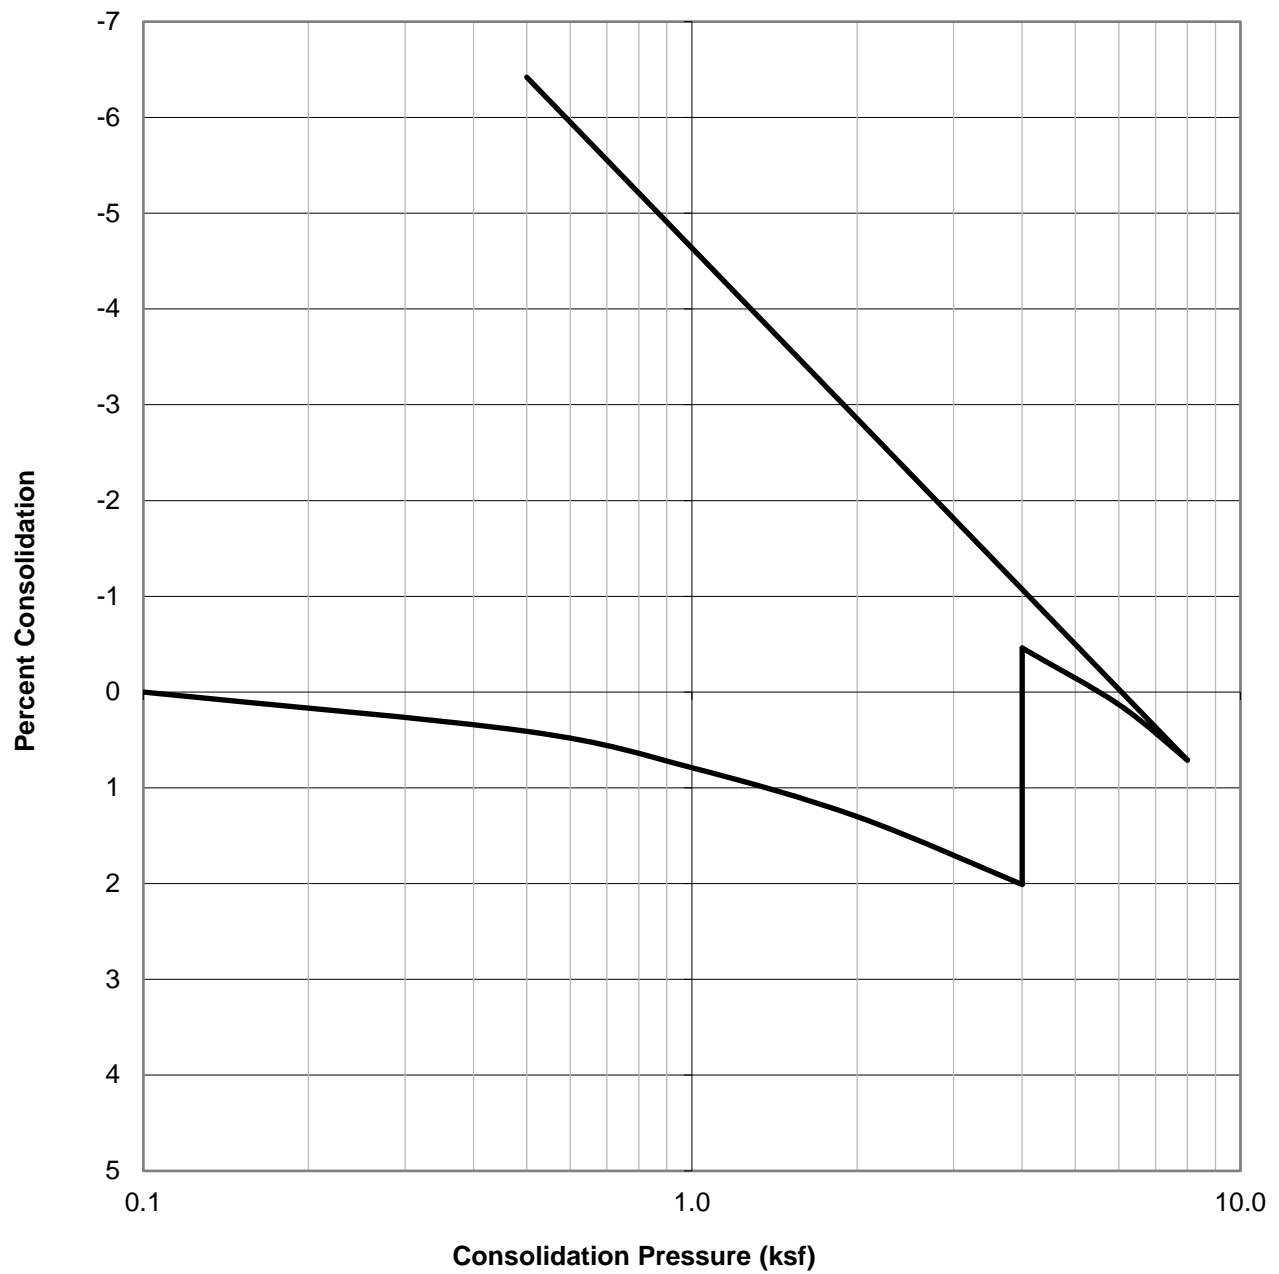
# WATER ADDED AT 2.0 KSF

SAMPLE ID.	SOIL TYPE	DRY DENSITY (PCF)	INITIAL MOISTURE (%)	FINAL MOISTURE (%)
B2@10	Sandy SILT (ML), grayish brown	103.4	17.1	30.1

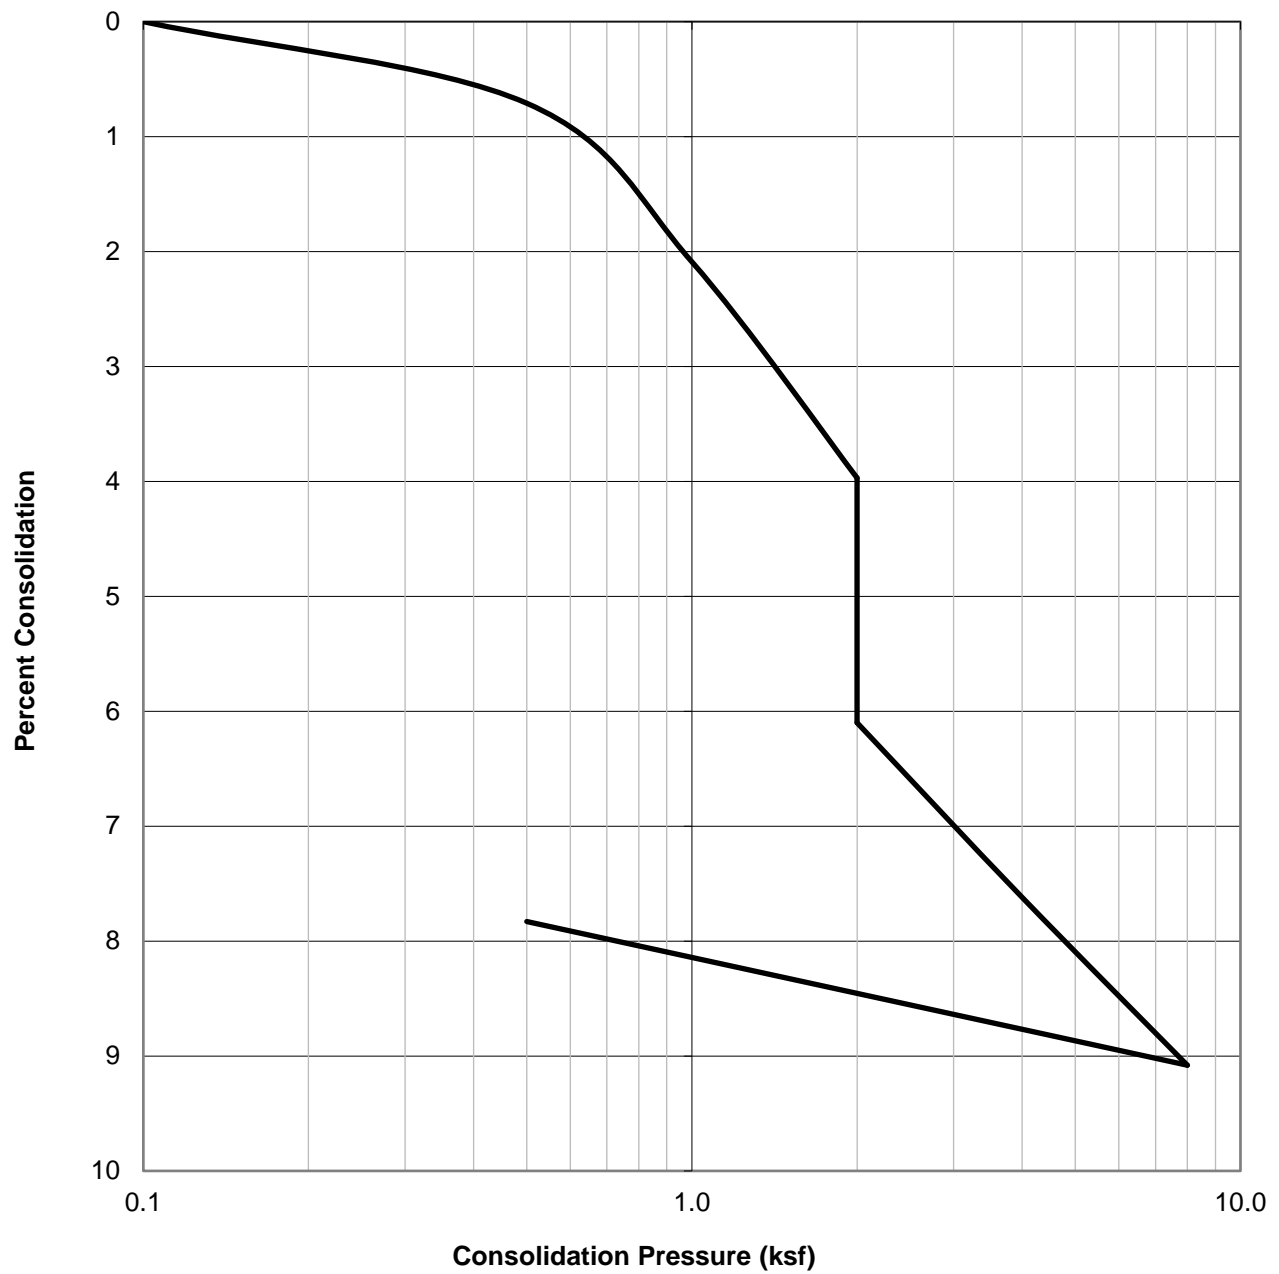
# WATER ADDED AT 2.0 KSF

SAMPLE ID.	SOIL TYPE	DRY DENSITY (PCF)	INITIAL MOISTURE (%)	FINAL MOISTURE (%)
B3@5	Silty SAND (SP), gray	87.3	2.7	26.2

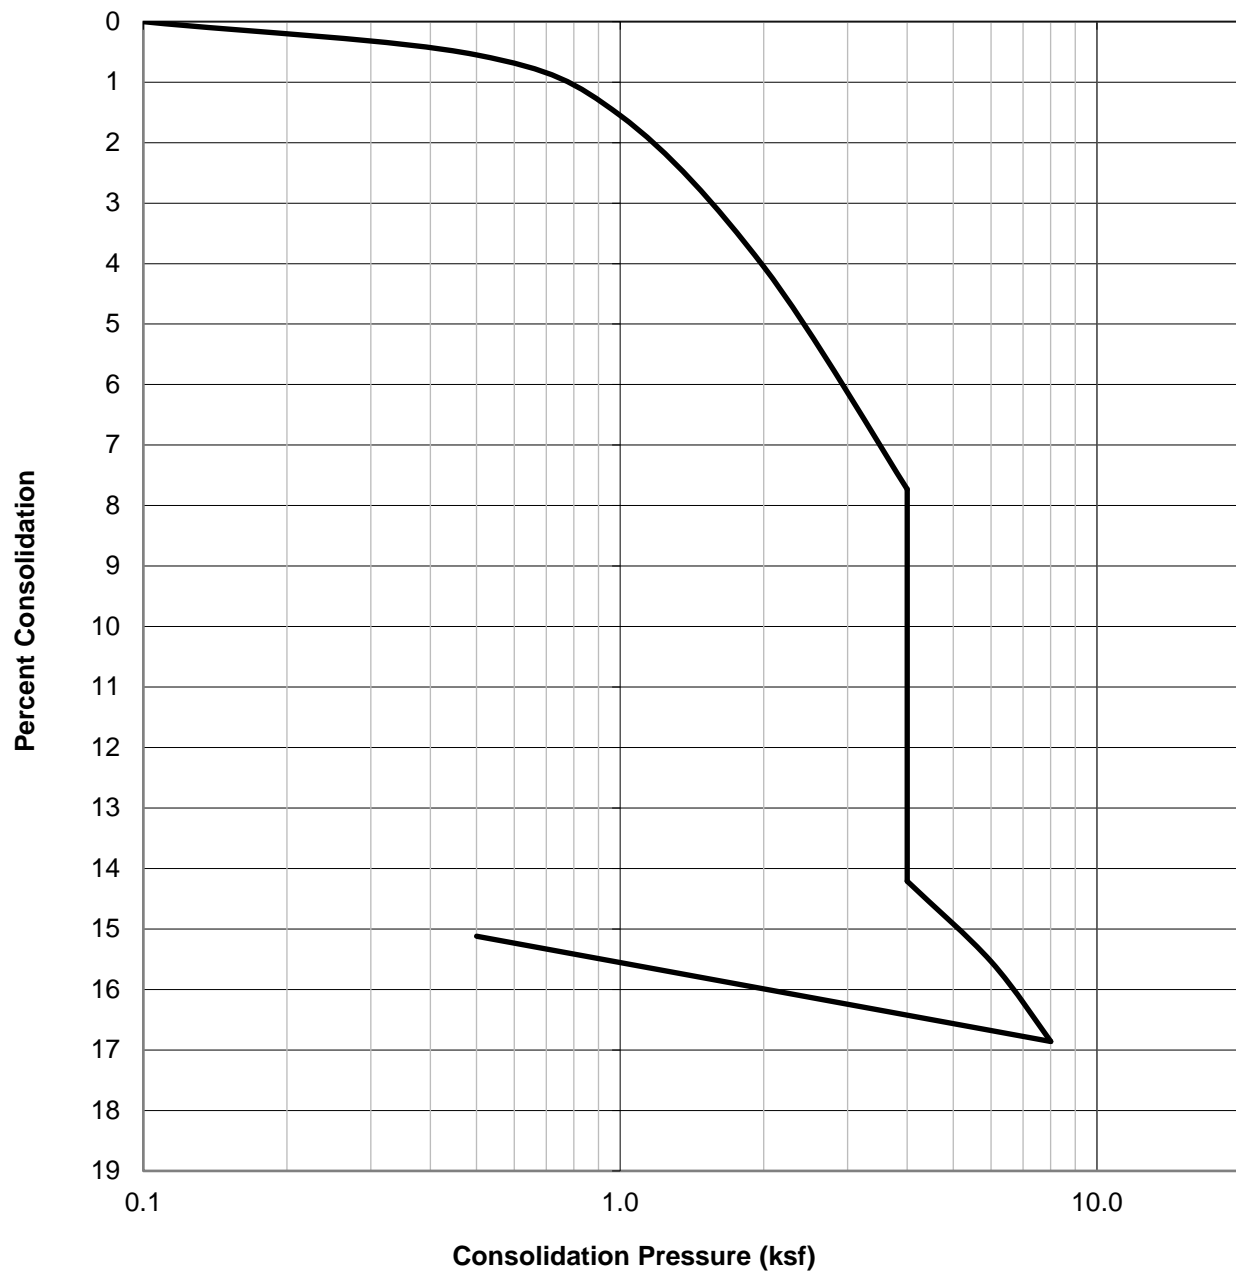
# WATER ADDED AT 2.0 KSF

SAMPLE ID.	SOIL TYPE	DRY DENSITY (PCF)	INITIAL MOISTURE (%)	FINAL MOISTURE (%)
B4@5	Sandy SILT (ML), grayish brown	88.2	6.1	25.8

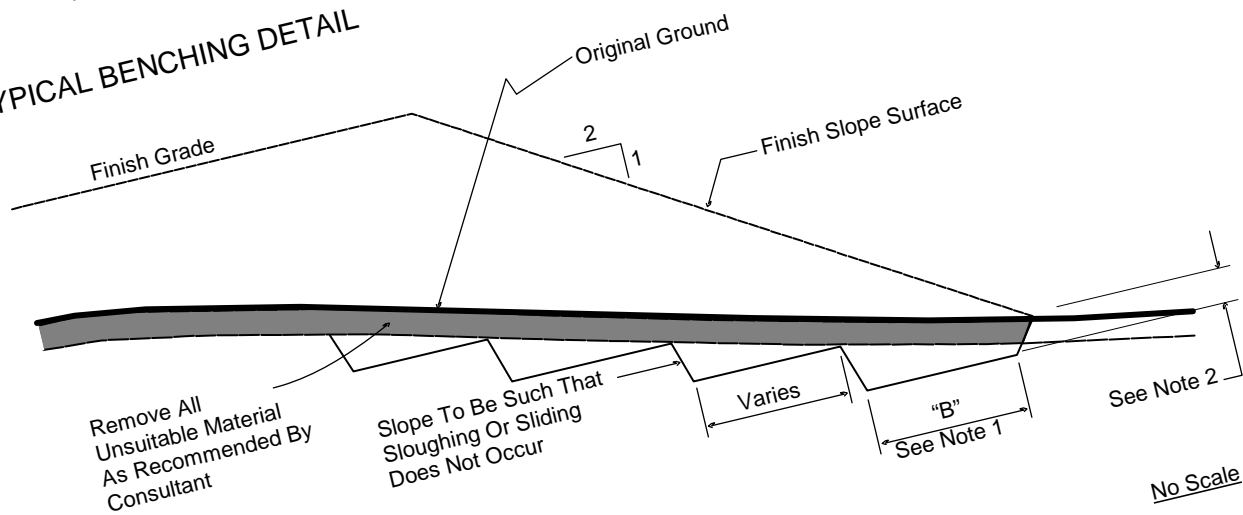
### TYPICAL BENCHING DETAIL

- DETAIL NOTES:
- (1) Key width "B" should be a minimum of 10 feet, or sufficiently wide to permit complete coverage with the compaction equipment used. The base of the key should be graded horizontal, or inclined slightly into the natural slope.
  - (2) The outside of the key should be below the topsoil or unsuitable surficial material and at least 2 feet into dense formational material. Where hard rock is exposed in the bottom of the key, the depth and configuration of the key may be modified as approved by the Consultant.
