Black Rascal Creek Watershed
Draft Plan and
Environmental Assessment
Black Rascal Creek Watershed, California

Natural Resources Conservation Service and
Merced County, California

Draft
Black Rascal Creek Watershed Draft Plan and
Environmental Assessment
for Management of Flood Flows in the Black Rascal Creek Watershed
Merced County, California

Prepared By: U.S. Department of Agriculture, Natural Resources Conservation Service

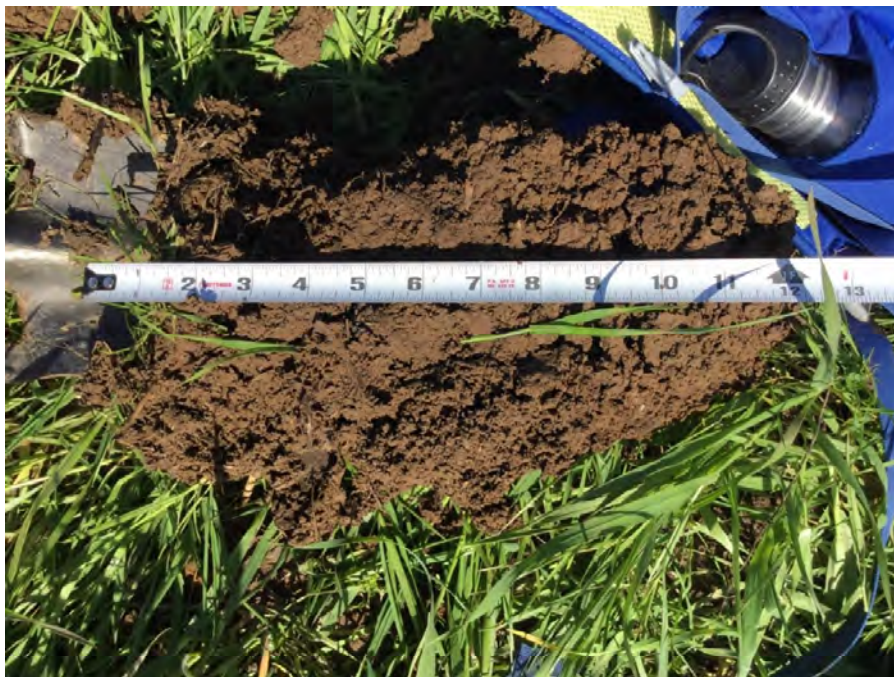
Photograph 3: SP-2 soil profile. No hydric soil indicators present.

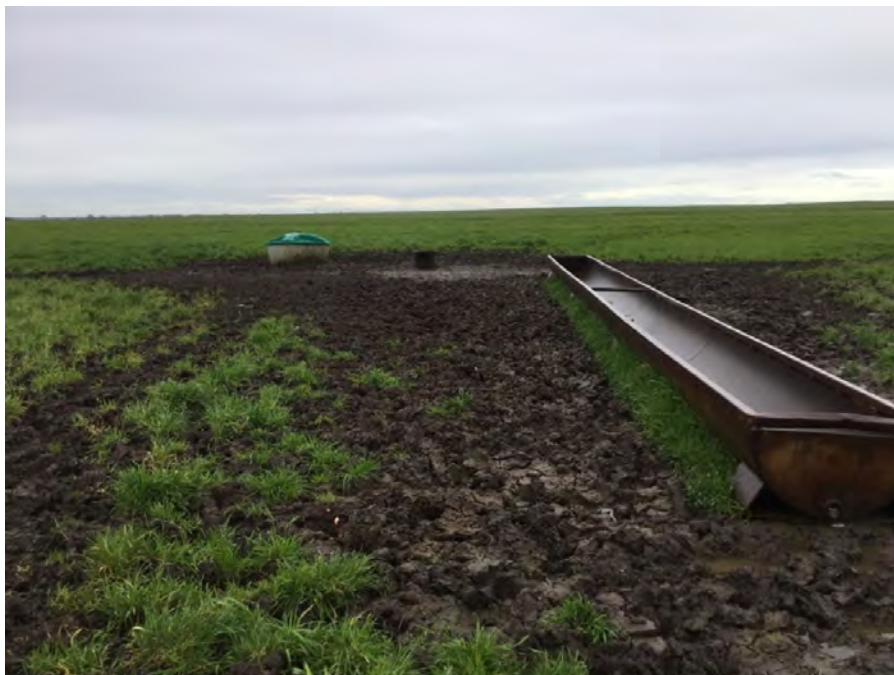
Photograph 18: Area trampled by cattle that appears saturated on aerial imagery. No wetland indicators were observed.

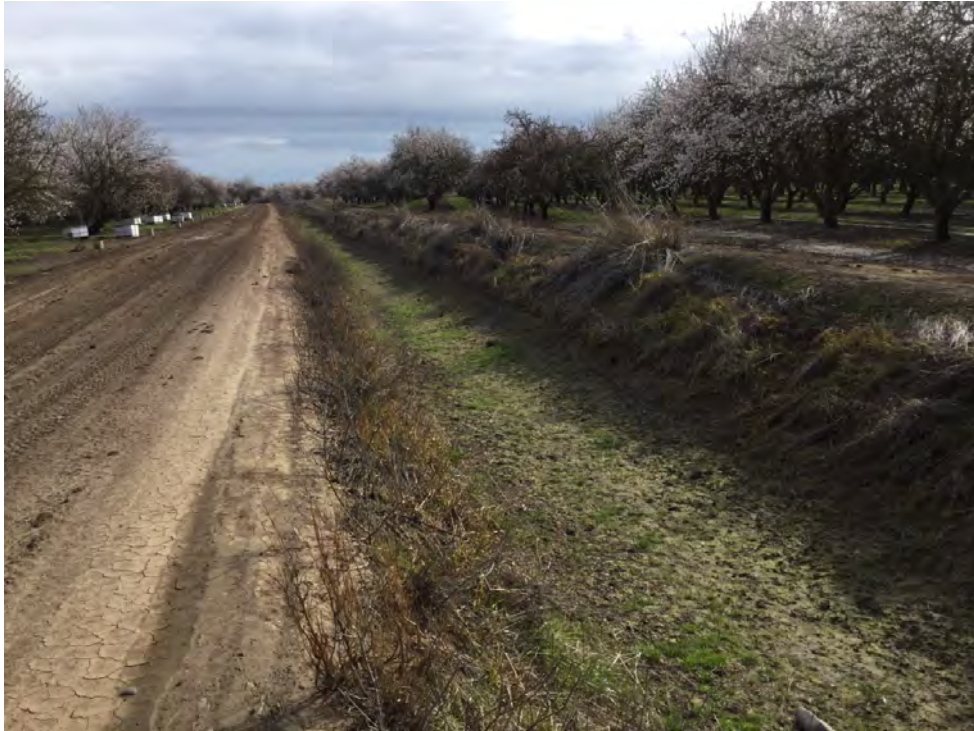
Photograph 19: Feature D-05 at OHWM-05.
