Black Rascal Creek Watershed  
Plan and  
Environmental Assessment  
Black Rascal Creek Watershed, California

Natural Resources Conservation Service and  
Merced County, California

**Black Rascal Creek Watershed Plan and  
Environmental Assessment  
for Management of Flood Flows in the Black Rascal Creek Watershed  
Merced County, California**

**Prepared By:** U.S. Department of Agriculture, Natural Resources Conservation Service

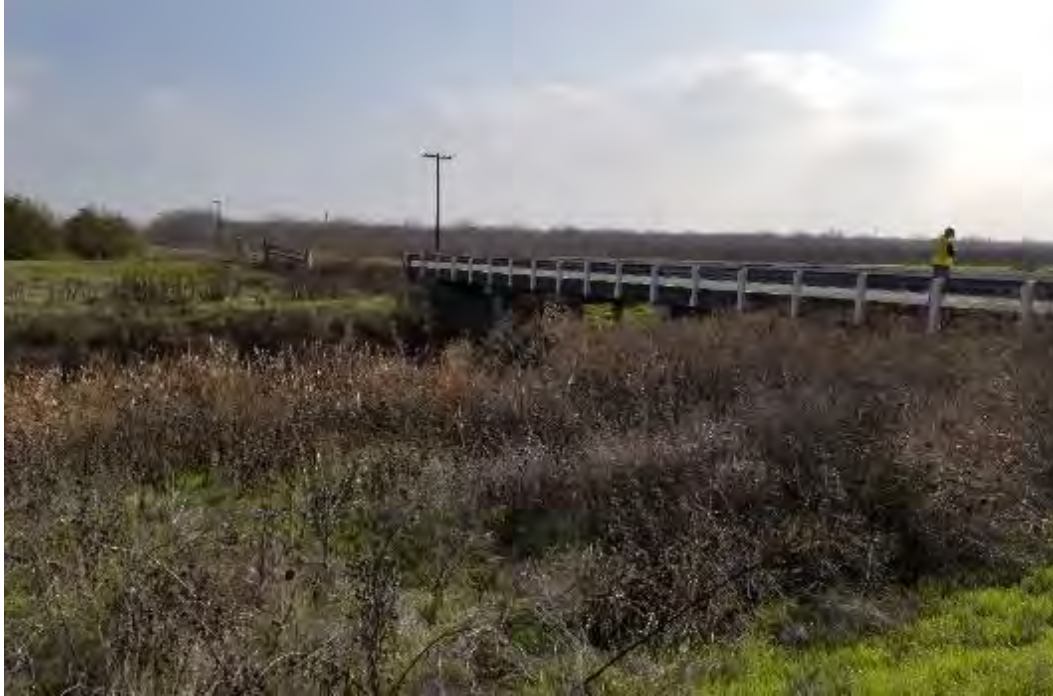
**Photo 1.** Southwestern corner of Project footprint looking southeast along East Yosemite Avenue. Location of the proposed, spillways, and southern embankment.

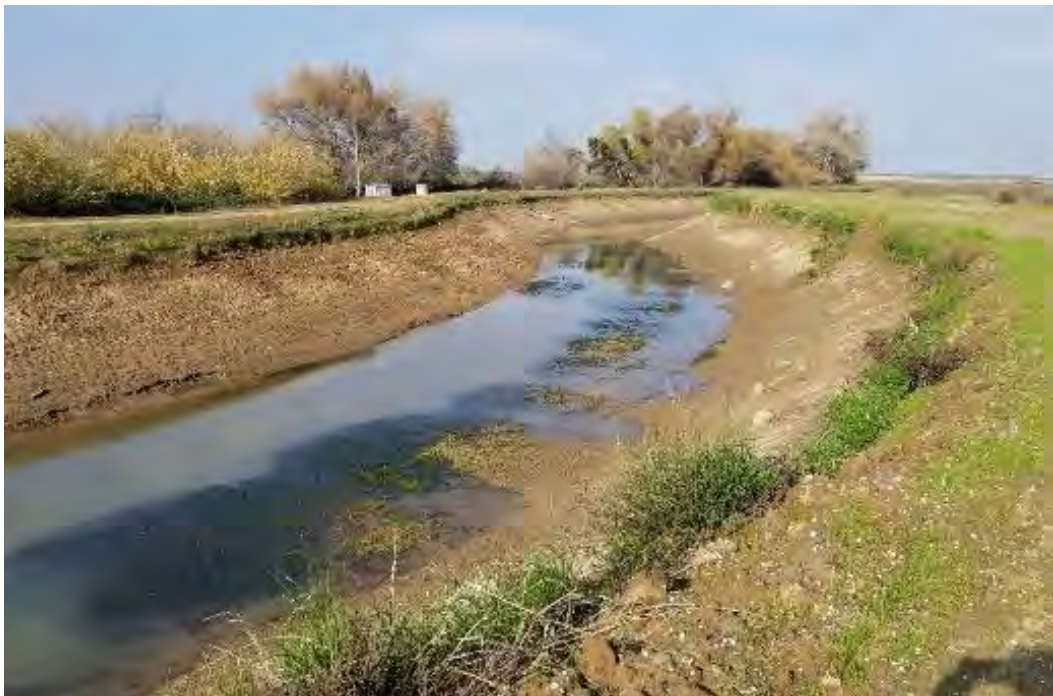
**Photo 2.** Fairfield Canal at the western edge of the Project footprint, looking north. Location of the proposed western embankment.

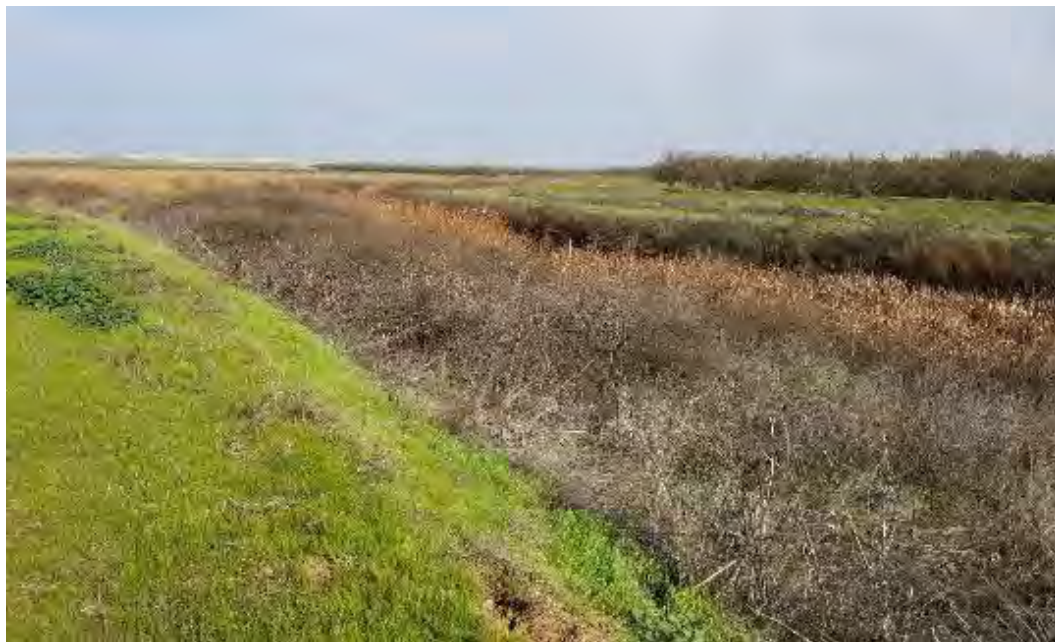
**Photo 3.** Project footprint with view of the proposed north basin, looking north. Proposed location of the north basin and aquatic and riparian habitat enhancement.

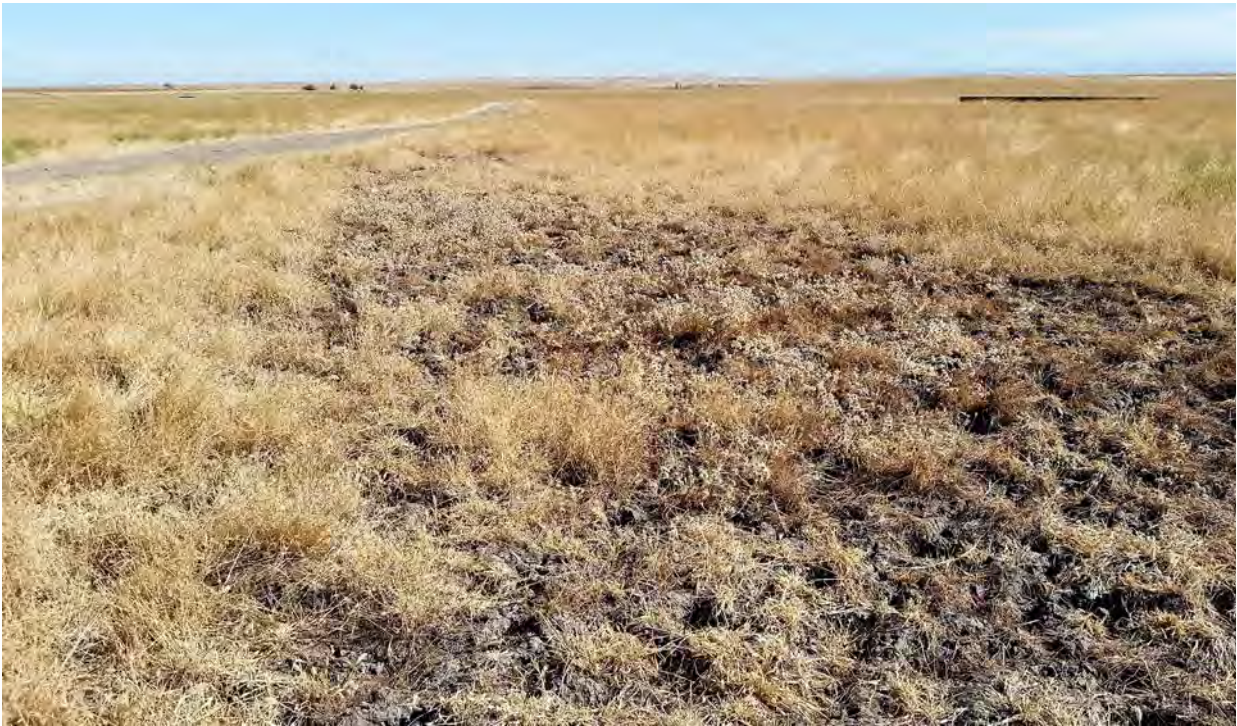
**Photograph 1:** Photograph depicts a dry vernal pool on the Project site. Note that there is extensive cover of dried, senescent *Eryngium* sp. within the vernal pool. In addition, the vernal pool/annual grassland interface is well defined.

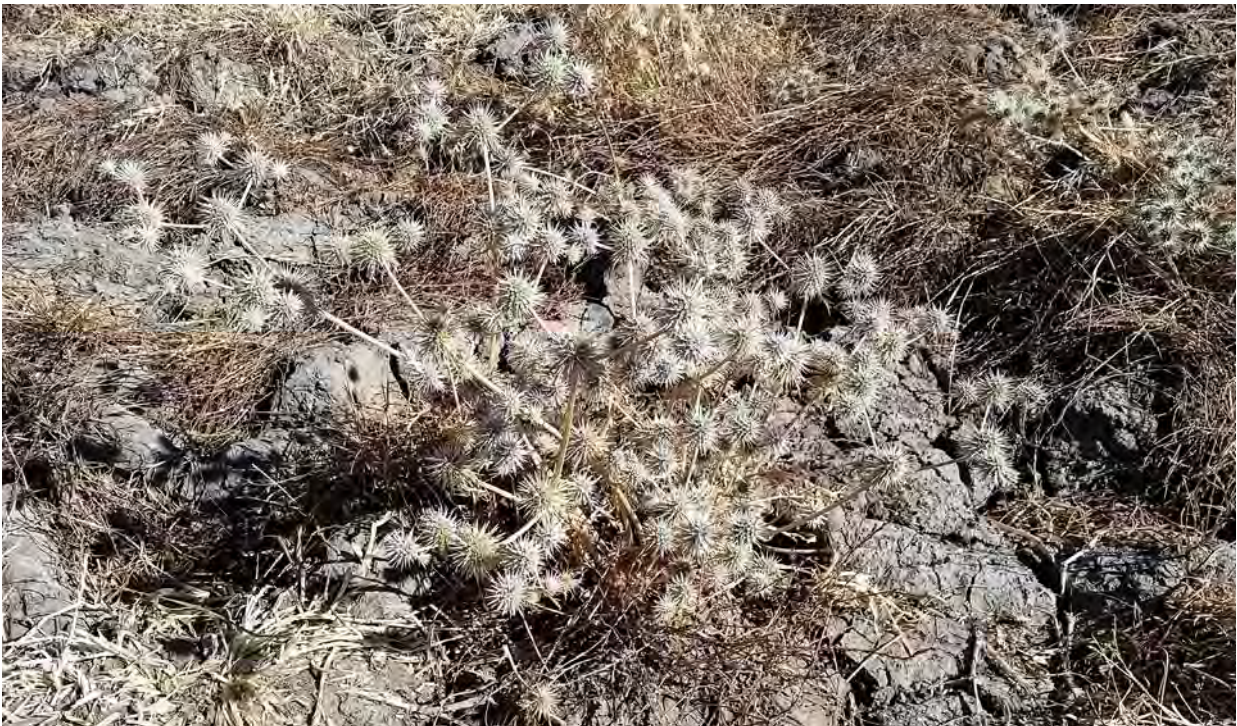
**Photograph 2:** Photograph shows a close-up view of the *Eryngium* sp. (a vernal pool obligate) that is prevalent in most of the vernal pools on the Project site.

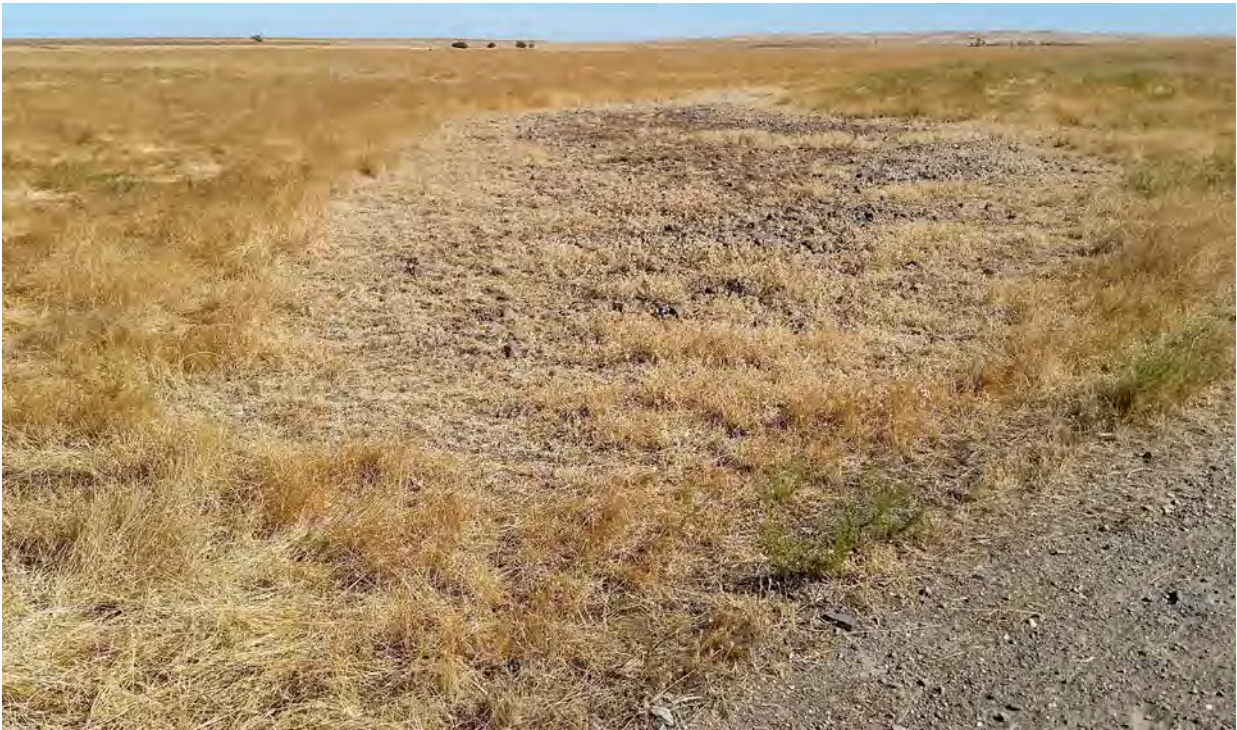
**Photograph 3:** Photograph depicts another dry vernal pool on the Project site. The dried, senescent cover of *Eryngium* sp. within this vernal pool is not as extensive as that depicted in Photograph No. 1.

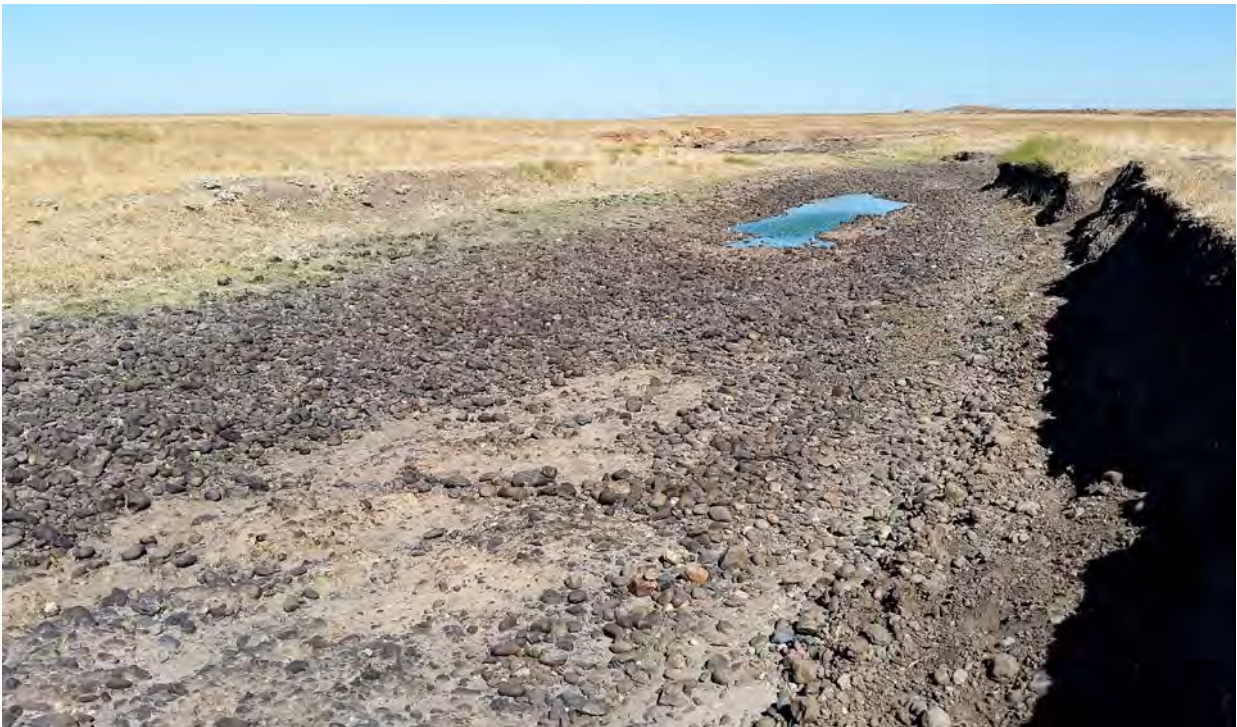
**Photograph 4:** Photograph shows the primary channel of Black Rascal Creek on the Project site. Although the channel is largely dry, there are occasional pools of standing water (even though it was late in the season).

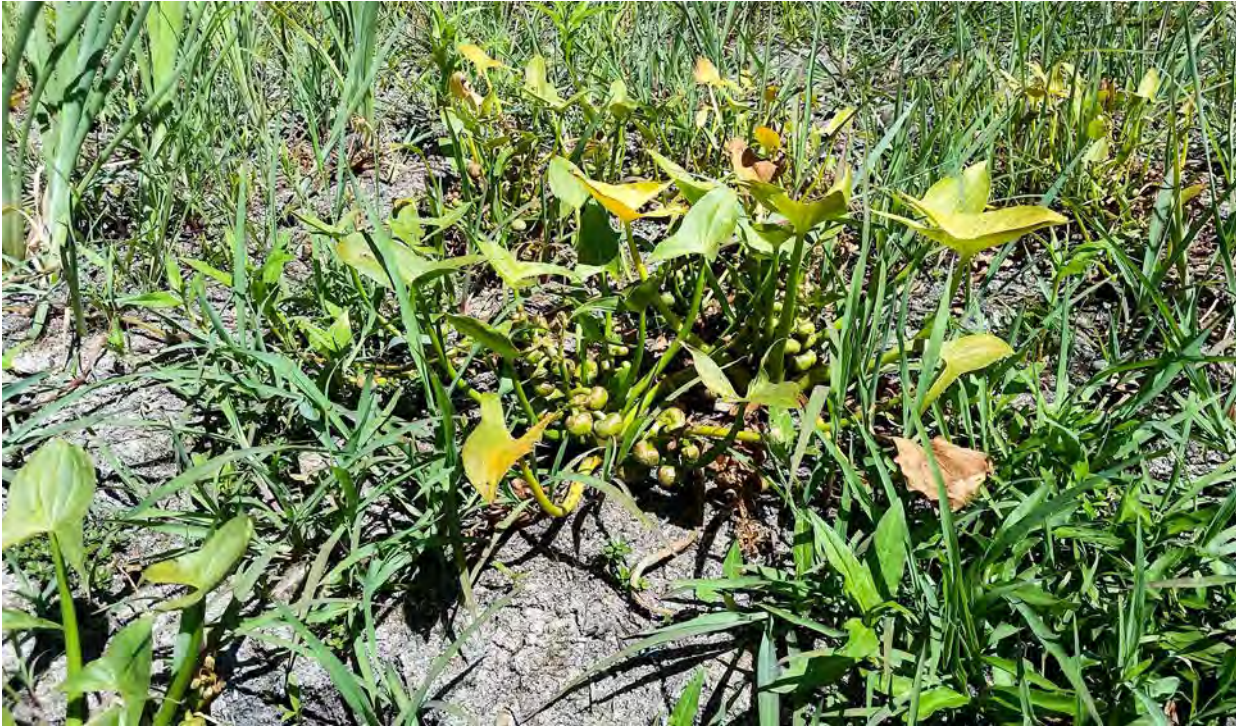
**Photograph 5: Photograph shows some of the freshwater marsh that is associated with the onsite downstream reaches of Black Rascal Creek. Other portions of the creek support freshwater marsh that is dominated by stands of cattail and tule. This particular stand of freshwater marsh supports broad-leaved arrowhead (*Sagittaria latifolia*).**

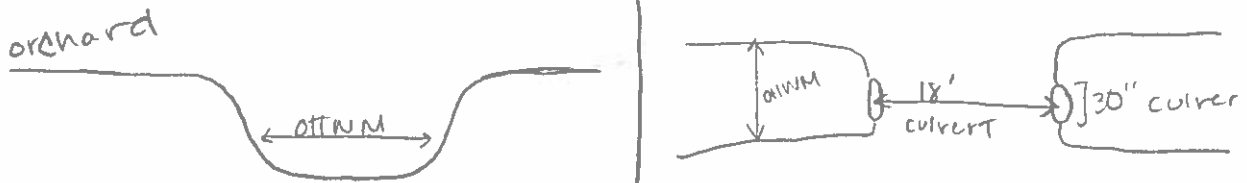
**Cross section drawing:**

**OHWM**

GPS point: OHWM 5 = 12' wide

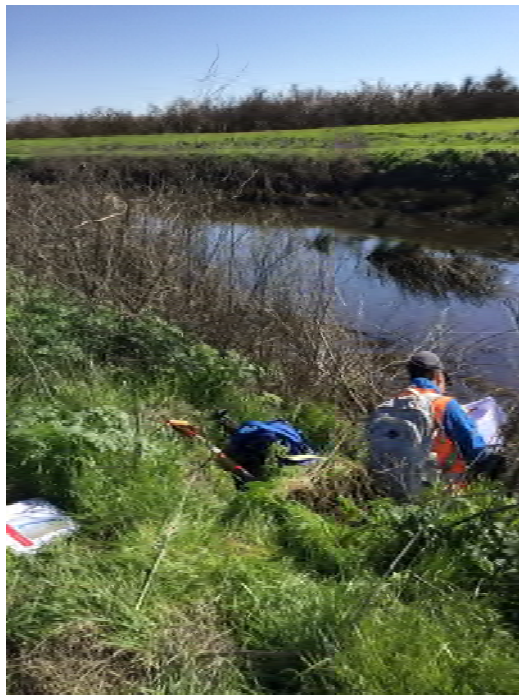
**Photograph 1: SP-1.** Sample point was established on the bank of Black Rascal Creek, just above the ordinary high water mark (OHWM).

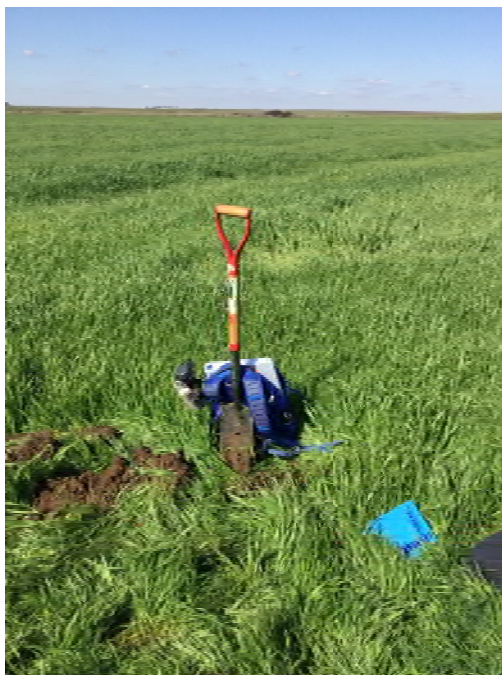
**Photograph 2: SP-2.** Sample point was established in an area where aerial imagery suggests there may be seasonal saturation. No evidence of wetland hydrology or hydric soils was observed.

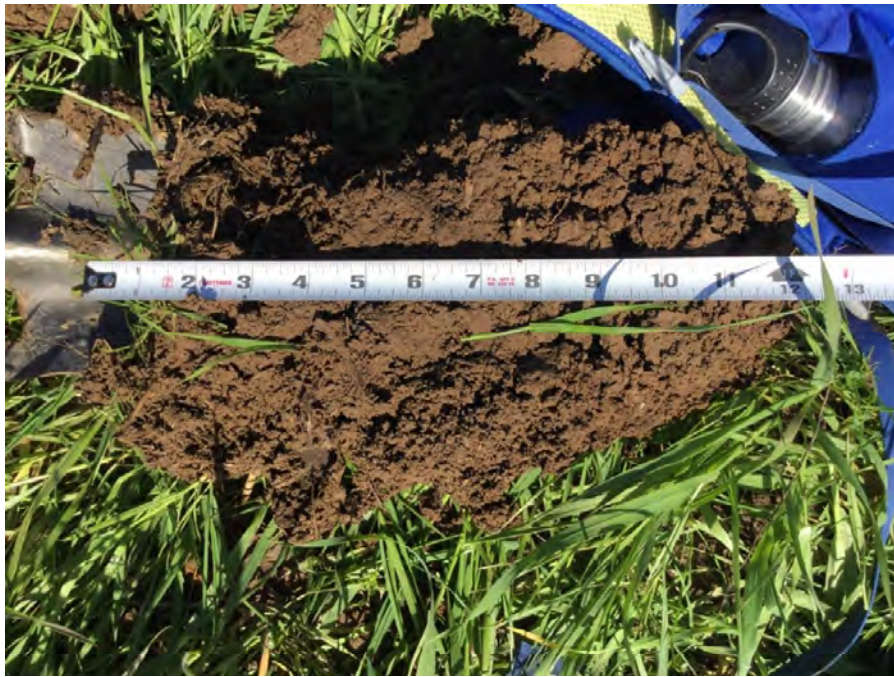
**Photograph 3: SP-2 soil profile. No hydric soil indicators present.**

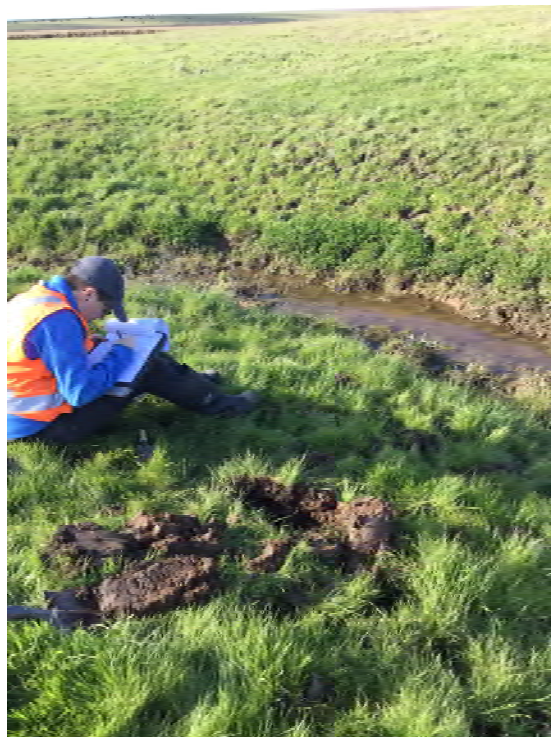
**Photograph 6: SP-6. Feature R-01a is the small channel in the center of the photograph.**

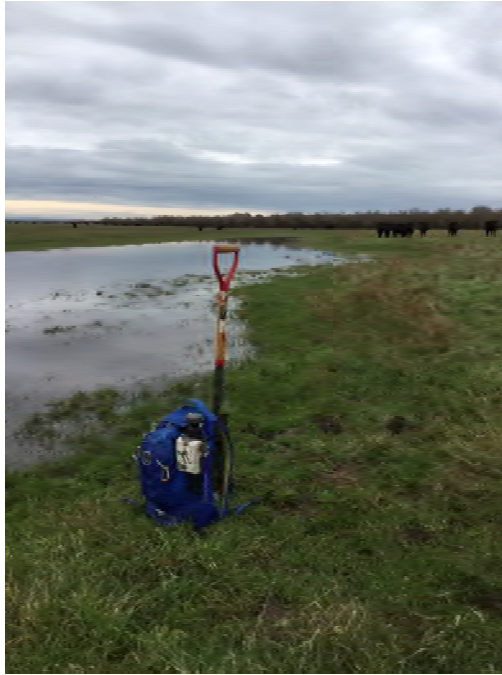
**Photograph 7: SP-10a. Feature VP-02 is on the left side of the photograph.**

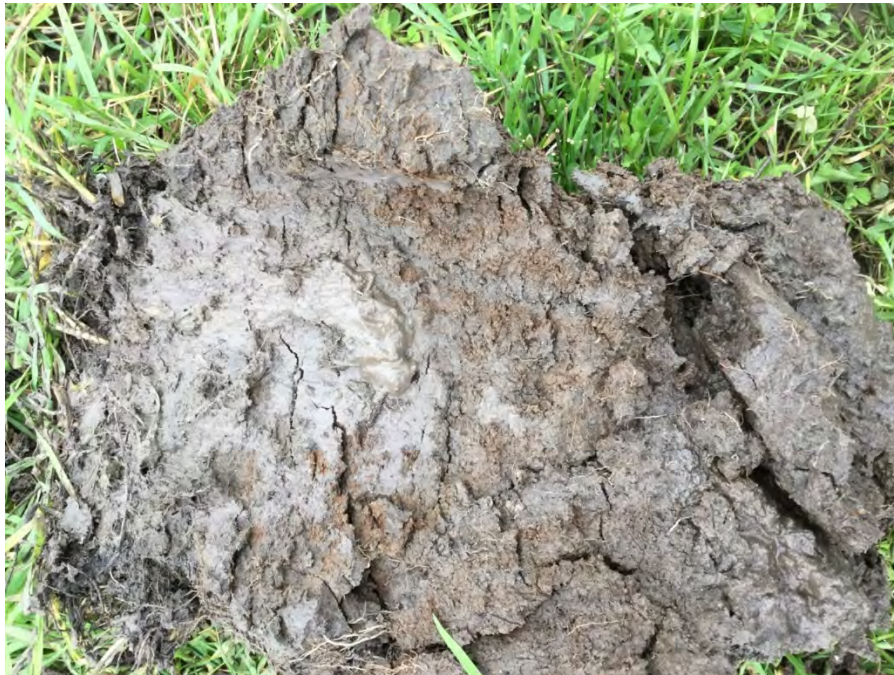
**Photograph 8: SP-10a soil profile. The soil surface is on the left side of photograph. Note redox features visible in the soil profile.**

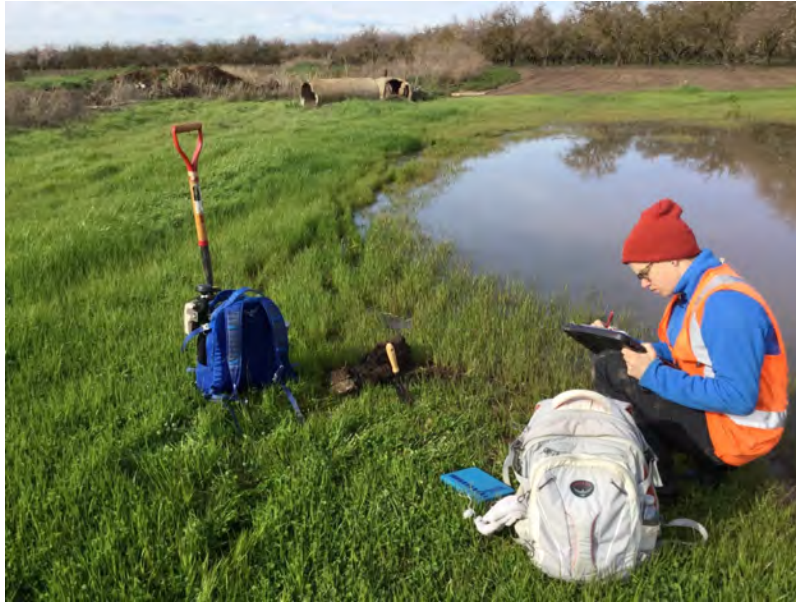
**Photograph 11: SP-11. The puddle in the photograph was determined not to be an aquatic resource because there were no indicators of hydric soils or hydrophytic vegetation, and there was no indication of OHWM.**

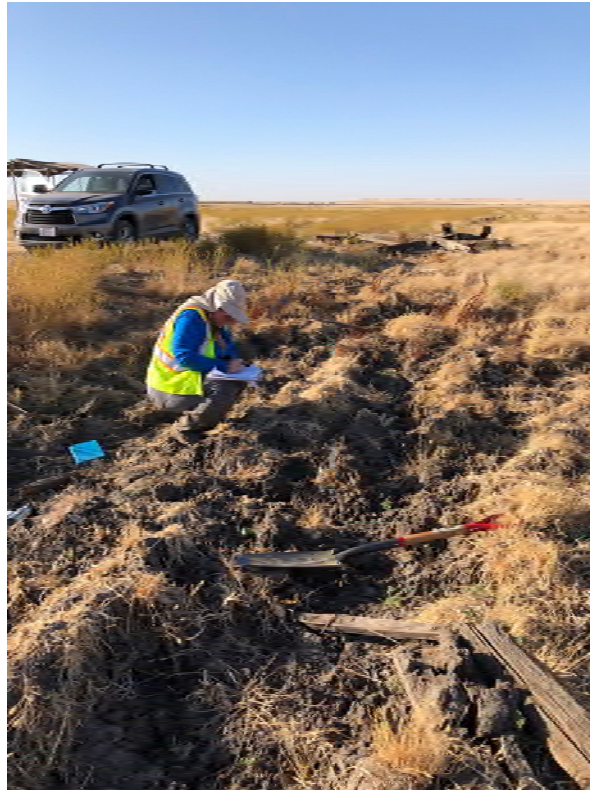
**Photograph 15: SP-23.** This area was ponded in the wet season but was determined not to be an aquatic resource because the sample point had no indicators of hydric soils, and there was no indication of an OHWM.

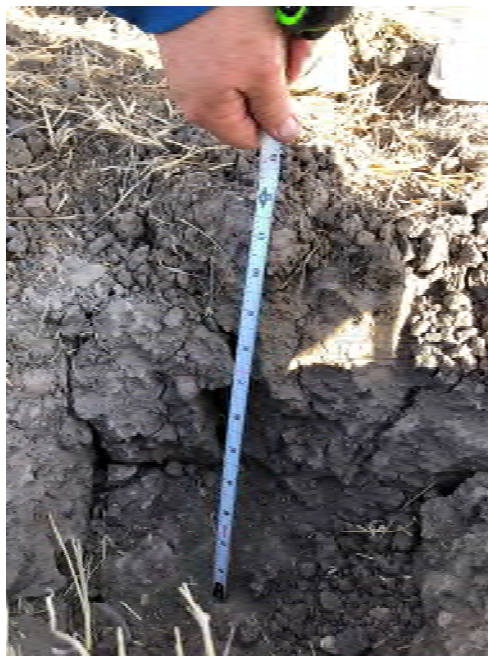
**Photograph 16: SP-23 soil profile.** No redox features.

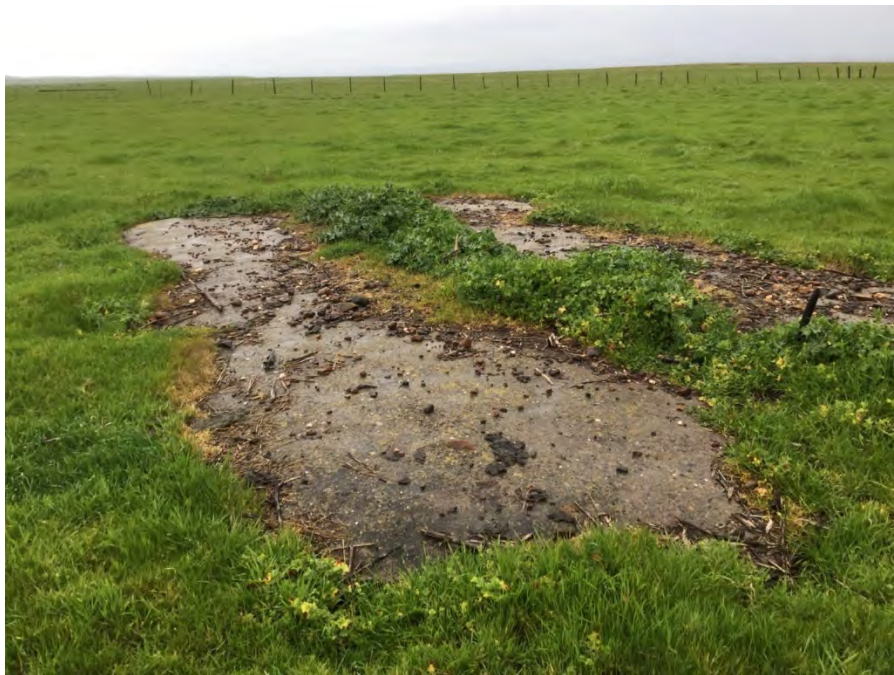
**Photograph 17: Asphalt slab. The signature of this feature on aerial imagery is similar to aquatic resources.**

*Date taken: 3/20/2019, facing east*

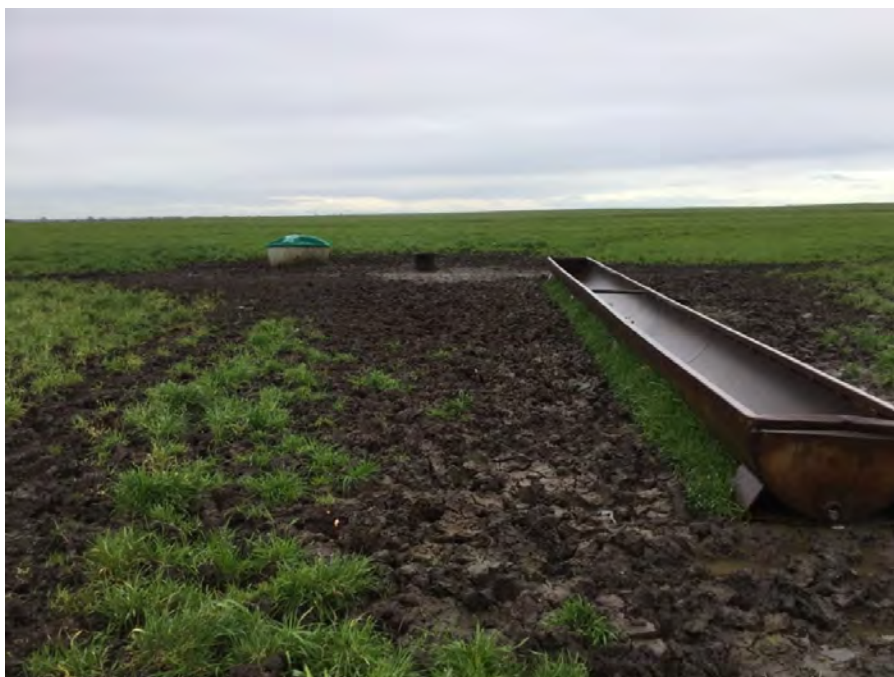
**Photograph 18: Area trampled by cattle that appears saturated on aerial imagery. No wetland indicators were observed.**

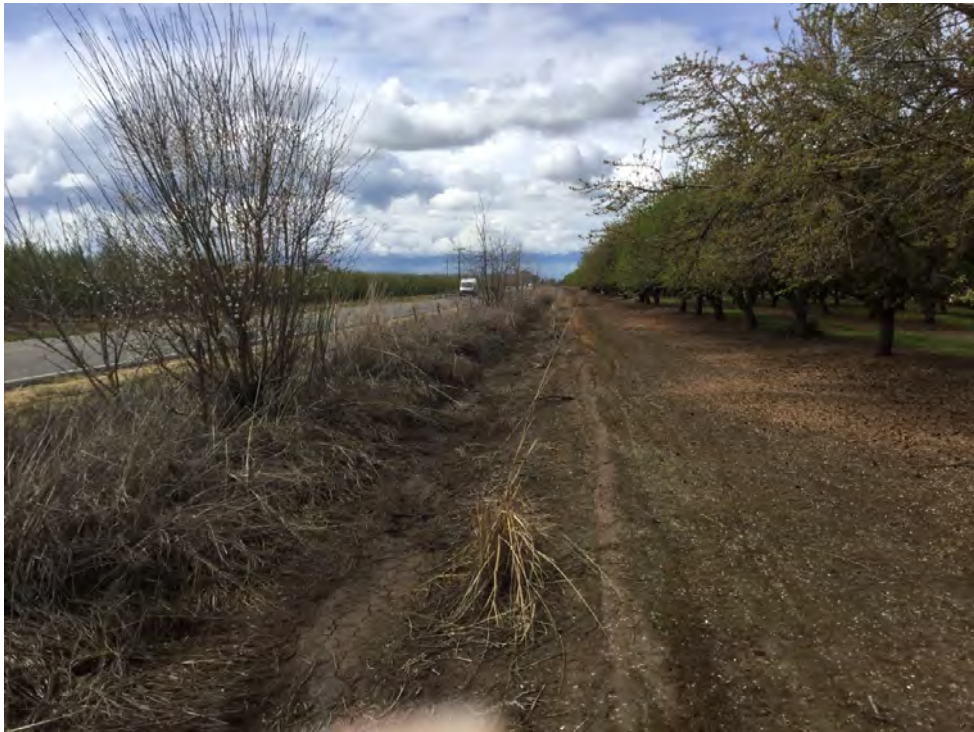
**Photograph 20: Feature D-10 at OHWM-09.**

*Date taken: 3/21/2019, facing west*
