APPENDIX B – BIOLOGICAL TECHNICAL REPORT

**BIOLOGICAL TECHNICAL REPORT FOR THE
CHERRY CHANNEL DRAINAGE PROJECT
CITY OF BEAUMONT, CALIFORNIA**

November 2024

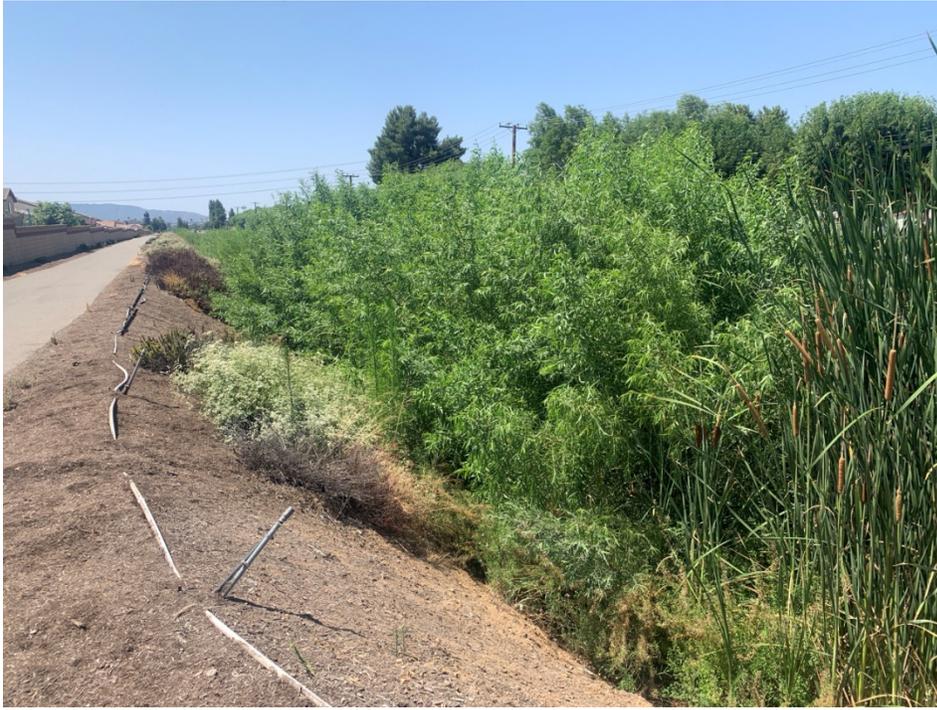
Photo 1.

Overview photo of Cherry Channel drainage from the north end. The northern half of the drainage is dominated by young Goodding's Willow Riparian habitat. Photo is facing south.

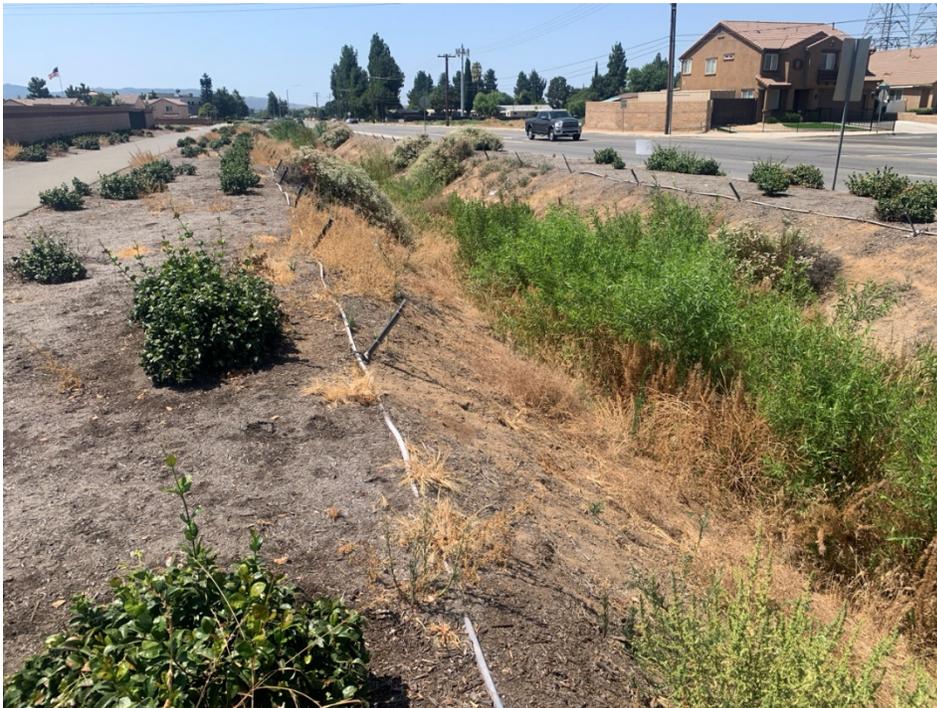
Photo 2.

Overview photo of Cherry Channel drainage from the middle of the Project site. Disturbed Goodding's Willow Riparian habitat begins to transition into cattail marsh habitat. Photo is facing south.

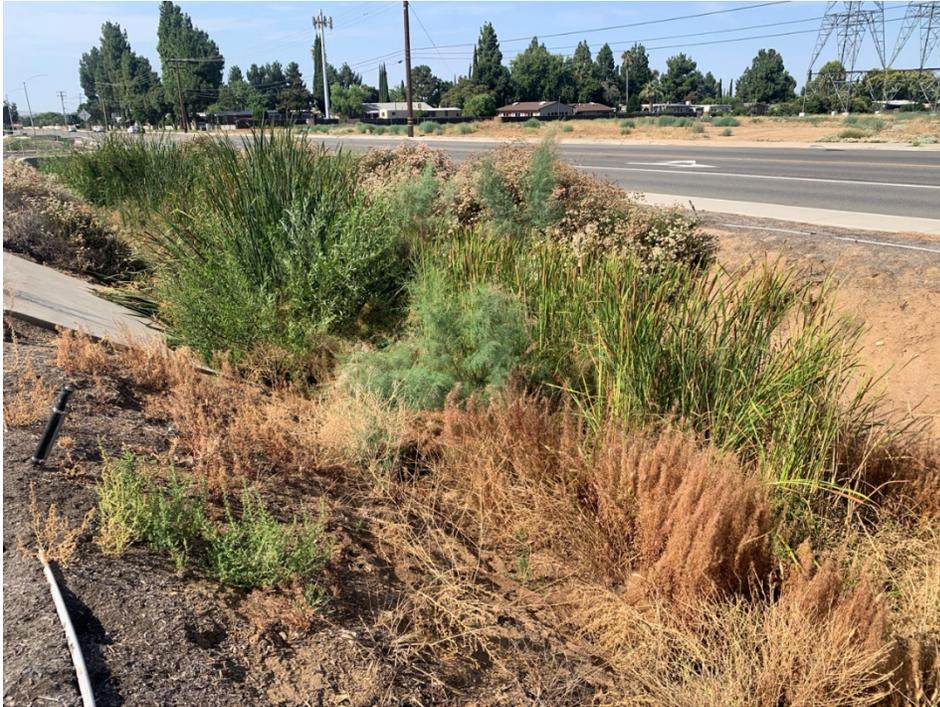
Photo 3.

Cattail marsh habitat with Ruderal vegetation lining the slopes located near the middle of the drainage. Photo is facing southwest.

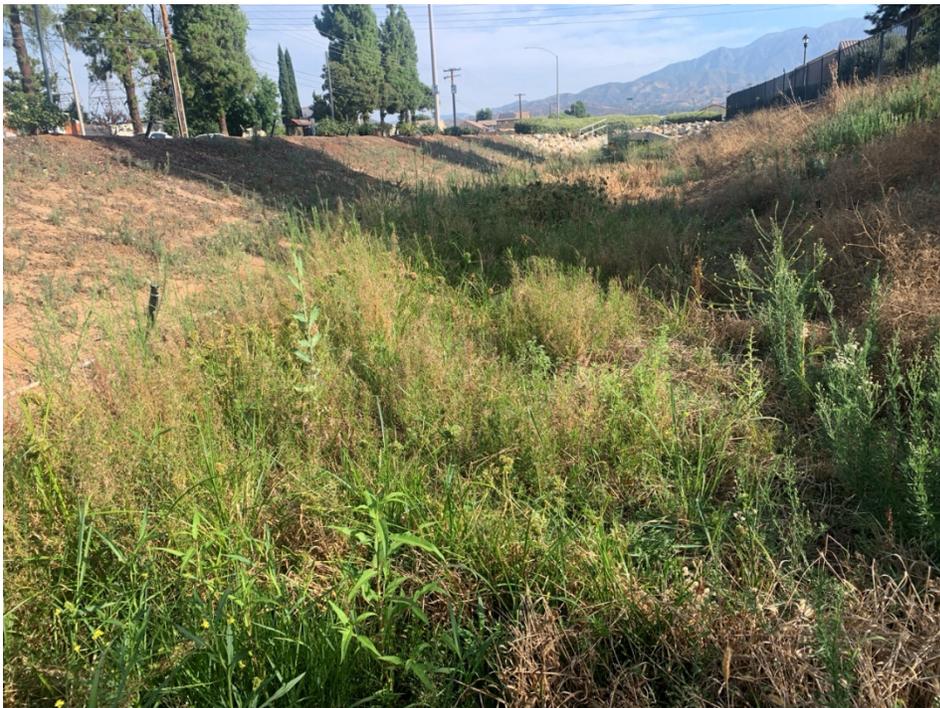
Photo 4.

Section on the southern half of the drainage that is dominated by Disturbed Wild Tarragon habitat. Slopes of the drainage are Ruderal with scattered natives including horseweed and California buckwheat. Photo is facing north.

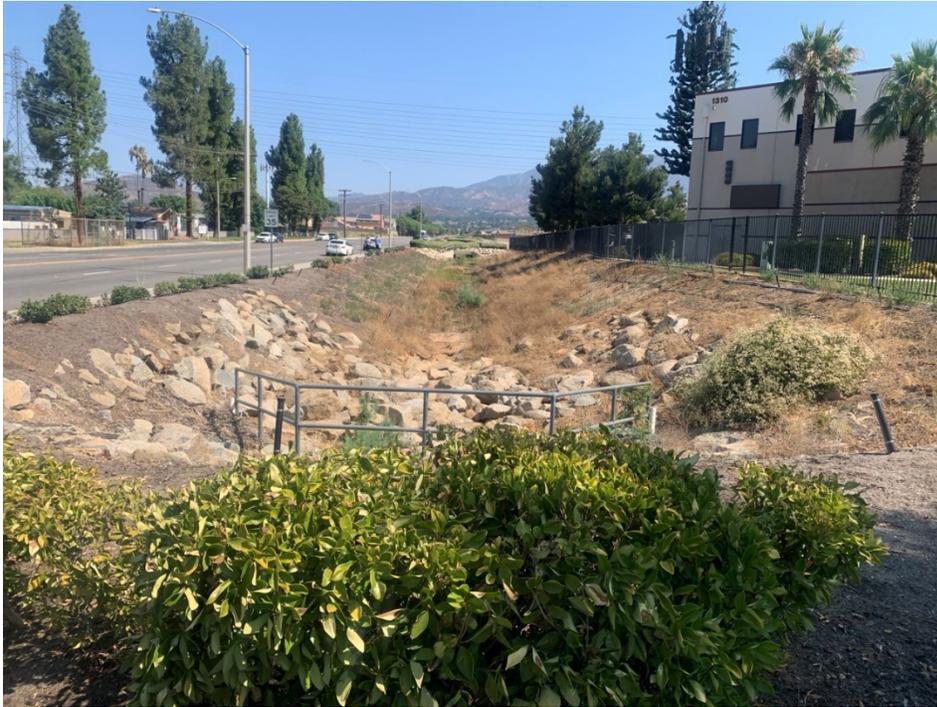
Photo 5.

Overview of the southern portion of the drainage. This area is dominated with Ruderal vegetation. Ornamental vegetation lines the outsides of the channel. Photo is facing north.

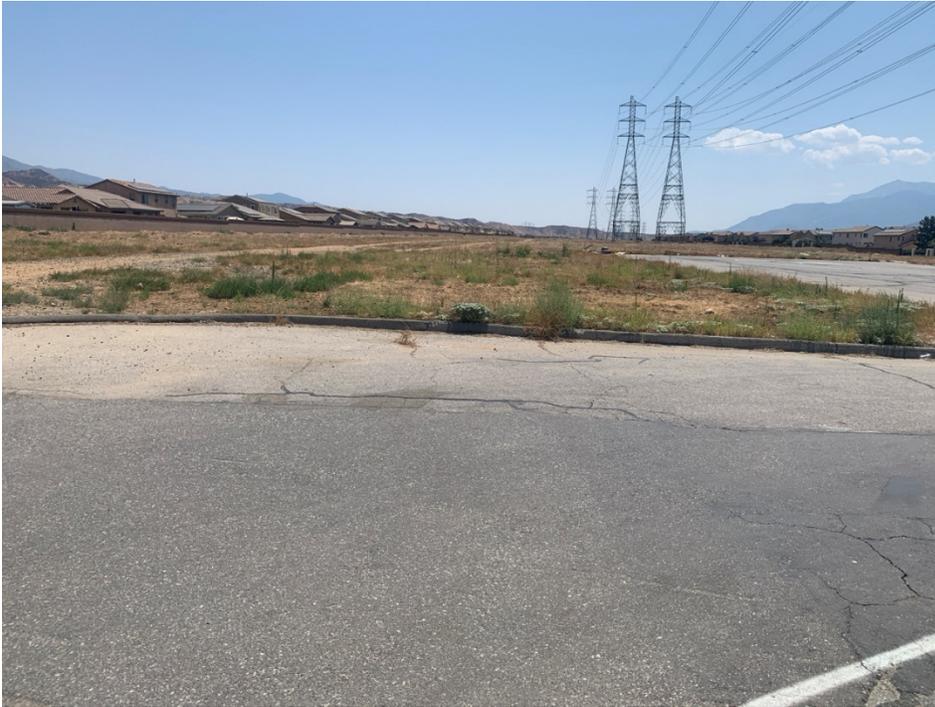
Photo 7.

Overview of the open space located along the SCE power lines. This area has a low potential for BUOW. Soils look freshly tilled/mowed. Photo is facing east.

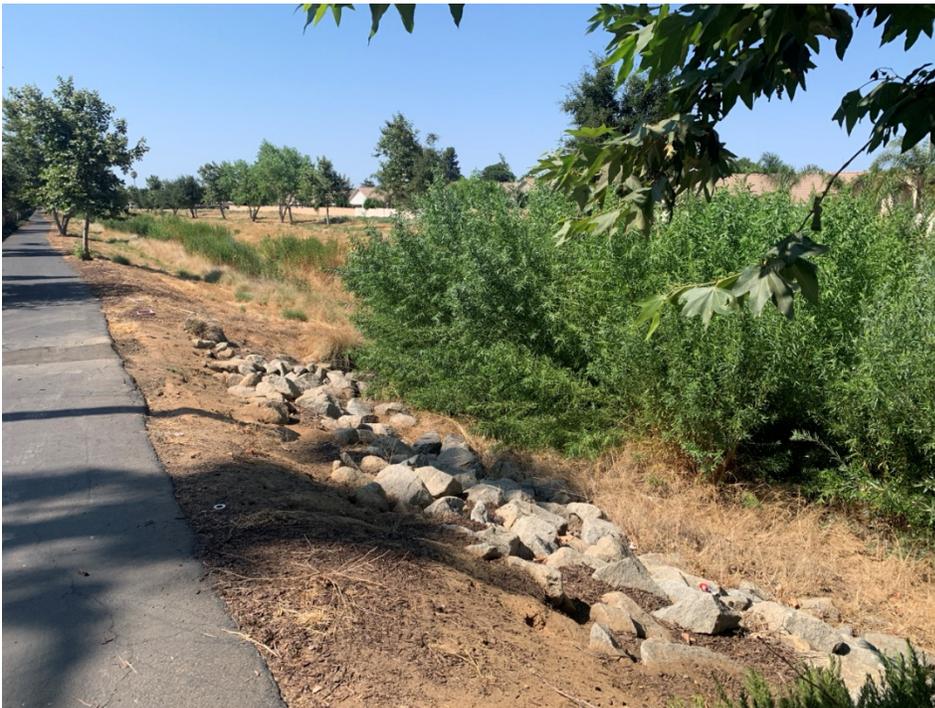
Photo 8.

Overview photo of the natural drainage (Potrero Creek) located south, outside of the Project site boundary. This drainage leads to San Jacinto River which is a NWI mapped waterway. Photo is facing southwest.

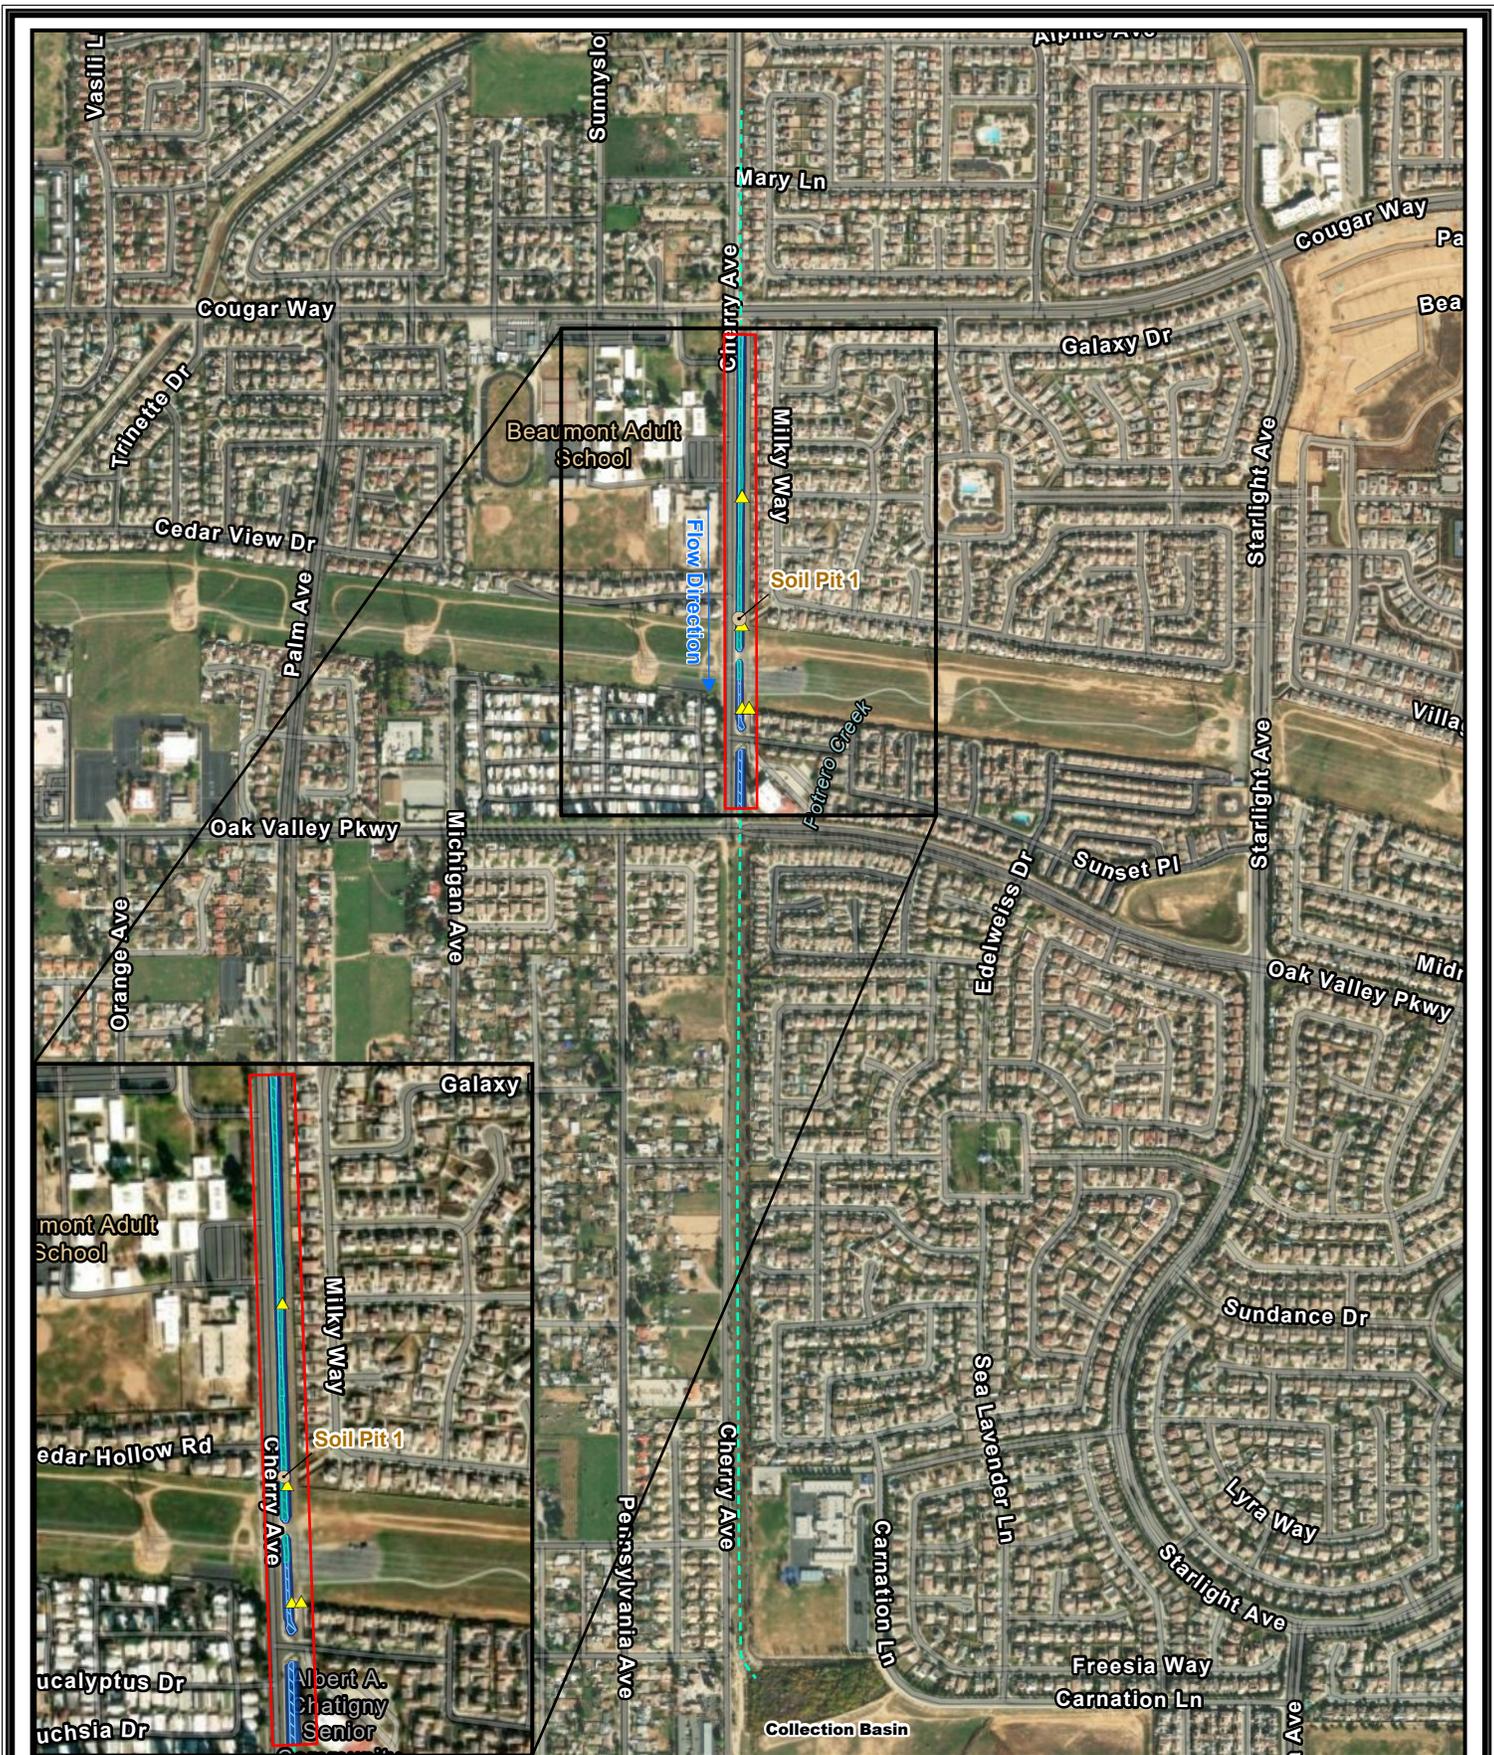
Jurisdictional Delineation

No NWI mapped wetlands were identified within the Project site. However, a cattail marsh and Gooding's Willow - Red Willow Riparian Woodland occur within the northern portion of the channel. An irrigational system with sprinklers is located along the top of the banks and within the channel, providing an artificial water source to this area. In addition, this area receives nuisance flow from the surrounding residential area. This riparian area is primarily vegetated with cattails, emergent Gooding's and red willows, and mulefat scattered throughout with an understory of cyperus and non-native grassland. Several soil test pits were attempted during the survey; however, due to the presence of the geo-mats and the compaction of the channel bottom, a soil pit could not be obtained. In addition, no hydric soils were revealed during the database soil search. Although the presence of hydric soils could not be confirmed, hydrophytic vegetation is present within this area, as evidence of hydrology was observed throughout the area; therefore, this riparian area is considered to be a wetland area with problematic soils. In addition, since bank-to-bank channelization occurs, this area should be considered under CDFW jurisdiction and an MSHCP Riparian area. However, this area appears to be fed solely by artificial and nuisance water sources and is maintained regularly by the City, which includes regular removal of vegetation within the channel. This area is not considered a natural wetland; if the sprinklers were to be permanently removed, this riparian area is not expected to persist.

- Project Location
- Sub Surface Flow
- Bank to Bank
- Ordinary High Water Mark
- RWQCB/CDFW Wetland and MSHCP Riparian
- Soil Pit
- ▲ Culvert

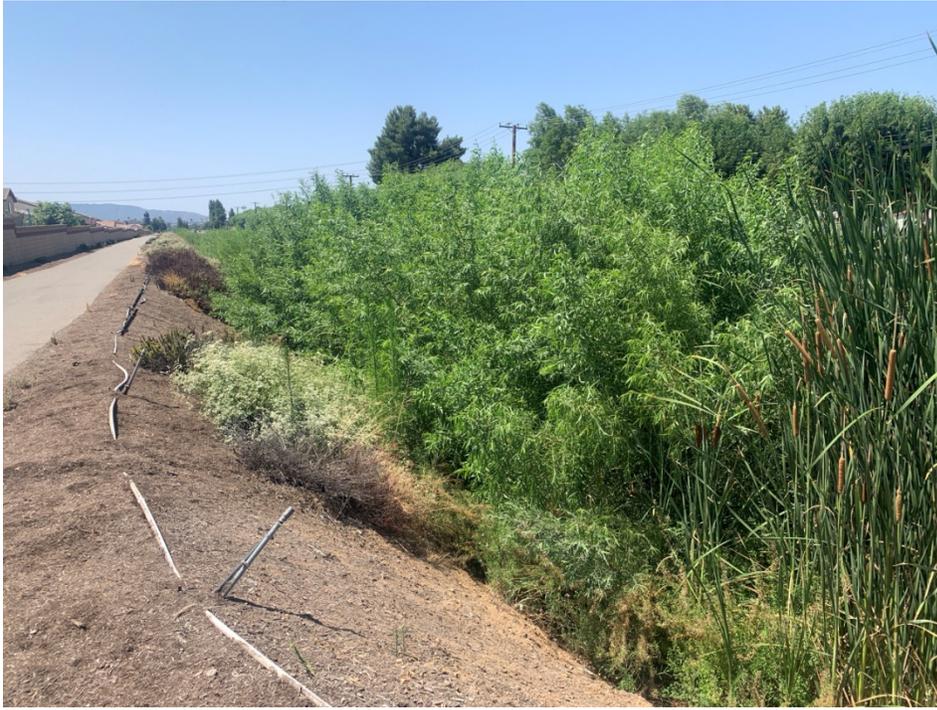
Photo 1.

Overview photo of Cherry Channel drainage from the north end. The northern half of the drainage is dominated by young Goodding's Willow Riparian habitat. Photo is facing south.

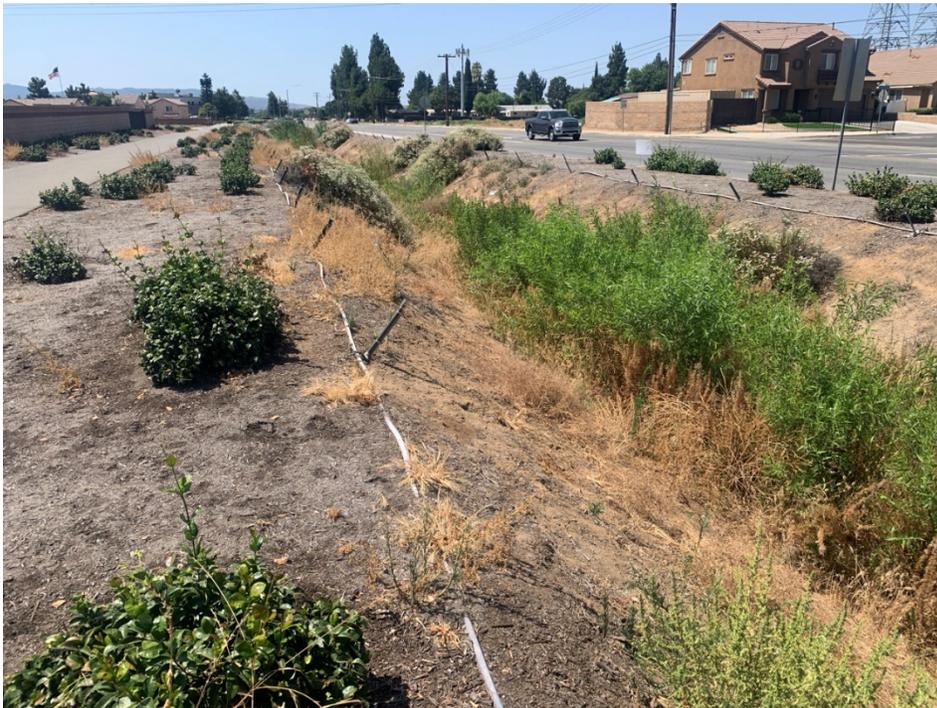
Photo 2.

Overview photo of Cherry Channel drainage from the middle of the Project site. Disturbed Goodding's Willow Riparian habitat begins to transition into cattail marsh habitat. Photo is facing south.

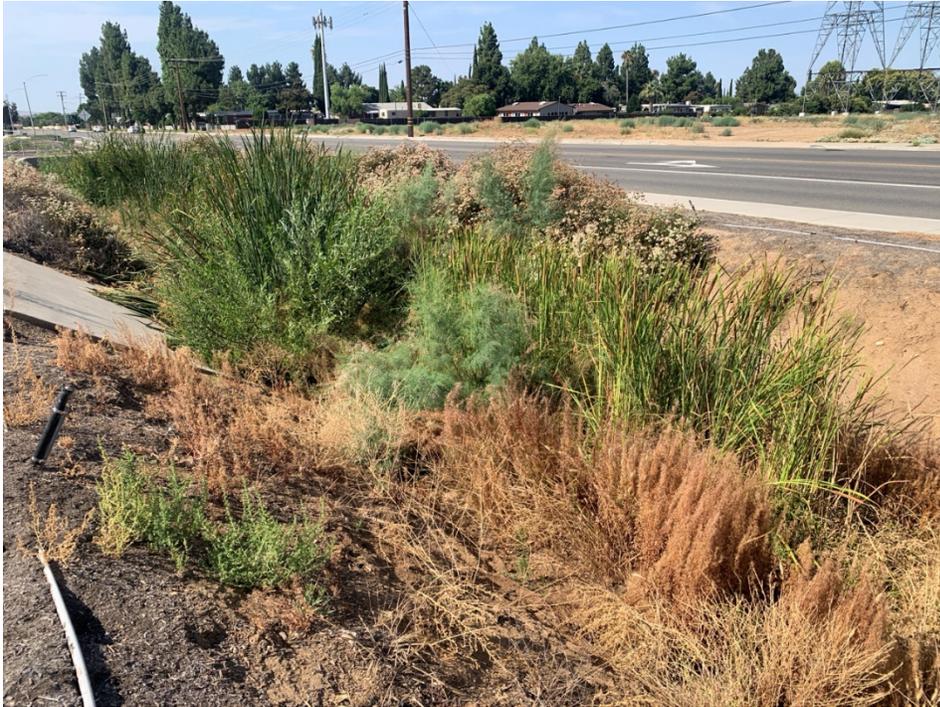
Photo 3.

Cattail marsh habitat with Ruderal vegetation lining the slopes located near the middle of the drainage. Photo is facing southwest.

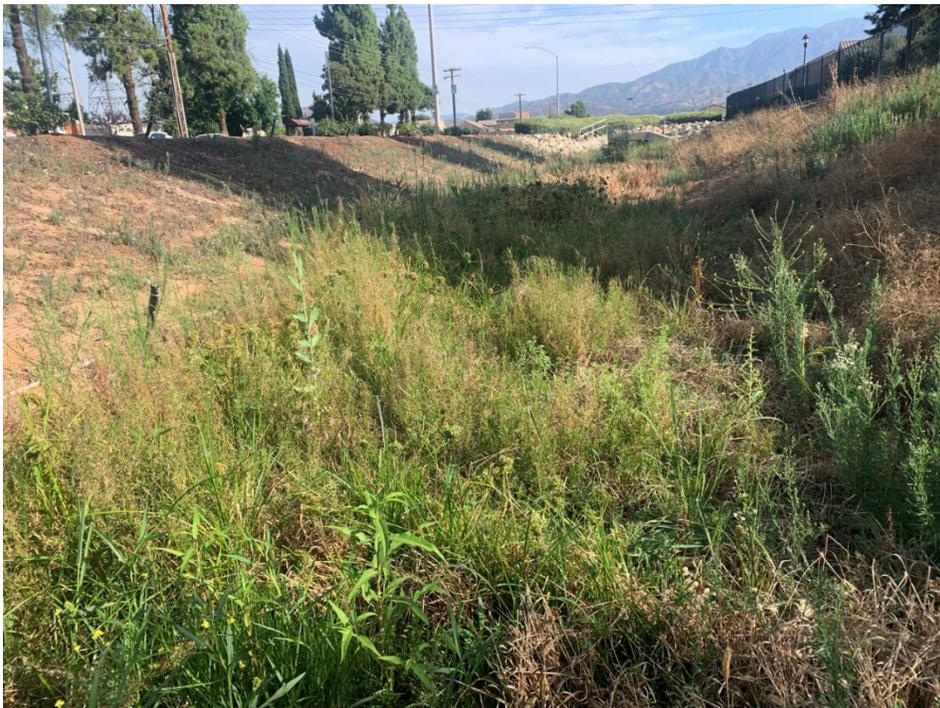
Photo 4.

Section on the southern half of the drainage that is dominated by Disturbed Wild Tarragon habitat. Slopes of the drainage are Ruderal with scattered natives including horseweed and California buckwheat. Photo is facing north.

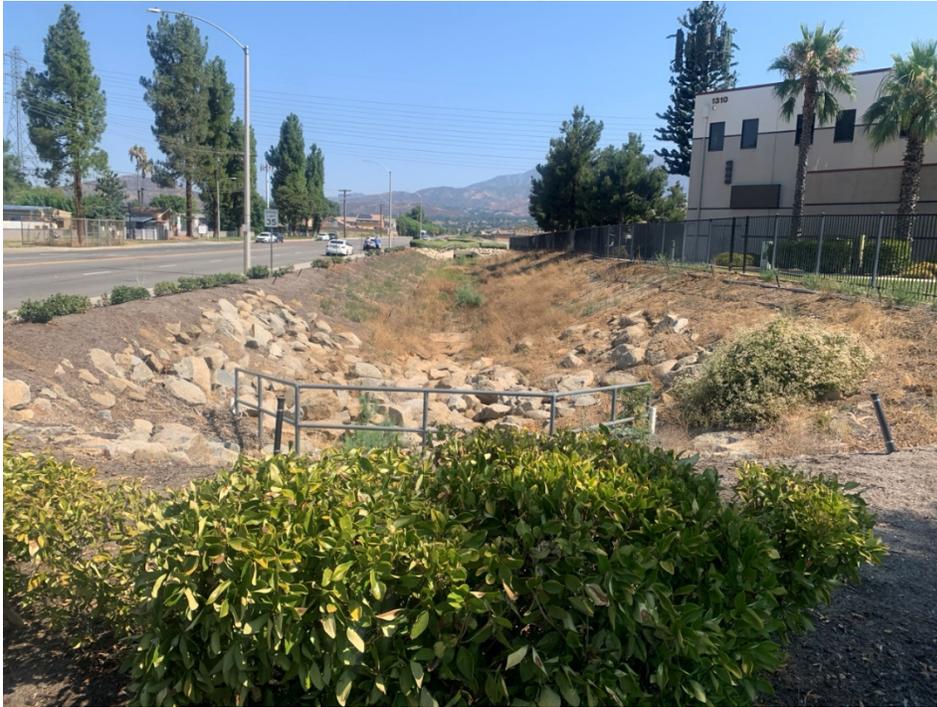
Photo 5.

Overview of the southern portion of the drainage. This area is dominated with Ruderal vegetation. Ornamental vegetation lines the outsides of the channel. Photo is facing north.

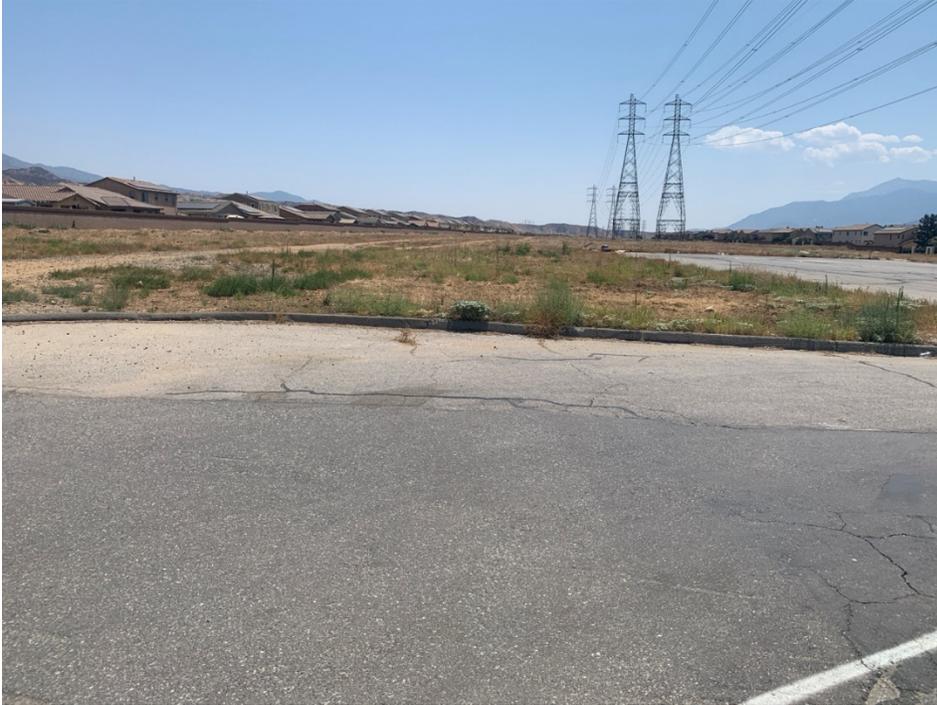
Photo 7.

Overview of the open space located along the SCE power lines. This area has a low potential for BUOW. Soils look freshly tilled/mowed. Photo is facing east.

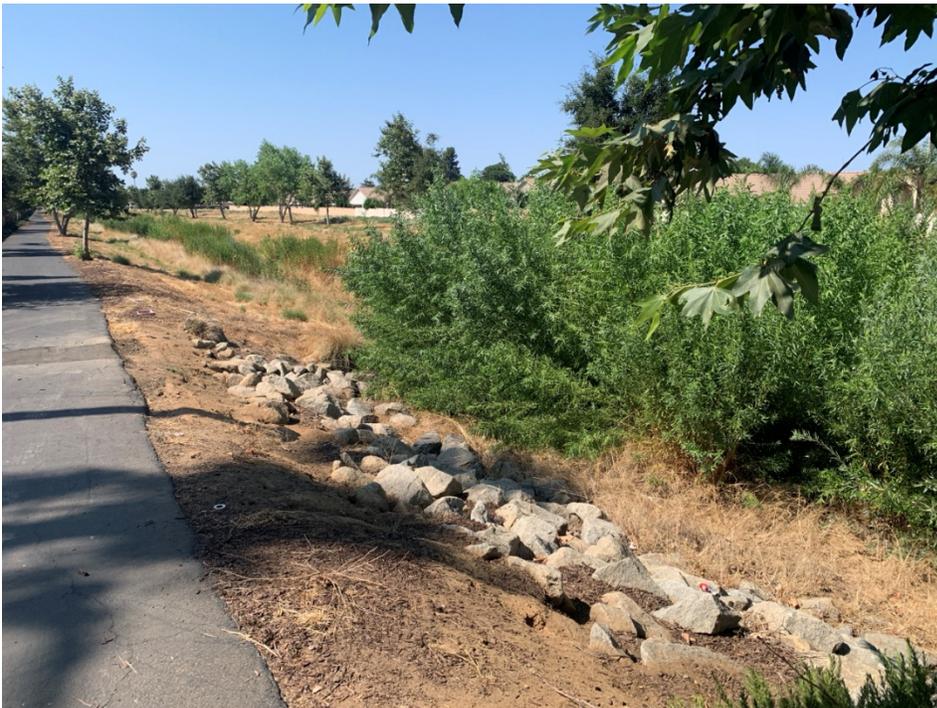
Photo 8.

Overview photo of the natural drainage (Potrero Creek) located south, outside of the Project site boundary. This drainage leads to San Jacinto River which is a NWI mapped waterway. Photo is facing southwest.
