# Aquatic Resources Delineation Report for the Seville 5 Solar Project Imperial County, California

FEBRUARY 2025

**Apex Energy Solutions, LLC**

**SWCA Environmental Consultants**

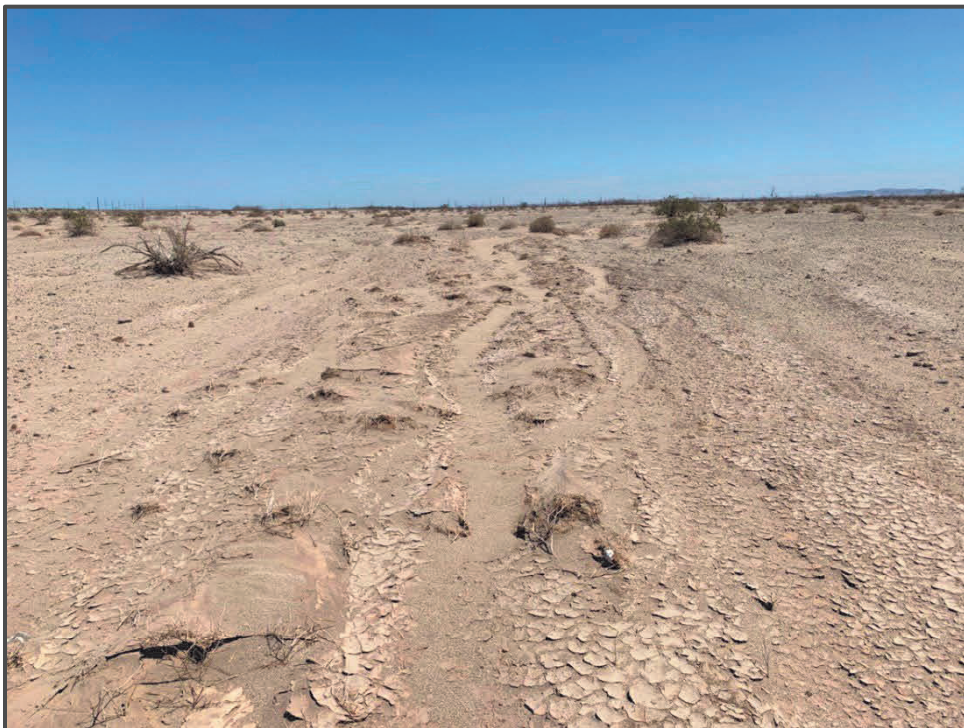
feature within the review area. The drainage limits were assessed via the limits of the active floodplain, which was characterized by shallow topographic changes, surface soil cracking, sediment sorting, and ripples. Vegetation within F01 was also sparser than the surrounding uplands.

**Photograph 2. F01 consisting of active floodplain indicators; view facing southeast (downstream).**

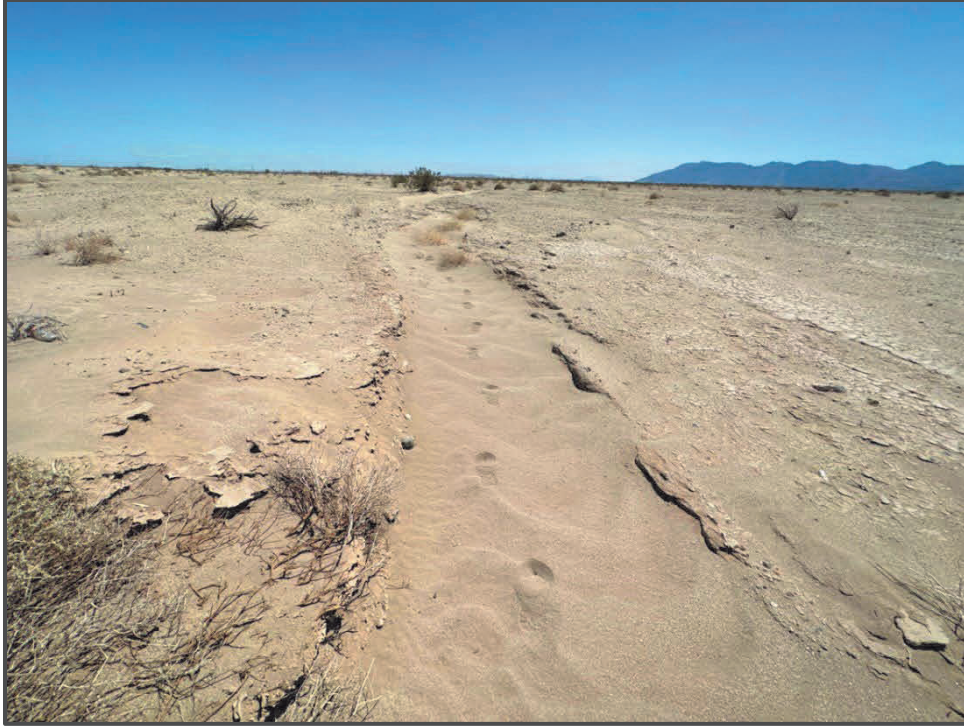
**Photograph 3. Example of low-flow channel in F01; view facing southeast (downstream).**

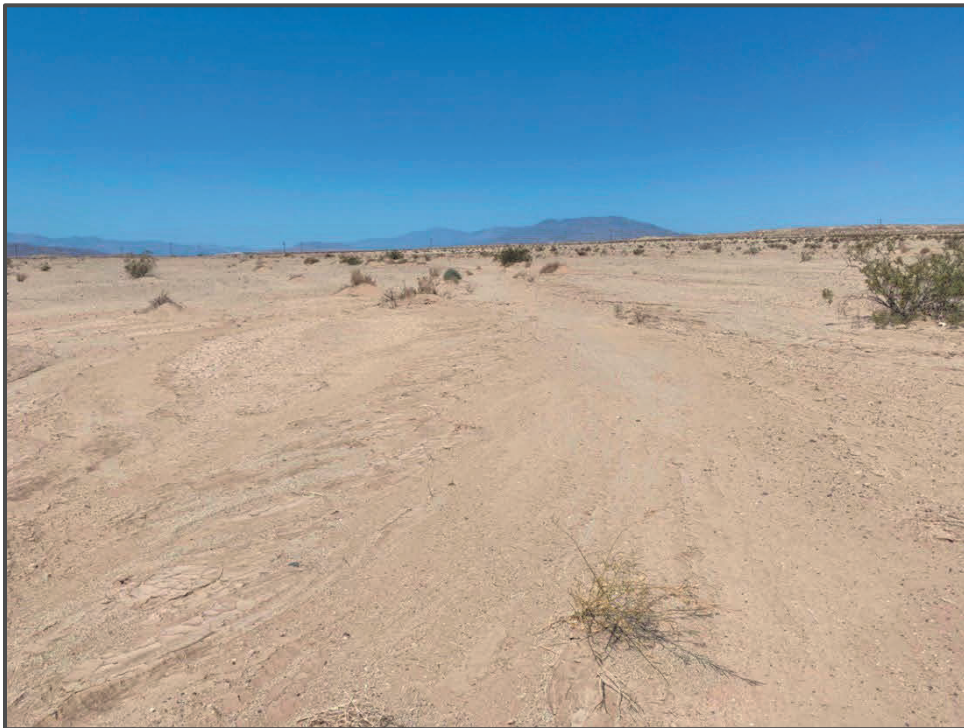
**Photograph 4. Active floodplain of F01 showing sheet flow; view facing northwest (upstream).**

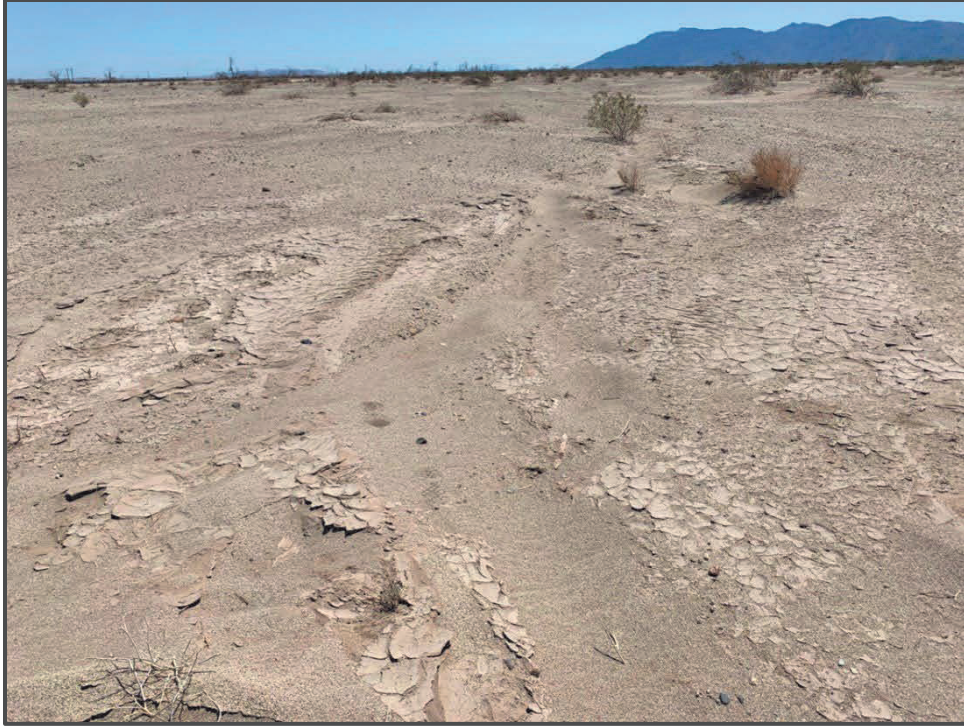
**Photograph 5. View of poorly developed low-flow channels in F01; view facing northwest (upstream).**

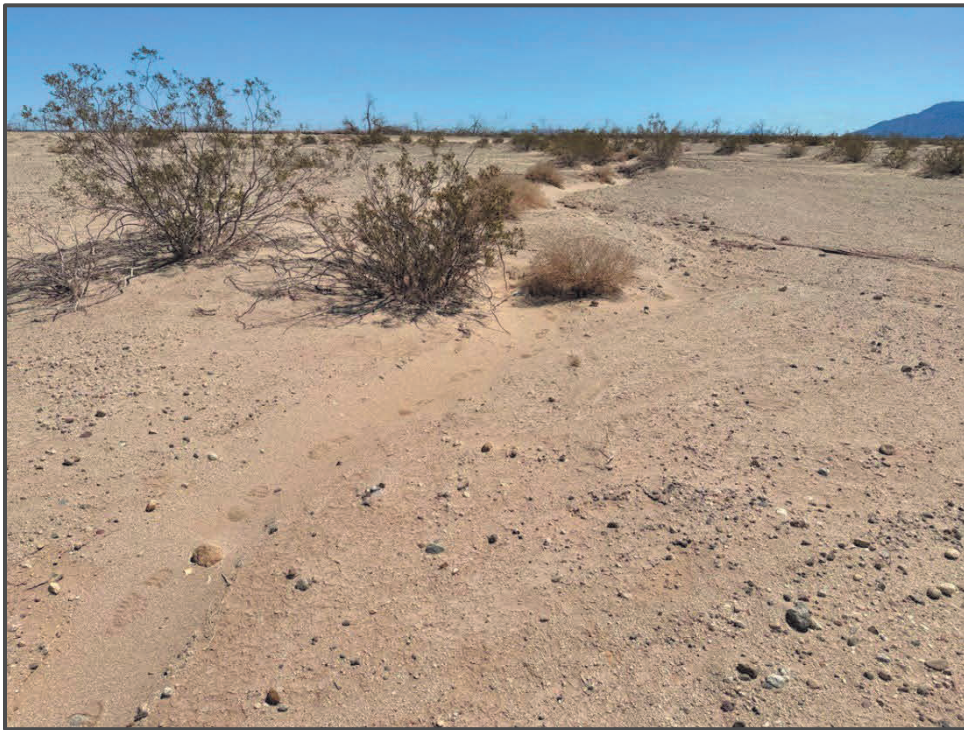
**Photograph 6. F01 channelizes into distinct drainages; view facing southeast (downstream).**

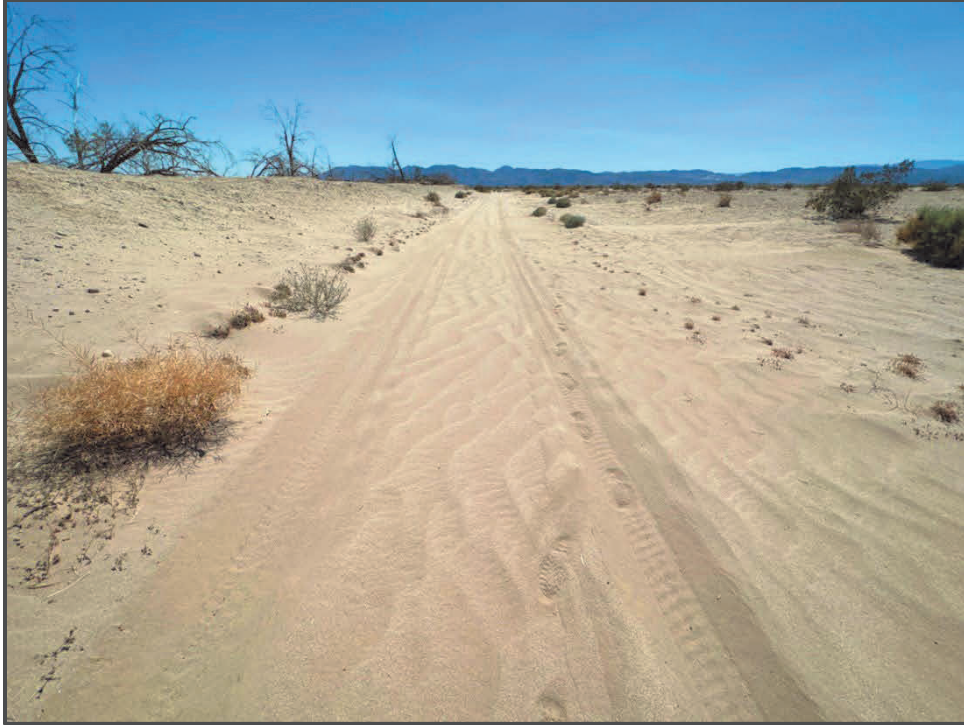
**Photograph 7. F02, showing access road which functions as a primary conveyor of flow; view facing south (downstream).**
