**DRAFT Aquatic Resources Delineation Report**  
28th Street and Q Street  
Rio Linda, Sacramento County

July 2022

**Recommended Citation:** Bargas Environmental Consulting. 2022. DRAFT Aquatic Resources Delineation – 28<sup>th</sup> Street and Q Street, Rio Linda, Sacramento County, California. Report prepared for Thomas Law Group.

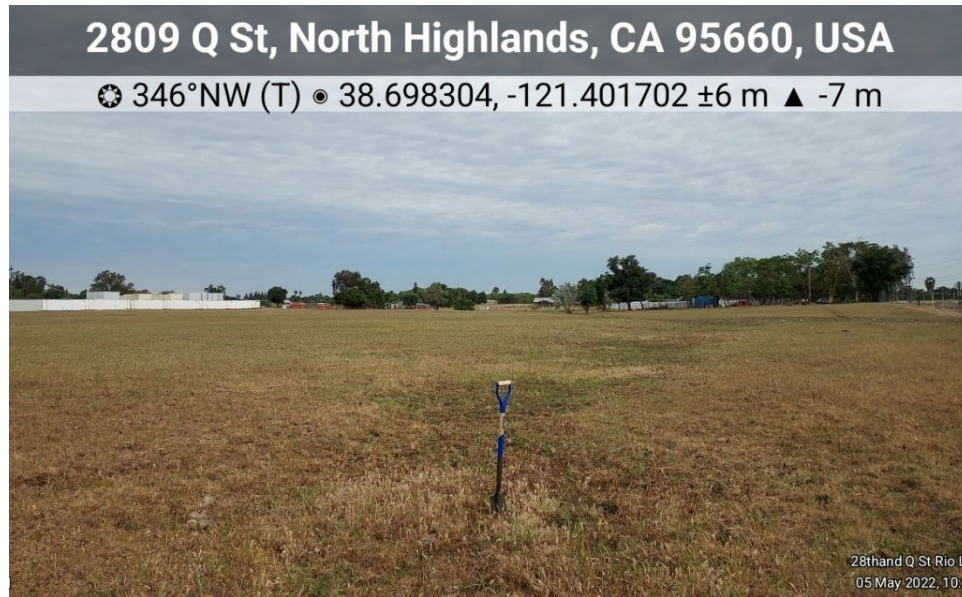
*Photo 1. SP-1; The southern end of SWS-1 mapped in the undeveloped half of the Study Area, looking northwest near the southeast corner.*

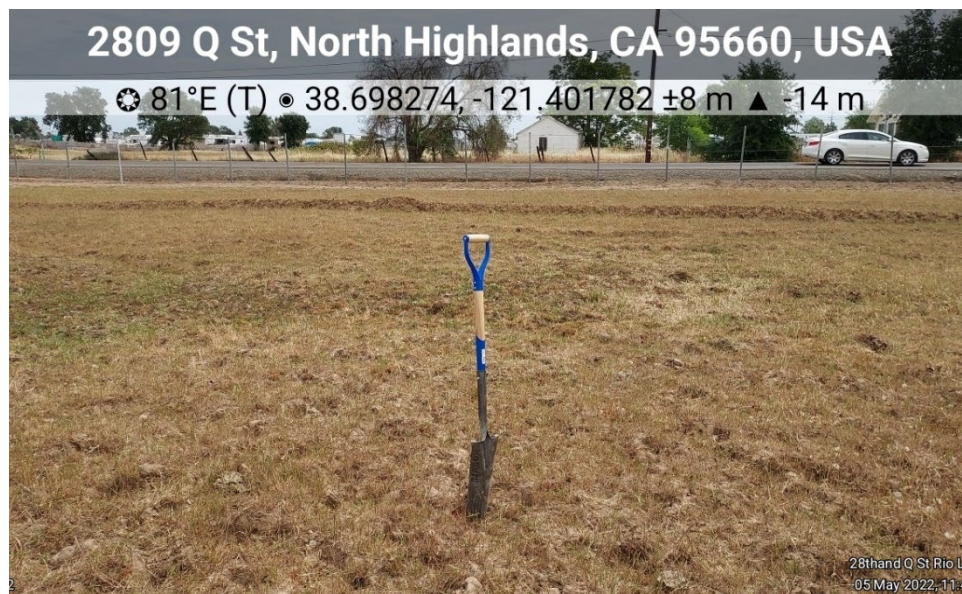
*Photo 2. SP-2; An upland point for SWS-1 mapped in the undeveloped portion of the Study Area looking east towards the feature.*

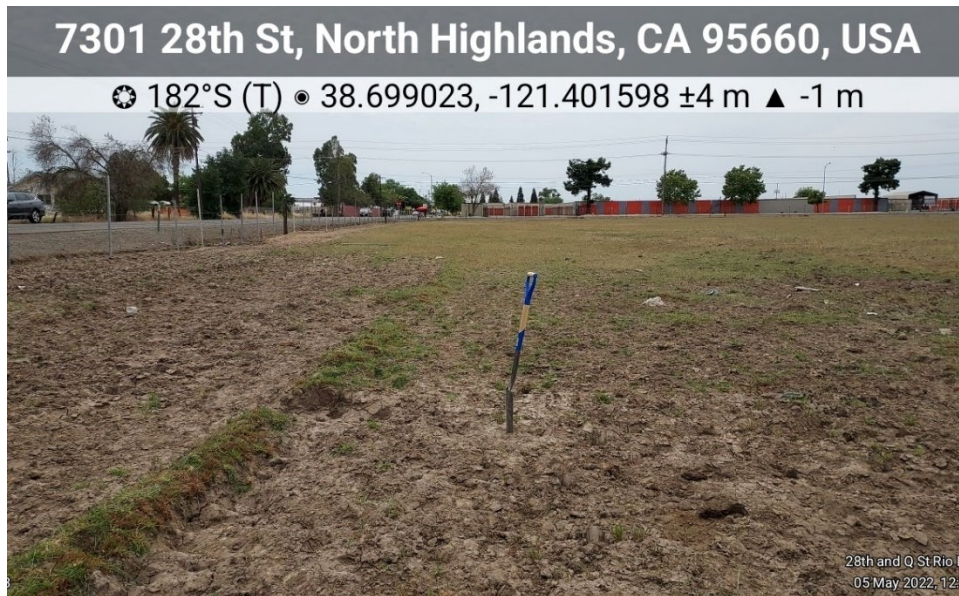
*Photo 3. SP-3 is located within SWS-3, mapped in the undeveloped half of the Study Area looking south.*

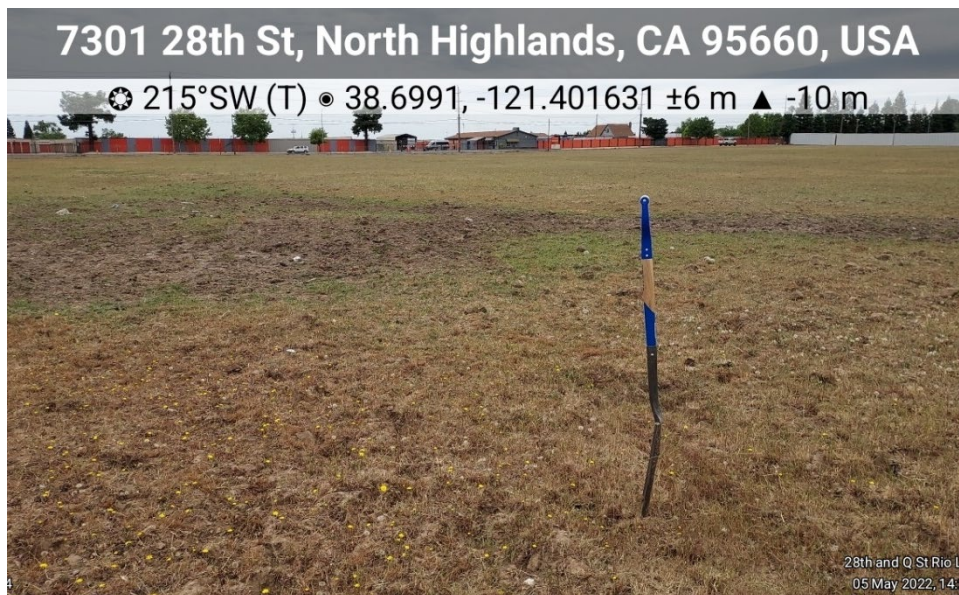
*Photo 4. SP-4; The upland point for SWS-3 mapped in the undeveloped portion of the Study Area looking southwest towards the feature.*

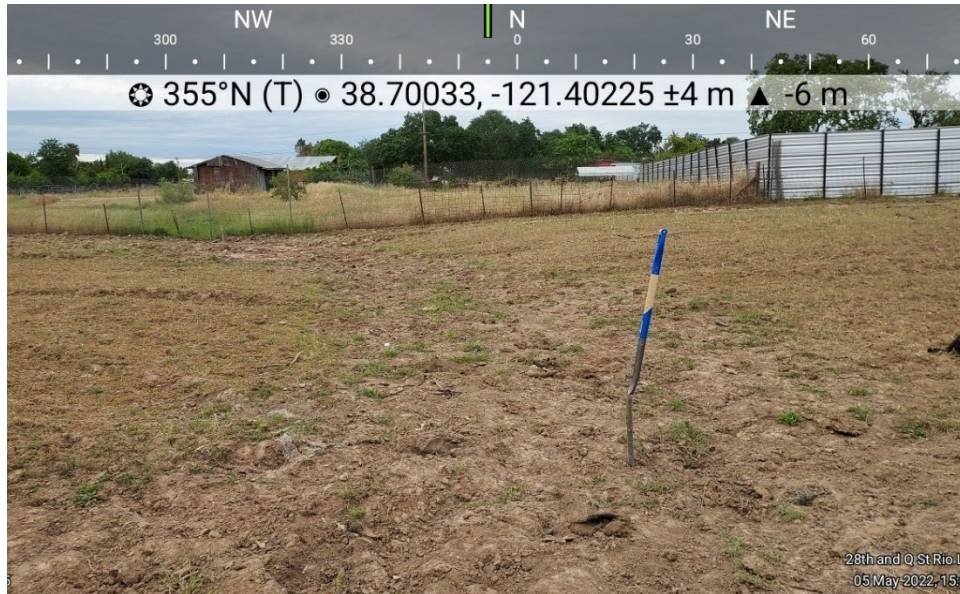
*Photo 5. SP-5 is located within SWS-1, mapped in the undeveloped half of the Study Area looking north towards the northern project boundary (fencing).*

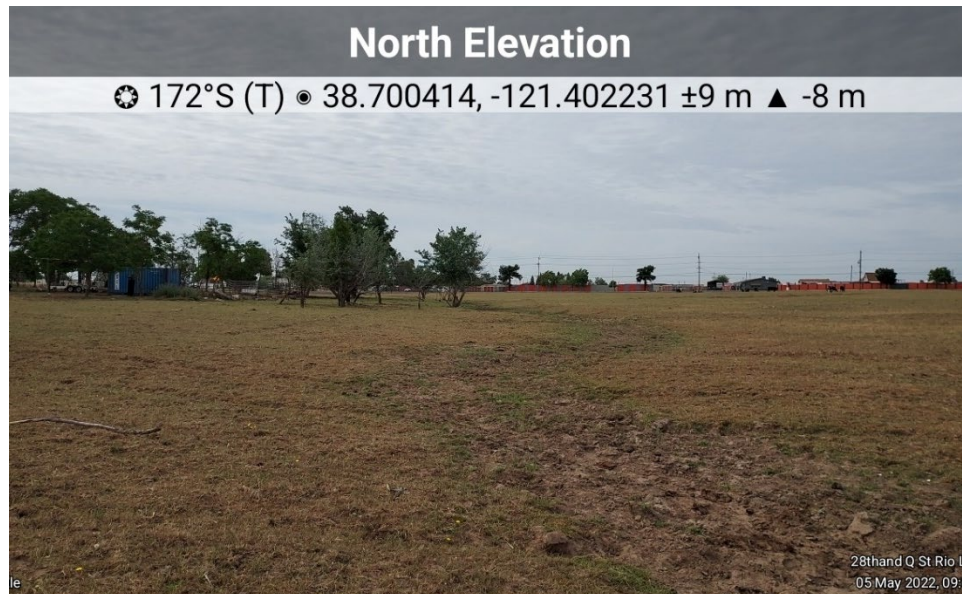
*Photo 7. Overview of SWS-1 from near the northern boundary of the project, looking south.*

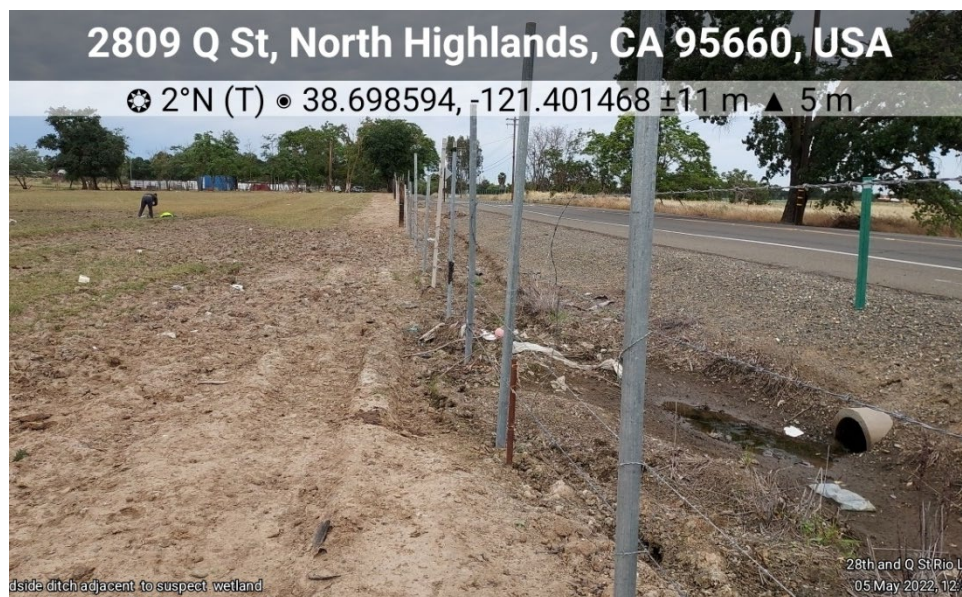
inches was observed. This feature receives ephemeral flow in the form of stormwater and irrigation runoff from adjacent fields and roads. Water was present at the time of the survey. A desktop review of available sources (Google 2021, USFWS 2021, USGS 2022) and the USGS topographic map indicate this feature is a source for a seasonal wetland swale (SWS-3). The wetland hydrology indicators included Surface Soil Cracks (B6), Saturation (A3) in some places, Biotic Crust (B12), Drift Deposits (B3), Sediment Deposits (B2), and Inundation Visible in Aerial Imagery (B7).

*Photo 8. Ditch-1, along the eastern project boundary, looking north.*

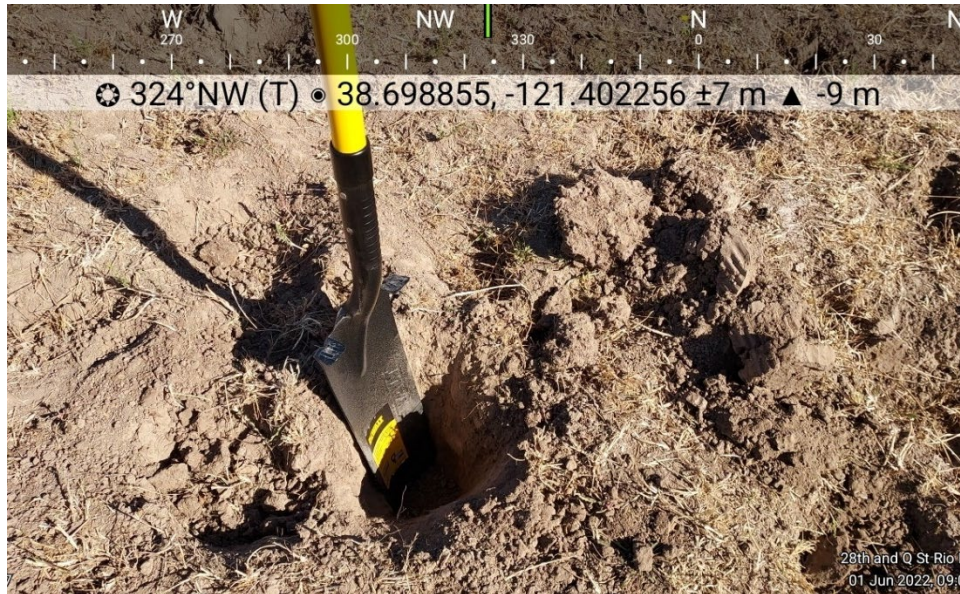
*Photo 9. SP-7; Collected within an area where potential wetland signature visible in aerial imagery but appears more upland in field observations. Hydrophytic vegetation and hydric soils observed, wetland hydrology not observed.*

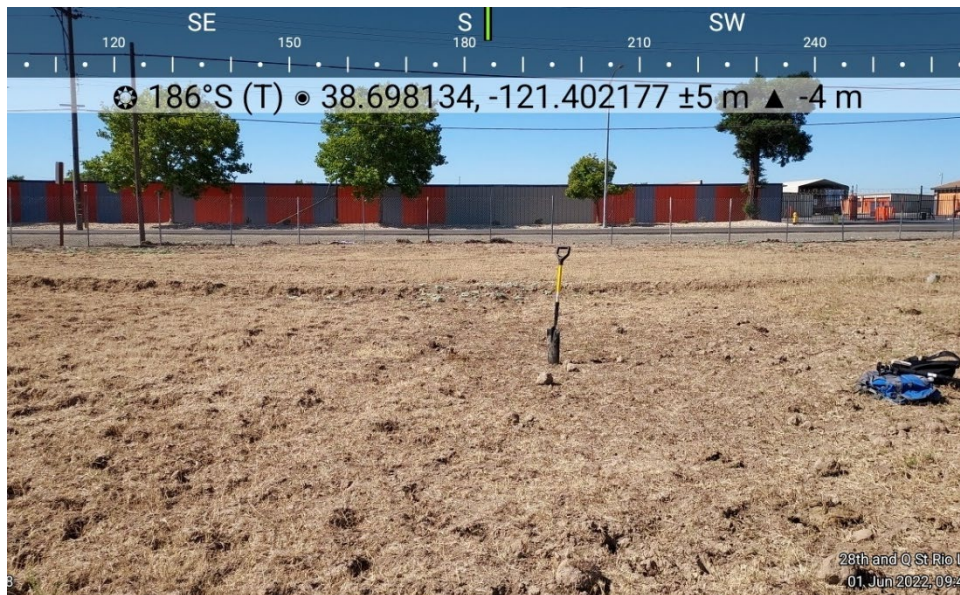
*Photo 10. SP-8 is located within SW-2, mapped in the undeveloped half of the Study Area looking south towards the southern project boundary (fencing).*

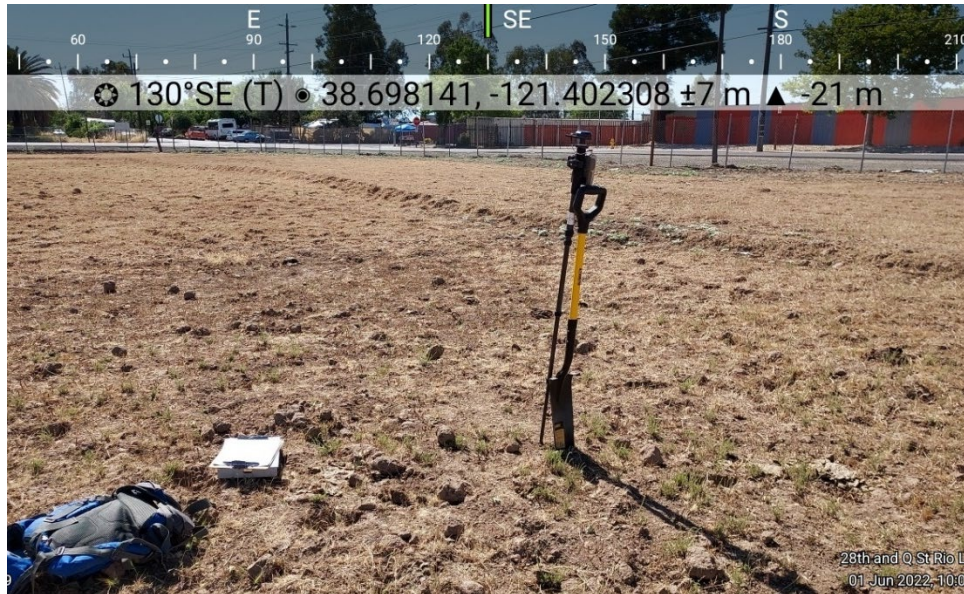
Photo 11. SP-9; The upland point for SW-2 mapped in the undeveloped portion of the Study Area looking southeast towards the feature.

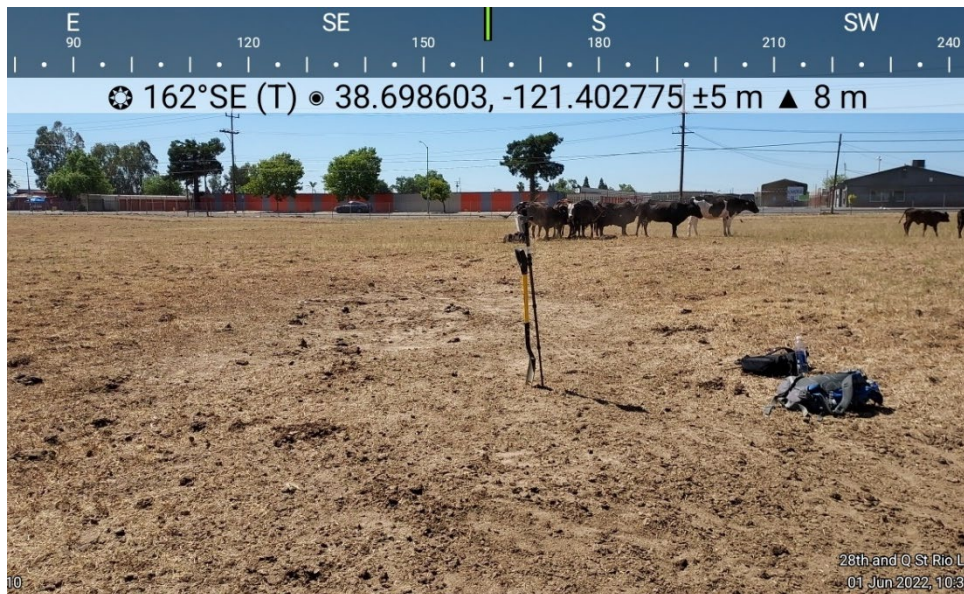
Photo 12. SP-10 is located within SW-3, mapped in the undeveloped half of the Study Area looking southeast.

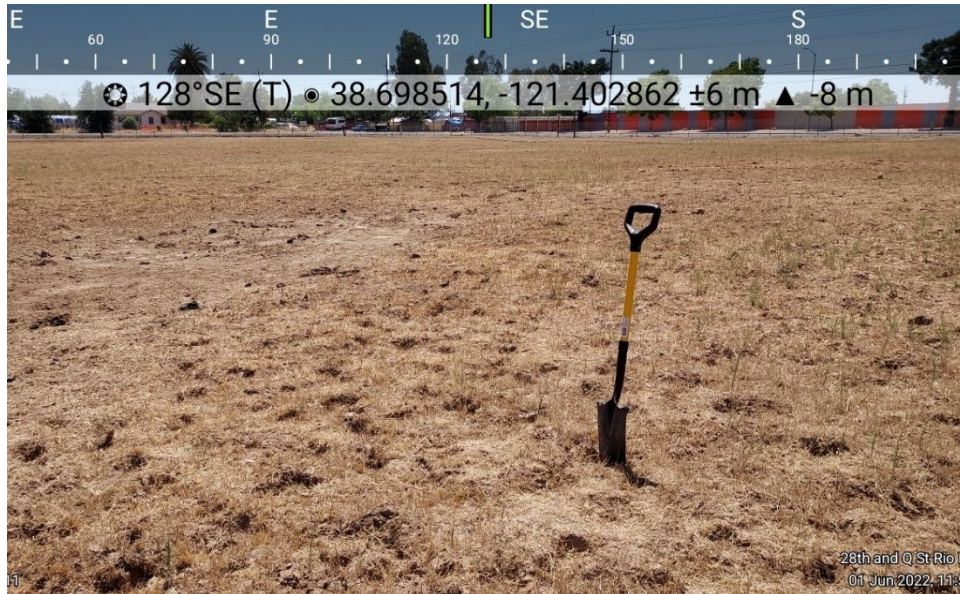
*Photo 13. SP-11; The upland point for SW-3 mapped in the undeveloped portion of the Study Area looking southeast.*

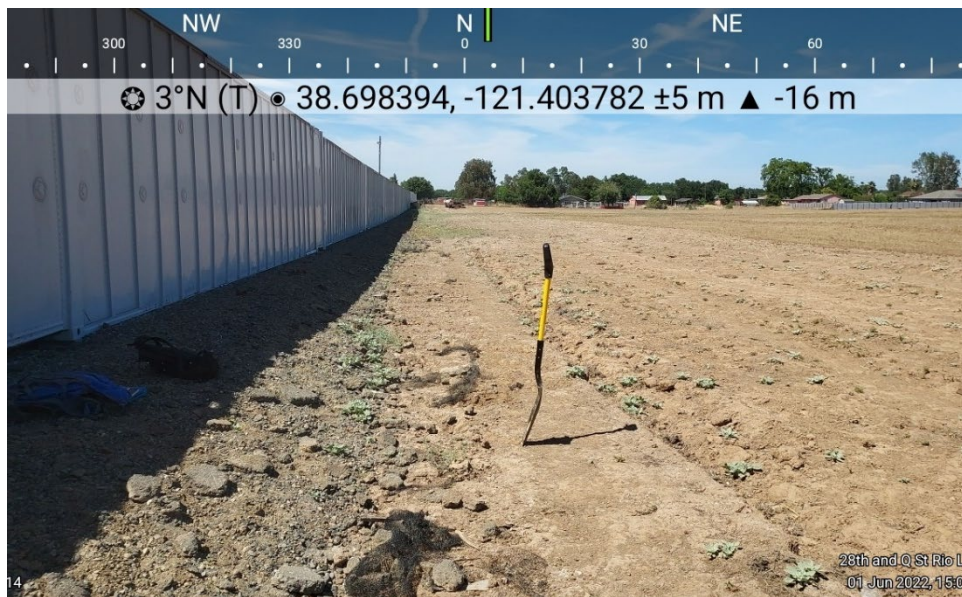
Photo 16. SP-14 is located within US-4, mapped in the undeveloped half of the Study Area looking north.

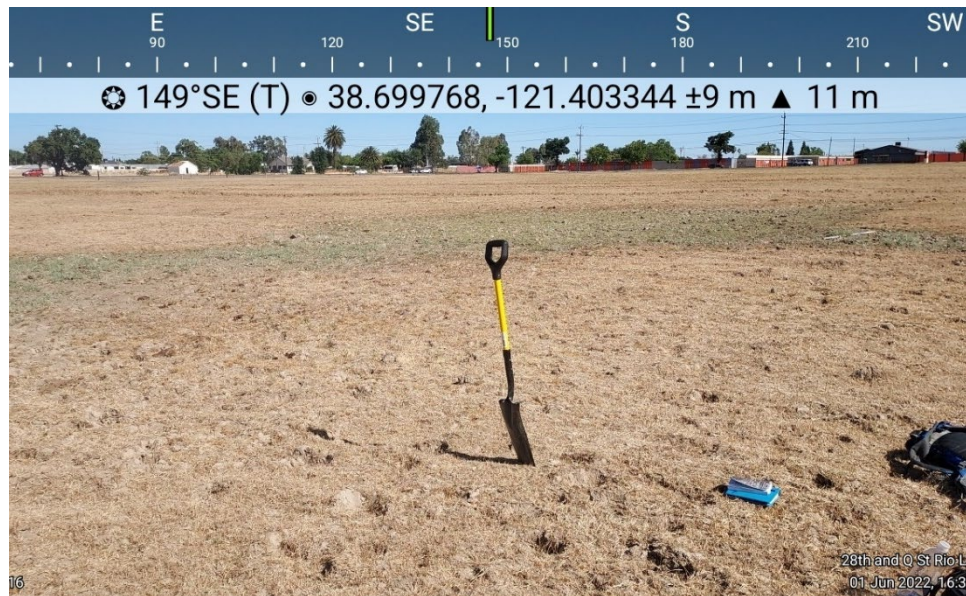
Photo 18. SP-16; An upland point for SWS-2 & SW-5 mapped in the undeveloped portion of the Study Area looking southeast, towards SW-5.

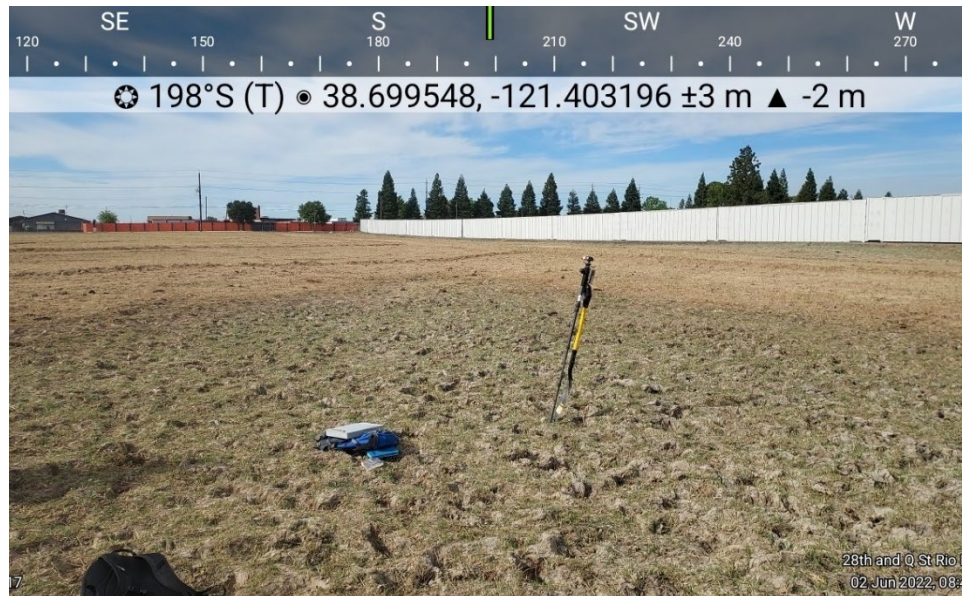
Photo 19. SP-17 is located within SW-5, mapped in the undeveloped portion of the Study Area looking south.

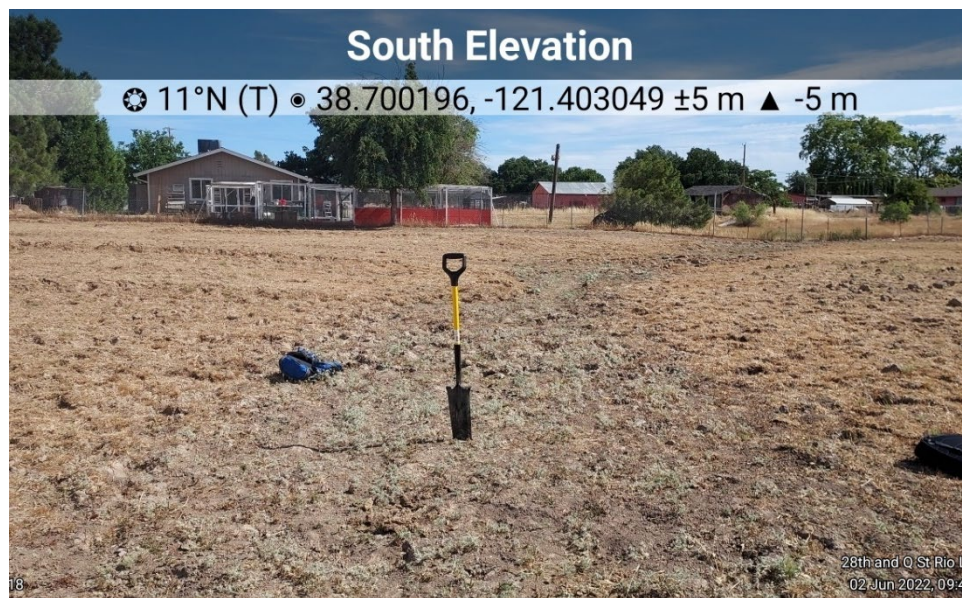
Photo 20. SP-18 is located within SWS-2, mapped in the undeveloped portion of the Study Area looking north.

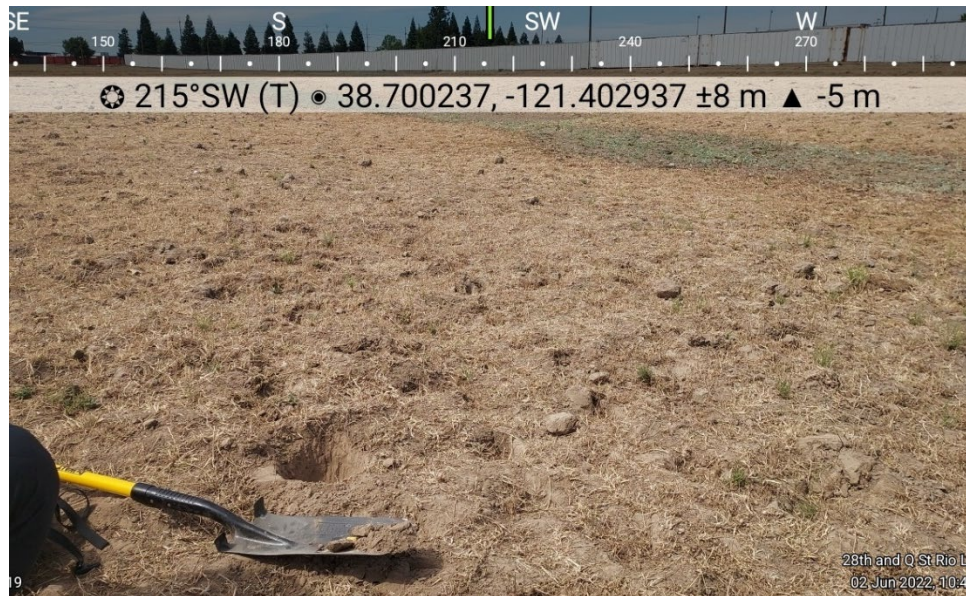
Photo 21. SP-19; An upland point for SWS-2 mapped in the undeveloped portion of the Study Area looking southwest, towards SWS-2.

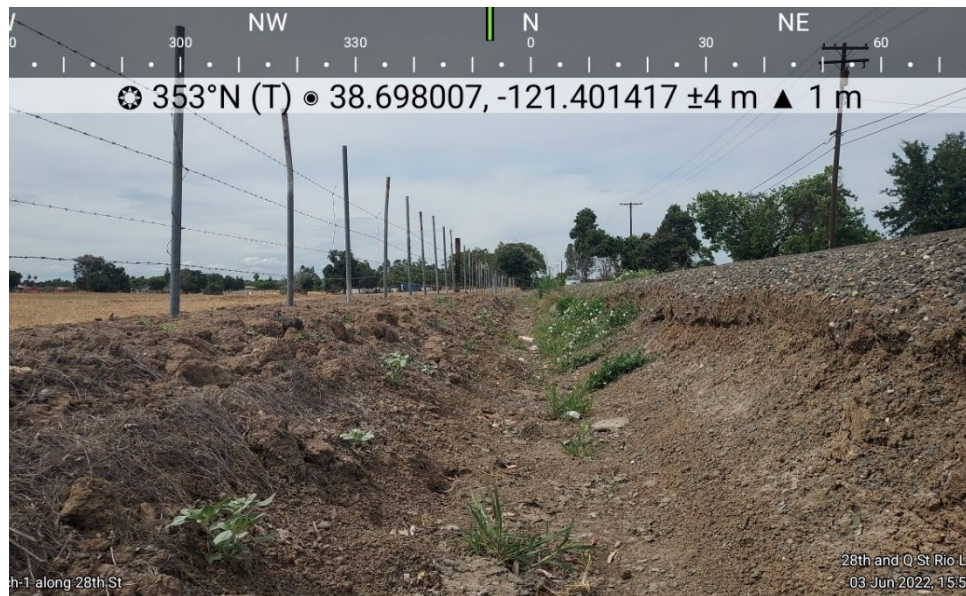
Photo 22. Ditch-1; Located along 28<sup>th</sup> Street, along the eastern project boundary, facing north.

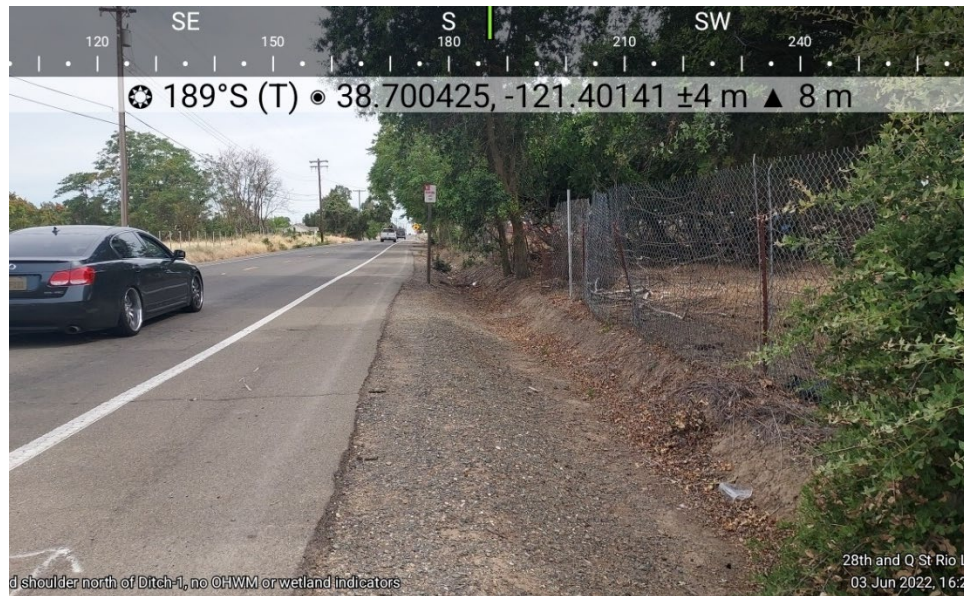
Both upland swales lack an OWHM. US-4 is located south and adjacent to a seasonal wetland swale. The wetland hydrology indicators observed in US-4 included Biotic Crust (B12). Indicators of wetland hydrology were not observed in US-1. US-1 is manmade, used to transmit storm water flows from adjacent lands and is isolated from other features. A semi buried metal culvert with a diameter of approximately 12 inches was observed at US-1.

Photo 23. Overview of US-1, located along 28<sup>th</sup> Street at the northeast corner of the Study Area, facing south.

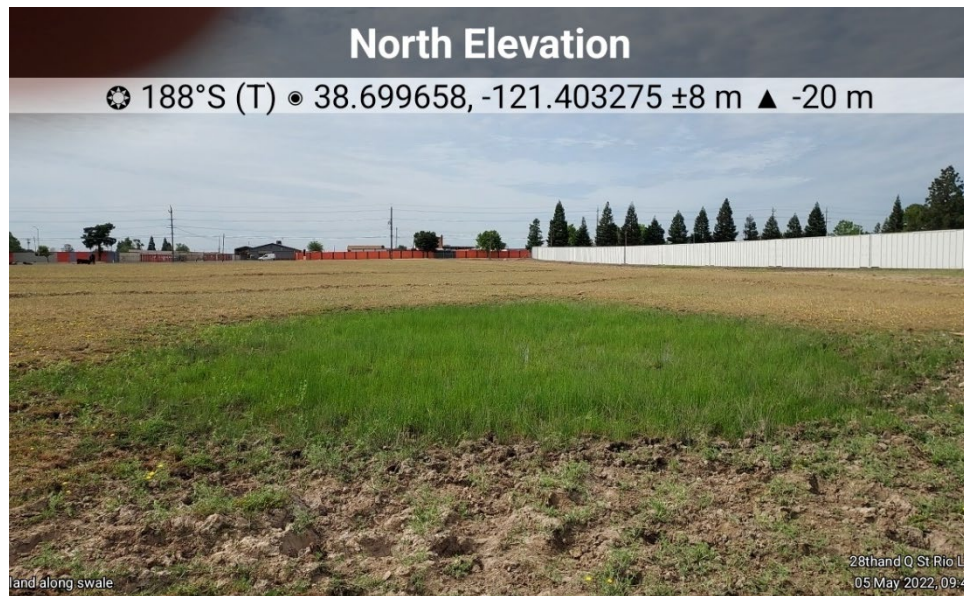
The vegetation community observed within one seasonal wetland (SW-5) located along a seasonal wetland swale (SWS-2) can best be described as Pale Spike Rush Marsh (*Eleocharis macrostachya* Herbaceous Alliance; CNPS 2022). The dominant plant species observed was Spike Rush (*Eleocharis macrostachya*; OBL) with Coyote Thistle observed within the periphery of the feature.

Photo 24. SW-5 located along SWS-2, mapped in the undeveloped portion of the Study Area looking south.

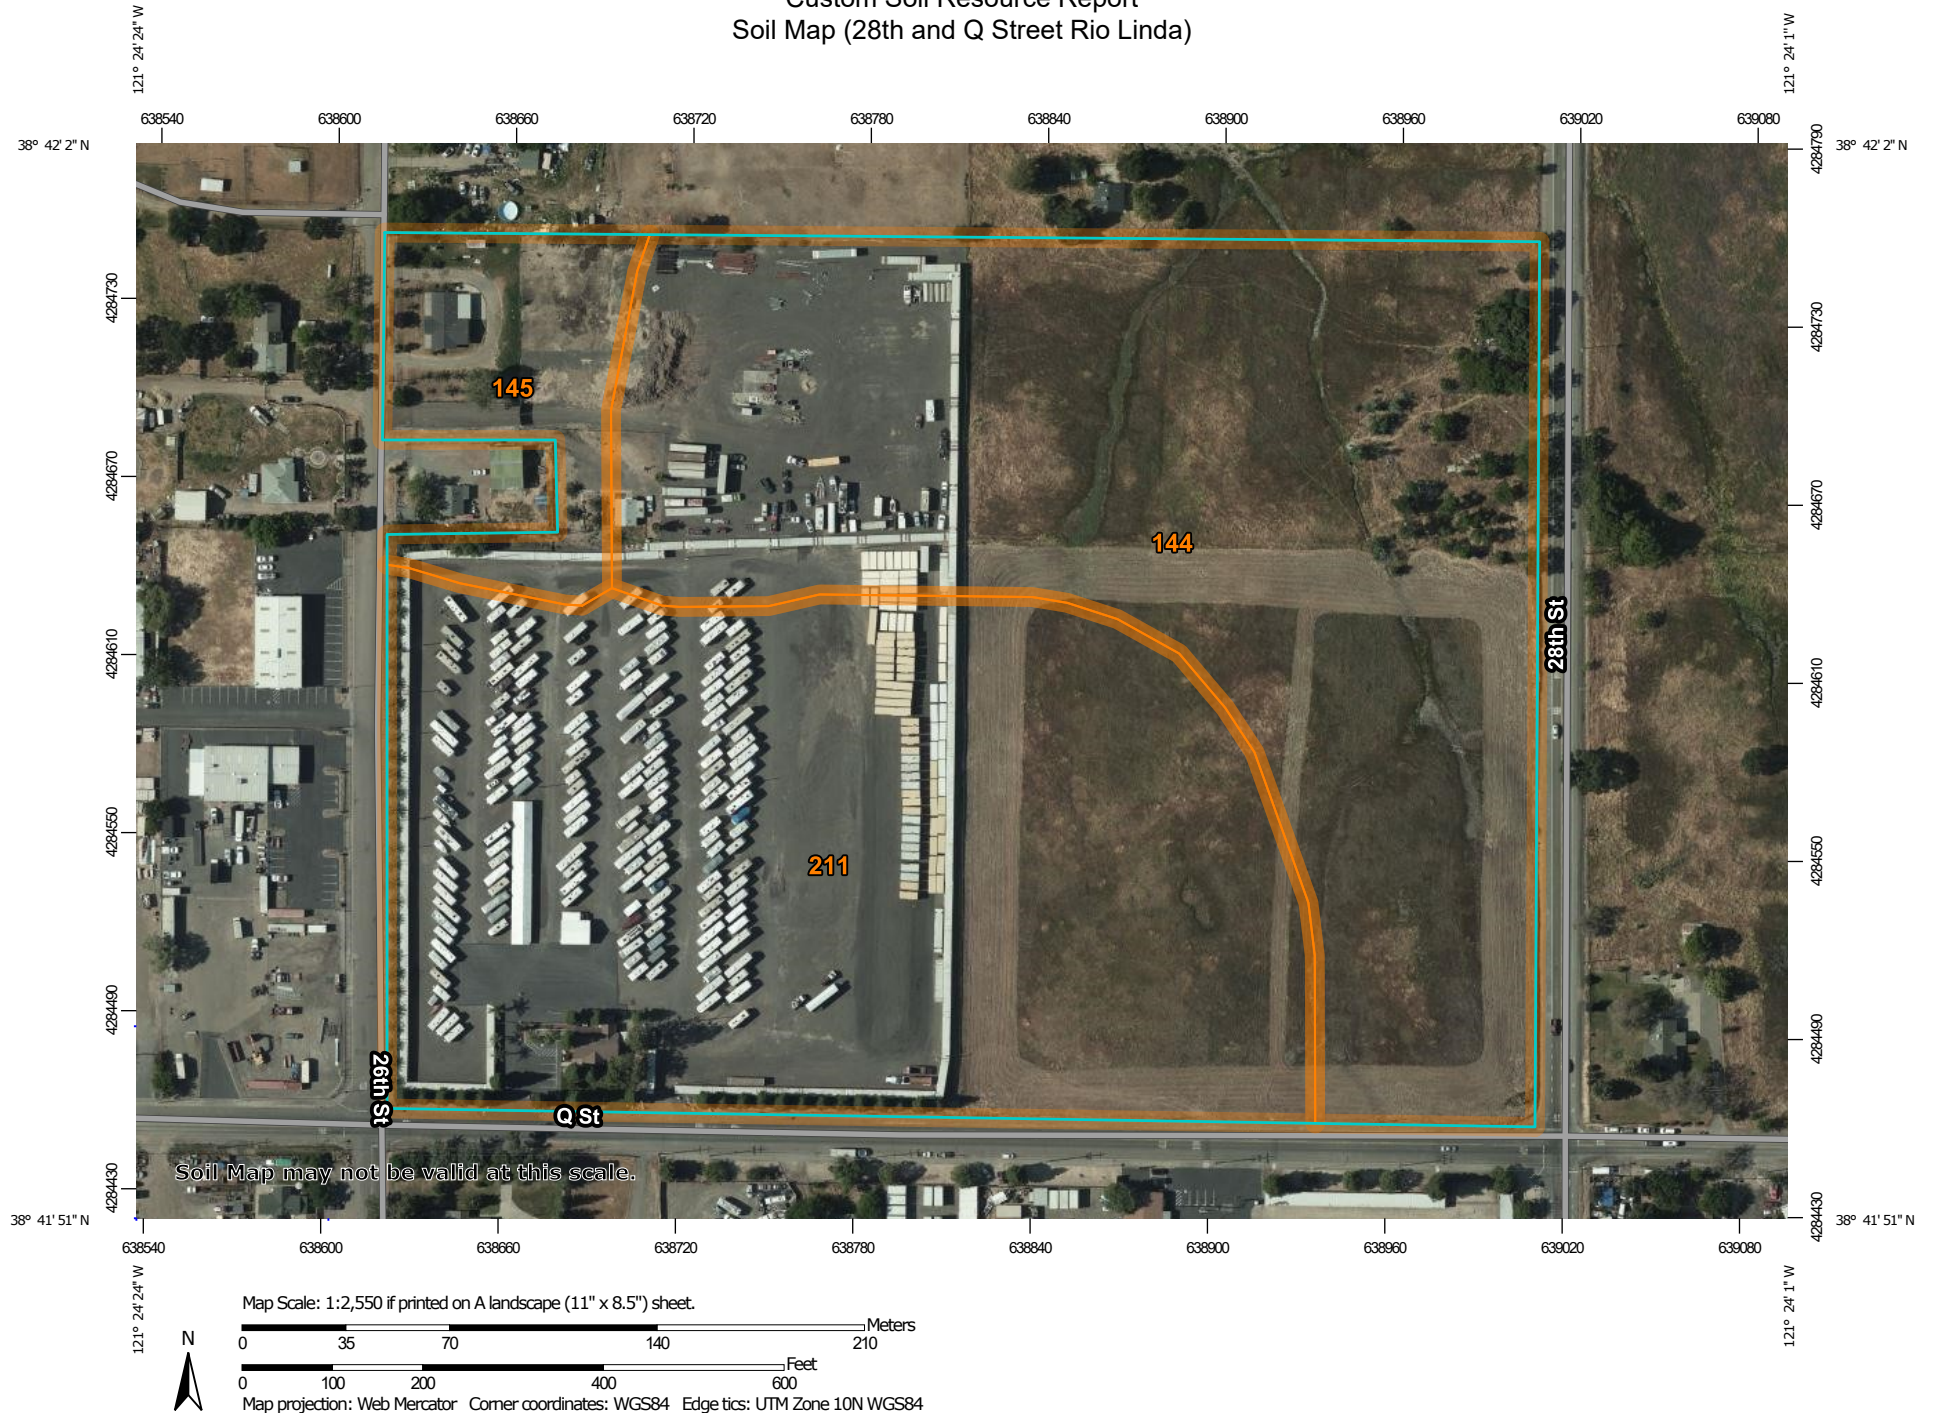
# Custom Soil Resource Report Soil Map (28th and Q Street Rio Linda)

The soil map section includes the soil map for the defined area of interest, a list of soil map units on the map and extent of each map unit, and cartographic symbols displayed on the map. Also presented are various metadata about data used to produce the map, and a description of each soil map unit.
