# EBRPD Anthony Chabot Sewer Improvements Construction Detailed Report

### **Phase I Environmental Site Assessment and Limited Hazardous Building Materials Survey**

# LIMITED HAZARDOUS BUILDING MATERIALS SURVEY

Two Structures within the Anthony Chabot Sewer Line Vicinity  
Redwood Road  
Castro Valley, California

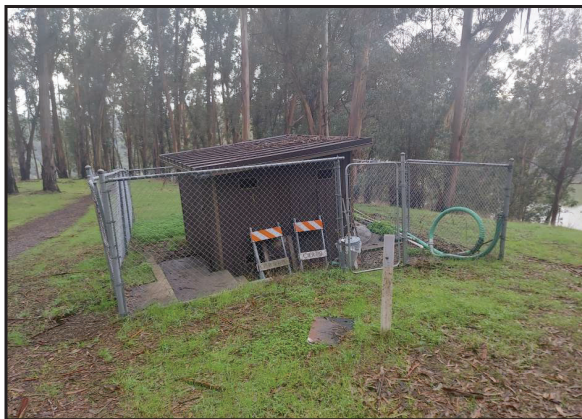
A sewage comminutor, used to grind the solid sewage waste into smaller pieces, was located at the beginning of the Site pathway, along Huck's Trail. A pump house, used to pressurize and pump the Redwood Canyon Golf Course's sewage, was located adjacent to the Redwood Road turnoff into the Redwood Canyon Golf Course, and the pond.

View of the Comminutor at the beginning of the Site pathway.

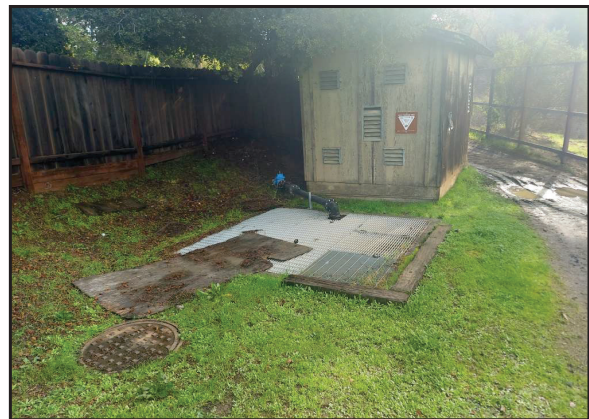
View of the sewage pump house adjacent to Redwood Road and the pond, that is planned for removal.
