**U.S. ARMY CORPS OF ENGINEERS
JURISDICTIONAL DELINEATION
FOR THE
KAISER MANTECA ED EXPANSION PROJECT
SAN JOAQUIN COUNTY, CALIFORNIA**

FEBRUARY 2025 DRAFT

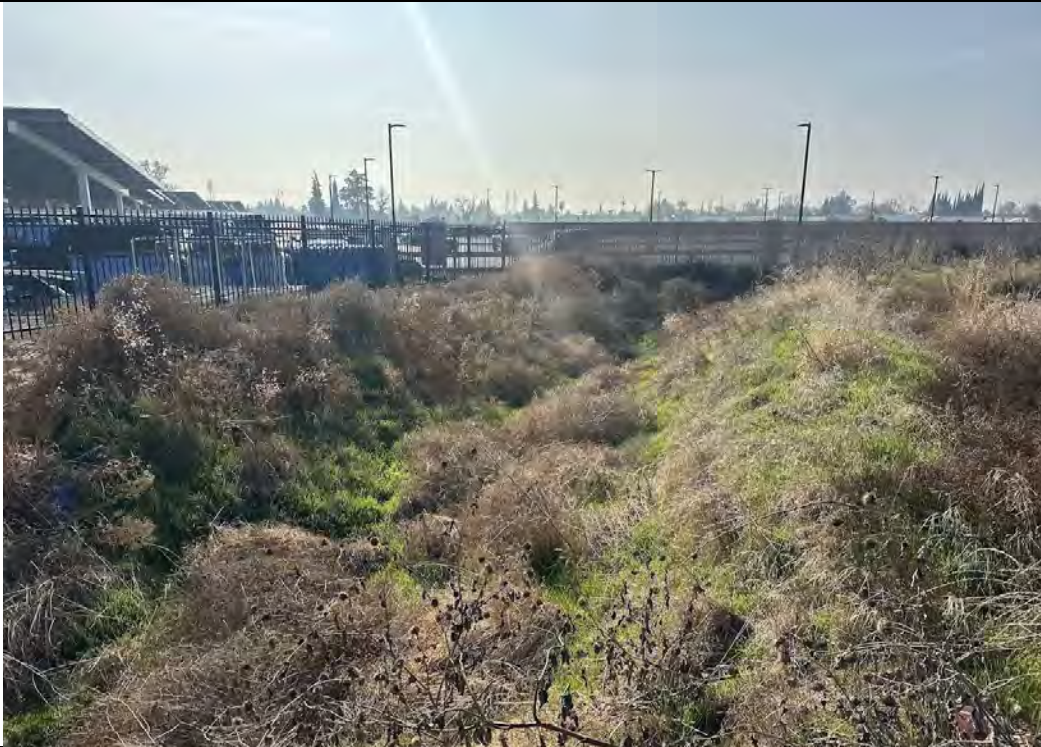
7. Facing southwest, the photo shows a portion of feature ED 1b. The feature contains large amounts of Russian thistle.

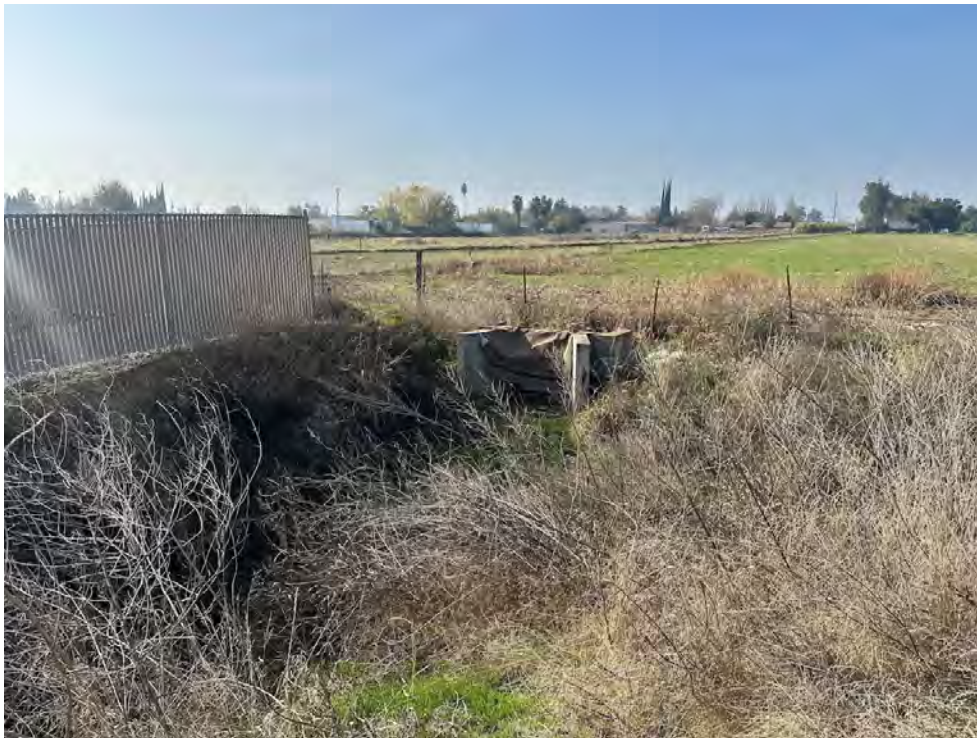
8. Facing west, the photo shows the culvert, located outside of the Survey Area, where water from feature ED 1b flows underground into the stormwater drainage system.
