RE: Arrow & Branch Winery (P21-00087)

This is in response to Napa County Planning, Building & Environmental Services' Application status letter dated May 19, 2021 for the Arrow & Branch Winery (Formerly Ideology) listed as P21-00087. The County was requesting clarification to: "Confirm that the proposed physical improvements will not impact nearby riparian woodland or sensitive biotic vegetation."

### **Arrow & Branch Winery General Information**

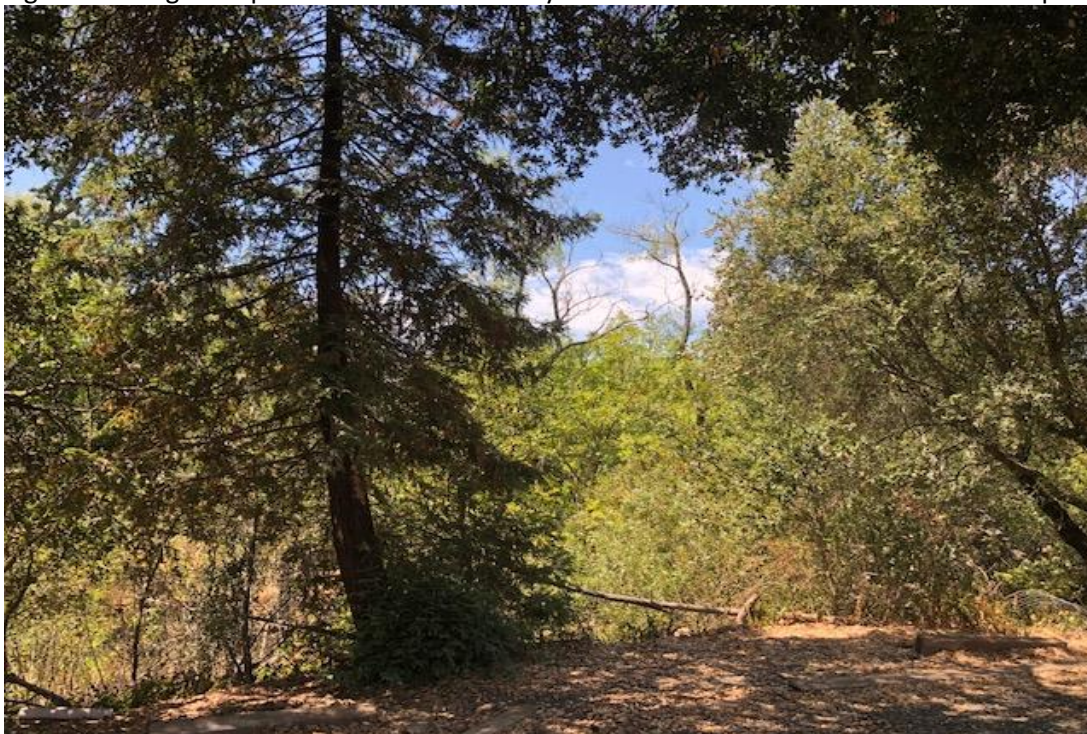
Figure #1: Edge of Upland Area – Immediately above the transitional zone down into riparian area.

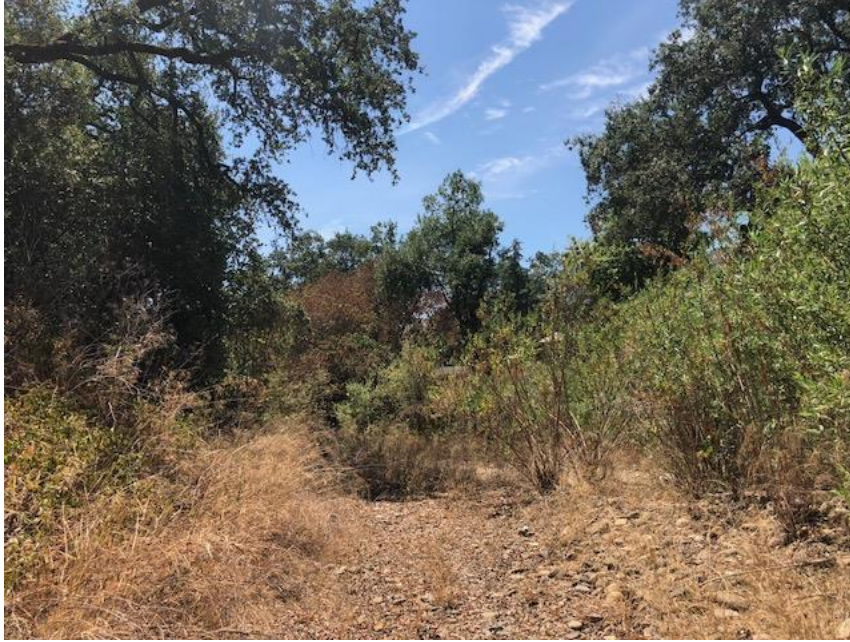
Figure #2: The main channel of Dry Creek (July 2021). Dusky willow can be seen in the immediate area of the channel. Larger, mature oaks are located at the top of the bank and adjacent to the vineyards.

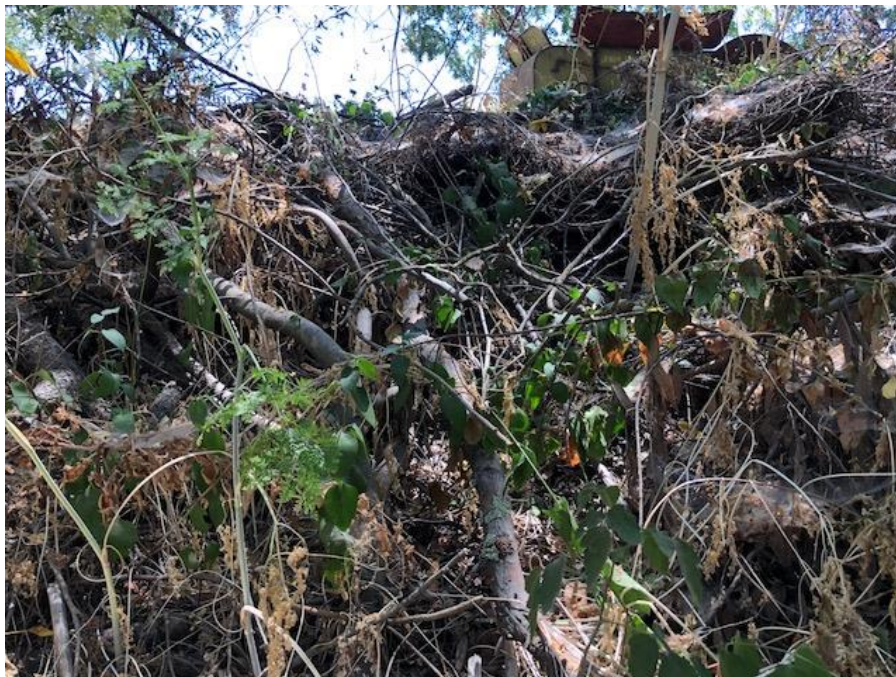
Evidence of dumping vegetation trimmings from vineyard maintenance can be found in various areas below the main bank.

Figure #3: Vegetative material thrown over the edge of the bank.

- Leftover material from vineyard/property maintenance has been thrown over the edge of the bank. This material can be a fire hazard and hinder growth of native vegetation. Non-organic material can also contribute to degradation of the watercourse.

- Existing non-organic material should be manually removed and disposed of property.
  - Existing organic material can be left and allowed to decomposed.

- Future organic vineyard material can be mulched, removed from the property, or piled outside the native vegetation zone.
  - Storage drums/containers should be stored within a way so potential spills can be property cleaned up, and located well away from the native vegetation zone.
