## **Appendix “G”**

*Phase I/II Environmental Site Assessment Update Report*

# *Phase I Environmental Site Assessment Update Report*

Tract Map 39011 Lake Matthews Area,  
Riverside County, California

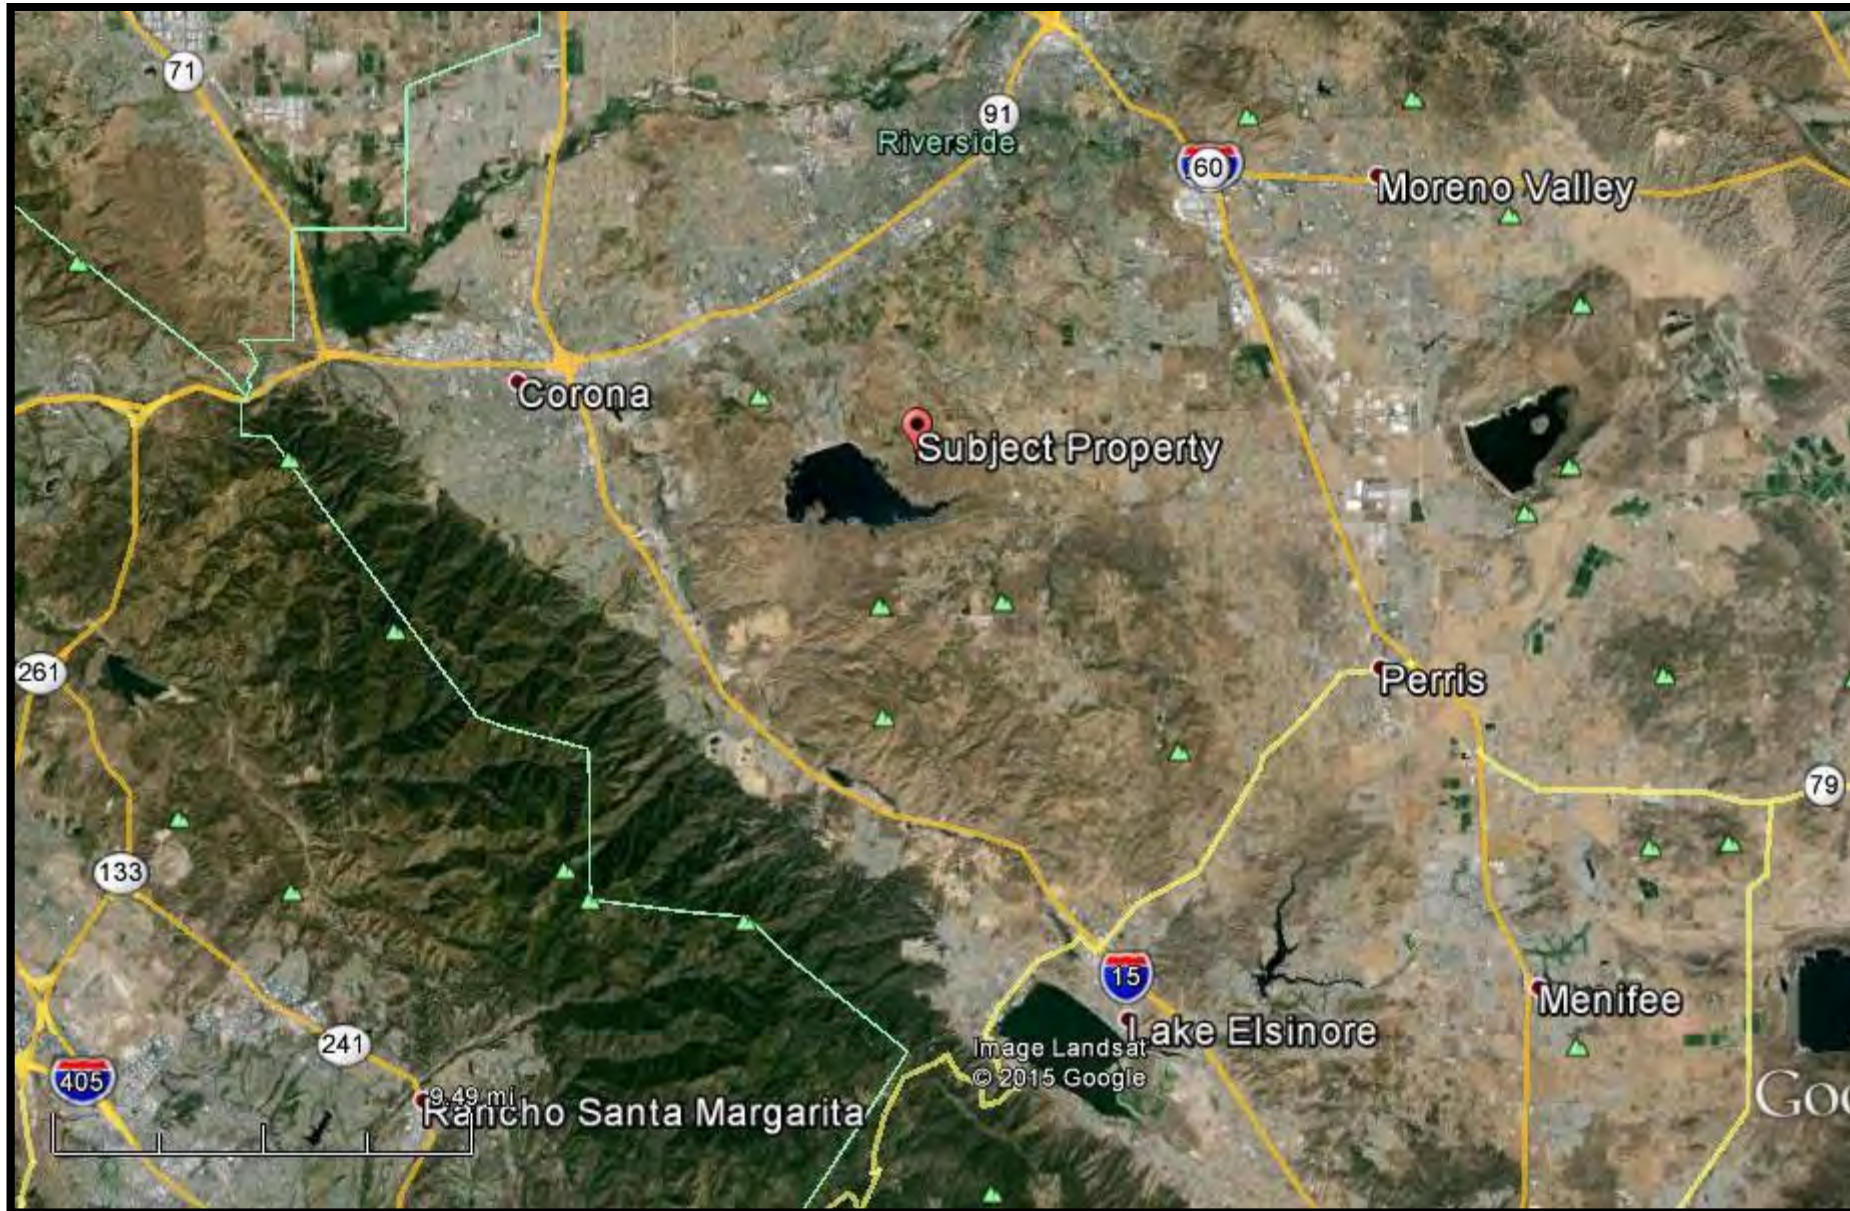
Figures depicting the Property and vicinity are found in the “Figures” section at the end of this report. Figure 1 is a site location map showing the location of the property. Figure 2 is a site plan showing additional detail and site features. Color copies of photographs taken during the site reconnaissance are found in Appendix A.

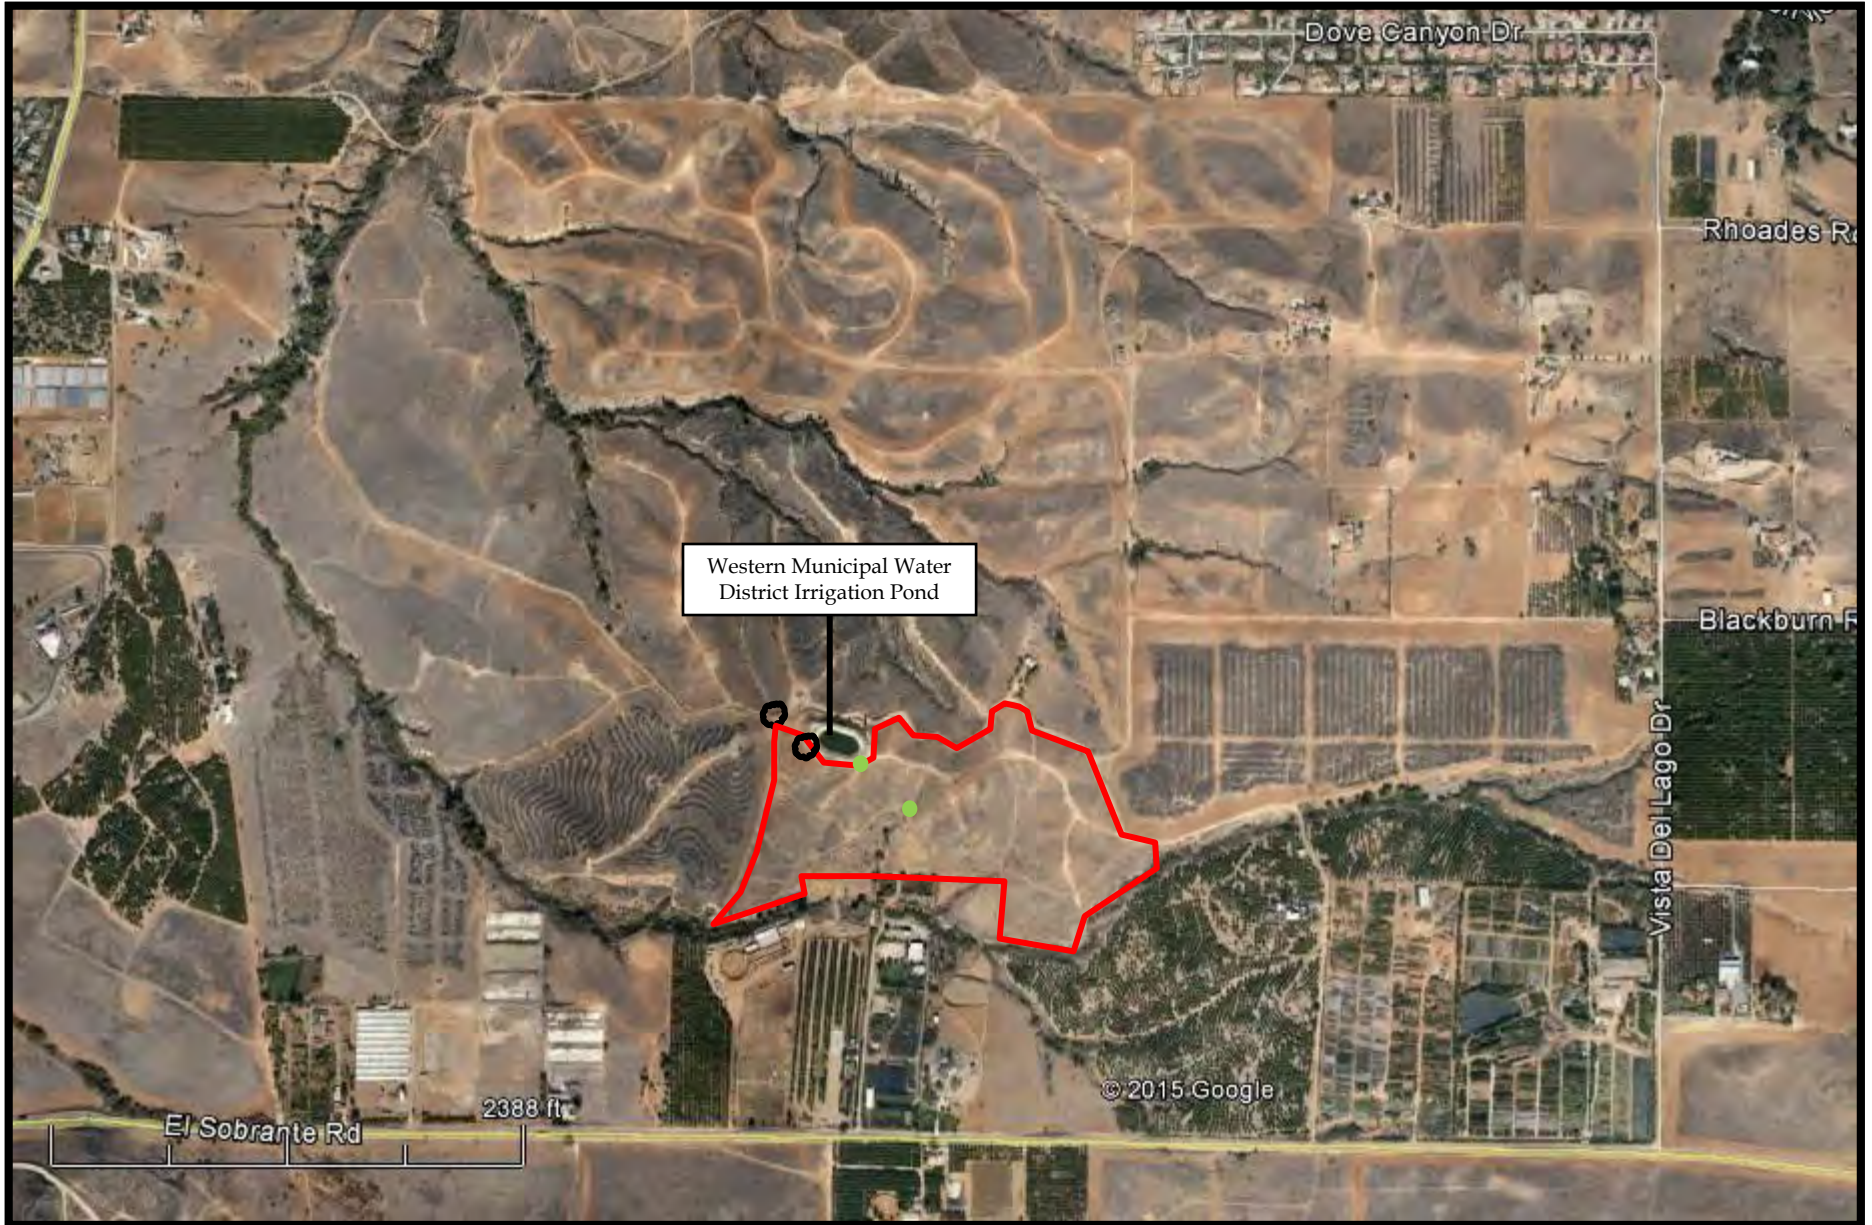
- Irrigation Standpipe
- Area of Household Trash Dumping

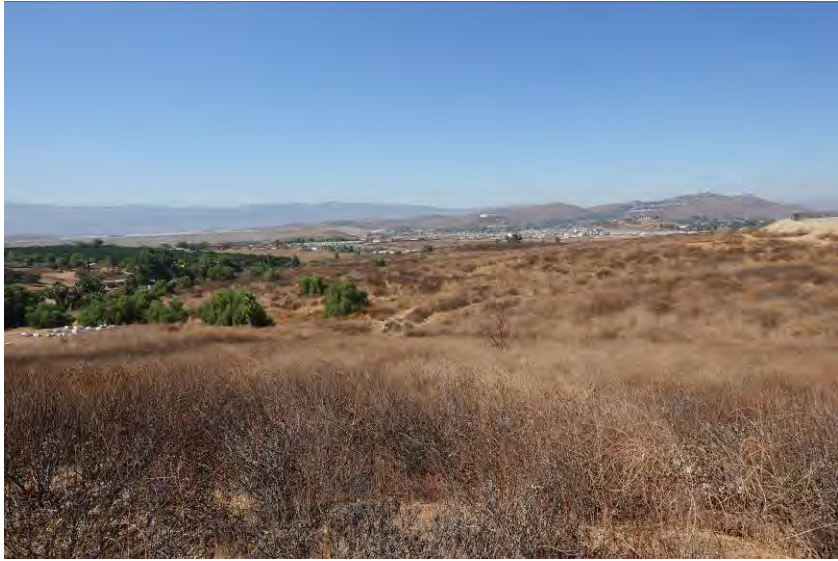
| <p><b>Photo: 1</b></p> <p><b>Description:</b></p> <p>The Subject Property consisting of undeveloped land.</p> <p><b>Orientation:</b></p> <p>Facing west</p> | |

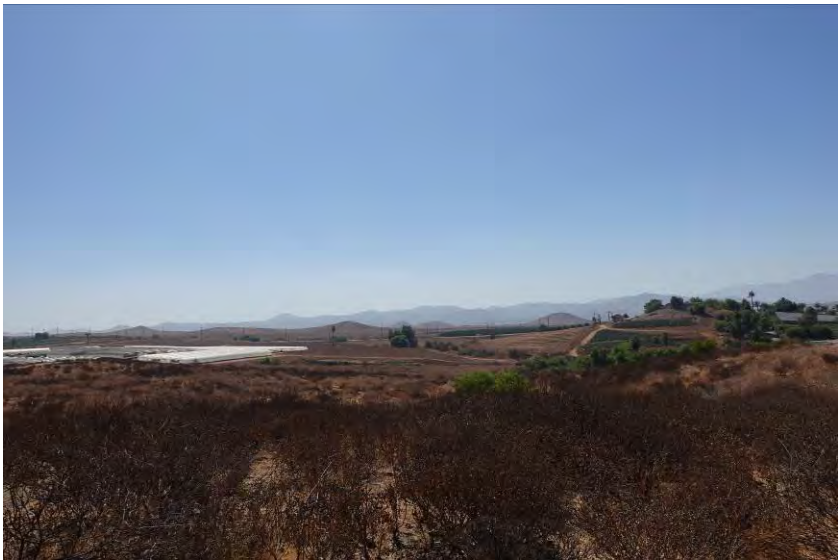
| <p><b>Photo: 2</b></p> <p><b>Description:</b></p> <p>Eastern portion of the Subject Property.</p> <p><b>Orientation:</b></p> <p>Facing southeast</p> | |

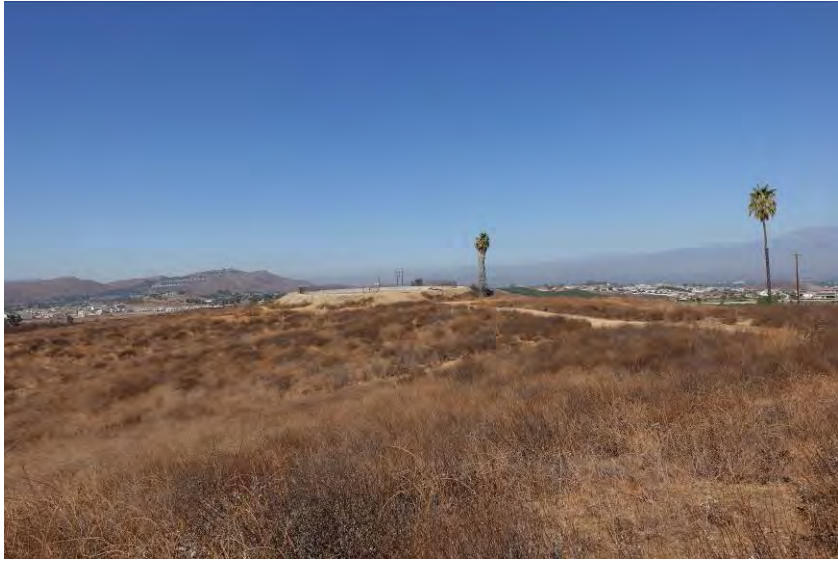
| <p><b>Photo: 5</b></p> <p><b>Description:</b></p> <p>Northern portion of the Subject Property.</p> <p><b>Orientation:</b></p> <p>Facing west</p> | |

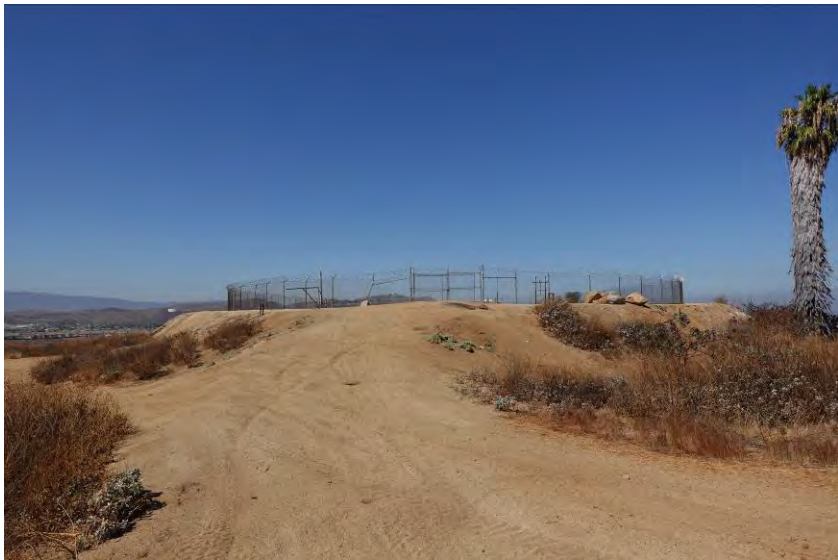
| <p><b>Photo: 6</b></p> <p><b>Description:</b></p> <p>Dirt roads throughout the property.</p> <p><b>Orientation:</b></p> <p>Facing west</p> | |

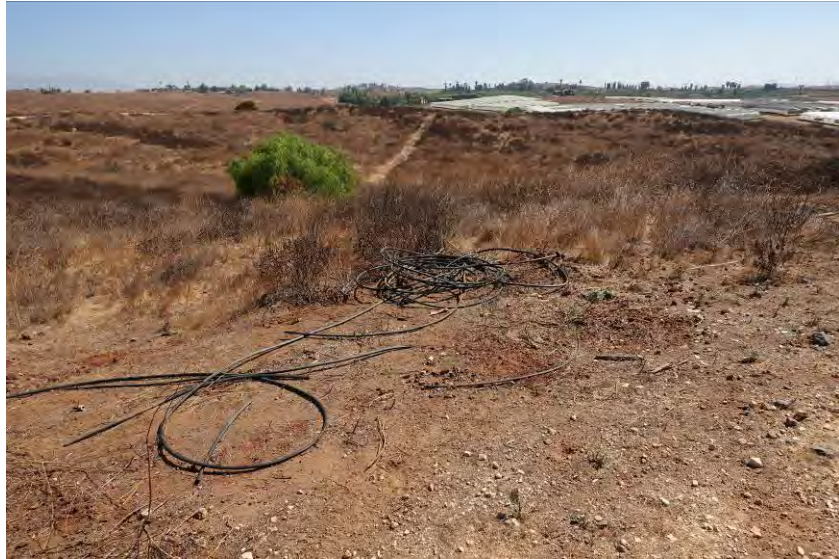
Irrigation piping  
observed.

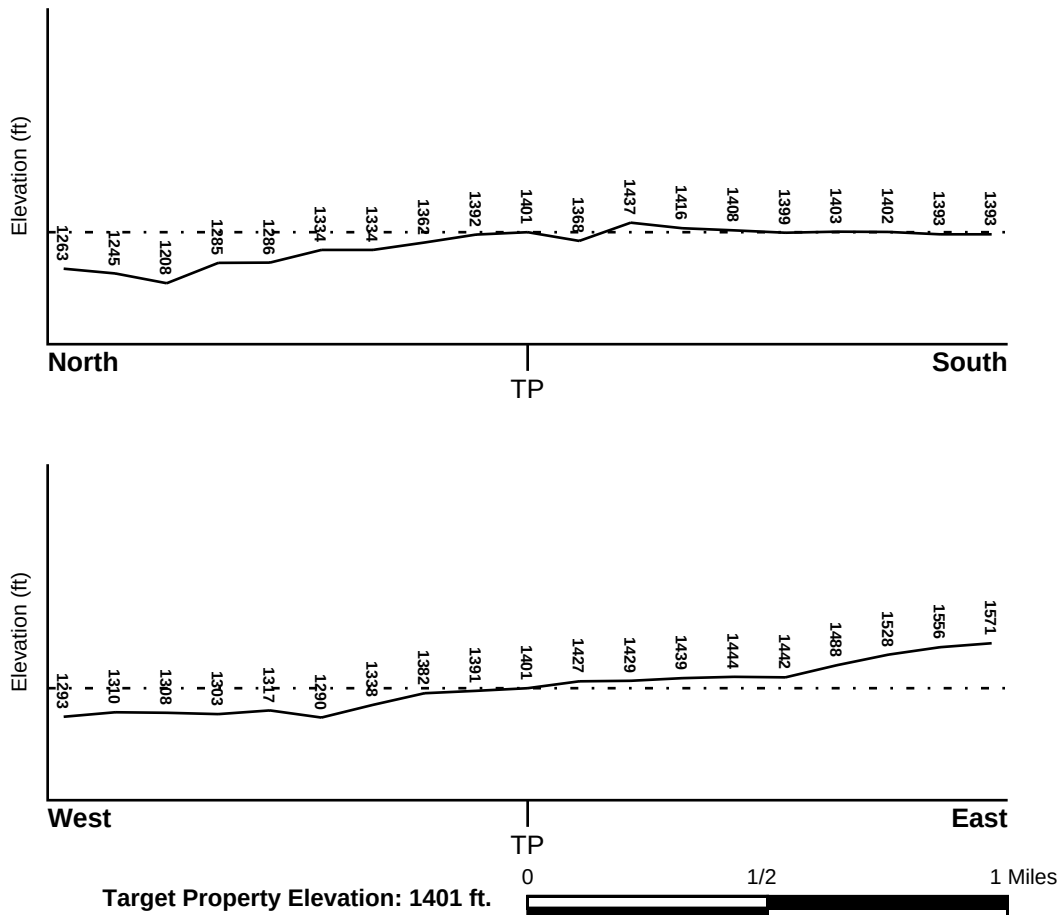
### SURROUNDING TOPOGRAPHY: ELEVATION PROFILES

Source: Topography has been determined from the USGS 7.5' Digital Elevation Model and should be evaluated on a relative (not an absolute) basis. Relative elevation information between sites of close proximity should be field verified.

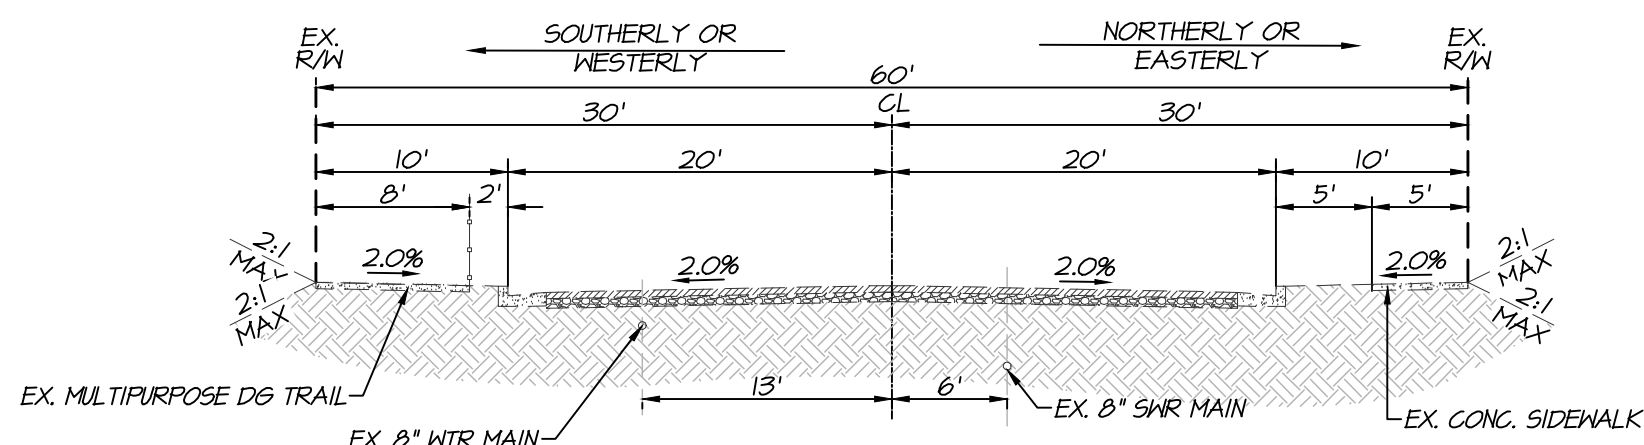
EX. TYPICAL TRAVERTINE DR. SECTION  
SCALE: 1" = 10'

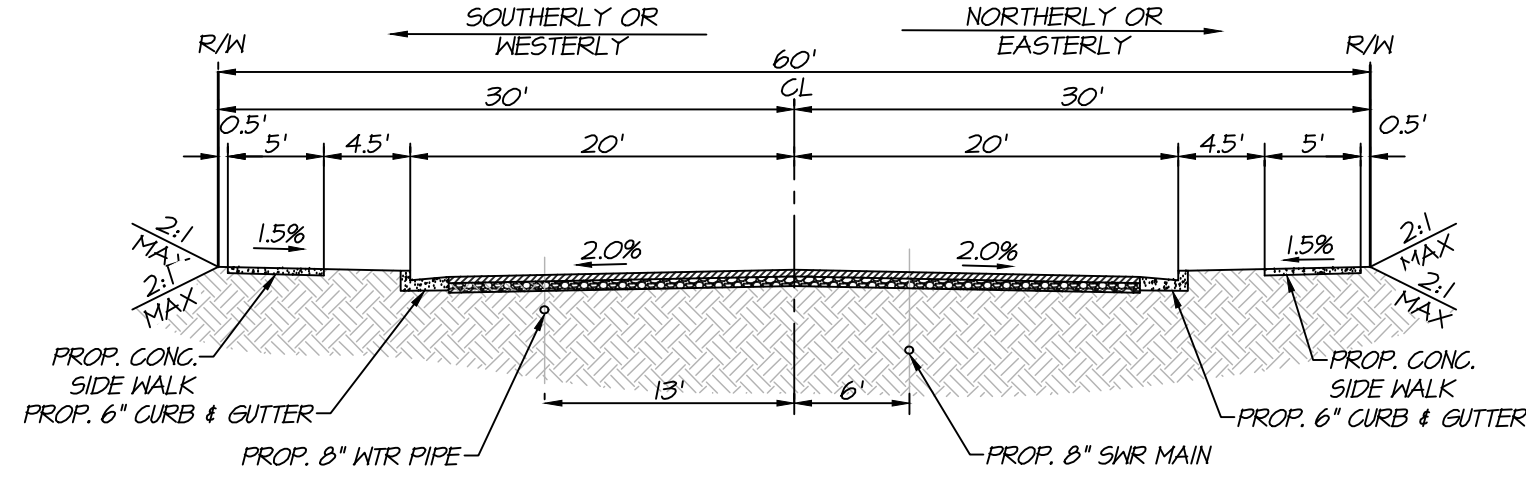
TYPICAL PUBLIC STREET SECTION  
OFFSITE STREET "G"  
SCALE: 1" = 10'

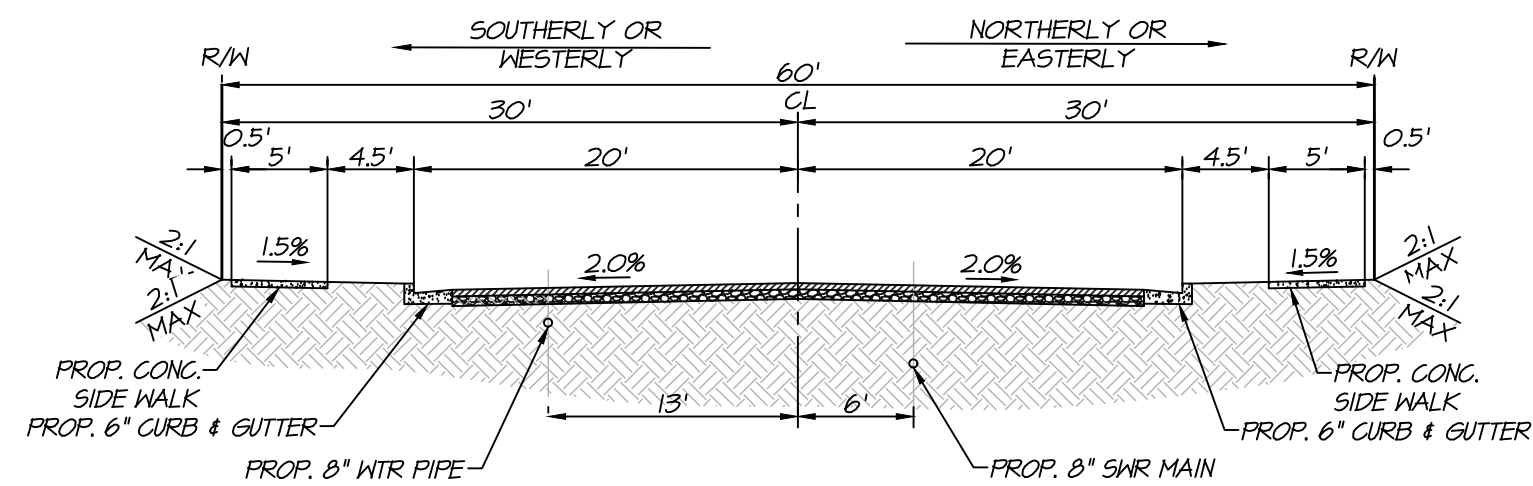
TYPICAL PUBLIC STREET SECTION  
STREET "A" - "G"  
SCALE: 1" = 10'

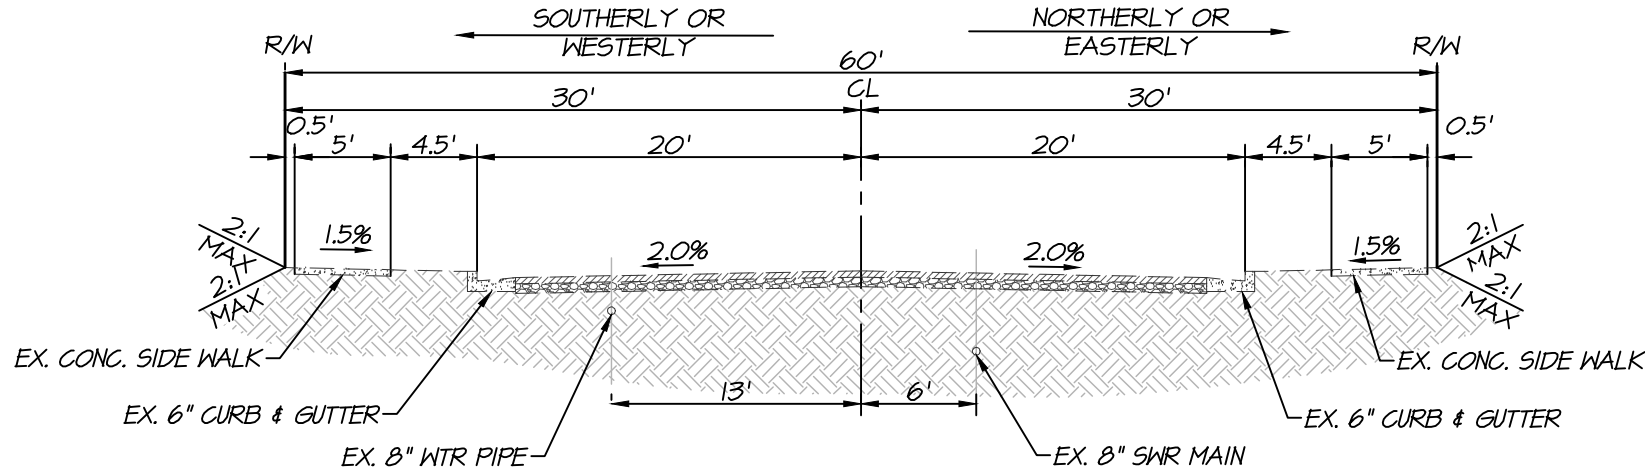
TYPICAL TTM 38605 STREET SECTION (PUBLIC)

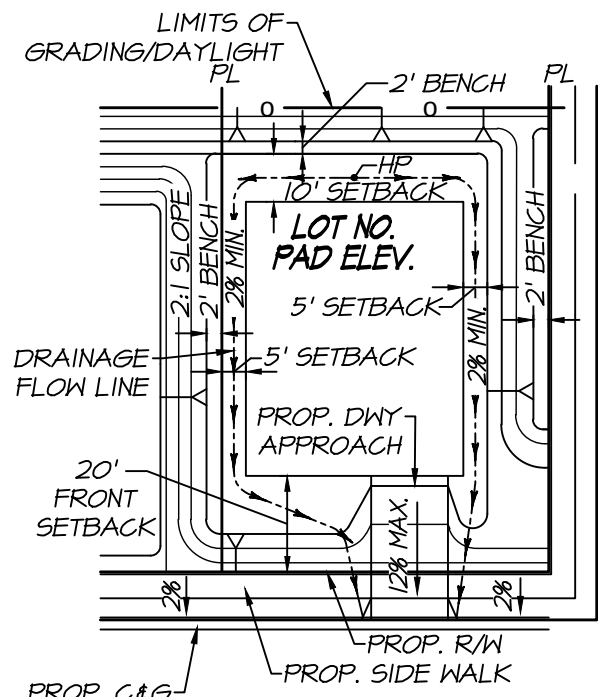
TYPICAL PAD & LOT DATA

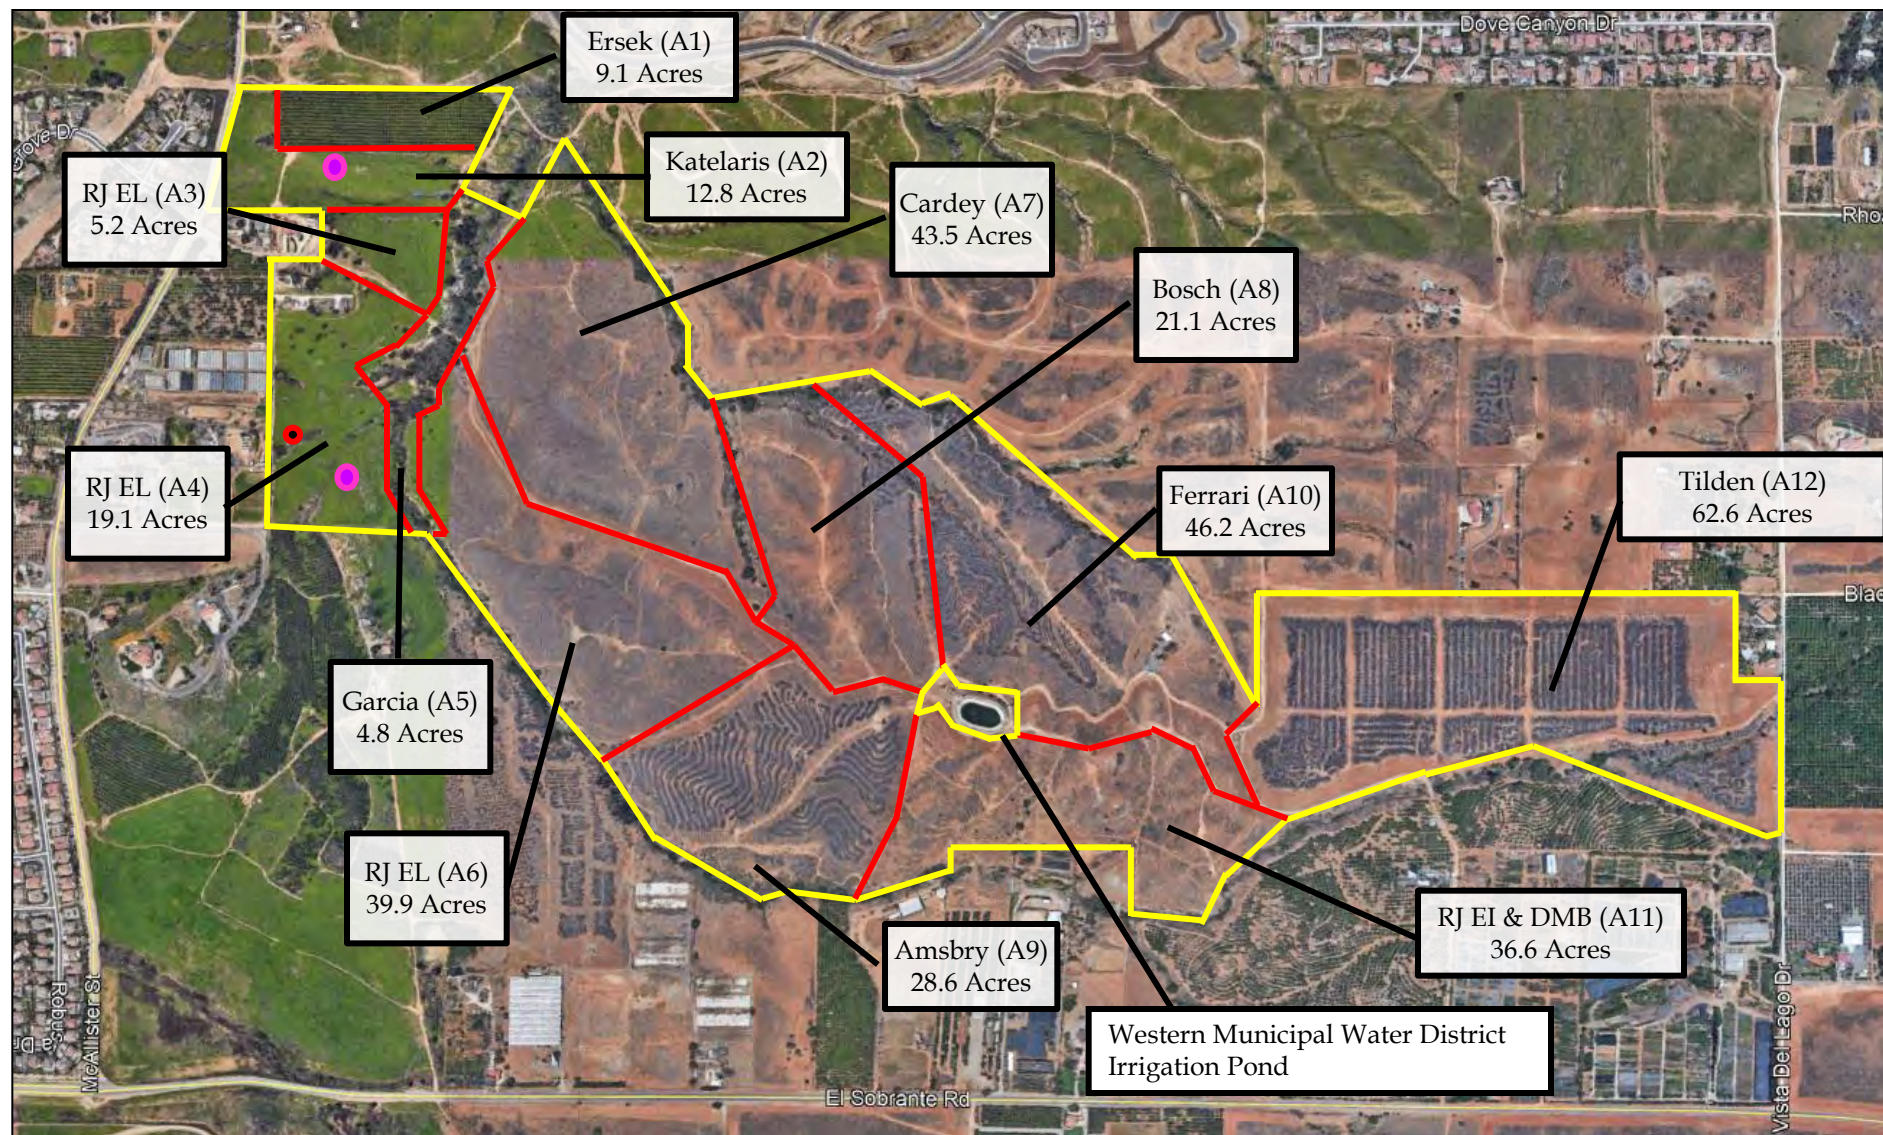
| | | | FIGURE:<br><b>2</b> |

- Property Boundary
- Internal Parcel Boundary
- Concentration of arsenic = 12 mg/kg,  
Equals naturally occurring screening level  
for southern California.
- Concentration of arsenic = 13 mg/kg,  
Exceeding naturally occurring screening  
level for southern California.

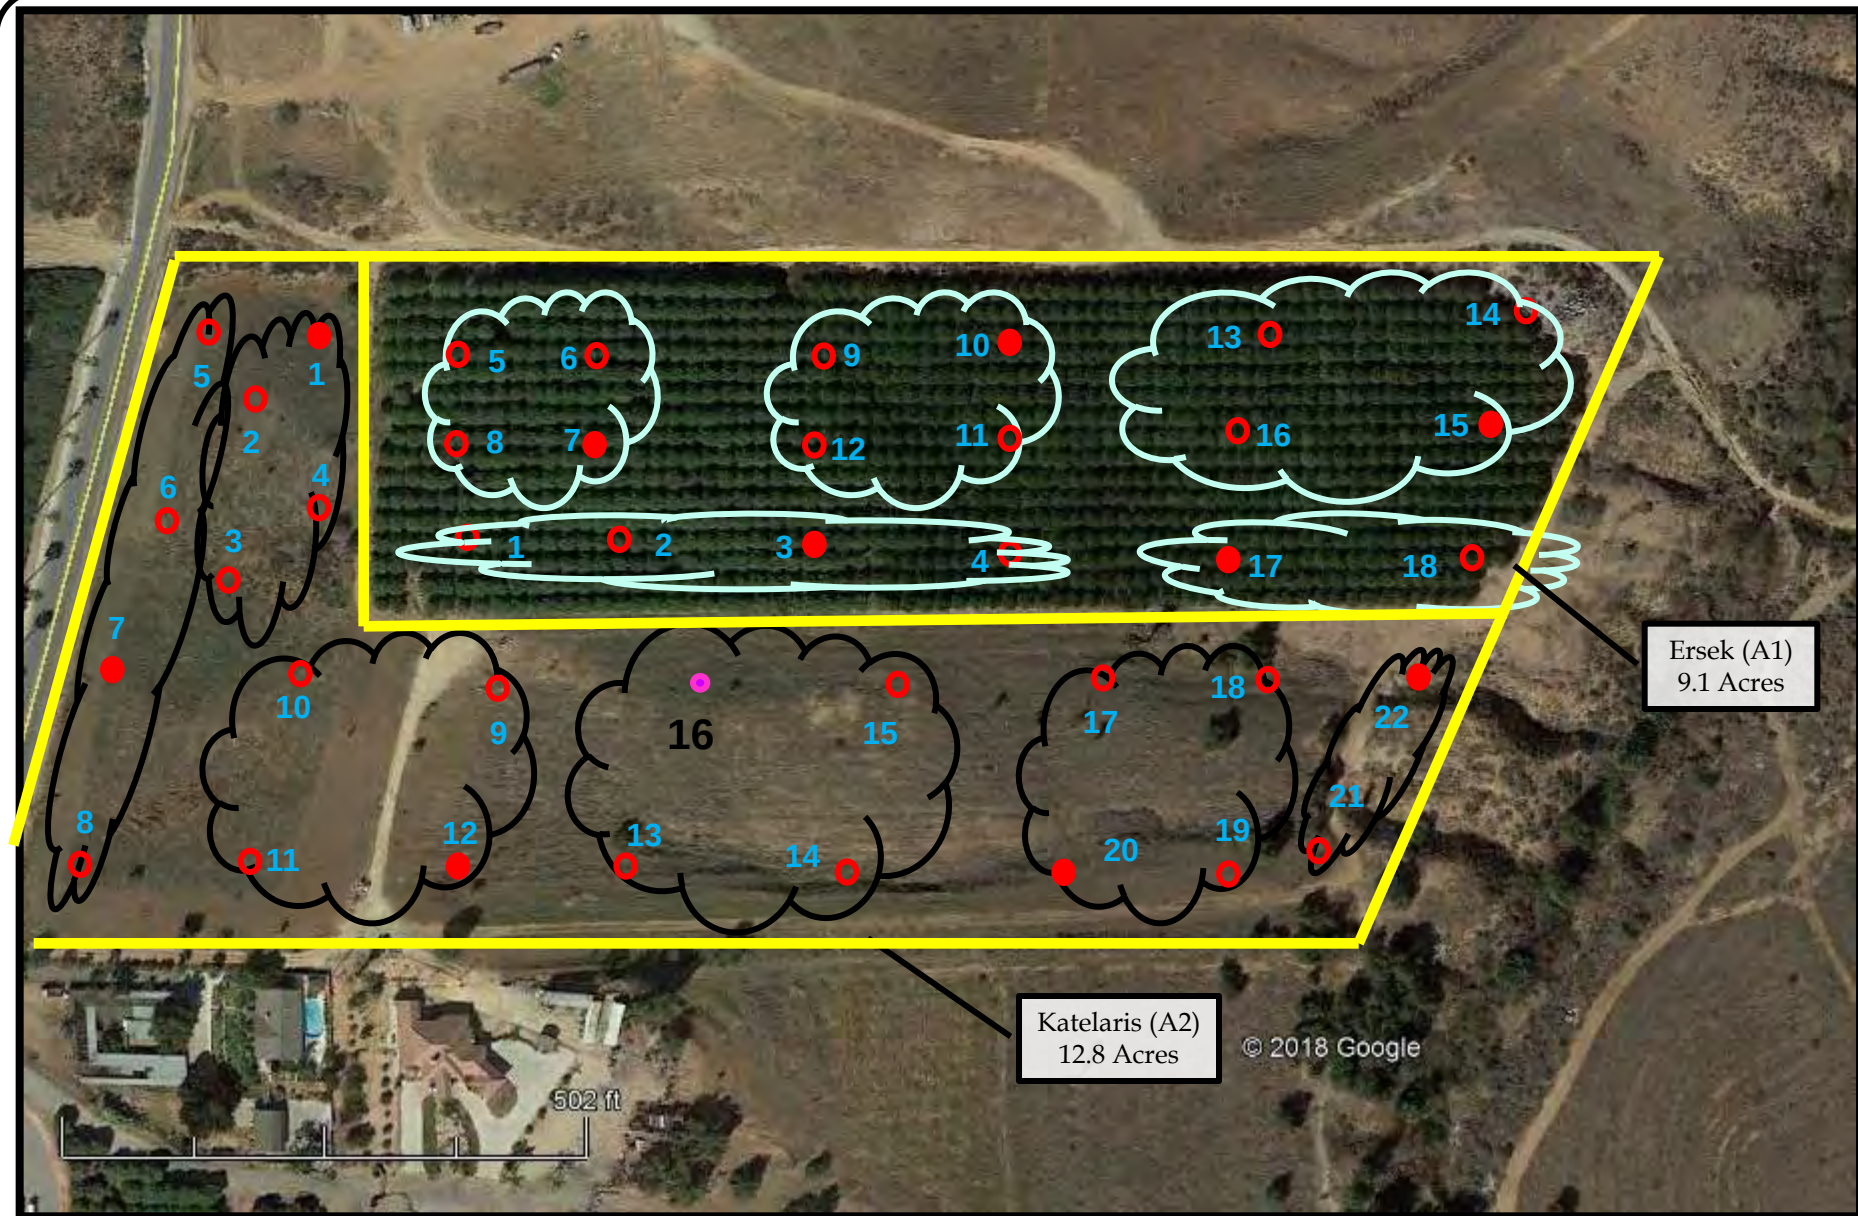
| | | | FIGURE:<br><b>3</b> |

- ▬ Property Boundary
- Sampling for Agricultural Chemicals
- Sampling for Arsenic
- Concentration of arsenic = 12 mg/kg,  
Equals naturally occurring screening level for southern  
California.

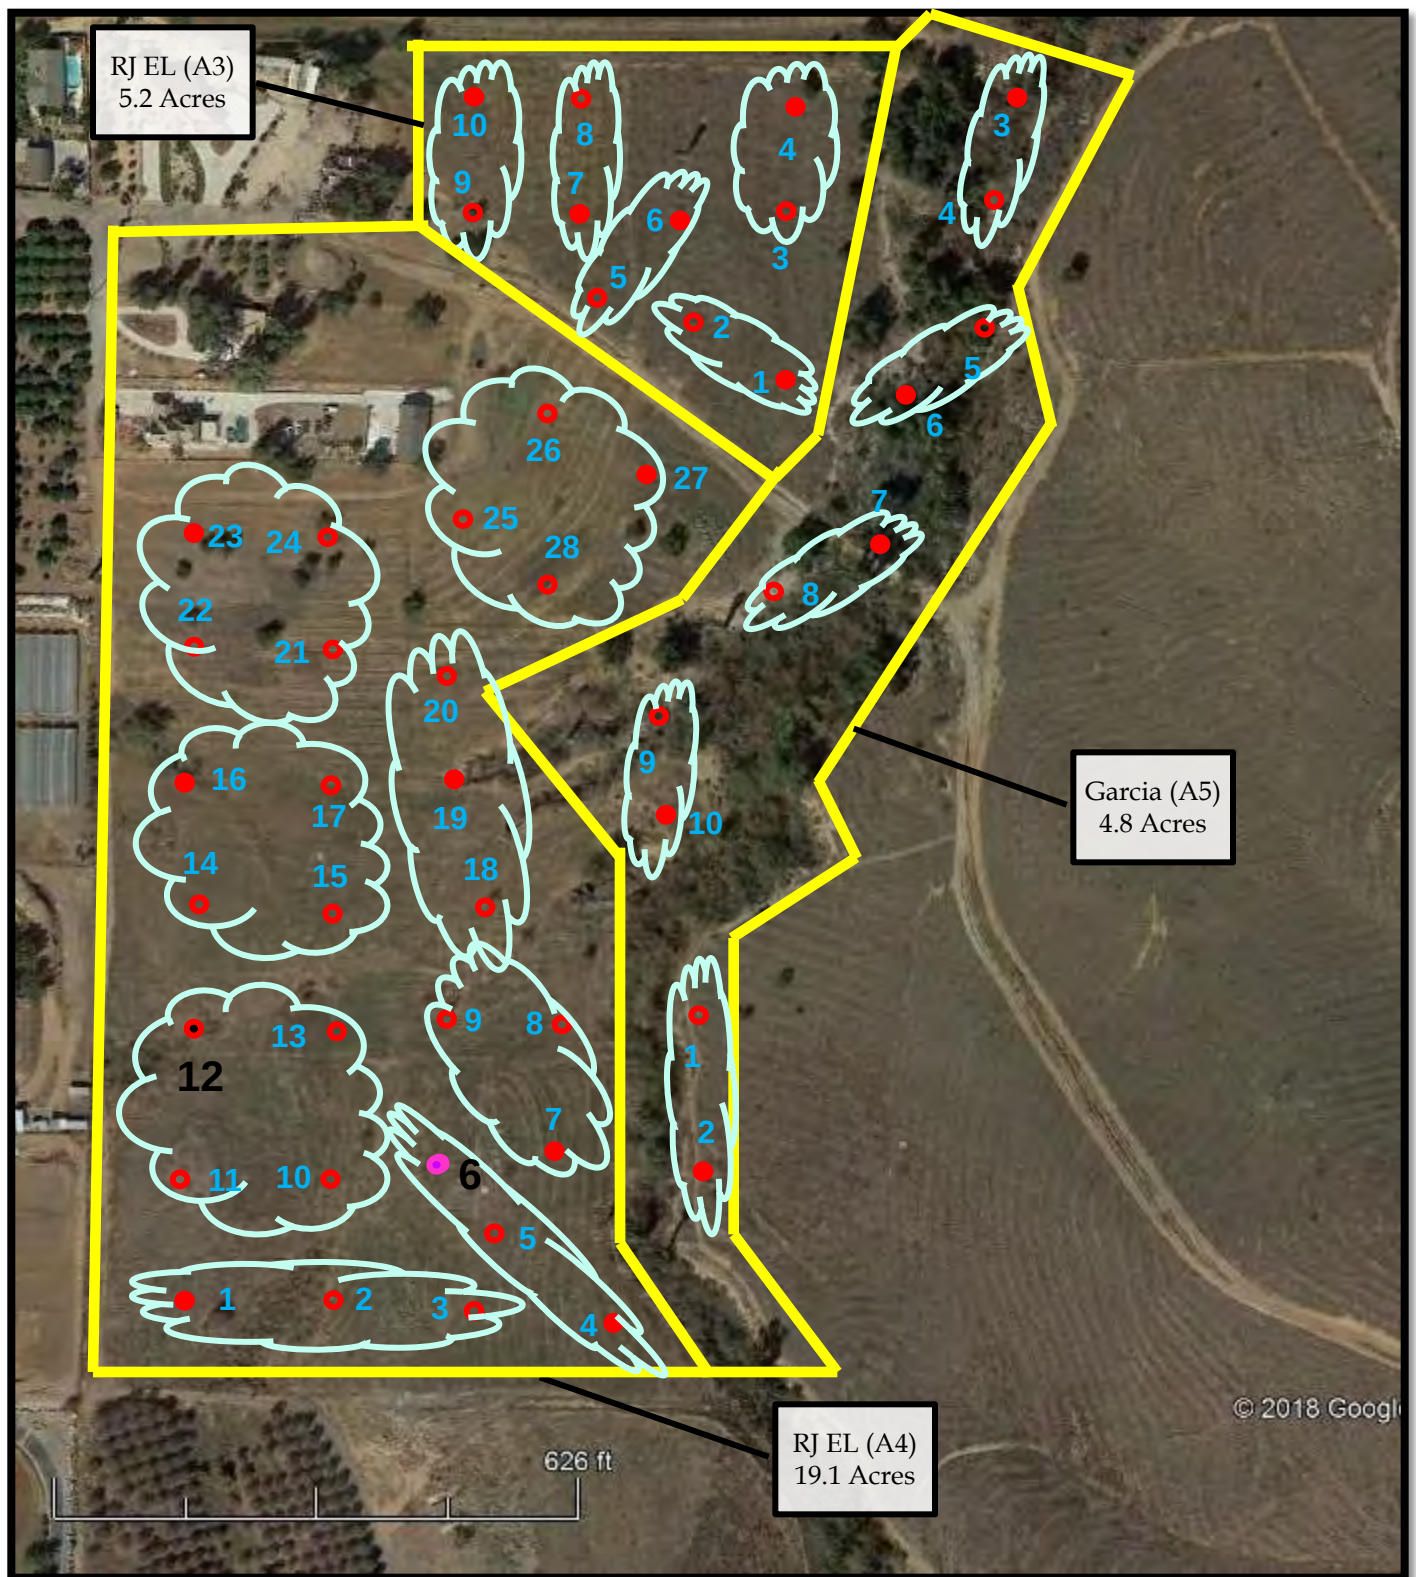
- ▬ Property Boundary
- Sampling for Agricultural Chemicals
- Sampling for Arsenic
- Concentration of arsenic = 13 mg/kg,  
Exceeding naturally occurring screening  
level for southern California.
- Concentration of arsenic = 12 mg/kg,  
Equals naturally occurring screening  
level for southern California.

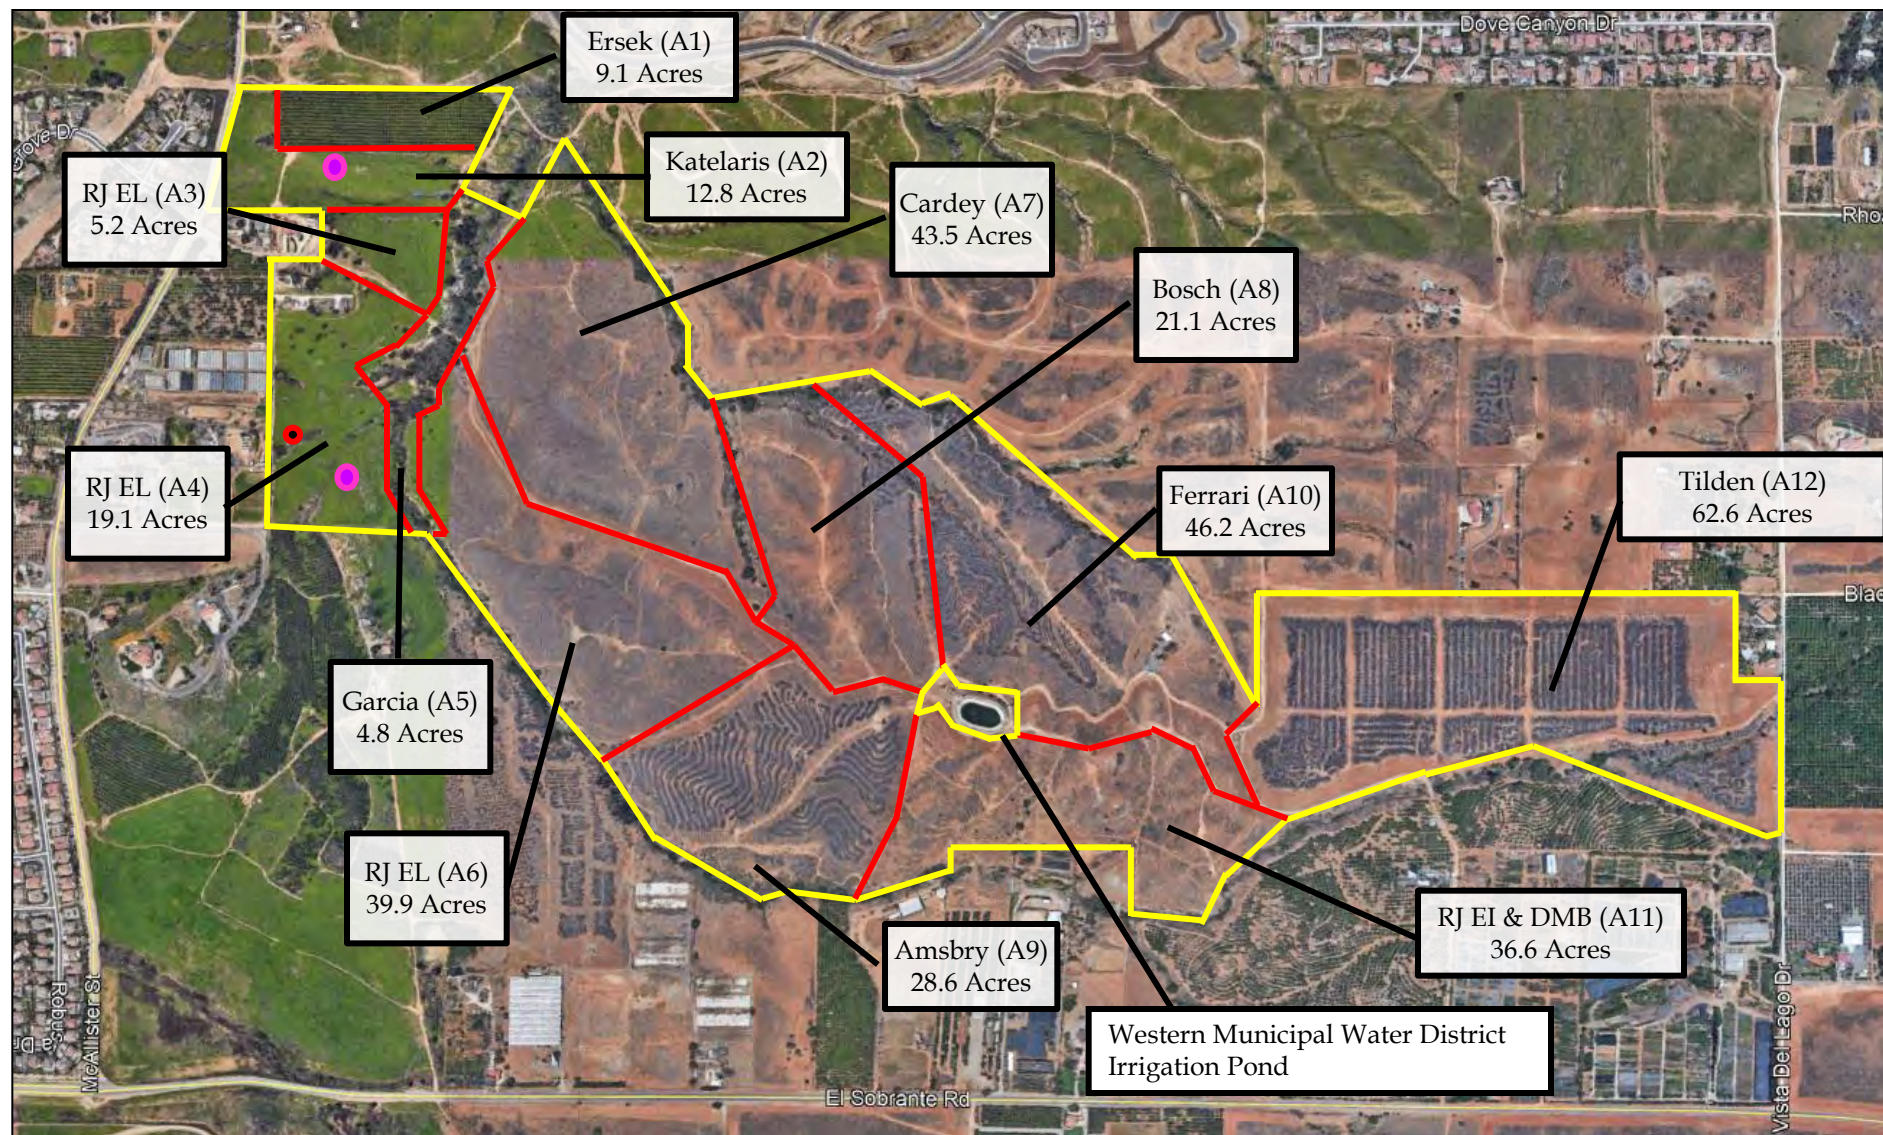
| | | | FIGURE:<br><b>2</b> |

- Property Boundary
- Internal Parcel Boundary
- Concentration of arsenic = 12 mg/kg,  
Equals naturally occurring screening level  
for southern California.
- Concentration of arsenic = 13 mg/kg,  
Exceeding naturally occurring screening  
level for southern California.

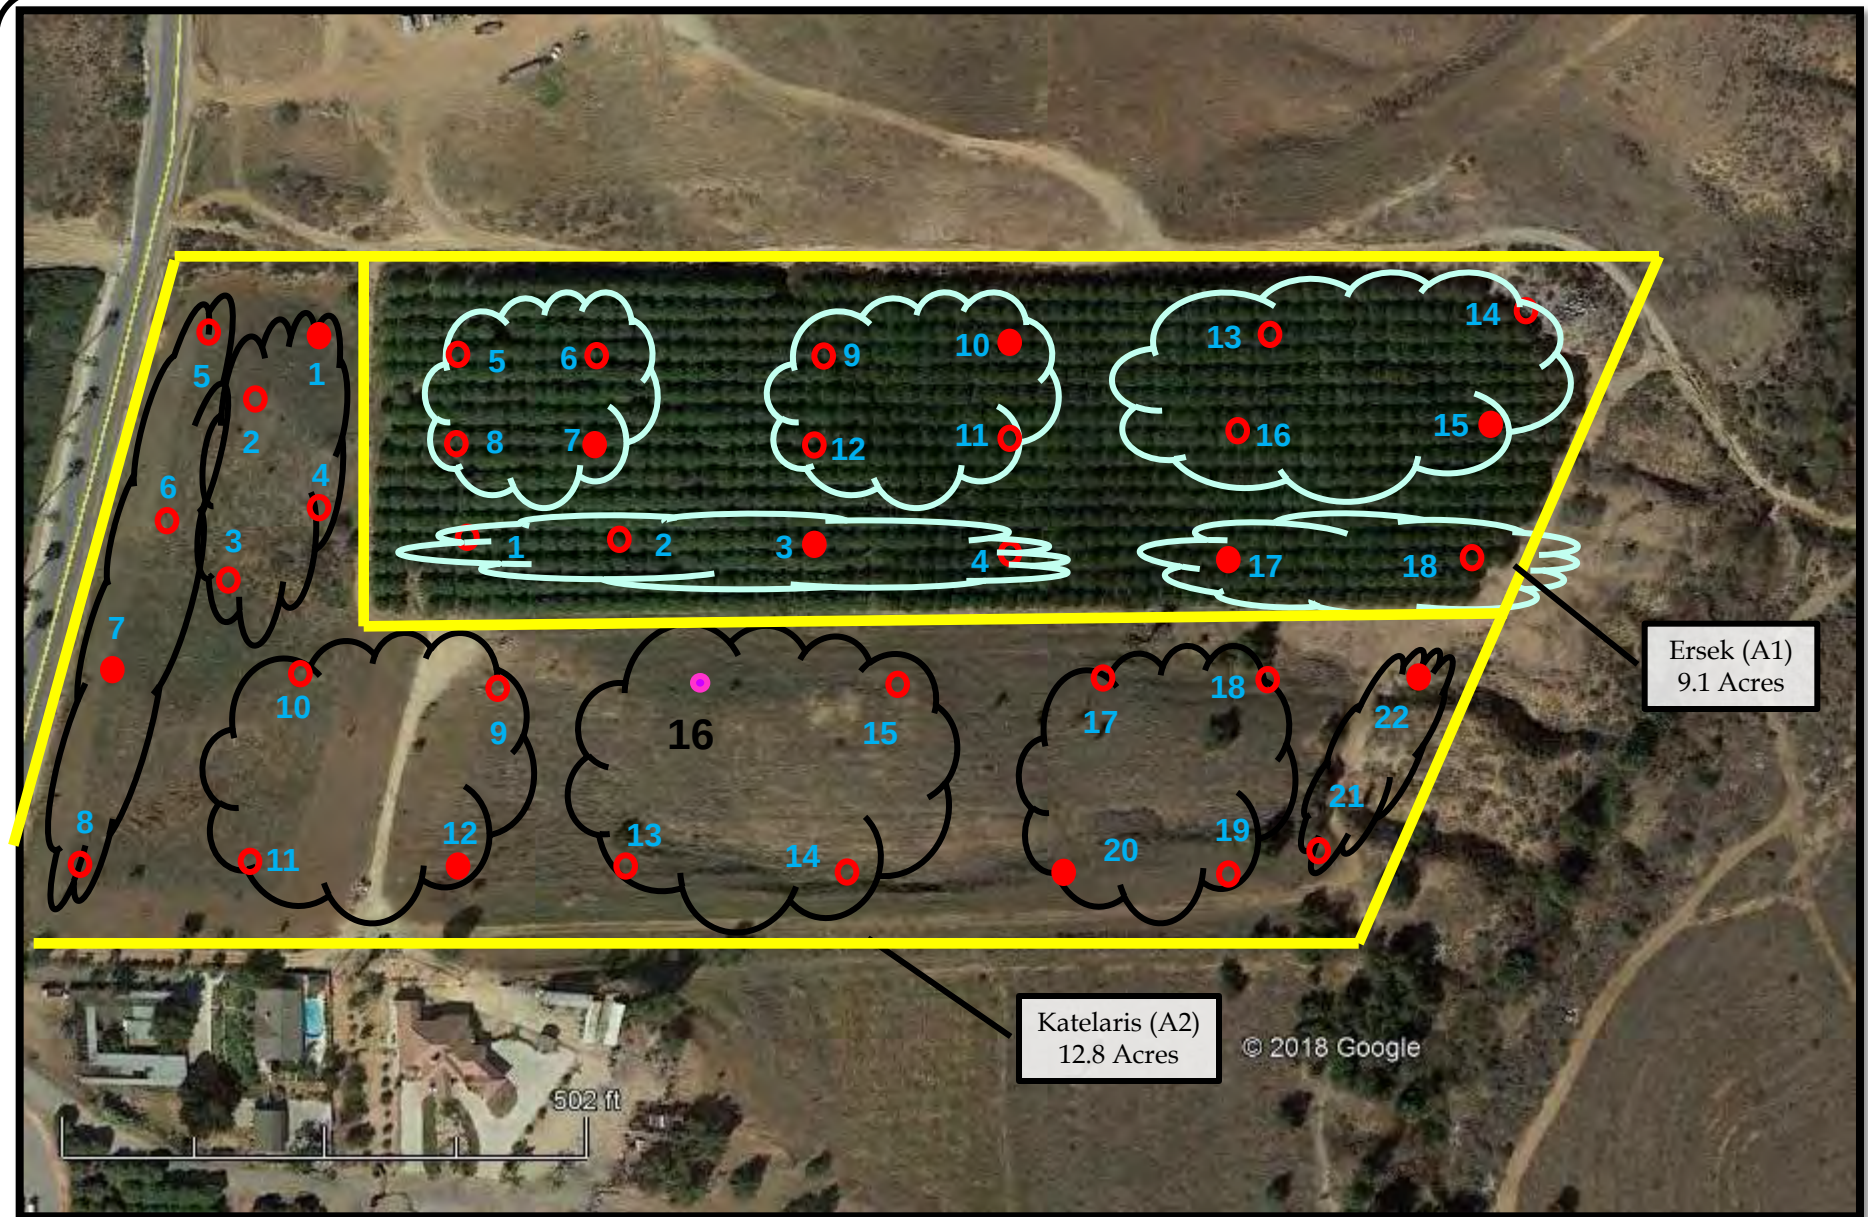
| | | | FIGURE:<br><b>3</b> |

- ▬ Property Boundary
- Sampling for Agricultural Chemicals
- Sampling for Arsenic
- Concentration of arsenic = 12 mg/kg,  
Equals naturally occurring screening level for southern  
California.
