## **Appendix “G”**

*Phase I/II Environmental Site Assessment Update Report*

# *Phase I Environmental Site Assessment Update Report*

Tract Map 39011 Lake Matthews Area,  
Riverside County, California

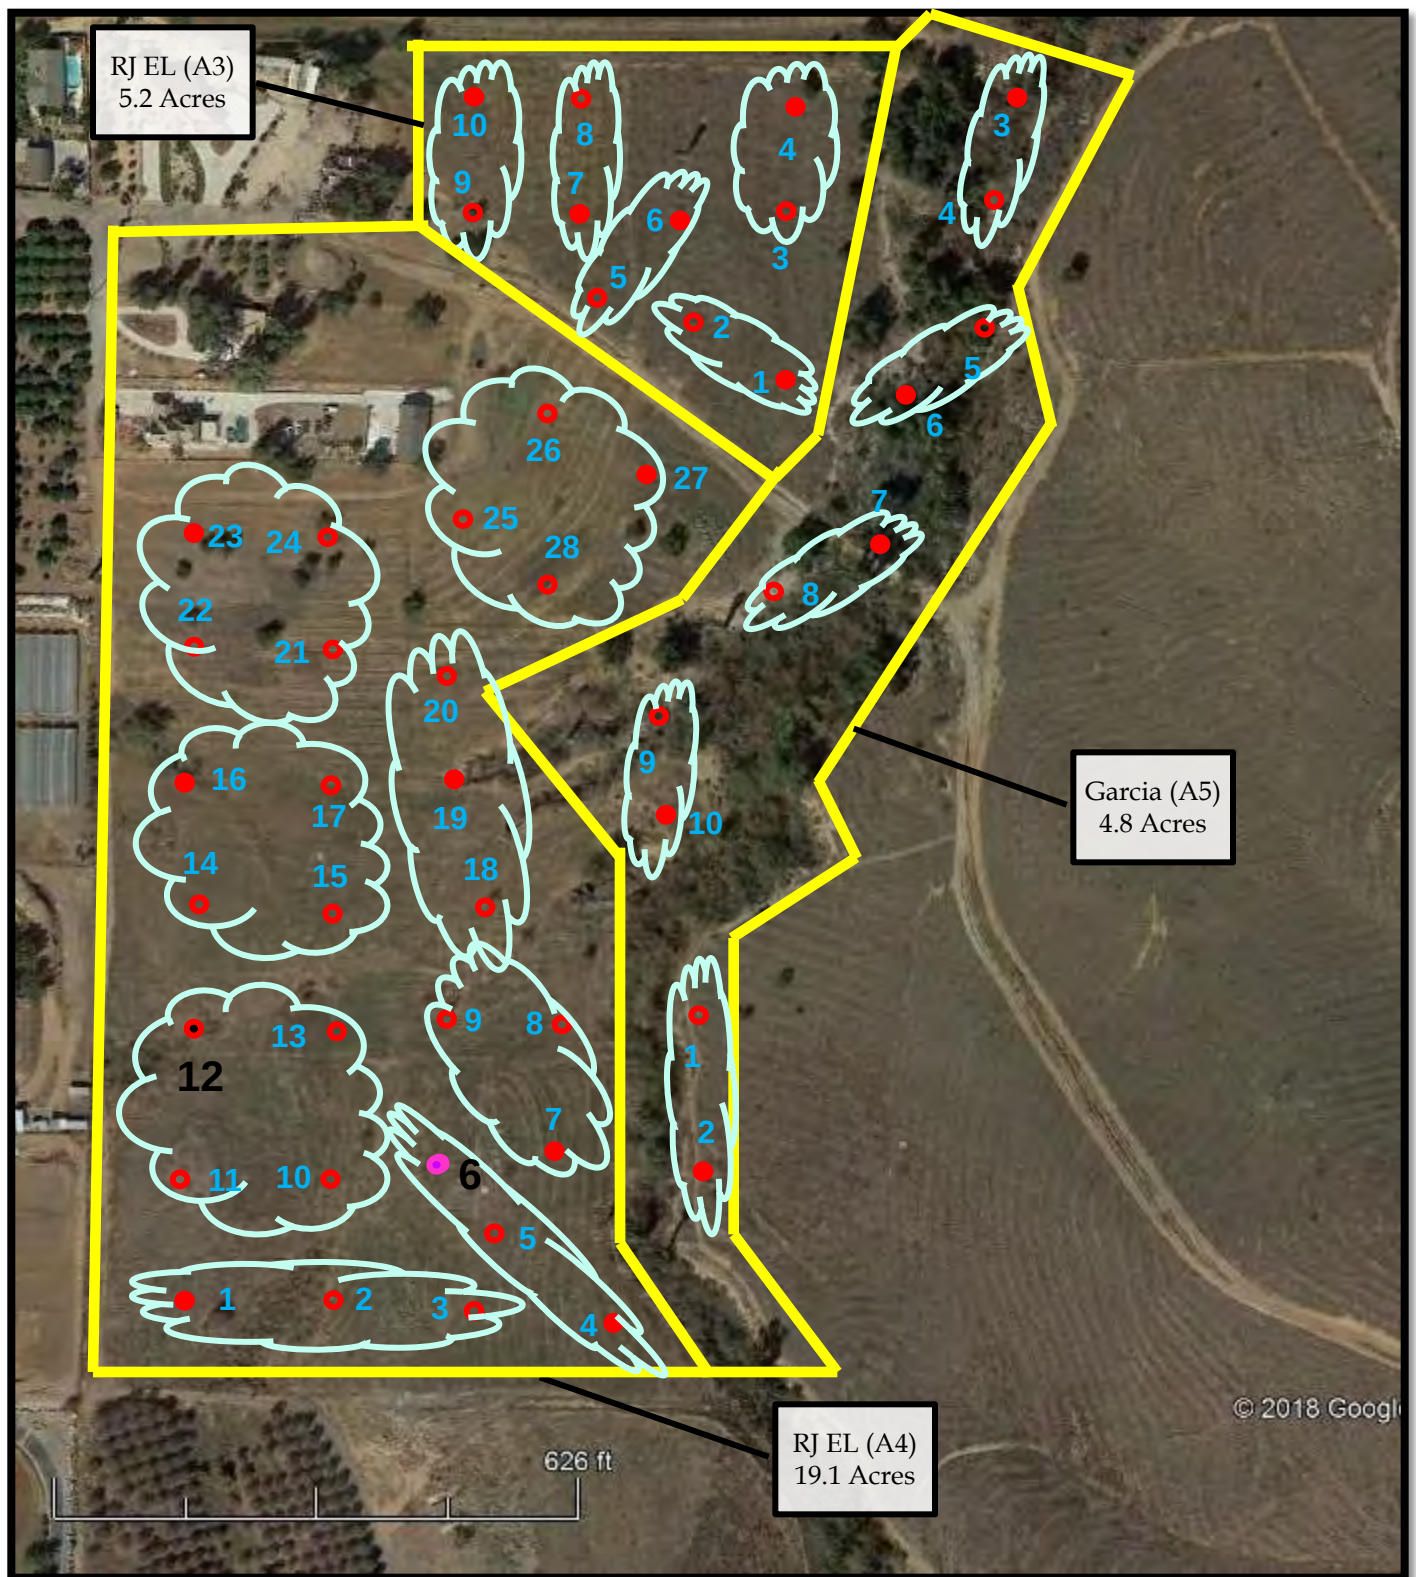
- ▬ Property Boundary
- Sampling for Agricultural Chemicals
- Sampling for Arsenic
- Concentration of arsenic = 13 mg/kg,  
Exceeding naturally occurring screening  
level for southern California.
- Concentration of arsenic = 12 mg/kg,  
Equals naturally occurring screening  
level for southern California.

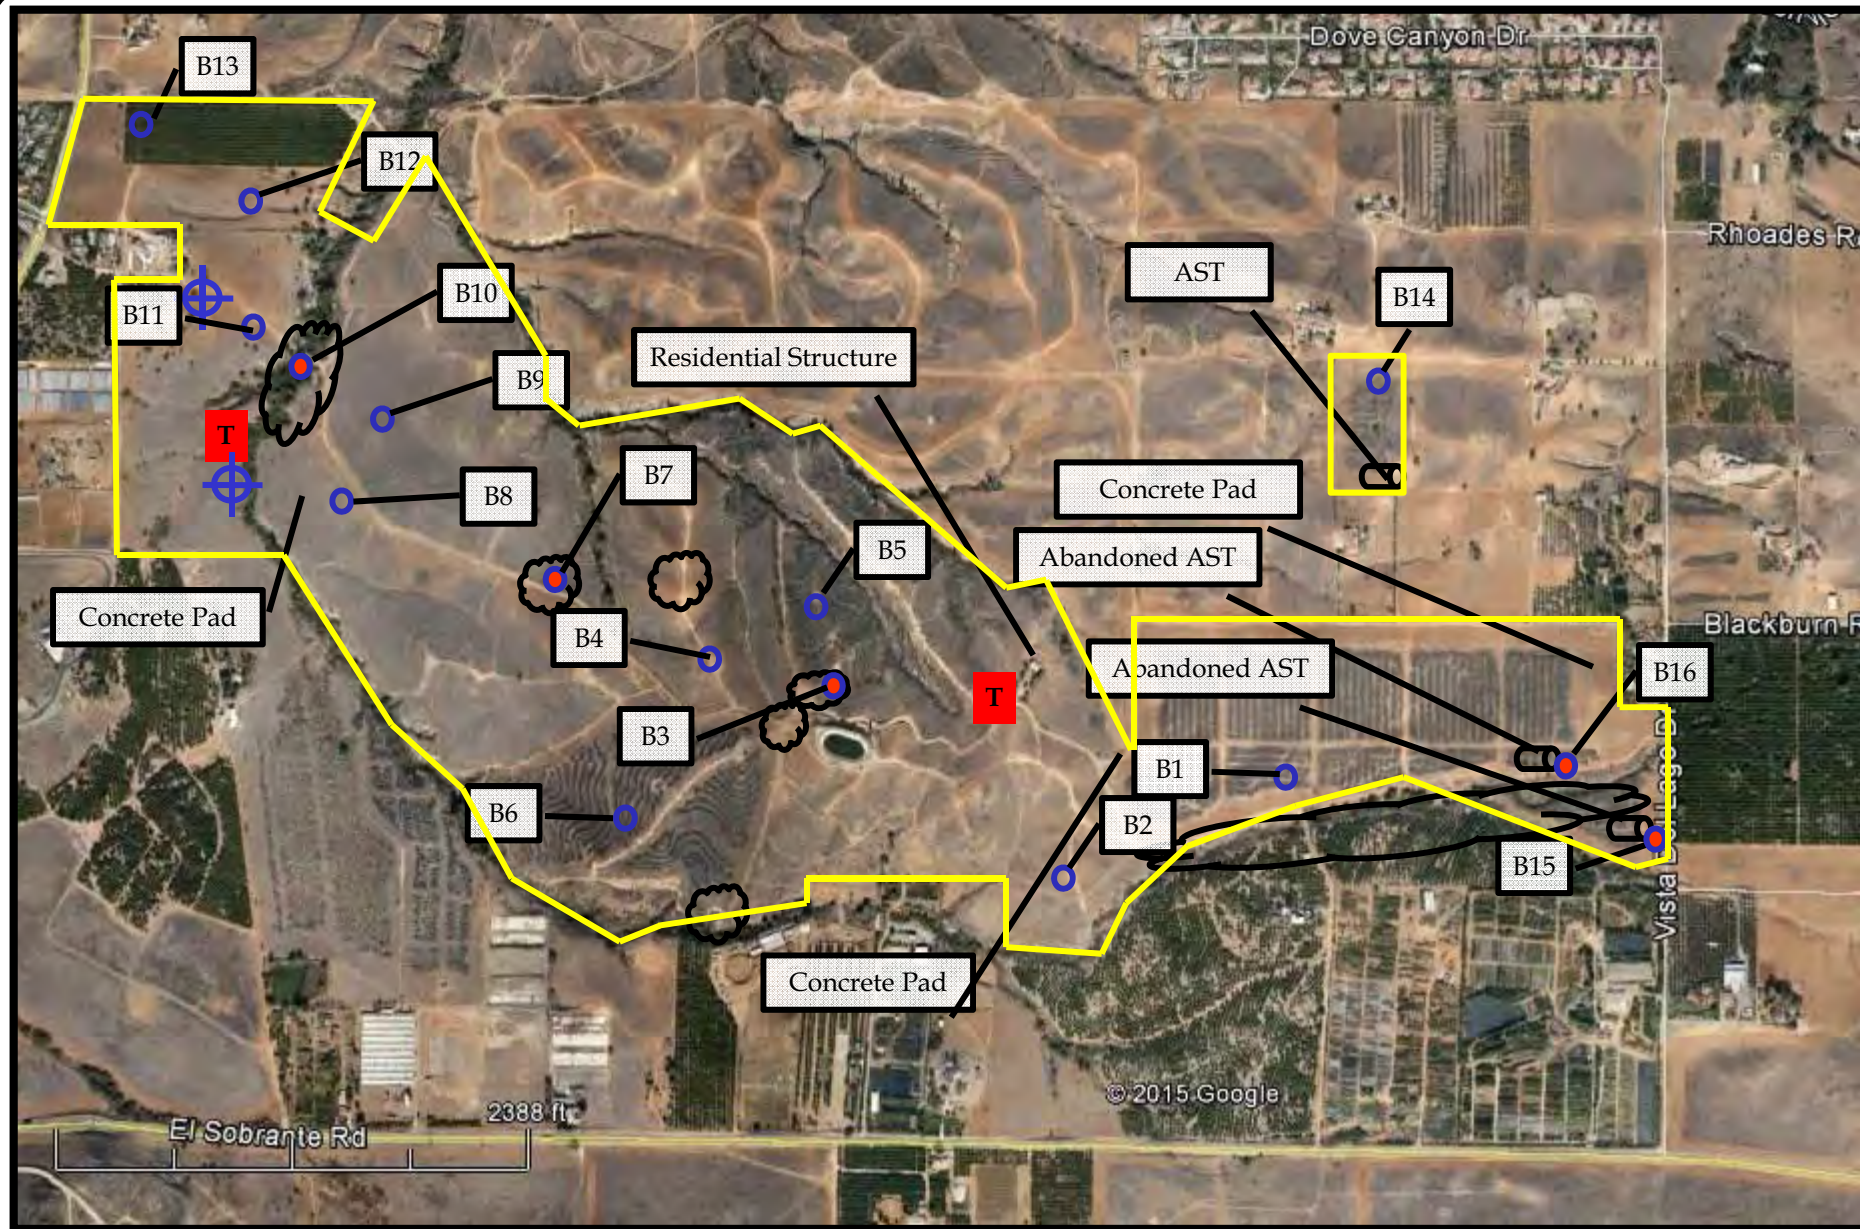
**Legend:**

- Pole-Mounted Transformer
- ⊕ Groundwater Well
- ☁ Area of Household Trash Dumping
- Sampling for Agricultural Chemicals
- Sampling for Household Trash Soil Impacts

Property and in the southwest portion of the Ferrari section of the Subject Property. These areas are identified on Figure 2.

Two suspected water tanks were located on the eastern side of the Subject Property. No visible staining or stressed vegetation was observed; therefore, there was no evidence of prior leakage and soil or groundwater impacts. One above ground storage tank was observed in the southeastern portion of the separated, northeastern Amsbry section of the Subject Property. Tank locations are identified on Figure 2.

Soil samples were field-screened for Volatile Organic Compounds (VOCs) with a Photo Ionization Detector (PID) calibrated to 100 parts per million (ppm) isobutylene and any staining, discoloration, and / or odors were noted. Soil sample locations are identified on Figure 2. Boring logs and field observations are included in Appendix E.

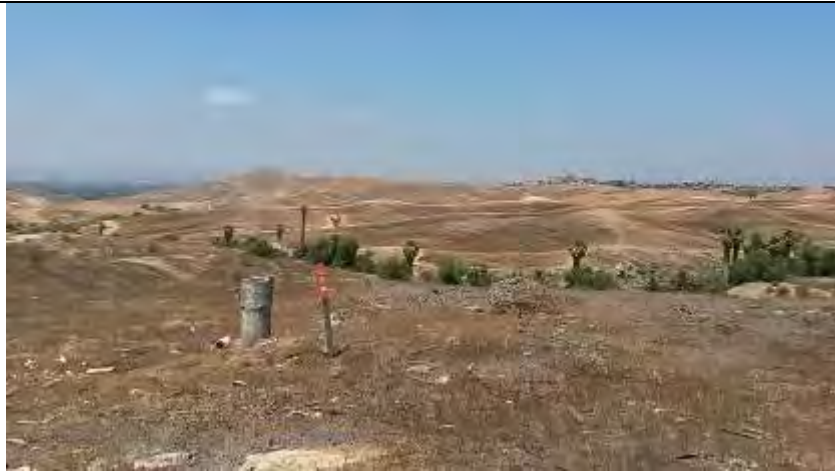
**Photo: 8****Description:**

Cement pad in the western portion of the Subject Property. Presumably for frost former management windmills.

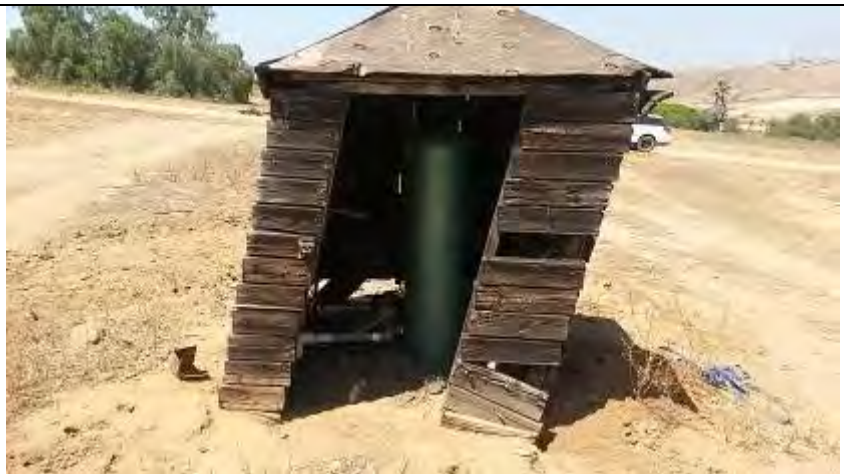
**Photo: 10****Description:**

Well in the western portion of the Subject Property.

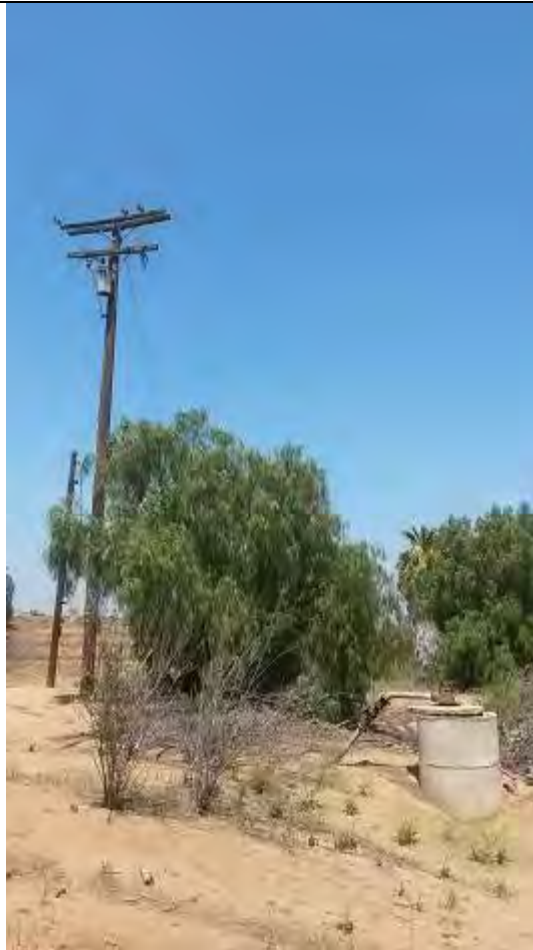
Groundwater well with associated pole-mounted transformer. Well is constructed with concrete casing and a vertical turbine pump (electric motor missing).

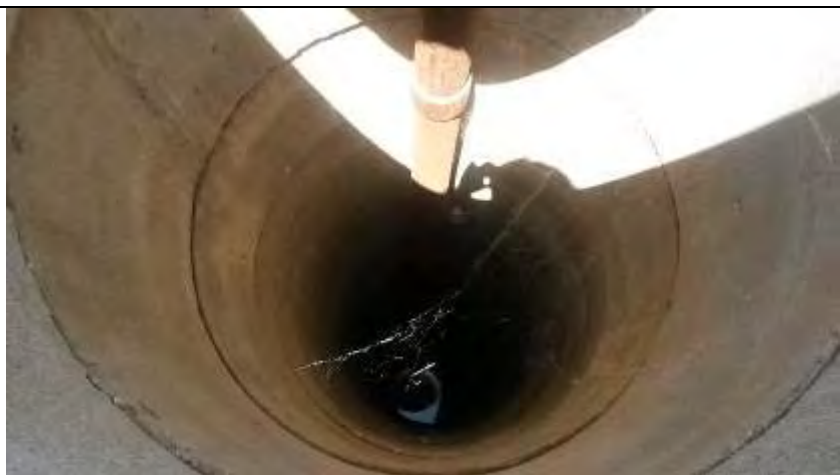
**Photo: 12****Description:**

View down the well located in the southwestern portion of the Subject Property.

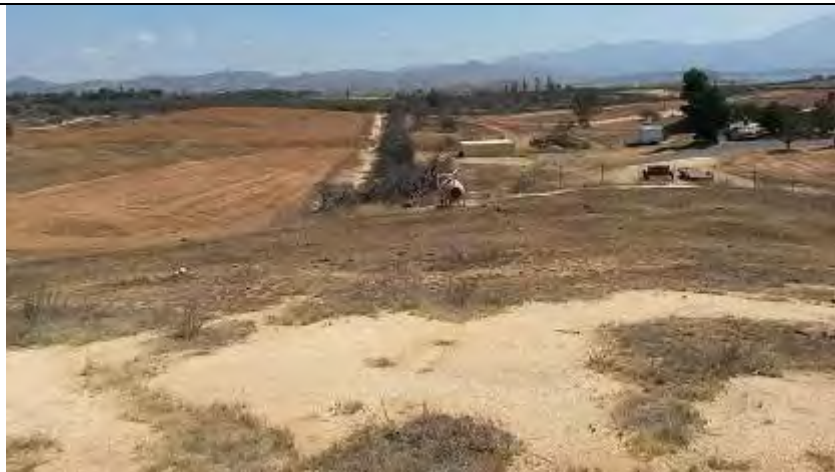
**Photo: 22****Description:**

Unused aboveground storage tank in the detached northeastern Amsbry section of the Subject Property.
