**U.S. ARMY CORPS OF ENGINEERS  
JURISDICTIONAL DELINEATION  
FOR THE  
ELDER CREEK PROPERTY  
SACRAMENTO COUNTY, CALIFORNIA**

**MARCH 2024**

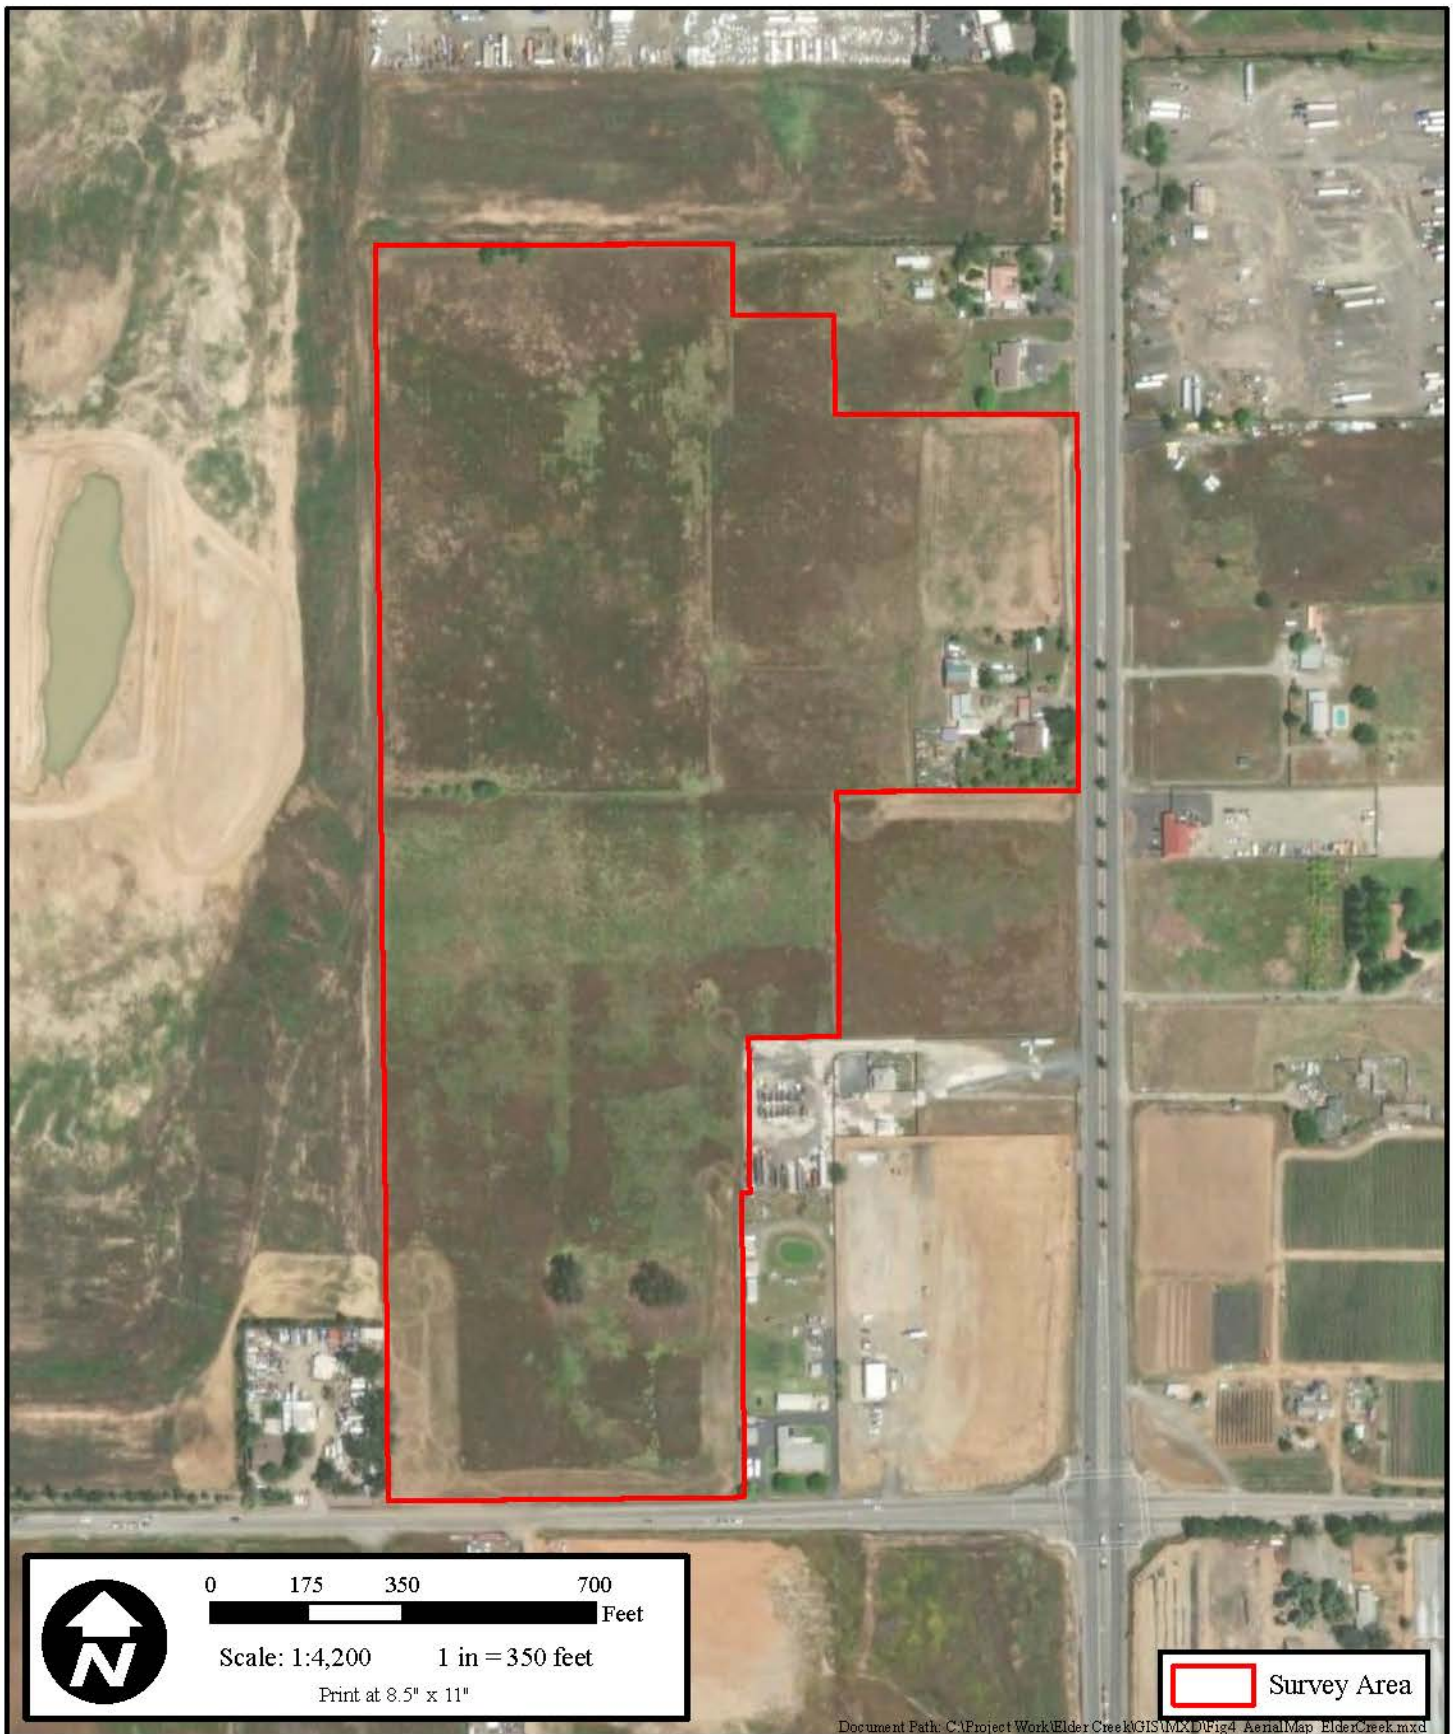
Figure 4: Aerial Map  
Elder Creek Property  
Sacramento County, California

Attachment 1, Figure 1 depicts the regional location of the Survey Area in Sacramento County, while Attachment 1, Figure 2 illustrates the vicinity of the Survey Area in relationship to CA-16. Attachment 1, Figure 3 identifies the location of the Survey Area on the Carmichael USGS 7.5' Quadrangle. An aerial photograph of the Survey Area has been included as Attachment 1, Figure 4.

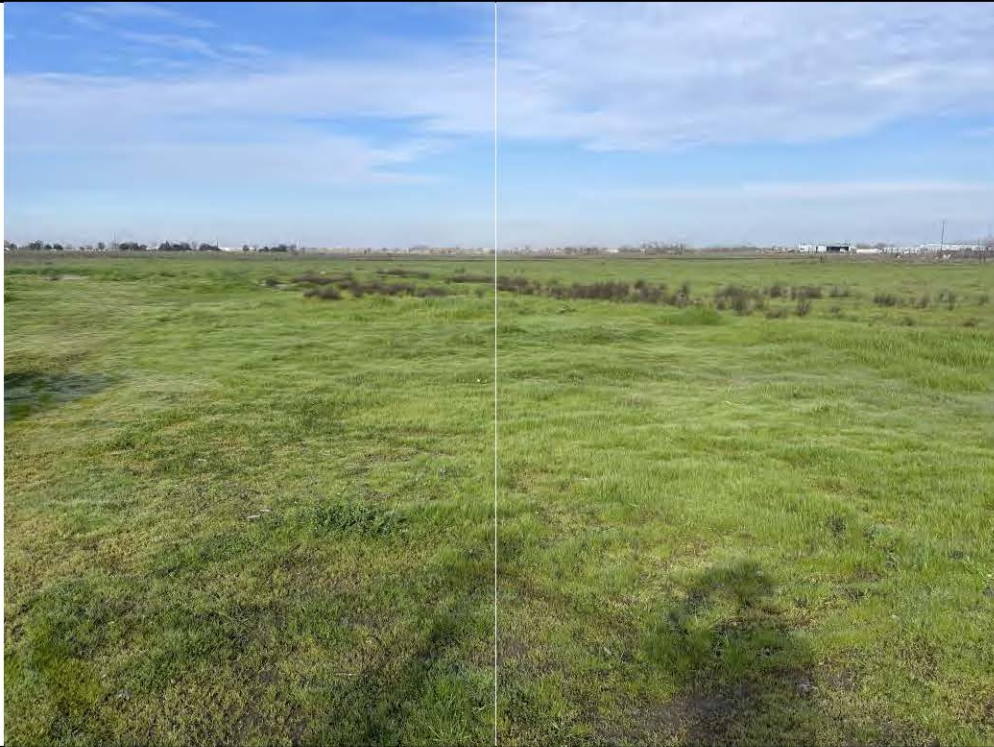
1. Photo 1 is taken from the northeastern boundary of the Survey Area, facing southwest. The photo shows the flat topography of the Survey Area. Photo taken 2/13/2024.

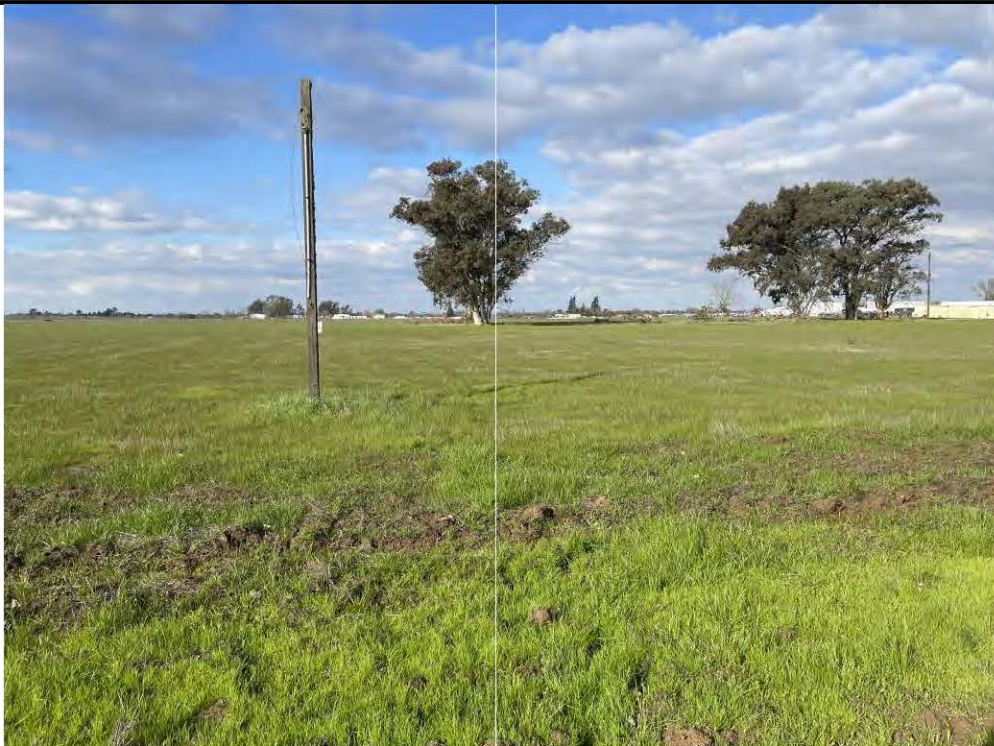
2. Photo 2 is taken from the southern boundary of the Survey Area, facing north. The photo shows some large blue gum trees growing in the southern portion of the Survey Area and the flat topography. Photo taken 2/13/2024.

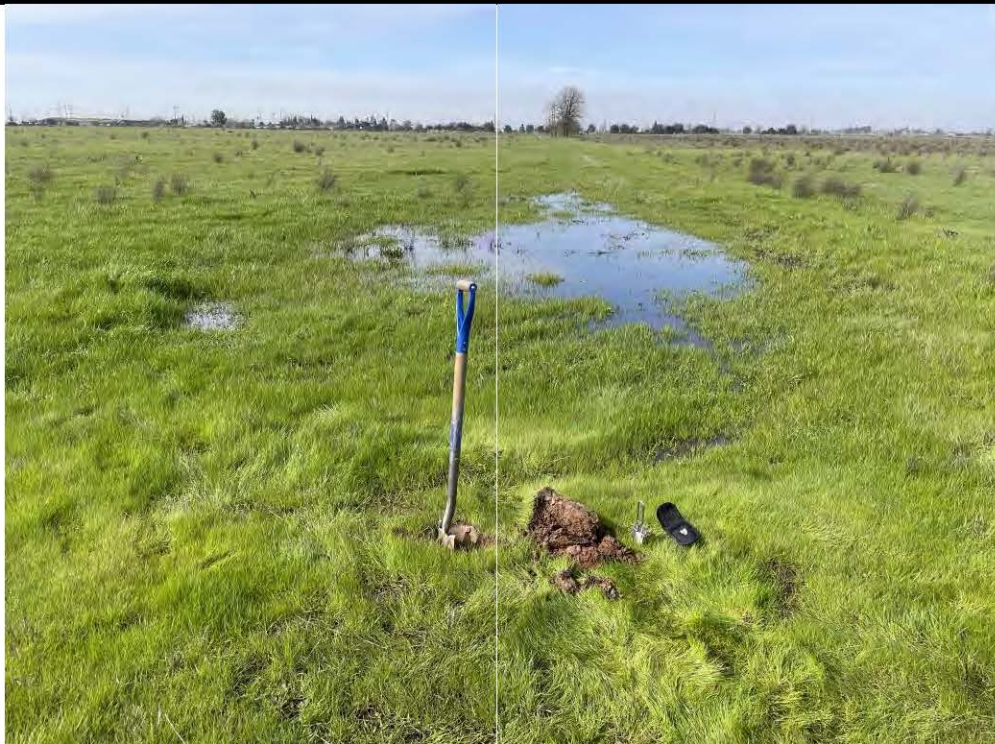
3. Photo 3 is taken facing west. This photo shows sample point 3B (blue shovel) and feature SW 1. Photo taken 2/13/2024.

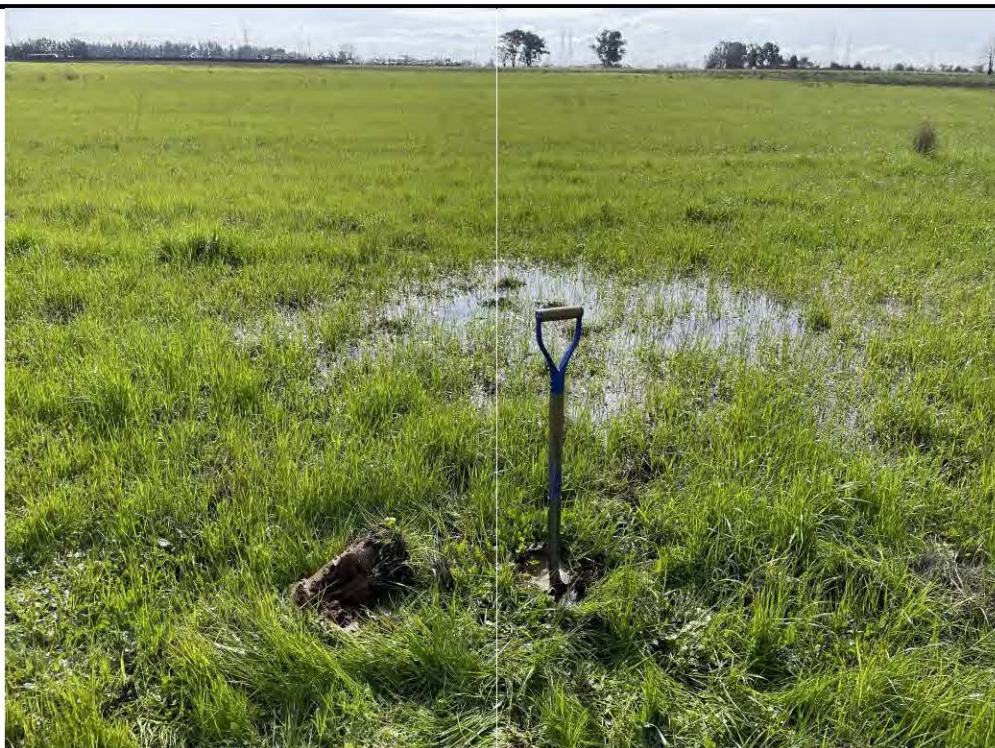
Feature SW 6 is a large feature in the northwest portion of the Survey Area. Vegetation within this feature was dominated by Mediterranean barley. The soils within this feature were too saturated to get an accurate reading of color or texture. This feature occurs within a natural depression in the landscape and contained scattered areas of standing water from 1"-4" deep, water-stained leaves, and a biotic crust of algae. The larger, deeper pools contained aquatic invertebrates.

4. Photo 4 is taken facing south. This photo shows sample point 6B and feature SW 6. Photo taken 2/13/2024.

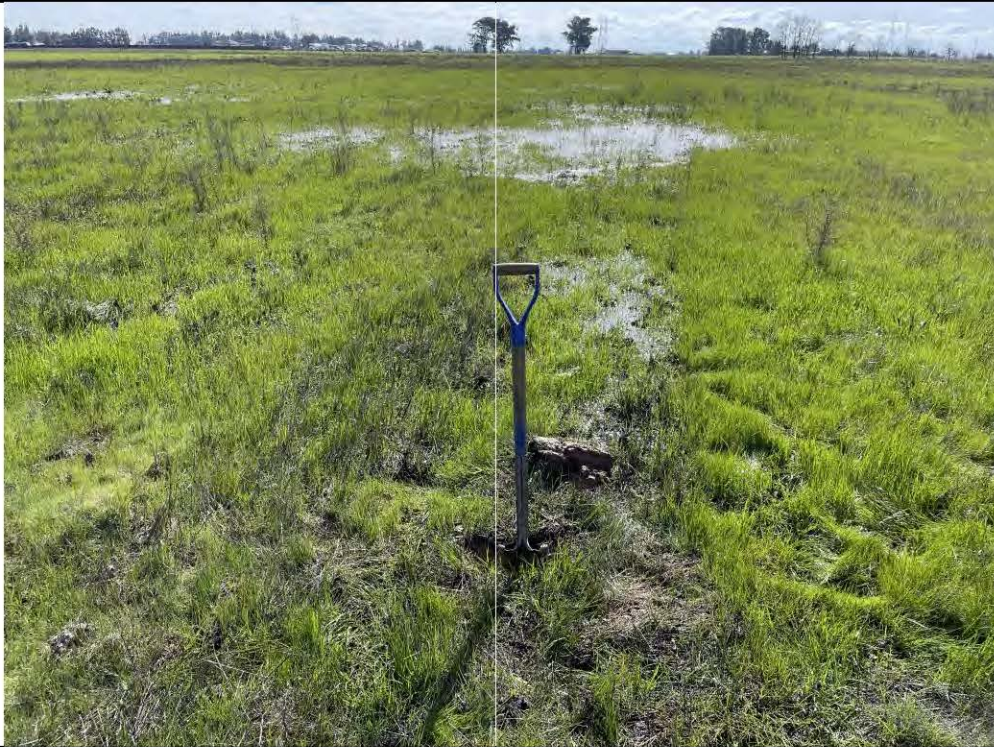
5. Photo 5 is taken facing south. This photo shows sample point 8B and feature SW 6. Numerous, scattered pools of water can be seen throughout the vegetation. Photo taken 2/13/2024.

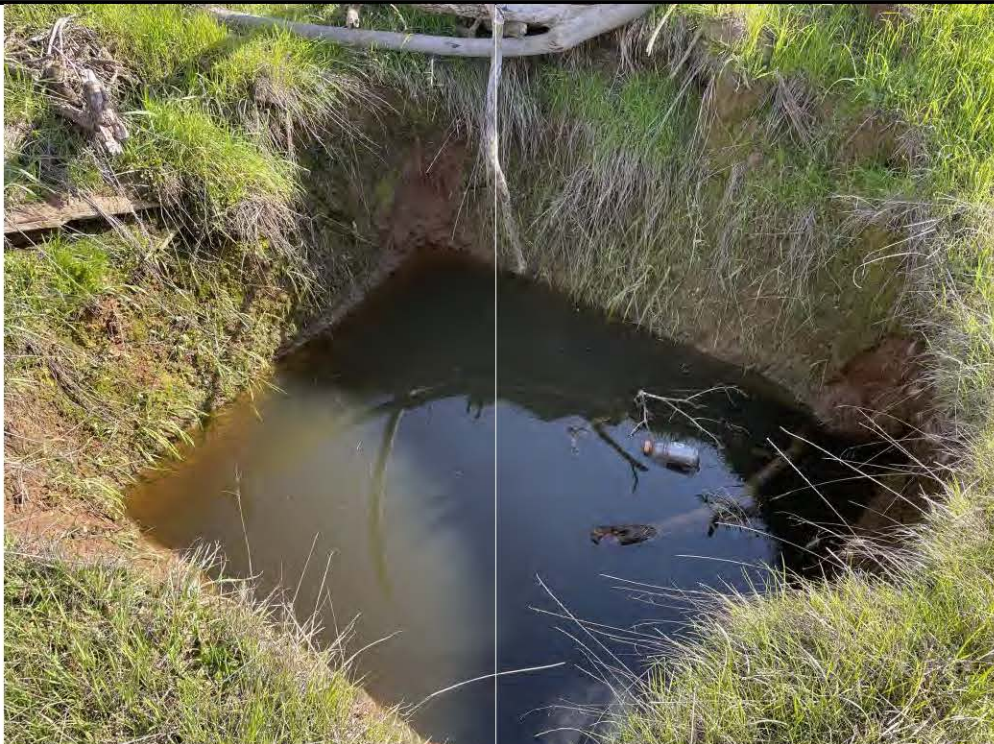
6. Photo 6 is taken near the middle of the Survey Area. The photo shows feature SW 9, which consists of an excavated pit approximately 6 feet across. Photo taken 2/14/2024.

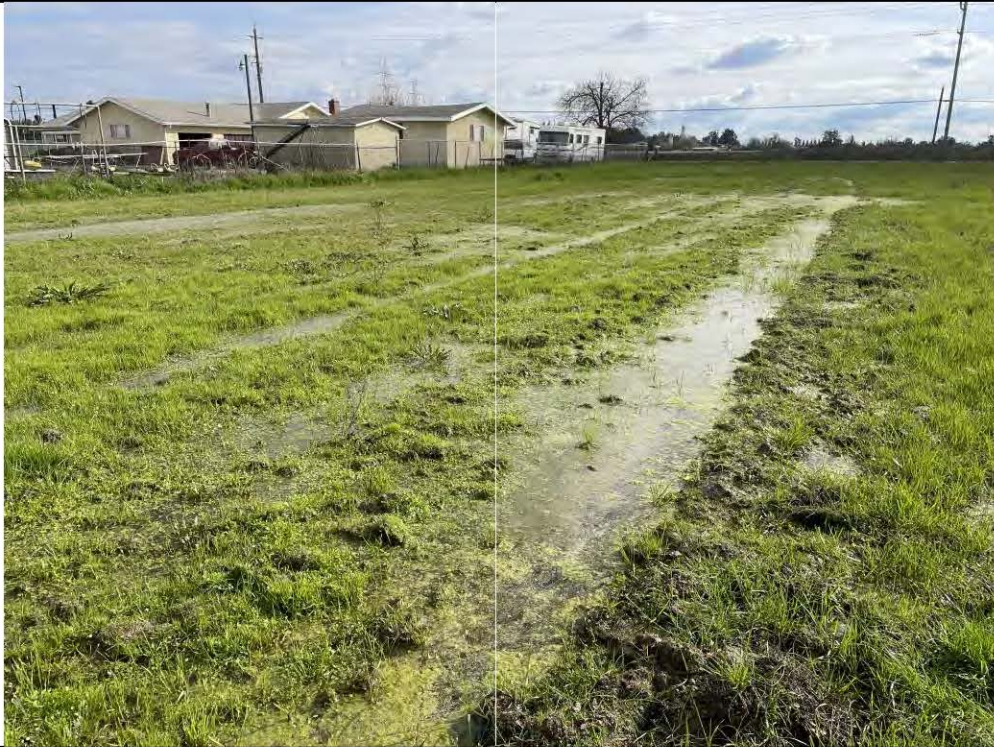
7. Photo 7 is taken from the north side of feature SW 10, facing southeast. The photo shows the ponding that is found throughout much of this feature. Photo taken 2/13/2024.

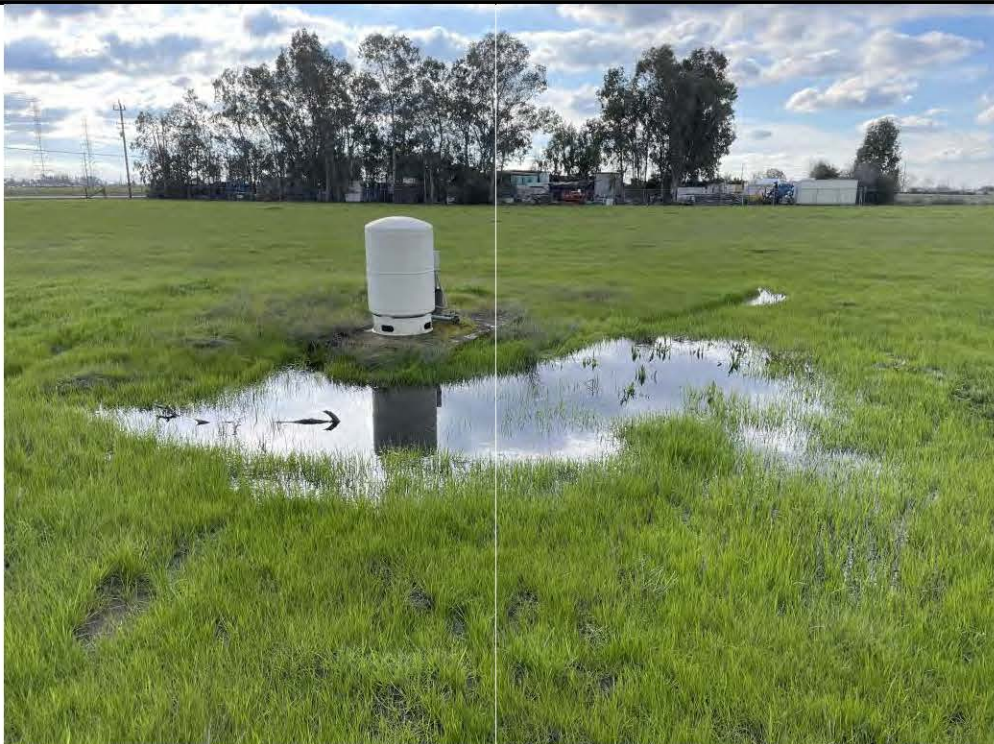
8. Photo 8 is taken in the southern portion of the Survey Area, facing west. The photo shows feature SW 11 located around a concrete pad. Photo taken 2/13/2024.

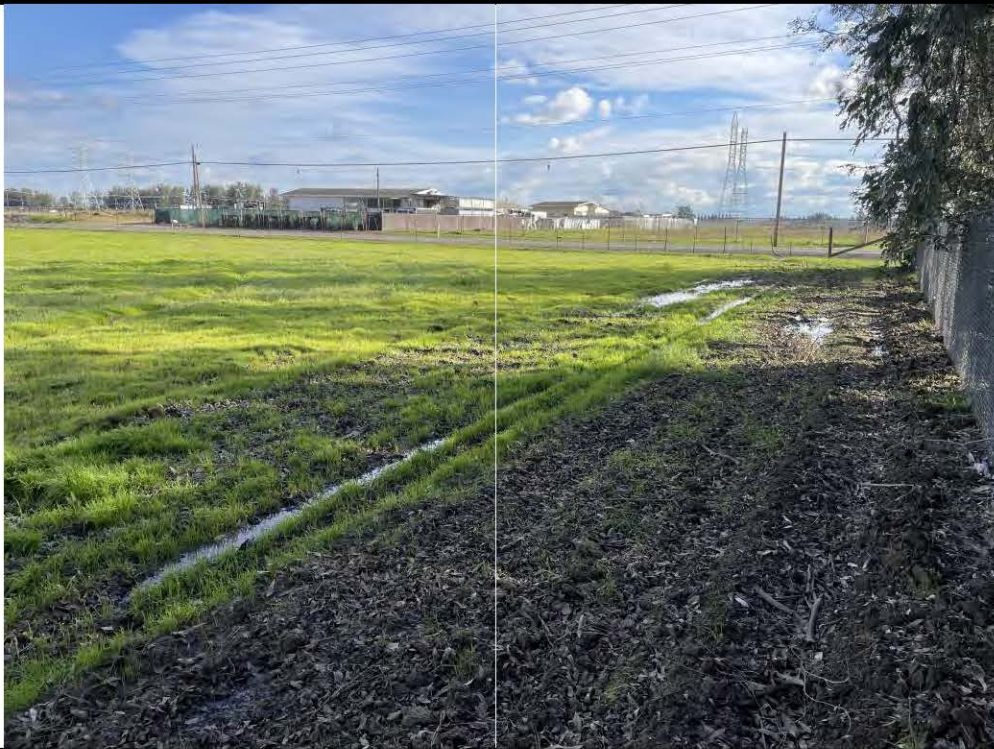
Feature SW 12 is a large feature that occurs in the southwest corner of the Survey Area. Vegetation within this feature was dominated by Mediterranean barley. Most of this feature occurs within an area that is regularly disked. Due to saturation and disked nature of the soil, a soil sample was not taken within this feature. This feature contained a couple of inches of ponded water throughout, in addition to algal matting, water-stained leaves, and drift deposits around its upland border.

9. Photo 9 is taken along the southwestern fence line of the Survey Area, facing south. The photo shows feature SW 12, much of which is located within an area that is regularly disced with little vegetation. Photo taken 2/13/2024.

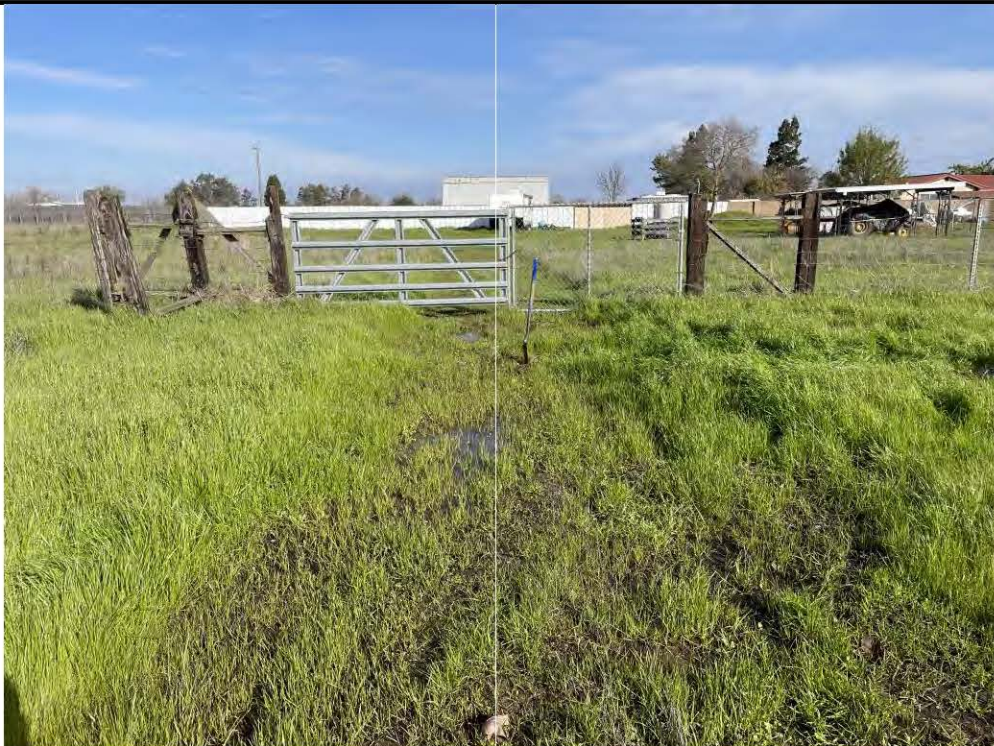
Feature SW 13 is a small, linear feature located in the northeastern portion of the Survey Area. This feature was dominated by spiny buttercup and common Timothy grass. This feature contained soils that met the requirements for Redox Depression (F8) and contained a hardpan layer of compacted clay at six inches. This feature contained several inches of ponded water, water-stained leaves, and aquatic invertebrates.

10. Photo 10 is taken near the northern border of the Survey Area, looking north. The photo shows feature SW 13. This feature occurs along an old dirt road. Photo taken 2/13/2024.
