NOTICE OF EXEMPTION

PROJECT TITLE: Ventura County Stream Gage Install and Upgrade - CalSIP Upgrade

Scope of Work

NEW INSTALLATION AND UPGRADES OF STREAMGAGING STATIONS PROJECT (CAL SIP)

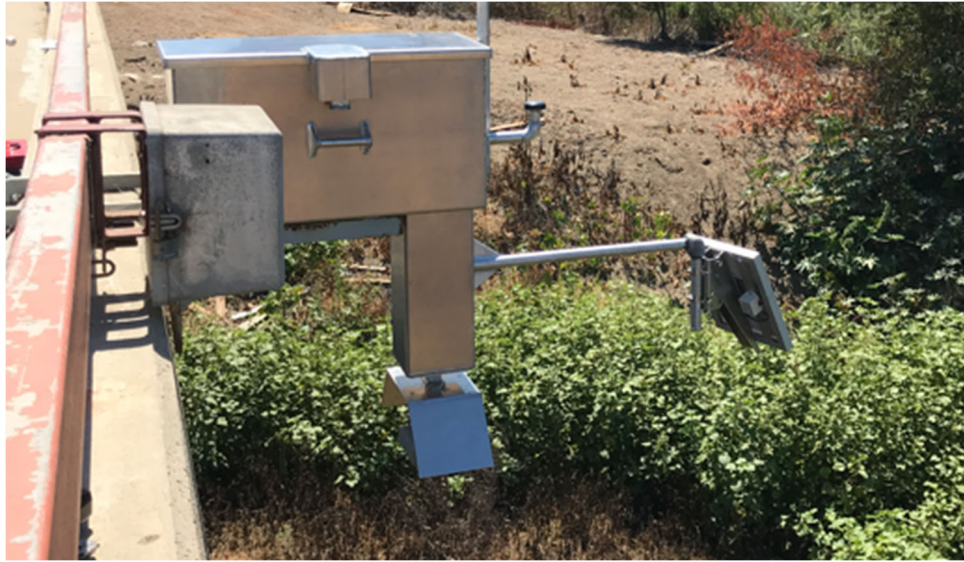
Photo from Ridgeview gaging location to show example of radar installation. The smaller box in front left is not part of the radar box.

The proposed location for this new stream gaging system is at Torrey Road Bridge near Piru. The new gage will be a radar unit, installed by either clamping the radar unit to the bridge rail along Torrey Road or installing it to the bridge through four small anchor holes. To install the unit, no major construction to the bridge or channel would occur and there would be little to no ground disturbance. This location was selected due to the low vegetation growth along the channel which will likely require little to no vegetation maintenance. This is a non-contact gage. Monthly to quarterly site visits would be conducted to check the equipment, change batteries, download data, and measure stream flow. Below is a photo of a similar unit to show what this site might look like.

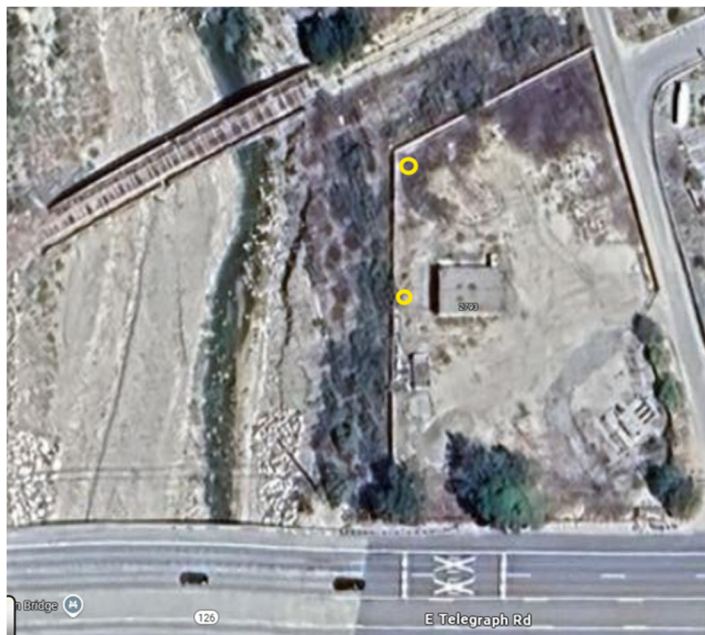
Photo shows two possible locations for the camera installation within the walls on the County property.

Hopper Creek near Piru has an existing stream gaging system that would be updated and includes the addition of a new camera. The proposed camera installation site is upstream within the walls of the County property (see photo). The camera pole requires a two foot by three foot concrete base that may require shovel ground disturbance in the small work area. All work would be done with hand tools. The system equipment would be similar to an existing station, called the Arundell station, pictured below. No work will occur in the channel and no new maintenance activities are proposed at this site. Monthly site visits would continue to be conducted to check the equipment, change batteries, download data, and measure stream flow. The camera site would be visited on an annual basis, unless maintenance of any kind was needed.

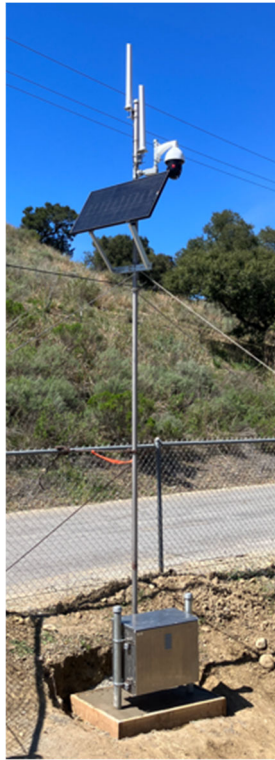
Photo from Arundell Camera location to show example of camera installation & concrete base.

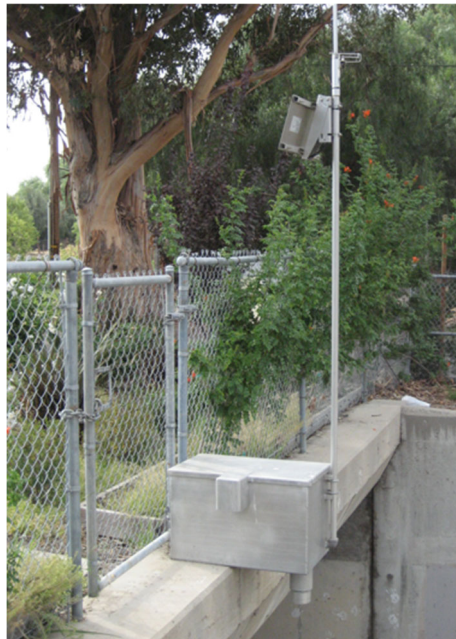
Photo of current Arroyo Tapo at Walnut stream gage.

The existing stream gaging system at this location will be upgraded. The equipment that will be upgraded is within a box mounted above the channel. While there is some vegetation near the channel, it is unlikely that maintenance events would occur (none have occurred at this location to date). Possible debris clearing could be required. Annual site visits would continue to check the equipment, change batteries, and download data.

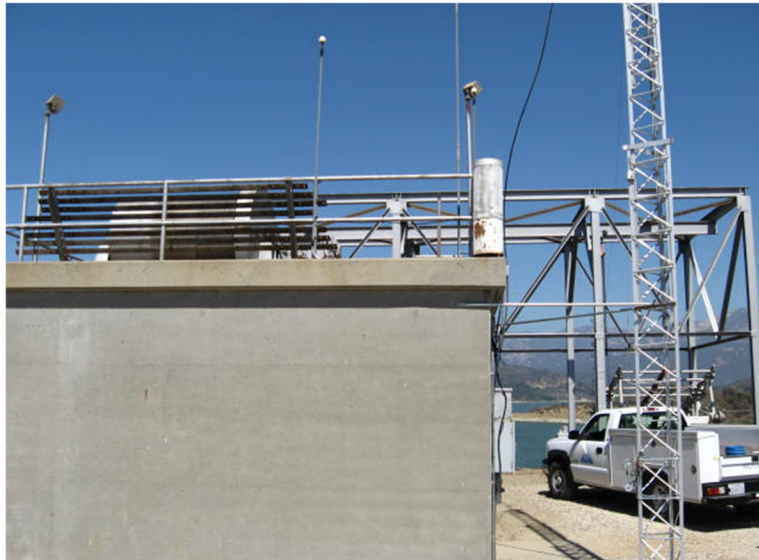
Photo of the concrete dam house which houses the lake level system.

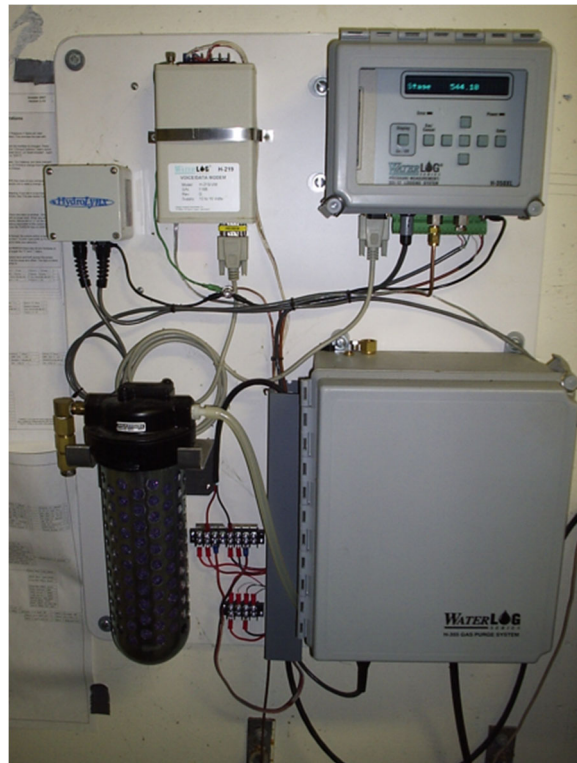
Photo showing current system at Lake Casitas which is inside the dam house mounted on the wall.

The bubbler stream gaging equipment at this location will be upgraded. The bubbler is located within the concrete dam house mounted on the wall. No work outside of the dam house would occur. The new bubbler system will be mounted in the same wall location. Annual site visits would continue to be conducted to check the equipment, change batteries, and download data. This site is checked daily by Casitas Municipal Water District (CMWD) staff who can inform WPD hydrology staff if there are any issues requiring additional site visits.
