# PHASE I ENVIRONMENTAL SITE ASSESSMENT

## Adesa Site

6464 33rd Street  
Jurupa Valley, California 92509  
Project Number: 1011602535

Report Date: June 6, 2024

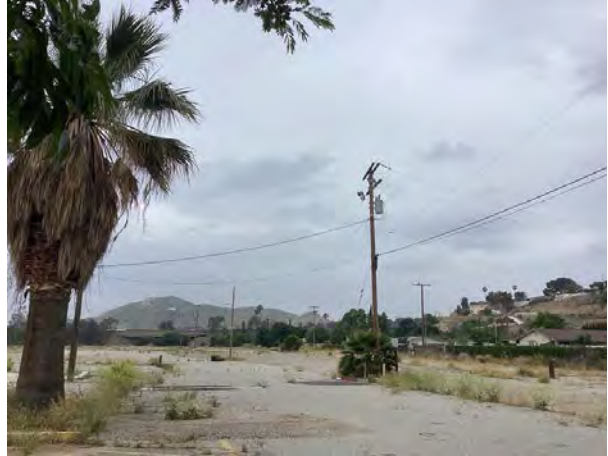
2 : View of Subject Property looking southwest and of pole-mounted transformer

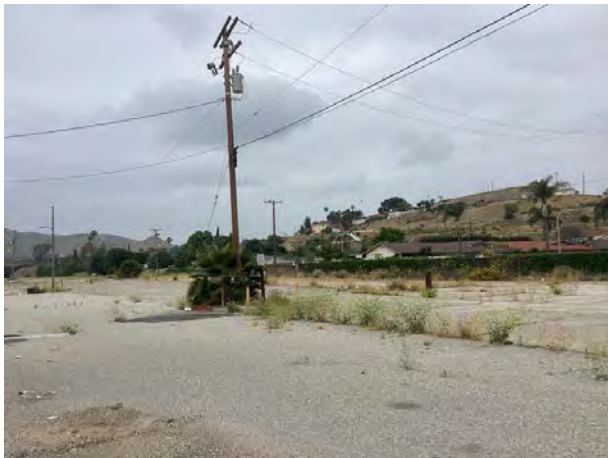
Atlas observed two pole-mounted transformers near the northeastern portion of the Subject Property. The transformers were not labeled as to their PCB content as viewed from the ground. The transformer units are owned and operated by Southern California Edison, which is responsible for the maintenance of the transformer units. No evidence of stains or leaks was observed at the time of the site visit.

3 : View of the pole-mounted transformer

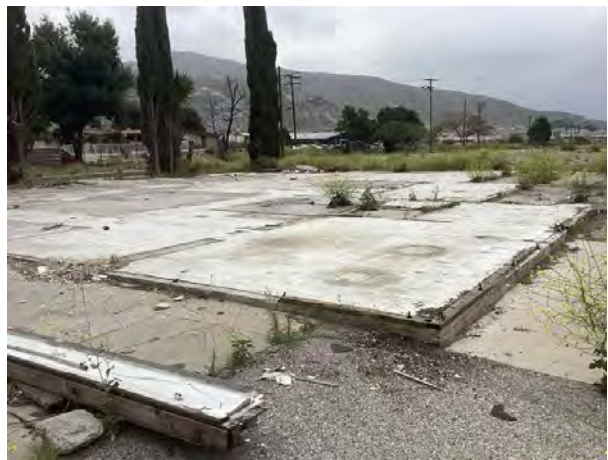
Atlas observed foundations of former buildings with flooring material including black mastic and floor tile, which are suspect ACMs.

6 : View of the remnant foundation of a building

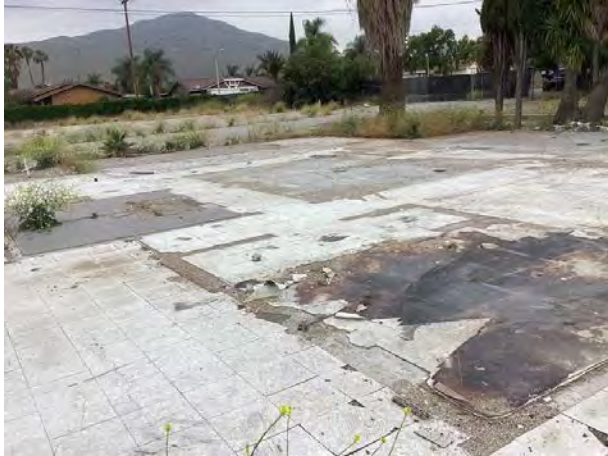
- Atlas observed suspect asbestos-containing materials (ACM) including floor tile and black mastic on remnant building foundations. The presence of suspect ACM is a non-ASTM Scope Consideration.

7 : View of floor tile and black mastic on remnant foundation

- Notify the RCDEH if the use of the Subject Property changes (i.e., if it is redeveloped).
- An asbestos survey of the suspect ACM on the remnant building components should be conducted prior to future disturbance/removal of those components.
- Trash / debris should be removed and disposed of at the appropriate facility. Some trash may need to be characterized prior to disposal.
- Since there are no enclosed structures at the Subject Property, no recommendations associated with the identified VEC/REC are offered at this time. However, a vapor mitigation system may be warranted for future structures.

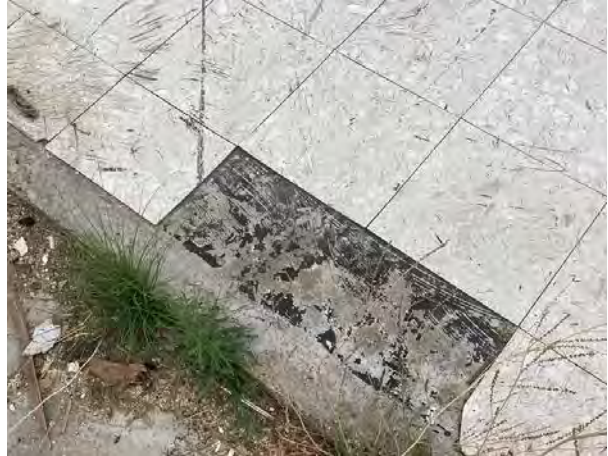
8 : Close up view of floor tile and black mastic on remnant foundation

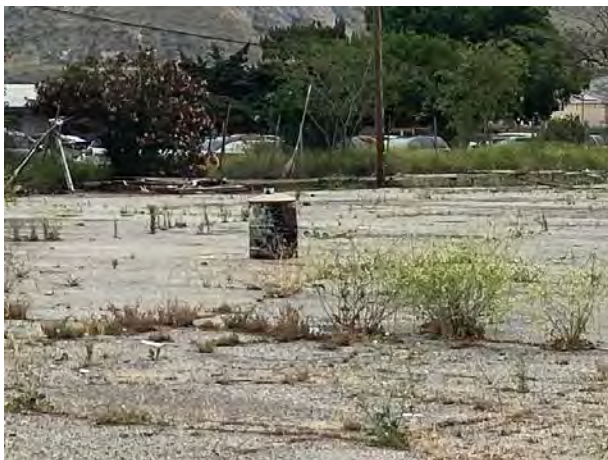
Atlas observed trash / debris along the perimeter and scattered throughout the the Subject Property that included paper, plastic, wood, metal drums (unknown contents), tires, etc.

11 : Subject Property looking northeast, drum of unknown contents

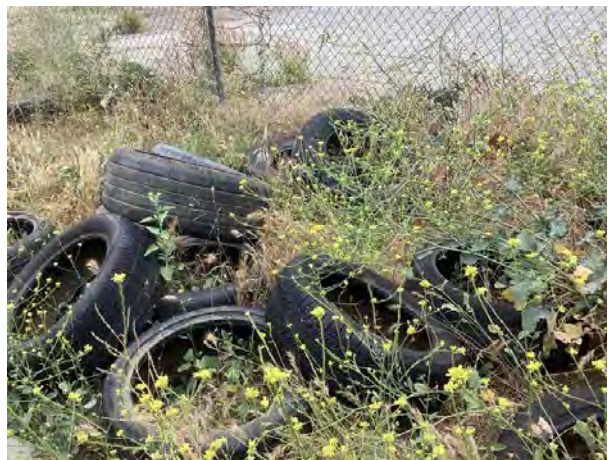
12 : Trash debris observed on Subject Property
