# APPENDIX B2: AQUATIC RESOURCES DELINEATION REPORT

## Lancaster Travel Center Project Draft IS/MND

**SUBJECT: Aquatic Resources Delineation of State and Federal Jurisdictional Waters for the Lancaster Travel Center Project – Lancaster, California**

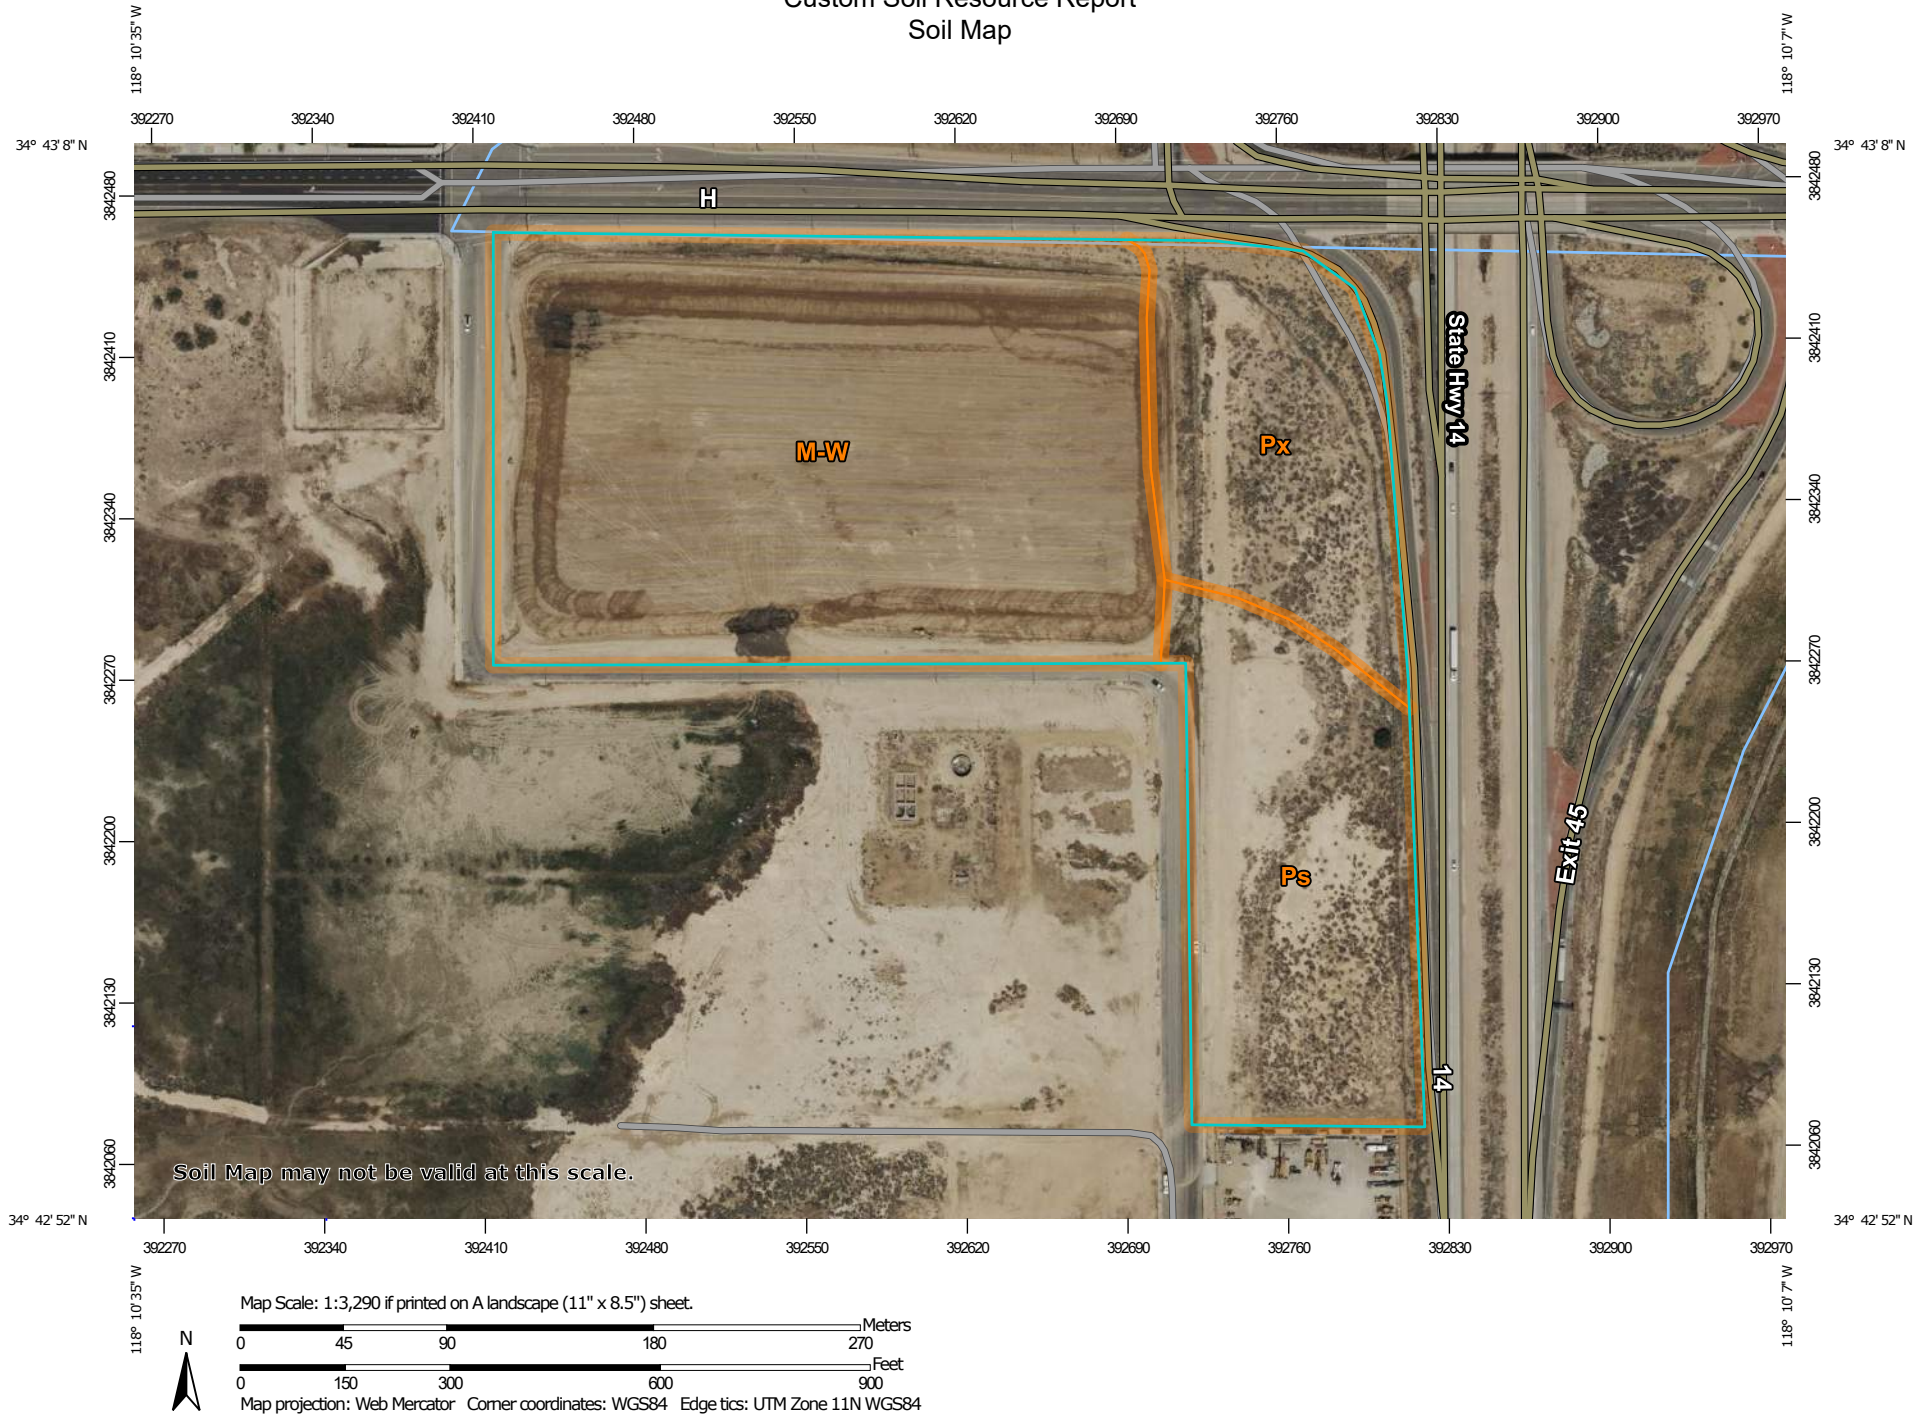
# Custom Soil Resource Report Soil Map

The soil map section includes the soil map for the defined area of interest, a list of soil map units on the map and extent of each map unit, and cartographic symbols displayed on the map. Also presented are various metadata about data used to produce the map, and a description of each soil map unit.

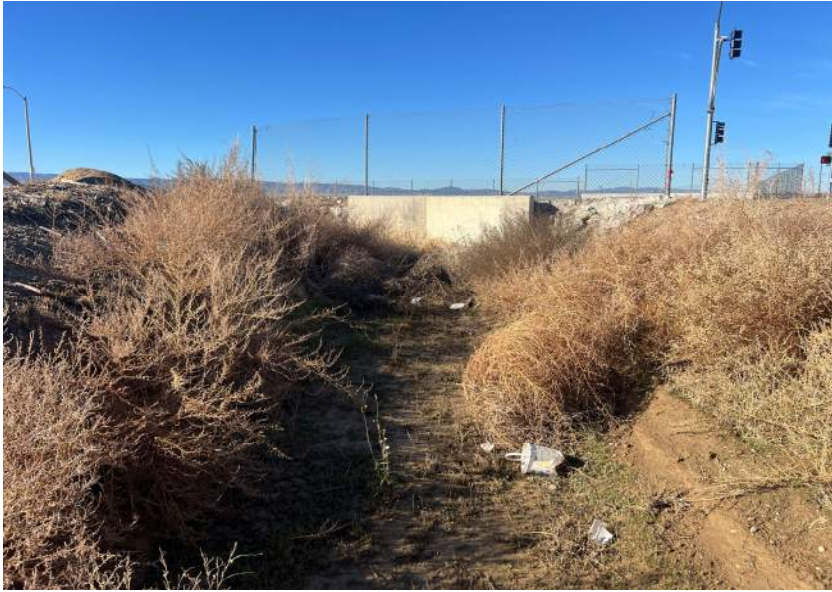
Photo 1: View looking southwest at Aquatic Feature 1 in the northwestern portion of the project site.

AF-1 enters the project site from the south as an engineered earthen channel. AF-1 collects surface flows from the undeveloped land, commercial developments, and 23<sup>rd</sup> Street West located to the south and conveys flows north through the eastern portion of the project site. At the northern boundary of the project site, AF-1 proceeds west through the northern portion of the project site towards a concrete culvert and proceeds off-site underneath 25<sup>th</sup> Street West and into a flood control basin to the west of the project site.

Areas of ponded surface water were present in AF-1 during the November 25, 2025 site visit. Additional hydrology and OHWM indicators observed within the active channel of AF-1 included soil saturation, the presence of litter (organic and non-organic debris), scouring, and the presence of a defined bed and bank. Vegetation within AF-1 primarily consists of Russian thistle (*Salsola tragus*, [FACU]), short-podded mustard (*Hirschfeldia incana*, [NL]) and allscale saltbush (*Atriplex polycarpa*, [FACU]). Within the project site, AF-1 measures approximately 1,131 feet in length.

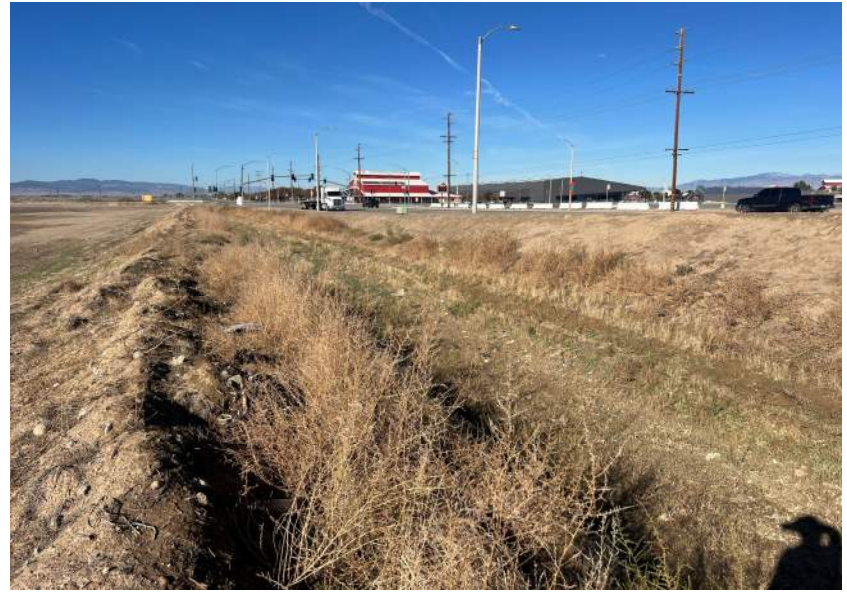
Photo 2: View looking west at Aquatic Feature 1 in the northern portion of the project site.

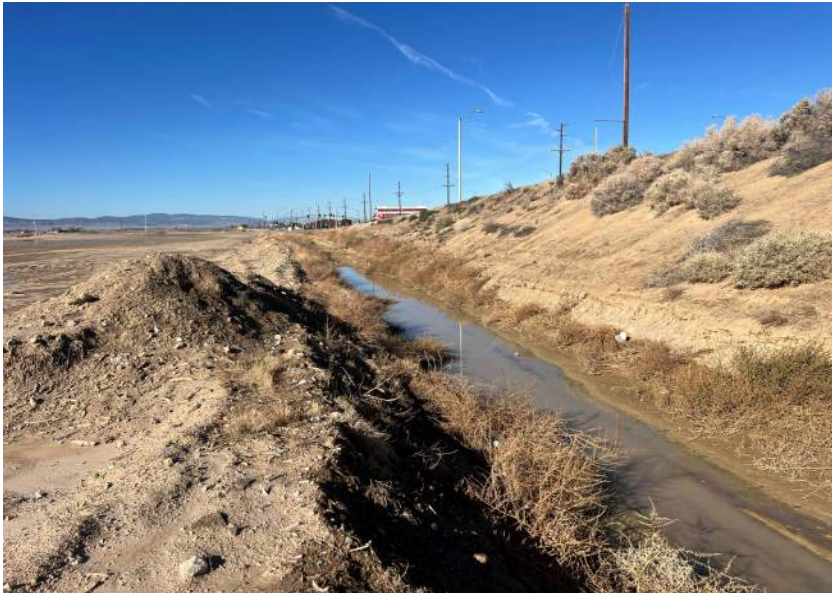
Photo 3: View looking west at Aquatic Feature 1 in the northern portion of the project site.

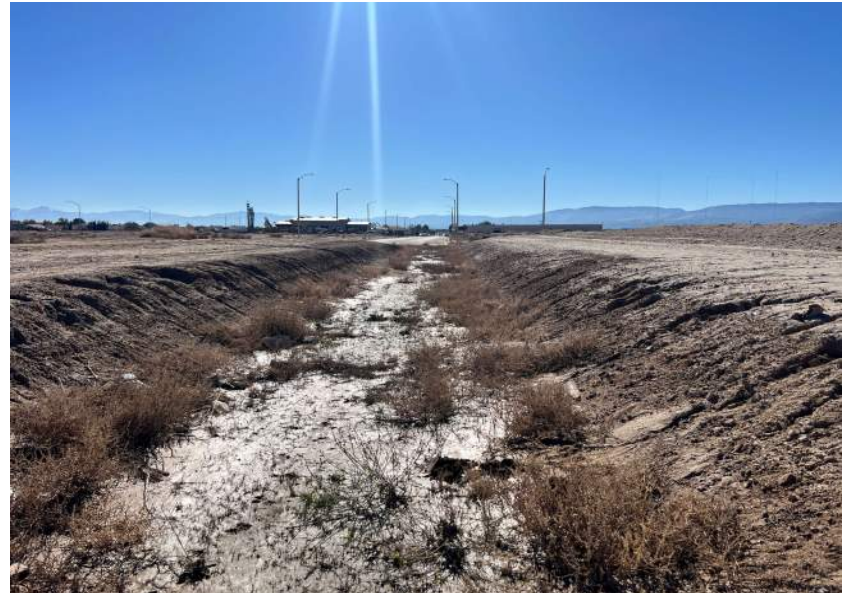
Photo 4: View looking south at Aquatic Feature 1 offsite and adjacent to the project site.

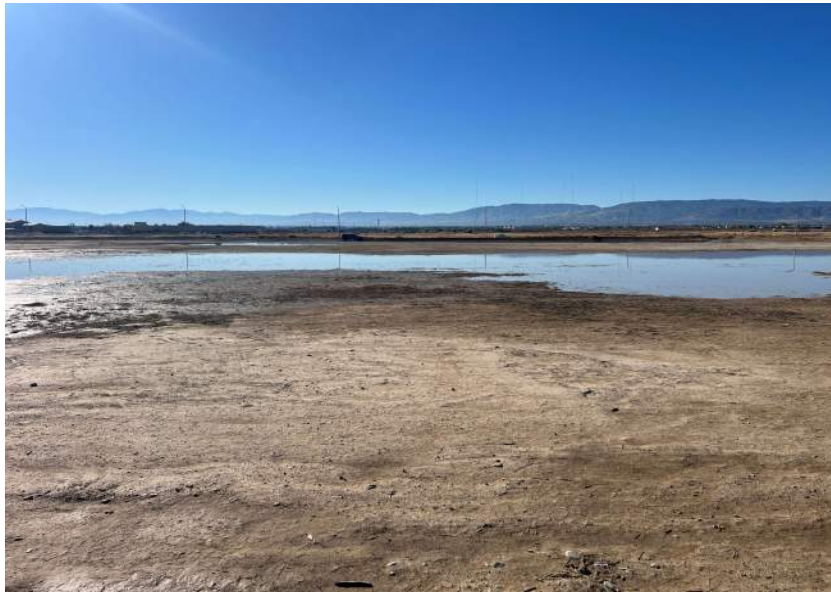
Photo 5: View looking south at precipitation-related pooling on disturbed flatlands in the northwestern portion of the project site.

Surface ponding was identified on the flatland areas within the western portion of the project site during the November 25, 2025 site visit and was attributed to historic rainfall earlier in the month, totaling 3.09 inches of precipitation<sup>2</sup>. The western portion of the site has been subject to extensive routine grading and scraping for use as an overflow parking lot, resulting in heavily disturbed, compacted, and manipulated soils. The site reconnaissance indicated the observed ponding occurred as a direct response to recent heavy precipitation in these disturbed areas rather than a natural hydrologic feature. No emergent or established vegetation was identified within the flatlands used as an overflow parking lot, and the areas of ponding lacked defined bed and banks and were not located contiguous with, and did not convey flow to any other aquatic feature (i.e. AF-1). Based on these characteristics, the observed surface ponding represents temporary precipitation-related pooling and were not considered jurisdictional aquatic features.

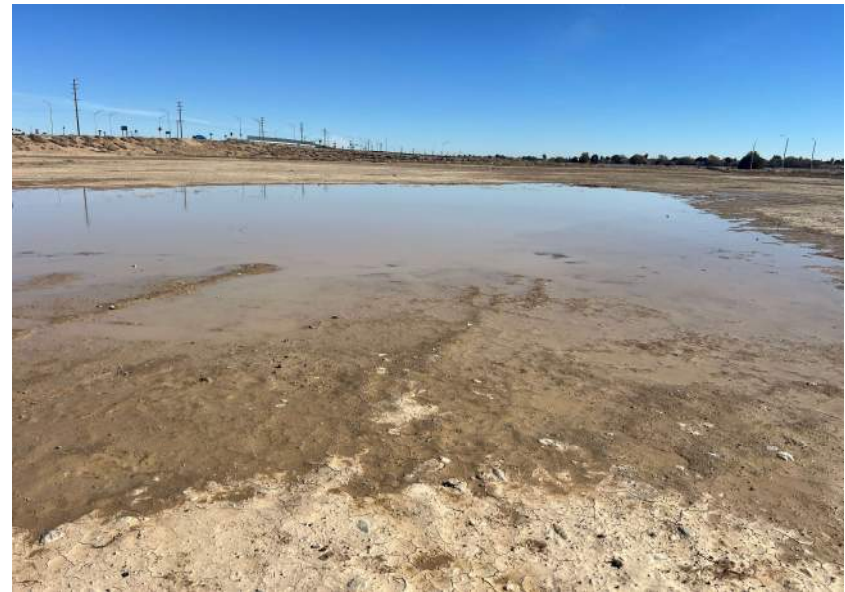
Photo 6: View looking east at precipitation-related pooling on disturbed flatlands in the central portion of the project site.

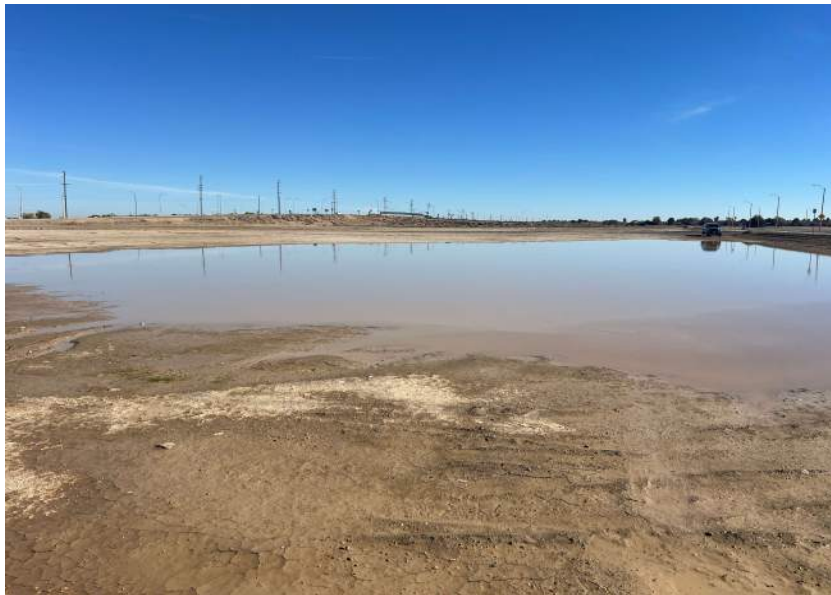
Photo 7: View looking at precipitation-related pooling on disturbed flatlands in the western portion of the project site.

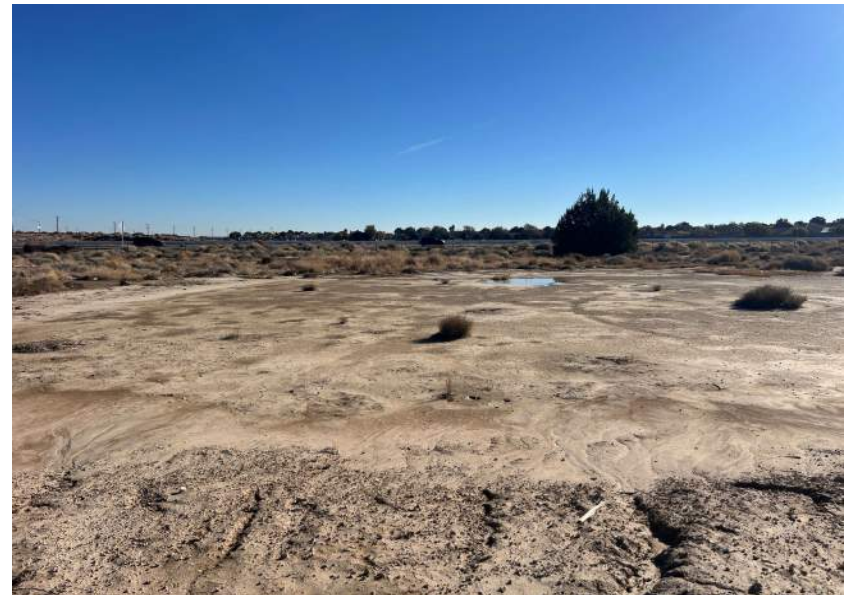
Photo 8: View looking east at an undeveloped area of the eastern portion of the project site adjacent to 23<sup>rd</sup> Street West.

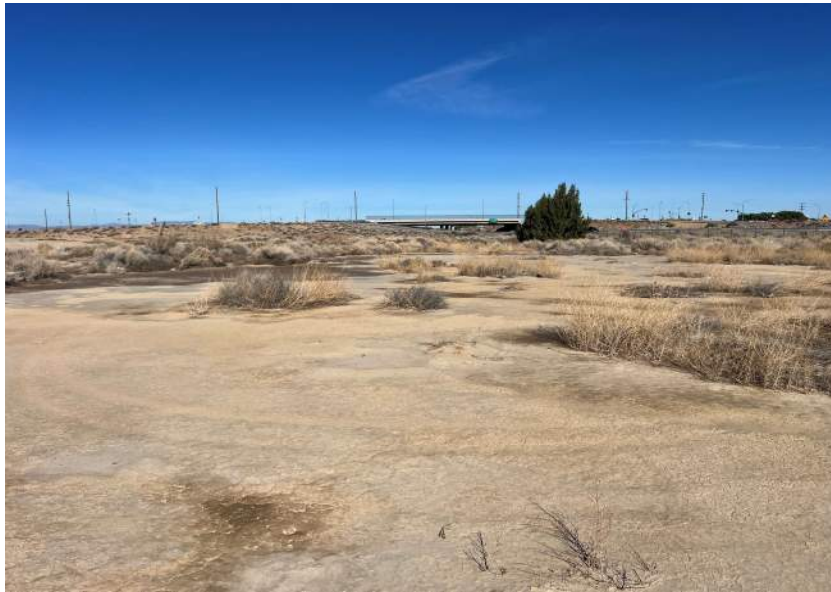
Photo 9: View looking northeast at an undeveloped area of the eastern portion of the project site.

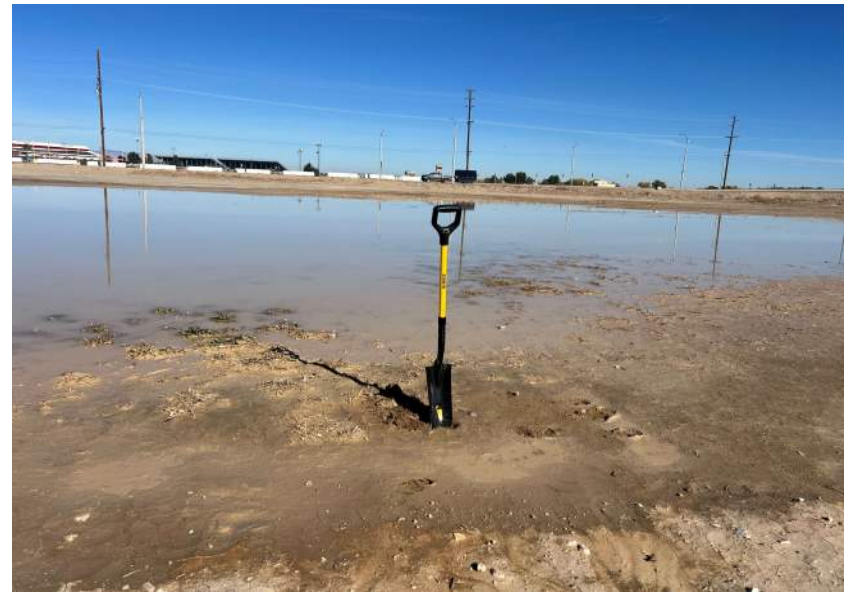
A second soil pit (SP2) was performed at the edge of a shallow unvegetated depression in the western portion of the project site where pooled water and surface soil cracks were identified. SP2 was dug to a depth of approximately 5 inches before encountering a restrictive layer of heavily compacted soil and consisted of a single layer. SP2 exhibited a texture of silty clay and displayed a matrix color of 10YR 5/3 when moist. No redoximorphic features were observed within the profile of SP2 and no vegetation was identified surrounding SP2. Based on the results of the field delineation, it was determined that SP2 only met one (hydrology) of the required three parameters and thus did not qualify as a wetland.

Photo 10: View looking north at Soil Pit 2 adjacent to pooling on compacted soils in the northwestern portion of the project site.

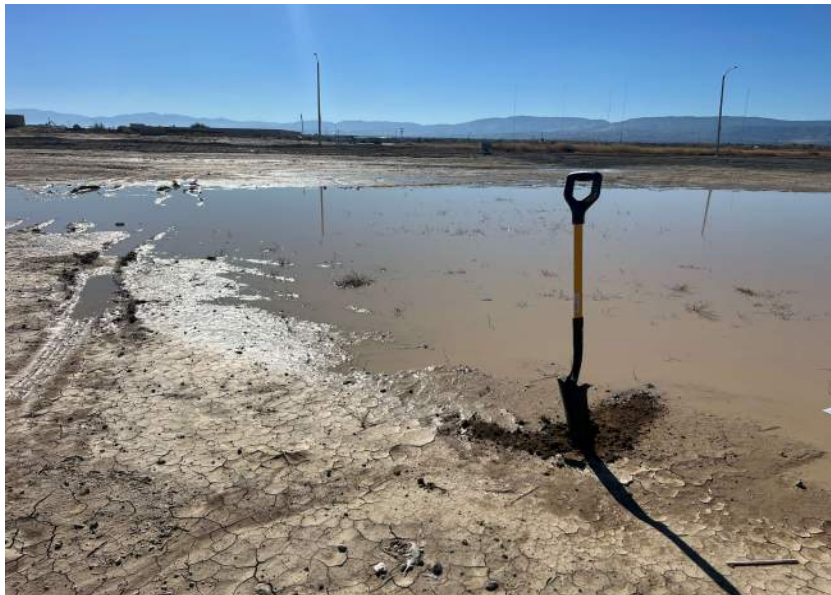
A third soil pit (SP3) was performed at the edge of a shallow unvegetated depression in the central portion of the project site where pooled water and surface soil cracks were identified. SP3 consisted of a single layer and was dug to a depth of approximately 6 inches prior to encountering a restrictive layer of heavily compacted soil and consisted of a single layer. SP3 exhibited a silty clay texture and displayed a matrix color of 10 YR 4/3 when moist. Redoximorphic features were not observed within the soil profile of SP3, and no vegetation was identified surrounding SP3. Based on the results of the field delineation, it was determined that SP3 only met one (hydrology) of the required wetland parameters and thus did not qualify as a wetland.

Photo 11: View looking south at Soil Pit 3 adjacent to pooling on compacted soils in the central portion of the project site.

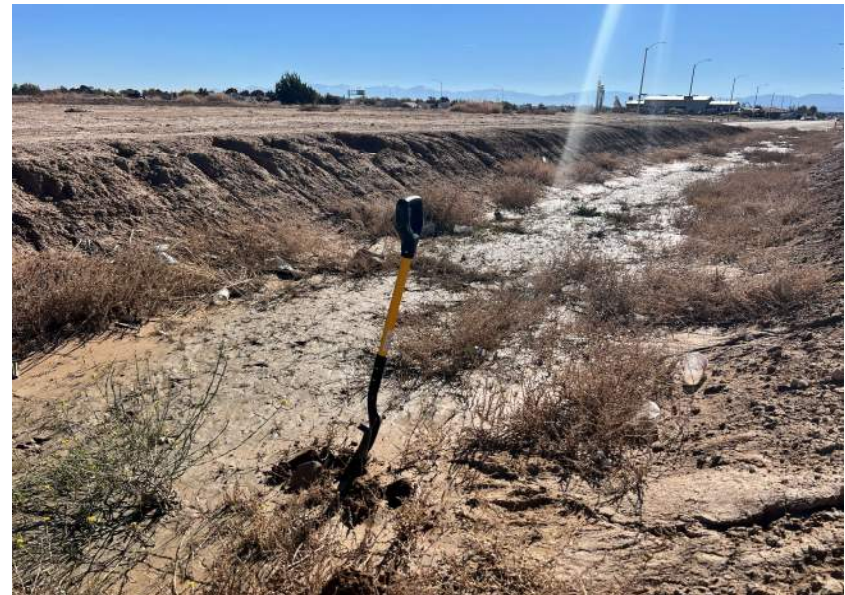
Soil Pit 4 (SP4) was performed within the active channel of AF-1 where surface soil cracking and soil saturation were identified. SP4 was dug to a depth of approximately 6 inches and consisted of a single layer. SP4 exhibited a silty clay loam texture and displayed a matrix color of 10YR 4/3 when moist. Redoximorphic features were not observed within the soil profile of SP4. Vegetation surrounding SP4 consisted of short-podded mustard (NL). Based on the results of the field delineation, it was determined that SP4 only met one (hydrology) of the required three parameters and thus did not qualify as a wetland.

Photo 12: View looking south at Soil Pit 4 in Aquatic Feature 1.

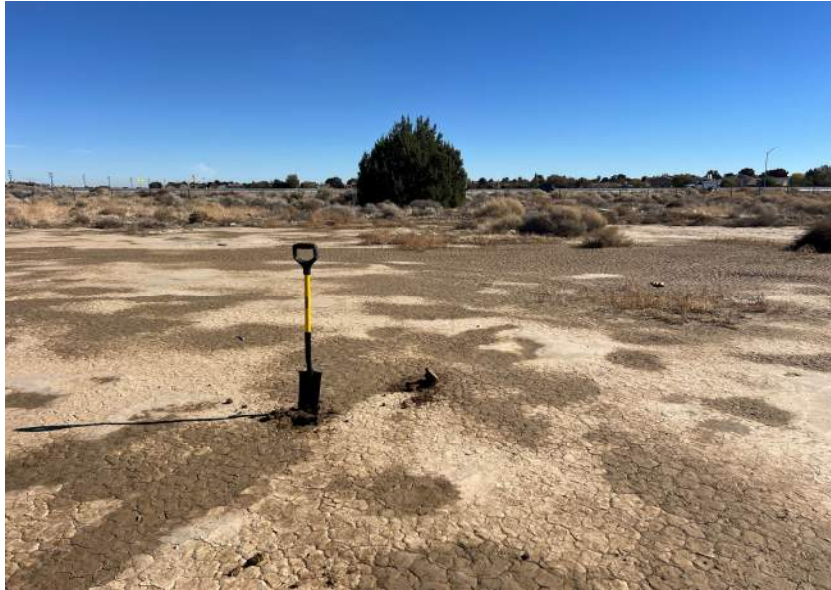
Soil Pit 5 (SP5) was performed in the eastern portion of the Project site where surface soil cracks were identified. SP5 was dug to a depth of approximately 6 inches and consisted of a single layer. SP5 exhibited a silty clay texture and displayed a matrix color of 10 YR 5/3 when moist. Redoximorphic features were not observed within the soil profile of SP5, and no vegetation was identified surrounding SP5. Based on the results of the field delineation, it was determined that SP5 only met one (hydrology) of the required three parameters and thus did not qualify as a wetland.

Photo 13: View looking east at Soil Pit 5 in the eastern portion of the project site.

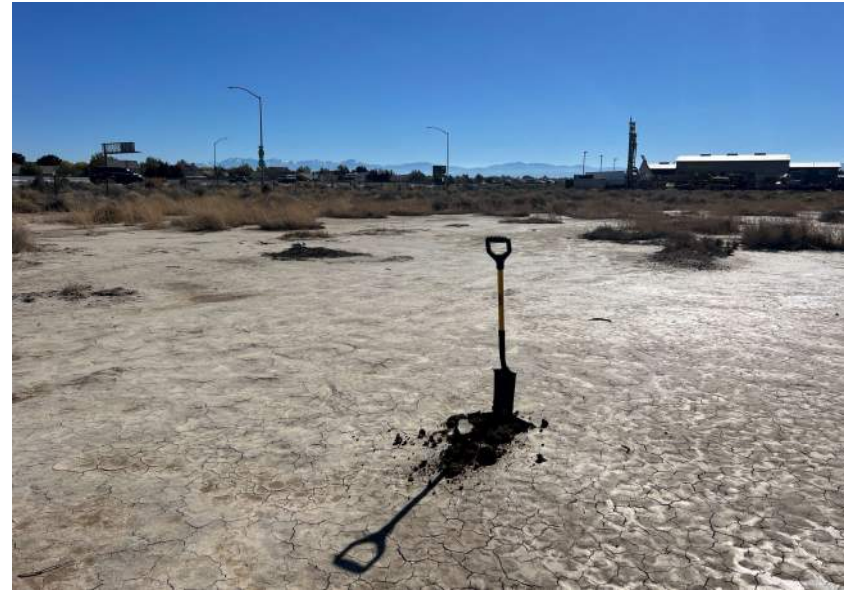
A sixth soil pit (SP6) was performed in the southeastern portion of the Project site where surface soil cracks were identified. SP6 was dug to a depth of 6 inches and consisted of a single layer. SP6 exhibited a silty clay texture and displayed a matrix color of 10 YR 5/3 when moist. Redoximorphic features were not observed within the soil profile of SP6, and no vegetation was identified surrounding SP6. Based on the results of the field delineation, it was determined that SP6 only met one (hydrology) of the required three parameters and thus did not qualify as a wetland.

Photo 14: View looking southeast at Soil Pit 6 in the eastern portion of the project site.
