## **PHASE II ENVIRONMENTAL SITE ASSESSMENT REPORT**

**528 EAST MISSION ROAD  
SAN MARCOS, CA 92069  
(San Diego County Assessor's Parcel Number [APN] 220-210-26)**

PIC Project No. ES9679

October 22, 2019

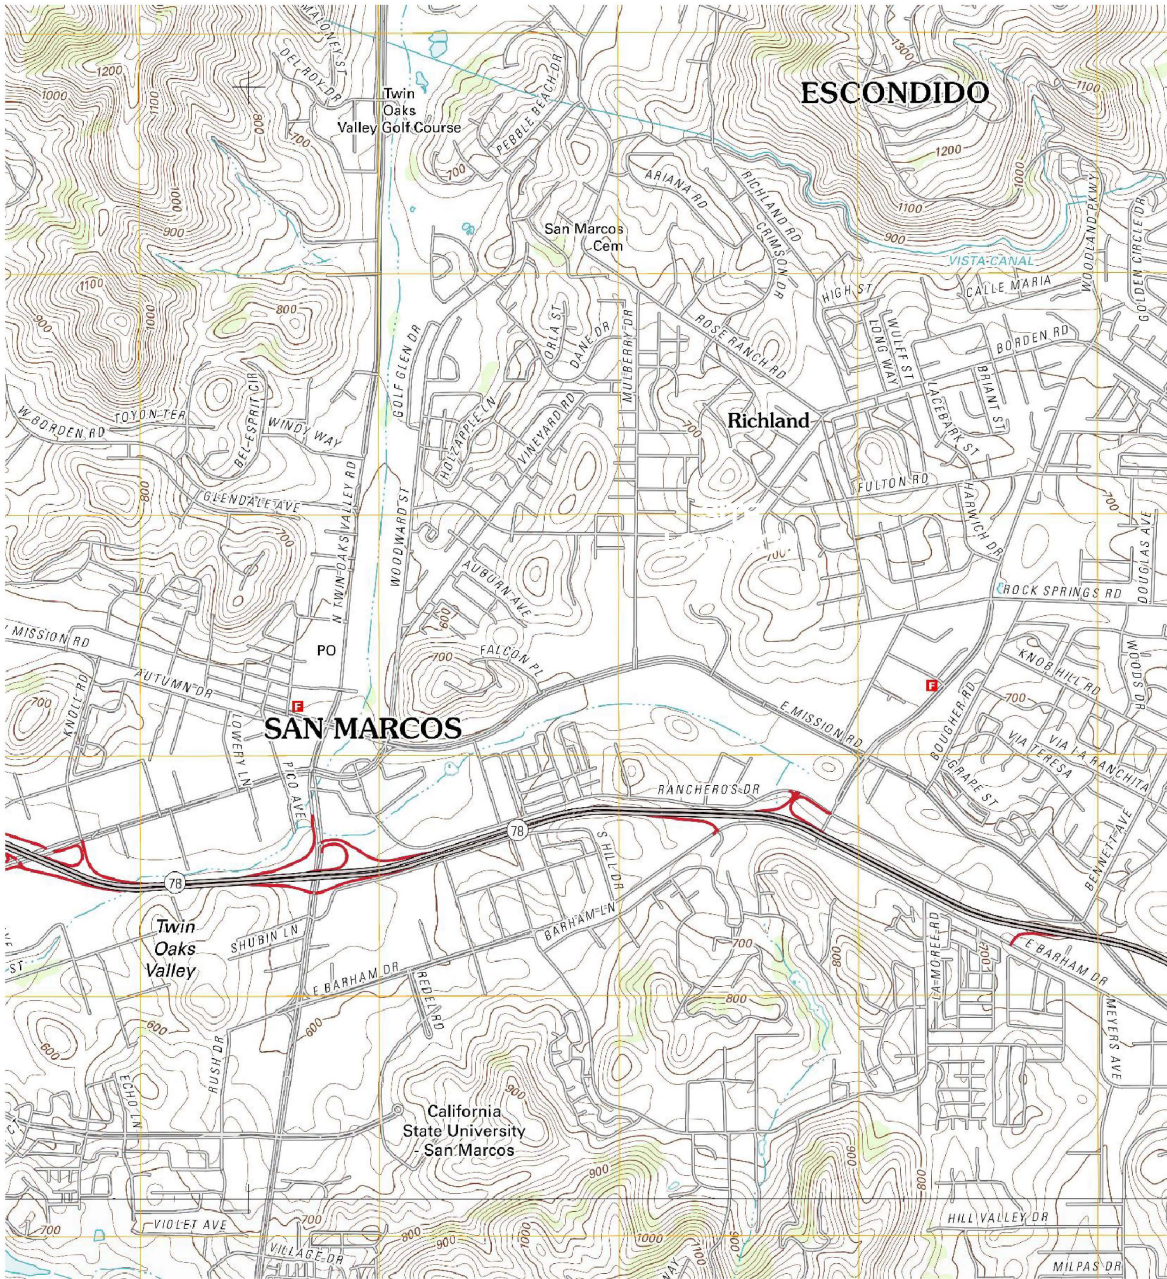
**Figure 2**

The elevation at the subject site ranges between approximately 600 and 650 feet above mean sea level. Grade on the site slopes generally to the south-southeast, toward San Marcos Creek (Figure 2).

No municipal groundwater production wells were depicted within ½-mile of the subject property on the USGS topographic quadrangle (Figure 2).

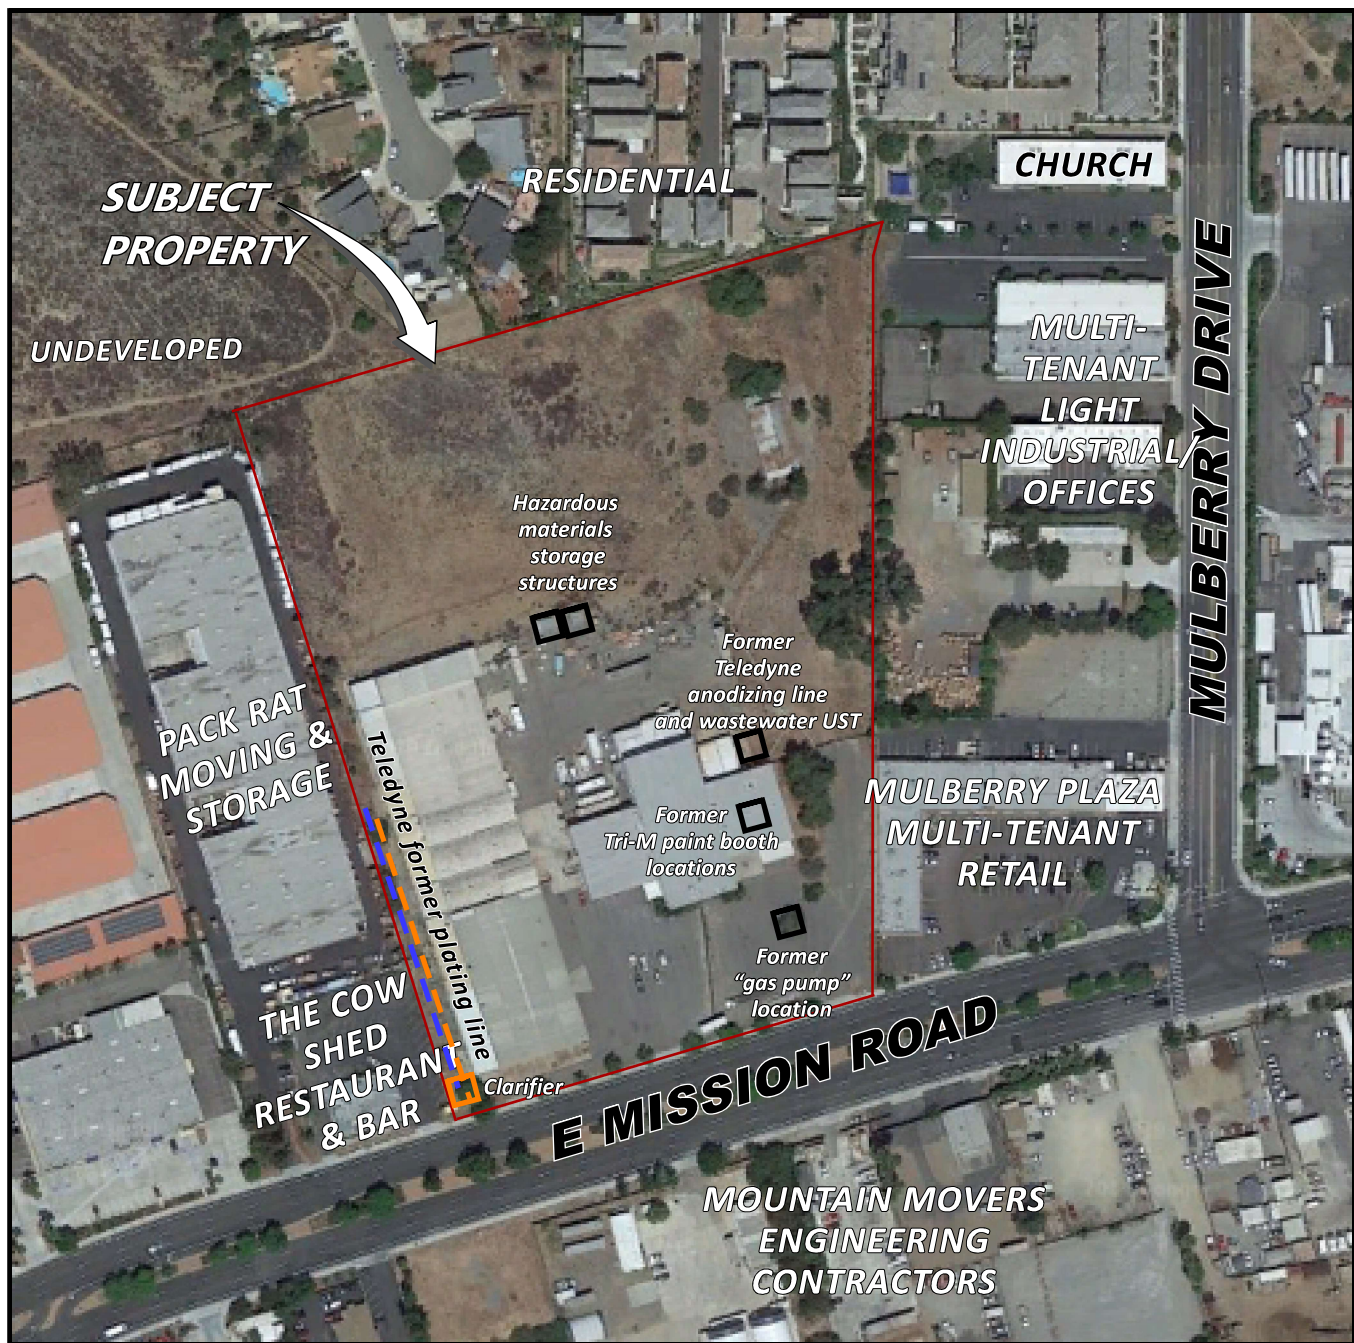
| | | <b>Figure 3</b> | |

Land use in the site vicinity is a mixture of mostly residential, light industrial, and retail (Figure 3). The subject property is bounded to the northwest by single family residential properties and undeveloped land, to the east by light industrial and multi-tenant retail properties, to the southeast by East Mission Road and light industrial properties beyond, and to the southwest by a moving and storage business property (Pack Rat) and a restaurant/bar (The Cow Shed). A visual reconnaissance survey of adjacent and nearby properties revealed no evidence of surface hazardous substances contamination threatening the subject property or other RECs.

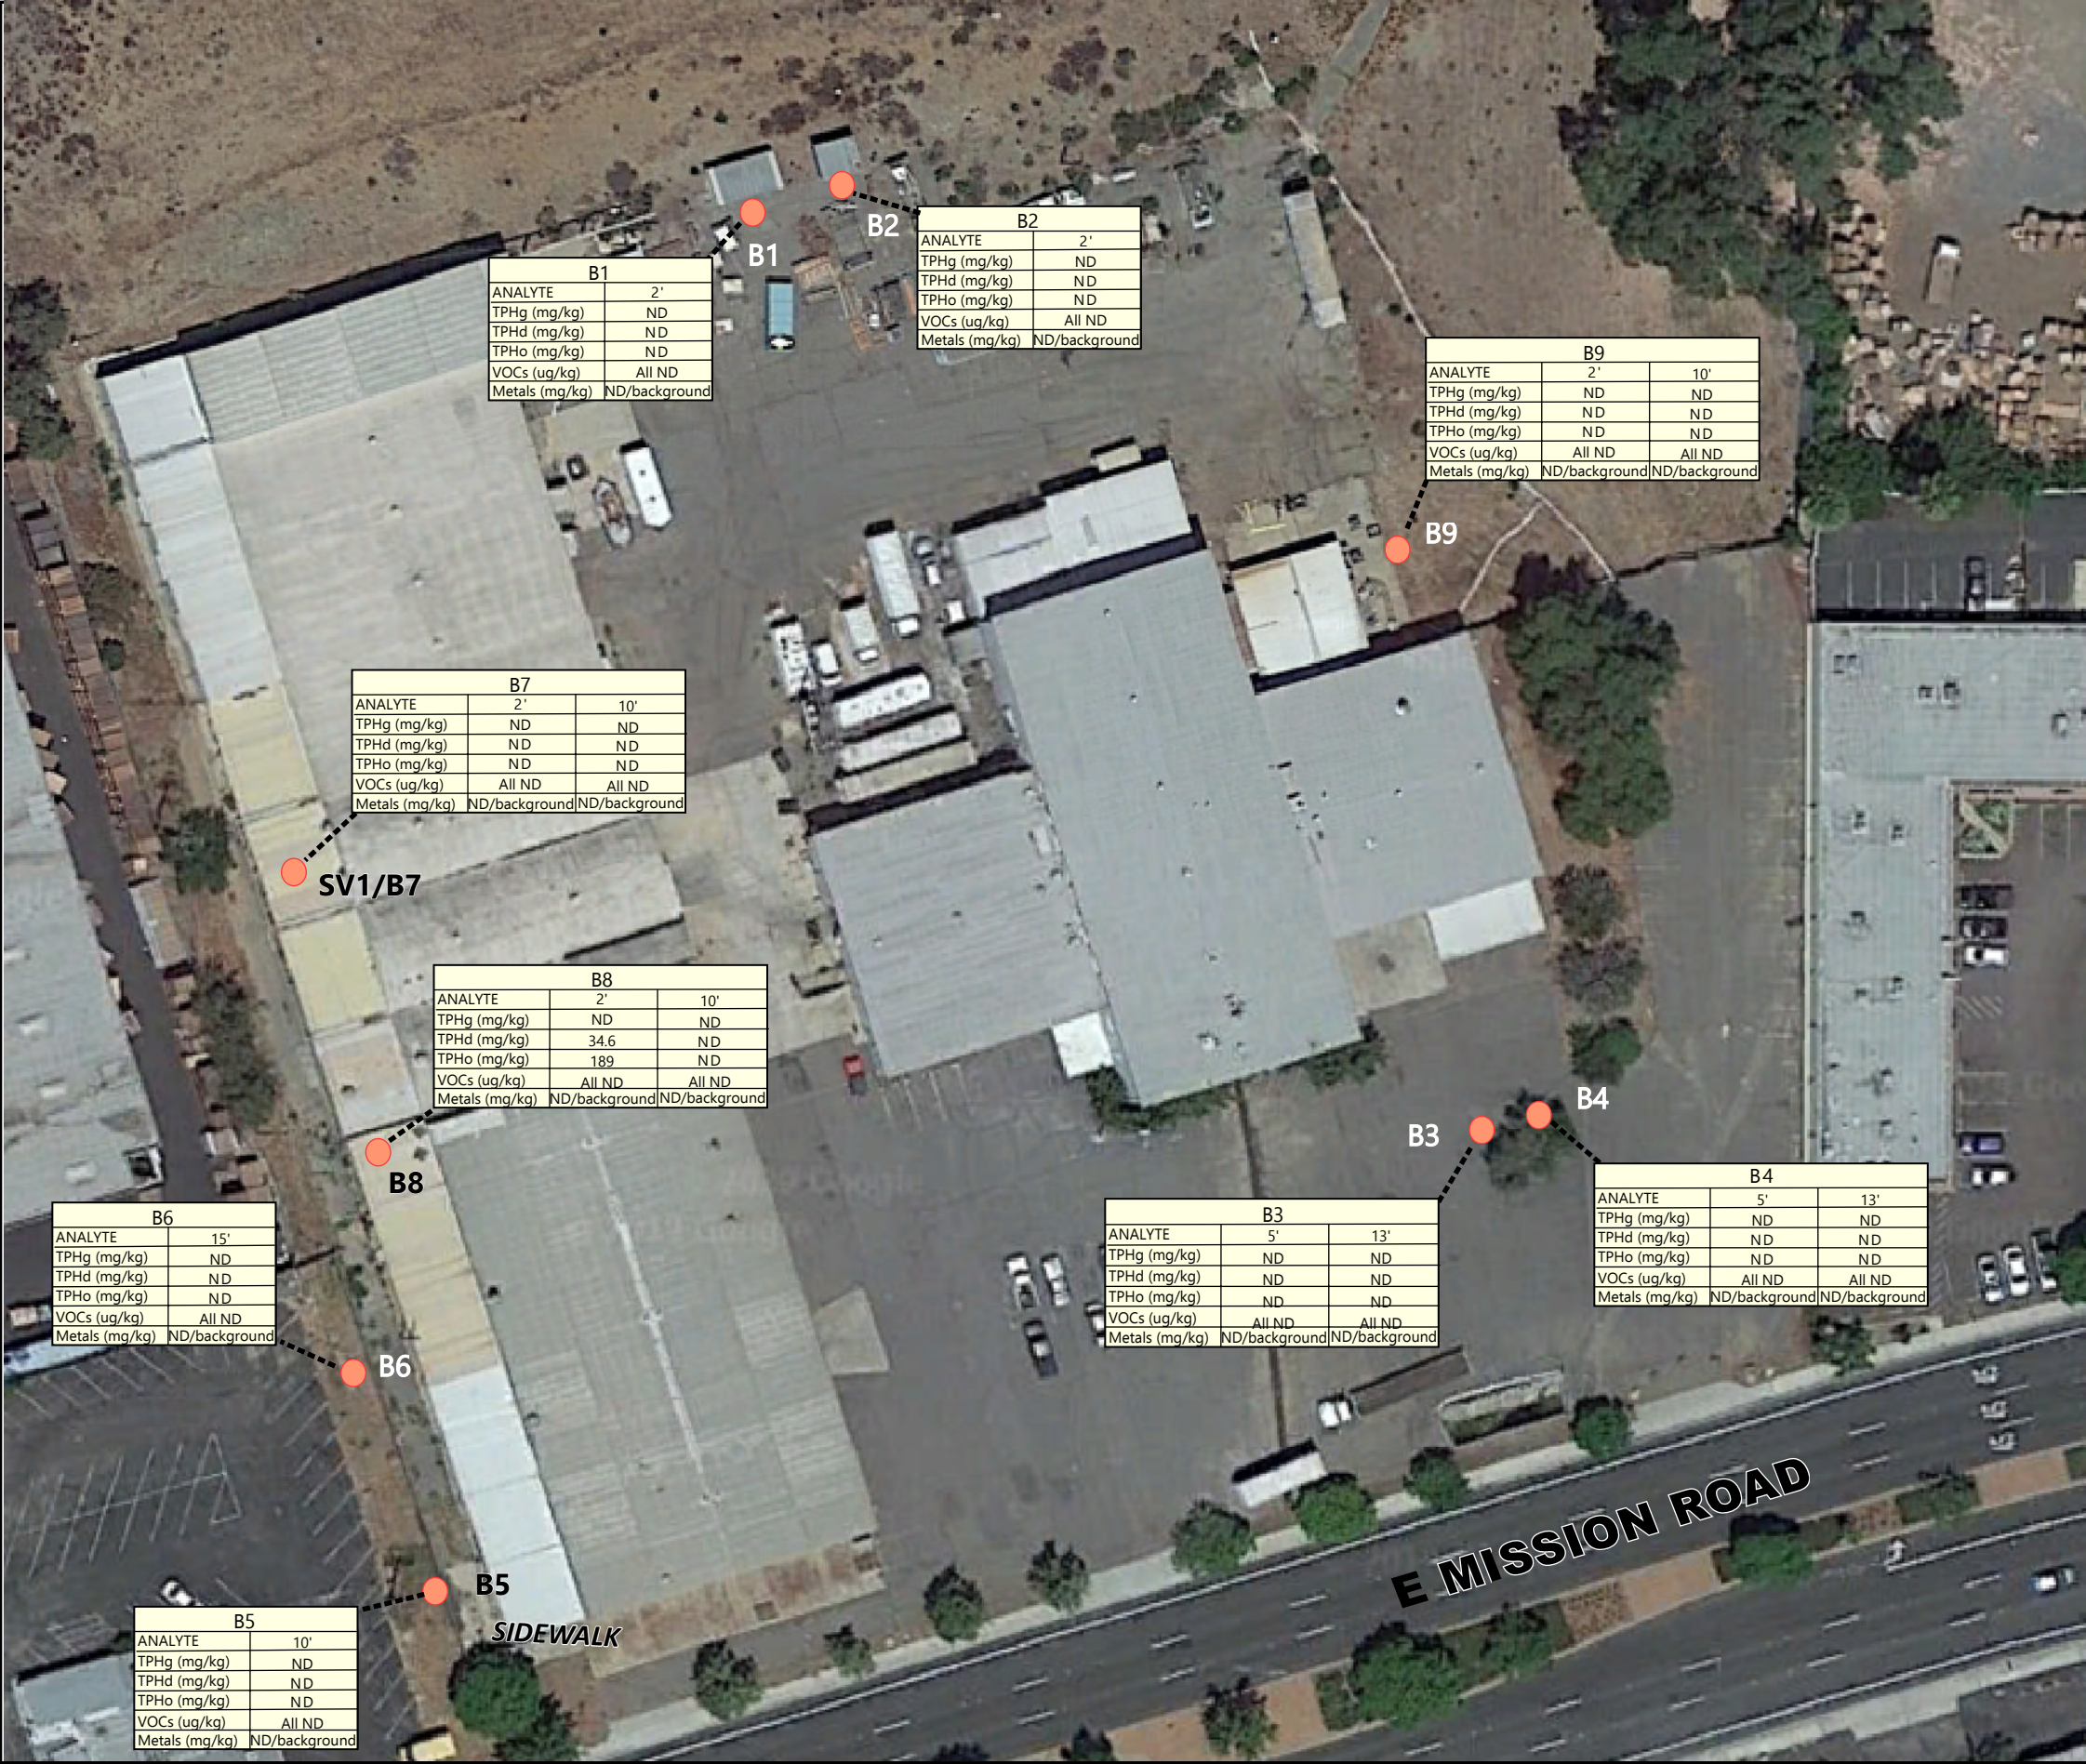
| <b>SITE PLAN SHOWING BORING LOCATIONS</b> | | |

Soil samples were collected at nine (9) locations (B1 to B9) between September 16 and 25, 2019 using GeoProbe® direct-push sampling equipment (Figure 4). Soil samples were collected in plastic sleeves that were sealed, labeled, and placed in an ice-chilled cooler. All soil sampling equipment was washed in a solution of detergent and water and rinsed with tap water between sample intervals to prevent cross-contamination. The lithology of subsurface soils was described in the field according to the Unified Soil Classification System on drilling log forms (Appendix B). Upon completion of soil sampling operations, the probe holes were backfilled with hydrated bentonite and capped with concrete.

Laboratory analytical results of soil samples are depicted on Figure 4. The laboratory report and chain-of-custody records are provided in Appendix C. Analytical test results for soil samples are summarized as follows:

1. The soil samples collected at two (2) feet bgs in B1 and B2 near the two (2) hazardous materials storage structures in the central portion of the site were analyzed for concentrations of TPH, VOCs, and Title 22 metals. TPH and VOCs were non-detectable at standard minimum detection limits. The detected concentrations of metals were consistent with naturally-occurring background levels. Based on these test results, it appeared unlikely that there have been any significant spills, leaks, or other releases of regulated and/or hazardous materials to the soil or bedrock beneath or near the above-referenced hazardous materials storage structures. No further action appears warranted with respect to the two (2) hazardous materials storage structures in the central portion of the site.

2. The soil samples collected at 5 feet and 13 feet bgs in B3 and B4 within an apparent asphalt patch near a “gas pump” location on a 1980 site plan were analyzed for concentrations of TPH, BTEX, and oxygenates. TPH, BTEX, and oxygenates were non-detectable at standard minimum detection limits. This location was probably where a 1,000-gallon diesel fuel UST was removed in 1985. The tank was removed and the permit was closed with no further action required by the County of San Diego, Department of Environmental Health (DEH). There was no evidence of any spills, leaks, or other releases of diesel fuel or other petroleum fuel products at the location of B3 and B4. No further action appears warranted with respect to this apparent former UST/dispenser pump location in the southeastern portion of the site.

operations by Teledyne prior to the mid 1990s. There were also several sewer and stormwater drains and a 3-stage clarifier observed in this area. There were detections of TPHd and TPHo in soil sample B8-2' at 34.6 mg/kg and 189 mg/kg, respectively. There were no other detections of TPH or VOCs. The detected concentrations of metals were consistent with naturally-occurring background levels. The TPH detections in sample B8-2' appeared negligible because there were no VOCs detected in B8-2' and there were no TPH or VOCs detected in a deeper soil sample collected at this location, B8-10'.

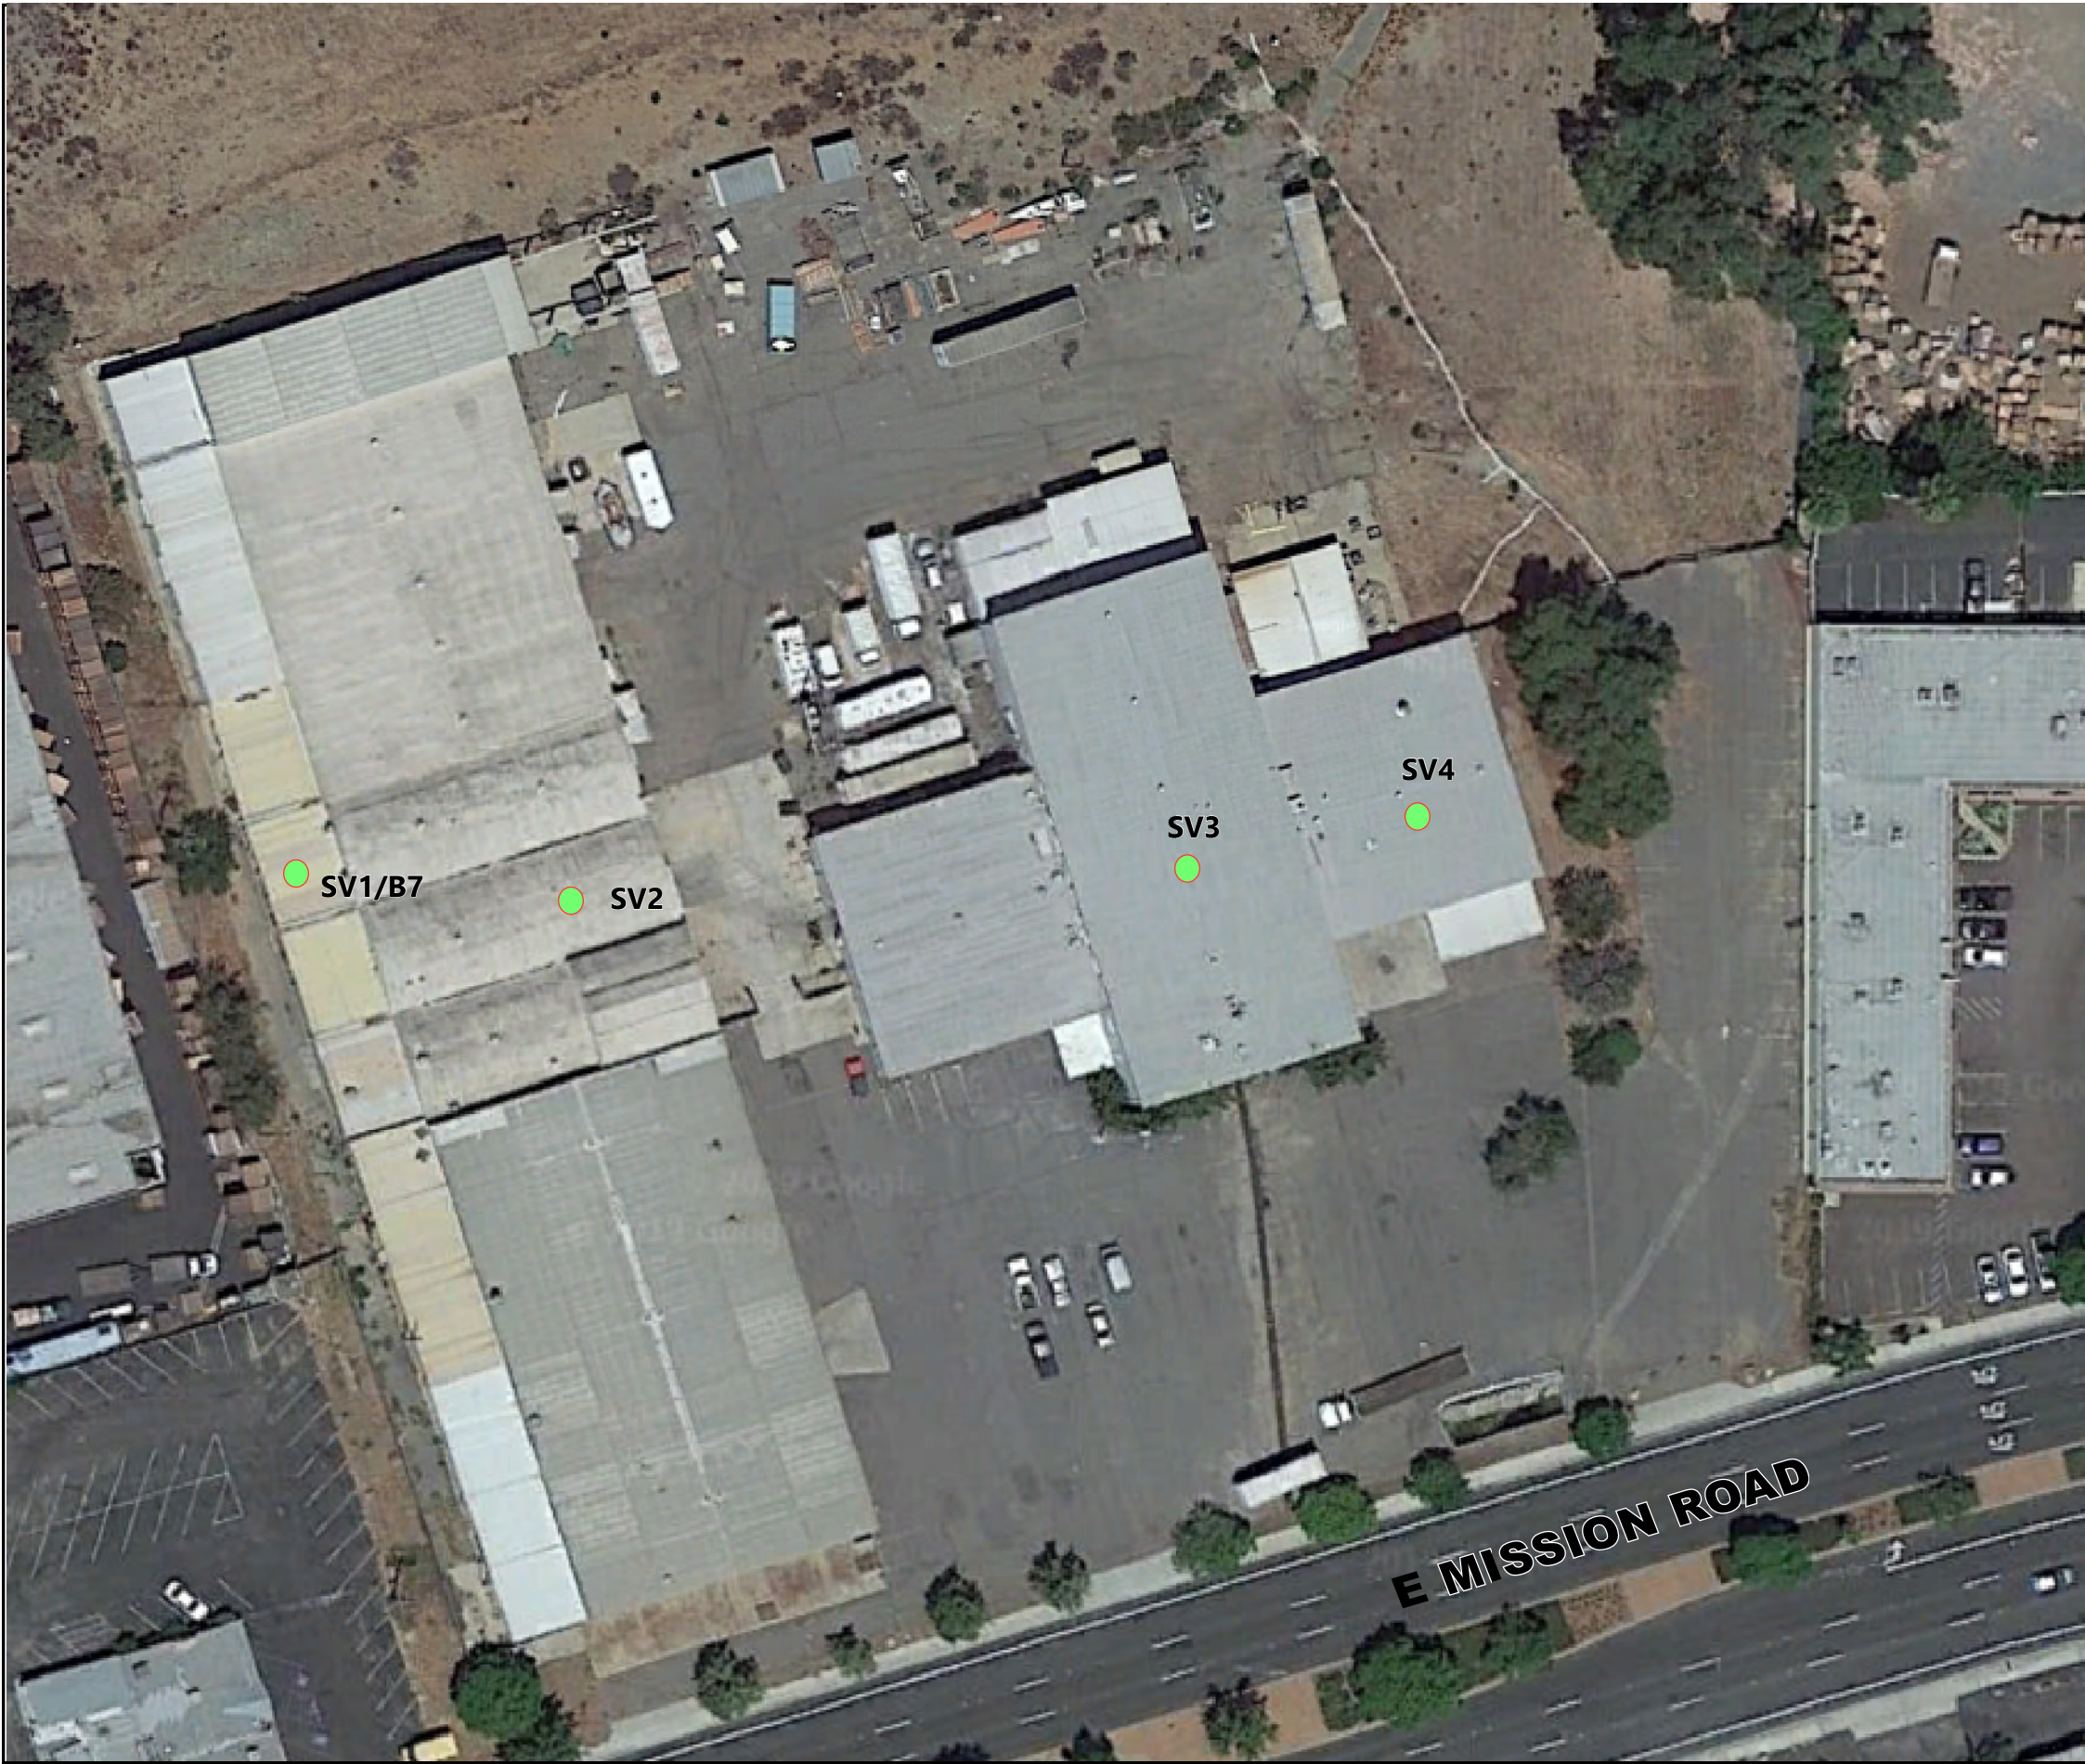
| SUMMARY OF SOIL VAPOR SAMPLE DETECTIONS | | | | | |

On September 20, 2019, PIC and its subcontractor (H&P Mobile Geochemistry, Inc.) collected five (5) sub-slab vapor samples at four (4) locations from vapor pins that were set at locations SV1, SV2, SV3, and SV4 (SV4 duplicate sample) on September 16, 2019. The vapor samples were collected in order to screen the site for a potential vapor encroachment condition.

Laboratory analytical results of soil vapor samples are depicted on Figure 5. The laboratory report and chain-of-custody records are provided in Appendix C. Concentrations of VOCs and oxygenates in the five (5) soil vapor samples were non-detectable, with the exception of the following:

In light of the continued commercial/industrial use of the subject property, the soil vapor detections of VOCs appeared negligible. The detected VOCs were reported at concentrations that were less than conservative commercial/industrial screening criteria, such as the recent environmental screening levels (ESLs) that were issued on-line by the San Francisco Bay Regional Water Quality Control Board (SFBRWQCB), with the exception of the tetrachloroethene (PCE) concentration detected in vapor sample SV1. The reported PCE concentration in SV1 was 460 ug/m<sup>3</sup> and exceeded the SFBRWQCB commercial/industrial cancer risk environmental screening level, 67 ug/m<sup>3</sup>. However, the location of SV1 is on the exterior of the western building in the area of a reported

Vapor samples SV2, SV3, and SV4 were collected beneath the interior spaces of the western and main t-shaped buildings on the subject property. None of the detected VOCs in these samples exceeded the applicable SFBRWQCB commercial/industrial cancer risk values.

There was no evidence of any significant releases of hazardous materials or regulated substances on the subject property based on the results of the above-referenced ESA activities. There appeared to be elevated concentrations of vapor-phase chlorinated VOCs, primarily PCE, beneath the concrete slab on the exterior west side of the western building in an area that was reportedly used by Teledyne for metal plating sometime prior to the mid-1990s. However, test results for soil samples collected throughout this area of the site were consistently non-detectable for VOCs.
