STABILITY EVALUATION OF THE WEST PIT, BOCA QUARRY HIRSCHDALE, CALIFORNIA

Submitted To: Teichert Aggregates
3500 American River Drive
Sacramento, California 95851

Submitted By: Golder Associates Inc.
1000 Enterprise Way, Suite 190
Roseville, California 95678

August 2010

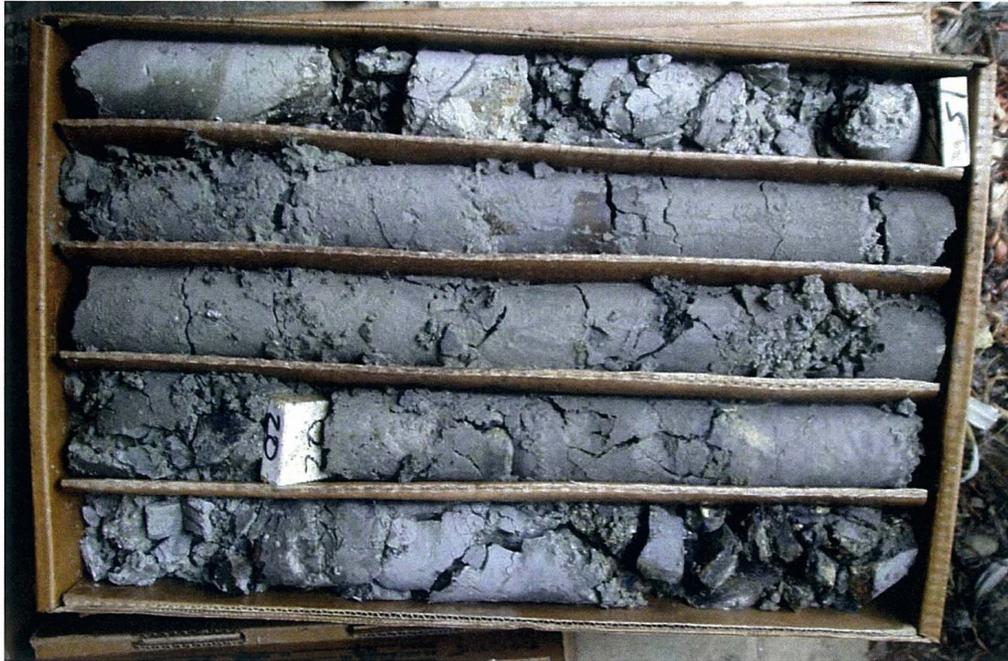
PHOTOGRAPH 1. Weak, highly fractured Upper Tuff in DOB05DH-08

silt grading to ash. The ash is underlain by a more consolidated, fractured tuff that has the texture of shale, appears to be partially devitrified, and is easily picked apart (Photograph 1).

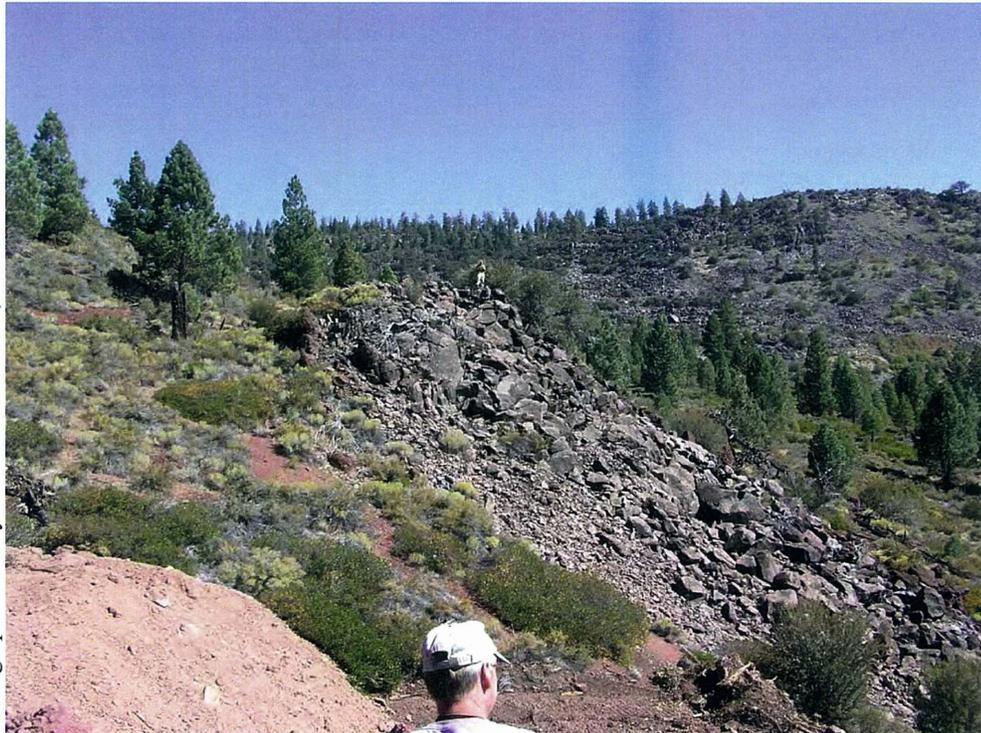
PHOTOGRAPH 2. Basalt (agglomerate?) along property line north of East Pit
