Appendix F. Phase I Environmental Site Assessment Technical Memorandum

MEMORANDUM

To: Jordan Moore, Senior Planner, City of San Diego
From: Kelsey Hawkins, Project Manager, Harris & Associates
RE: Revised De Anza Cove Amendment to the Mission Bay Park Master Plan – Phase I Environmental Site Assessment
Date: March 6, 2023
Att: Figures; 1, 2018 Phase I Environmental Site Assessment

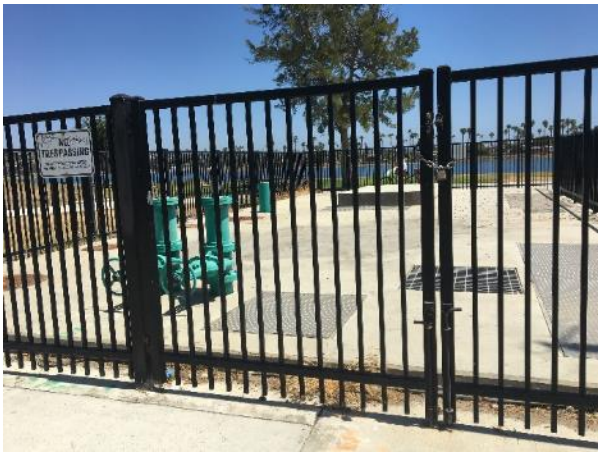
There are known sewer and water pipelines throughout the subject property (Figure 2). A large sewer and utilities vault is located in the southwest corner of De Anza Cove Park (Photograph 9).

Photograph 9 – Utilities and sewer vault on the southwest corner of De Anza Cove Park.

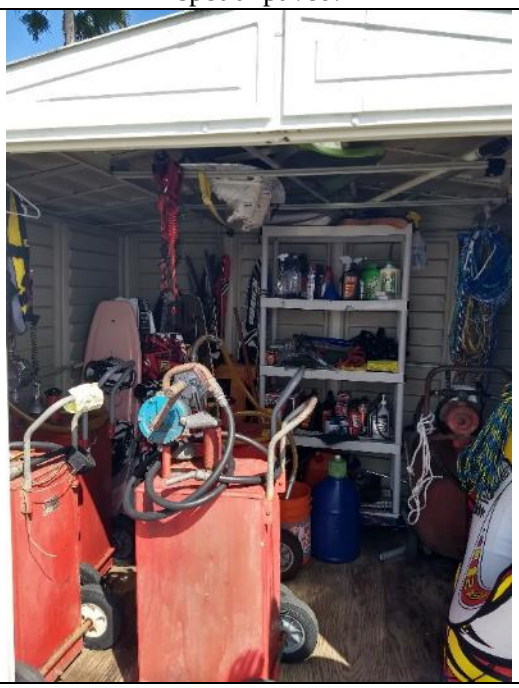
The small shed was located on the dock next to the marina building; it contained several approximately 30-gallon wheeled portable containers of gasoline (Photographs 62 and 63). No large storage tanks for gasoline are located on site. One more of the portable gasoline containers was located in the bike rental facility (Photograph 64) connected to the marina building.

Photograph 63 – Utility shed houses tools and supplies as well as wheeled portable gas containers.

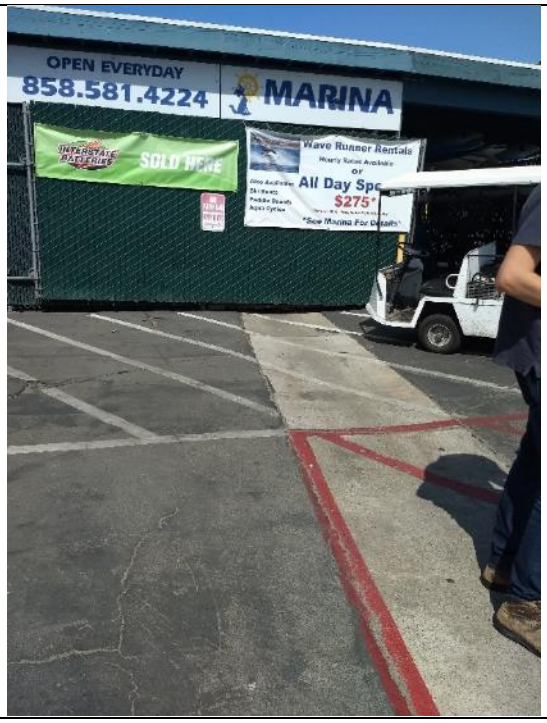
Photograph 65 – Storm gutter runs under the boat and bike rental.

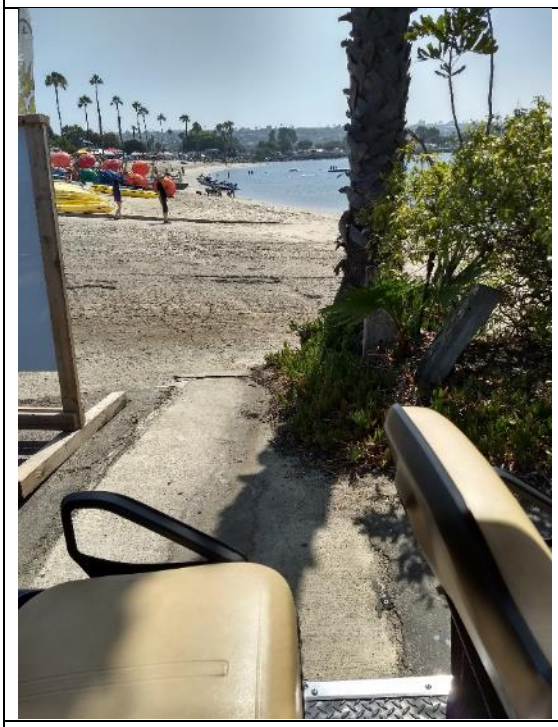
Photograph 66 – Storm gutter outlets to the boat ramp to the bay.

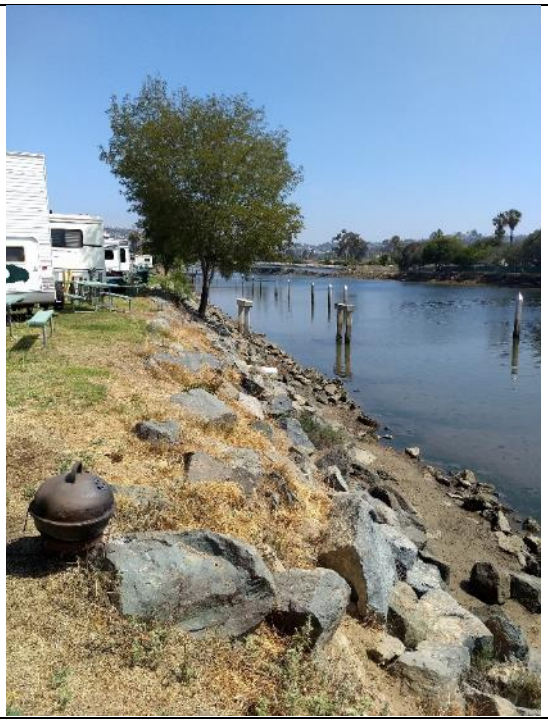
Photograph 68 – View north along Rose Creek from Campland. A storm drain from the road outlets into Rose Creek as seen in the center.

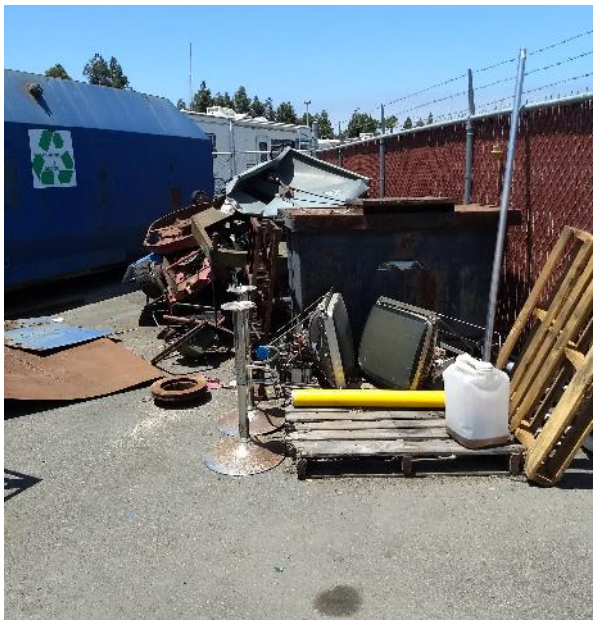
Photograph 93 – Debris storage with cooking oil waste at Campland.
