PHASE I - ENVIRONMENTAL SITE ASSESSMENT

1214 - 1220 DONNELLY, BURLINGAME, CA

PROTECH PROJECT #601-OH16

7 SEPTEMBER 2016

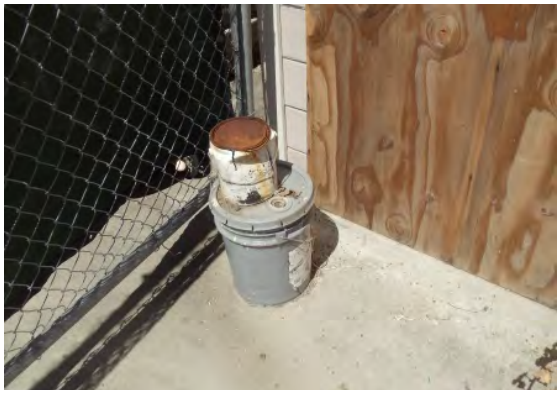
Figure 8-1214 Donnelly Paint Containers

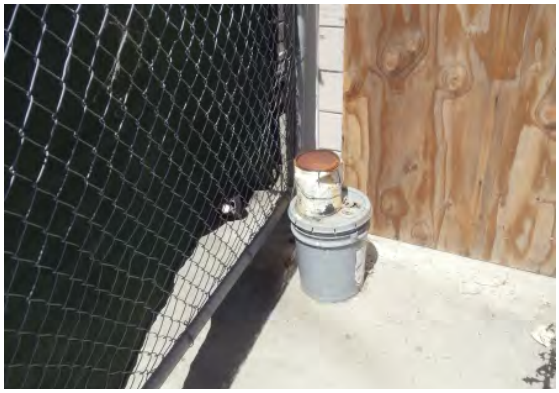
Figure 16-1214 Donnelly Paint containers

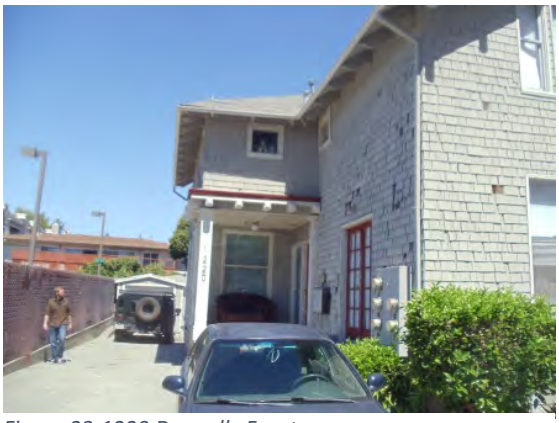
Figure 23-1220 Donnelly Front

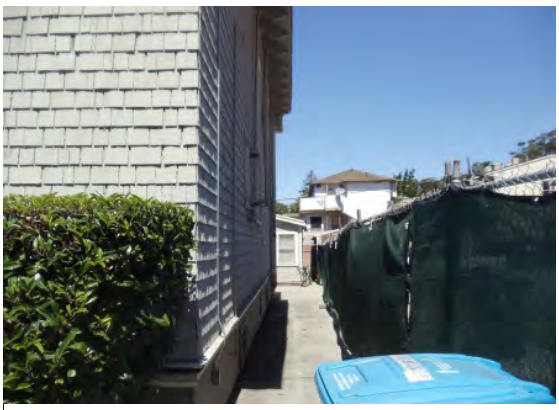
Figure 24-1220 Donnelly Northeast side
